# Inspection Report

## Mrs. Sample Report

123 Sample Street  
Bonita Springs FL 34134

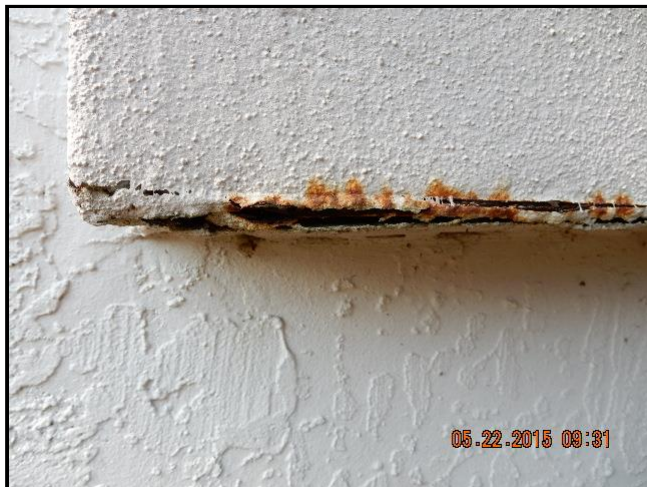
1.0 Item 1(Picture)

The Stucco coating at the exterior rear of the home, near master bedroom, was deteriorated along bottom edge. Further deterioration can occur if not corrected. A qualified person should repair or replace as needed.

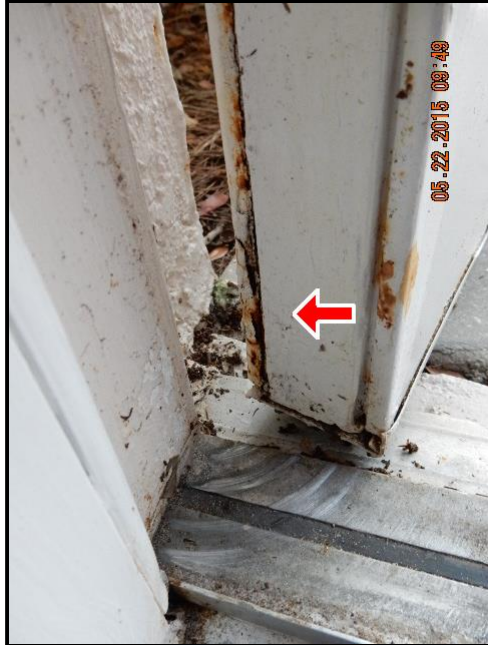
1.1 Item 1(Picture)

The side entry door to the garage is deteriorated at the bottom. Further deterioration may occur if not repaired. I recommend prep and paint using a qualified contractor.

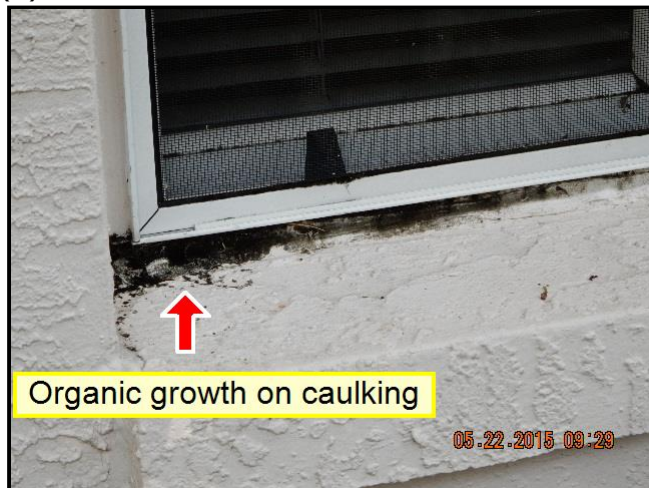
1.2 Item 1(Picture)

Below the window frame of the den/office needs to be caulked/sealed at right side of the home. This is a maintenance issue and is for your information. I recommend monitoring these areas and repair as needed.

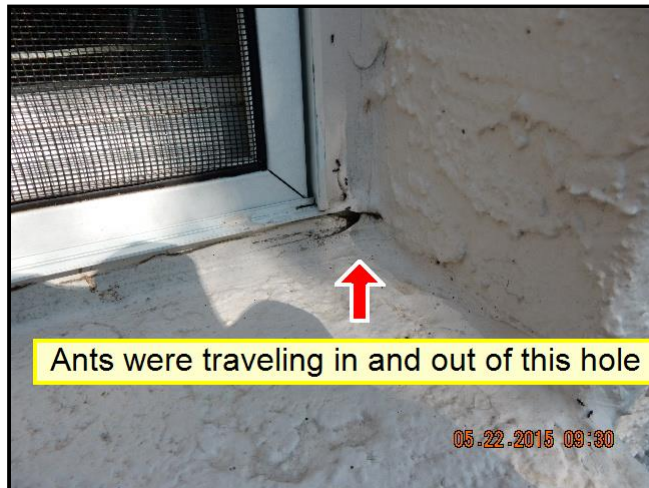
1.2 Item 2(Picture)

The window frame needs to be caulked/sealed at right side of the home. Further deterioration may occur if not repaired. A qualified person should repair or replace as needed. Ants were entering/exiting this hole.

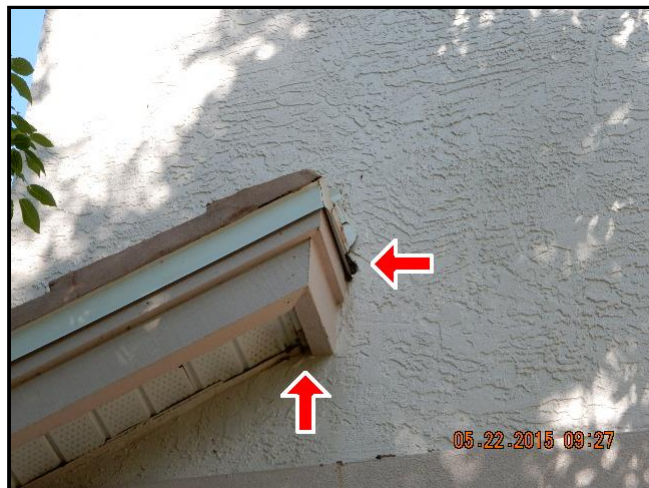
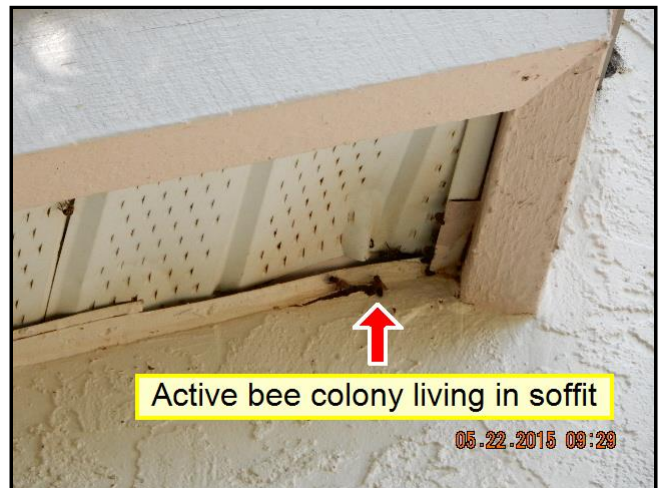
1.5 Item 1(Picture)

A gap at the fascia or soffit exists which allows insects or bees to enter attic. Live bee colony was present at this location.

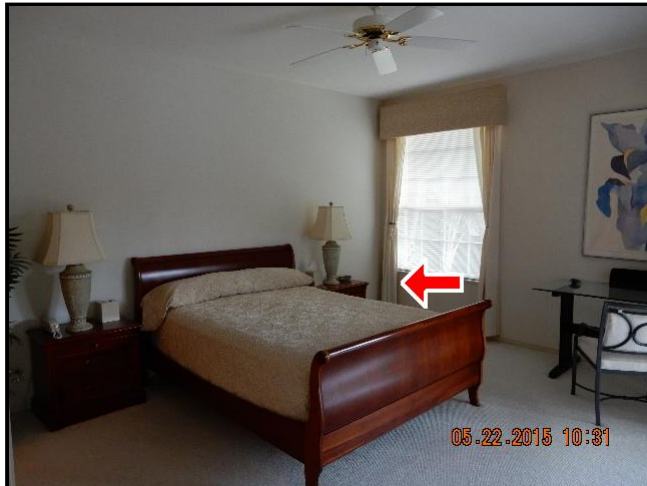
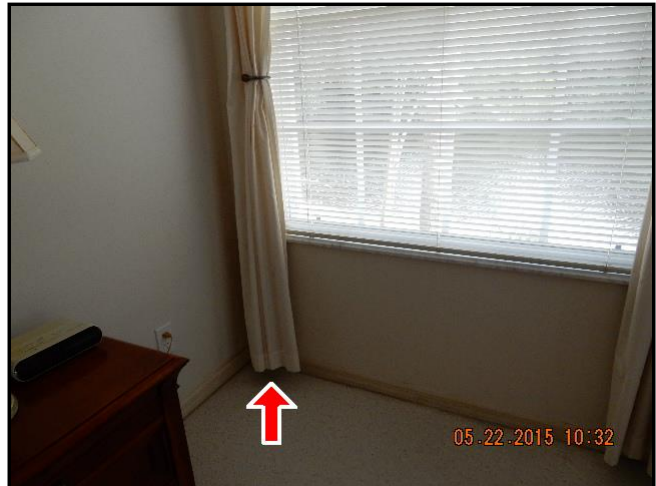
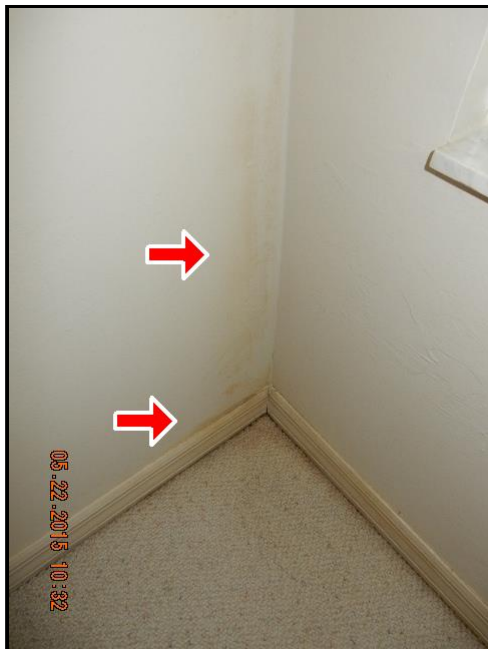
3.1 Item 1(Picture)

The drywall in the corner near window shows wet stains indicating moisture intrusion in the Master Bedroom. The moisture meter was used and it did not indicate an active leak. I recommend monitoring these areas and repair as needed.

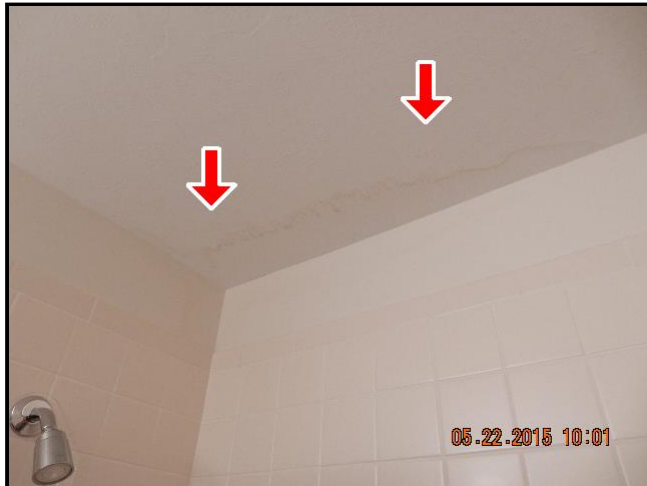
3.1 Item 4(Picture)

The drywall on the ceiling of the shower shows wet stains indicating moisture intrusion in the guest bathroom. The moisture meter was used and it did not indicate an active leak. I recommend monitor and repair or replace if the leak repair was not successful.

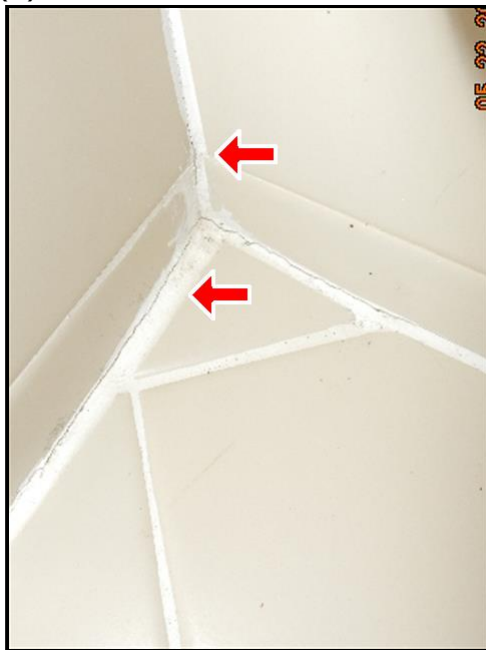
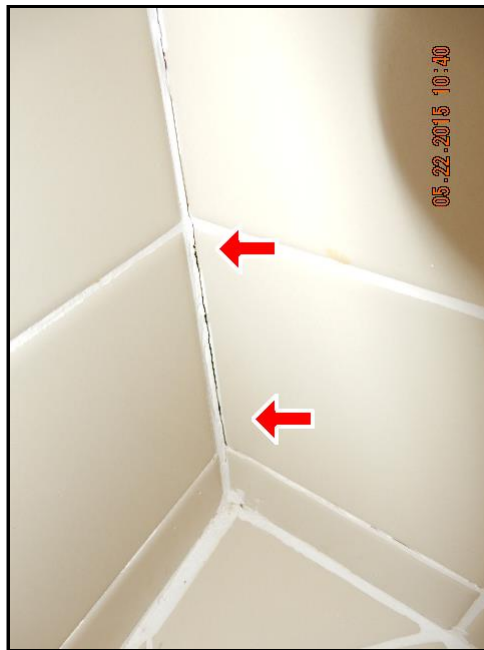
3.1 Item 5(Picture)

The tile surround in the shower on the wall has several hairline cracks in the grout in the master bathroom. Repairs are needed to prevent water damage to shower/bath. A qualified person should repair or replace as needed.

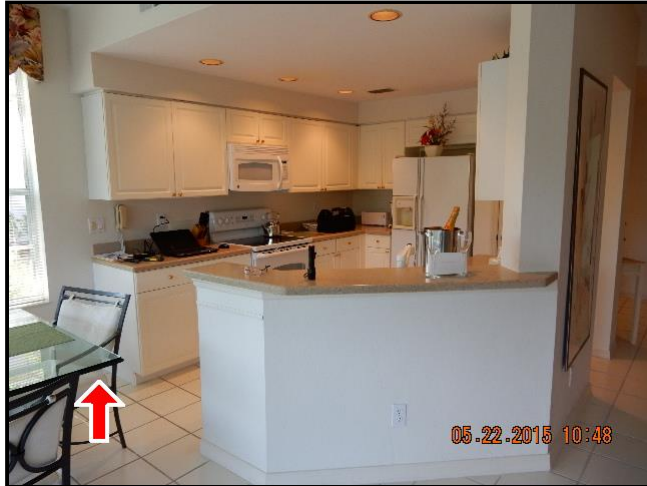
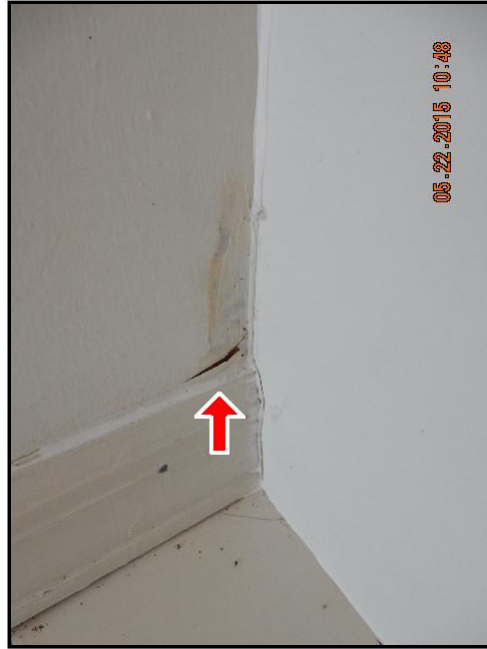
3.1 Item 7(Picture)

The drywall at the base of the cabinets/floor shows wet stains indicating moisture intrusion in the Kitchen. The moisture meter was used and it did not indicate an active leak. I recommend monitor and repair or replace if the leak repair was not successful.

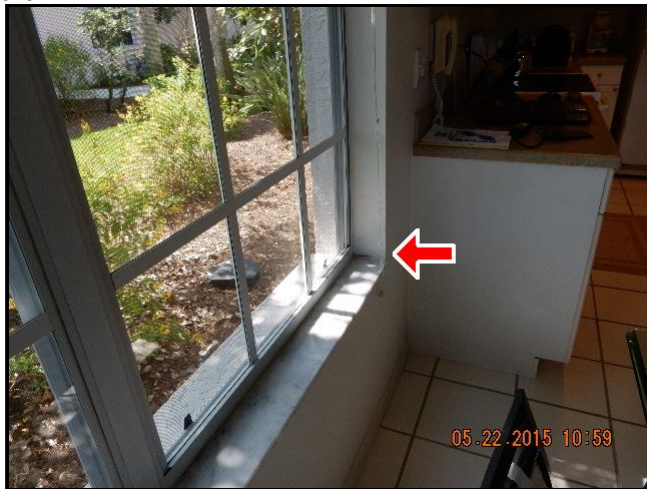
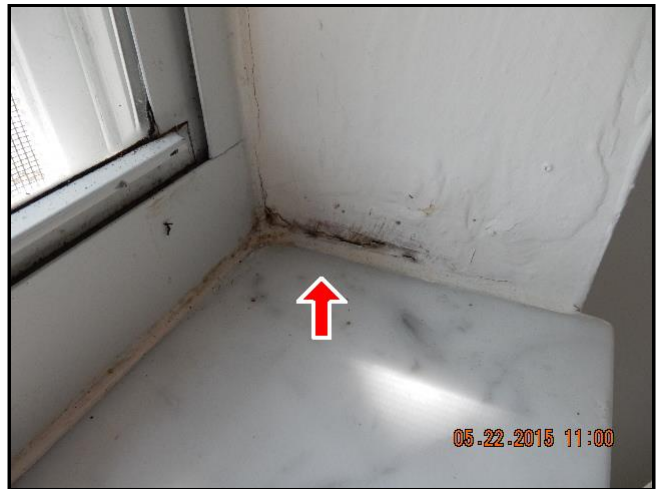
3.1 Item 9(Picture)

The drywall around the base of the window in the kitchen shows wet stains indicating moisture intrusion. The moisture meter was used and it did not indicate an active leak. I recommend monitor and repair or replace if the leak repair was not successful.

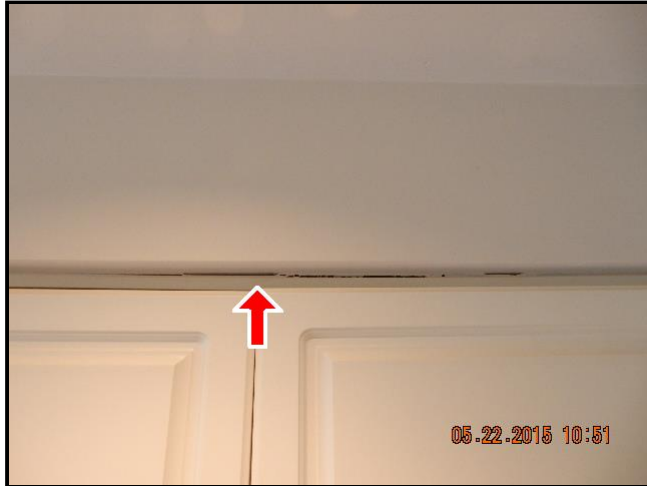
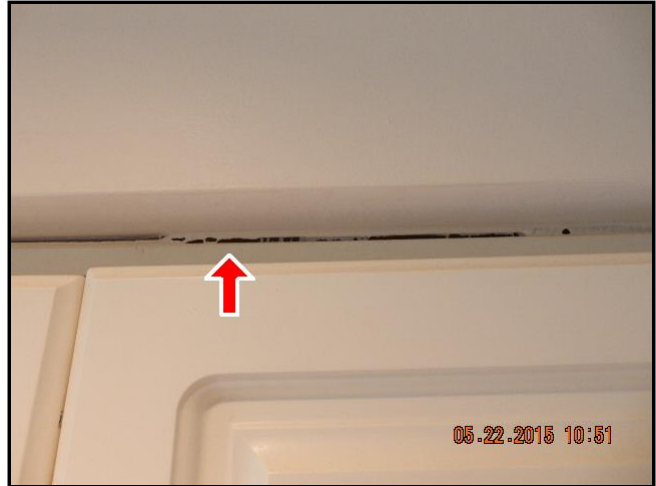
3.4 Item 1(Picture)

Wall cabinetry above stove needs to be caulked/sealed along wall. Recommend repair or replace as necessary.

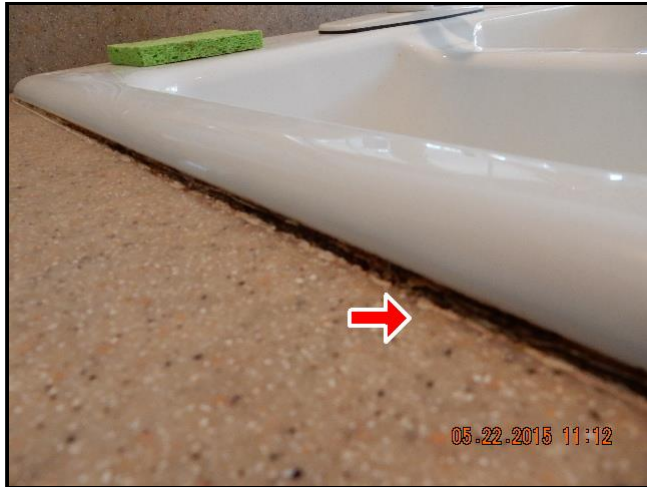
3.4 Item 3(Picture)

The kitchen sink is separated from the countertop, needs to be caulked/sealed. Recommend repair or replace as necessary.

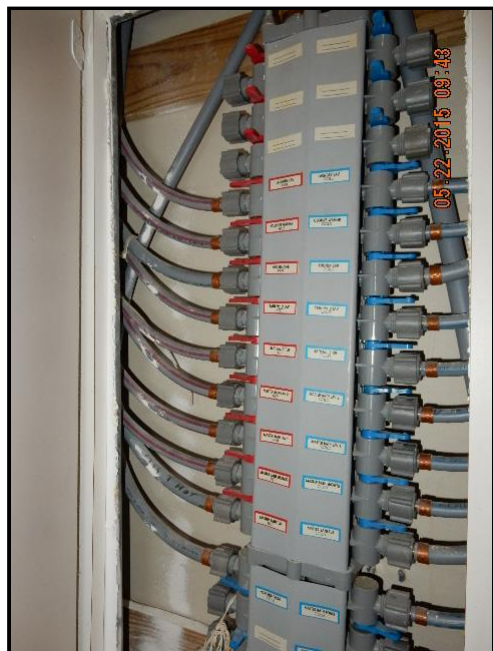
5.1 Item 1(Picture)

Polybutylene plastic plumbing supply lines (PB) are installed in the subject house. Polybutylene has been used in this area for many years, but has had a higher than normal failure rate, and is no longer being widely used. Copper and Brass fittings used in later years have apparently reduced the failure rate. This subject house has copper fittings. For further details contact the Consumer Plumbing Recovery center at 1-800-392-7591 or the web at <http://www.pbpipe.com>

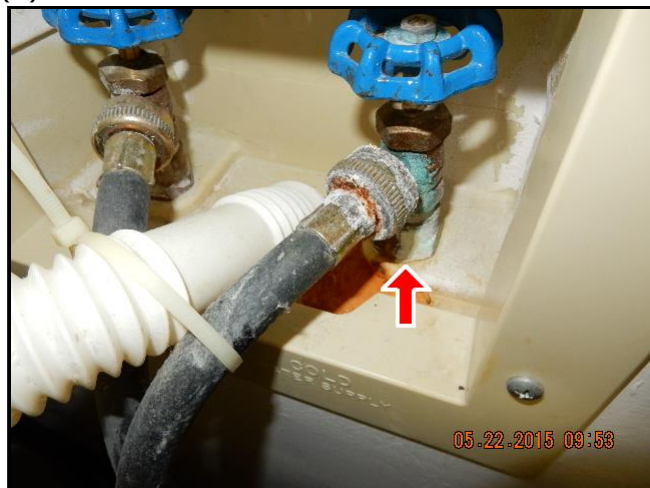
5.1 Item 2(Picture)

The washing machine water supply hose shows previous evidence of leaking at the supply valve. I recommend repair or replace as needed.

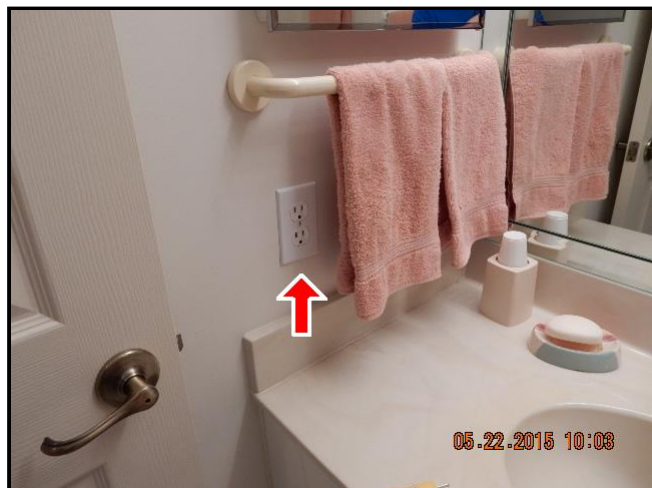
6.4 Item 1(Picture)

One outlet is outdated and not a three-prong GFCI (Ground Fault Circuit Interrupt) in the guest bathroom. Electrical issues are considered a hazard until repaired. A qualified licensed electrical contractor should perform repairs that involve wiring.

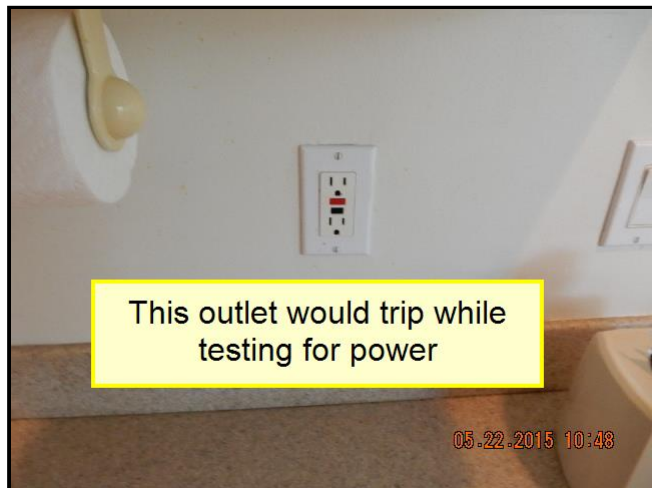
6.5 Item 1(Picture)

GFCI (Ground Fault Circuit Interrupter) outlet in the Kitchen is damaged or defective. Electrical issues are considered a hazard until repaired. A qualified licensed electrical contractor should perform repairs that involve wiring.

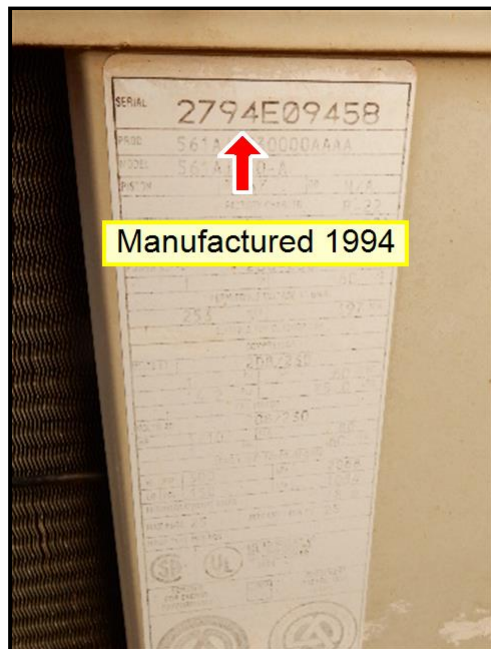
7.4 Item 1(Picture)

The HVAC (AC/Heat unit) is at the end of life expectancy. Life expectancy is 12-20 years. This is for your information. This condenser was manufactured in 1994.

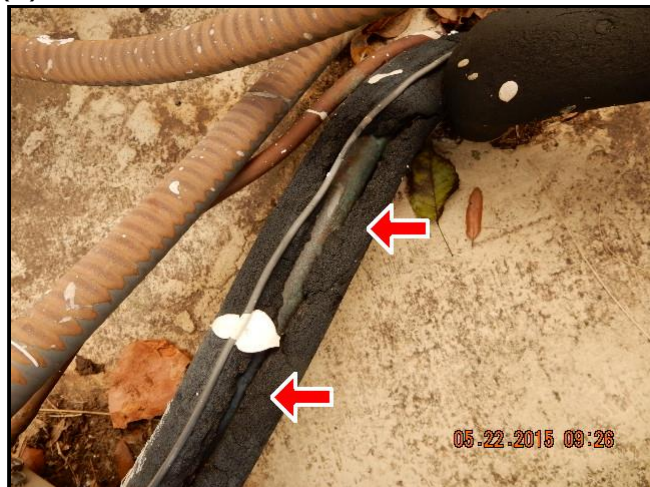
7.4 Item 2(Picture)

The foam sleeve on the suction line is missing or damaged in area(s) at the outside unit. Missing foam on the suction line can cause energy loss and condensation. I recommend service or repair as needed.

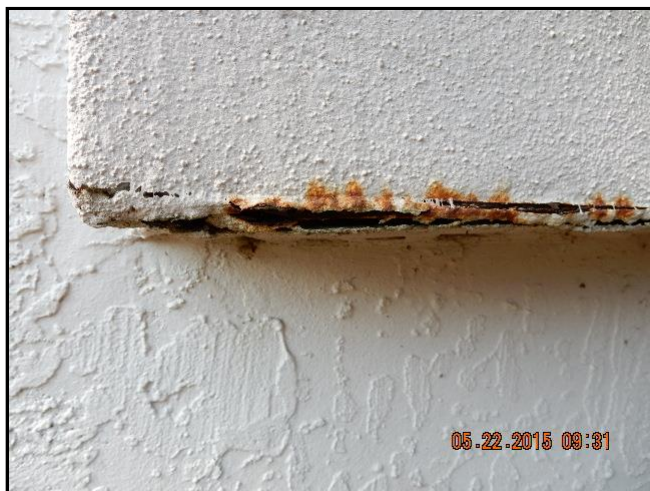
1.0 Item 1(Picture)

**1.0** The Stucco coating at the exterior rear of the home, near master bedroom, was deteriorated along bottom edge. Further deterioration can occur if not corrected. A qualified person should repair or replace as needed.

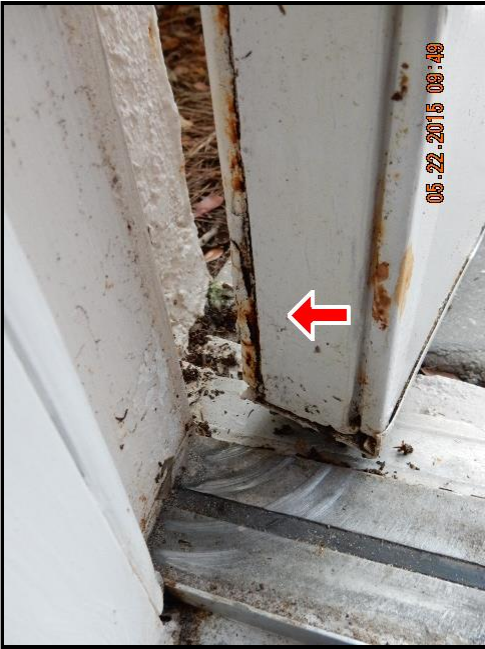
1.1 Item 1(Picture)

**1.1** The side entry door to the garage is deteriorated at the bottom. Further deterioration may occur if not repaired. I recommend prep and paint using a qualified contractor.

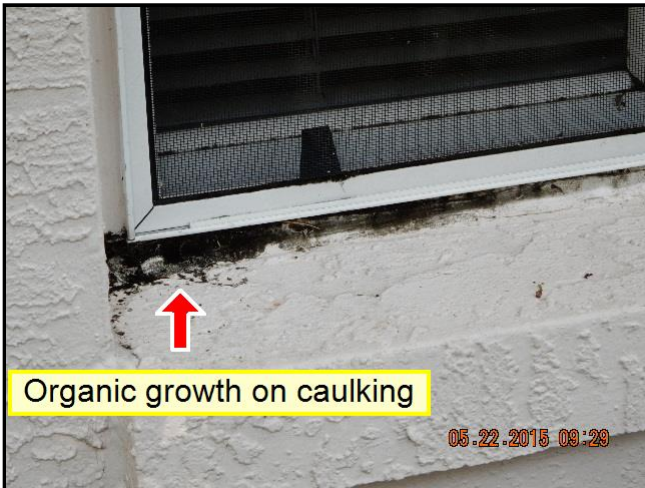
1.2 Item 1(Picture)

**1.2** (1) Below the window frame of the den/office needs to be caulked/sealed at right side of the home. This is a maintenance issue and is for your information. I recommend monitoring these areas and repair as needed.

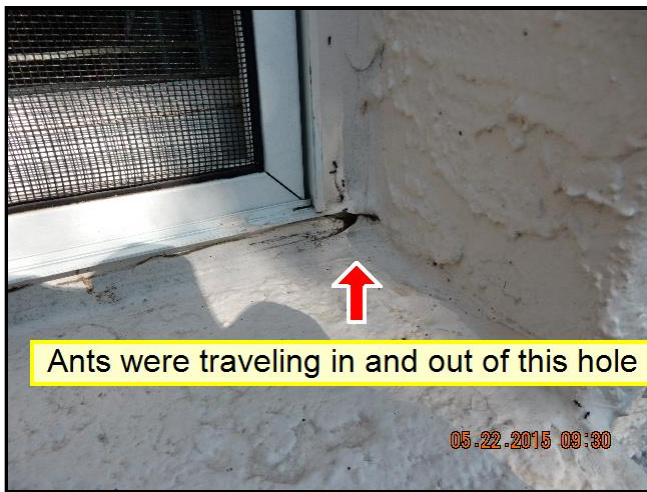
1.2 Item 2(Picture)

(2) The window frame needs to be caulked/sealed at right side of the home. Further deterioration may occur if not repaired. A qualified person should repair or replace as needed. Ants were entering/exiting this hole.

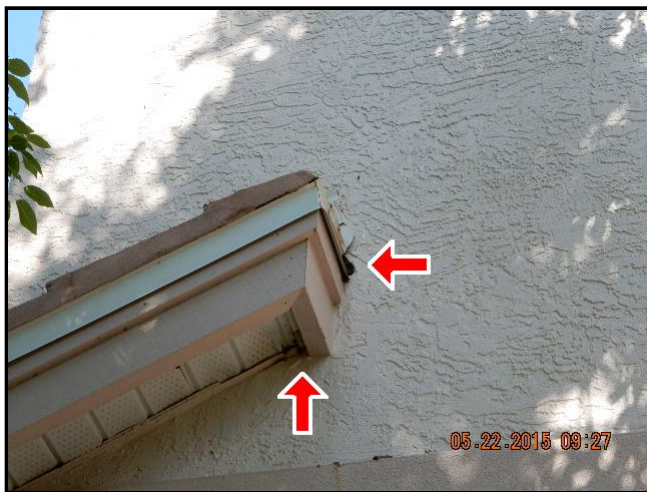
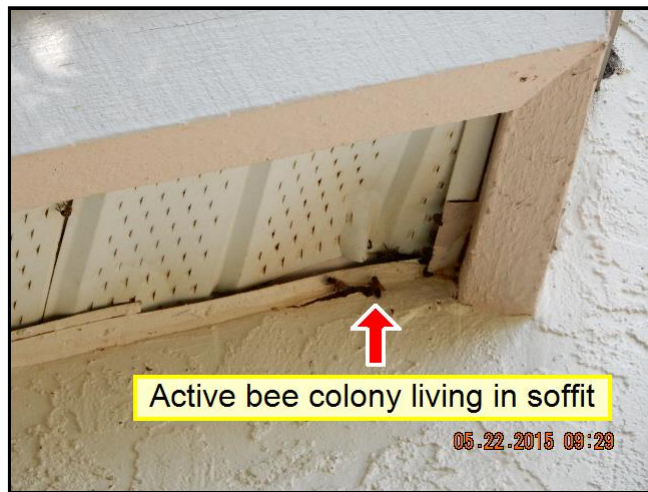
1.5 Item 1(Picture)

**1.5** A gap at the fascia or soffit exists which allows insects or bees to enter attic. Live bee colony was present at this location.

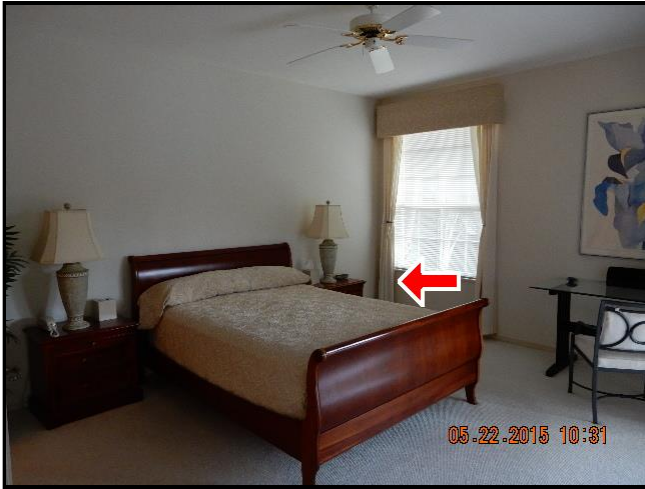
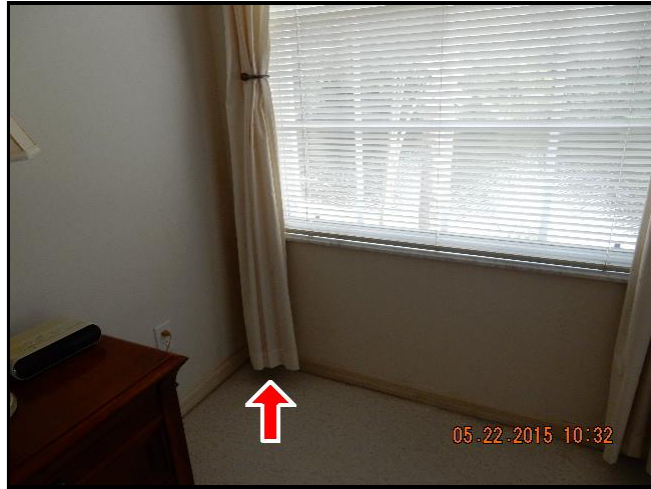
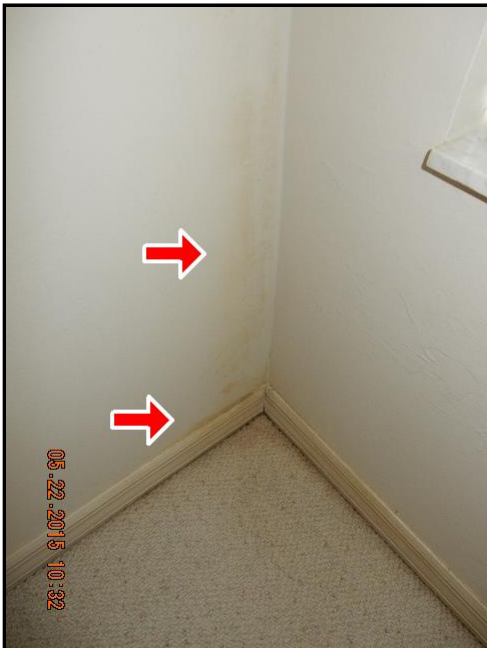
3.1 Item 1(Picture)

**3.1** (1) The drywall in the corner near window shows wet stains indicating moisture intrusion in the Master Bedroom. The moisture meter was used and it did not indicate an active leak. I recommend monitoring these areas and repair as needed.

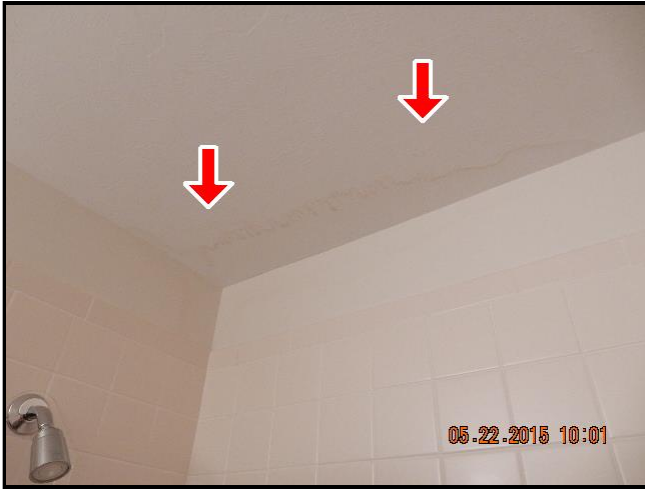
3.1 Item 4(Picture)

(2) The drywall on the ceiling of the shower shows wet stains indicating moisture intrusion in the guest bathroom. The moisture meter was used and it did not indicate an active leak. I recommend monitor and repair or replace if the leak repair was not successful.

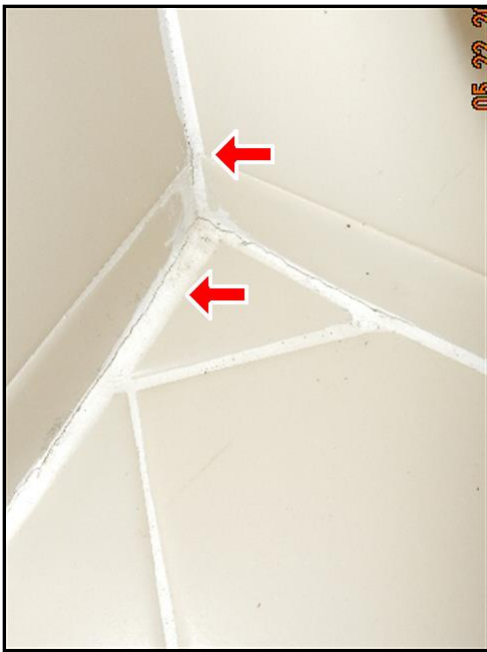
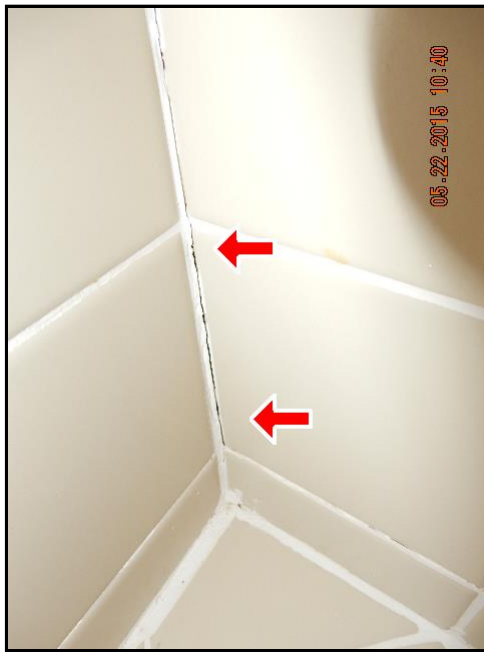
3.1 Item 5(Picture)

(3) The tile surround in the shower on the wall has several hairline cracks in the grout in the master bathroom. Repairs are needed to prevent water damage to shower/bath. A qualified person should repair or replace as needed.

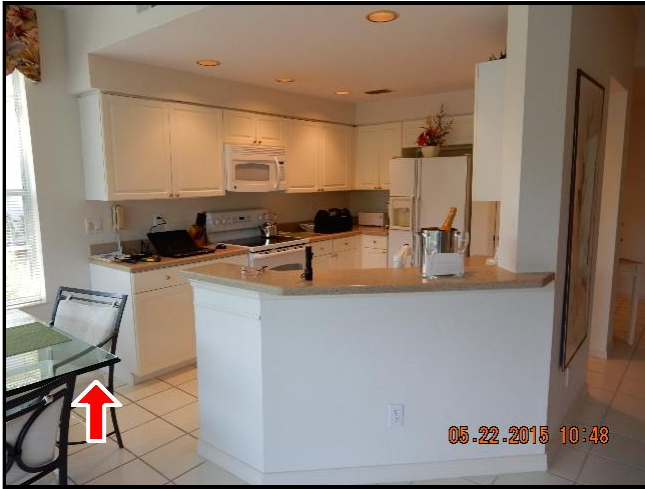
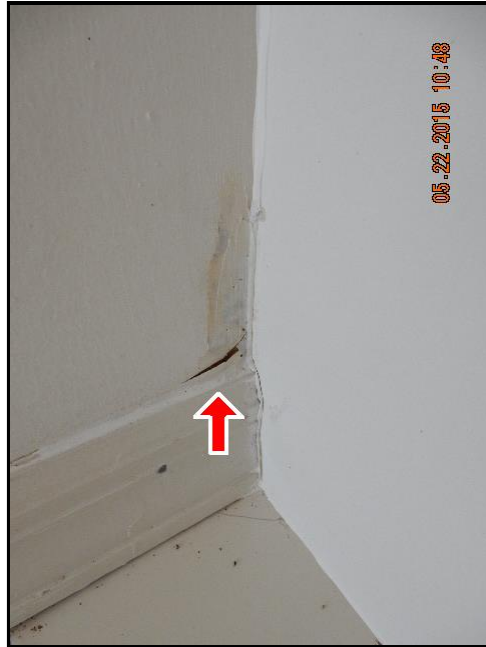
3.1 Item 7(Picture)

(4) The drywall at the base of the cabinets/floor shows wet stains indicating moisture intrusion in the Kitchen. The moisture meter was used and it did not indicate an active leak. I recommend monitor and repair or replace if the leak repair was not successful.

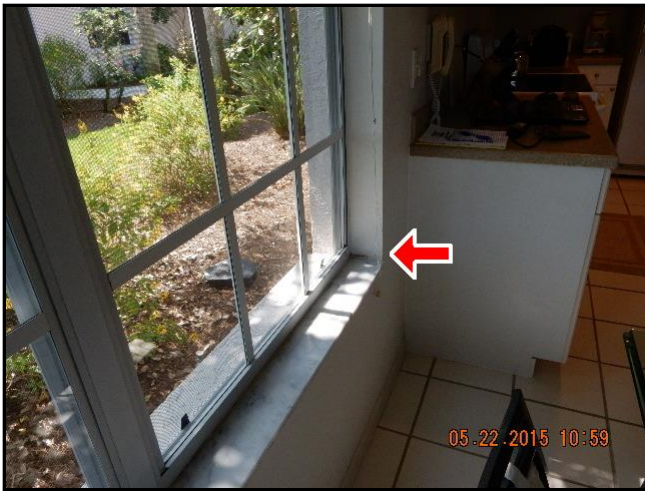
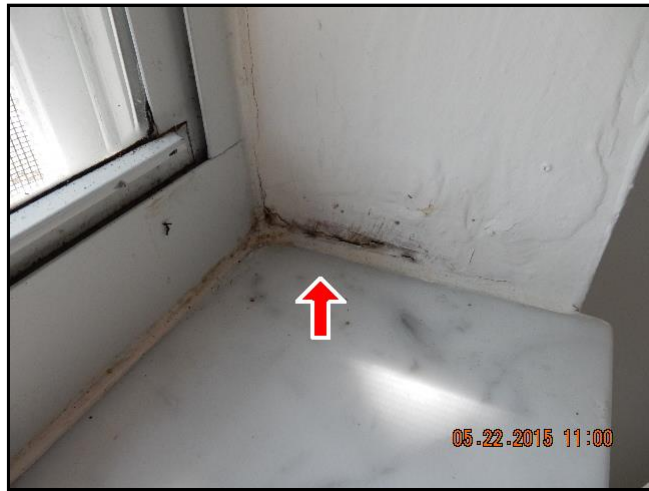
3.1 Item 9(Picture)

(5) The drywall around the base of the window in the kitchen shows wet stains indicating moisture intrusion. The moisture meter was used and it did not indicate an active leak. I recommend monitor and repair or replace if the leak repair was not successful.

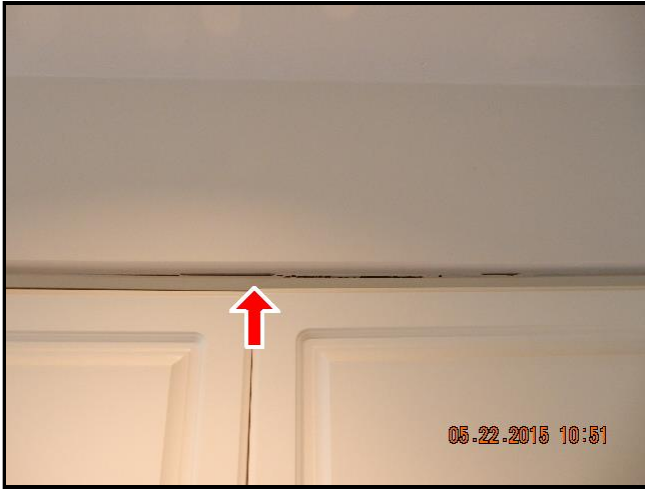
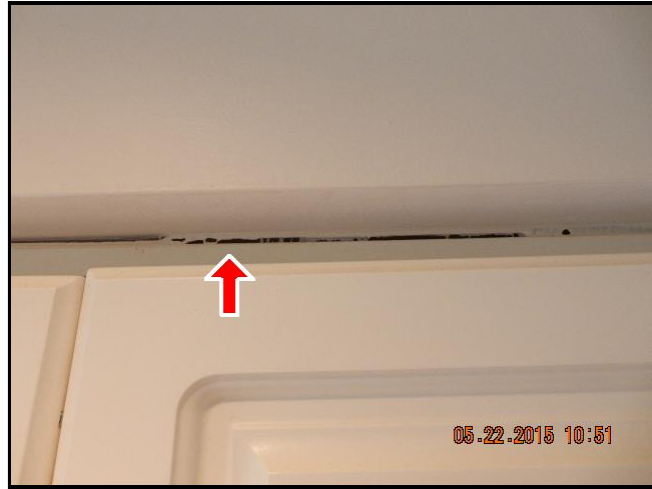
3.4 Item 1(Picture)

**3.4** (1) Wall cabinetry above stove needs to be caulked/sealed along wall. Recommend repair or replace as necessary.

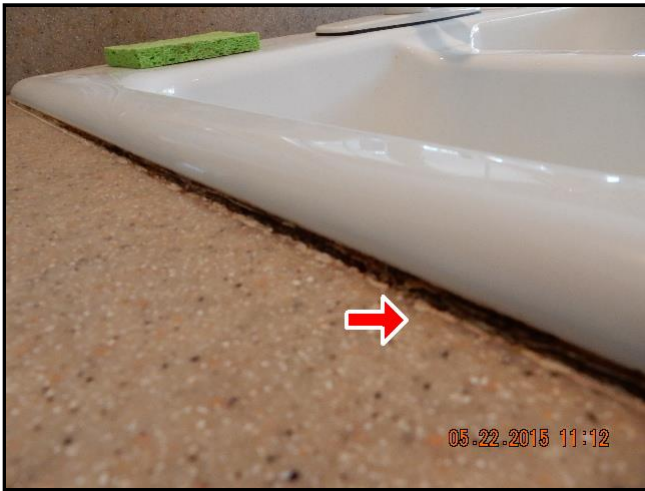
3.4 Item 3(Picture)

(2) The kitchen sink is separated from the countertop, needs to be caulked/sealed. Recommend repair or replace as necessary.

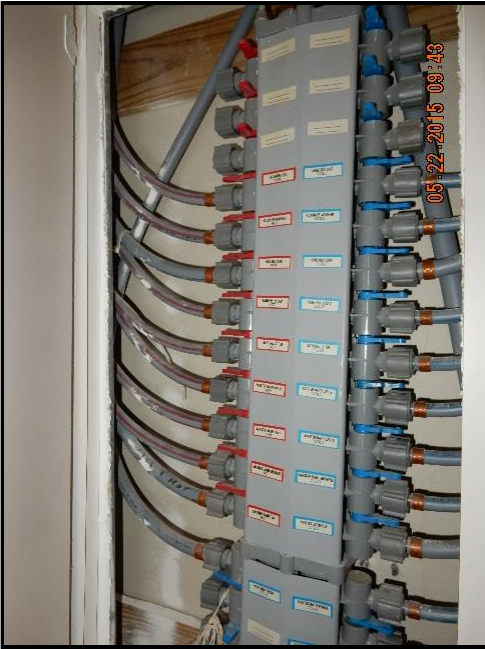
5.1 Item 1(Picture)

**5.1** (1) Polybutylene plastic plumbing supply lines (PB) are installed in the subject house. Polybutylene has been used in this area for many years, but has had a higher than normal failure rate, and is no longer being widely used. Copper and Brass fittings used in later years have apparently reduced the failure rate. This subject house has copper fittings. For further details contact the Consumer Plumbing Recovery center at 1-800-392-7591 or the web at <http://www.pbpipe.com>

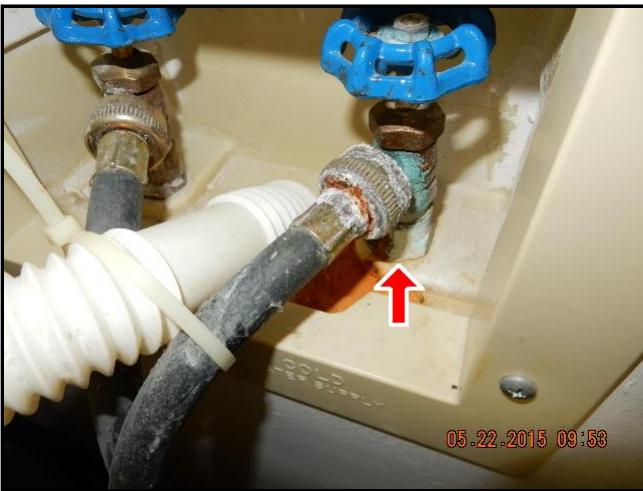
5.1 Item 2(Picture)

(2) The washing machine water supply hose shows previous evidence of leaking at the supply valve. I recommend repair or replace as needed.

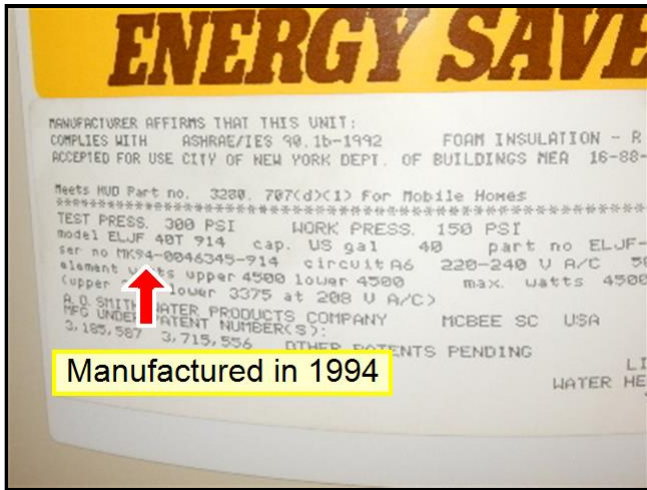
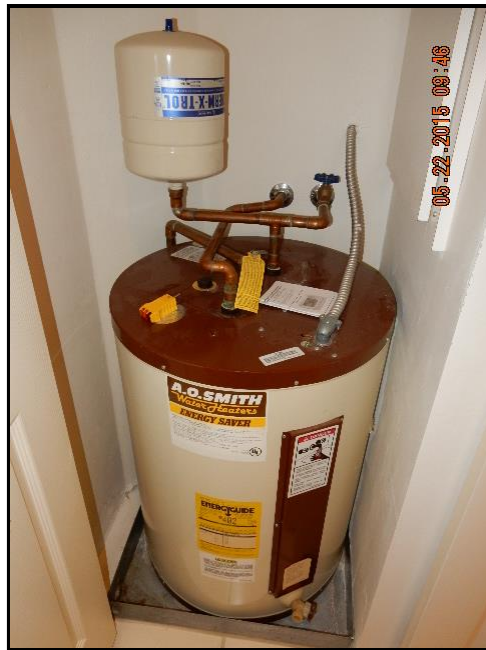
5.2 Item 1(Picture)

**5.2** The water heater is at the end of its life expectancy of 15 years, however there are no visible leaks. This is for your information. No apparent problems were found.

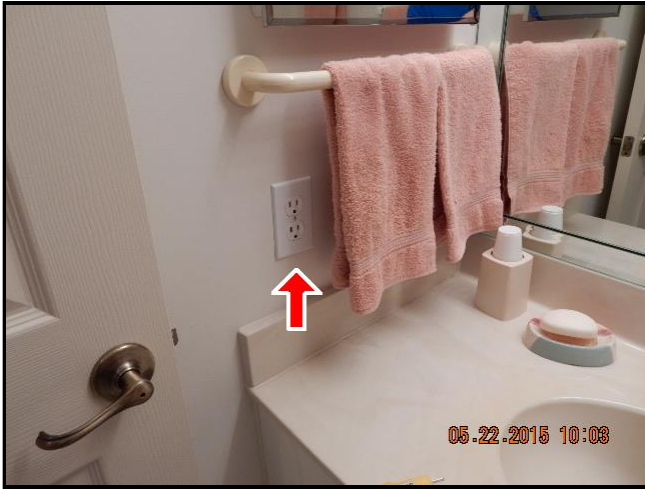
6.4 Item 1(Picture)

**6.4** One outlet is outdated and not a three-prong GFCI (Ground Fault Circuit Interrupt) in the guest bathroom. Electrical issues are considered a hazard until repaired. A qualified licensed electrical contractor should perform repairs that involve wiring.

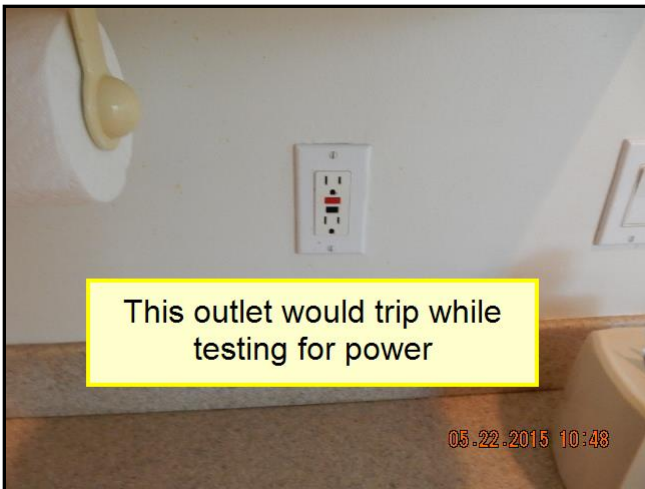
6.5 Item 1(Picture)

**6.5** GFCI (Ground Fault Circuit Interrupter) outlet in the Kitchen is damaged or defective. Electrical issues are considered a hazard until repaired. A qualified licensed electrical contractor should perform repairs that involve wiring.

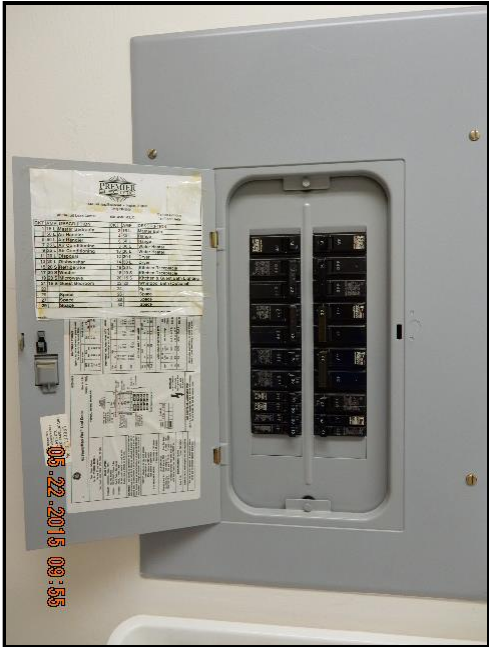
6.6 Item 1(Picture)

- 6.6 The main panel box is located in the laundry room.
- 6.7 The smoke detectors should be tested in all areas upon moving in to home.

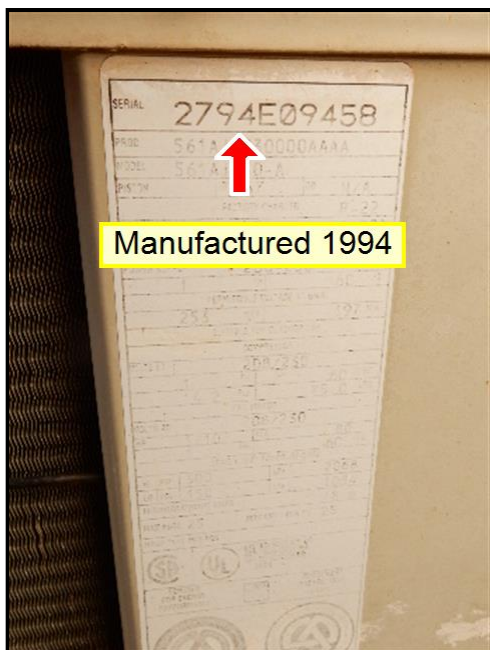
7.4 Item 1(Picture)

**7.4** (1) The HVAC (AC/Heat unit) is at the end of life expectancy. Life expectancy is 12-20 years. This is for your information. This condenser was manufactured in 1994.

(2) The air test was performed by using thermometers on the air handler of Air conditioner to determine if the difference in temperatures of the supply and return air are between 14 degrees and 22 degrees which indicates that the unit is cooling as intended. The supply air temperature on your system read 59 degrees, and the return air temperature was 74 degrees. This indicates the range in temperature drop is normal.

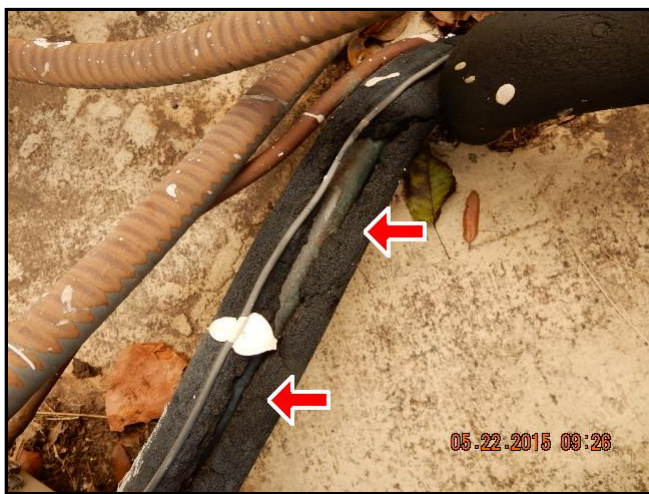
7.4 Item 2(Picture)

(3) The foam sleeve on the suction line is missing or damaged in area(s) at the outside unit. Missing foam on the suction line can cause energy loss and condensation. I recommend service or repair as needed.
