A CUSTOM TECHNIQUE TO RETRIEVE WORN OUT IMPLANT MOUNT FROM IMPLANT DURING IMPLANT PLACEMENT: A CASE REPORT

ABSTRACT:

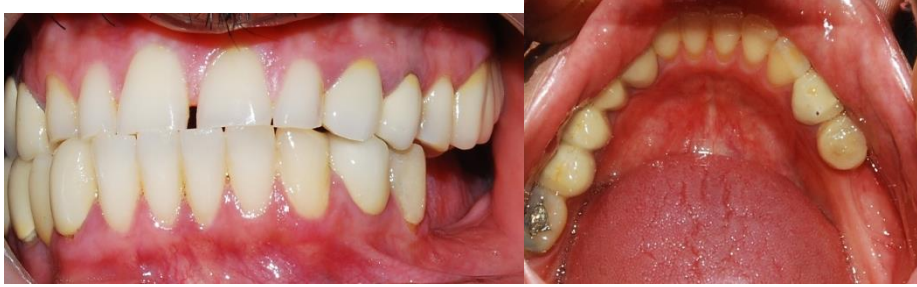
Fig 1-a,b

A 48 year old male, reported to the department of prosthodontics for prosthetic rehabilitation of his missing teeth. Patient was partially edentulous in relation to mandibular left first and second molar with no distal abutment tooth. An implant supported fixed partial denture was planned for the patient [Fig 1].

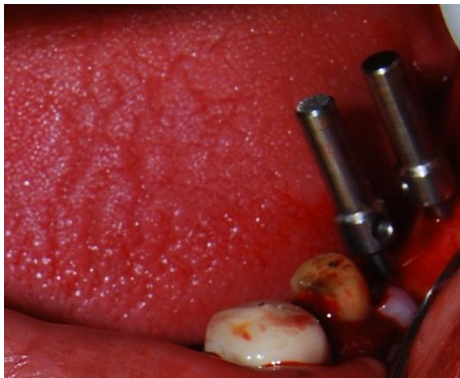
Fig 2

Tapered dental implants (3.5 X10mm, MIS) were selected based on the bone sounding data. Once the implant site was prepared, the implant was removed from the capsule and placed into the prepared site [Fig 2]. The hex driver was used to torque the implant to a 35N force. But when implant mount was attempted to be removed from the implant, difficulty was encountered in inserting the hex driver for the cover screw into the mount [Fig 3]. This was due to the interference from the

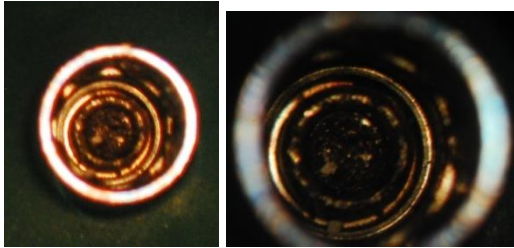
opposing natural teeth. Unscrewing was pursued with a tilted position of the hex driver which resulted in wear of the internal hex, technically resulting in locking of the implant mount on to the implant. As the implant mount interfered with the occlusion of the patient, removal of the implant mount was necessary. It was decided to remove the implant mount without damaging the implant. Vertical sections were made on the implant mount under rubber dam isolation. Rubber dam isolation was done to prevent contamination of metal particles into the soft tissues of surgical site [Fig 4]. These sections extended till the cover screw and a notch was created on it. This was done to design a lever arm around the central axis. The lever arm is the perpendicular distance from the axis of rotation to the line of action of the force. An enamel chisel of desired diameter was bent 90 degrees and was engaged to the notch in cover screw [Fig 5]. The chisel was gradually rotated in and the worn out component was retrieved. [Fig 6, 7]

Fig 6-a,b-Appearance of worn internal hex screw under 2x and 3x magnification

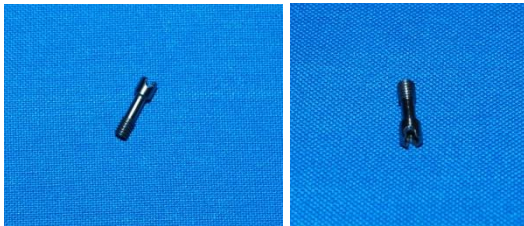
Fig 7- a,b-Retrieved internal hex with prepared notches
