HOLDERNESS : HUMAN INTERACTION WITH THE COAST

Mappleton

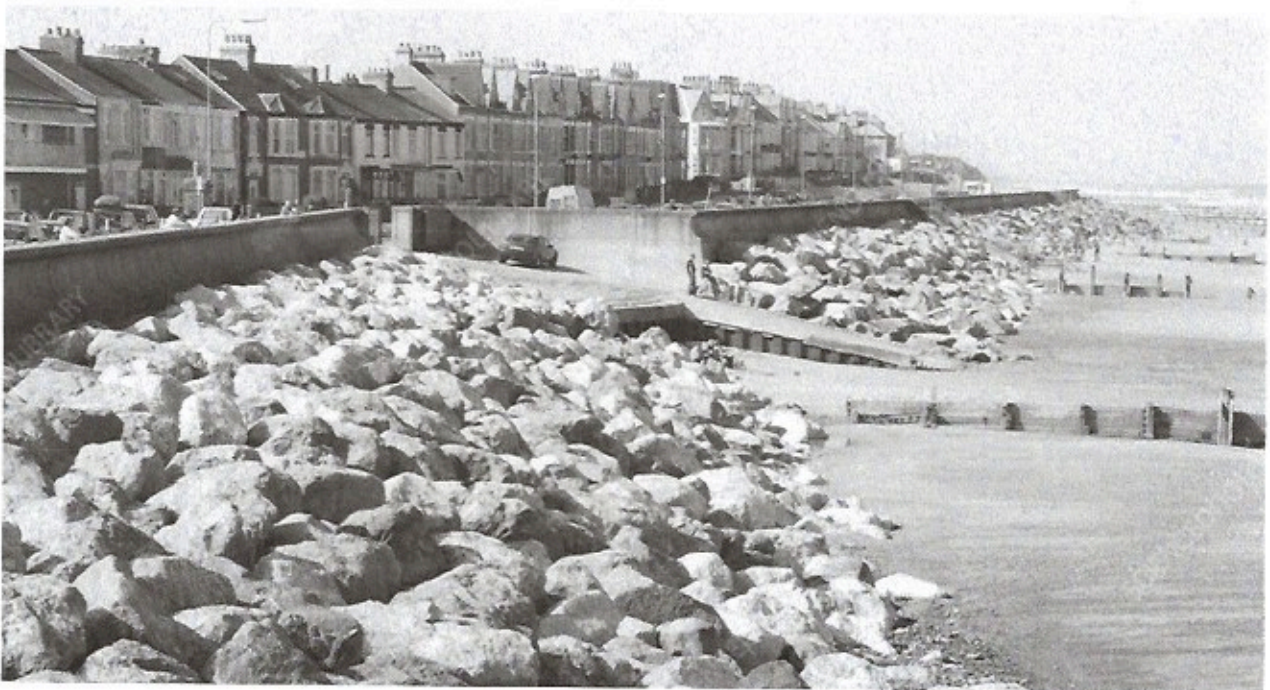
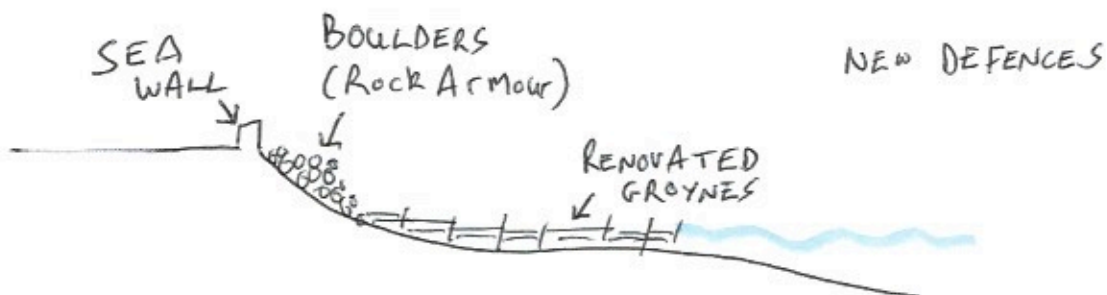
Withernsea

A sea wall was built and in front of this a system of wooden groynes attempt to retain enough sand to absorb much of the wave energy.

Recent improvements to the defensive system have included renovating the groynes, bringing in extra sand (beach replenishment) and protecting the foot of the sea wall by armouring it with large boulders, which along with the air spaces between them are efficient at dissipating incoming wave energy.

There have been recent problems caused by the sea wall and the groynes nearing the end of their design life. During extreme high tides and storm conditions the sea has come over the defensive wall and flooded sea front properties

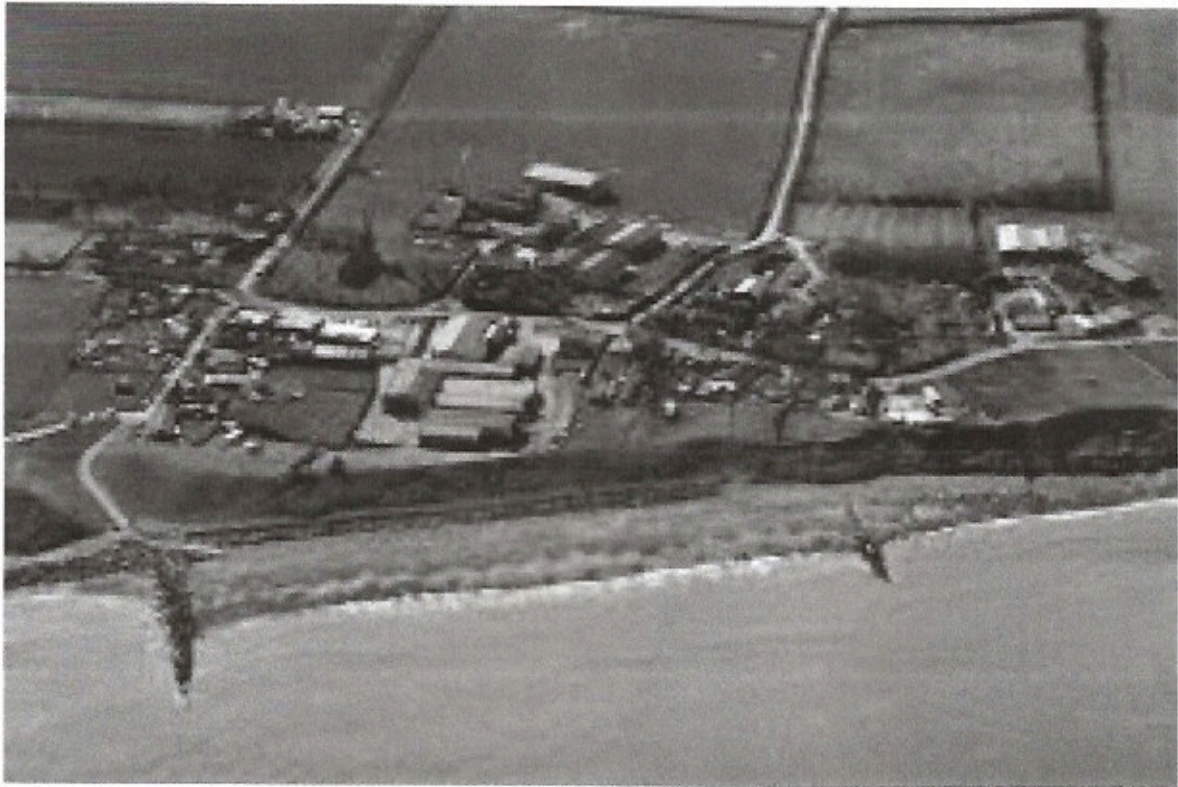
NEW COASTAL DEFENCES AT MAPPLETON

1. A pair of stone groynes, a small one to the north and a larger one to the south to prevent longshore drift and the loss of beach material in the southerly downdrift direction.

2. Beach replenishment between the two groynes to build up the beach and help to absorb wave energy and prevent waves from reaching the soft boulder clay cliffs.

3. A defensive boulder wall of rock armouring or rip-rap at the base of the cliff to prevent undercutting and slumping of the cliff.
4. Degradation of the angle of the cliff to reduce the effect of gravity and prevent sub-aerial processes such as slumping and sliding of the soft, unconsolidated cliff material.

To the south of the scheme the beach has been starved of beach material due to the larger of the two groynes preventing longshore drift in that direction. This has allowed the full impact of the waves to attack the base of the cliff, and slumping, sliding and general erosion have caused increased recession in this area.

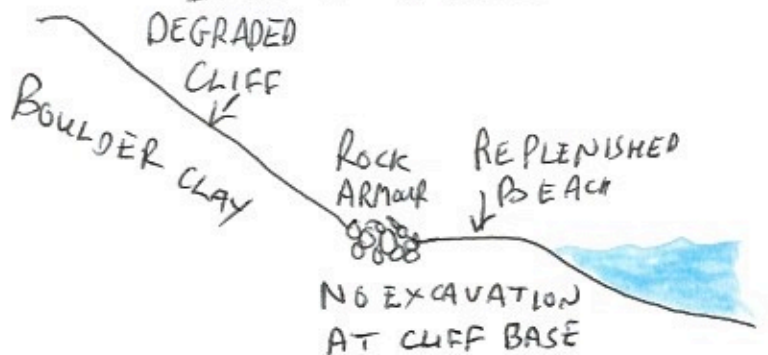
NEW CLIFF SECTION

5. Improved drainage of that section of cliff to prevent saturation by water which had increased the probability of sub-aerial downslope loss of material. The new lower angle cliffs were also grassed and in places fixed with plastic material to help consolidate it and stop surface failure and surface wash.

Although the scheme has generally been very successful in preventing the erosion and recession of the cliff at Mappleton, there have been problems. Some slipping and soil/earth flow has already occurred on the degraded cliff, and in places where people have taken a short cut from the cliff top car park to the beach the grass has been worn away and runoff has removed material.
