Effects of Yellow Rectangular Rapid-Flashing Beacons on Yielding at Multilane Uncontrolled Crosswalks

PUBLICATION NO. FHWA-HRT-10-043

SEPTEMBER 2010

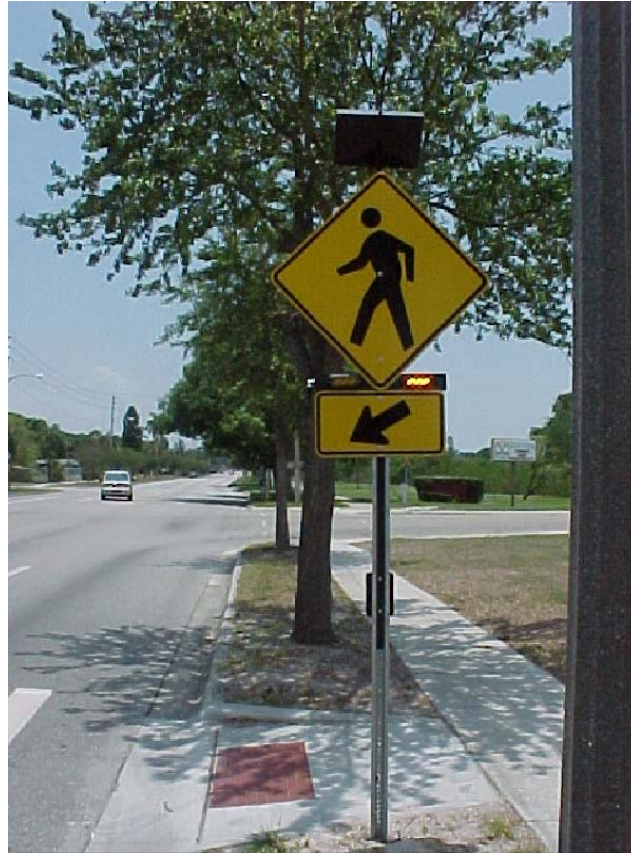
The treatment in this experiment was a standard pedestrian warning sign with two rectangular yellow LED flashers attached (see figure 1). The warning sign was either yellow or yellow-green depending on whether it was a regular sign or a school crossing sign. Each LED flasher is 6 inches wide and 2.5 inches high and placed 9 inches apart. In addition, each unit is dual indicated, with LEDs on the front and back. Each side of the LED flasher illuminates in a wig-wag sequence (left and then right). The left LED flashes two times in a slow volley each time it is energized (124 ms on and 76 ms off per flash). This is followed by the right LED, which flashes four times in a rapid volley when energized (25 ms on and 25 ms off per flash) and then has a longer flash for 200 ms. This flash pattern violates a person's expectation and results in a pattern that can be described as a "stutter flash effect."⁽⁶⁾ In addition to the LED beacons, four signs were installed at each crosswalk. Radio frequency transmitters linked the devices so that depressing any of the pedestrian call buttons activated the flashers on all four signs. A flashing LED display facing the pedestrians flashed to indicate to them that the system was operating. The system also presented an audible message informing pedestrians that the light flashing across the street indicated that the device was operating and instructing them to wait for cars to stop before crossing. This message was also visible on a plaque posted by the call button.

Figure 1. Photo. RRFB with two forward-facing LED flashers and a side-mounted LED flasher.

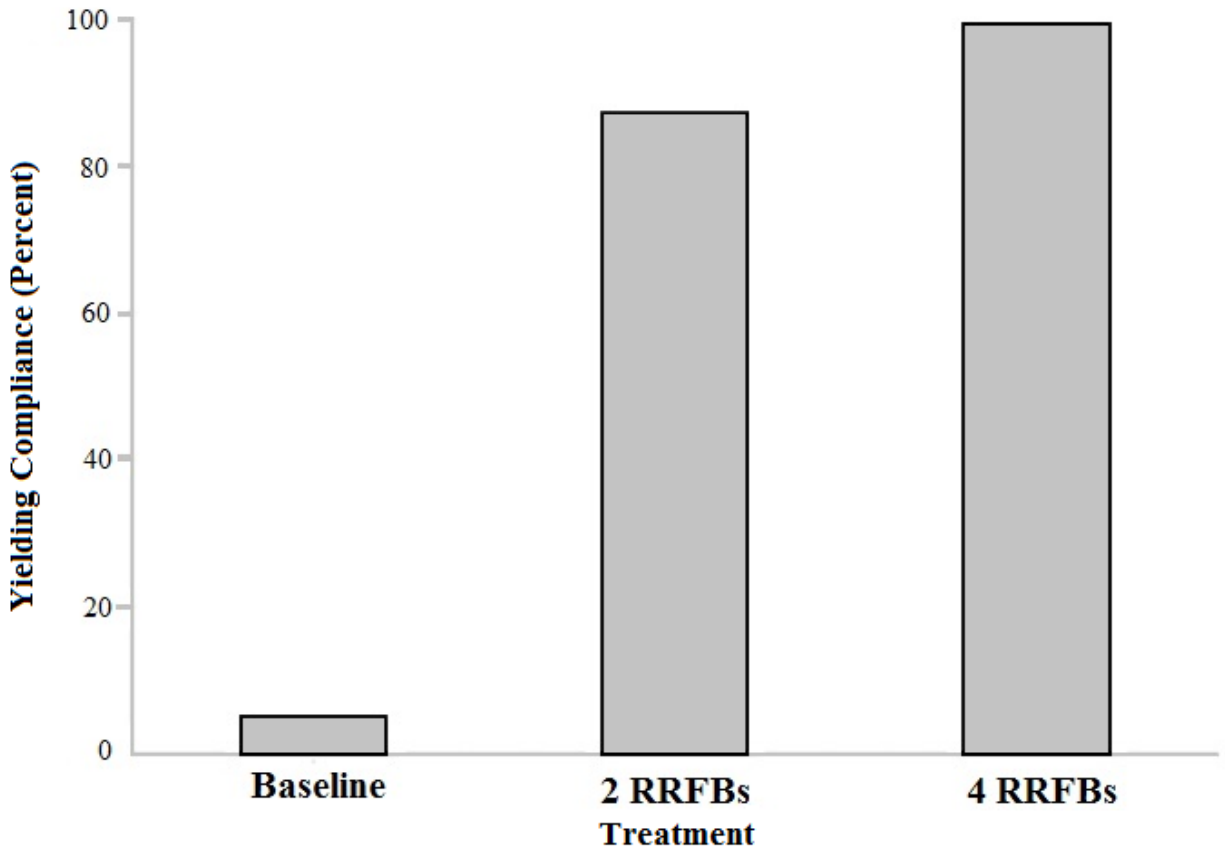
A two-sample *t*-test for matched pairs was performed to test the significance of the reported yielding percentages between the two- and four-beacon systems. The test showed significance at the 0.05 level. Figure 2 illustrates the average yielding percentage per condition at night at one site where night data were collected.

Figure 2. Graph. Yielding compliance for three conditions during nighttime observations at the third site at 1st Street and 37th Avenue S.

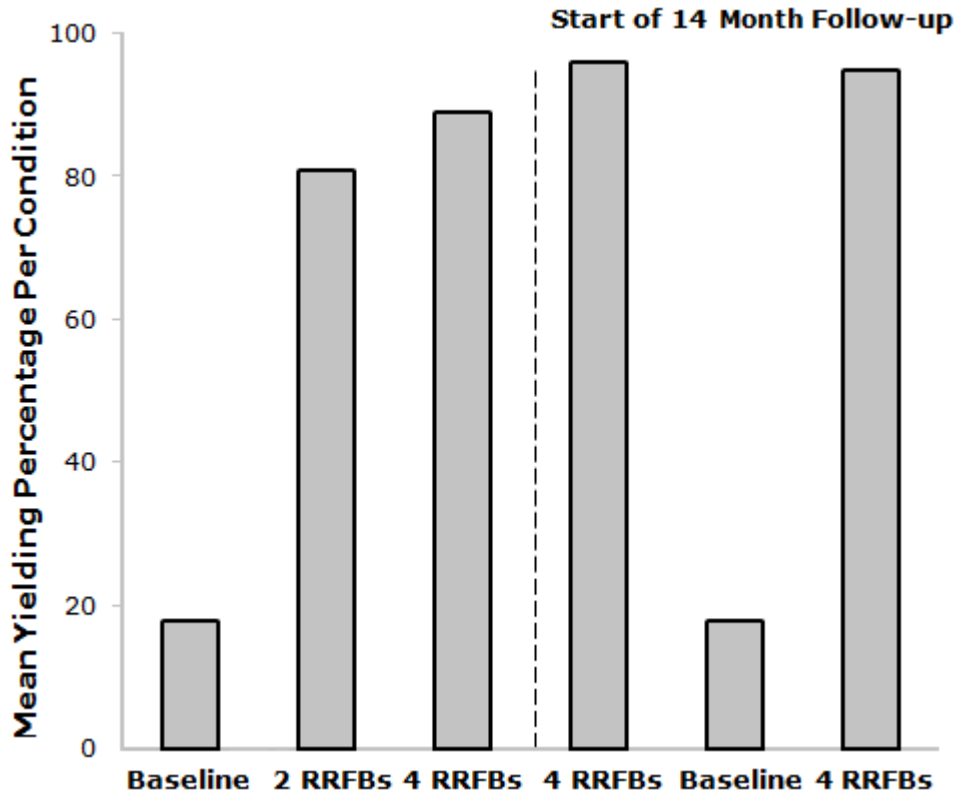
Figure 3. Graph. Mean yielding percentage for each condition.

Figure 3 represents all of the data from the four experimental sites averaged together per treatment condition. The data to the right of the dashed line show yielding during the follow-up data collected 14 months after installation.

The data collected during each of the follow-up sessions show that the RRFB devices were able to maintain a high level of driver yielding behavior during the follow-up condition. The first original site at 22d Avenue produced an average yielding compliance of 99 percent for the four-beacon treatment. The second site at 58th Street N had an average yielding compliance of 90 percent. The third site at 1st Street N produced an average four-beacon yielding compliance of 100 percent. The final site at 31st Street S had an average yielding compliance of 93 percent during the four-beacon system follow-up evaluation. The third site was evaluated during nighttime conditions as a follow-up to previous night evaluations. This location was evaluated for 60 consecutive crossings with an average yielding compliance of 97 percent. Brief reversals back to the baseline for the above follow-up locations produced low yielding compliances similar to pre-installation. These data are shown in table 1 and figure 3.

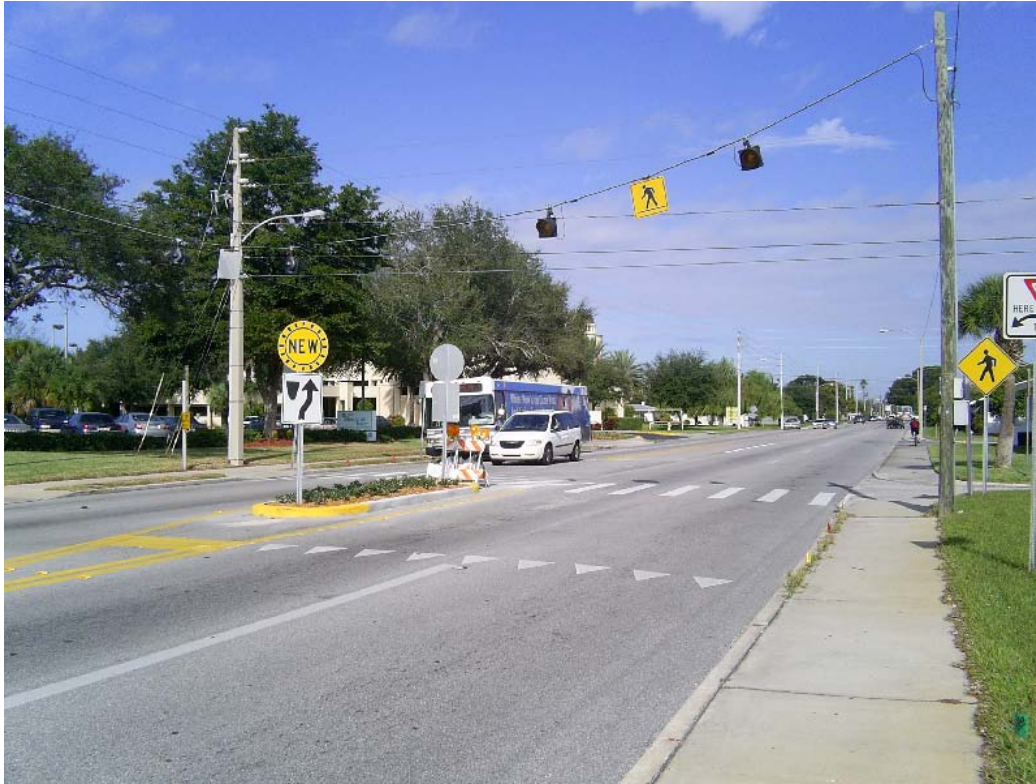
The treatment in this experiment was the standard overhead yellow flashing beacon (see figure 4) and a standard side-mounted yellow beacon. These systems are activated when the pedestrian call button is pressed. The system has two 12-inch-diameter yellow beacons facing both directions of traffic. The beacons flash 55 times per minute, and the illumination period of the beacon is 50 percent of the time.

Figure 4. Photo. Northbound view of standard overhead beacon system and crosswalk at 58th Street N with advance yield markings.

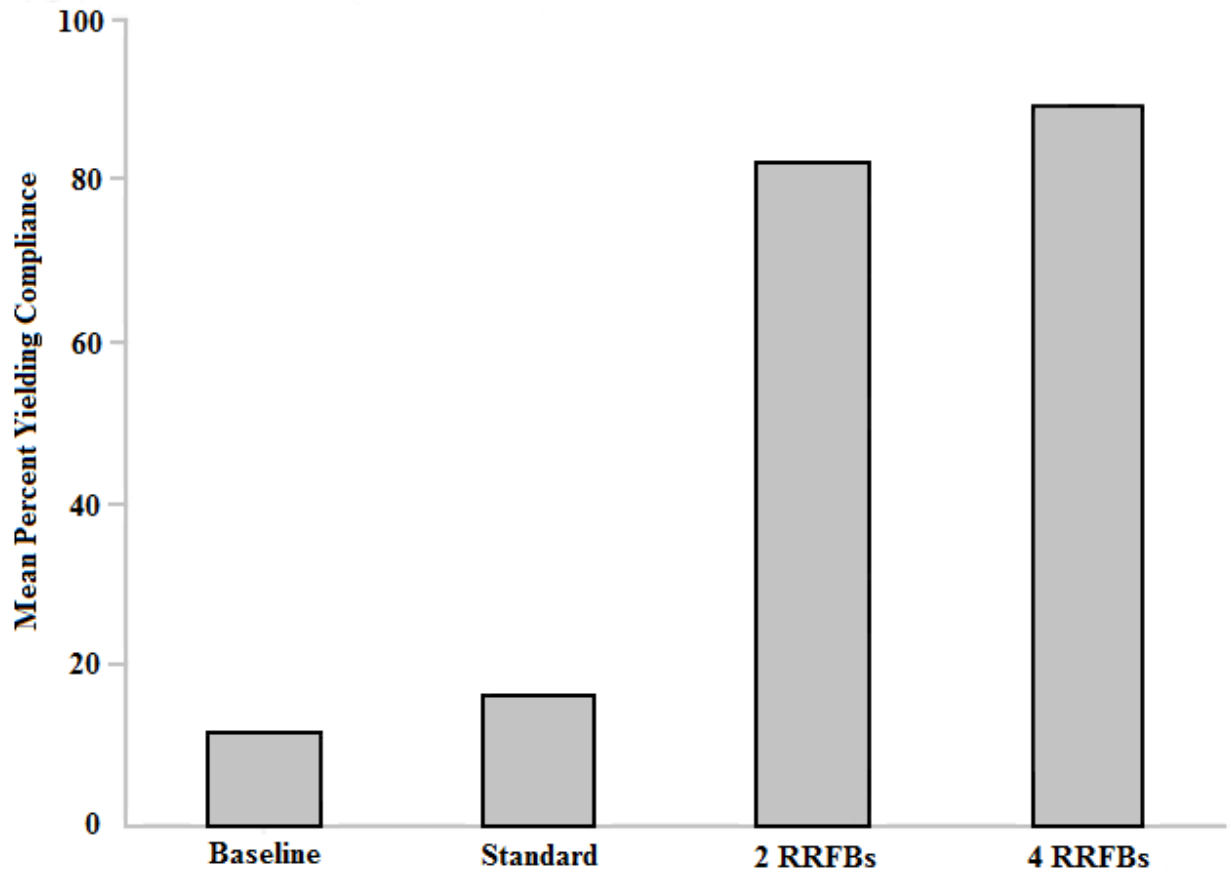
The average yielding compliance at the first site at 58th Street N Avenue during the baseline recording was 11 percent. The activation of the overhead standard beacon produced an average yielding percentage of 16 percent—an increase of 5 percentage points above the baseline. The introduction of a two-beacon RRFB system produced an increase in yielding compliance to 78 percent. A four-beacon RRFB system was associated with 88 percent yielding compliance. Reversal back to the two-beacon system produced a yielding compliance of 85 percent followed by 89 percent yielding compliance for the second four-beacon system treatment. The average yielding compliance for a two-beacon system was 82 percent. The average yielding compliance for the four-beacon system was 89 percent. The introduction of a two- and four-beacon system produced 71 and 78 percentage point increases over the baseline and increases of 66 and 73 percentage points over the standard-beacon system, respectively (see figure 5).

Figure 5. Graph. Driver yielding behavior at the 58th Street N site.

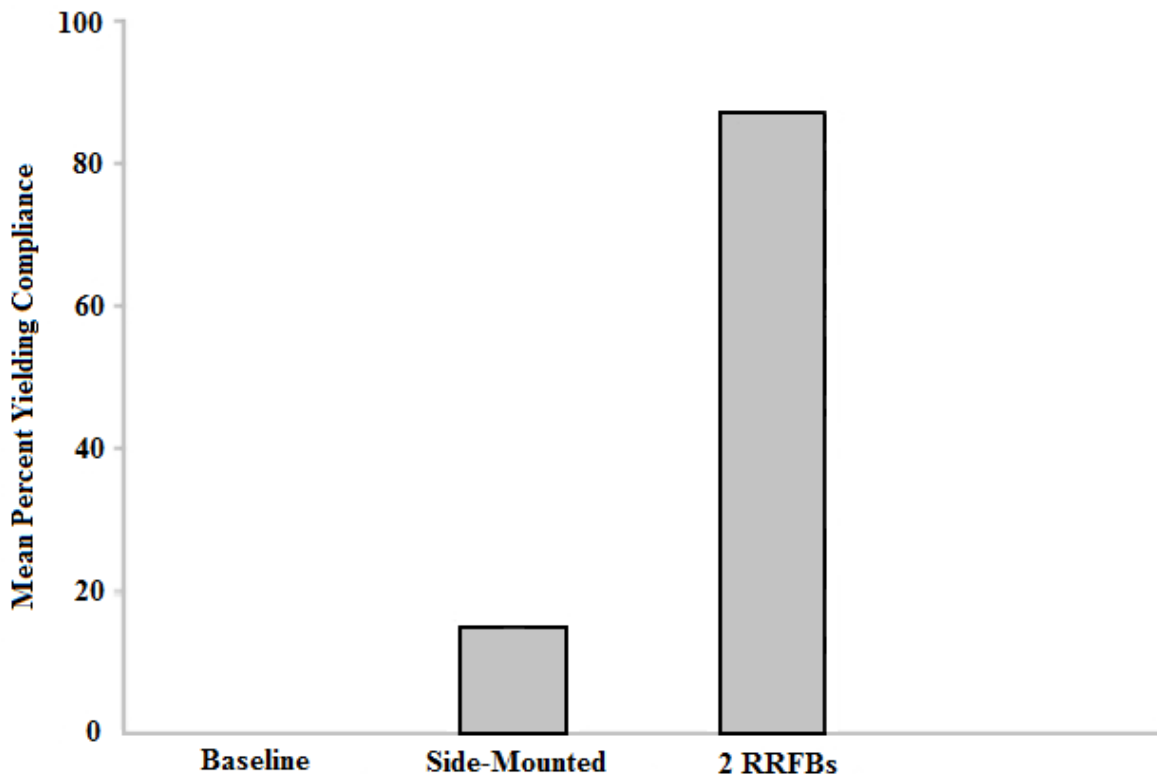
Baseline data from the second site at 4th Street and 18th Avenue showed zero percent yielding compliance. Activating the side-mounted standard beacon produced a yielding compliance of 15 percent after 30 days. The RRFB system produced a yielding compliance of 87 percent after 30 days. The RRFB percentages are representative of a two-beacon system only (see figure 6).

Figure 6. Graph. Relative efficacy of the side-mounted yellow beacon at the 4th Street S site.

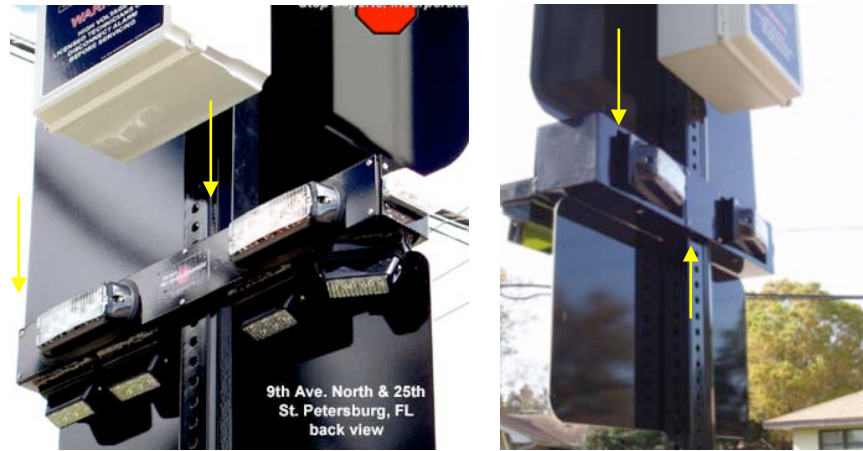
In this study, an alternating treatment design was employed to record driver yielding percentages in an evaluation of two devices in an effort to further increase driver yielding to pedestrians at a single midblock crossing. The alternating treatment design was chosen due to its ability to evaluate multiple treatments while offering experimental control. This is accomplished by rapidly alternating between two or more different treatments in succession after an initial stable baseline has been achieved. The design allows for the alleviation of any possible confounding or nuisance variables.⁽¹³⁾ First, baseline data were collected by having staged pedestrians (researchers) cross as the drivers' yielding behavior was recorded for three datasheets, each consisting of 20 crossings. After this, data were collected on the preexisting RRFB device for a total of 70 crossings following the baseline at 7, 30, 270, and 365 days. The third stage involved the installation of Direct Aim[®] LED lights along with an MLB to the RRFB.

Figure 7. Photo. Perpendicular lighting (left panel) and Direct Aim[®] lighting (right panel).

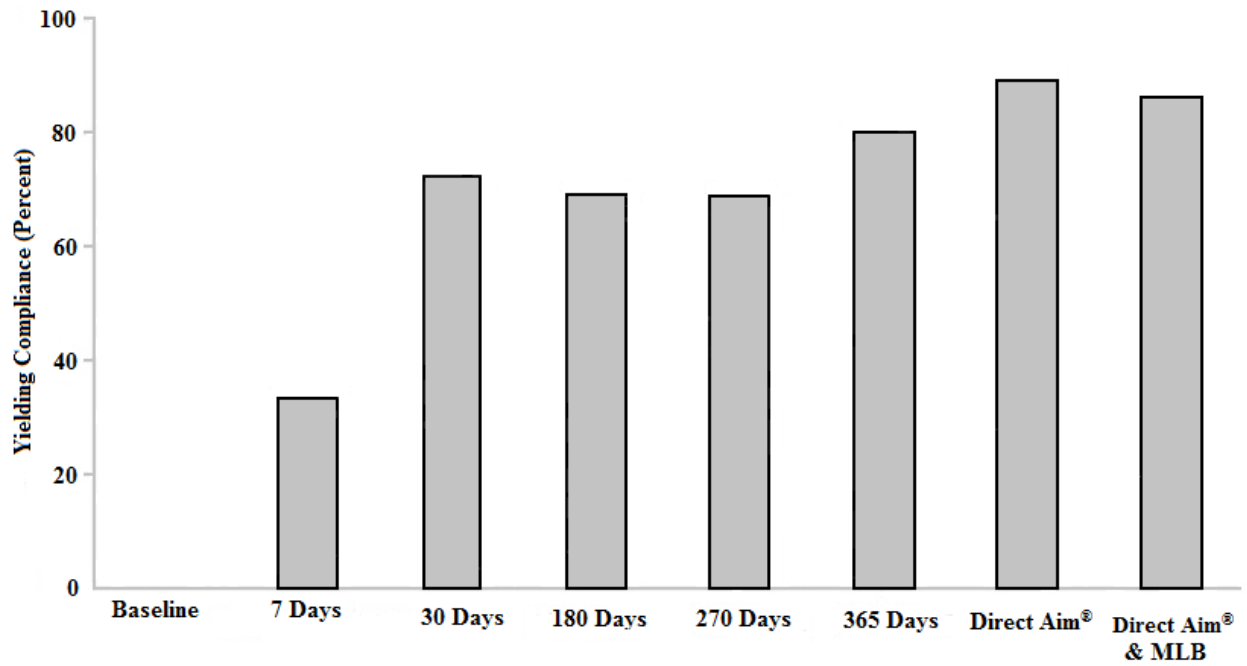
The percentage of drivers who yielded to pedestrians during the baseline condition was zero percent. The average yielding compliance 7 days after RRFB installation increased to 33 percent. Yielding compliance continued to increase to 72 percent 30 days after installation. Average yielding compliance was 69 percent after 180 days and remained unchanged 270 days after installation. Yielding compliance 365 days after installation averaged 80 percent (see figure 8). The average yielding compliance during the duration of the RRFB with perpendicular lighting was about 80 percent.

The change from perpendicular LEDs to Direct Aim[®] lighting produced an average increase of 89 percent. Sessions including the MLB produced an average of 86 percent. These averages included 100 crossings per condition.

Figure 8. Graph. Yielding compliance for experiment 4 located at 4th Street and 18th Avenue S in St. Petersburg, FL.

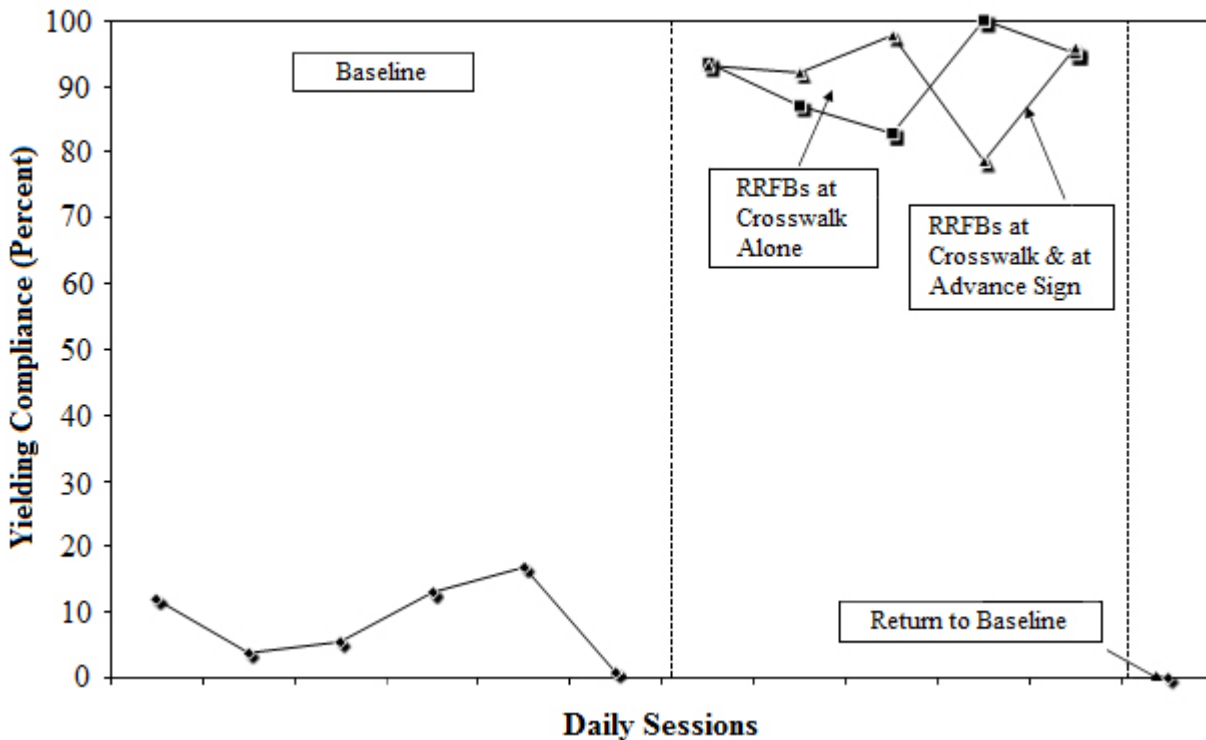
The average yielding compliance at the site during the initial baseline recording was 8.6 percent. The yielding compliance during the initial baseline ranged from 0.8 to 17 percent. The RRFB unit alone produced yielding averages of 95, 85, 83, 100, and 95 percent per session. The average yielding compliance during the RRFB at the crosswalk alone was 92 percent. The RRFB plus advance warning device had yielding averages of 93, 92, 98, 79, and 96 percent, respectively. The average yielding compliance during the RRFB plus advance warning condition was 92 percent (see figure 9). A return to baseline conditions for 20 consecutive crossings produced a yielding compliance of zero percent. The number of vehicles observed as not yielding during the return to baseline conditions was 344.

Figure 9. Graph. Yielding compliance during the baseline and the RRFBs at the crosswalk alone versus the RRFB at the crosswalk plus the RRFB at the advance sign.

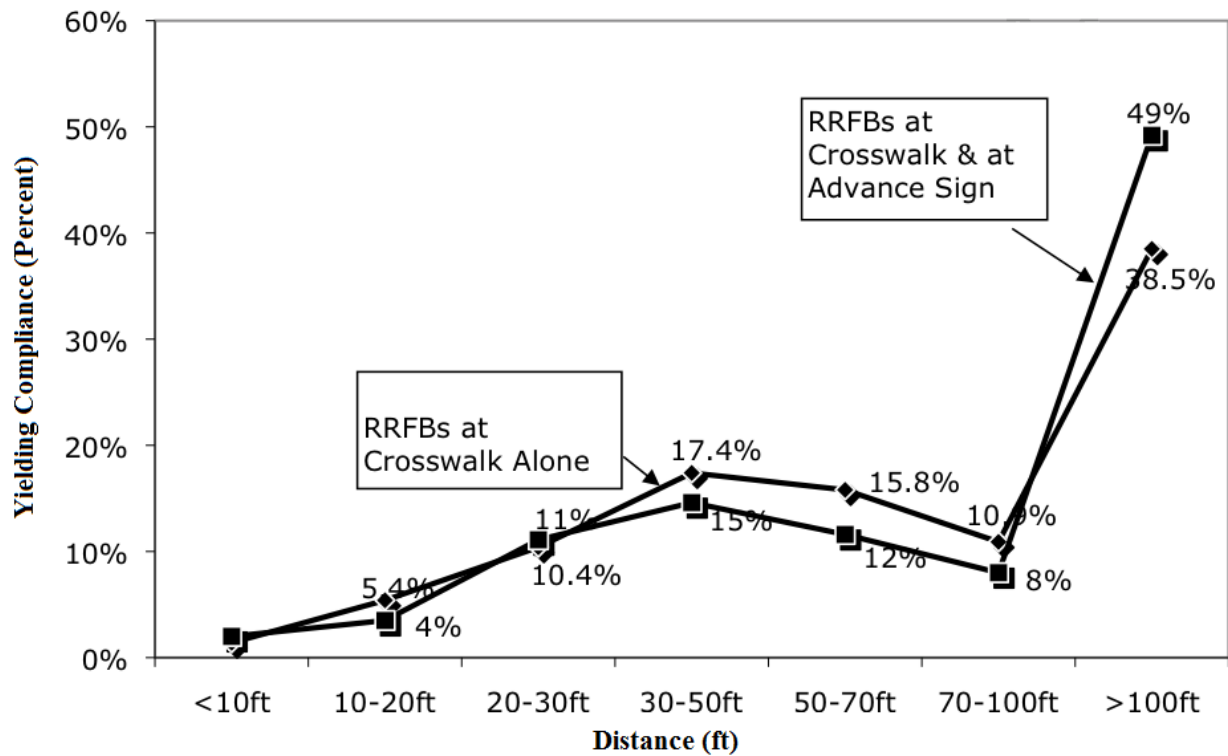
The absence of LED devices at this site was associated with a large proportion of driver yielding at 30–50-ft, with a yielding compliance of 37 percent. The second and third highest yielding distances during the baseline were the 20–30-ft and 10–20-ft intervals, with yielding compliances of 30 and 13 percent. During the RRFB at crosswalk alone condition, the largest proportion of drivers (39 percent) yielding more than 100 ft in advance of the crosswalk. The second and third highest percentages of yielding occurred at the 30–50-ft and 50–70-ft intervals, with 18 and 16 percent yielding compliance. The RRFB on the crosswalk and advance warning sign condition produced the highest proportion of drivers (49 percent) yielding over 100 ft from

the crosswalk. Drivers yielding farther in advance of the crosswalk can be expected to improve the safety of pedestrians (see figure 10).

Figure 10. Graph. Average yielding percentage during the RRFBs at the crosswalk alone and the RRFBs at the crosswalk and on the advance sign.
