**Home Inspection Report
Provided for:**

Property Address:

123 Main Street
Anytown, PA

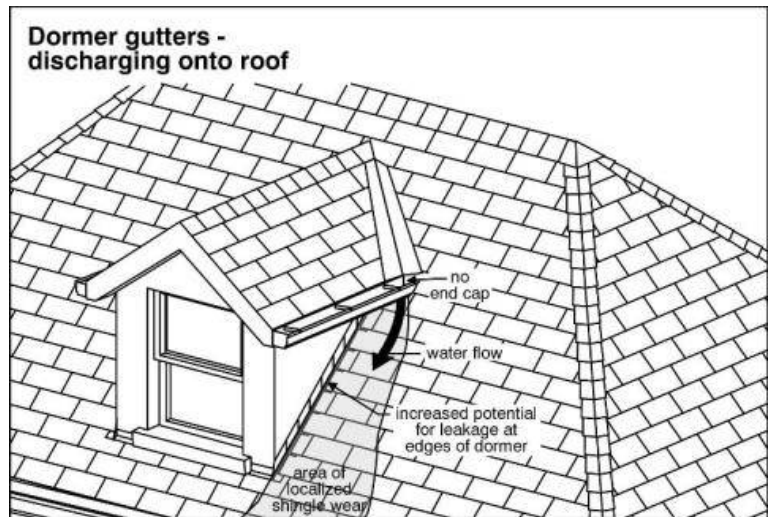
TYPE & CONDITION:	Full, Debris was observed in gutters. Recommend having gutters cleaned to ensure proper operation, Add downspout extensions to prevent water from downspouts from draining onto roof surface. This can cause premature wearing of the roof at this location. Downspouts enter into an underground drainage line. Inspection of underground drainage systems is not part of the scope of a home inspection.
-------------------	--

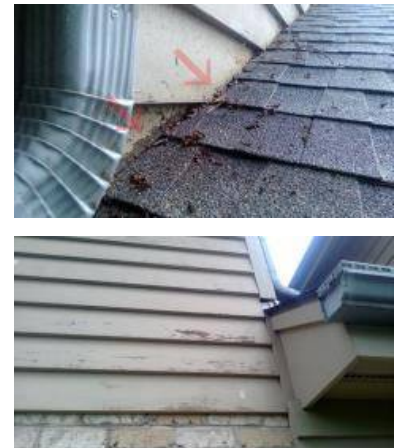
Peeling of paint observed at various locations.

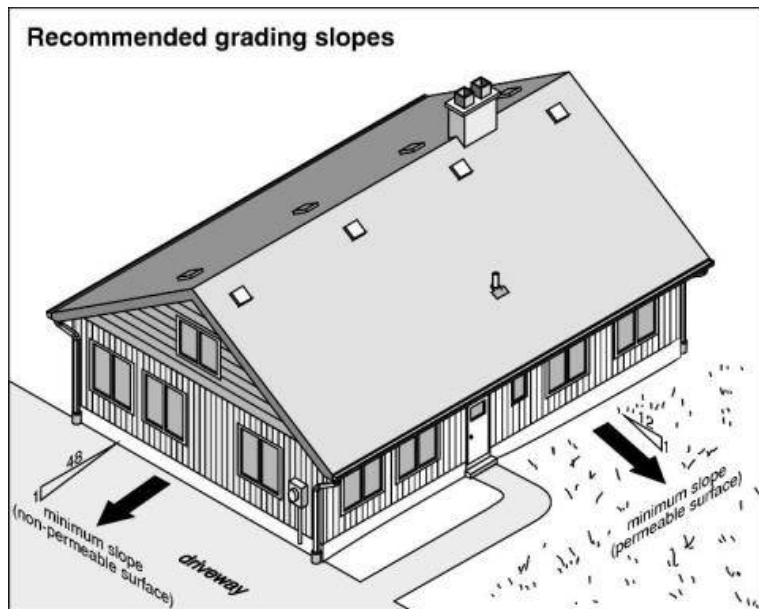
The home had areas of neutral or negative drainage at grade which will route runoff from precipitation to the foundation. This could allow moisture to accumulate at the foundation and risk entry to the basement. The ground should slope away from the home 1-inch per foot for a distance of at least six feet from the

foundation.

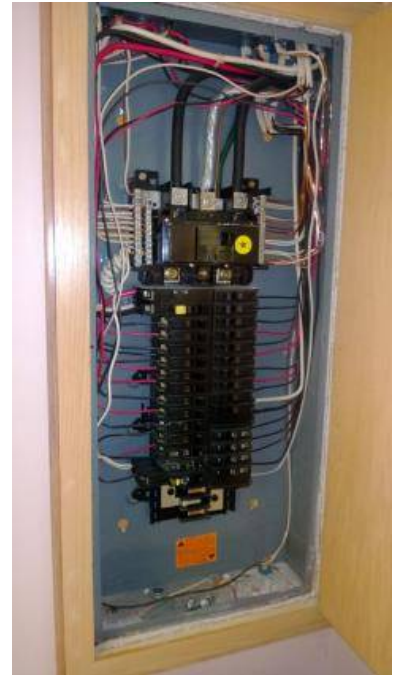
The main electrical service panel was located in the basement. The main electrical service panel label listed the panel rating at 200 amps.
