### Research Article

## Investigations on microbiologically influenced corrosion

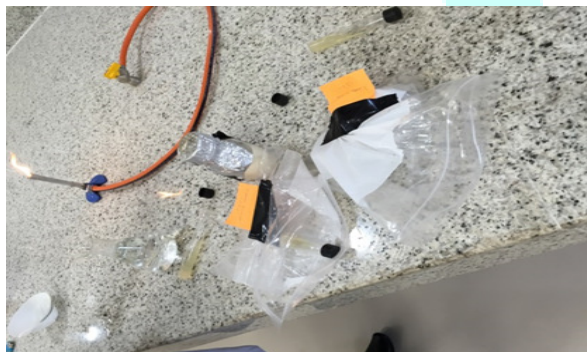
Thus 3 gm of TSB weighted using the balance as, then it's added to 100 ml of distillate water. Media was mixed and kept in the incubator for 24 hours at 35°C. Then original *E. coli* bacteria were used for growing a new generation of the bacteria, as shown in figure 1.

Figure 1. Preparing a new generation of the bacteria

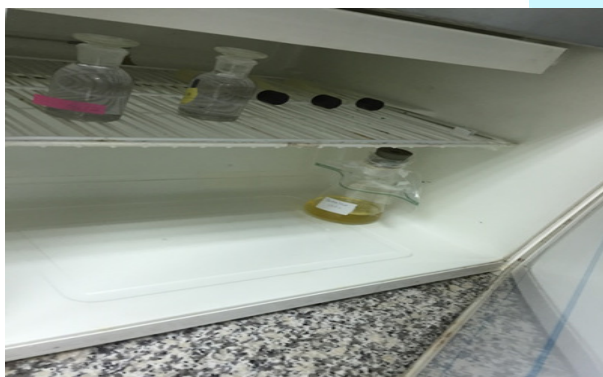
A flame is used to sterilize the loop used to take part of the bacteria. After sterilization the loop enters slowly to the bacteria tube and a small part of the original bacteria is taken. Then the bacteria were put by drawing on the media that already prepared specially for bacterial growth. The tubes which have drawn bacteria put in the incubator for 24 hrs at 35°C for growing new generation of bacteria as shown in figure 2.

Figure 2. Prepared media and bacteria in the incubator

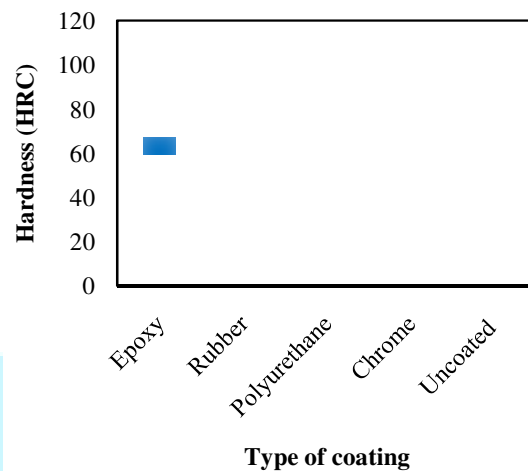
The Rockwell hardness values of different coatings are listed below and shown in figure 3.

Figure 3. Hardness for samples

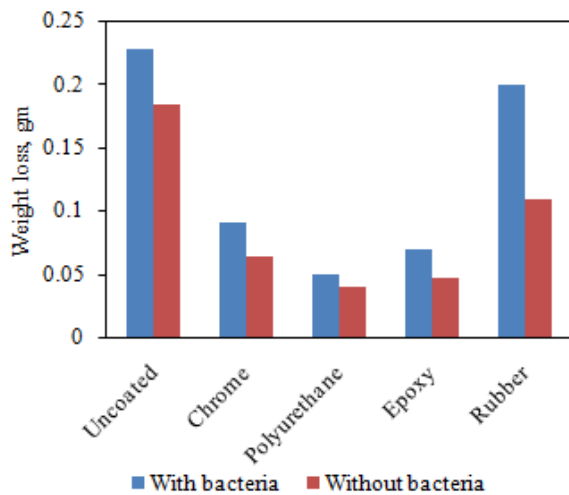
The samples were tested in 1liter of filtered sea water, which is done in two pool's, one with bacteria and the second without bacteria. The samples were monitored every day. Total period of exposure was for 12 weeks. Corrosion started on different coatings and they are shown in table 2 and figure 4.

Figure 4. Weight loss of different coatings in comparison test
