WORK ORDER REPORT

Service Request #933

Summary
Date Requested 02/28/2014
Description 1st time PM- CHANGE FILTERS
Created 02/28/2014 10:58 AM
Customer

Work Order #933-2-1

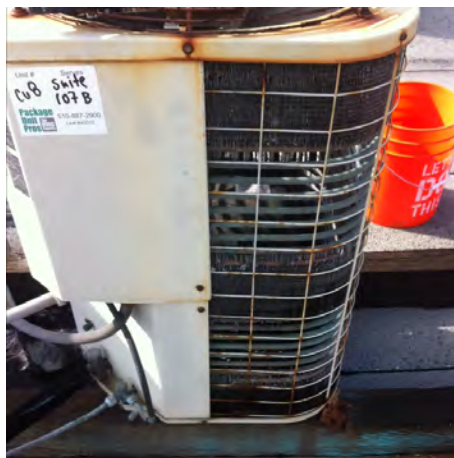
Customer
Address
Urgent! YES!
Date 03/06/2014
AC Number Cu 8 suite 107
Make BDP
If Other, Make
Model Number 661cj030-a
Serial Number 4496e19295
Type Number
Type of Unit
If Other, Type
Issue R&R condensing unit
Parts Required Condensing unit
Hours Required
OT Required?
Unit Age
Tonnage
Rigging
Photo 03/06/14 9:21 AM.png

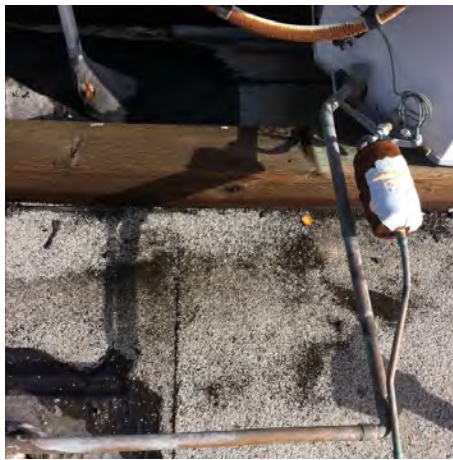
Customer
Address
Urgent! YES!
Date 03/06/2014
AC Number Cu9 suite 100
Make Carrier
If Other, Make
Model Number 38ycc030300
Serial Number 3100e23342
Type Number
Type of Unit Split System
If Other, Type
Issue Suction line not insulated
Parts Required Insulation
Hours Required 2
OT Required?
Unit Age
Tonnage
Rigging
Photo 03/06/14 9:29 AM.png

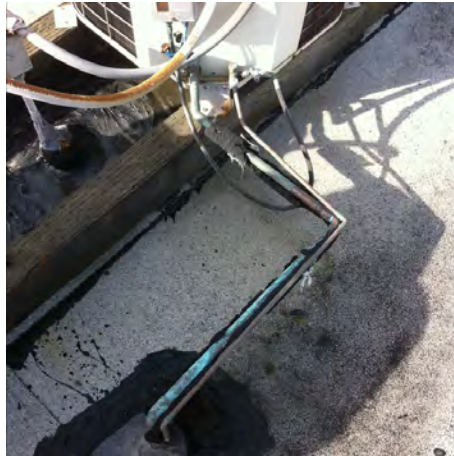
03/06/14 9:43 AM.png

Customer
Address
Urgent! YES!
Date 03/06/2014
AC Number Cu7 suite 107a
Make Other
If Other, Make Bryant
Model Number 661cj030-a
Serial Number 4299e19996
Type Number
Type of Unit Split System
If Other, Type
Issue Condenser fan not coming on, jumped out pressure control and fan came on. Also suction line insulation torn
Parts Required Pressure control, suction line insulation
Hours Required 4
OT Required?
Unit Age
Tonnage
Rigging
Photo

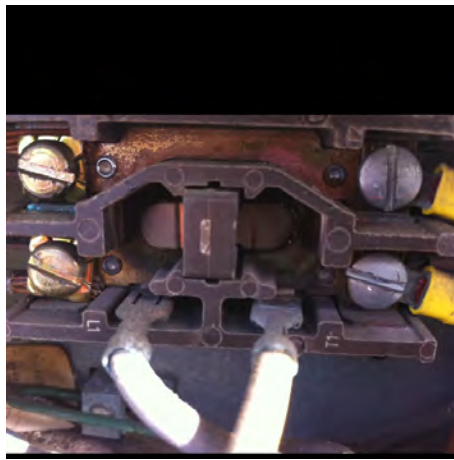
Customer
Address
Urgent! YES!
Date 03/06/2014
AC Number Cu6 suite 100
Make Other
If Other, Make Day and night
Model Number 541dj030
Serial Number 1784a30870
Type Number
Type of Unit Split System
If Other, Type
Issue Comp contactor burnt and pitted. Also no suction line insulation.
Parts Required 1p 30a 24v comp contactor, insulation
Hours Required 4
OT Required?
Unit Age
Tonnage
Rigging
Photo 03/06/14 9:54 AM.png

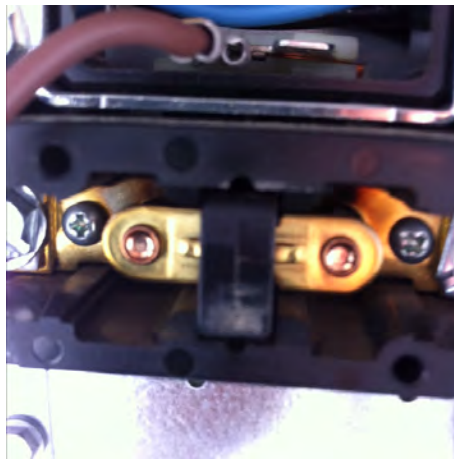
Customer
Address
Urgent! YES!
Date 03/06/2014
AC Number Ac4 suite 203b
Make Carrier
If Other, Make
Model Number 50eza2430
Serial Number 2709c11315
Type Number
Type of Unit Package Unit - Heat Pump
If Other, Type
Issue Contactor pitted and burnt compressor
Parts Required 1p 30a 24v comp contactor
Hours Required
OT Required?
Unit Age
Tonnage
Rigging
Photo 03/06/14 10:19 AM.png

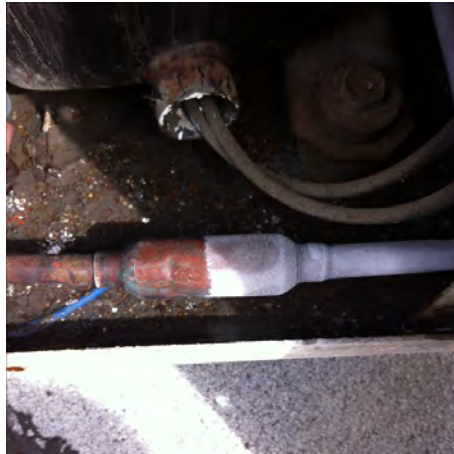
Customer
Address
Urgent! YES!
Date 03/06/2014
AC Number Cu5 suite 100
Make BDP
If Other, Make
Model Number 541dj030
Serial Number 1784a30881
Type Number
Type of Unit Split System
If Other, Type
Issue Suction line and compressor are very hot possible restriction.
Need time to troubleshoot
Parts Required
Hours Required 2
OT Required?
Unit Age
Tonnage
Rigging
Photo 03/06/14 11:05 AM.png

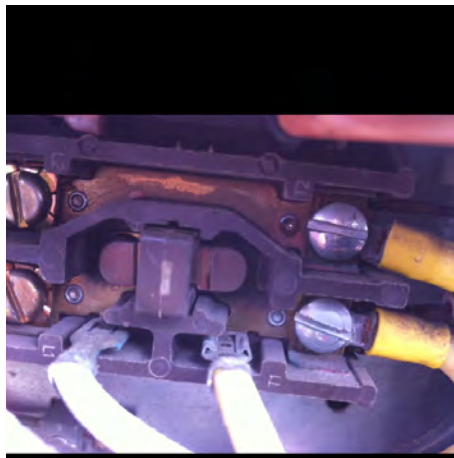
Customer
Address
Urgent! YES!
Date 03/06/2014
AC Number Cu2 suite 101a
Make BDP
If Other, Make
Model Number 541du030
Serial Number 784a30893
Type Number
Type of Unit Split System
If Other, Type
Issue Suction line has no insulation. Comp contactor burnt and pitted.
Parts Required 1p 30a 24v contactor. Suction line insulation
Hours Required 3
OT Required?
Unit Age
Tonnage
Rigging
Photo 03/06/14 11:24 AM.png

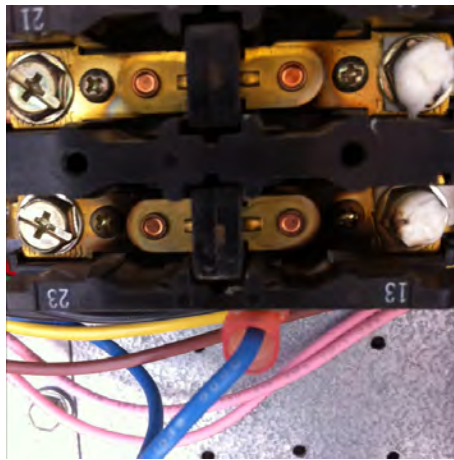
Customer
Address
Urgent! YES!
Date 03/06/2014
AC Number Ac7 suite 202a
Make Carrier
If Other, Make
Model Number 50js060501
Serial Number 0406g21097
Type Number
Type of Unit Package Unit - Heat Pump
If Other, Type
Issue Comp contactor burnt and pitted
Parts Required 2p 30a24v contactor
Hours Required 2
OT Required?
Unit Age
Tonnage
Rigging
Photo 03/06/14 11:57 AM.png

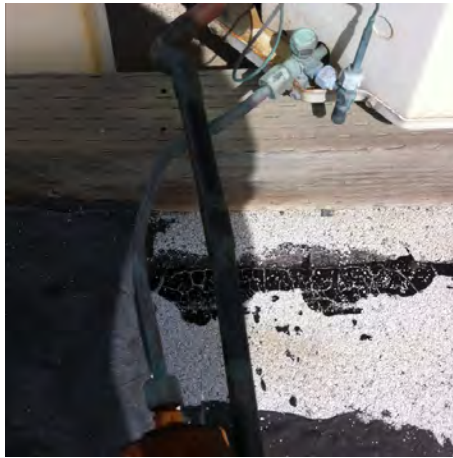
Customer
Address
Urgent!
Date 03/06/2014
AC Number Cu3 suite 100
Make Carrier
If Other, Make
Model Number 661cj030-a
Serial Number 4295e12358
Type Number
Type of Unit Split System
If Other, Type
Issue No suction line insulation
Parts Required Insulation
Hours Required 1
OT Required?
Unit Age
Tonnage
Rigging
Photo 03/06/14 12:21 PM.png

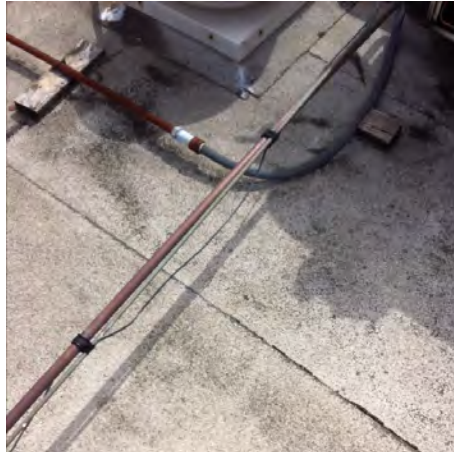
Customer
Address
Urgent! YES!
Date 03/06/2014
AC Number Cu1 suite 101a
Make BDP
If Other, Make
Model Number 541d
Serial Number 1884a32547
Type Number
Type of Unit Split System
If Other, Type
Issue Top off charge, and compressor contactor burnt and pitted. Also suction line is not insulated
Parts Required R-22 amount tbd. 1p 30a24v comp contactor. Suction line insulation 10 feet.
Hours Required 5
OT Required?
Unit Age
Tonnage
Rigging
Photo 03/06/14 12:52 PM.png

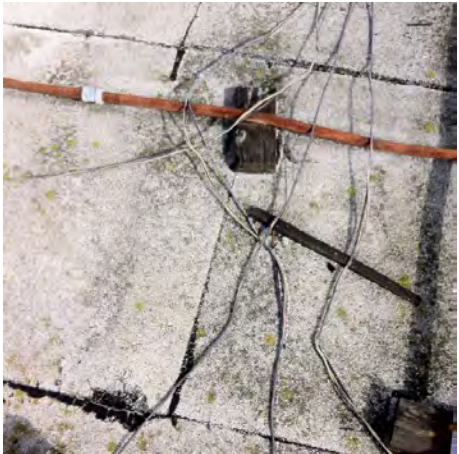
Customer
Address
Urgent! YES!
Date 03/06/2014
AC Number Ac1 suite209, ac2 suite 210, ac4 suite 200, ac5 suite207, ac6 suite200, ac7 suite 203, ac8 suite200, ac9 suite201.
Make Carrier
If Other, Make
Model Number ?
Serial Number ?
Type Number
Type of Unit Package Unit - Heat Pump
If Other, Type
Issue All units except ac3 suite208 have there stat wires ran across the roof from one end to the other end. We need to run stat wires through the plentum. All exposed and ready to short out
Parts Required Stat wire
Hours Required 16
OT Required?
Unit Age
Tonnage
Rigging
Photo 03/06/14 1:21 PM.png
