Priority Home & Property Inspections, LLC

Home Inspection Report

Sample Report

Date of Inspection: 2/15/2017

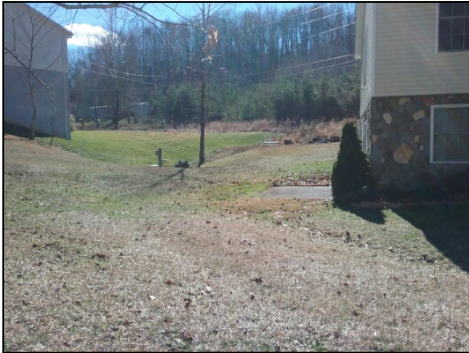
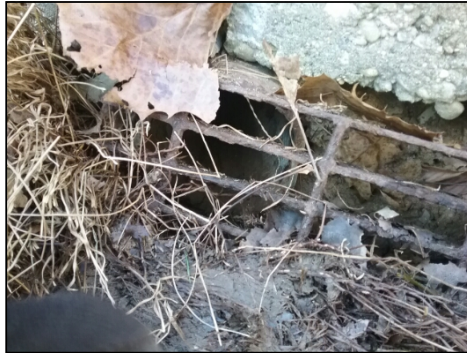
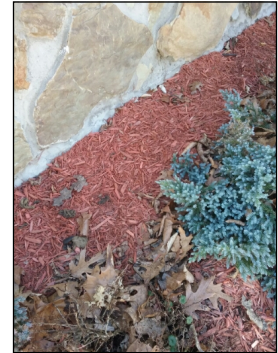
1. Grading Conditions

- Mulch was observed at or near the foundation. This product is known to retain moisture and may cause damage to the foundation. Recommend clearing this away for proper drainage at the foundation.
- Low and settled grading was observed at the time of inspection along the flower bed(s). Water can affect the foundation in this area. Recommend repair as needed.
- Recommend regular maintenance as needed by a licensed qualified professional for proper operation.

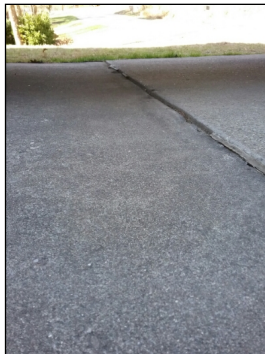
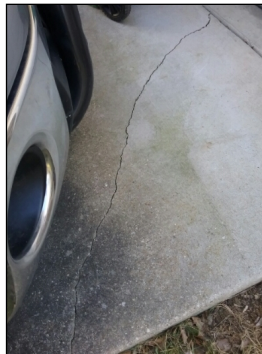
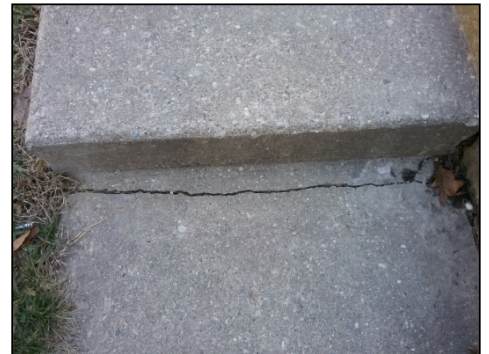
2. Driveway and Walkway Condition

- Common cracks and/or settling were observed at the time of inspection in the driveway and/or walkway.
- Uneven slab and/or material were observed in the walkway/driveway at the time of inspection. This is a potential tripping hazard.
- Recommend further inspection, evaluation, maintenance or repair as needed by a licensed qualified professional.

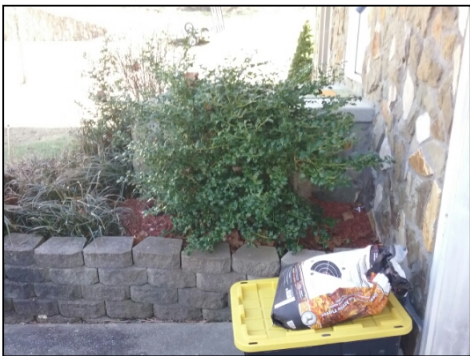
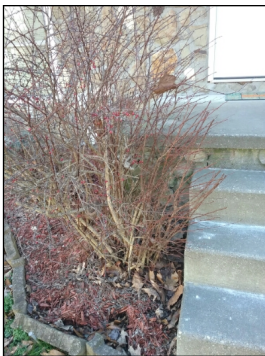
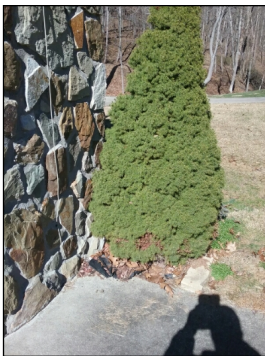
3. Vegetation Conditions

- Recommend keeping all trees and shrubs cut back away from the home to allow the sun to keep this area dry and avoid moisture and pest intrusion.
- Recommend regular maintenance as needed by a licensed qualified professional for proper operation.

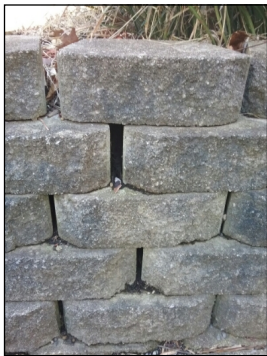
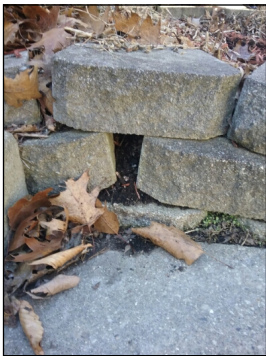
4. Retaining Wall(s) Conditions

- Minor movement of the retaining wall(s) was observed at the time of inspection. The most common reason for a retaining wall to fail is due to the lack of drainage or weep holes in the wall. Without proper drainage the wall may have excessive pressure on the back side therefore causing the wall to push outward away from the earth it is holding back.
- Recommend further inspection, evaluation, maintenance or repair as needed by a licensed qualified professional.

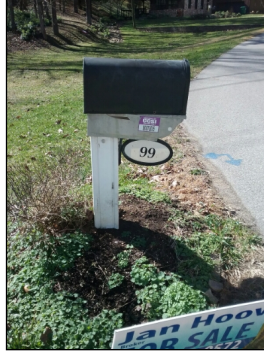
1. House Numbering Conditions

- The general condition of the observed and readily accessible house numbering appeared to be in satisfactory condition at the time of inspection.

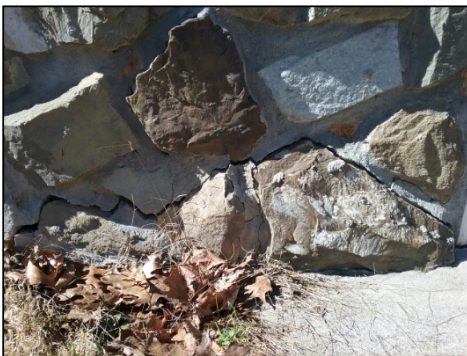
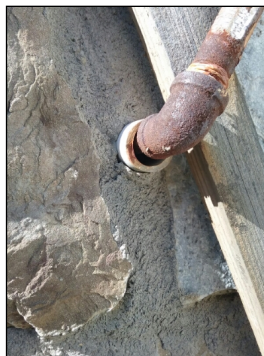
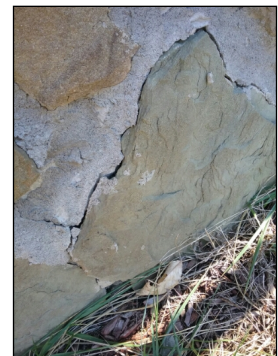
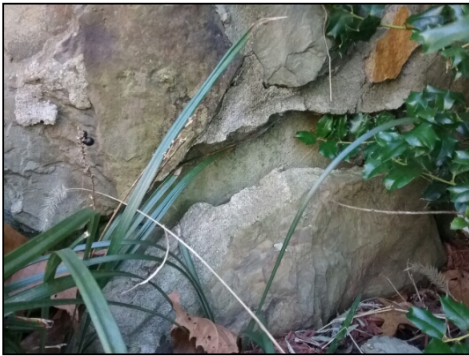
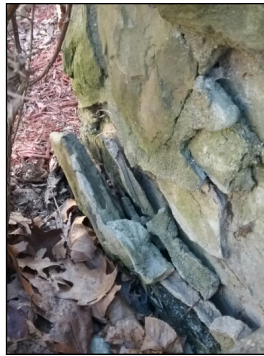
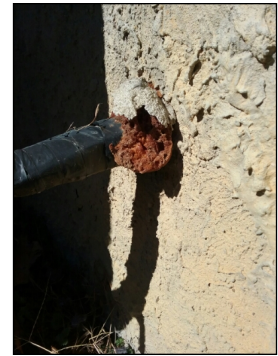
2. Siding Conditions

- Missing caulk or sealant was observed at several locations of wall penetrations throughout the home. Recommend re-caulking and sealing as needed to prevent moisture and pest intrusion.
- Recommend regular maintenance as needed by a licensed qualified professional for proper operation.
- Damaged material and/or missing siding was observed on the exterior of the home. Due to conditions observed, hidden damage and/or water penetration may exist in areas not readily accessible.
- Recommend further inspection, evaluation, maintenance or repair as needed by a licensed qualified professional.

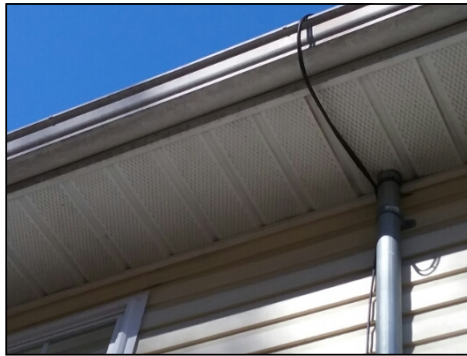
- The general condition of the observed and readily accessible portions of the eaves / soffits appeared to be in satisfactory condition at the time of the inspection.

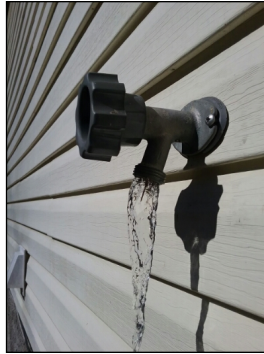
- The observed and readily accessible exterior faucet(s) were tested at the time of inspection and appeared to be functional.

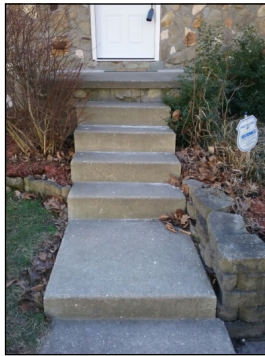
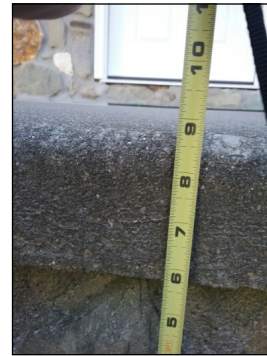
7. Stair/Steps/Railing Conditions

- No railing and/or missing baluster was observed at the time of inspection at the steps. This is a potential safety hazard. Recommend installing protective railing by a licensed qualified professional.
- The step rise appeared at the time of inspection to be inconsistent or insufficient. Current building practices allow a max difference of 3/8 inch in step height as well as a minimum of 4 inch riser height.
- Recommend further inspection, evaluation, maintenance or repair as needed by a licensed qualified professional.

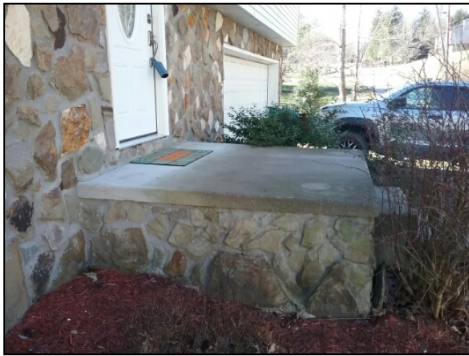
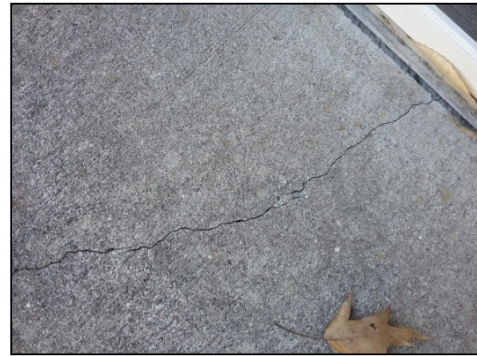
8. Porch/Patio Conditions

- Common cracks were observed at the time of inspection. Although these conditions are common in most homes, client is advised to monitor cracks for future movement.
- Recommend regular maintenance as needed by a licensed qualified professional for proper operation.
- The hand rail and/or guardrail were observed at the time of inspection to be missing or too low when compared to current building standards.
- It is recommended a "Licensed General Contractor" be contacted for further inspection, evaluation and repair as needed.

Exterior		
Page 11 Item: 8	Porch/Patio Conditions	<ul style="list-style-type: none"> • The hand rail and/or guardrail were observed at the time of inspection to be missing or too low when compared to current building standards. • It is recommended a "Licensed General Contractor" be contacted for further inspection, evaluation and repair as needed.
Garage/Carport Conditions		
Page 18 Item: 11	Heat/Air Source Conditions	<ul style="list-style-type: none"> • Heat and air source was observed at the time of inspection. • It is recommended a qualified "Licensed HVAC Contractor" be contacted for further inspection, evaluation and repair as needed.
Electrical		
Page 35 Item: 3	Electrical Panel Conditions	<ul style="list-style-type: none"> • Grounding bus bar was observed at the time of inspection to not be bonded to the enclosure. Recommend bonding the bus bar to the electric panel enclosure for proper grounding protection. • It is recommended a qualified "Licensed Electrical Contractor" be contacted for further inspection, evaluation and repair as needed.

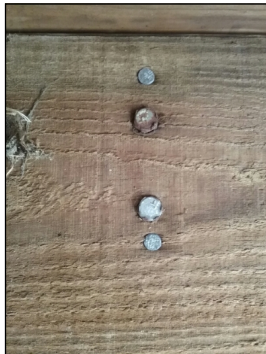
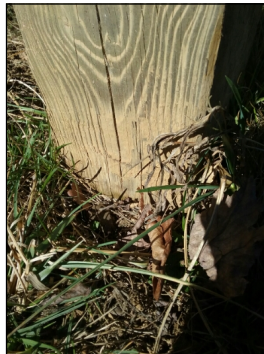
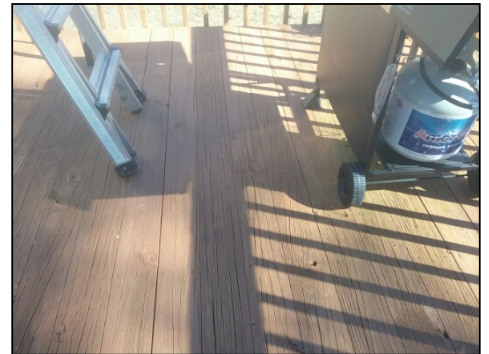
9. Deck Conditions

- The deck appeared at the time of inspection to be weathered and/or deteriorated. Recommend maintenance to prevent further deterioration.
- Recommend regular maintenance as needed by a licensed qualified professional for proper operation.
- The deck ledger board was observed at the time of inspection to be nailed or screwed to the house. Recommend installing bolts to securely attach ledger board to house.
- Recommend further inspection, evaluation, maintenance or repair as needed by a licensed qualified professional.

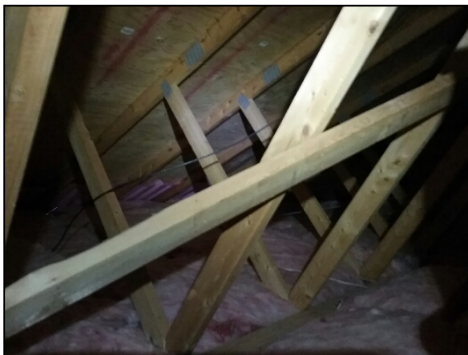
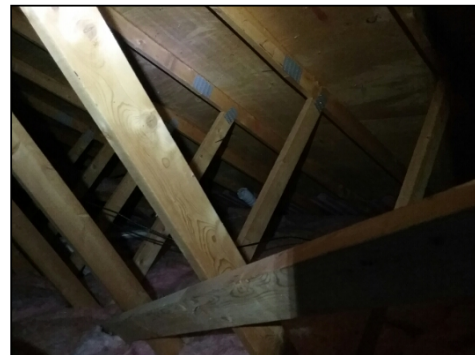
- The general condition of the observed and readily accessible portions of the roof framing and sheathing appeared to be in satisfactory condition at the time of the inspection.

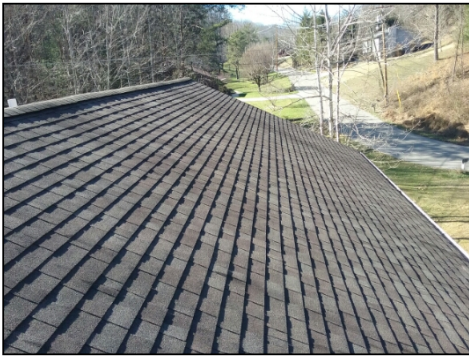
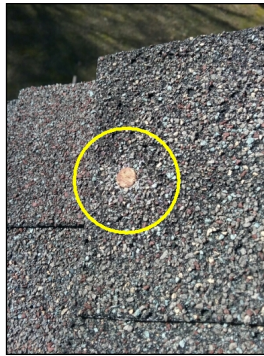
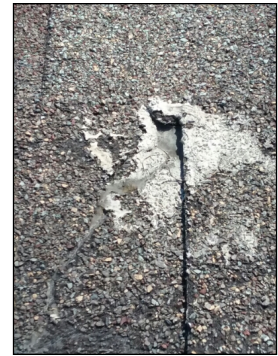
3. Roof & Roof Covering Conditions

- Previous repairs were observed at the time of inspection.
- Recommend sealing all nail heads in the flashing to reduce the possibility of moisture penetration.
- Recommend regular maintenance as needed by a licensed qualified professional for proper operation.
- Some damaged or missing shingles were observed at the time of inspection. This may be due to many different factors. Recommend repair as needed to help prevent future damage.
- Recommend further inspection, evaluation, maintenance or repair as needed by a licensed qualified professional.

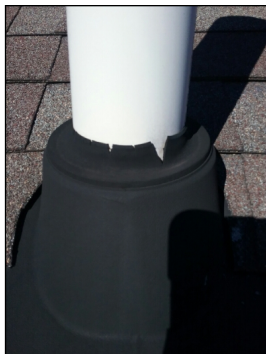
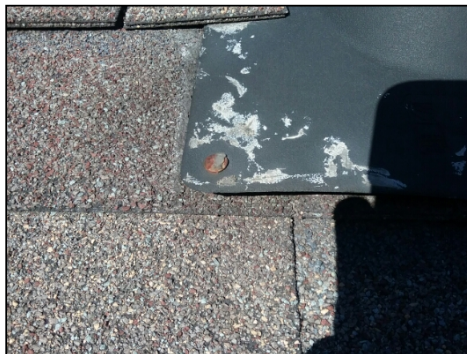
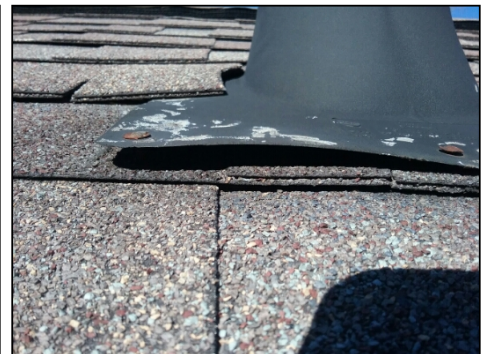
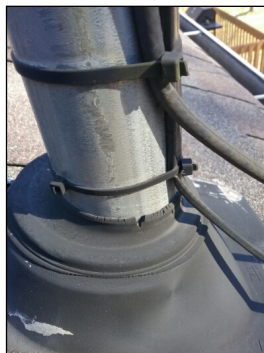
5. Roof Penetrations Conditions

- Exposed fasteners in the flashing were observed at the time of inspection. It is recommend not to have nails driven through this flashing; may cause water intrusion into the attic.
- Recommend regular maintenance as needed by a licensed qualified professional for proper operation.
- The vent pipe boot was observed at the time of inspection to be cracked/damaged on one or more of the plumbing vent pipes. Hidden water damage may have already occurred. Recommend repair as needed to prevent water intrusion/damage.
- Recommend further inspection, evaluation, maintenance or repair as needed by a licensed qualified professional.

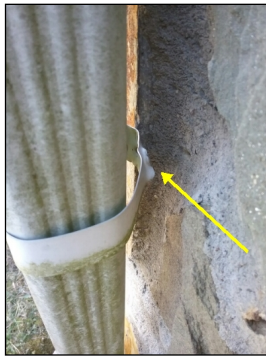
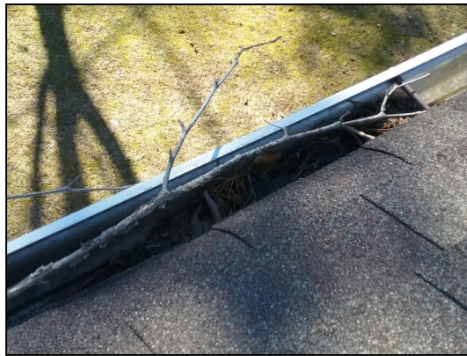
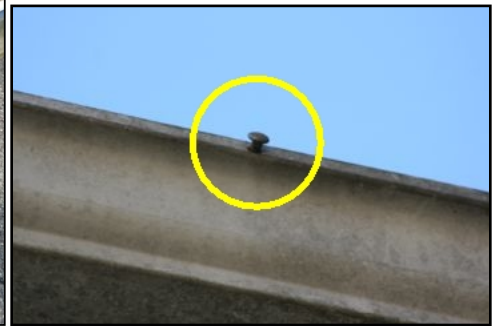
6. Gutter/Downspout Conditions

- The gutters were observed at the time of the inspection to be filled with leaves and debris. Recommend cleaning and removal of debris on a regular basis. This condition can cause water penetration at the eave area.
- Recommend regular maintenance as needed by a licensed qualified professional for proper operation.
- Loose, damaged and/or missing downspout(s) were observed around the home. Recommend repair or replacement as needed.
- Loose, leaking, damaged and/or improperly installed or sloped gutters were observed at the time of inspection in several locations around the home. Recommend repair as needed for proper operation.
- Recommend further inspection, evaluation, maintenance or repair as needed by a licensed qualified professional.
