Copper Dwelling Property Inspections

CONFIDENTIAL INSPECTION REPORT PREPARED FOR: **Sample Report**

INSPECTION ADDRESS
000 Sample Street, Sample, AZ 85000

SUMMARY REPORT

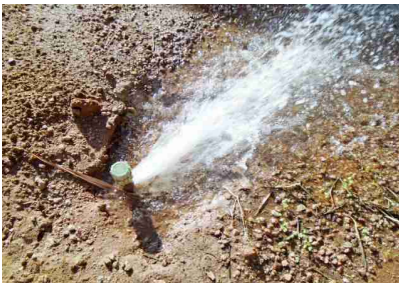
2.2 - √ The property is served by an irrigation system. However, there is a broken head or riser in the rear yard area, that should be repaired.

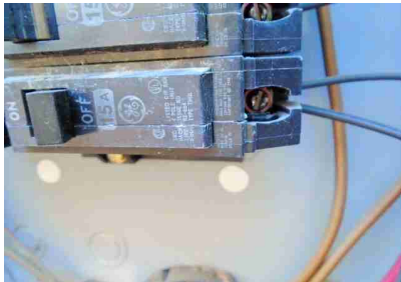
5.1 - v A fifteen amp breaker is serving two circuits (double tapped). This condition should be evaluated by an electrician.

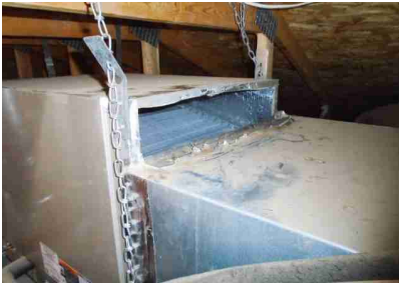
7.2 - v There is a section of duct work in the attic area at the airhandler that is missing and air loss was noticed in the attic area, recommend further inspection and repairs by a licensed HVAC contractor

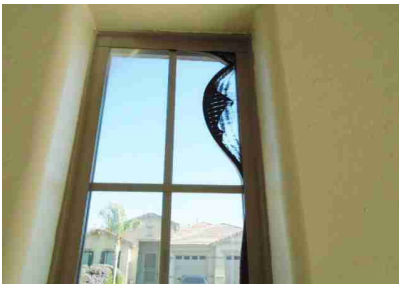
9.1 - √ The rubber seals between the dual panes of glass are beginning to separate and in time will lead to thermal failure for one of the bedroom window, recommend having a qualified glass technician inspect and make recommendations for repairs/ replacement

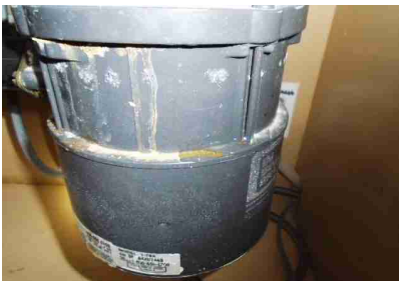
14.1 - √ The casing of the garbage disposal leaks at the kitchen sink, recommend replacement of the disposal by a licensed plumber.

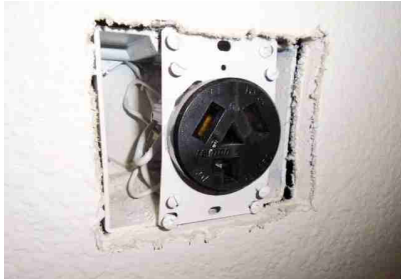
16.1 - √ The 220 cover for the dryer receptacle is missing and should be replaced for safety purposes

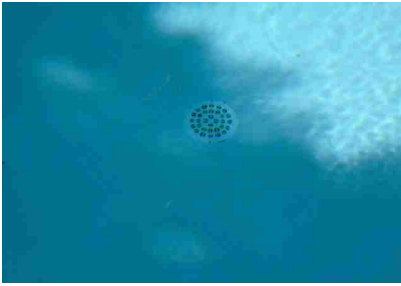
19.2 - √ The drain covers are present, however by today's standard vortex covers are required to prevent any entrapment, recommend having installed by a licensed pool contractor for safety purposes

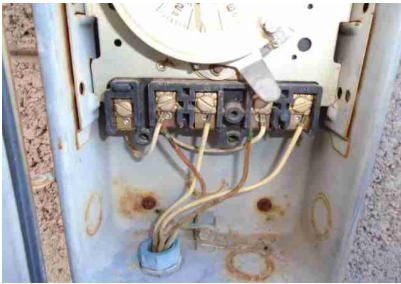
Pool time clock

19.3 - ✓ The plastic guard inside the pool timer box is missing and should be replaced for safety purposes
