**Appendix E**  
**Scott's Mill Dissolved Oxygen Sampling**

## **Scott's Mill Hydropower Project (FERC No. 144525)**

**Lynchburg City and Amherst Counties, Virginia**

**Phase II Architectural Survey of the  
Water Works Dam and Canal (118-0209-  
0002), James River Dam (118-0209-  
0003), and Scott's Mill Ruin (118-5497)  
City of Lynchburg, Virginia.**

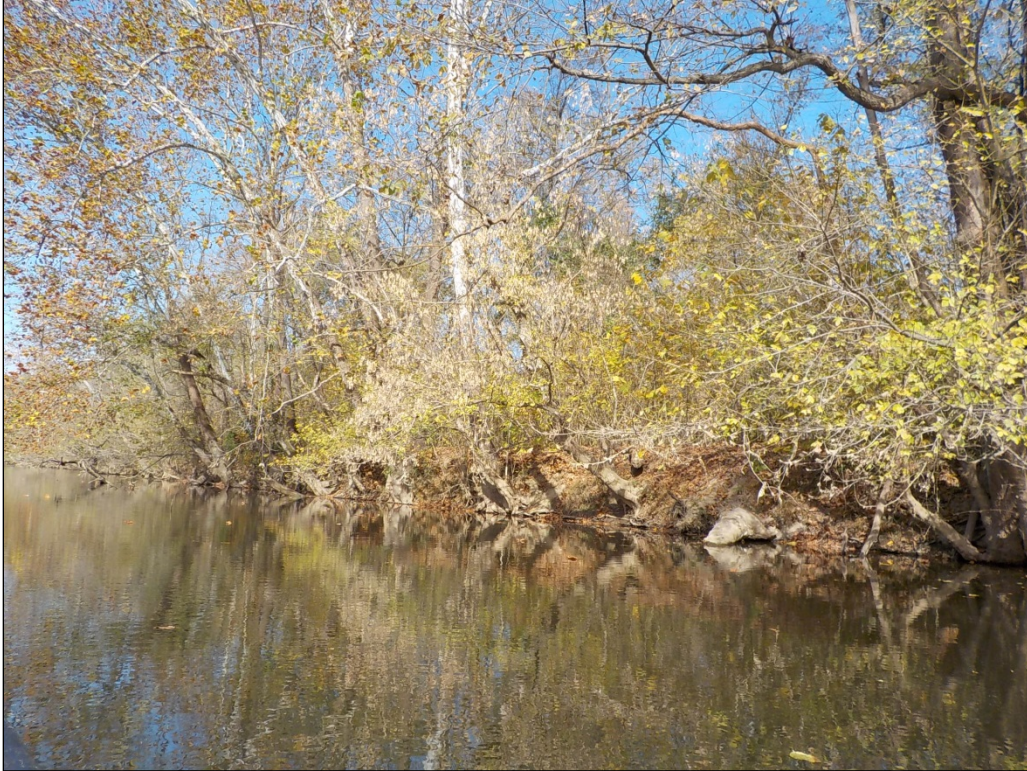
Photograph 1 – Southwestern shoreline of Daniel’s Island (note erosion), view N

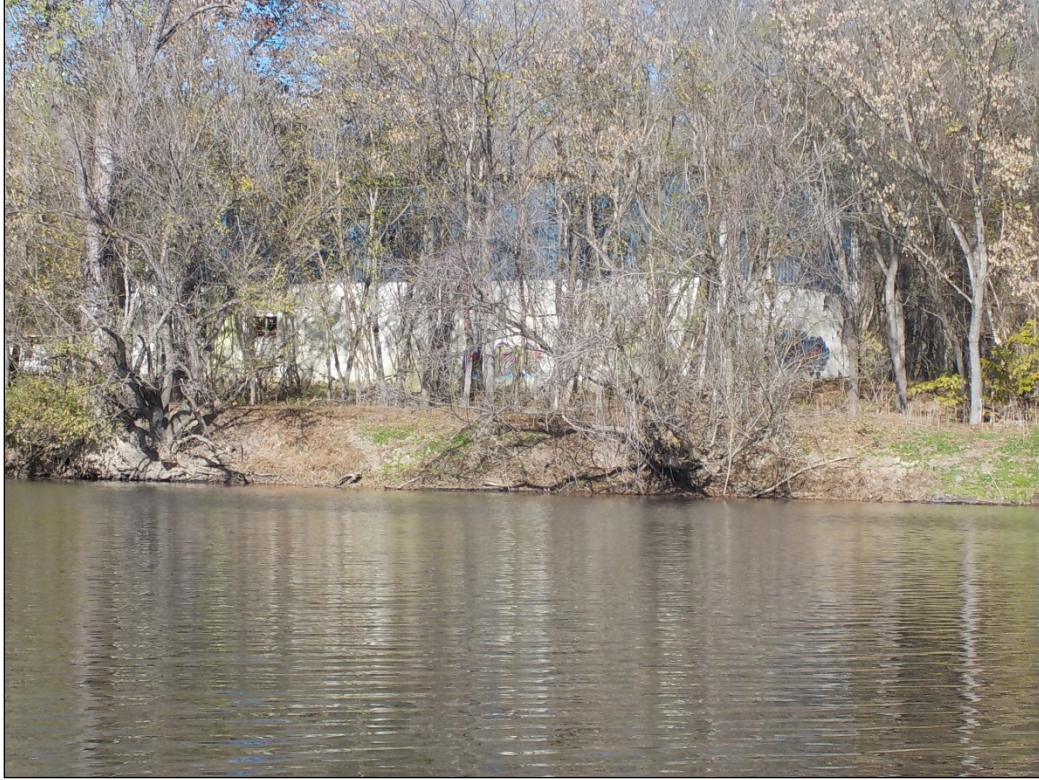
Photograph 5 – Relic structure on Treasure Island (note 6-8' high shoreline), view NE

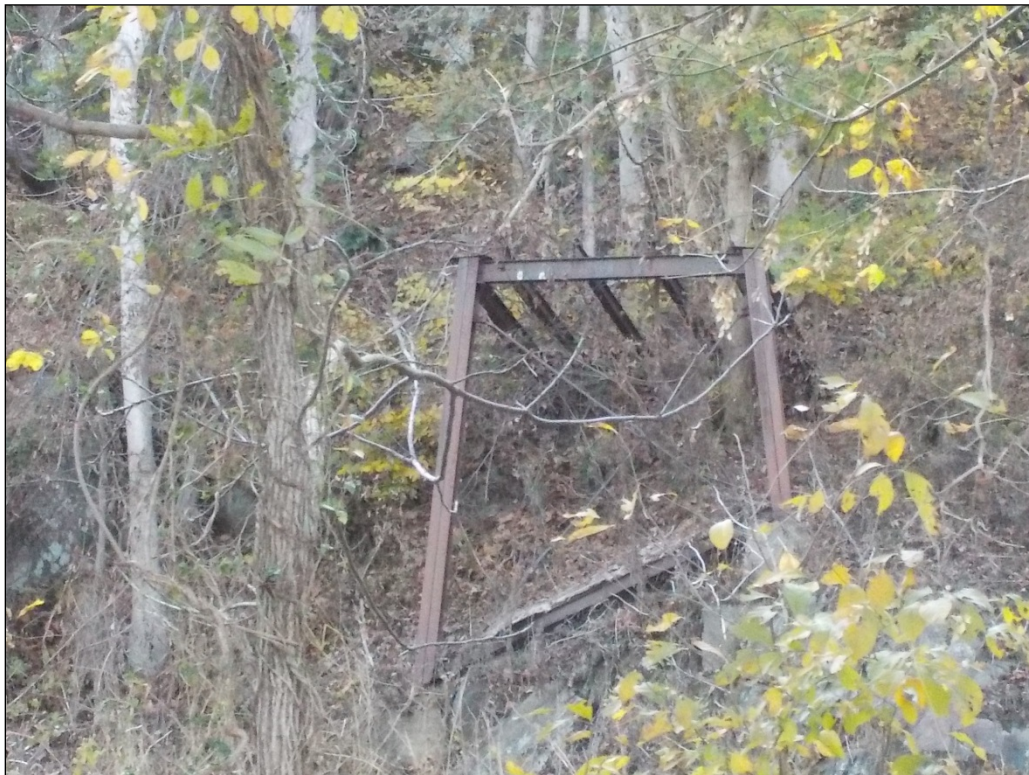
Photograph 6 – Relic bridge abutment on SW riverbank (view NW)

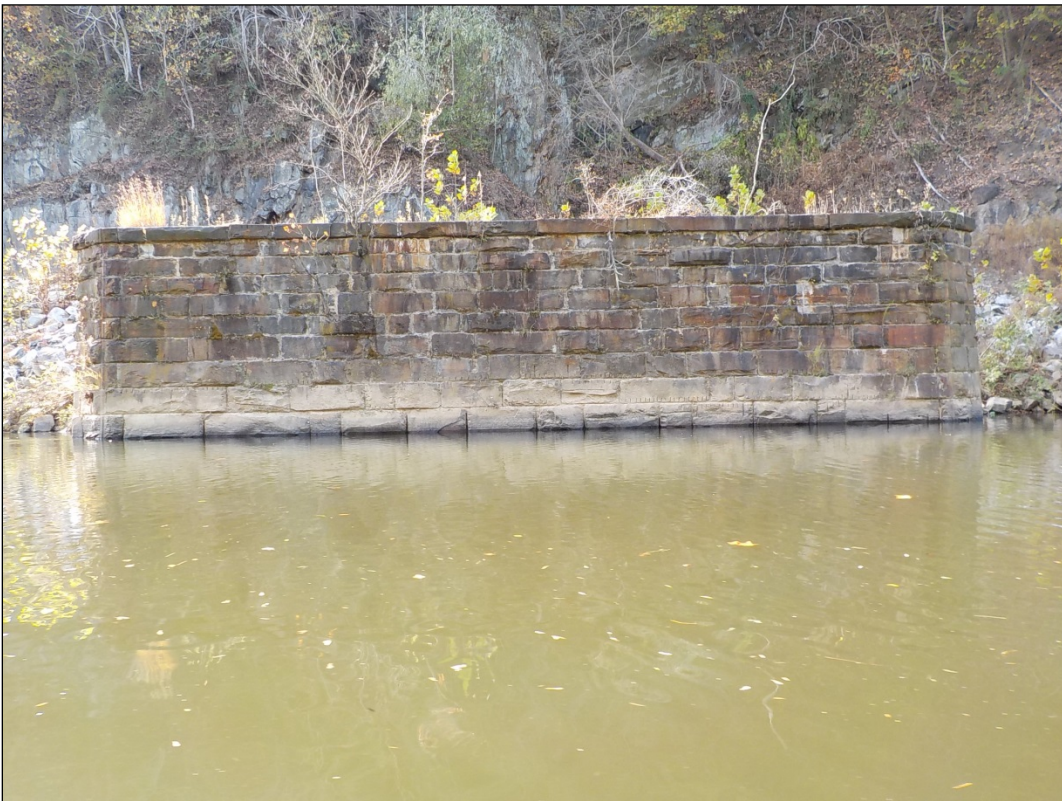
Photograph 8 – Relic stone railroad bridge pier, view SW

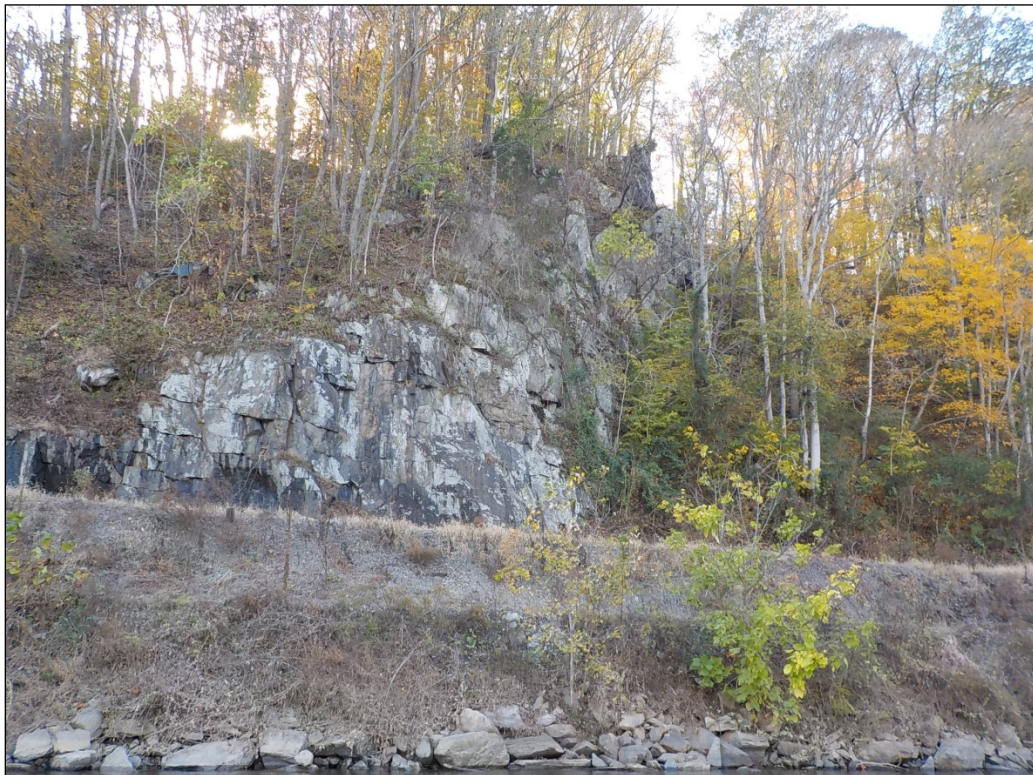
Photograph 10 – Typical SW riverbank, with railroad and >10' high riprap stabilization (view W)

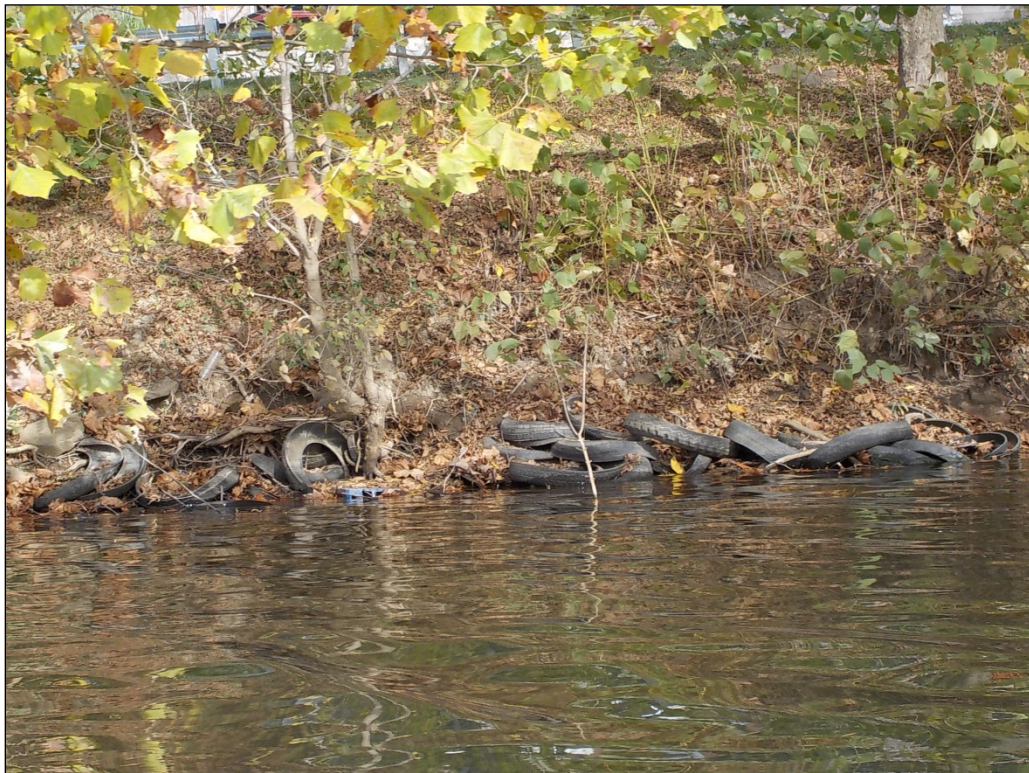
Photograph 20 – NE riverbank stabilization using waste tires, view NE

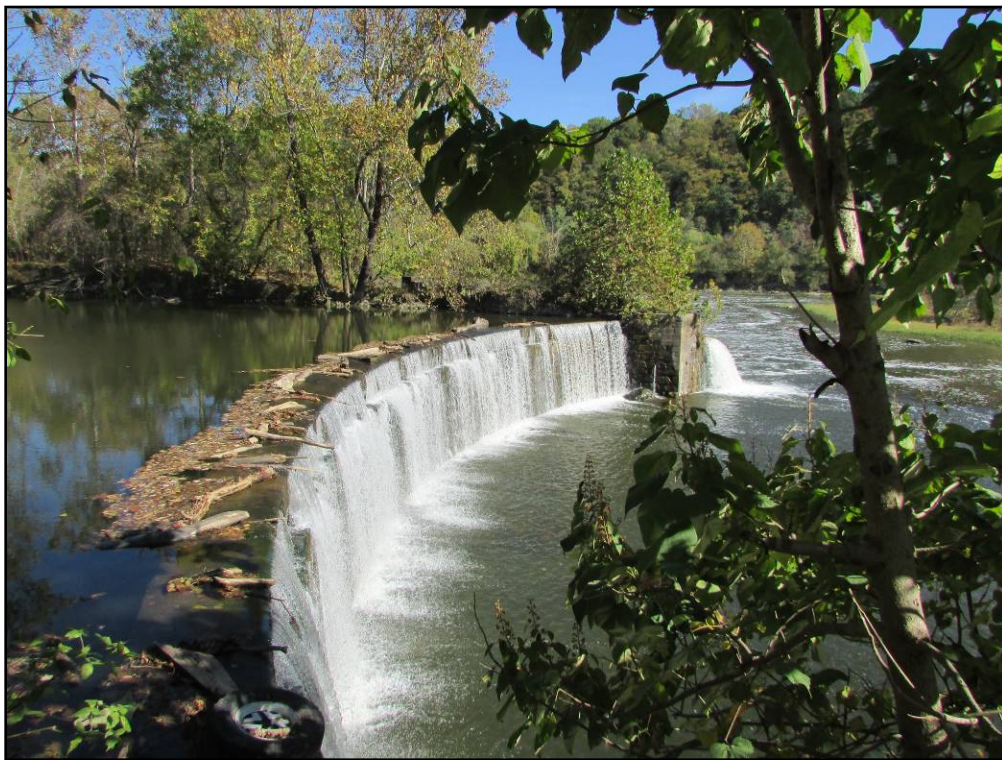
**Figure 3. Water Works Dam, view to the North.**

The Water Works Dam is still a prominent feature along the James River in the City of Lynchburg. Constructed of stone and designed in a curved shape, the dam runs between the shore of the river and Daniel's Island (Figure 3). The NRHP nomination form states that the dam has been heightened over the years and there is a ledge present that indicates that may be the case. It is possible that when the Glamorgan Pipe Factory (VDHR No. 118-0109) was established in 1882 and acquired the property from the City of Lynchburg, the dam was raised (VDHR Survey File).

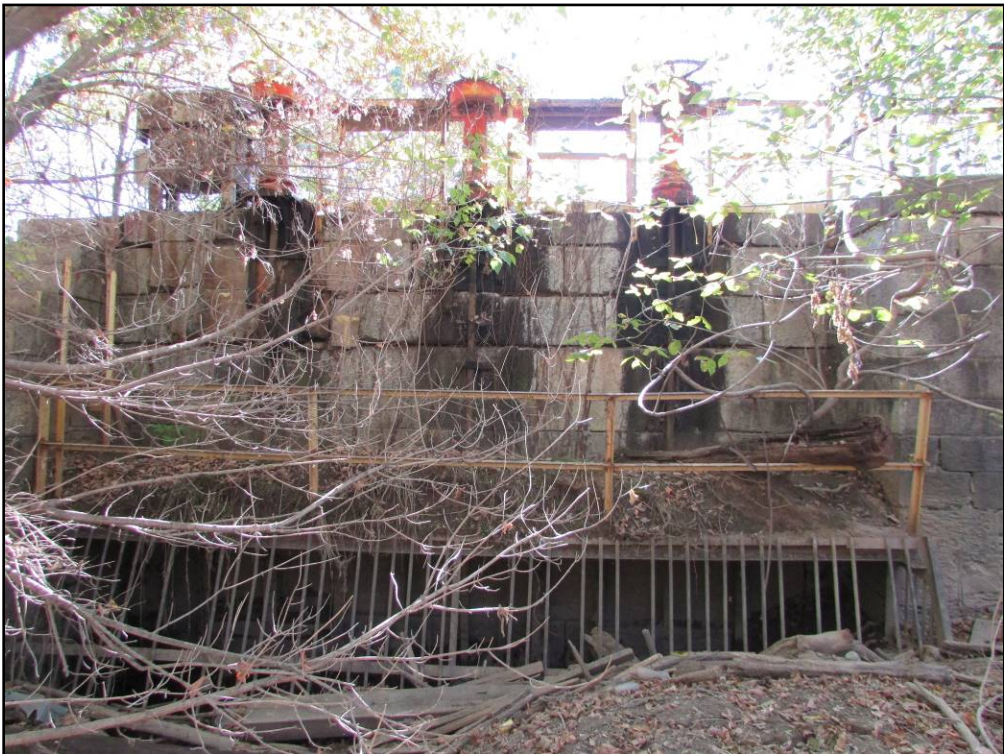
**Figure 5. Water Works Gate and Locks, view to the East.**

The Water Works Canal is still present on the Griffin, formerly Glamorgan, Pipe Works property, though the canal has been filled in and is currently used as storage for the company (Figure 4). The gate at the head of the canal is also still present, though changes to the resource are visible. For example, the hand operated wheels which regulate water flow are dated 1884 (Figures 5 and 6).

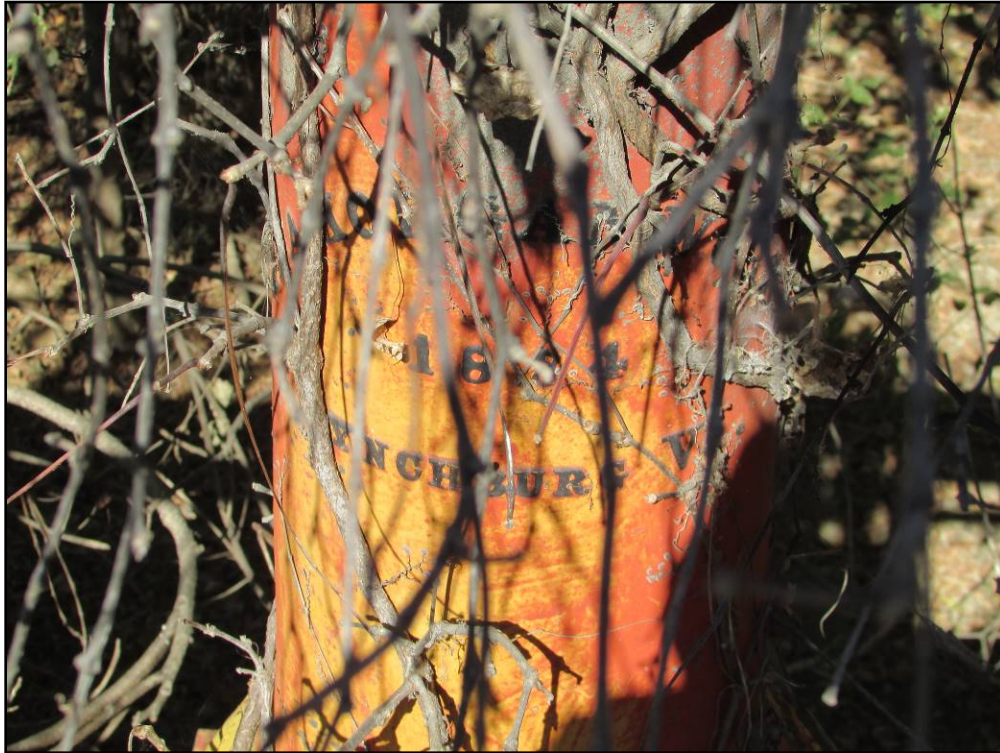
**Figure 6. Gate Wheels at the Water Works Dam and Canal.**

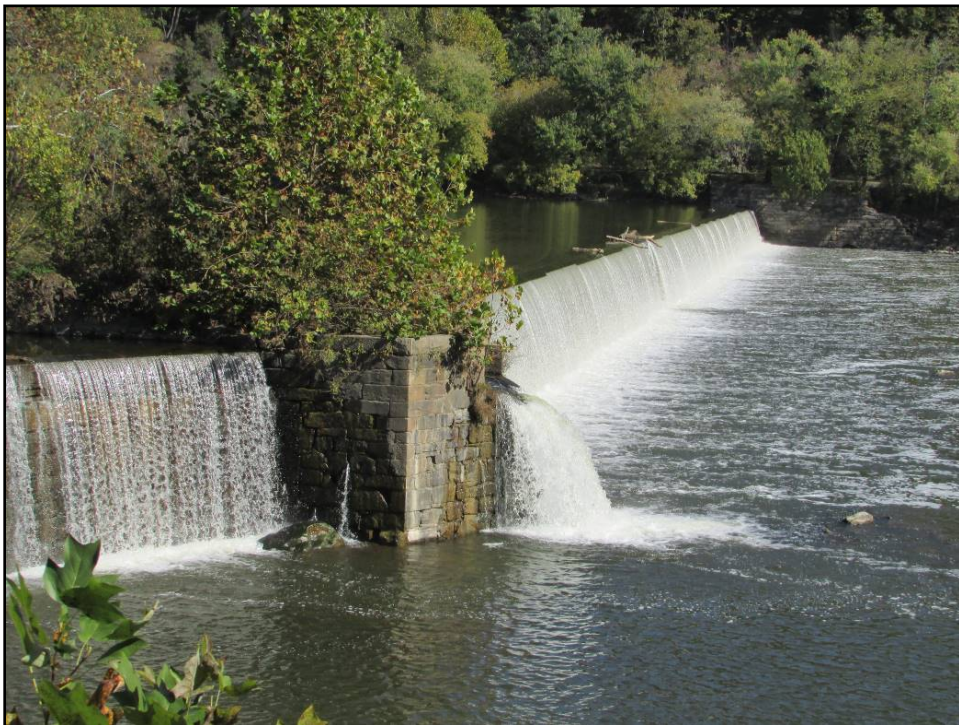
**Figure 8. James River Dam, view to the north.**

The James River Dam is a 200 foot dam that spans the James River from Daniel's Island to the north shore of the James River in Amherst County. Like the Water Works Dam to the south, the James River Dam is also constructed of massive stones and stands 20 feet above the riverbed of the James River (Figures 7, 8, and 9).

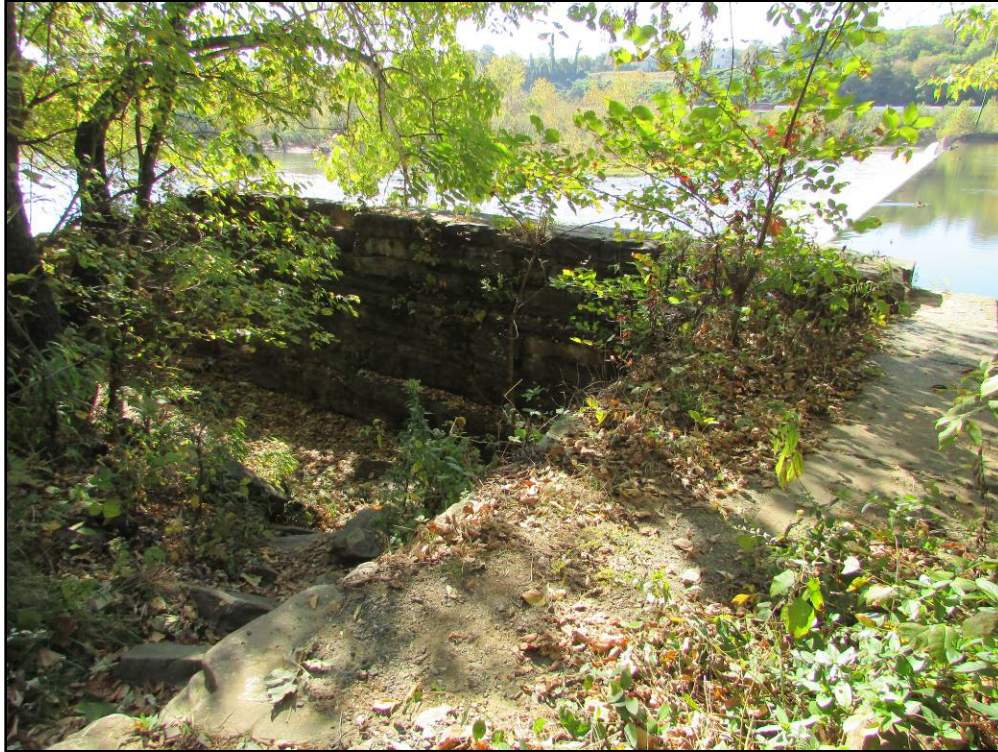
**Figure 11. Scott's Mill Ruin, view to the southwest.**

The Scott's Mill Ruin is located on the north shore of the James River in Amherst County, across the James River from the Water Works Dam and Canal (Figure 10). The mill ruin consists of two walls; the south wall and west wall. The walls are of masonry construction and consist of dry-laid stone; however, there is some evidence that concrete was also used. The concrete may be the result of repairs that were done after the initial construction of the mill. The west wall measures approximately 33 feet long and 6.8 feet wide. The height of the west wall varies from less than 3 feet to 7 feet. The south wall is approximately 80.6 feet long and the width varies from 4.6 feet to 3 feet. The south wall stands 12.4 feet tall and consists of three distinct sections. The top section measures 3.4 feet, the middle section 7 feet, and the bottom section or footing measures 2 feet (Figure 11).

The Scott's Mill Ruin is located on the north shore of the James River in Amherst County. The ruin consists of two walls; the south wall and west wall. The walls are of masonry construction and consist of dry-laid stone; however, there is some evidence that concrete was also used. The concrete may be the result of repairs that were done after the initial construction of the mill. The west wall measures approximately 33 feet long and 6.8 feet wide. The height of the west wall varies from less than 3 feet to 7 feet. The south wall is approximately 80.6 feet long and the width varies from 4.6 feet to 3 feet. The south wall stands 12.4 feet tall and consists of three distinct sections. The top section measures 3.4 feet, the middle section 7 feet, and the bottom section or footing measures 2 feet.

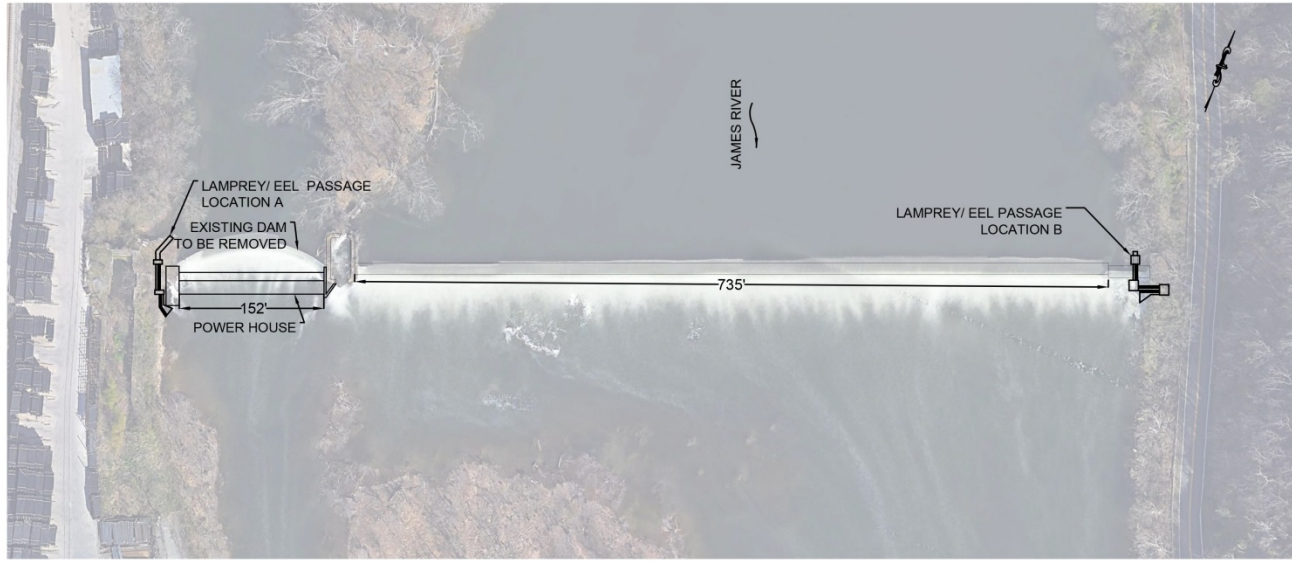
1  
C1 PLAN

# CONCEPTUAL LAMPREY AND EEL PASSAGE SCOTT'S MILL DAM JAMES RIVER LYNCHBURG, VA
