**Performance Report for Rust Bullet**

**The Performance of Rust Bullet When Applied to Louver Arrays:  
A Series of Fish Swimming Experiments in Marine and Fresh Water**

**April 2008 to April 2011**

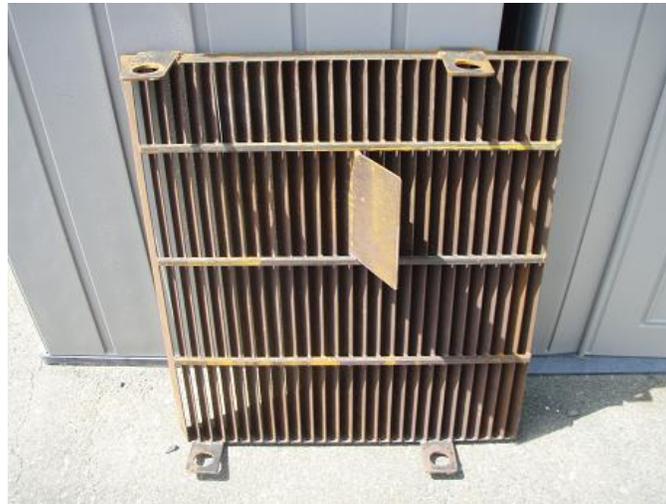
We constructed two steel louver-arrays that would be used to deter fish from passing into the downstream section of a laboratory flume. The experiment was designed to determine the frequency that fish would pass between the louvers blades when they were vibrating compared to when they were stationary. We wanted to coat the louver arrays with a product that would adhere to the unpainted steel, prevent rust from forming on the structure, and cause no toxic effects to the fish swimming in its presence. An image of an unpainted louver array is shown below.

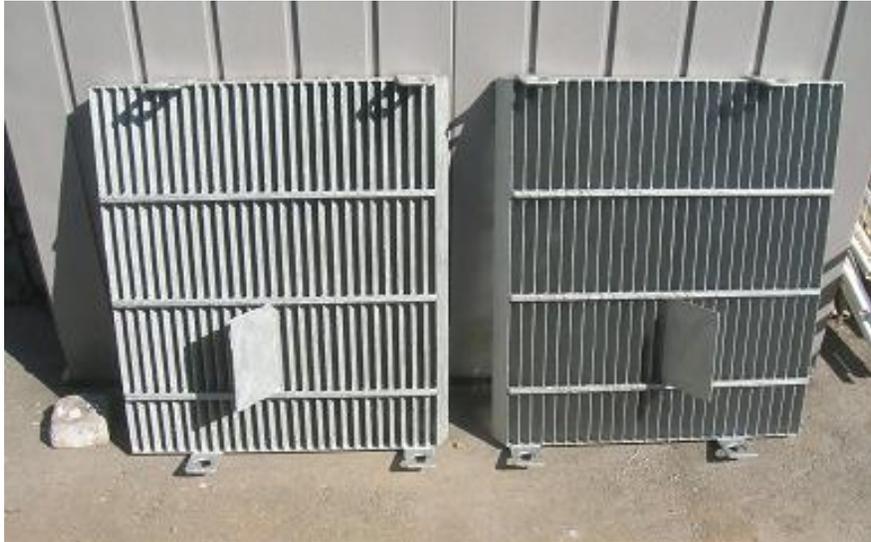
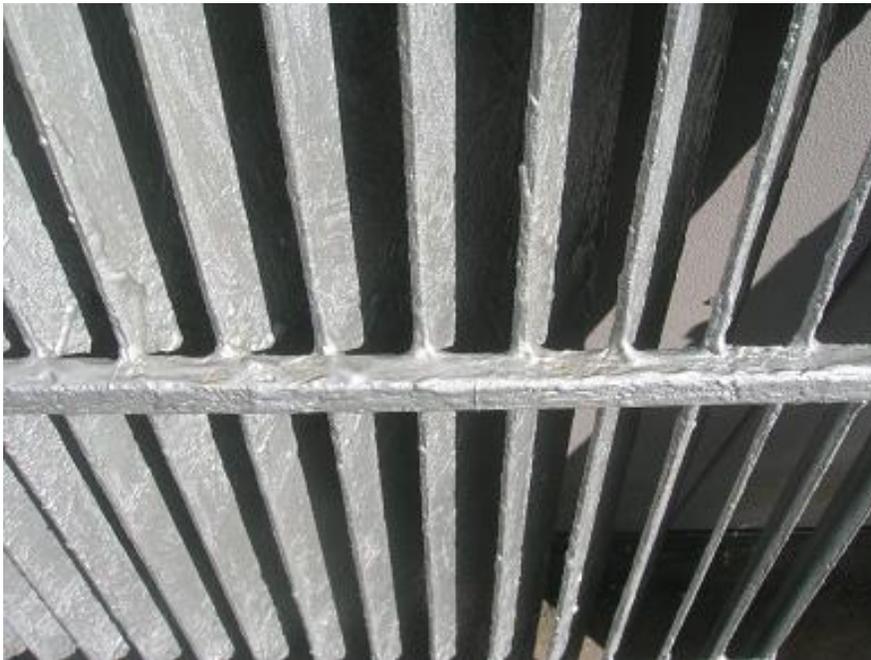
We suspect the close proximity to the ocean, resulting in cool temperatures and fog-like conditions, started to rapidly cure the paint, making it difficult to apply. The louvers were left outside to cure for a week. Pictures of the painted louvers are shown below.

A close-up image of the louver array above shows that the paint was applied thick and uneven in areas, giving the louvers a slightly rough, patchy and lumpy texture.

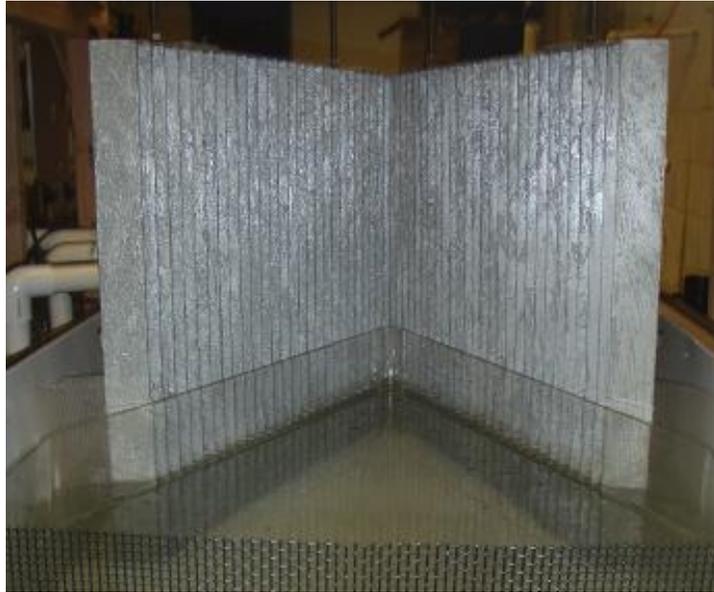
The louvers were then used in laboratory fish swimming trials, where their base was submerged in sea water for three weeks. Below is a picture of the louver-array placed in the indoor fish-swimming flume.

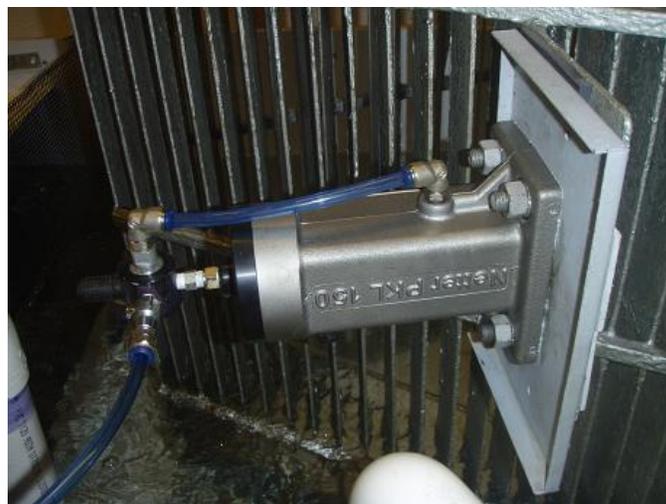
During these trials, an industrial impactor (Martin PKL 150, <http://www.shake-it.com/pkl-interval-imp.shtml>) was used to produce rapid movements of the louver array. The impactor contacted the louver with individual blows, similar to being struck by hammer. We are pleased to report that none of the Rust Bullet coating appeared damaged or was removed by the impactor's operation. Below is a picture of the attached impactor.

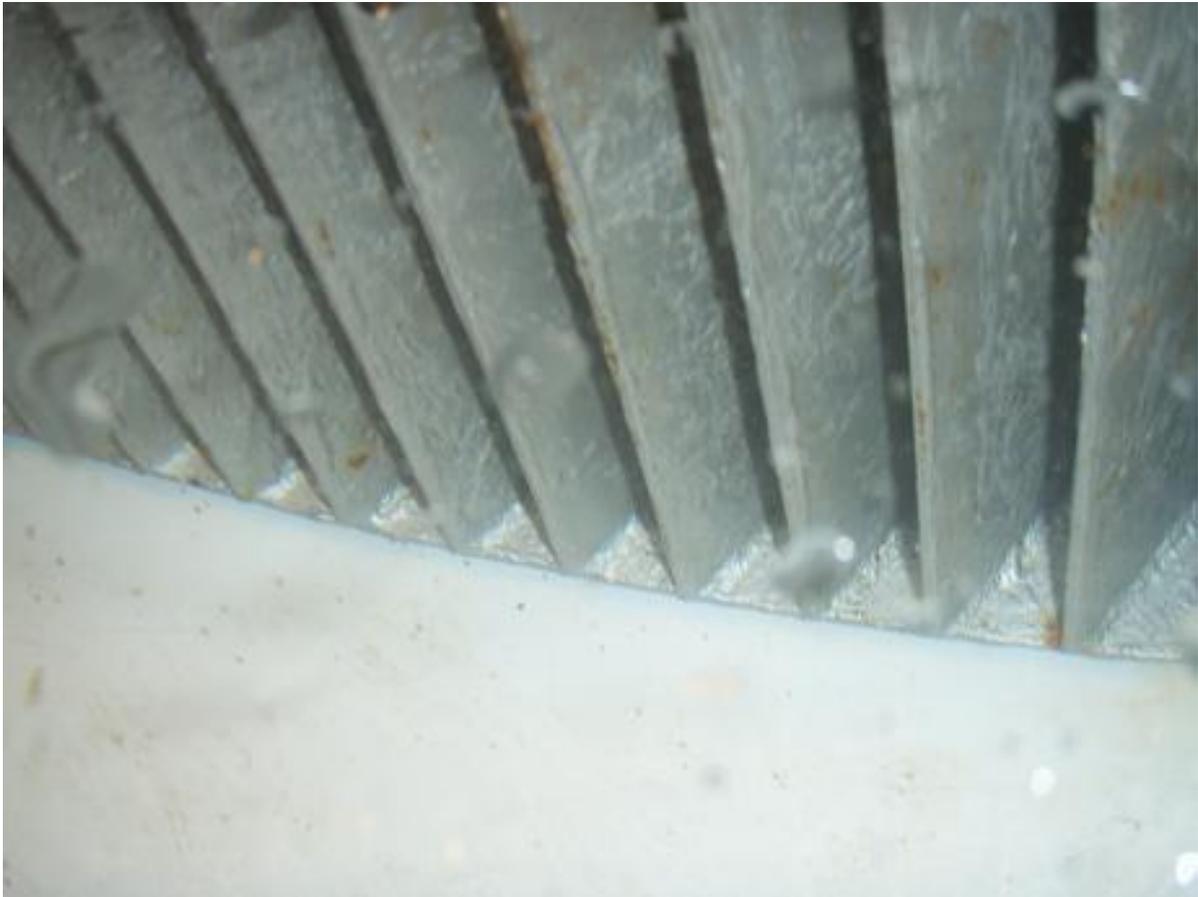
The fish exposed to the Rust Bullet-coated louvers, during 15-min swimming experiments, showed no signs of acute exposure to a toxic substance. Chronic exposure effects were not evaluated. After three weeks of exposure to sea water, patches of rust appear on the louver-arrays. Some exposed rust spots and the uneven texture of the paint's coating can be seen in the picture below.

These small patches of rust likely resulted from small gaps being left in the coating when the thick paint was applied, which allowed water to contact the steel.

Overall we think the product served its intended purpose well. Once the louvers were fully covered with Rust Bullet, the paint adhered well to the steel louver blades, prevented the majority of the metal from rusting and did not appear to harm our fish. However, the application of the paint was fairly challenging, and the texture it left on the louvers was not smooth and even. We suspect that if we had used Rust Bullet Automotive, and spray painted the louver blades, the paint might have created an even, rust-proof coating on the louvers and would have been less likely to develop small rust spots or to flake off.

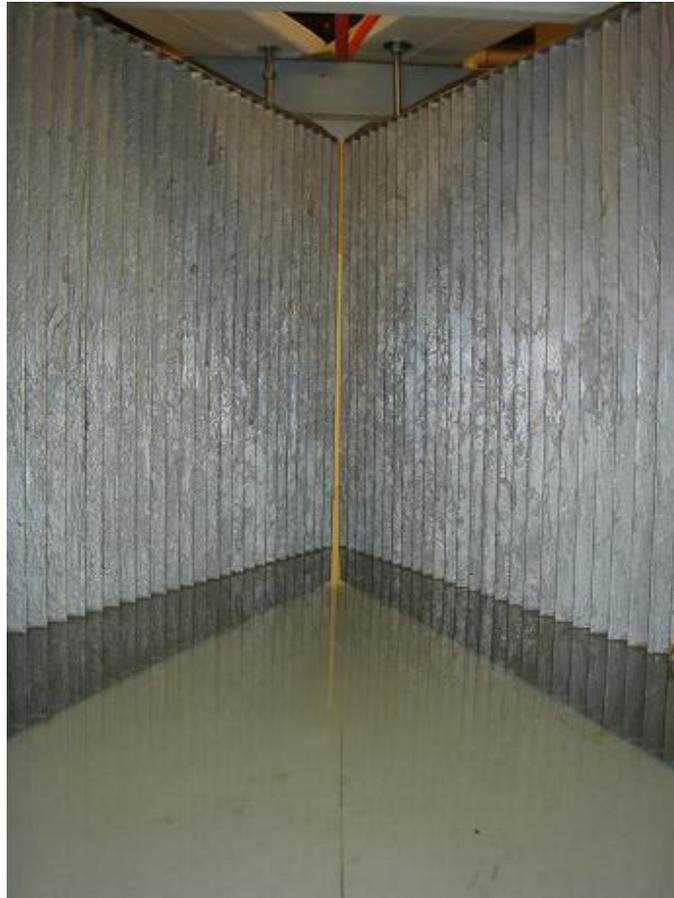
Following the marine experiments, the louver arrays were transported to the University of California Campus in Davis, CA, and used in multiple, freshwater fish-swimming experiments in 2009 and 2010. When the louvers first arrived, before any of the freshwater experiments were started, we purchased an additional supply of Rust Bullet and applied a third coat of the product onto the louvers. The Rust Bullet was much easier to spread in Davis, where the temperature was higher and relative humidity was significantly lower so the paint did not become thick. Also smaller-sized hand brushes were used, that fit easily between the louver-blades. Below is a picture of the repainted louver arrays, mounted in our freshwater flume.

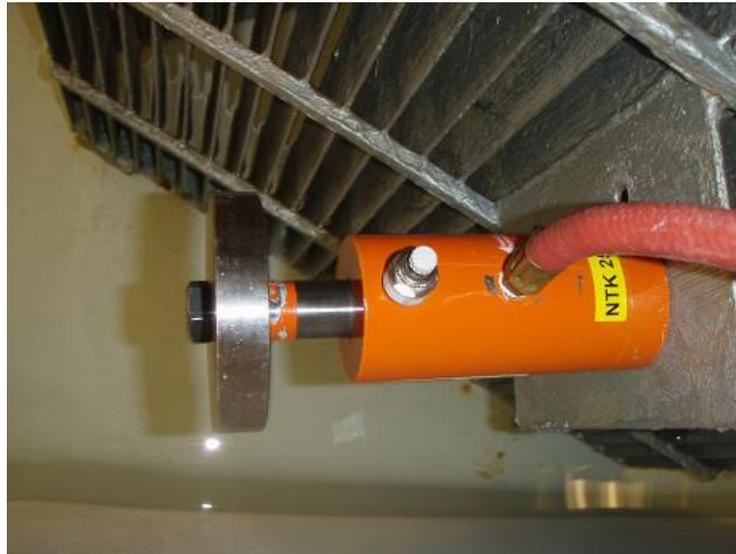
During the freshwater fish swimming experiments, the base of the louver arrays were submerged in freshwater (well water), and the louvers were vibrated with an oscillating industrial vibrator at a low frequency (Martin NTK 25, <http://www.shake-it.com/ntk->

oscillators.shtml). A picture of the industrial vibrator attached to the louver array is shown below.

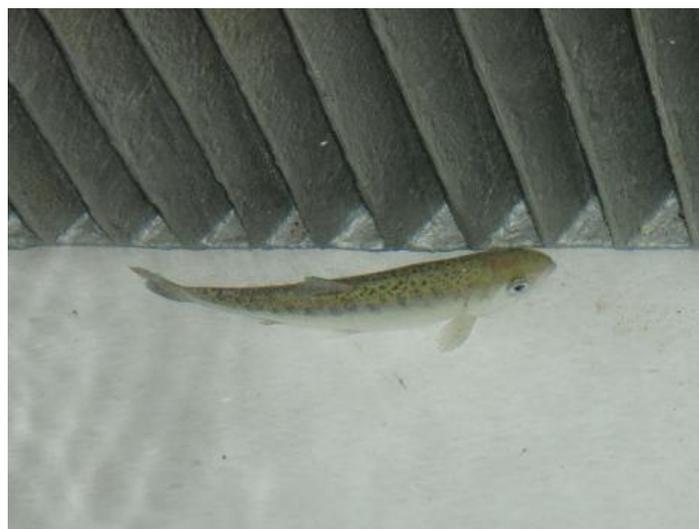
The Rust Bullet coating appeared to hold up well during the first set of freshwater fish swimming trials and only a few small patches of rust were observed. The vibrations induced throughout the louver arrays also did not appear to damage or detach any the paint. While swimming in the vicinity of the louver arrays, in 15-min freshwater swimming experiments, fish showed no signs of acute exposure to a toxic substance. No chronic exposure studies were conducted. A picture of a Chinook salmon (*Oncorhynchus tshawytscha*) resting near the base of a louver array is shown below.

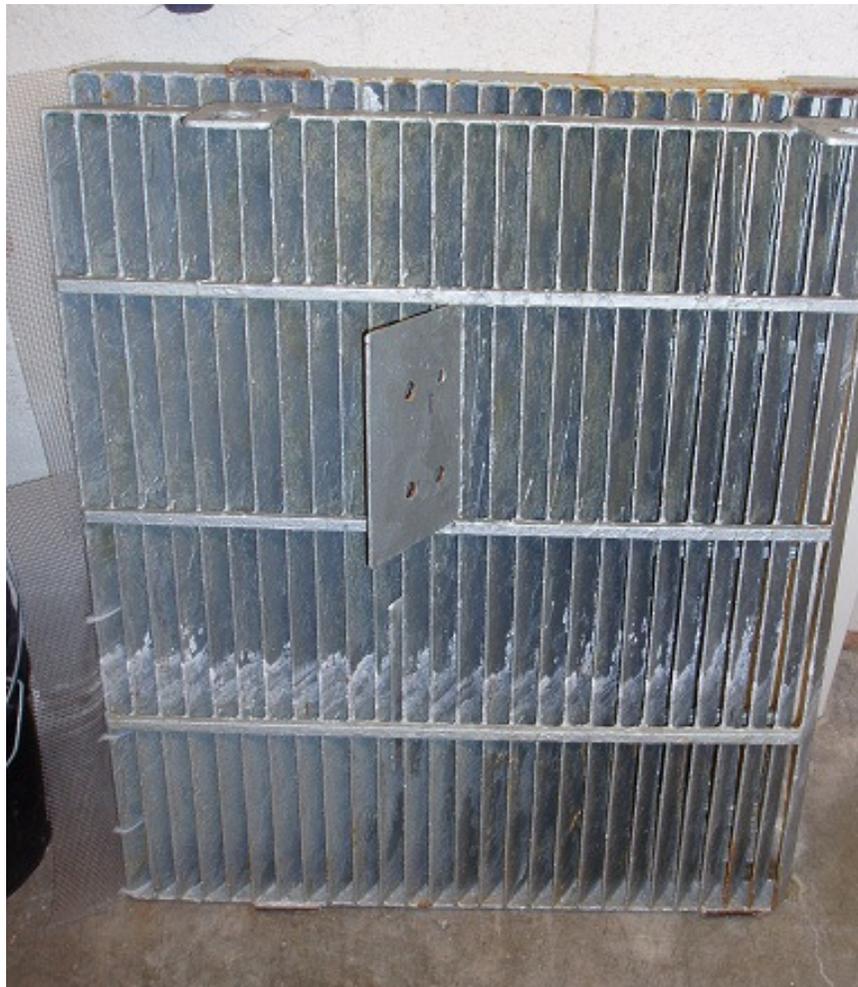
The fish swimming experiments using the Rust Bullet-painted louver arrays continued intermittently throughout 2009 and 2010. The louver arrays have not received any additional coats of Rust Bullet since the application they received when they reached UC Davis in 2009. The final coating of the Rust Bullet has held up well with only a few spots of rust on its base where the coating has flaked off. The freshwater flume is located indoors and the louver arrays have been stored indoors to protect the Rust Bullet coating from exposure to the sun. Below is a current picture of the Rust Bullet coating on the louver arrays.

The white layer on the louver array has been made by “hard” water deposits forming on the louver array, just above the water's surface.

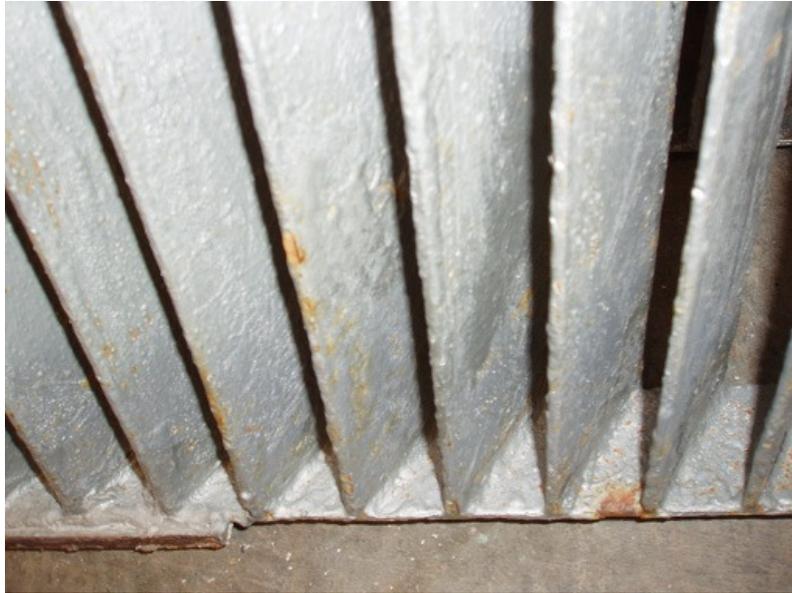
The images below show that only a few patches of rust are currently on the louver arrays, two years after the third coating of Rust Bullet was applied.

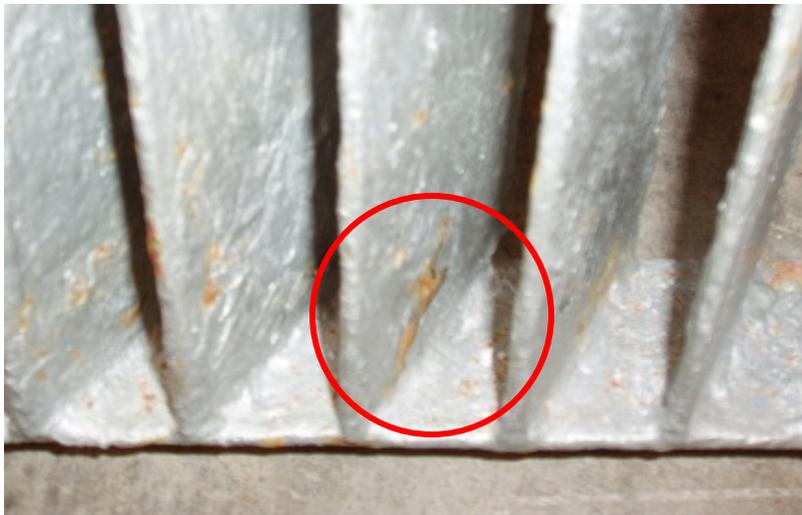
Currently, there are also a few places on the louver arrays where small sections of paint are peeling off as shown on middle louver blade in the picture below. Unfortunately, the image is slightly out of focus.
