**ROSS VALVE Mfg. Co., Inc.**  
 6 OAKWOOD AVENUE - TROY, NEW YORK, 12180 - TEL. (518) 274 0961  
 POST OFFICE BOX 595 - TROY, NEW YORK, 12181 - FAX (518) 274 0210  
 WEBSITE: www.rossvalve.com - E-MAIL: sales@rossvalve.com

DRAWING	40DAWR	DATE	9/6/00 RJC
GLOBE BODY	4" - 14"	NO SCALE	FIGURE 33

Model 40DAWR  
 DOUBLE ACTING ALTITUDE VALVE

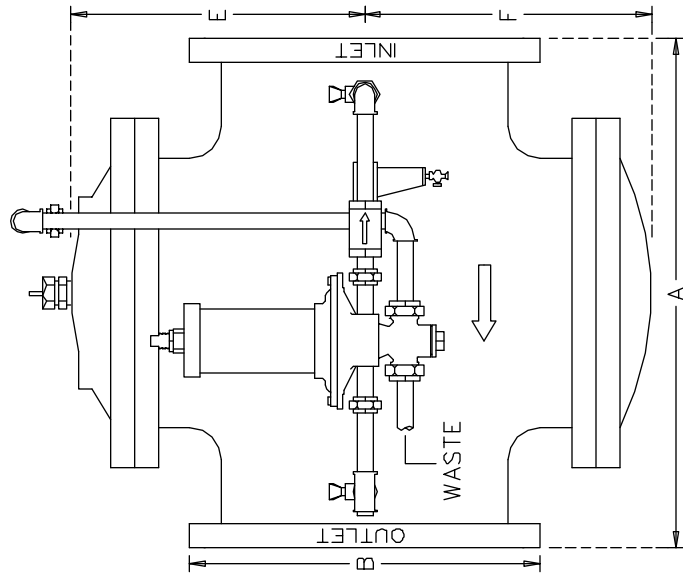
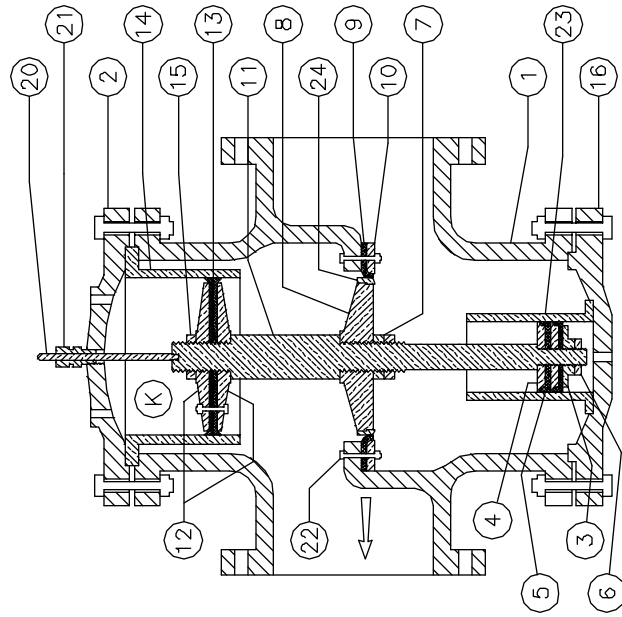
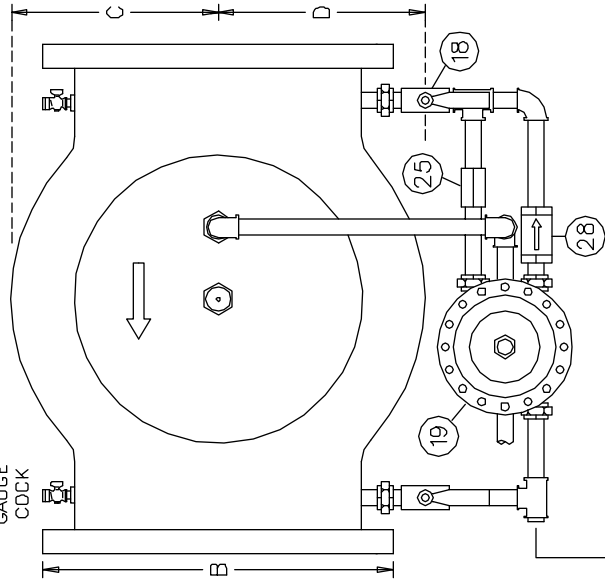
OPTION: WHEN THE VALVE IS NOT ADJACENT TO THE TANK RISER, REMOVE THE PLUG IN THE "TEE" AND PIPE TO RISER FOR TRUE STATIC HEAD. THIS CHANGE REQUIRES THAT THE ISOLATION VALVE ON THE CONTROL PIPING OUTLET SIDE BE CLOSED.

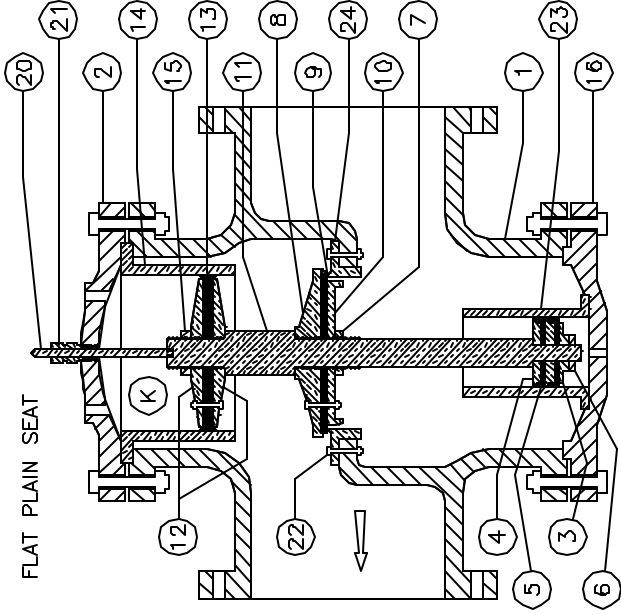
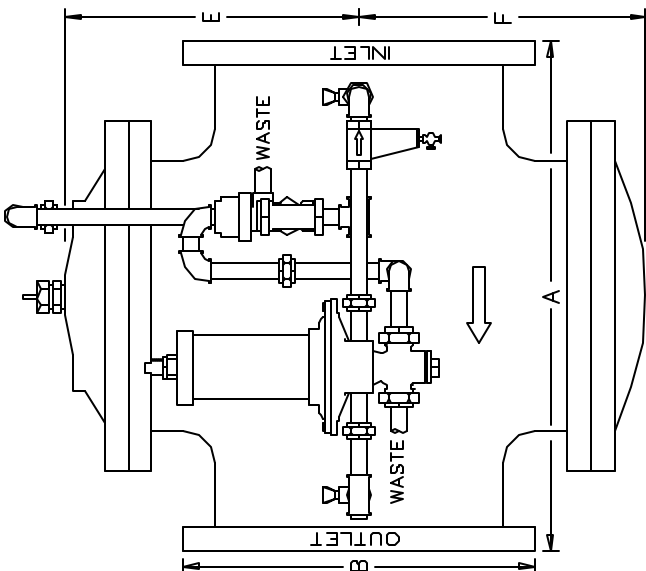
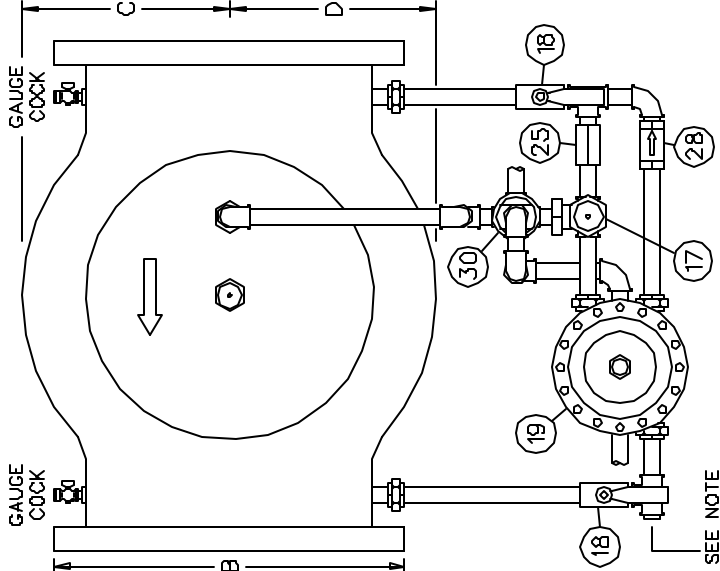
DRAWING 40DAWR-F-N\_16-36 DATE 3-20-01 TJS  
 GLOBE BODY 16" - 36" NO. SCALE FIGURE 33

NOTE: WHEN THE VALVE IS NOT ADJACENT TO THE TANK RISER, REMOVE THE PLUG IN THE "TEE" AND PIPE TO RISER FOR TRUE STATIC HEAD. THIS CHANGE REQUIRES THAT THE ISOLATION VALVE ON THE CONTROL PIPING OUTLET SIDE BE CLOSED.

Model 40DAWR  
 DOUBLE ACTING ALTITUDE VALVE

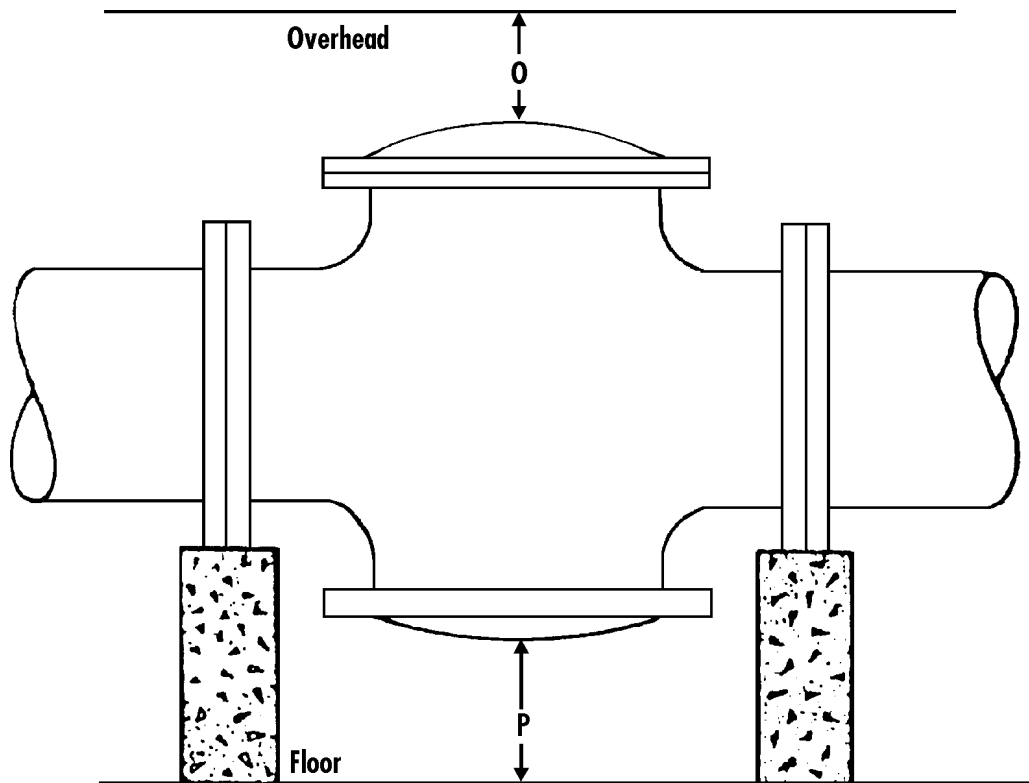
Globe Body Minimum Clearances

Piston Valve Sizes: 4" - 36"

1. Dimension "O" is clearance for removal of the top cap and piston for repacking the main valve. Additional working space for the convenience of the service man should be considered above as well as around the valve.
2. Dimension "P" as listed is the desirable clearance under the valve for removal of the STANDARD bottom cap. This dimension may be reduced to 1 inch for all valves on special applications.

- A. **Do not obstruct vent hole located at the center of the bottom cap.**
- B. Consideration should be given for installation of valves 14" or larger under manhole in the roof of the valve vault or for additional clearance above the valve since a mechanical hoist will probably be required for removal of the piston. An eye bolt or hook cast in the cover slab over the center of the valve is useful.
- C. If clearance under the valve is limited, dimensions "O" and "P" can be modified. Consult the factory concerning special applications.

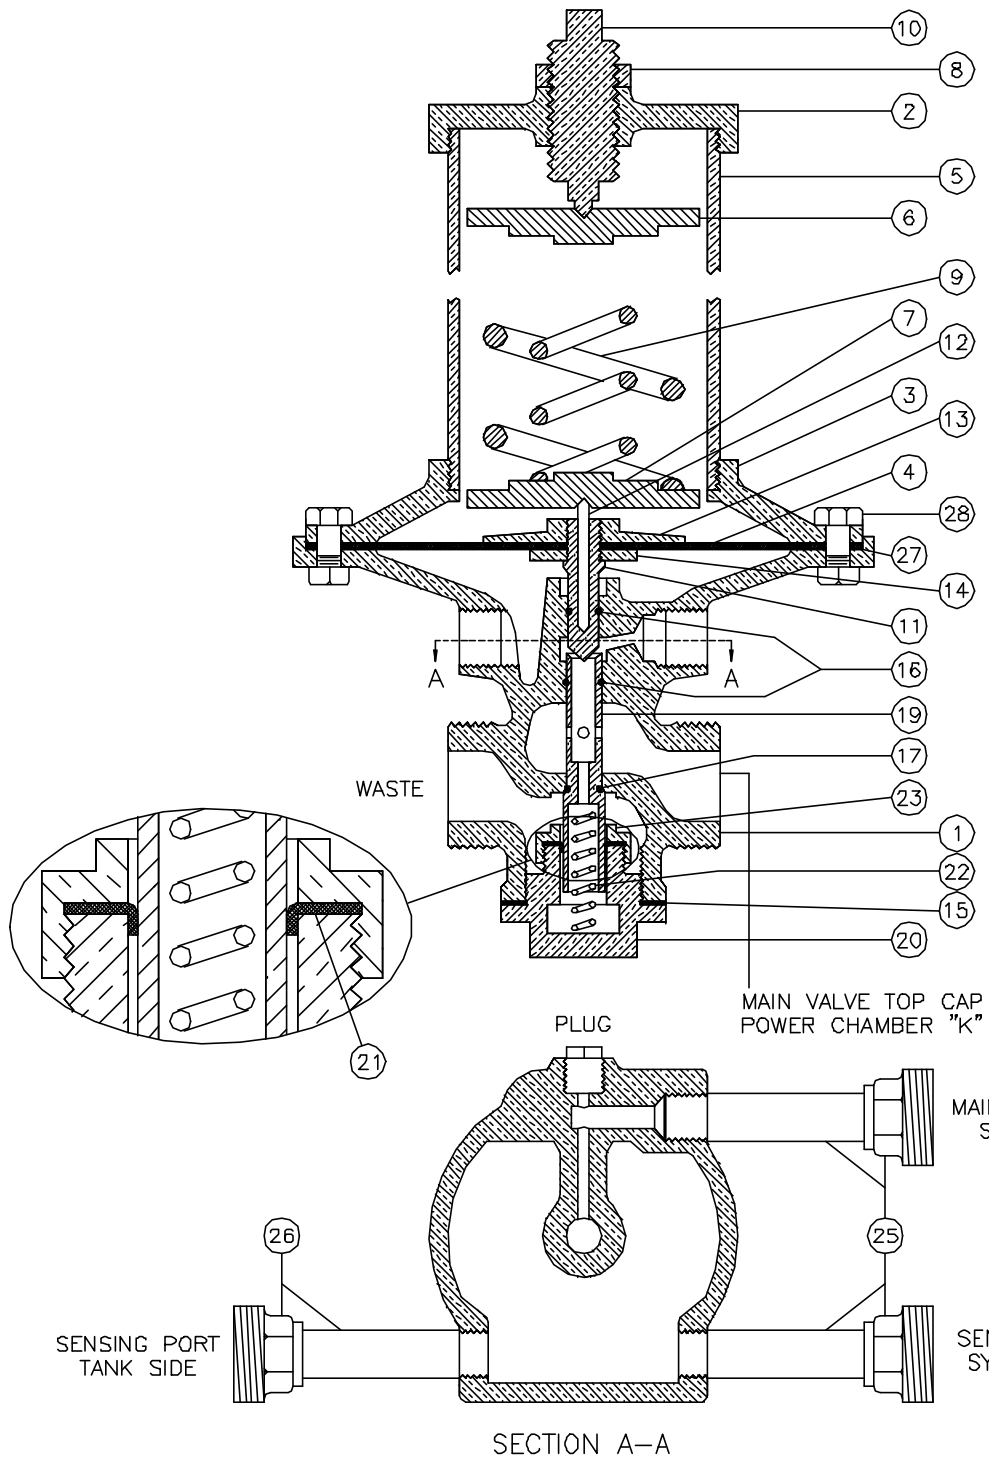
NO SCALE DRAWING 40DAWR PILOT (.08)  
 DATE 2-28-61 3104C REVISED 10-26-00 DMB

OPERATION: WHEN HIGH WATER IN TANK, RESERVOIR OR BASIN IS REACHED, WATER LEVEL PRESSURE IS COMMUNICATED TO THE UNDERSIDE OF PILOT DIAPHRAGM AND OVERCOMES LOADING ON THE SPRING(S). THIS OPENS THE SEAT BETWEEN UPPER AND LOWER STEMS TO INTRODUCE WATER FROM THE SUPPLY SIDE OF MAIN VALVE TO POWER CHAMBER "K" ABOVE THE PISTON OF MAIN ALTITUDE VALVE FOR CLOSURE.

WHEN WATER LEVEL IN TANK RECEDES, OR WHEN SUPPLY PRESSURE BECOMES LESS THAN TANK HEAD, SPRING LOADING OVERCOMES WATER LEVEL PRESSURE UNDER DIAPHRAGM. THIS OPENS THE LOWER SEAT ON THE LOWER STEM OF PILOT TO PERMIT FLOW FROM MAIN VALVE POWER CHAMBER "K" ABOVE PISTON TO WASTE, THUS OPENING MAIN VALVE.

NOTE: DIAPHRAGM ASSEMBLY AND SPRING CHAMBER ASSEMBLY, INCLUDING SPRING(S), VARIES DEPENDING UPON OPERATING PRESSURE RANGE.

MODEL 40DAWR PILOT VALVE (.08)  
 DOUBLE ACTING ALTITUDE

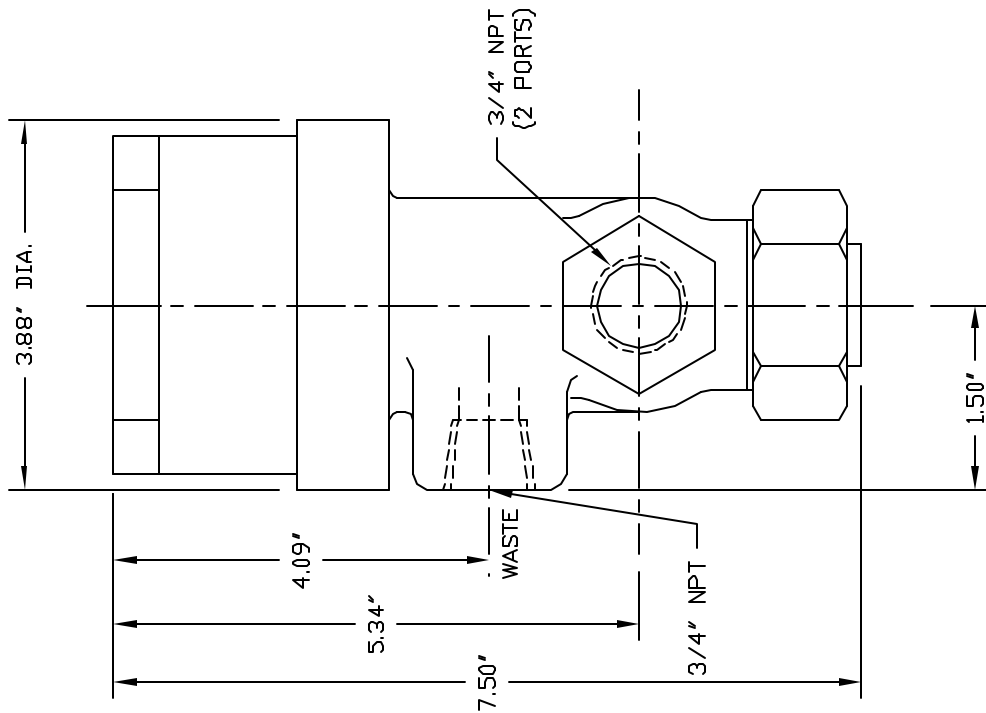
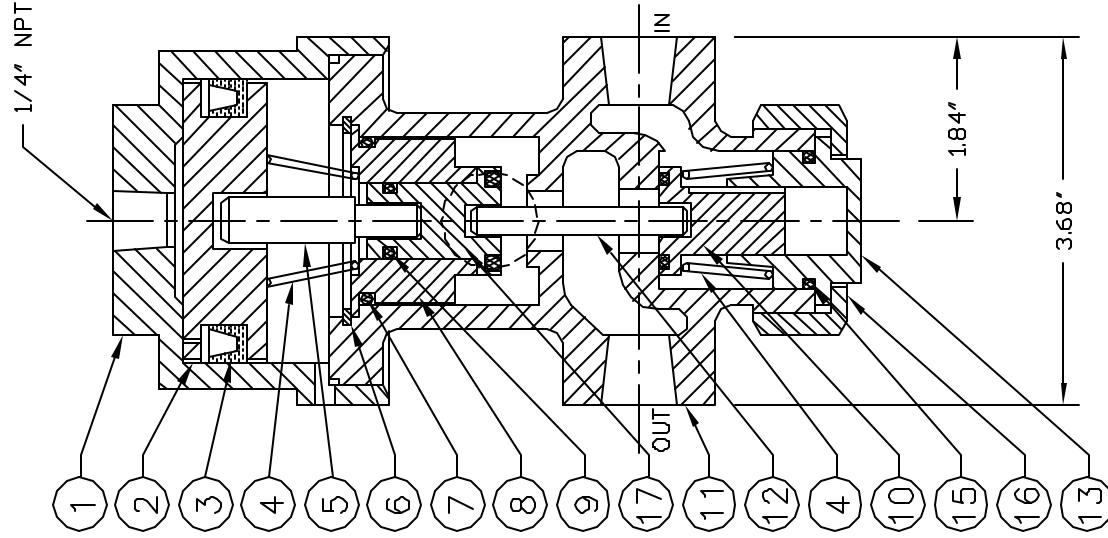
NO SCALE	DRAWING	LEXAIR 333412
DATE 2-14-91	REVISED	1-10-01 TJS

OPERATING PRESSURE 500 PSI MAX  
PILOT RATIO 1D:1

LEXAIR 3/4" MODEL 333412  
3-WAY AUXILIARY PILOT VALVE

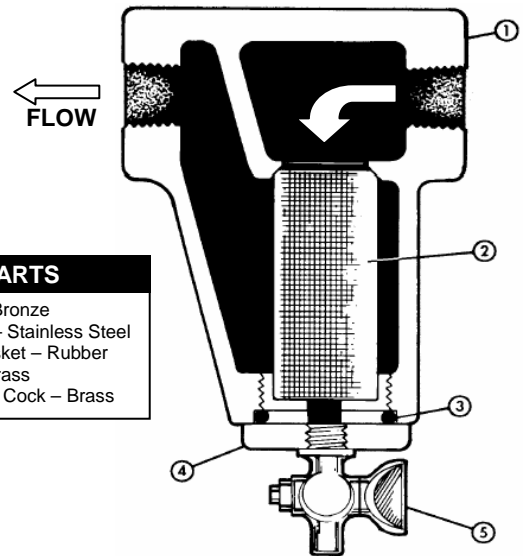
Model Number: 5F-2

# STRAINER

1. Water enters the cylindrical screen (#2) from the top and passes out through the sides of the cylinder.
2. Any particle too large to pass through .012 inch openings gets trapped in the cylinder, where, unless there is unusual turbulence, they settle at the bottom.

1. Body – Bronze
2. Screen – Stainless Steel
3. Cap Gasket – Rubber
4. Cap – Brass
5. Flushing Cock – Brass

1. To clean without shutting down the line, open the flush cock (#5) in the bottom cap (#4) for several seconds.
2. To remove the screen (#2), which requires shutting down the line, unscrew the bottom cap assembly (#5).

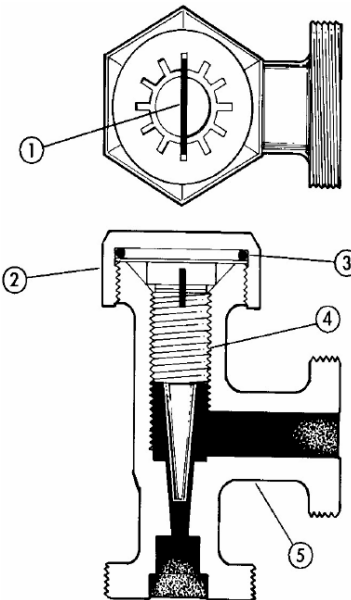
# NEEDLE VALVE

The simple construction reliably limits maximum flow through the external piping, depending on the position of the adjustable stem/needle (#4) relative to the seat.

1. When the needle (#4) is adjusted counter-clockwise to a raised position,
  - a. More water can pass through the needle valve.
  - b. Water enters (leaves) the operating chamber more quickly.
  - c. The main valve piston moves up and down more quickly.
2. When the needle (#4) is adjusted clockwise to a lowered position,
  - a. Less water can pass through the needle valve.
  - b. Water enters (leaves) the operating chamber more slowly.
  - c. The main valve piston moves up and down more slowly.

1. Remove the hex cap (#2) and lock (#1).
2. With a screw driver;
  - a. Turn the needle (#4) counter-clockwise to raise it
  - b. Turn the needle (#4) clockwise to lower it
3. Once the optimum position is determined, no further adjustment of the needle should be required.

It is advisable to occasionally remove the cap (#2) and lock (#1) and change the position of the needle (#4) momentarily to insure against gradual plugging.

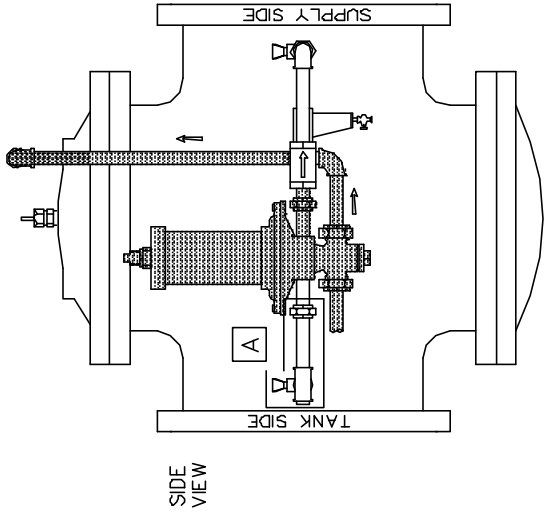
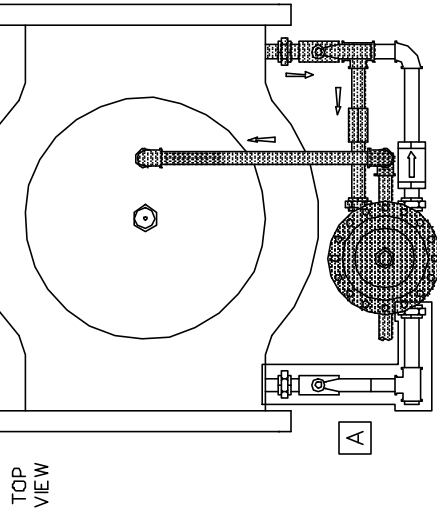
**TANK FULL  
MAIN VALVE CLOSED**

SENSES TANK PRESSURE/LEVEL AT **A**

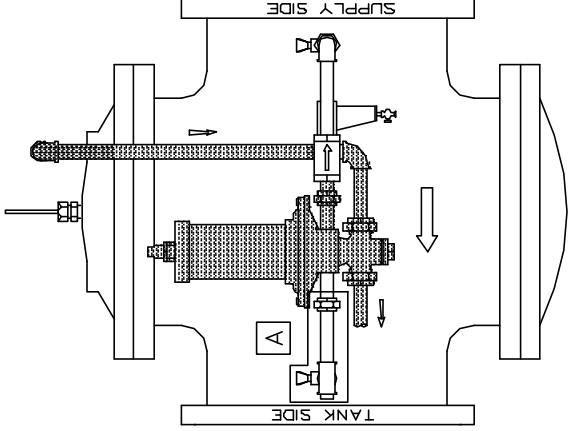
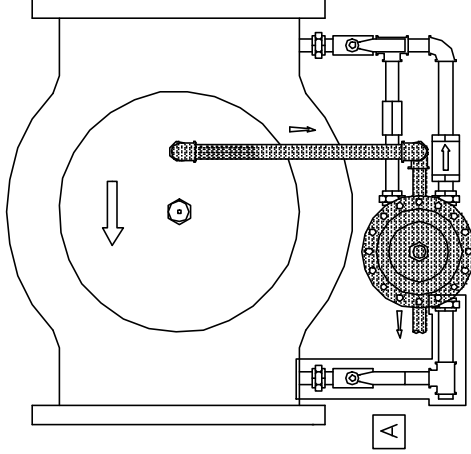
**TANK LOW  
MAIN VALVE OPEN**

SENSES TANK PRESSURE/LEVEL AT **A**

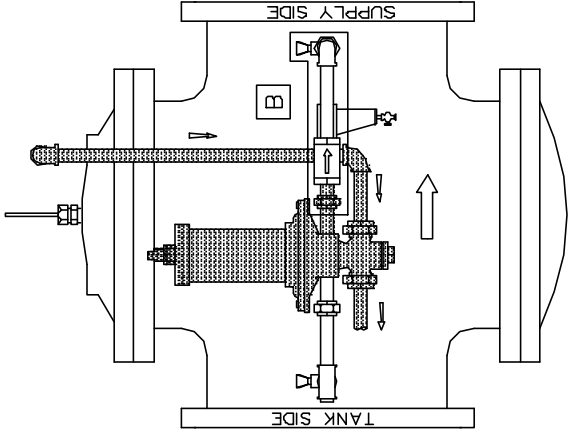
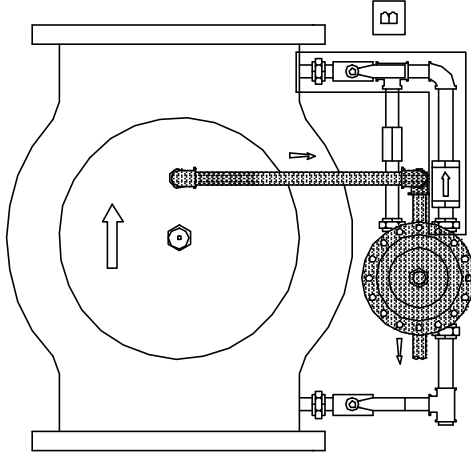
**SYSTEM LOW  
MAIN VALVE OPEN**

SENSES SYSTEM PRESSURE AT **A**

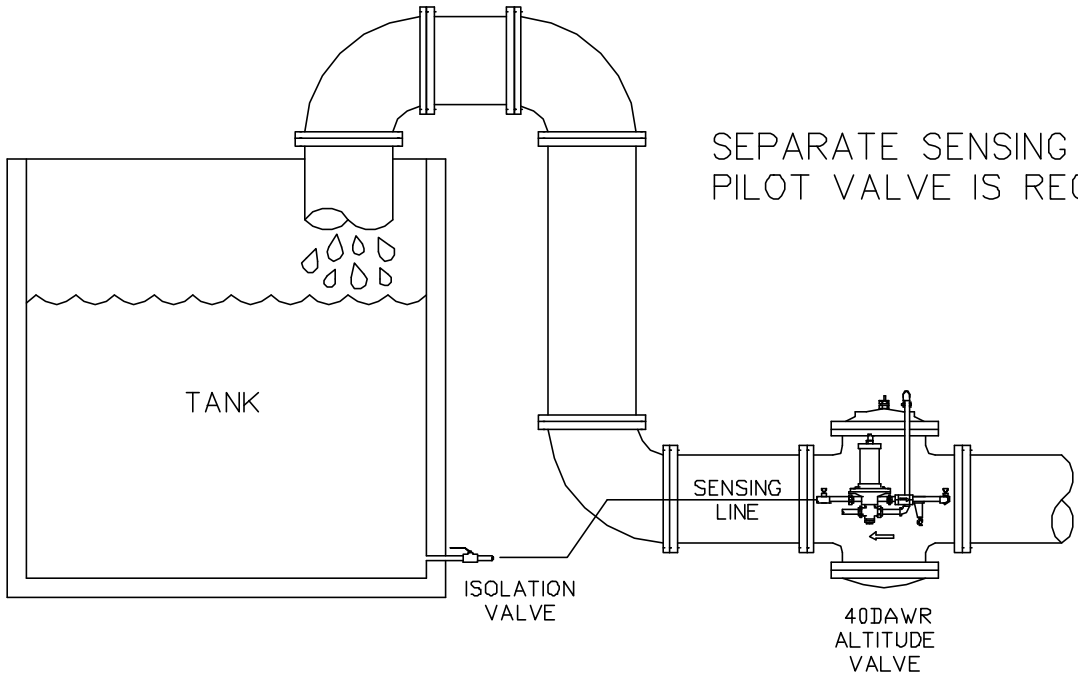
1

SEPARATE SENSING LINE TO PILOT VALVE IS REQUIRED.

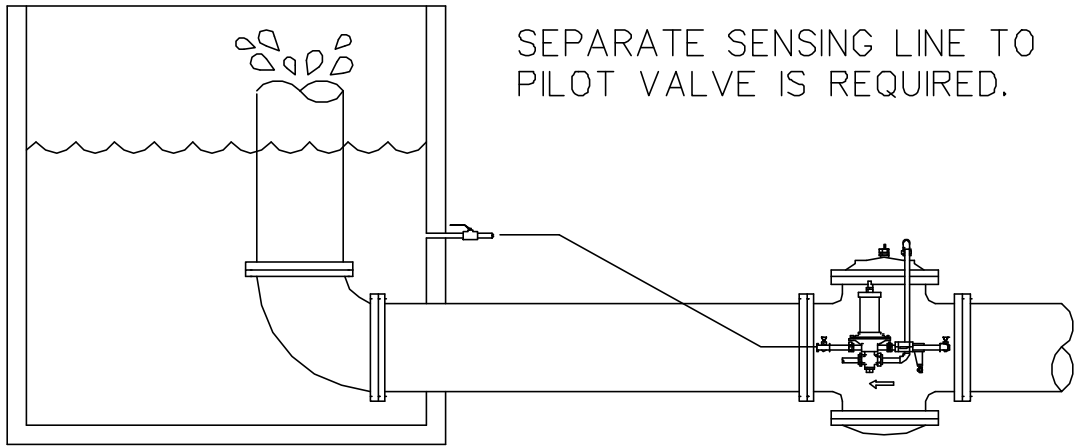
2

SEPARATE SENSING LINE TO PILOT VALVE IS REQUIRED.

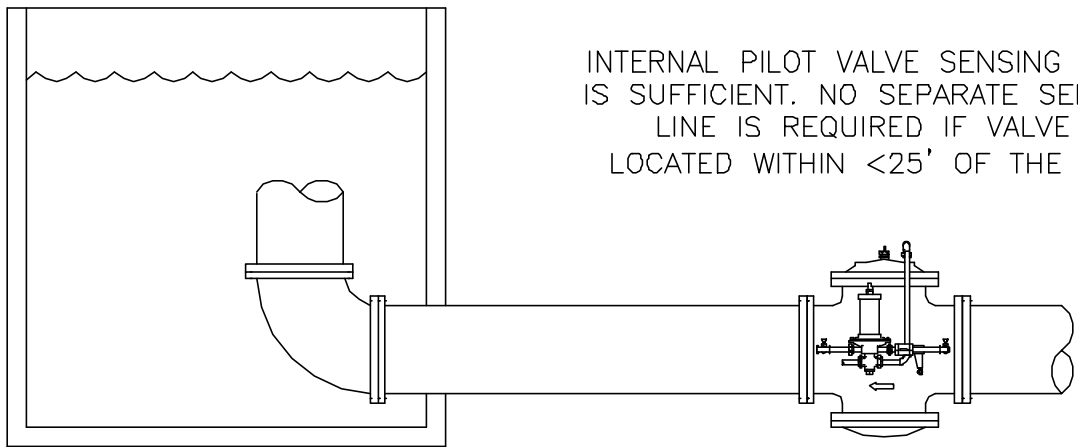
3

INTERNAL PILOT VALVE SENSING PORT IS SUFFICIENT. NO SEPARATE SENSING LINE IS REQUIRED IF VALVE IS LOCATED WITHIN <25' OF THE TANK.

MODEL 40DAWR ALTITUDE VALVE INSTALLATION OPTIONS

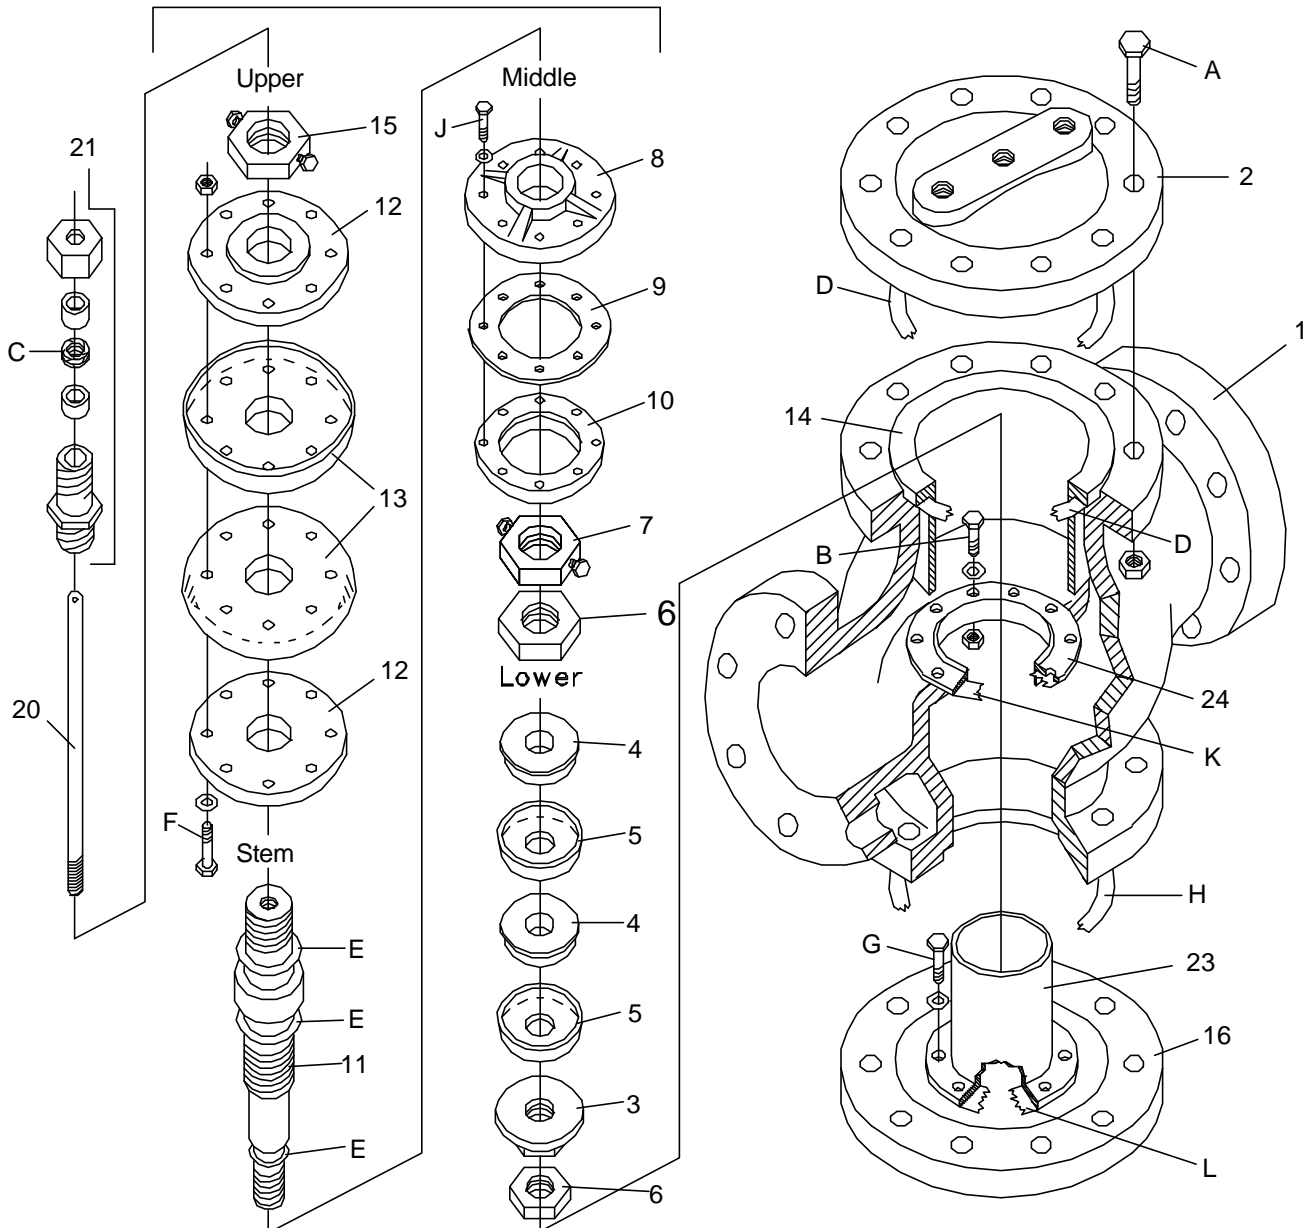
## Piston Assembly

GLOBE VALVE & PISTON ASSEMBLY  
WITH FLAT SEAT & PLAIN PACKING SUPPORT

PART	DESCRIPTION	QUANTITY
1	SHELL	1
2	TOP CAP	1
3	BOTTOM STEM GUIDE NUT	1
4	PISTON CUP FOLLOWERS (SET OF 2)	1
*5	PISTON CUP PACKING	2
6	BOTTOM STEM LOCK NUT	2
7	STEM NUT W/ SET SCREWS	1
8	SEAT DISC	1
*9	SEAT PACKING	1
10	SEAT PACKING SUPPORT	1
11	STEM	1
12	MAIN CUP PLATES (SET OF 2)	1
*13	MAIN CUP PACKING	2
14	MAIN BUSHING	1
15	UPPER STEM NUT W/ SET SCREWS	1
16	BOTTOM CAP	1

PART	DESCRIPTION	QUANTITY
*20	INDICATOR ROD	1
21	INDICATOR STUFFING BOX	1
23	BOTTOM CAP CYLINDER	1
24	SEAT RING	1
A	BOLT & NUT - TOP & BOTTOM CAP	VARY
B	BOLT, NUT & WASHER - SEAT RING	VARY
*C	PACKING - INDICATOR STUFFING BOX	1 SET
*D	GASKET - TOP CAP & MAIN BUSHING	2
*E	GASKET - STEM	3
F	BOLT, NUT & WASHER - CUP PLATES	VARY
G	BOLT & WASHER - BOTTOM CAP CYLINDER	VARY
H	GASKET - BOTTOM CAP	1
J	BOLT, NUT & WASHER - SEAT DISC	VARY
K	GASKET - SEAT RING	1
L	GASKET - BOTTOM CAP CYLINDER	1

Secure main piston on a pipe threading stand (or lay piston on floor on rags or a similar cushioning material). Loosen top stem nut (Part No. 15) which holds the cup plate assembly. Remove cup plate bolts, nuts and copper washers on 8" cups and larger. Replace the leather cups (one faces up, one faces down). Re-install with new packings in the reverse order as outlined above.

To replace the seat packing, it is necessary to determine if the valve is constructed with a "sliding" or a "flat" type seat. The sliding type seat has the seal or seat packing clamped in the valve body underneath the iron wall that separates the inlet and outlet valve chambers. It consists of a flanged packing held in place by a split bronze seat support ring. The lip of the packing "looks down" and care should be taken that the packing is concentric with the valve bore before the clamping bolts are tightened. In the "flat" type seat, the seat packing is located on the valve piston, where it is clamped between two plates and held by a stem nut (Part No. 7). Removal of this nut allows the plates to be separated and the packing replaced.

Replacement of the bottom cups (Part No. 5) is accomplished by removing the bottom stem lock nut (Part No. 6) and the flanged bottom guide nut (Part No. 3). Install the seals with the lip of both cups "looking up". Again, when re-assembling, be careful not to over tighten so that the cups are deformed.
