Inspection Report

Stewart Certified Home Inspections

Property Address:

1234 W. Main Street

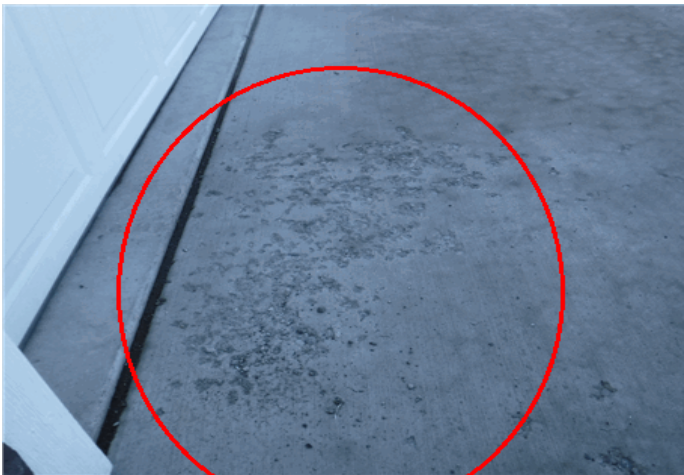
2) Driveway Conditions

The driveway appeared to be in serviceable condition at the time of the inspection. The driveway has some surface erosion and minor deterioration (see picture).

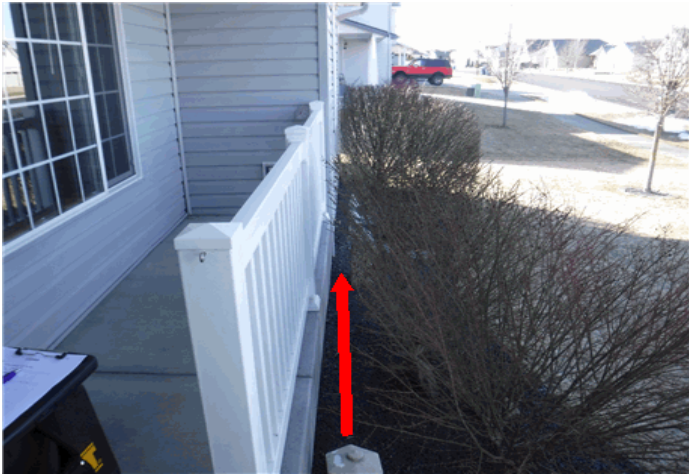
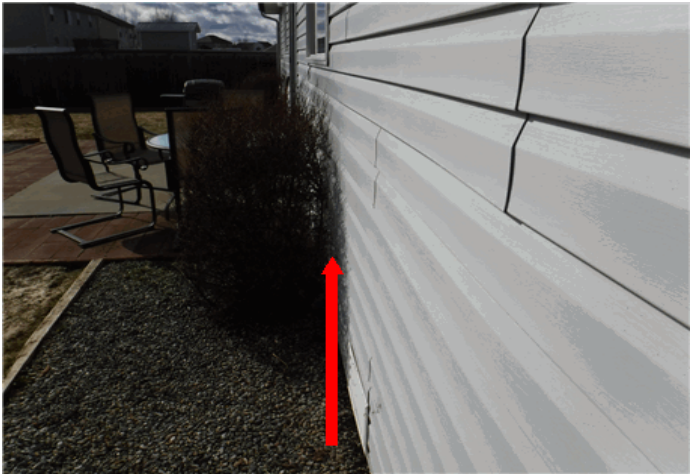
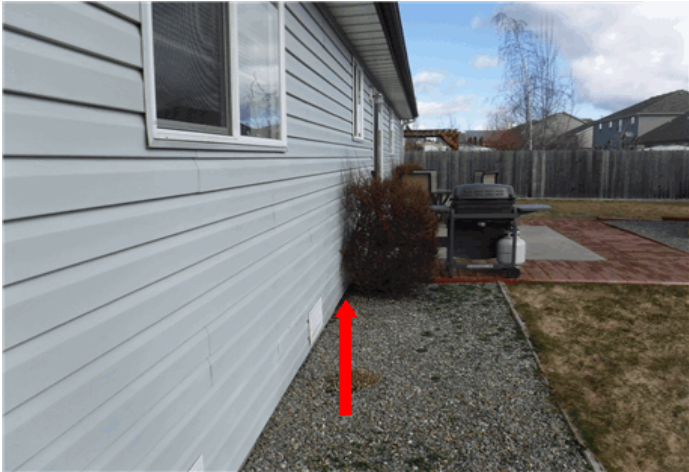
4) Vegetation Conditions

Vegetation growing on or near the exterior walls may introduce insects, pests, and/or accelerate deterioration of the exterior wall covering by retaining moisture. The inspector recommends trimming/removing vegetation from exterior walls.

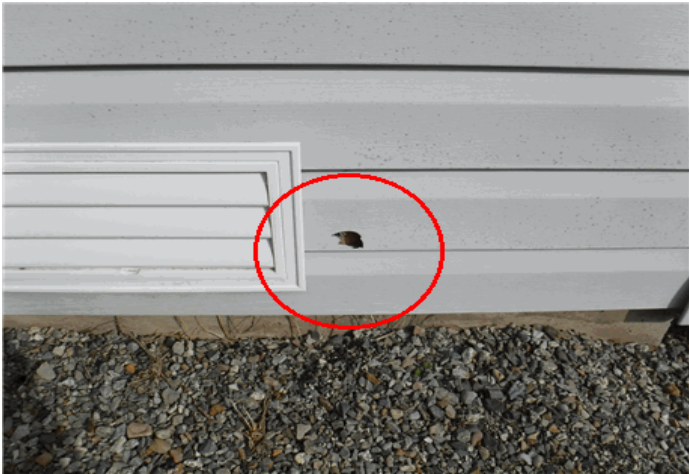
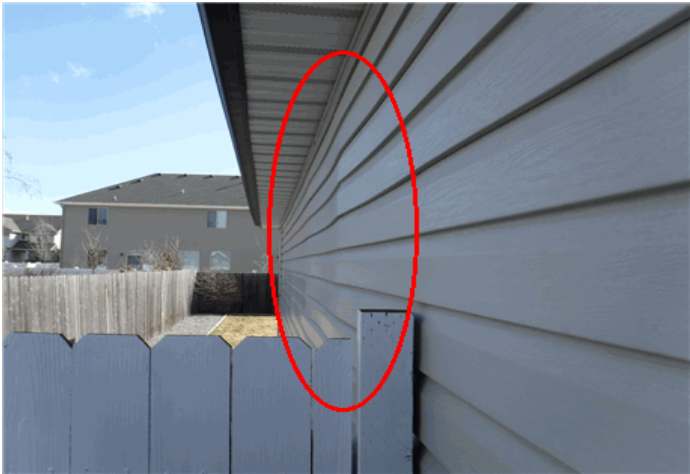
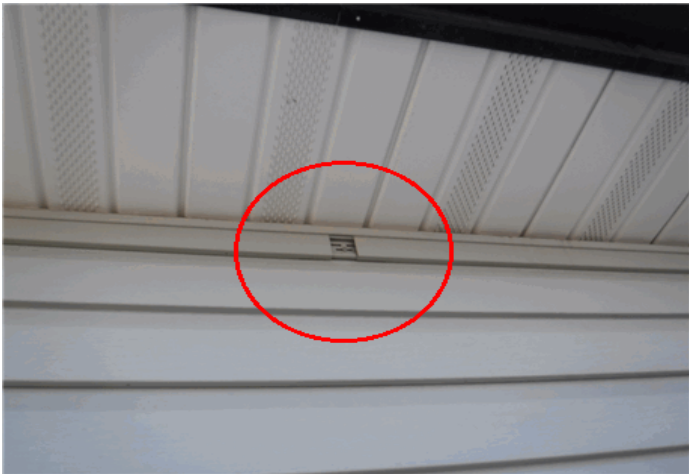
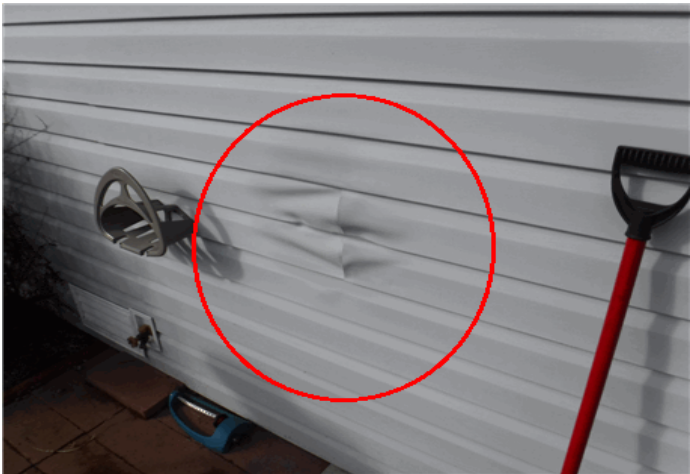
7) Exterior Wall Conditions

Pic 1. Small hole located at the Southeast corner of the home.
Pic 2. Wavy siding was observed at the time of the inspection located at the North side of the home.
Pic 3. Small gap in the siding trim located at the North side and Northeast corner of the home.
Pic 4. Defect in siding possibly due from extreme heat from cooking device located at the East side of the home.
Recommend further evaluation by a qualified siding Contractor.

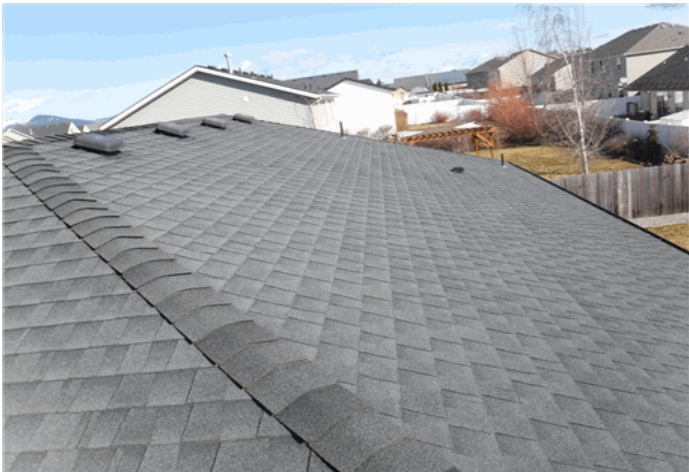
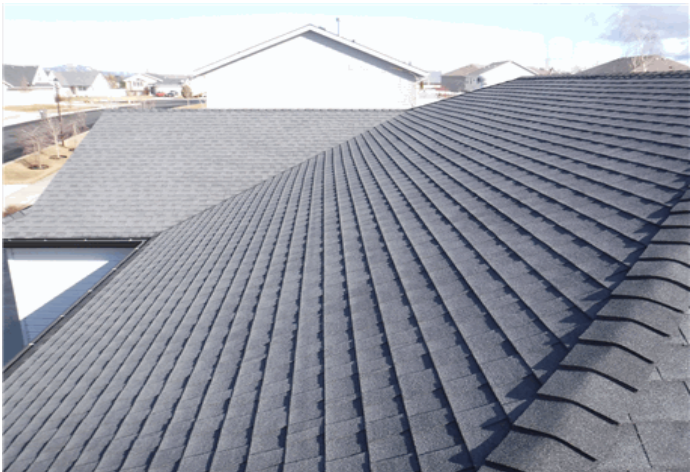
15) Roof Covering Condition **F** The roof covering shows normal wear for its age and appeared to be in serviceable condition at the time of the inspection.

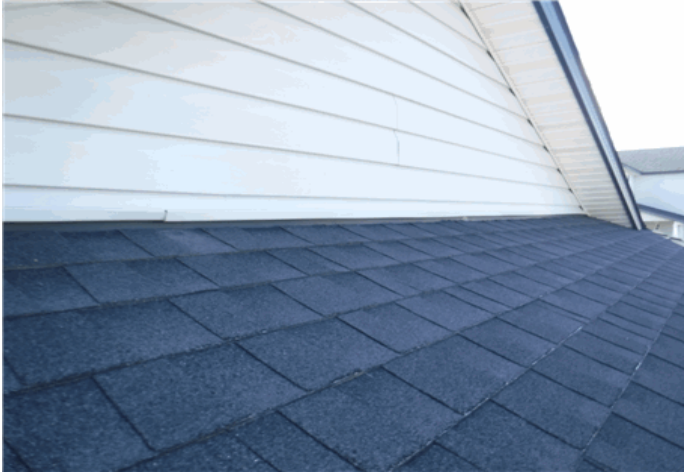
16) Flashing Conditions**F**

The exposed flashings appeared to be in serviceable condition at the time of inspection.

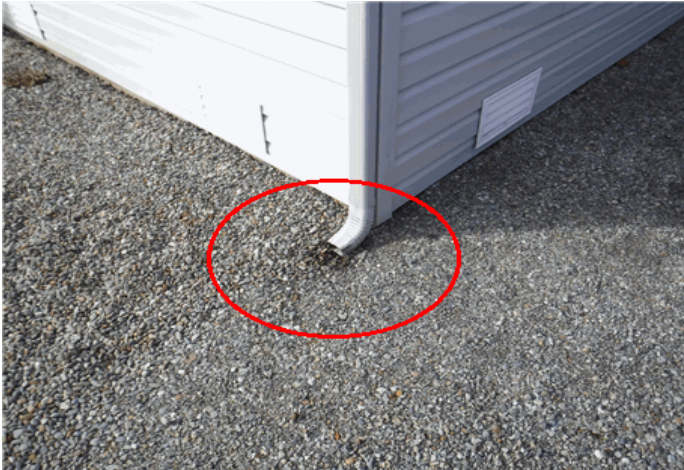
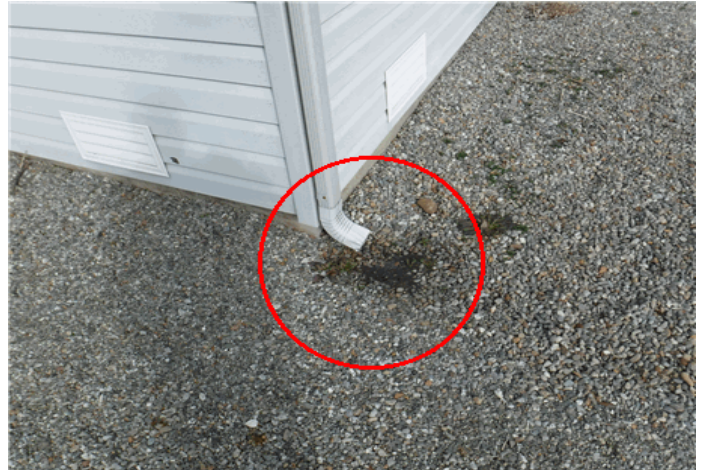
**17) Gutter & Downspout Conditions****D**

The gutter system appeared to be in serviceable condition at the time of the inspection. Recommend gutter downspouts be extended and routed away from the building for proper drainage. Water seepage into crawl spaces, basements and under foundations can be caused by inadequate removal of rainwater from the perimeter of the house.

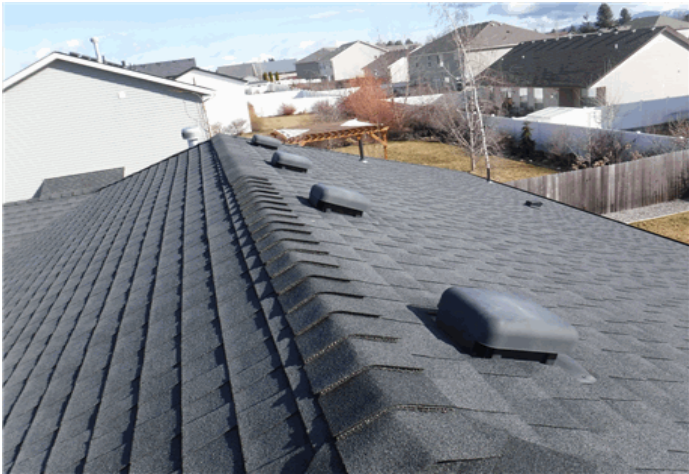
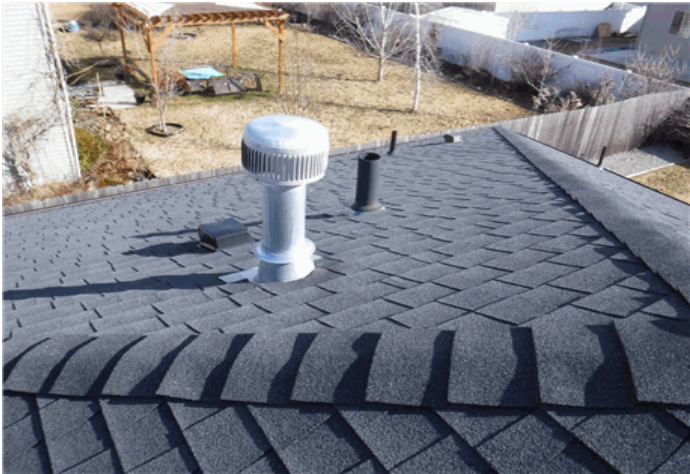
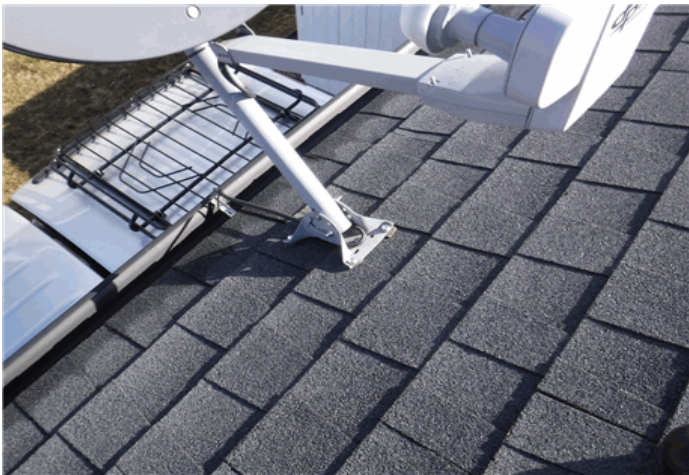
Attic Area

Attic Access Location	Laundry Room
Method of Inspection	The attic inspection was limited to those areas visible from the access.
19) Attic Conditions	<div>F</div> The visible and accessible portions of the attic appeared to be in serviceable condition at the time of the inspection.
Attic Ventilation Type	Soffit and roof vents.
20) Attic Ventilation Conditions	<div>F</div> The visible and accessible portions of the attic ventilation appeared to be in serviceable condition at the time of the inspection.
Attic Insulation Type	Loose fill and Blown-in

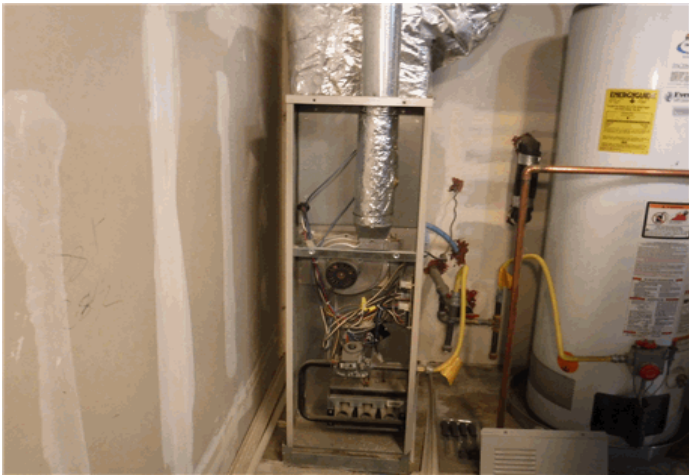
The heating system was operational at time of inspection.
This is not an indication of future operation or condition.

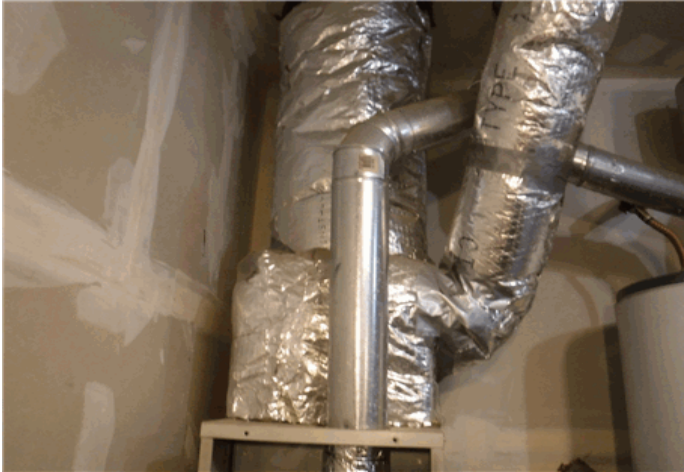
Distribution Type

The visible areas of the heat distribution system is ductwork with registers.

The visible and accessible areas of the distribution system appeared to be in serviceable condition at the time of inspection.

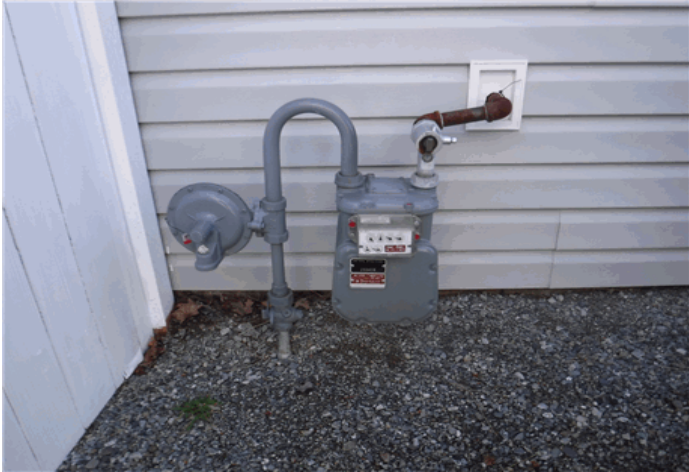
30) Gas Leak Check Inspected using Gas Trac NGX-6 Combustible Gas and Vapor Detector. No leaks were detected.

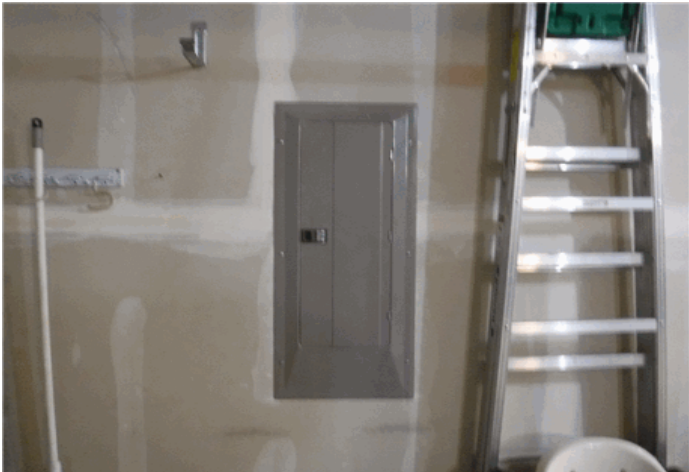
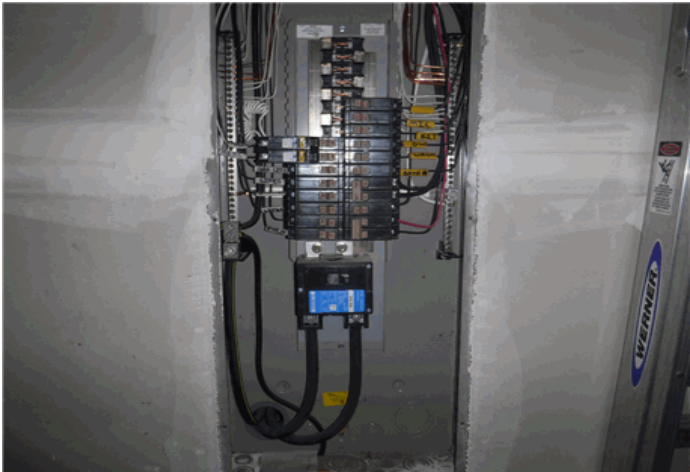
34) Wiring Conditions **F** The visible and accessible portions of the electrical wiring at the main electrical panel appeared to be in serviceable condition at the time of the inspection.

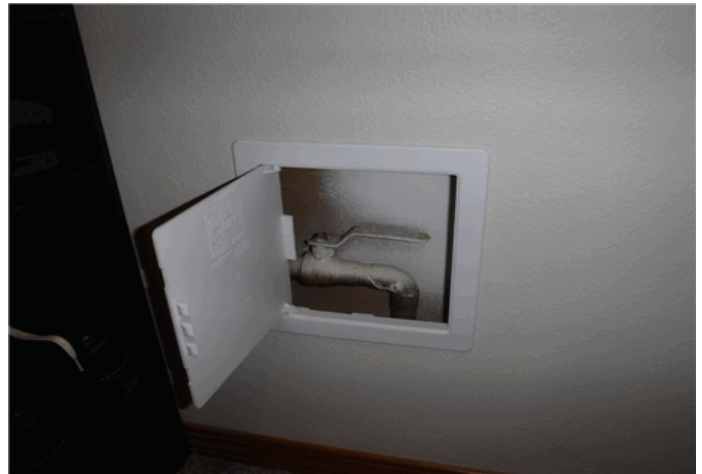
The visible portion of the main pipe and valve appeared to be in serviceable condition at the time of the inspection.

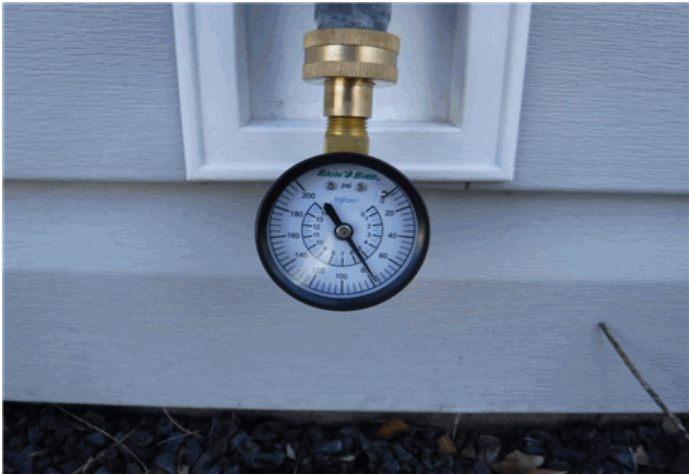
Water pressure is approximately 78 psi (pounds per square inch) as measured at the front exterior hose bib.

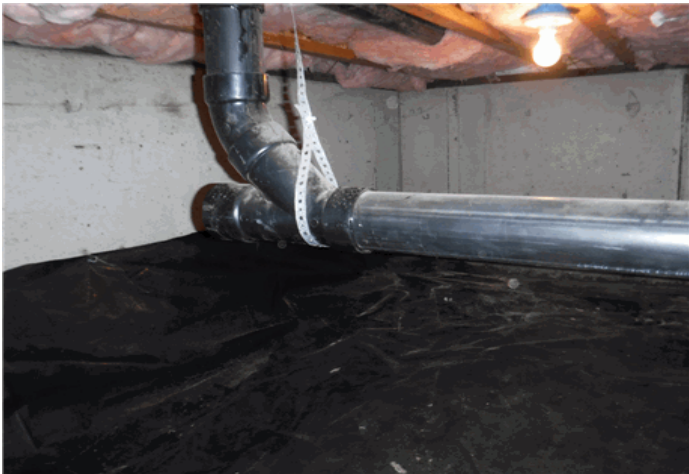
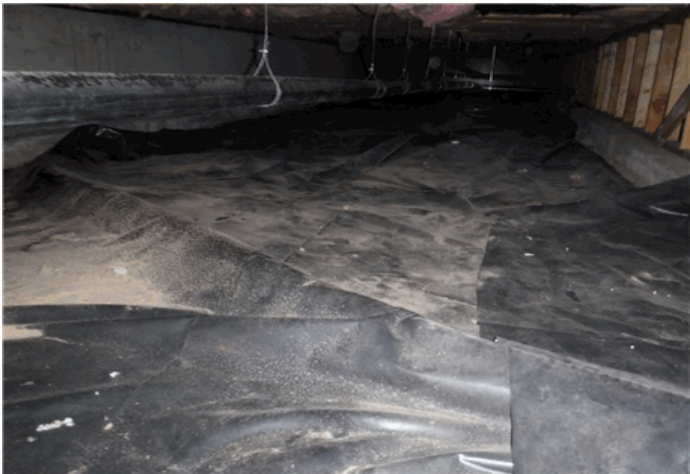
The visible portions of the waste lines appeared to be in serviceable condition at the time of inspection. All of the waste lines were not fully visible or accessible at the time of the inspection.

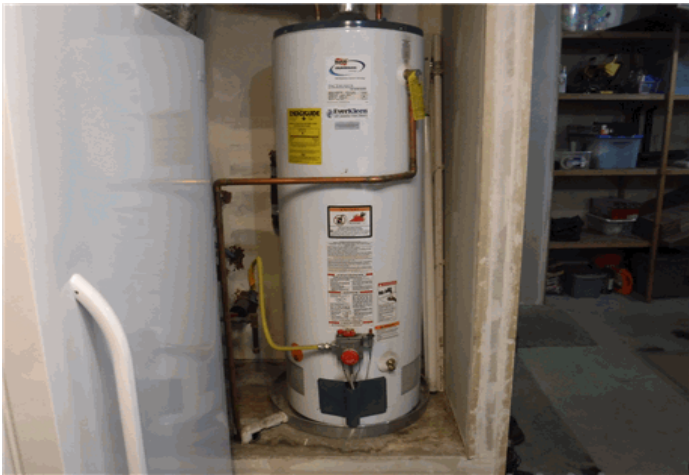
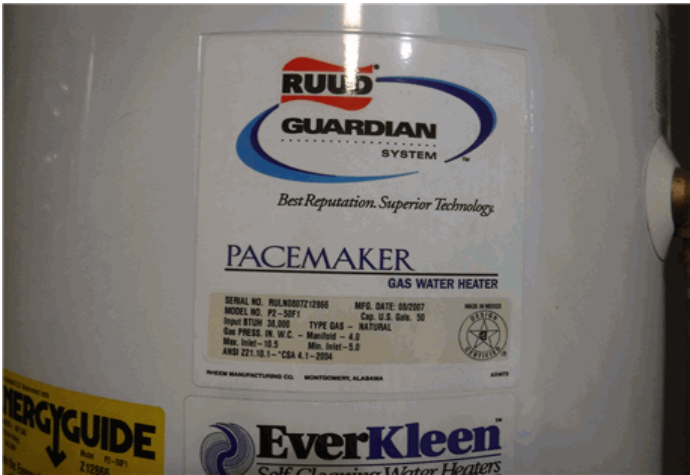
F = Functional	NI = Not Inspected	AE = Additional Evaluation Recommended
DM = Deferred Maintenance	S = Safety Concern	R = Repair
D = Defect		
Hot Water Temperature	144 degrees Fahrenheit. The temperature of domestic hot water should not be above approximately 120 degrees Fahrenheit to help prevent scalding. Recommend adjusting thermostat.

40) Water Heater Conditions	<div>F</div>	The water heater was operable at the time of inspection. This does not however guarantee future performance, operation, or condition.

41) Year Of Manufacture	According to the manufacture's serial number the water heater was produced in August of 2007, therefore it is 10 years old. Although it was functioning as intended, and produced hot water throughout the inspection, it is considered nearing the end of its average life expectancy and replacement should be planned. Predicting the life expectancy is based on the building industry averages of a specific component but there are many variables that can affect the life expectancy in both a positive and negative way. The industry averages are only a guide and not a specific determination of the components life span.

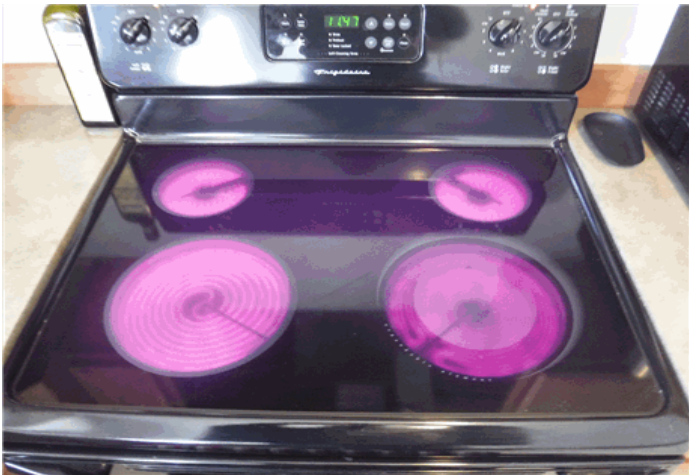
54) Stove - Range Condition **F** The oven and cook top was in operational condition at the time of the inspection. This does not however guarantee future conditions after the time of inspection.

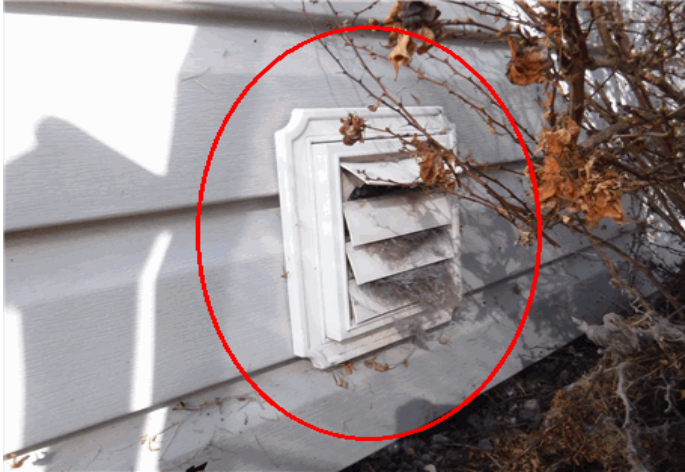
The visible and accessible portions of the laundry plumbing components appeared to be in serviceable condition at the time of inspection. For increased fire safety, recommend cleaning of lint from extended exhaust duct on a regular basis (see picture).

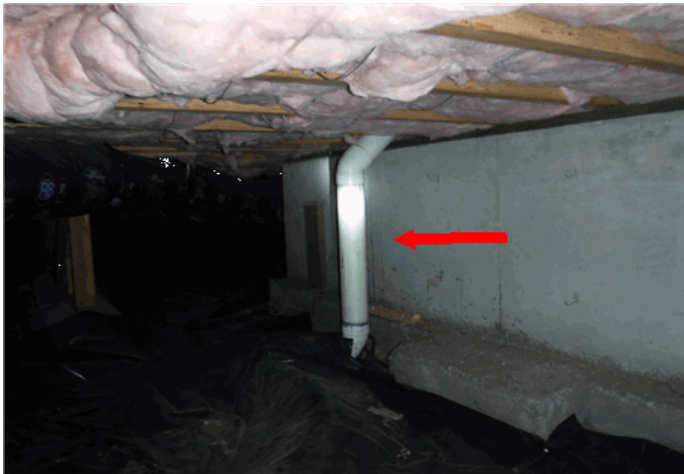
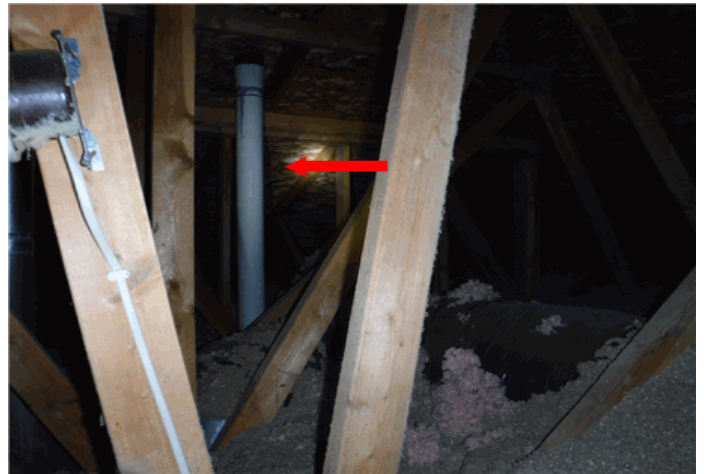
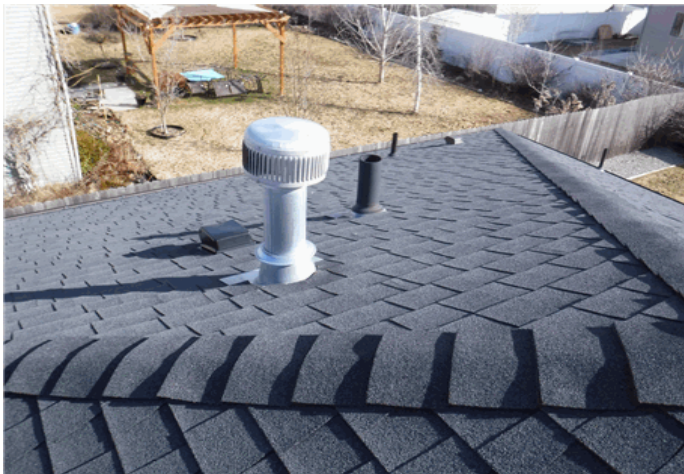
100) Other Crawl Space Conditions

A Passive Radon Mitigation System was present at the time of inspection. Vent pipe ran from crawl space through roof. See pictures.
