SAIWI Trip Report: Kenya 2013

By: Karena Carpenter – Trip Leader

May 20 – June 19

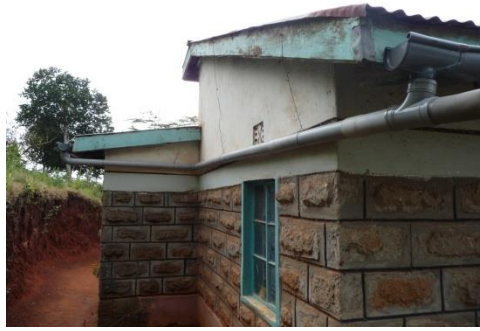
The next day we installed the gutter system on two sides of the main house which is pictured in Figure 1.

Fig 1: Gutter system on main house.

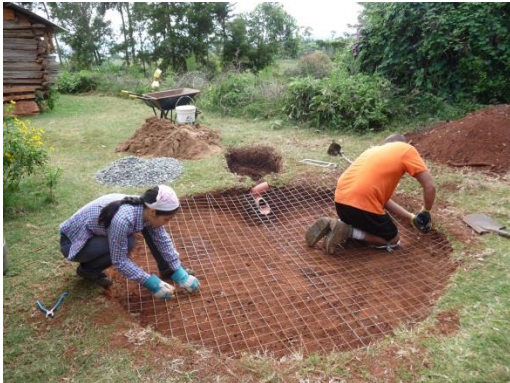
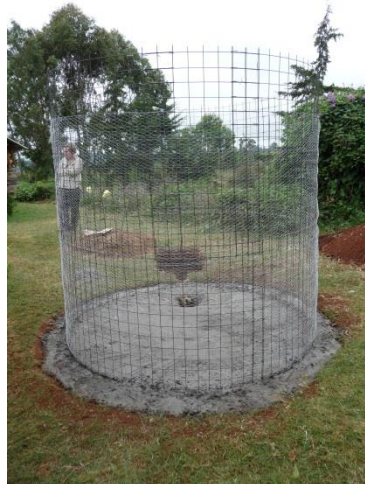
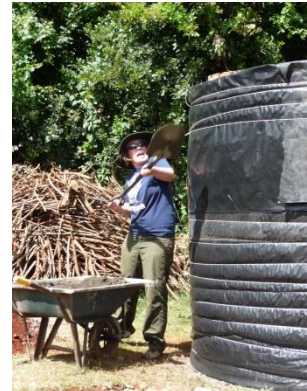
The next three days were devoted to pouring the foundation over the wire mesh base, building the wall frames, and plastering the inside of the walls. The inside was plastered only after plastic was wrapped around the walls to ensure the plaster did not just squeeze through the holes in the walls. The walls were constructed of layers of wire mesh, chicken wire, and a thick gage wire wrapped around it all and tied in place. The walls were set before the foundation was laid so that they were structurally sound. See Figures 2, 3, and 4 for these steps.

Fig's 2, 3, 4: Foundation wire, wall frame, plastic wrapped walls with plaster being shoveled in by student.

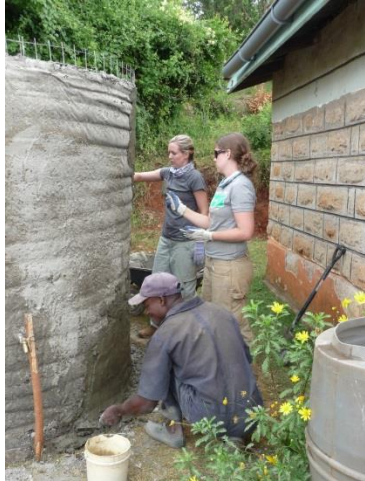
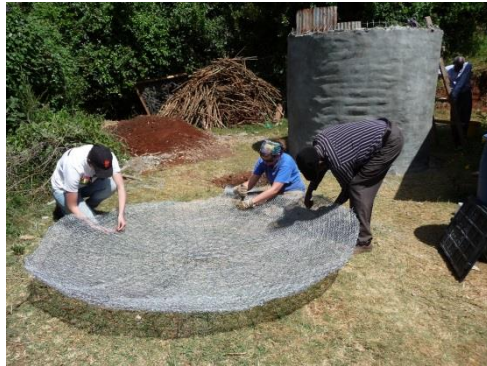
After the weekend the outside of the walls were plastered on one day, a shopping trip was made for more supplies for the roof the next day, and the fourth team member arrived in time to help cut and tie the dome roof frame together on the fourth day. The roof was covered in chicken wire, the manhole was cut out of the roof, and the dome was attached to the top all in one day, which can be seen in Figures 5 and 6. These tasks took us to the end of the third week.

Fig's 5 and 6: Plastering the outside wall, constructing the domed roof.

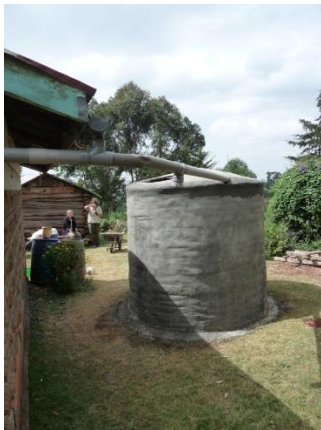
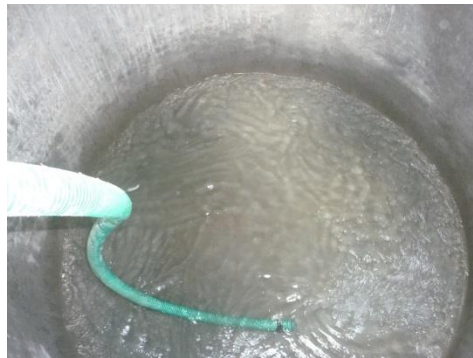
The next week was extremely productive with the completion of the cement tank and the installation of the plastic tank. The remaining steps for the cement tank included installing inlet and outlet pipes, installing the manhole and cover, and mortaring the inside and outside of the roof. Figure 7 shows the back side of the tank with gutter inlet. Figure 8 show the filling of the tank so that it can cure, and it also allowed us to check for leaking. Figure 9 shows the team of students and one other volunteer in front of the completed tank. The plastic tank took two days total to complete; one day for planning and supply buying and one day for gutter and tank installation. The completed tank with its proud owners can be seen in Figure 10.

Fig's 7 and 8: Completed tank and filling.

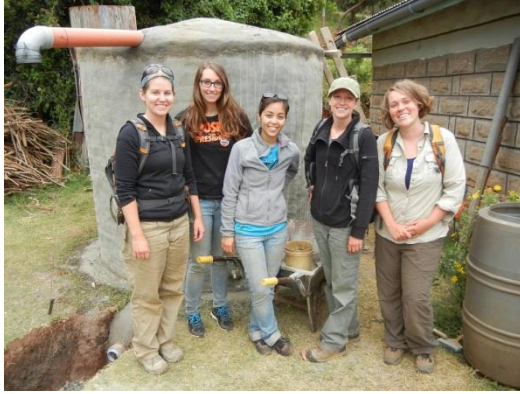
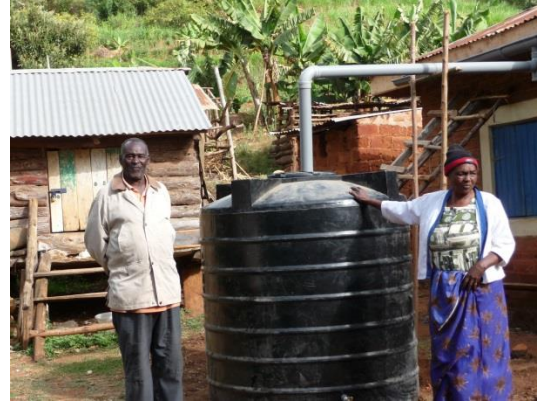
Fig's 9 and 10: Completed cement tank and plastic tank.

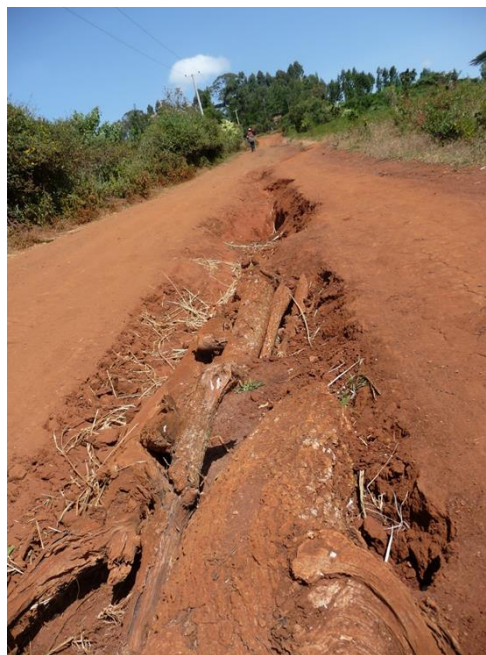
Overall the trip was a resounding success with the completion of two tanks instead of one, while staying well under budget. The students learned valuable skills like designing in the field, hands on construction skills, problem solving, and all of the benefits of an international cultural trip. If a future trip were planned, it could be centered on the enormous problem of road erosion which can be seen in Figure 11.

Fig 11: Road erosion in Mua Hills.
