Waupaca Chain O' Lakes

2018 HWM Monitoring & Control Strategy Assessment Report

April 2019

Onterra, LLC

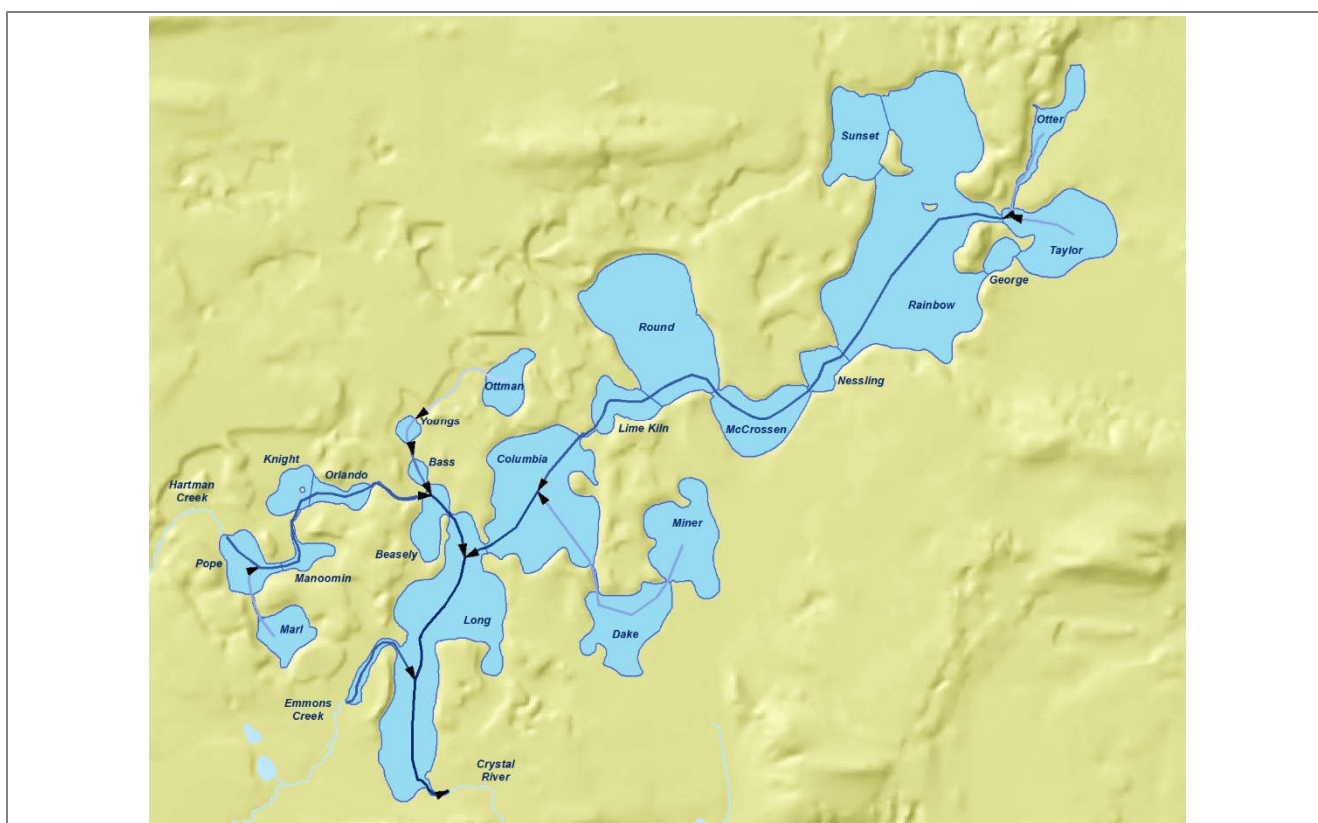
Figure 1.0-1. Waupaca Chain Flow and Lake Boundaries.

The Waupaca Chain O' Lakes consists of 22 lakes totaling approximately 792 acres in Waupaca County, Wisconsin (Figure 1.0-1). Eurasian watermilfoil (*Myriophyllum spicatum*; EWM) was first documented in the Waupaca Chain in 2001. Genetic DNA analysis later confirmed that the milfoil was a hybrid (HWM) between EWM and the native northern watermilfoil. The Waupaca Chain O' Lakes Protection and Rehabilitation District, known locally as the Waupaca Chain O'Lakes District (WCOLD), is the local entity that oversees management of the Chain and has sponsored numerous WDNR funded grant projects. With the assistance of Onterra in 2015, the WCOLD was awarded a WDNR AIS-Education, Planning and Prevention Grant to aid in funding studies aimed at documenting the current state of the Chain's native and non-native aquatic plant populations to guide the development of future management strategies. Surveys conducted in 2015 found that HWM can be found throughout much of the project waters.

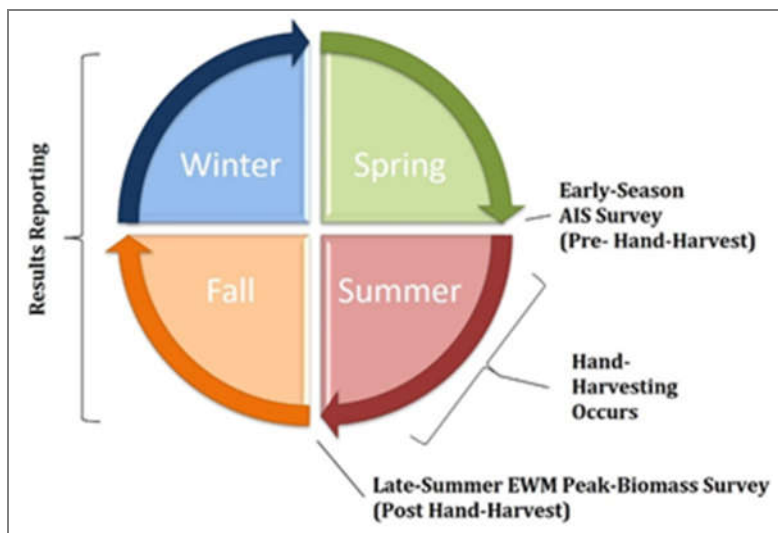
Figure 2.0-1. Hand-Harvesting Control and Monitoring Timeline.

A set of HWM mapping surveys were used within this project to coordinate and qualitatively monitor the hand-harvesting efforts. In early summer 2018, Onterra conducted an Early Season AIS Survey (ESAIS Survey). Based on the results of the ESAIS Survey, the hand-harvesting control strategy was revised, if necessary, and finalized (Figure 2.0-1). The final WDNR approved mechanical harvesting permit was based on the strategy developed following Onterra's 2018 ESAIS survey. Hand-harvesting activities took place between the ESAIS (pre) and the late-summer HWM Peak-Biomass (post) surveys, allowing for evaluation of the management activity.

The hand-removal program would be considered successful if the density of HWM within the hand-removal areas was found to have decreased from the ESAIS Survey to the Late-Summer Peak-Biomass Survey.

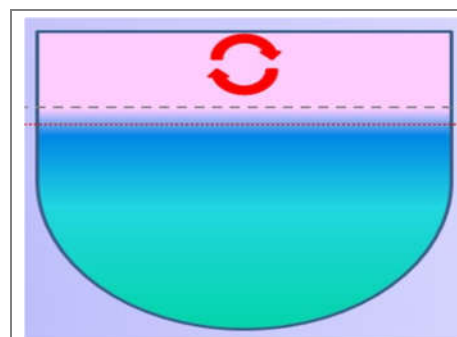
Figure 3.2-1 Mixing zone of a stratified lake. Grey dashed line indicates start of metalimnion. Red dashed line indicates mixing volume used in dosing calculations.

In order to finalize the dosing volume for the 2018 whole-lake treatments, it was necessary to understand the volume of water in which the herbicide was expected to mix. As the water warms, a thermal barrier develops in many lakes essentially separating the lake into an upper epilimnion with warmer water temperatures and a lower hypolimnion with cooler water temperatures (Figure 3.2-1). The transitional area separating the upper and lower portions of the water column is known as the metalimnion. In recent years, it has become common for lake managers to predict the mixing volume of a lake based on the middle/upper-middle of the metalimnion, understanding that some amount of herbicide will be lost to the metalimnion.

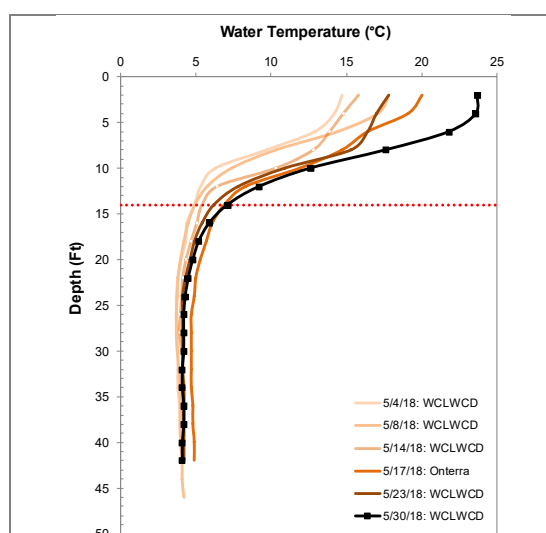
Figure 3.2-2 Pre-Treatment Temperature Profiles Collected on Beasley Lake. Red dashed line indicates dosing depth.

Staff from Waupaca County LWCD provided numerous temperature profiles leading up to the whole-lake herbicide treatment on Bass and Beasley Lakes (Figures 3.2-2). During May, the lake was warming, and towards the end of the month, stratification parameters became apparent in Beasley Lake. Due to the shallower depth and smaller size of Bass Lake, only near surface water temperatures were monitored in the weeks leading up to the treatment as the lake was not expected to thermally stratify. The final dosing depth for Beasley Lake was 14 feet.

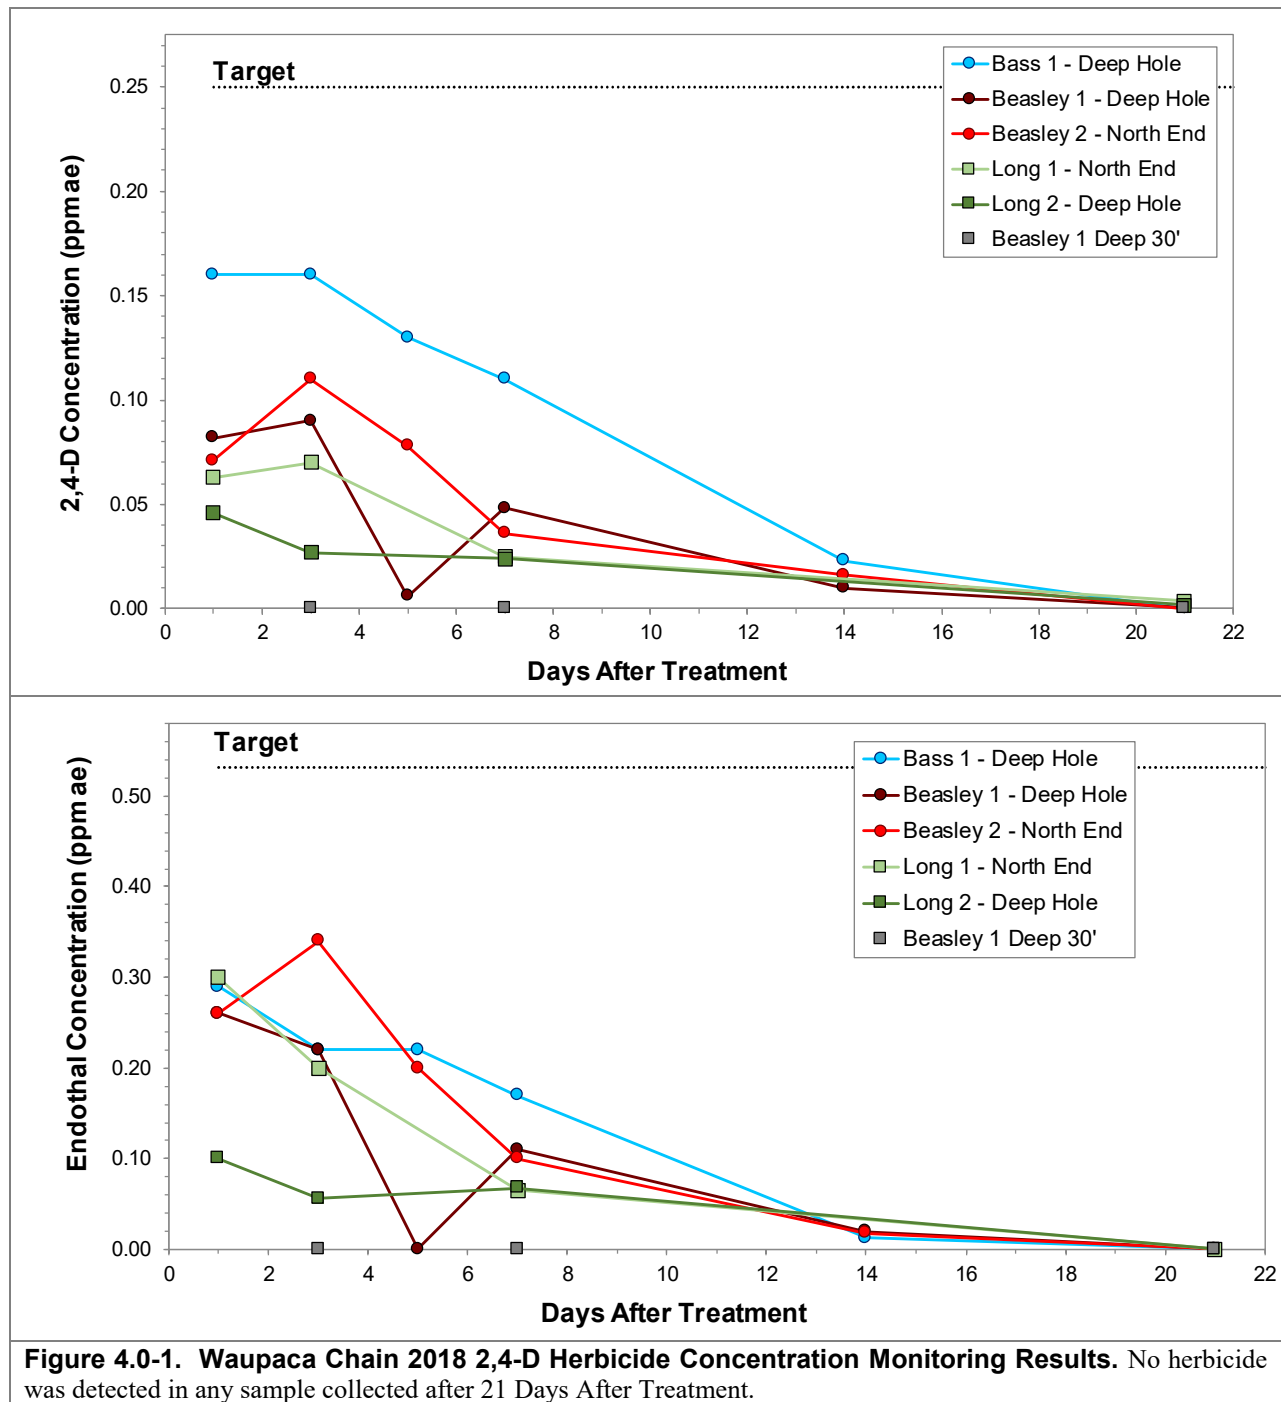
The black square symbols on Figure 4.0-1 represent water collected at 30 feet of water from the deep hole monitoring site (Beasley 1). No herbicide was detected in the hypolimnion of Beasley Lake

concentrations observed in the downstream sampling sites in Long Lake. Herbicide concentrations at the deep hole sampling site in the middle part of Long Lake were less as the herbicide diluted within that larger volume of water. Minimal 2,4-D or endothall was detectable by 21 DAT in all sampling sites, and no 2,4-D or endothall herbicide was detected in any sample collected on 28 DAT, 35 DAT, 49 DAT, or 70 DAT.

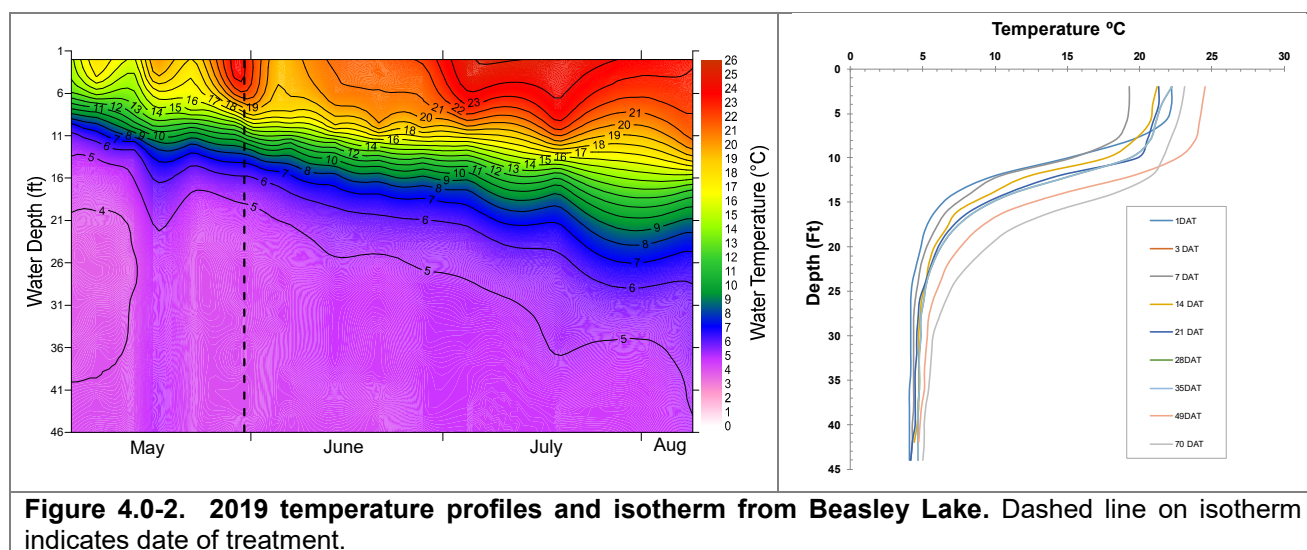
Temperature profiles collected at each herbicide concentration sampling interval indicate that Beasley Lake remained thermally stratified throughout the duration of the monitoring timeframe. The closely spaced water temperature contours on the isotherm (Figure 4.0-2, left frame) indicate a thermal gradient separating the epilimnion and hypolimnion beginning at approximately 12-14 feet on the treatment date. As the water temperatures increased during the summer months, the thermal gradient appears to have shifted slightly deeper. This can also be observed on the temperature profiles (Figure 4.0-2, right frame), where uniform temperatures were observed down to about 10 feet before getting much colder in a short amount of depth.

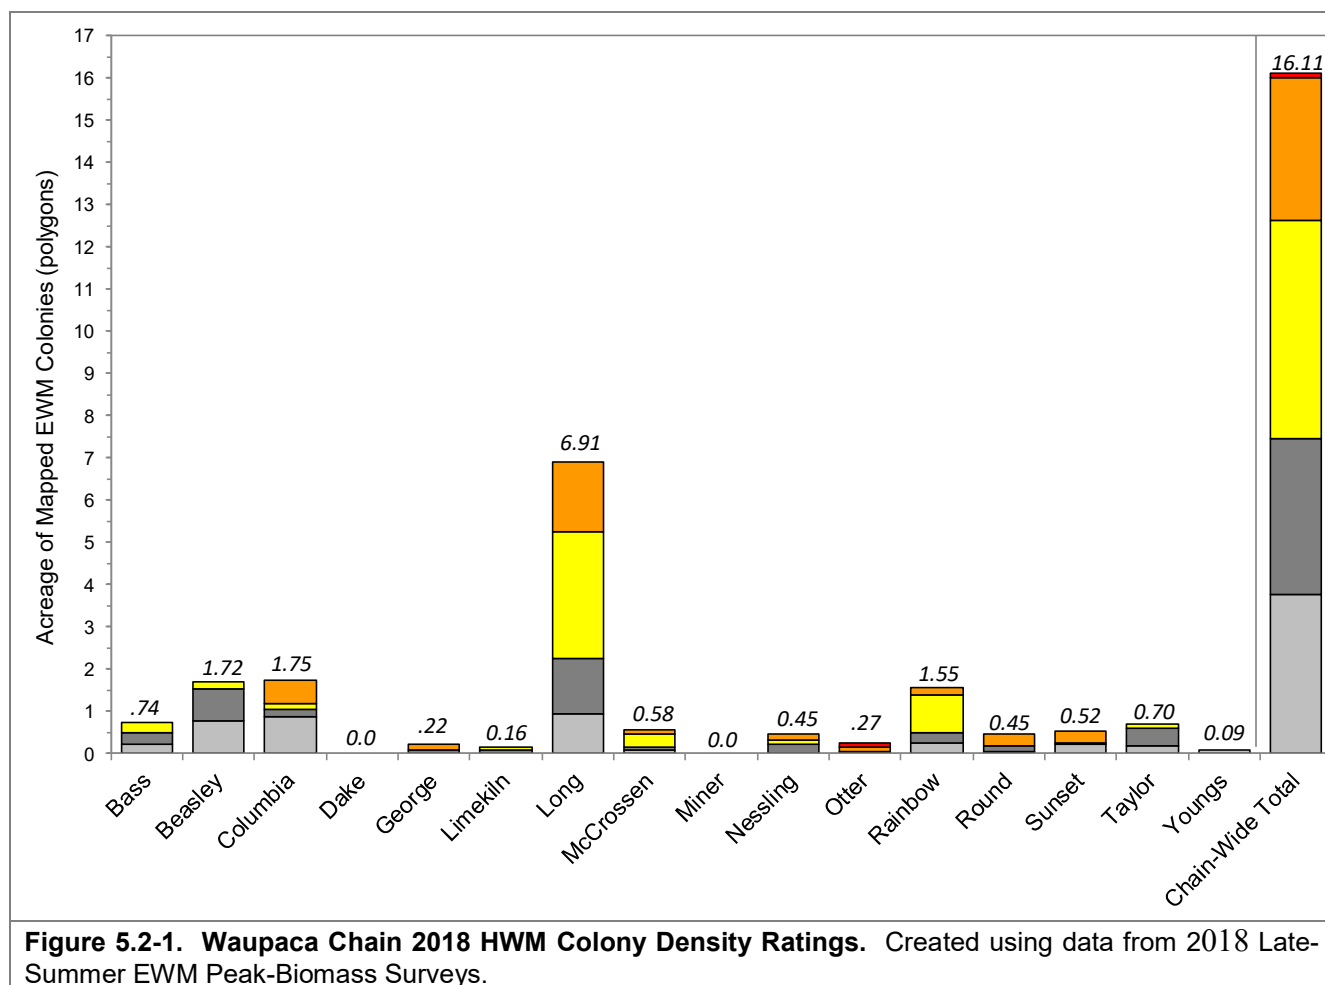
Figure 5.2-1. Waupaca Chain 2018 HWM Colony Density Ratings. Created using data from 2018 Late-Summer EWM Peak-Biomass Surveys.

During the Chain-wide peak-biomass mapping survey, all lakes with the exception of Ottman Lake were surveyed. Ottman Lake requires access through a private property and no HWM was located in this lake during surveys completed in 2015. The population of HWM was found to be widespread throughout the Chain with some of the largest and most dense colonies being found in Long Lake, Beasley Lake, and Columbia Lake. A total of 16.1 acres of HWM was mapped throughout the Chain in the 2018 survey. Of the HWM acreage mapped in 2018, approximately 6.9 acres or 42% was within Long Lake, 1.75 acres or 11% in Columbia Lake, and 1.72 acres or 11% in Beasley Lake (Figure 5.2-1).

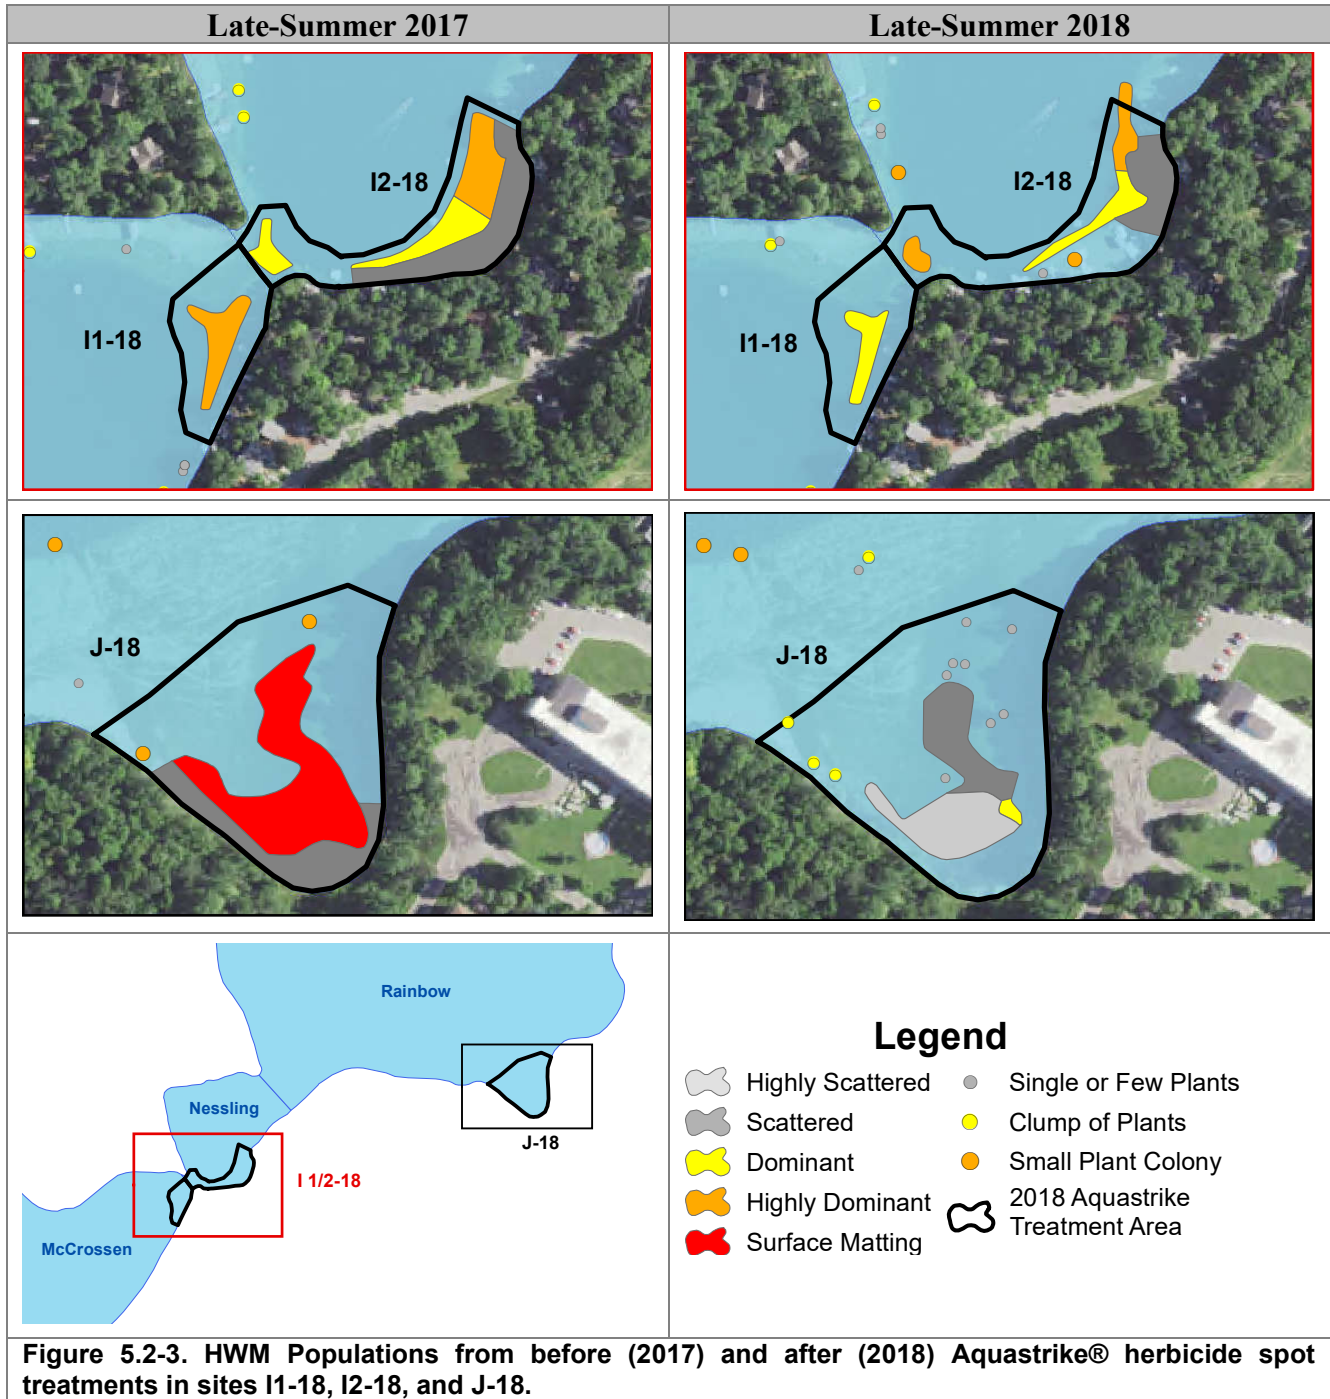
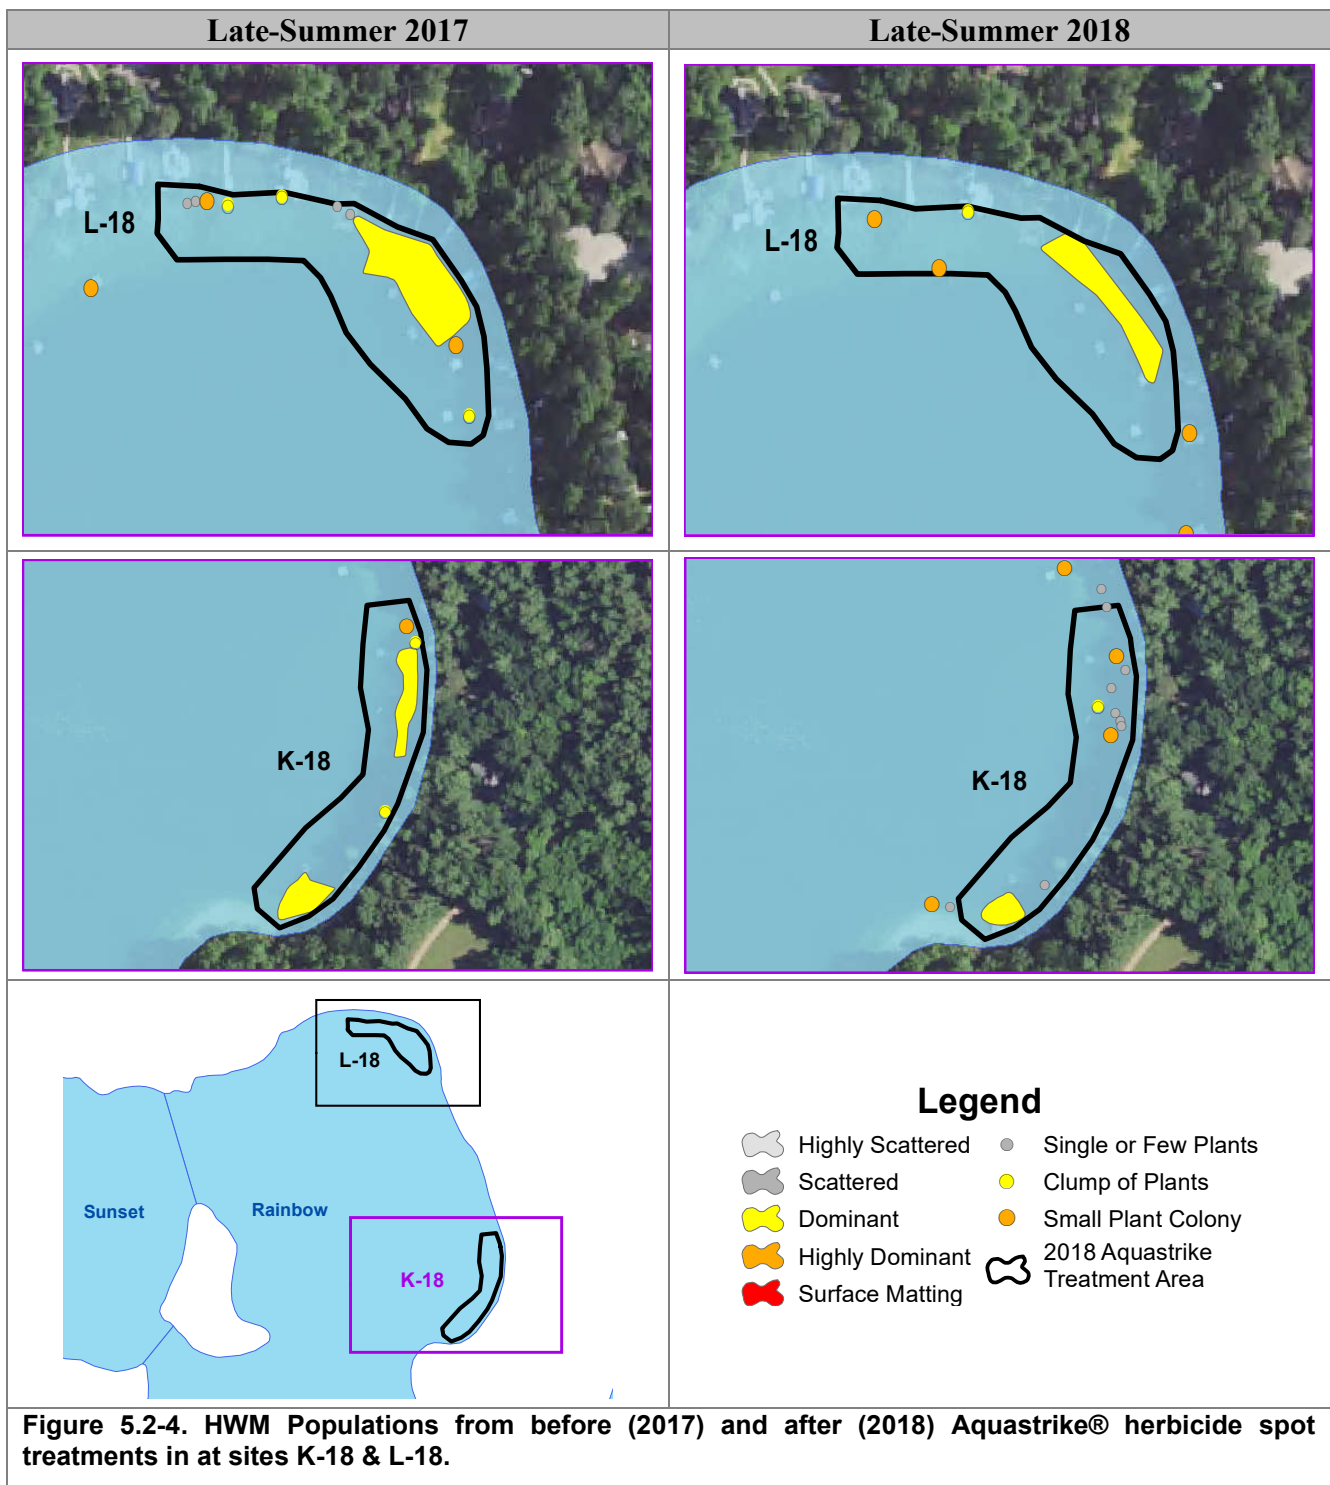
The sites that were targeted for herbicide control in 2018 with spot treatments using AquaStrike® (combination diquat/endothall) are highlighted in Figures 5.2-2 through 5.2-4 where the left frame shows the pre-treatment HWM population mapped in late-summer 2017 and the right frame shows the post-treatment HWM population mapped in late-summer 2018.

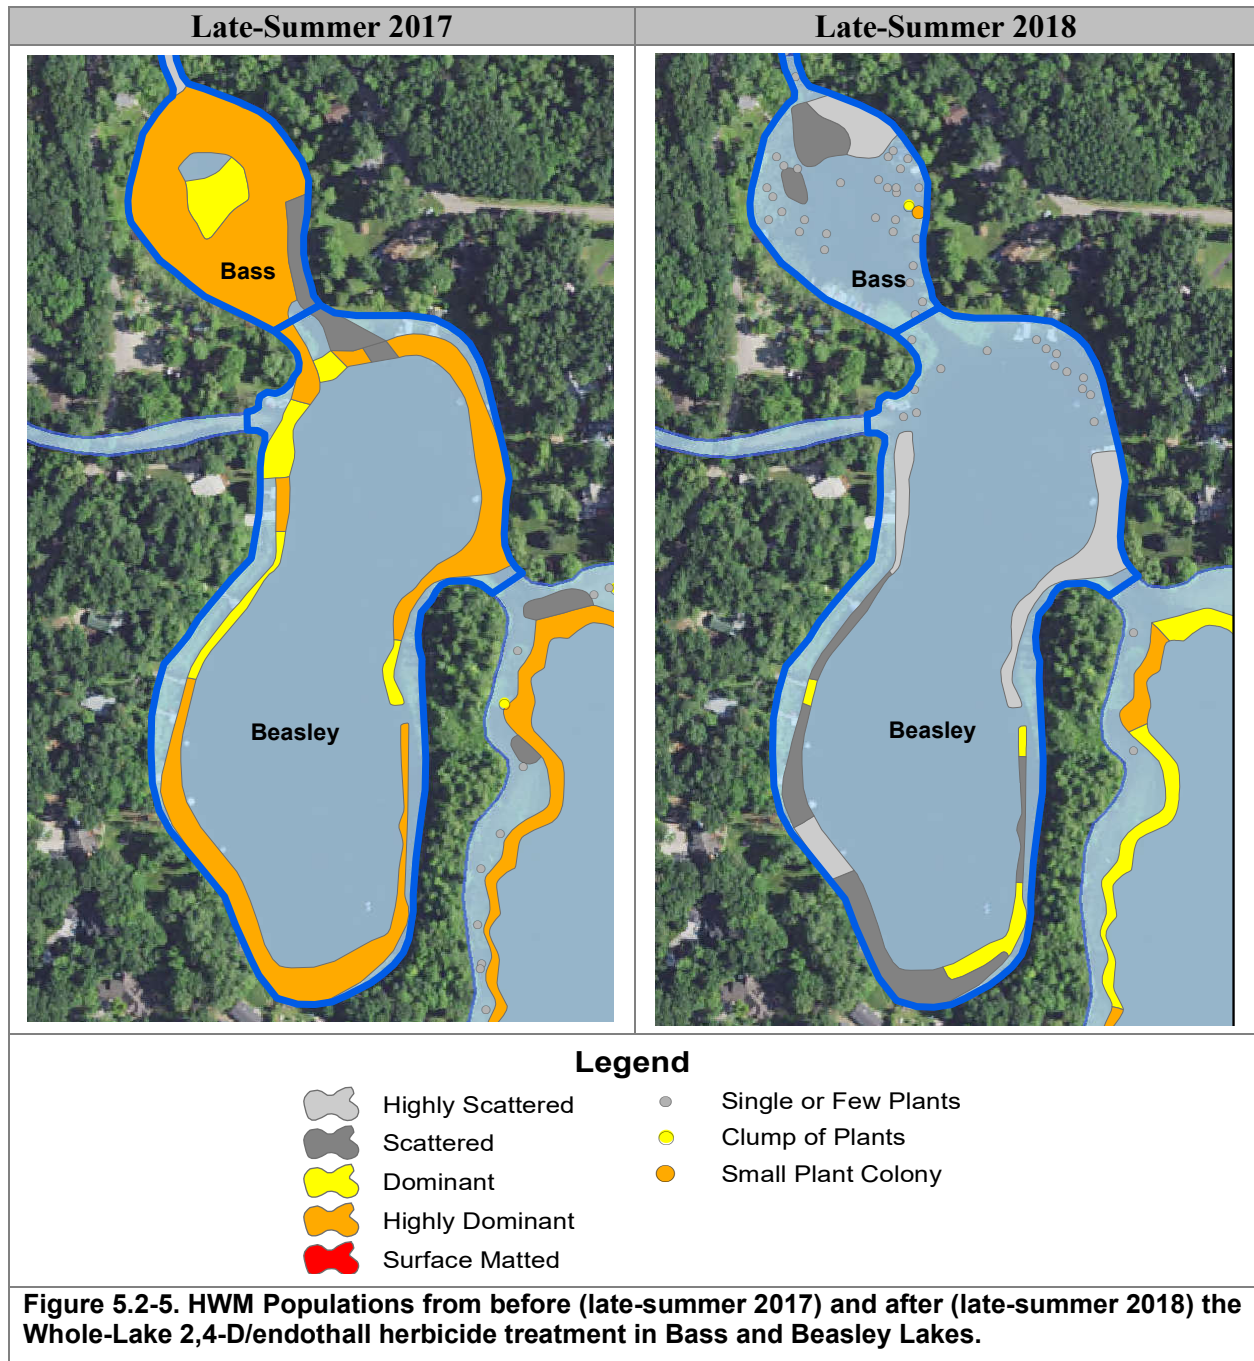
A total of 2.7 acres of colonized HWM was mapped in Bass Lake in the late-summer 2017 survey of which the majority was designated as either *dominant* or *highly dominant* in density (Figure 5.2-5). The late-summer 2018 HWM mapping survey indicated that the HWM population was decreased in Bass Lake in total acreage to 0.7 acres. An area of *scattered* and *highly scattered* plants remained present on the north side of the lake in the late-summer 2018 survey (Figure 5.2-5).

The HWM population in Beasley lake was found to have decreased in density in the majority of the lake; however, large continuous areas of colonized HWM remained present in most of the lake in areas where it had been mapped before the treatment. Acreage of colonized HWM in Beasley Lake were reduced from 2.5 acres in 2017 to 1.7 acres in 2018. Of the 1.7 acres mapped in Beasley Lake in 2018, 1.5 acres consisted of lower density ratings of either *scattered* or *highly scattered*, with an additional approximately 0.2 acres described as *dominant* in density.

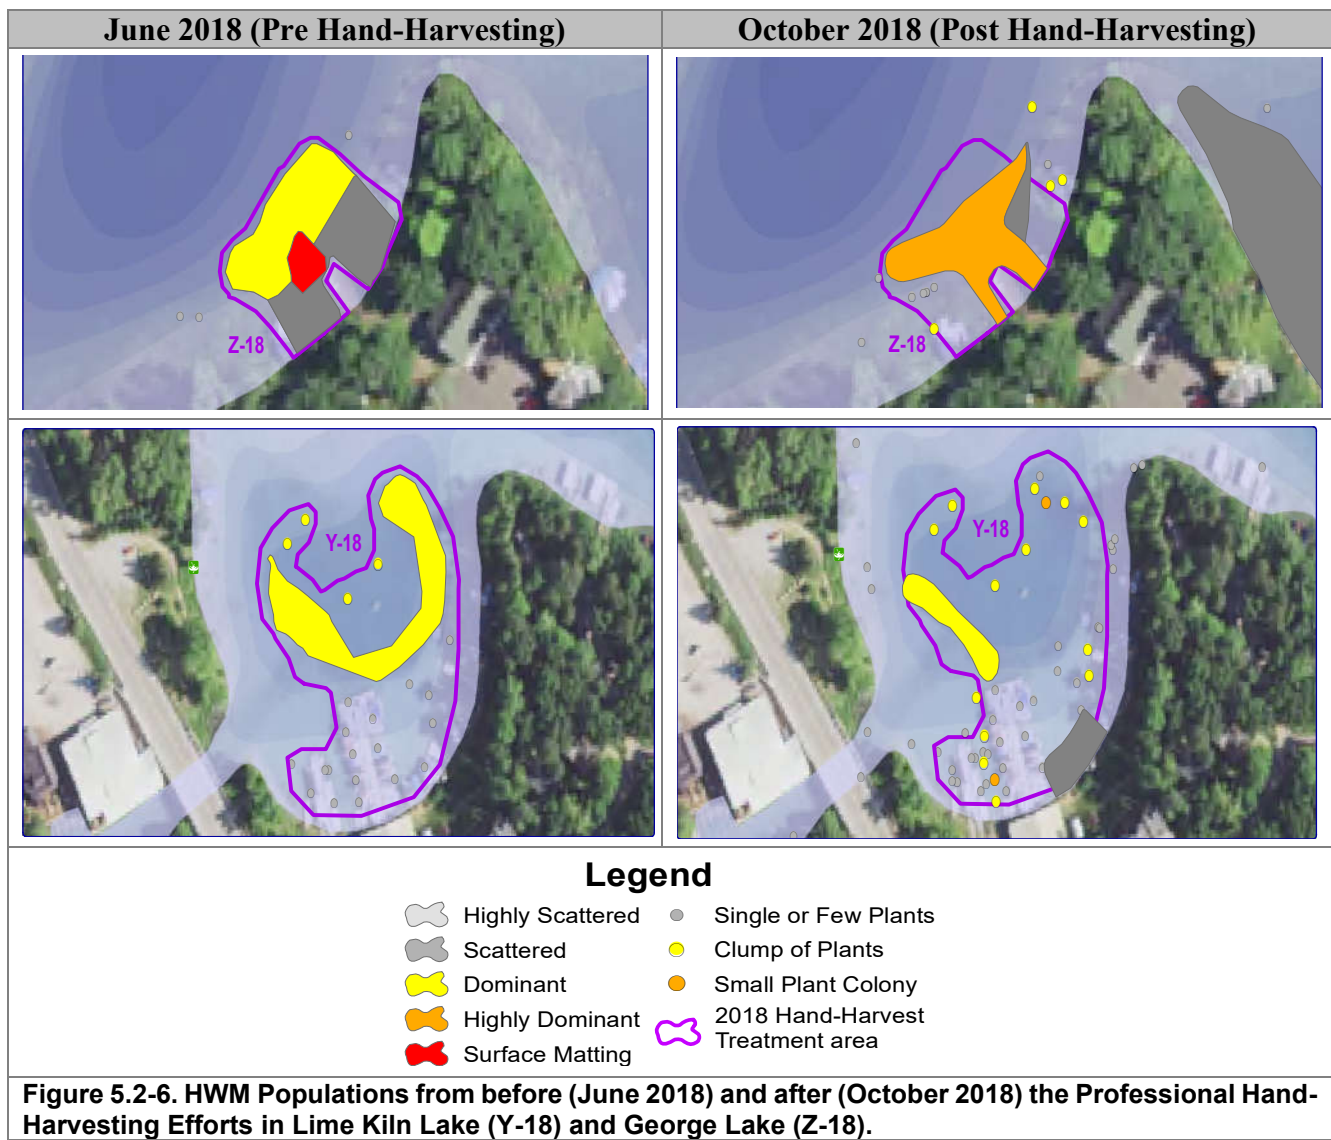
The sites that were targeted for HWM management in 2018 with professional hand-harvesting (DASH) efforts are evaluated in the figure below (Figure 5.2-6). The 2018 June ESAIS survey mapped a dense colony of HWM directly in front of the dock of the Wisconsin Veterans Home in George Lake (site Z-18). The colony included 0.02 acres of *surface matting*, 0.13 acres of *dominant*, and 0.12 acres of *scattered* HWM. DASH efforts concluded in late summer 2018, and Onterra staff returned to conduct the HWM peak biomass survey in October. Post hand-harvesting results showed a slight reduction in acreage in site Z-18. A total of 0.15 acres of *highly dominant* and 0.02 acres of *scattered* HWM were recorded in the October survey. Onterra staff noted HWM was less dense near shore, but denser adjacent to the dock. Small gaps from hand harvesting were present in the main colony.

Site Y-18 is located in front of Becker Marine in Lime Kiln Lake. A horseshoe-shaped colony of *dominant* HWM was observed in the June 2018 survey. This colony was 0.32 acres in size and had *clumps* and *single* HWM plants also within the harvest site. After hand-harvesting efforts, the size of the *dominant* colony was significantly reduced to 0.09 acres. A new, *scattered* colony was mapped amongst the docks and shore in the marina. This colony was 0.08 acres in size. Numerous *single* plants, *clumps of plants* and two *small plant colonies* were mapped within the site.

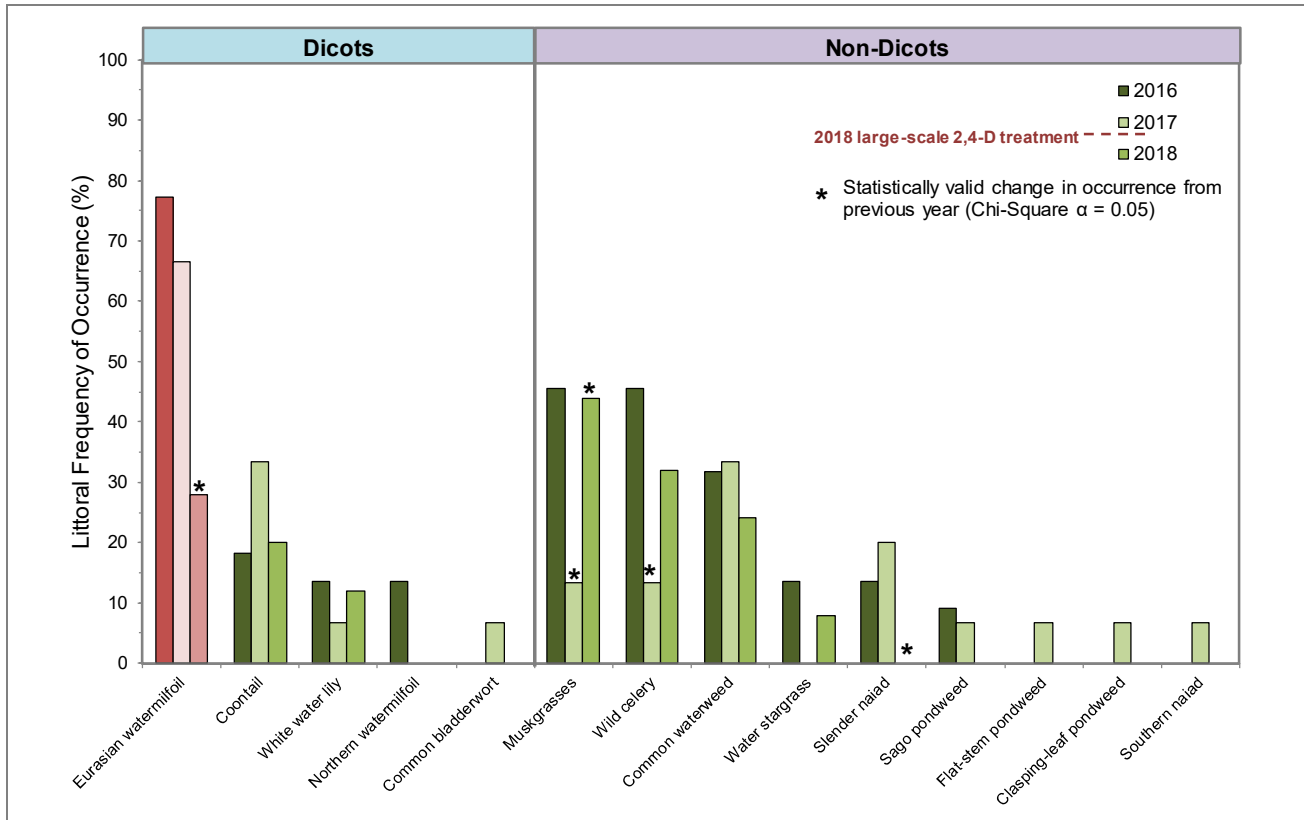
Figure 5.3-2. Littoral frequency of occurrence of aquatic plant species from 2016-2018 in Bass and Beasley Lakes. Whole-lake 2,4-D/endothall herbicide treatment occurred in spring 2018.

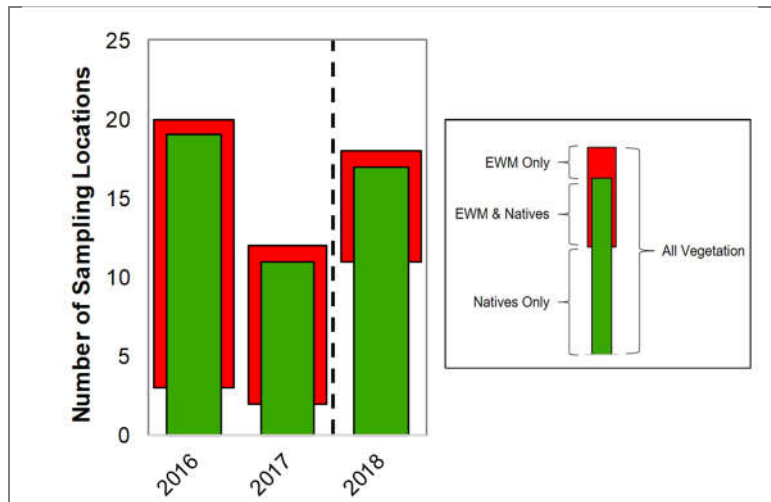
Figure 5.3-3 Vegetation composition of point-intercept locations in Bass and Beasley Lakes.

Figure 5.3-3 displays the number of point-intercept survey sampling locations that contained either native plants only, HWM plants only, or native plants and HWM plants from surveys completed in 2016-2018 in Bass and Beasley Lakes. In 2016, 17 sampling locations in Bass and Beasley Lakes contained HWM and in 2017, 10 of the sampling sites contained HWM. Hybrid watermilfoil was located on seven sampling points in 2018. The number of sampling locations with native plants increased from 11 in 2017 to 17 in 2018.

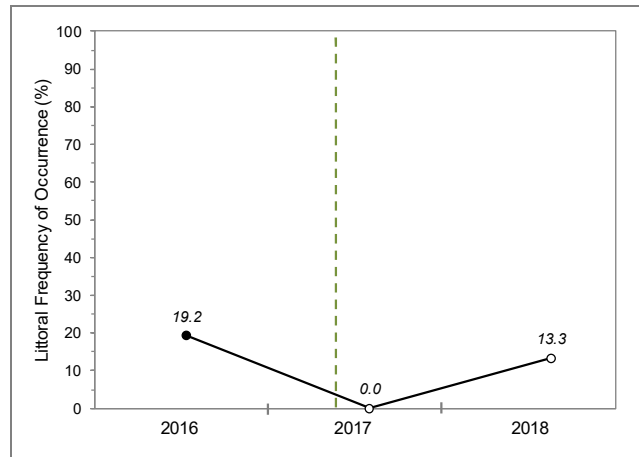
Figure 5.4-1. Littoral Frequency of Occurrence of HWM in Otter Lake from 2016-2018. Data from Onterra 2016, 2017, and 2018 Point-Intercept Surveys. Open circle indicates a statistically valid change from previous survey. Green dashed line represents whole-lake herbicide treatment.

Along with understanding the level of HWM control achieved from the control action, the point-intercept data also allows for an understanding of non-target native plant impacts from the treatment. No native species in Otter Lake exhibited a statistically valid decrease in population from 2016-2017. Sago pondweed (*Stuckenia pectinata*) exhibited a statistically valid increase in population from 2017-2018. Stoneworts (*Nitella spp.*), a type of macroalgae, exhibited a statistically valid decrease in population from 2017-2018 (Figure 5.4-2).

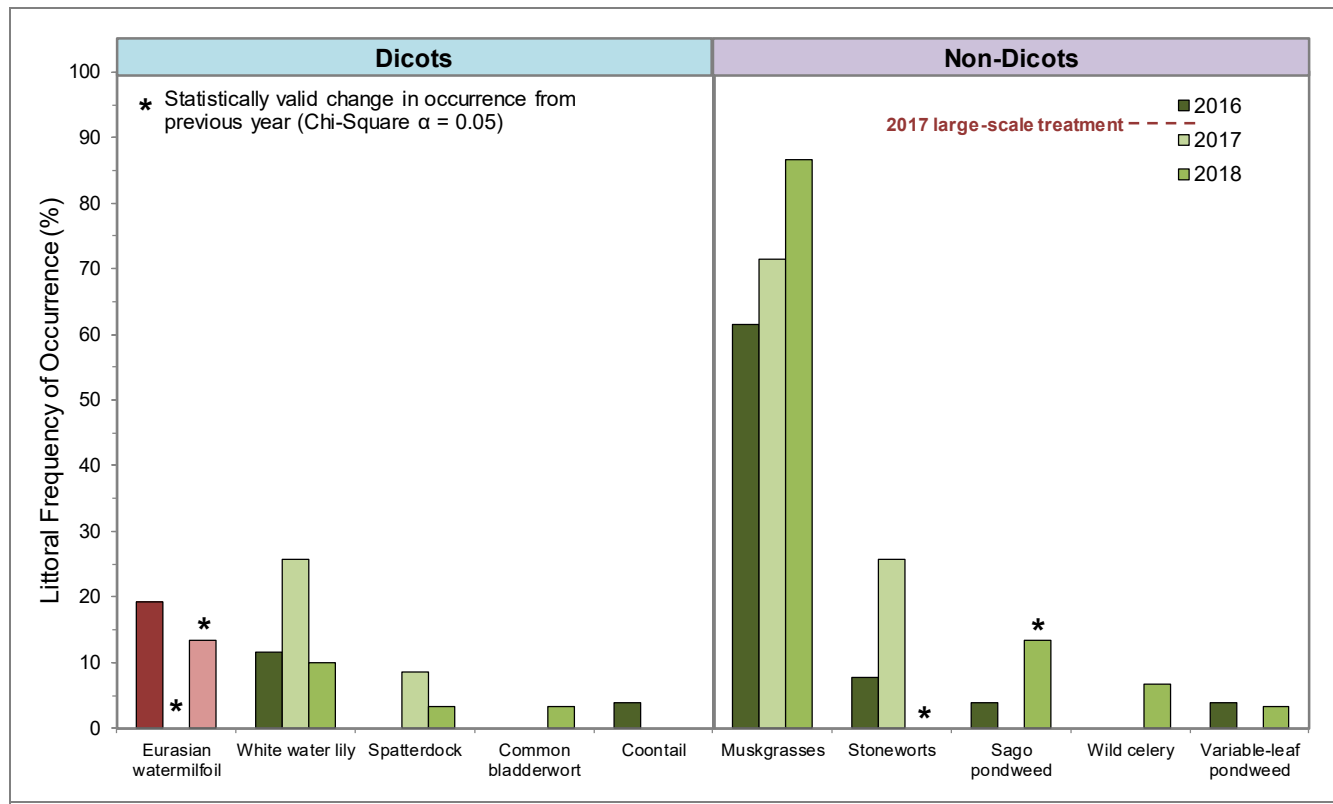
Figure 5.4-2. Littoral frequency of occurrence of aquatic plant species from 2016-2018 in Otter Lake. Whole-lake 2,4-D/endothall herbicide treatment occurred in spring 2017.

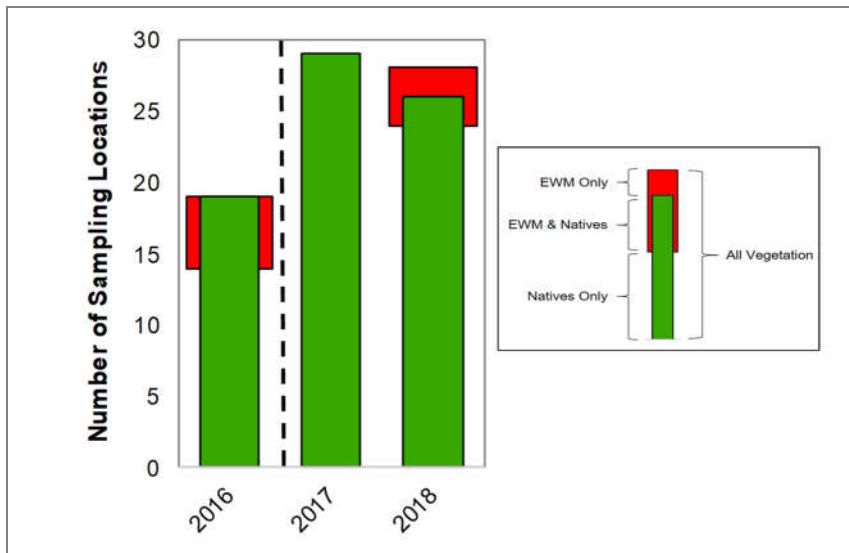
Figure 5.4-3. Vegetation composition of point-intercept locations in Otter Lake.

Figure 5.4-3 displays the number of point-intercept survey sampling locations that contained either native plants only, HWM plants only, or native plants and HWM plants from surveys completed in 2016-2018 in Otter Lake. An increase in the number of sampling points with native vegetation was exhibited between 2016-2017. In 2018, 26 sampling points contained native plants and four points contained HWM. Two of the sampling points contained both HWM and native plants in 2018.

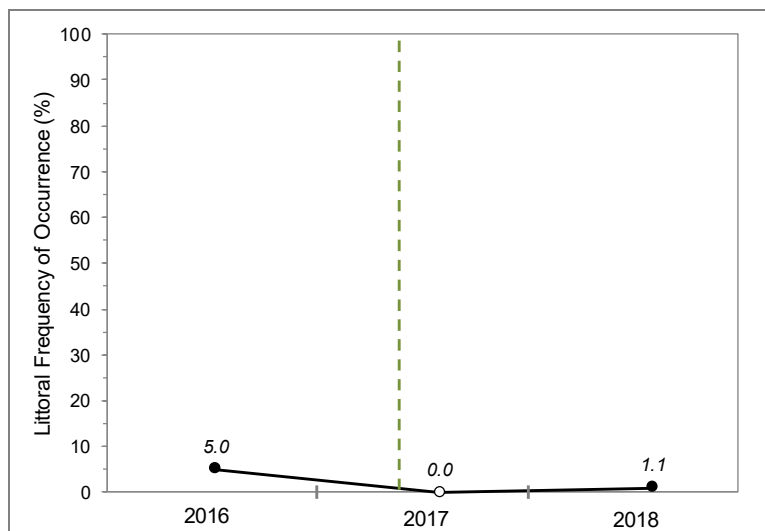
Figure 5.5-1. Littoral Frequency of Occurrence of HWM in Dake Lake from 2016-2018. Data from Onterra 2016,2017 & 2018 Point-Intercept Surveys. Green dashed line indicates whole-lake treatment. Open circle indicates statistically valid difference from previous survey.

Two native species, sago pondweed (*Stuckenia pectinata*) and slender naiad (*Najas flexilis*), exhibited a statistically valid decrease in occurrence between 2016-2017. Slender naiad is an annual that relies on seed production and has been shown to be particularly susceptible to auxin herbicides (e.g. 2,4-D, triclopyr). Both sago pondweed and slender naiad populations rebounded in 2018 to levels approximately the same as the 2016 survey (Figure 5.5-2.) Stoneworts exhibited a statistically valid increase in occurrence between 2017-2018 in Dake Lake.

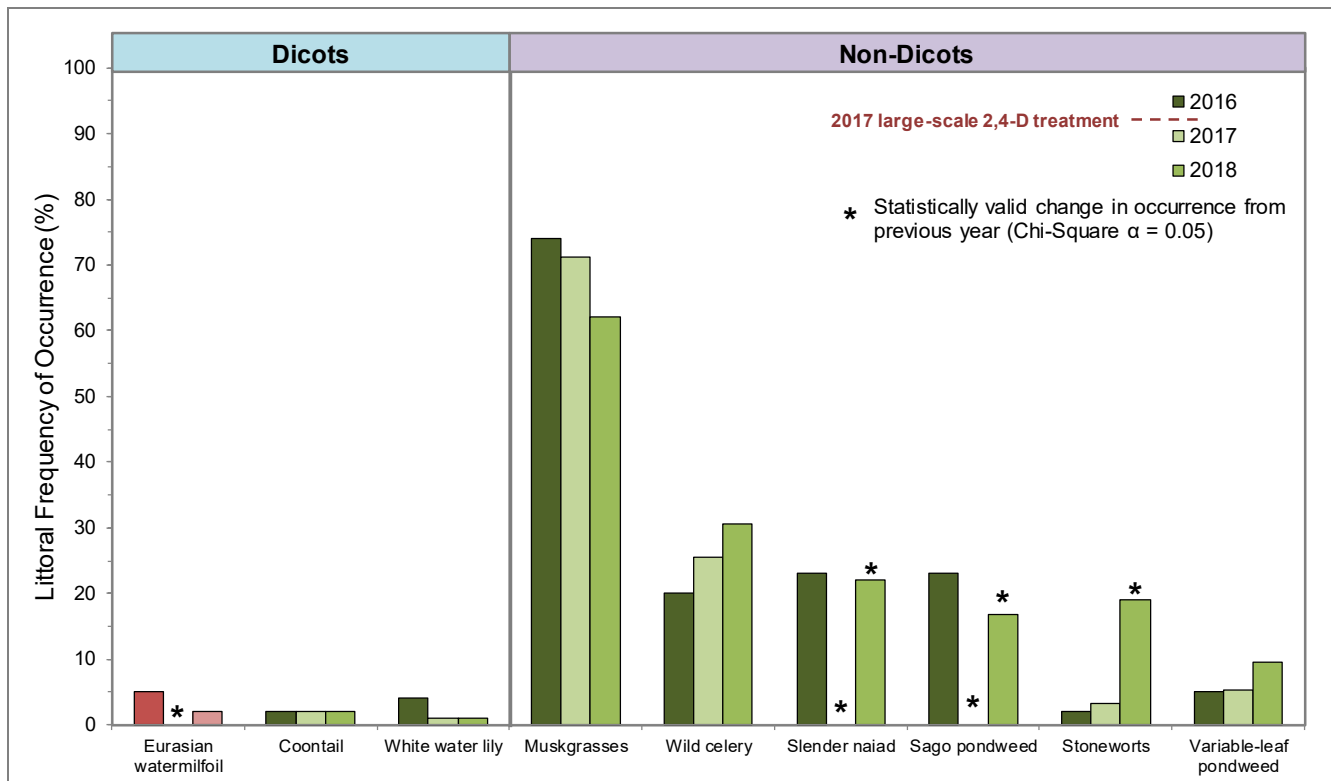
Figure 5.5-2. Littoral frequency of occurrence of aquatic plant species from 2016-2018 in Dake Lake. Data from Onterra 2016-2018 Point-Intercept Surveys. Whole-lake 2,4-D herbicide treatment occurred in spring 2017.

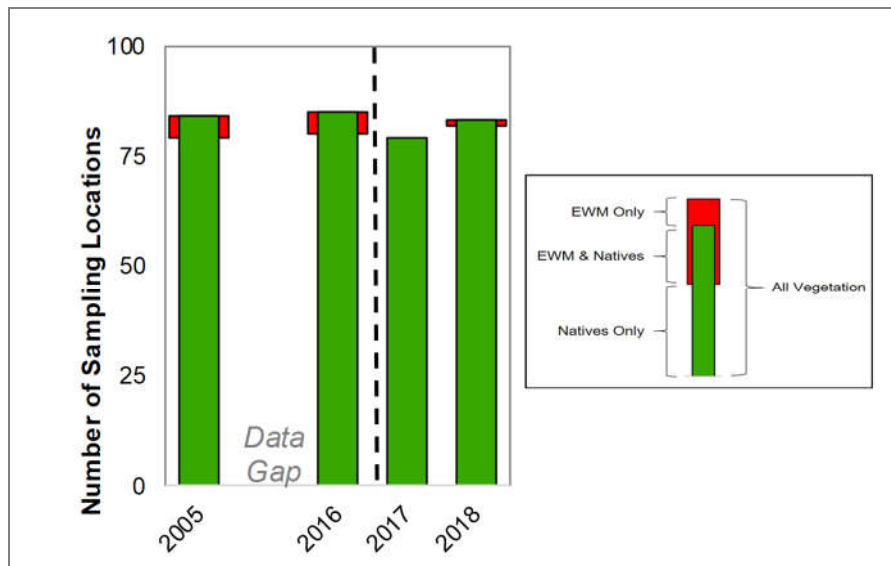
Figure 5.5-3. Vegetation composition of point-intercept locations in Dake Lake.

Figure 5.3-2 displays the number of point-intercept survey sampling locations that contained either native plants only, HWM plants only, or native plants and HWM plants from surveys completed in 2016-2018 in Dake Lake. The number of sampling locations with native plants has been relatively stable between all surveys completed in 2005 and 2016-2018. In 2018, 83 sampling locations contained native aquatic plants, while just two points contained HWM.

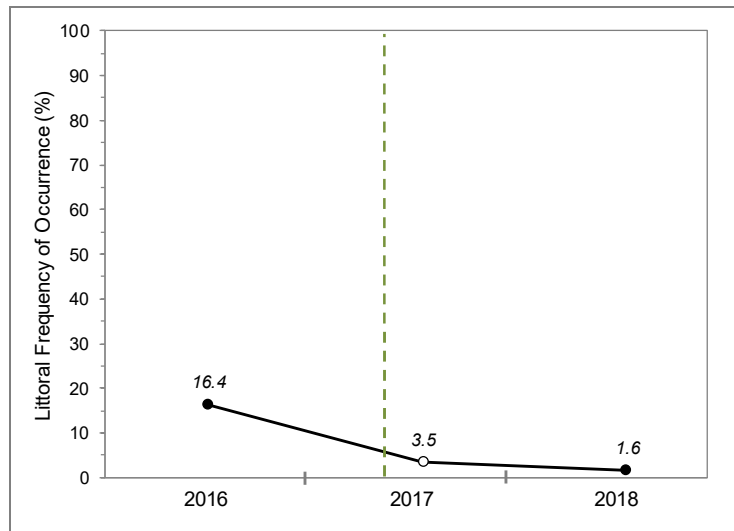
Figure 5.6-1. Littoral Frequency of Occurrence of HWM in Miner Lake from 2016-2018. Data from Onterra 2016, 2017, and 2018 Point-Intercept Surveys. Green dashed line indicates whole-lake treatment. Open circle indicates statistically valid difference from previous survey.

Hybrid watermilfoil was located at nine sampling locations in the 2016 survey (16.4% littoral frequency). Two sampling points contained HWM in the 2017 survey representing a statistically valid 78.6% decrease from 2016 (Figure 5.6-1). Hybrid watermilfoil was present at one sampling location in the 2018 survey (1.6%), which represents a 90% decrease in littoral frequency from the year before treatment (2016). Three native species, sago pondweed (*Stuckenia pectinata*), slender naiad (*Najas flexilis*), and muskgrasses (*Chara* spp.) exhibited a statistically valid decrease in occurrence between 2016-2017, while one species, stoneworts (*Nitella* spp.), showed a statistically valid increase. Continued monitoring in 2018 showed the population of slender naiad rebounded to approximately the same pre-treatment levels, while sago pondweed and muskgrasses increased between 2017-2018 but remained below pre-treatment levels observed in 2016.
