Waupaca Chain O' Lakes

2018 HWM Monitoring & Control Strategy Assessment Report

April 2019

Onterra, LLC

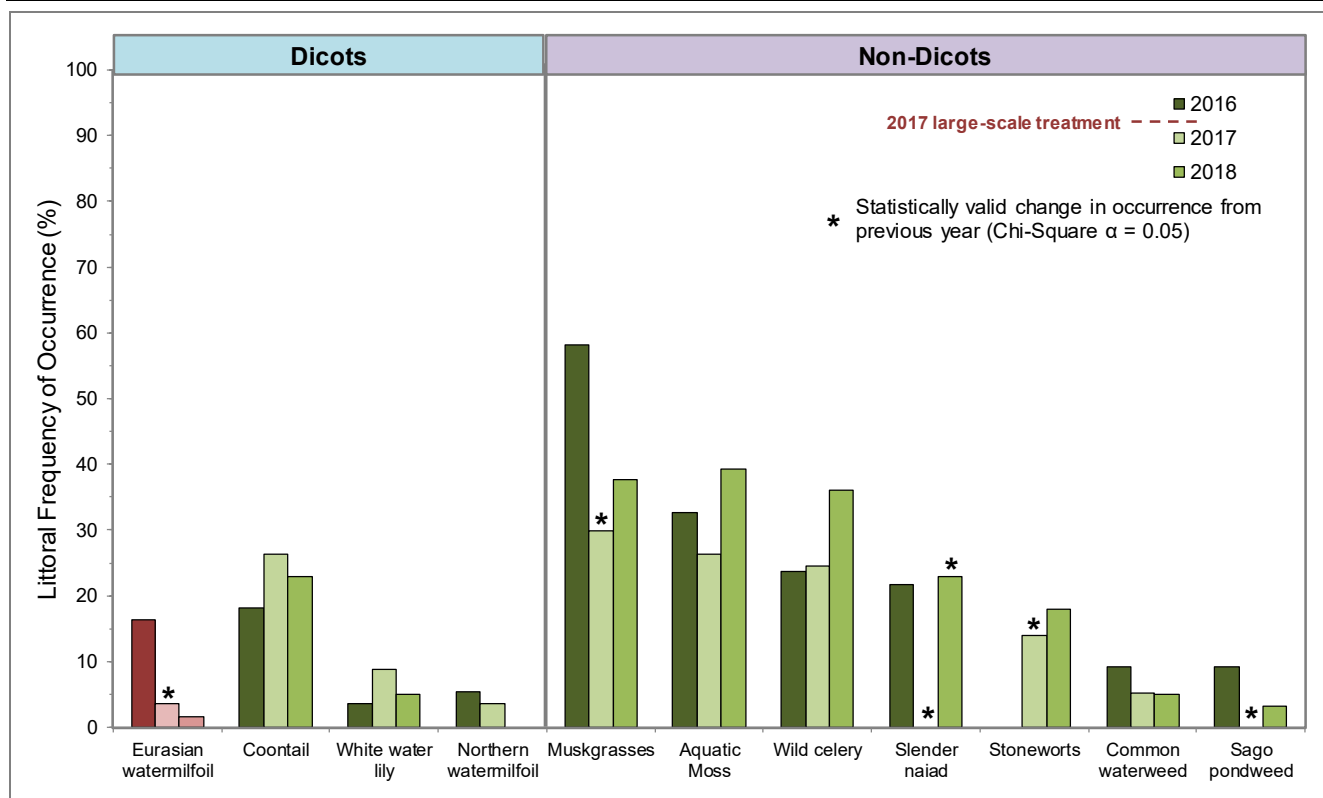
Figure 5.6-2. Littoral frequency of occurrence of aquatic plant species from 2016-2018 in Miner Lake. Data from Onterra 2016-2018 Point-Intercept Surveys. Whole-lake 2,4-D herbicide treatment occurred in spring 2017.

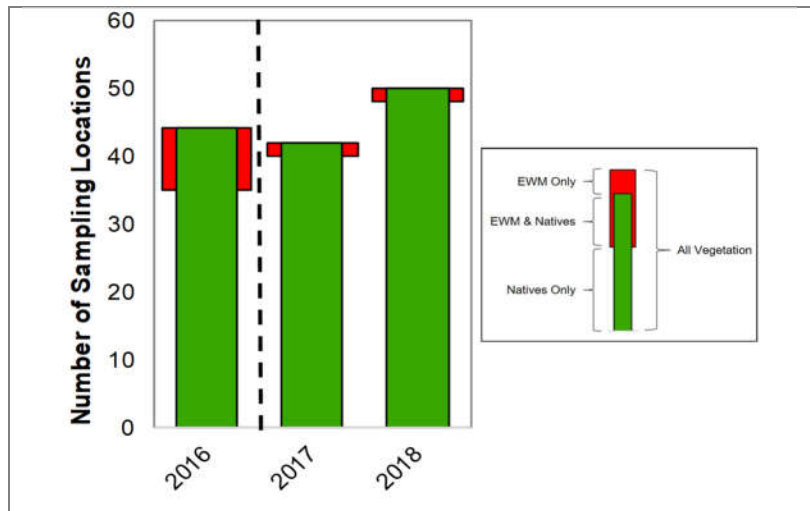
Figure 5.6-3. Vegetation composition of point-intercept locations in Miner Lake.

Figure 5.6-3 displays the number of point-intercept survey sampling locations that contained either native plants only, HWM plants only, or native plants and HWM plants from surveys completed in 2016-2018 in Miner Lake. The number of sampling locations with native plants increased in 2018 to 50 points compared to 42 in 2017 and 44 in 2016. In 2018, two sampling locations contained HWM compared to two in 2017 and nine in 2016.

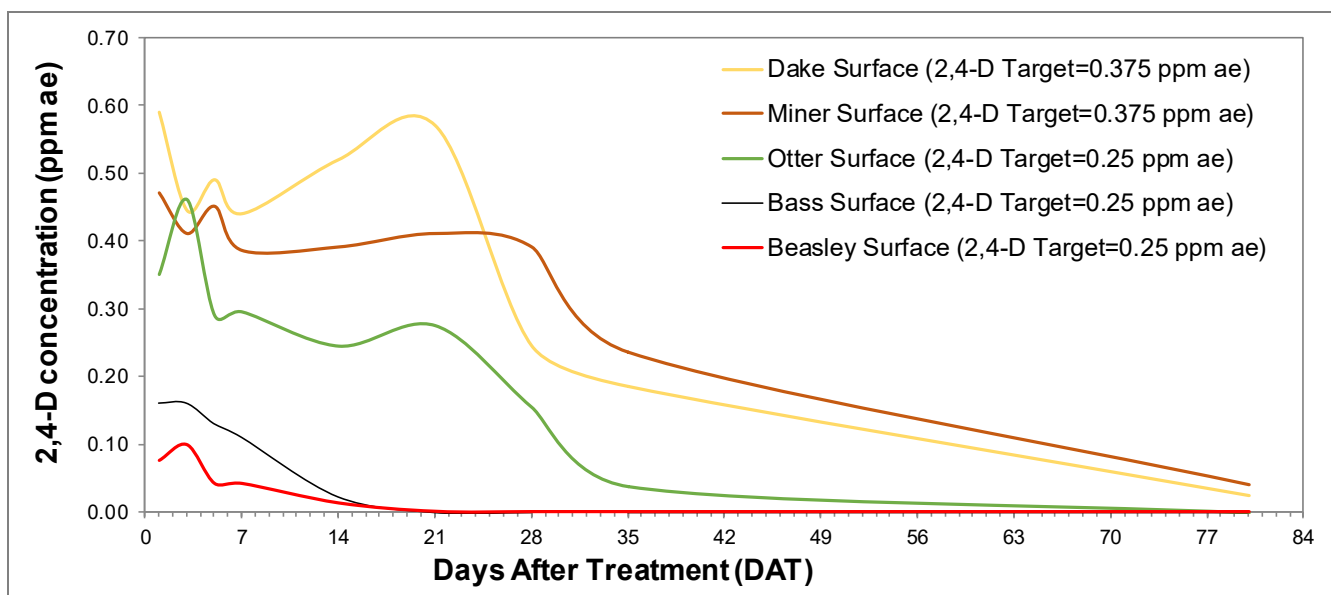
Figure 6.0-1. 2017-2018 Waupaca Chain whole-lake treatment average 2,4-D surface concentrations.

Trial whole-lake treatment strategies implemented on the Waupaca Chain to date have provided valuable insight into this management technique. These field trials targeted Dake and Miner Lakes with 2,4-D alone at 0.375 ppm ae and Otter, Bass, and Beasley Lakes with a combination of 2,4-D and endothall at 0.25 ppm ae/0.75 ppm ai, respectively. Please note that Figure 6.0-1 only shows the 2,4-D component of the monitoring on these lakes. Otter, Dake, and Miner Lakes are all relatively isolated waterbodies, with minimal influence of water exchange (i.e. flow) to other parts of the Chain. These lakes were able to hold the herbicide concentrations longer, sustaining initial concentrations for almost 21 DAT before significant herbicide decline (Figure 6.0-1). The field trials on Bass and Beasley had the same target concentration as Otter Lake. Herbicide loss to Long Lake from the Bass and Beasley Lakes treatment on 1 DAT exemplifies why target concentrations were not met. Also, the rate of herbicide decline on Bass and Beasley Lakes was immediate, suggesting the primary method of concentration reduction was caused by dissipation downstream rather than herbicide degradation or decomposition.

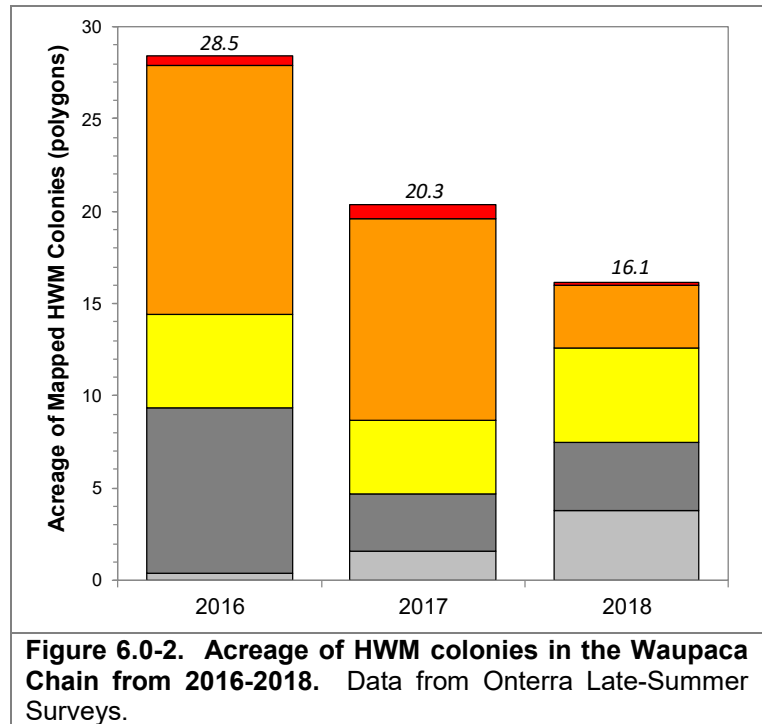
Maps 11 and 12 show the results of the 2018 Late-Season HWM Mapping Surveys. No HWM was located within the Upper Chain. Using the same methodology and consistent density rating system, Late-Season HWM Mapping Surveys also occurred in 2016 and 2017. Please note that Figure 6.0-2 represents only the acreage of mapped EWM polygons, not EWM mapped within point-based methodologies (*single or few plants, clumps of plants, or small plant colonies*). In 2016, 28.5 acres of colonized HWM was located in the system along with numerous additional locations of HWM marked with point-based data. A total of 16.1 acres of HWM were mapped throughout the Chain in 2018, demonstrating an overall reduction of colonized HWM during this timeframe. The largest reductions in HWM acreage can be attributed to the success of the whole-lake treatments in Dake and Miner Lakes, with additional HWM suppression occurring in Otter, Bass, and Beasley Lakes.

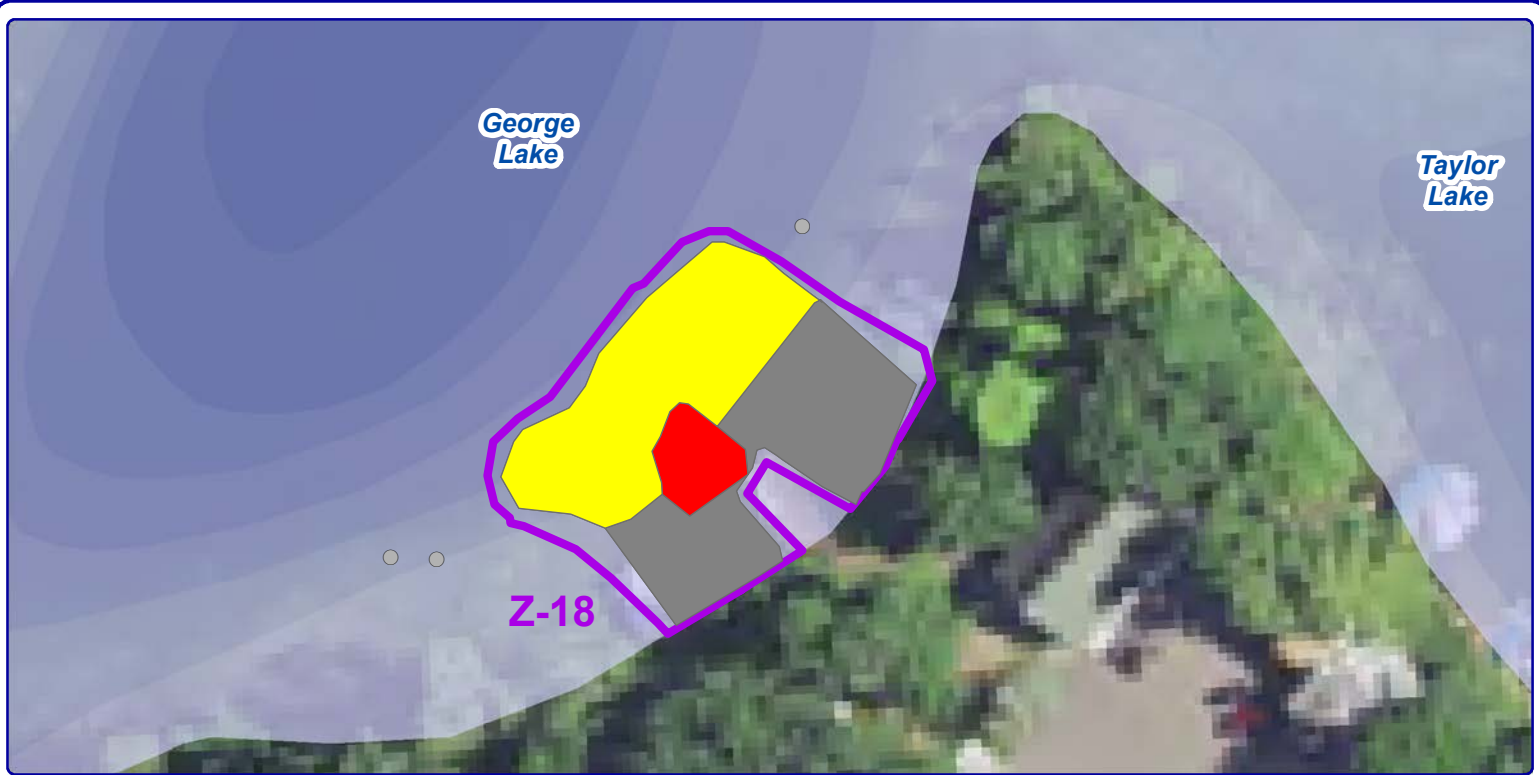
Waupaca Chain O' Lakes						
2018 Final Professional Hand-Harvest HWM Control Strategy						
Site	Lake	Target	Final Acres	Average Depth (feet)	Notes	Priority
Y-18	Limekiln	HWM	1.4	4.0	Becker Marine and thoroughfare between Columbia/Limekiln	1st
Z-18	George	HWM	0.4	6.0	docks near veterans home	2nd
Total			1.7

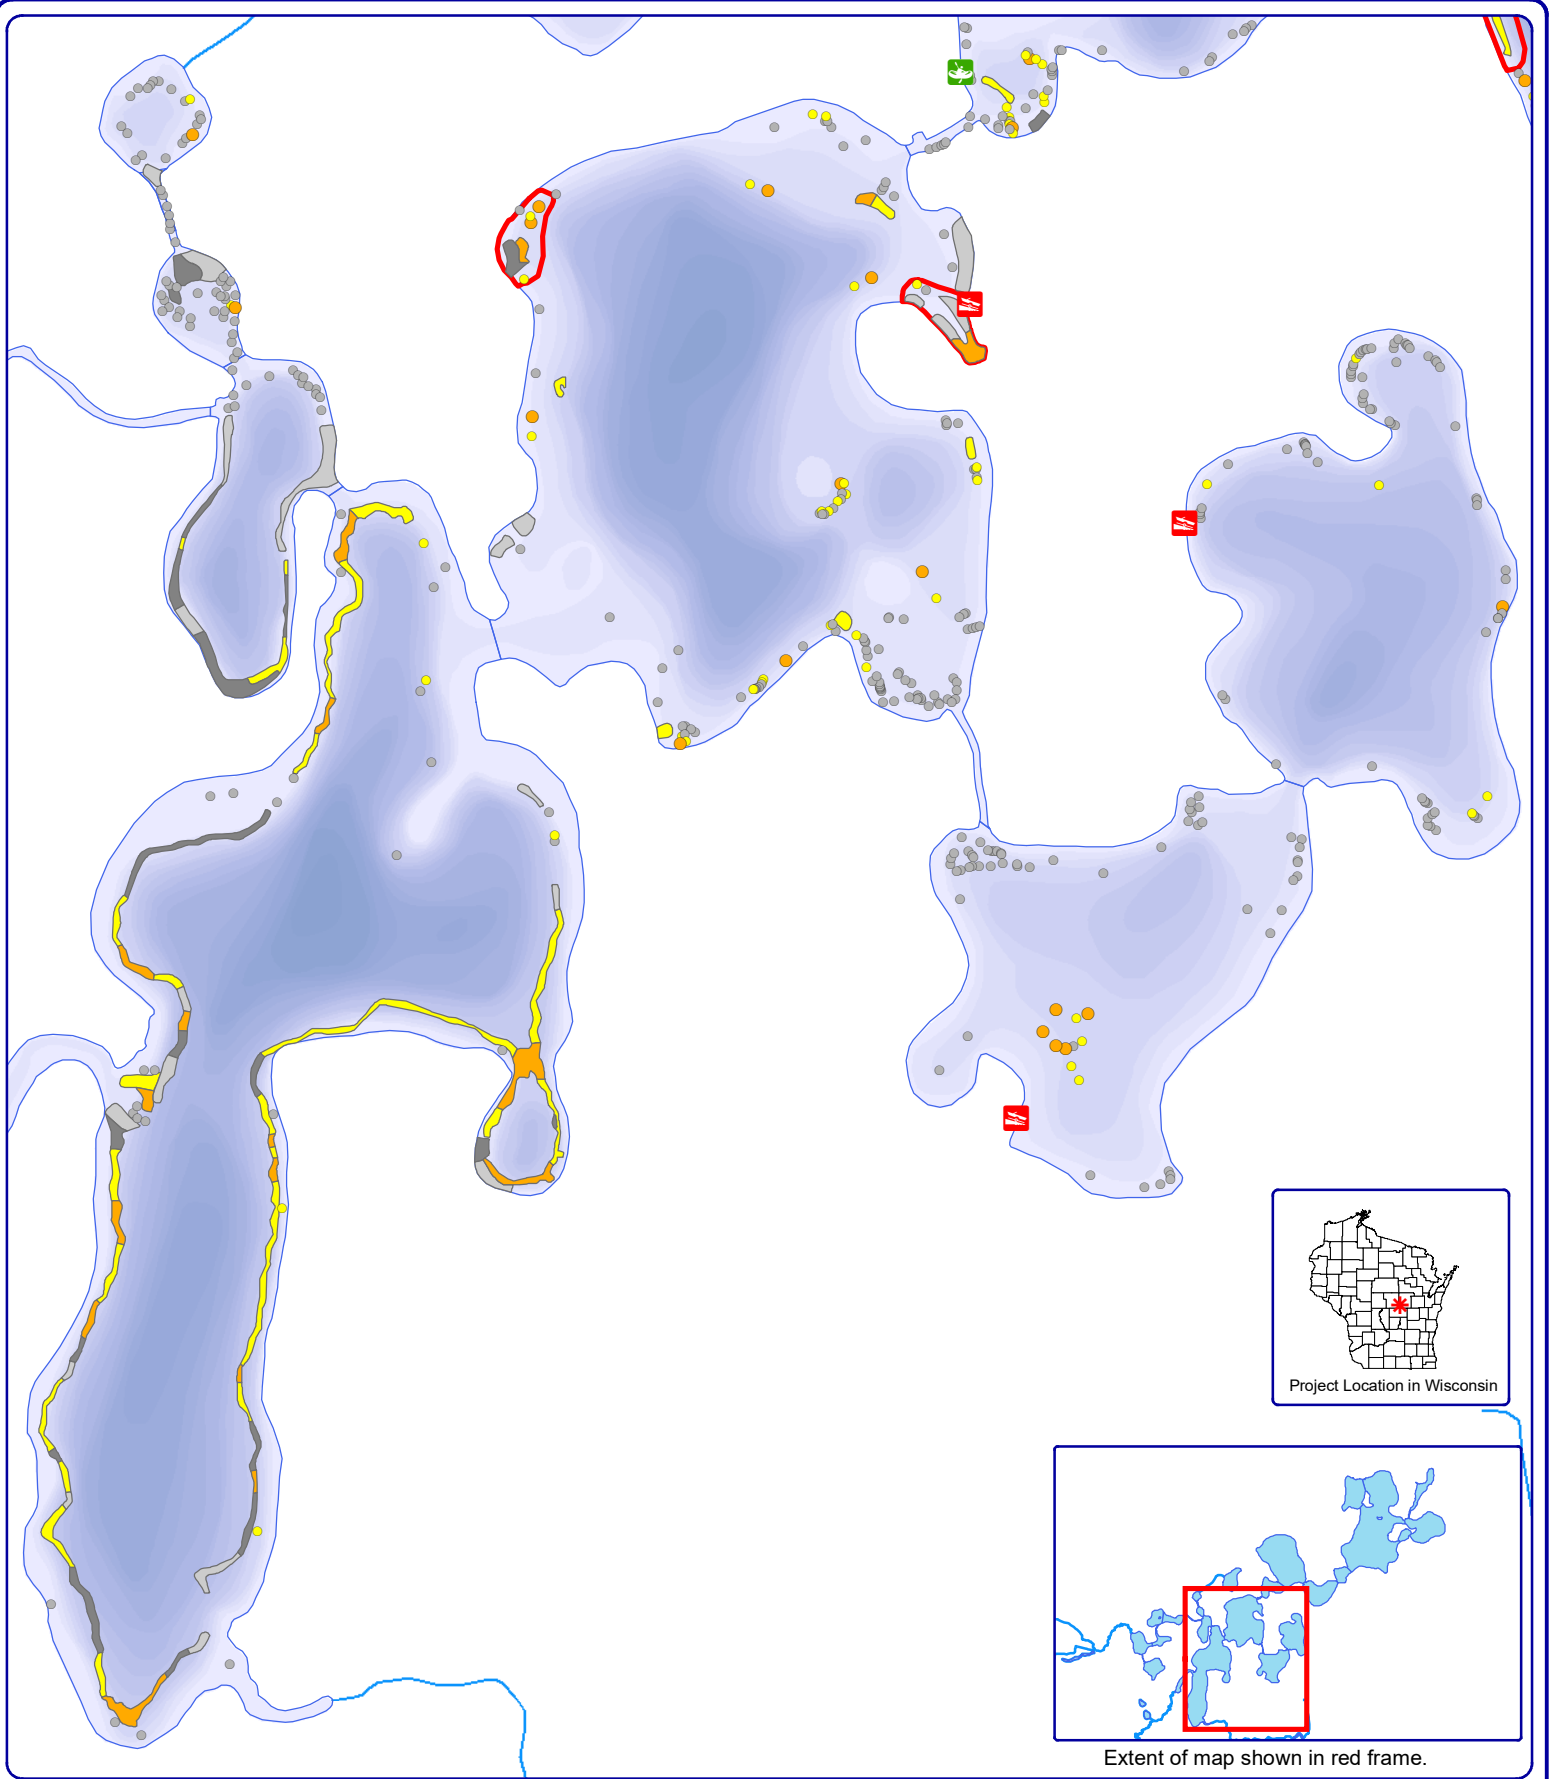
**2018 Late-Season
HWM Survey Results**
