NOLAN CREEK

WPP Partnership Meeting

October 30, 2017

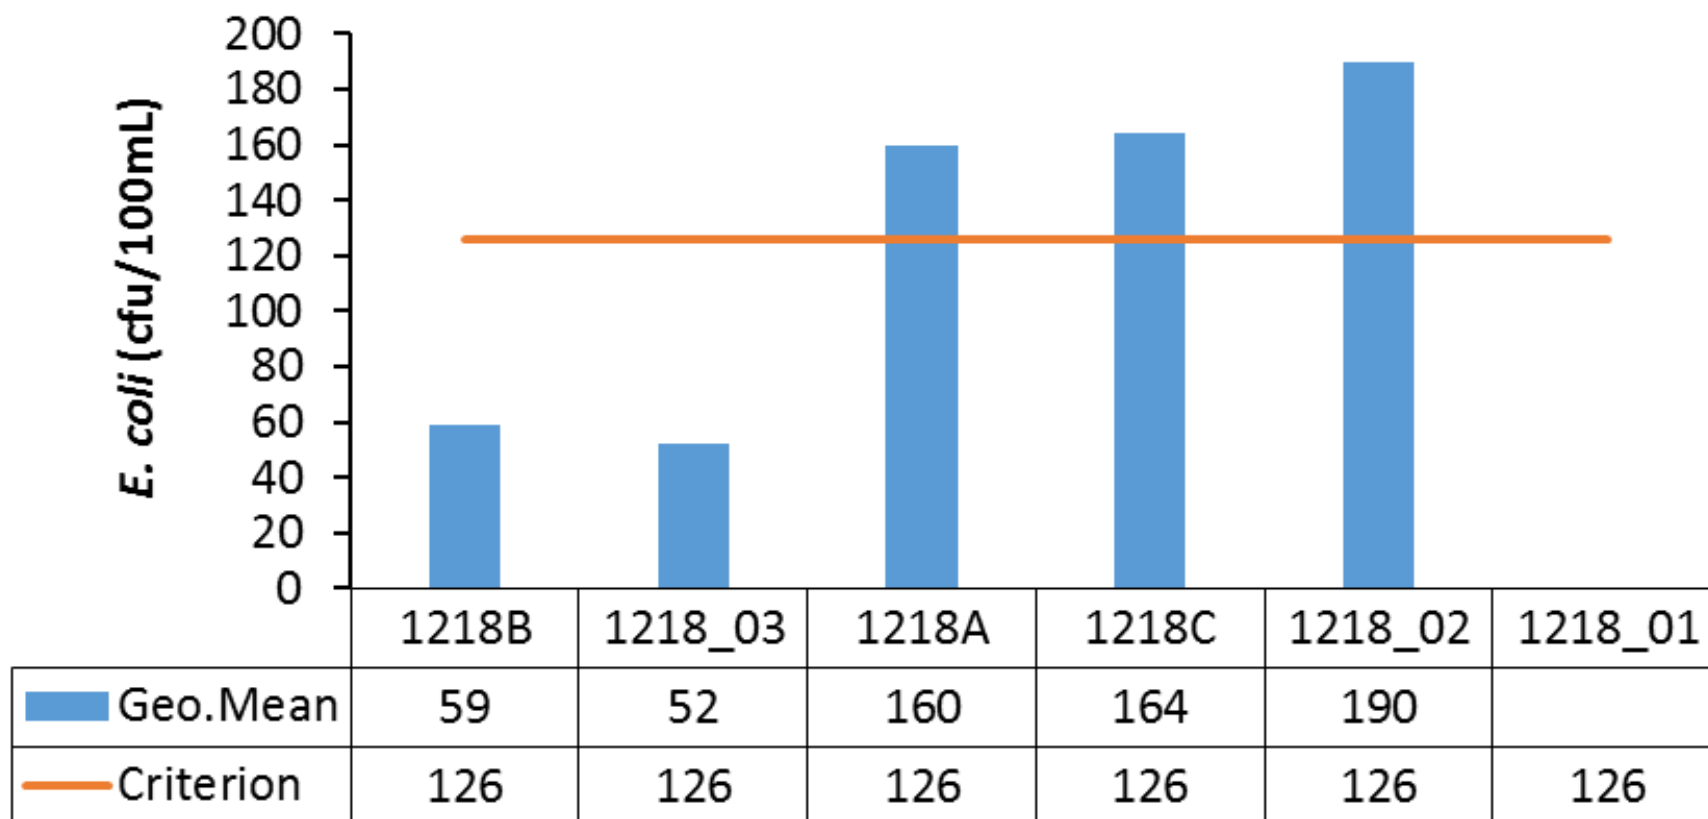
2014 Assessment Results

(01Dec2005 – 30Nov2012)

Source: 2014 Texas Integrated Report: Assessment Results for Basin 12 - Brazos River

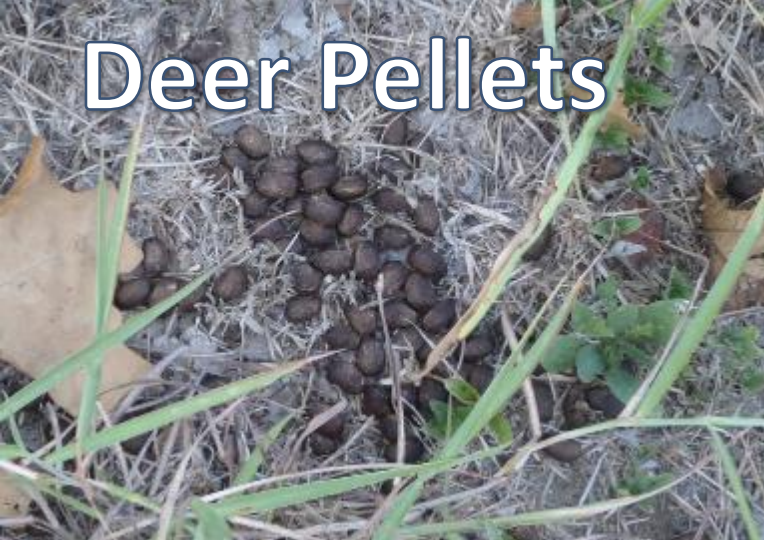
Swallows under
Bridges

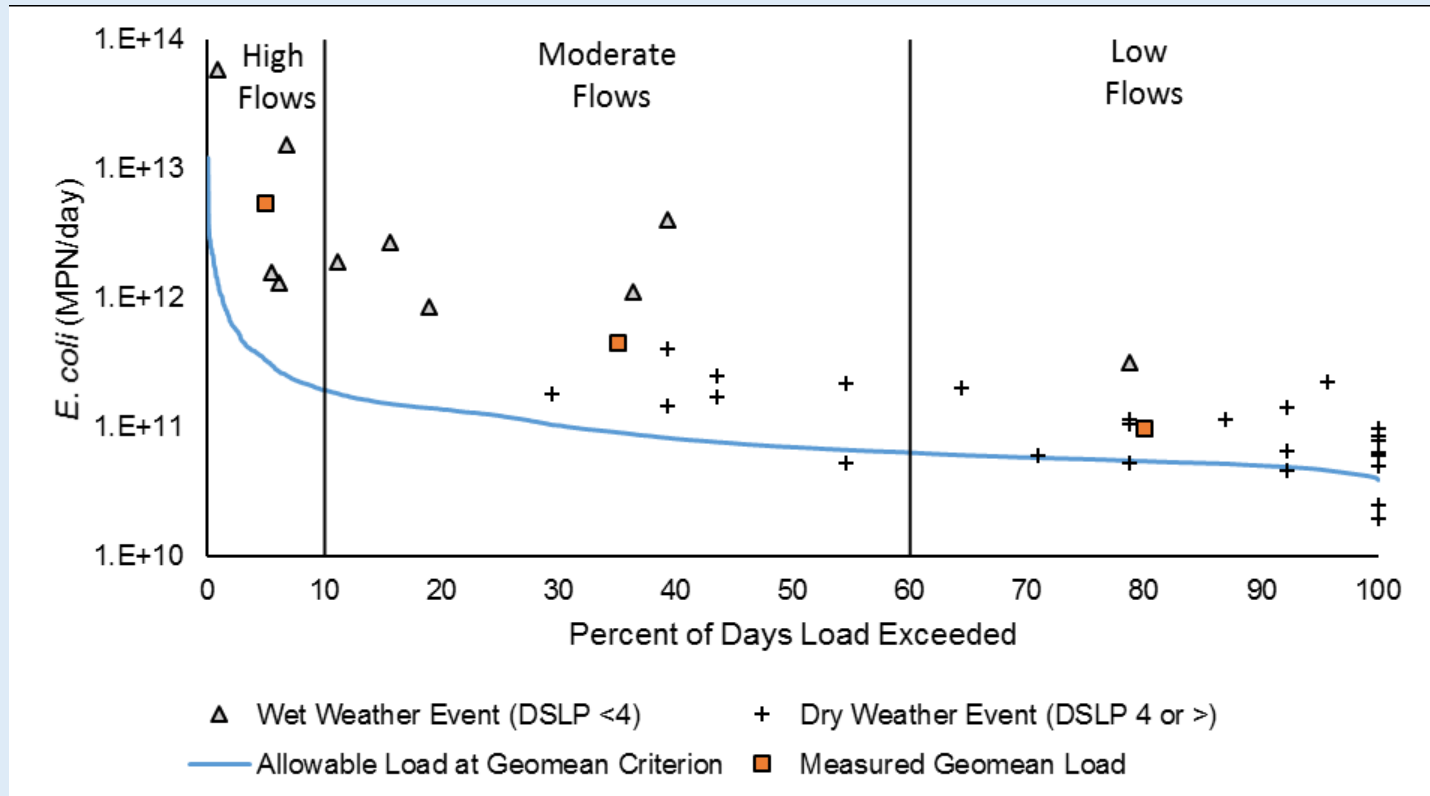
- Defined using Load Duration Curves

Across sites at moderate to low flows, 39% to 62% reduction needed
