Roof Outer Latch Actuator Repair

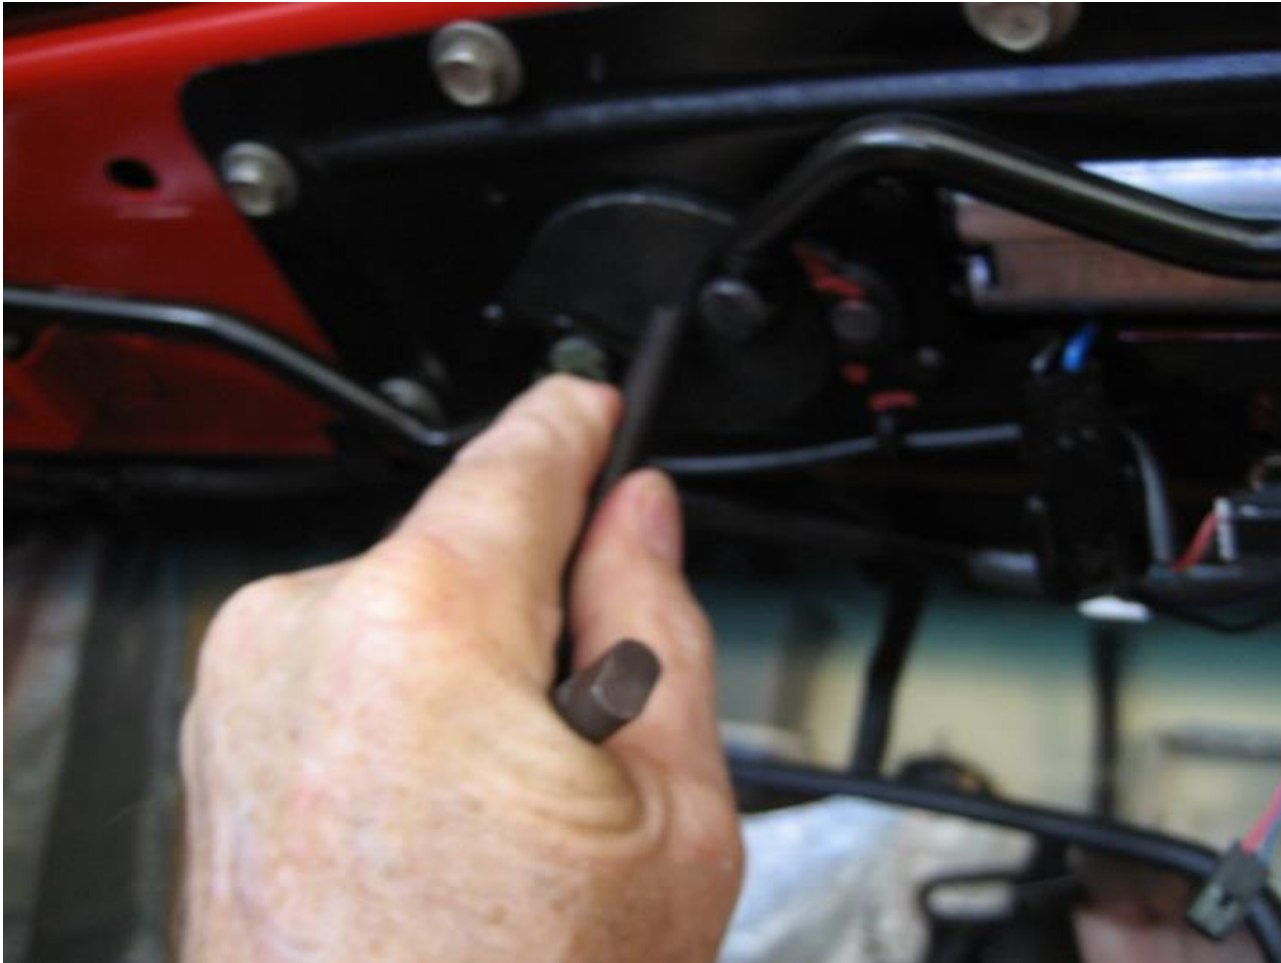
Outer Latch Connecting Rod

(Note the red mark to L.D. the left rod)

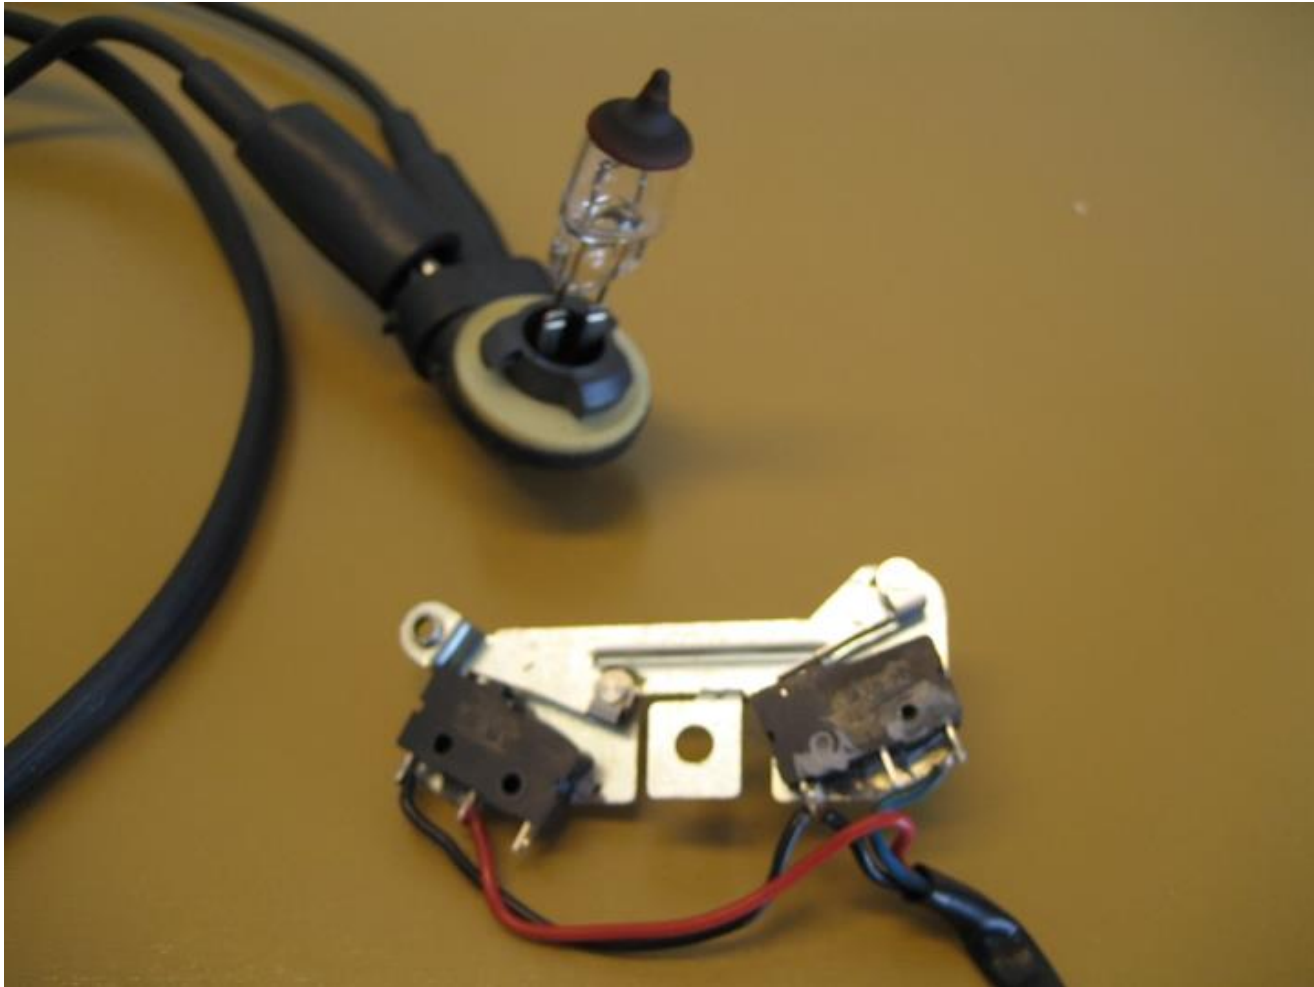
replacement micro switches (Radio Shack)
Micro switches were retested using the 12
Volt lamp after mounting

Repaired micro switch has been in use for over a year.
