# Conservation Analysis for Bonavenia Enterprises Subdivision

East Noxon Road and Clapp Hill Road  
Town of Union Vale  
County of Dutchess

**Date:** March 25, 2024

**DAY | STOKOSA**  
ENGINEERING P.C.

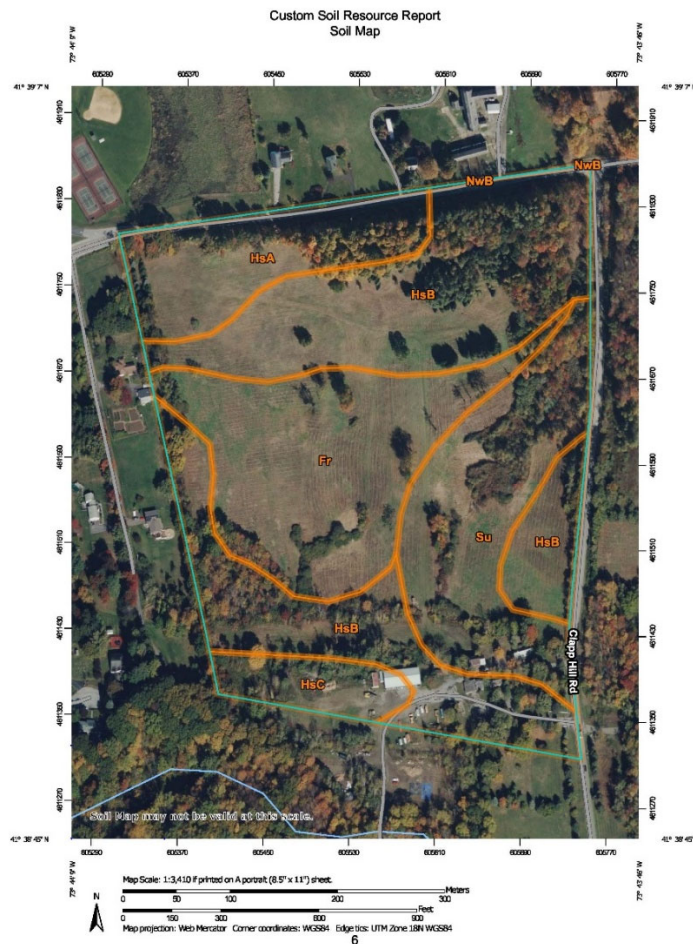
Figure B - Soil Map

The official soil types indicated by the USDA National Resources Conservation Service for the Site is “Hoosic Gravelly Loam” of various slopes, “Fredon Silt Loam” and “Sun Silt Loam”. Refer to the soil report and soils map in the appendix for additional soil information and descriptions.

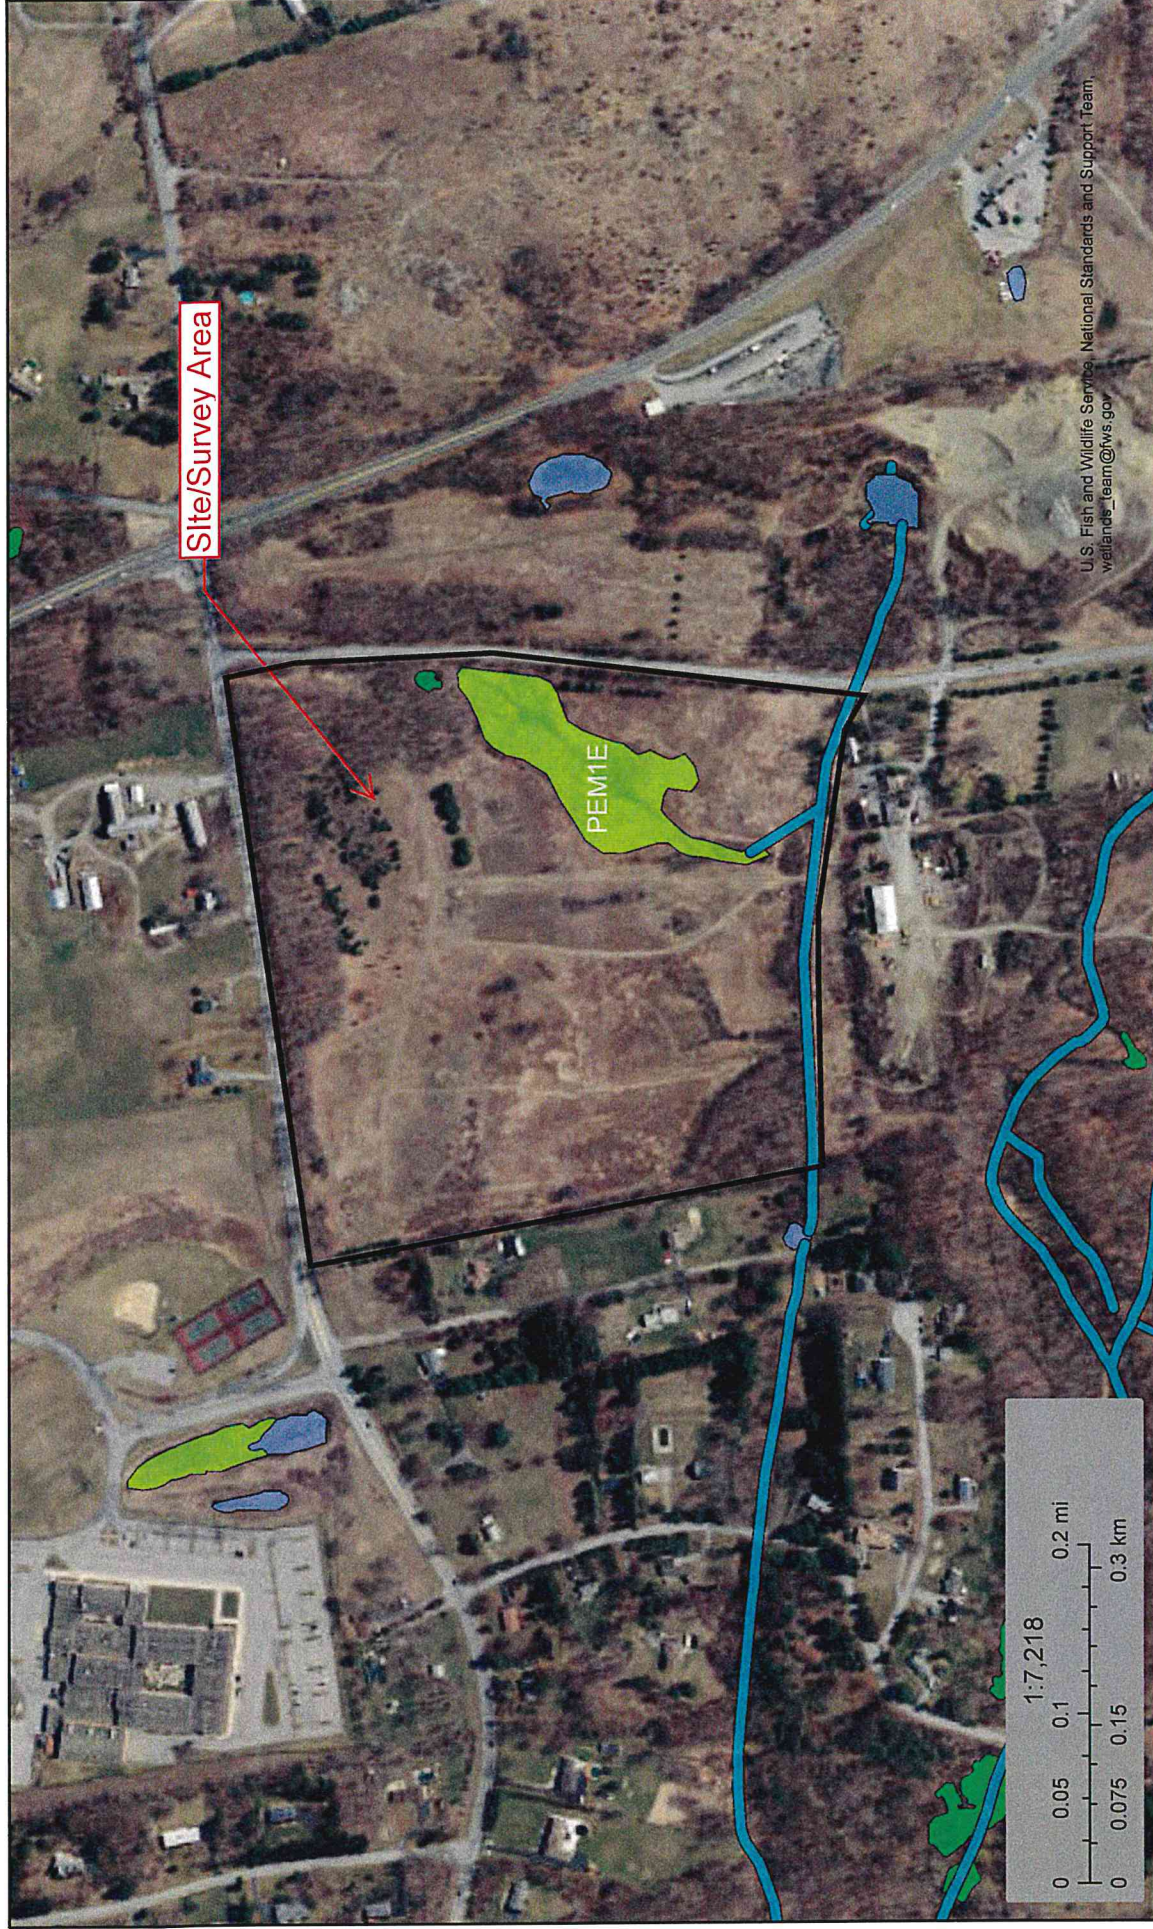
**Figure 3**  
Clapp Hill Road, Union Vale, NY  
NWI Wetland Mapping

## NWI Wetlands Mapping

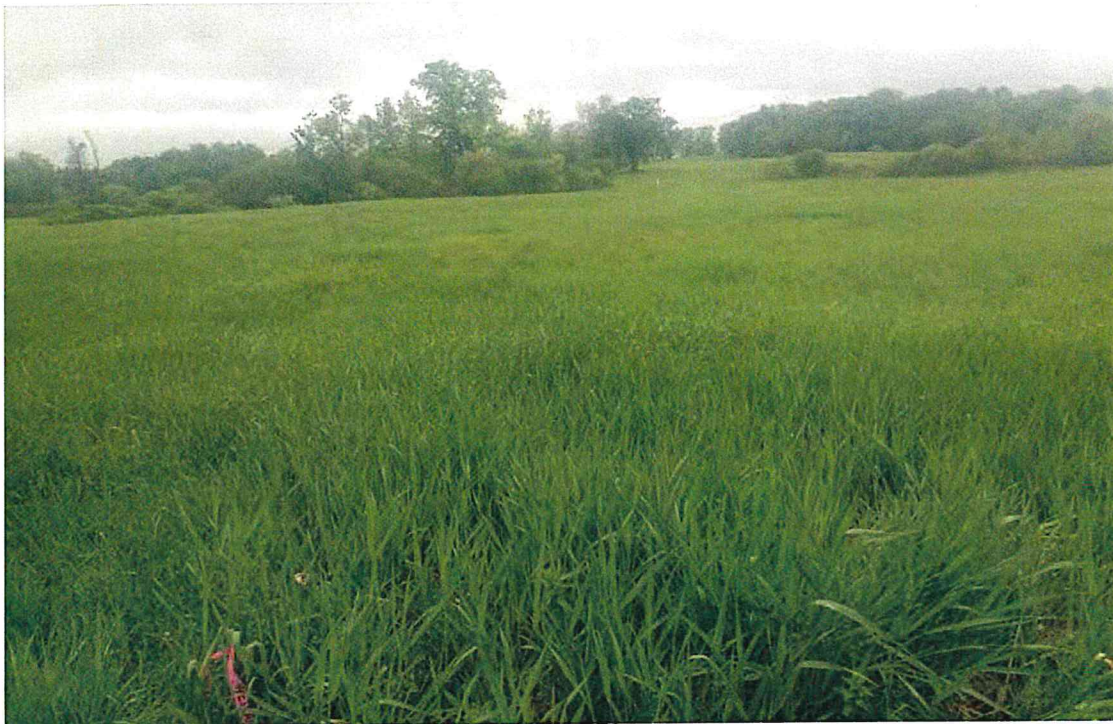
**PHOTO 3** Representative view of emergent portion of Wetland 1 looking northwest from southeastern corner of the Site.

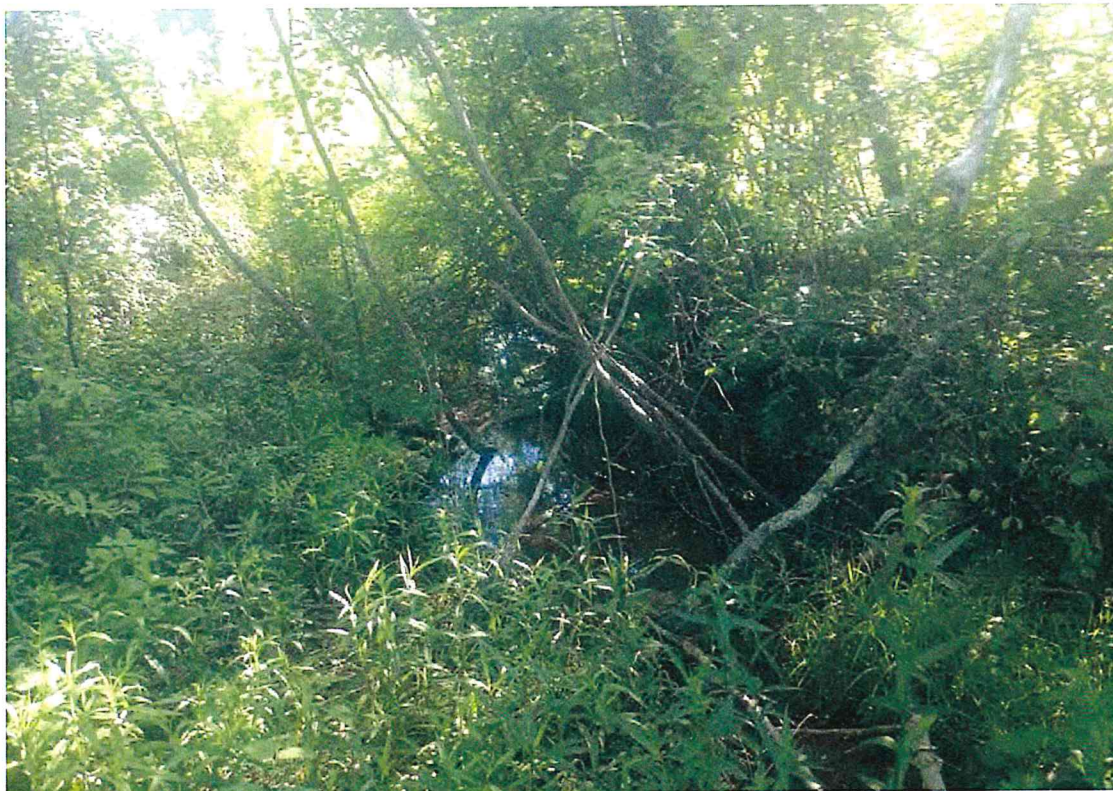
**PHOTO 4** Intermittent tributary to Stream B1 (Stream B2), looking south from path/culvert crossing. Stream B2 borders Wetland 1 in southern part of the Site.

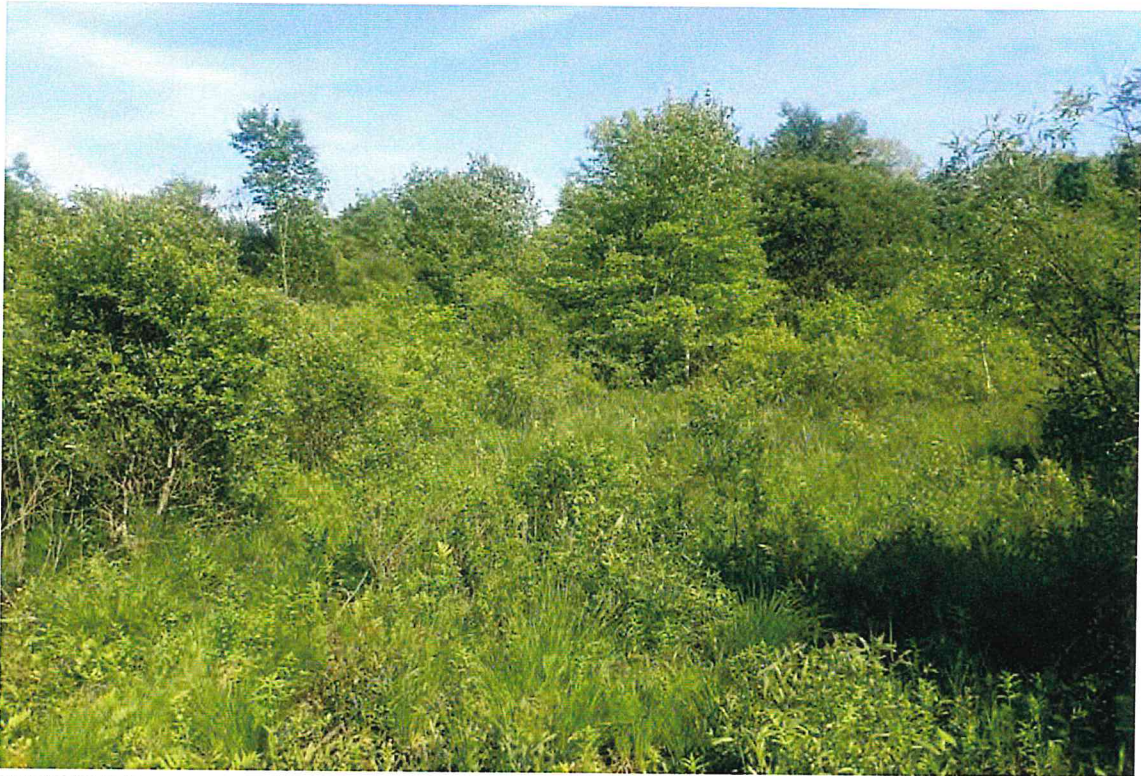
PHOTO 5 Representative view of the scrub-shrub wetland community in Wetland 1.

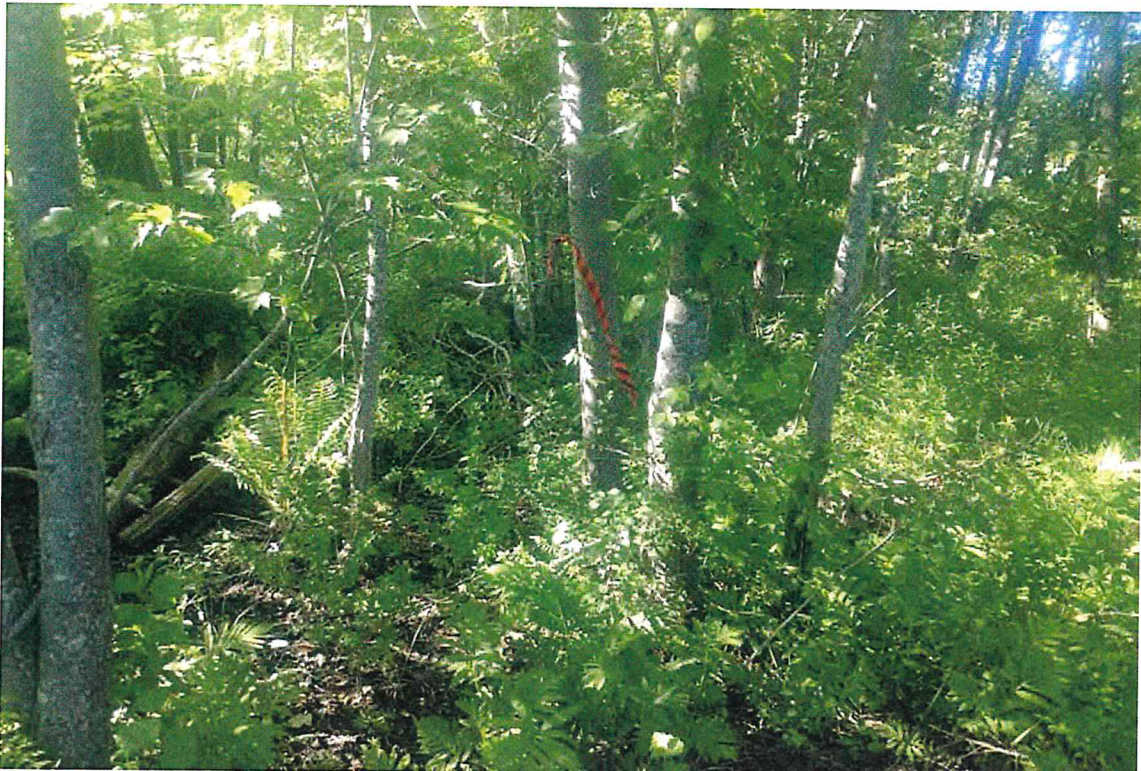
PHOTO 6 Representative view of the forested wetland community in Wetland 1 (present in Wetland 2 also).

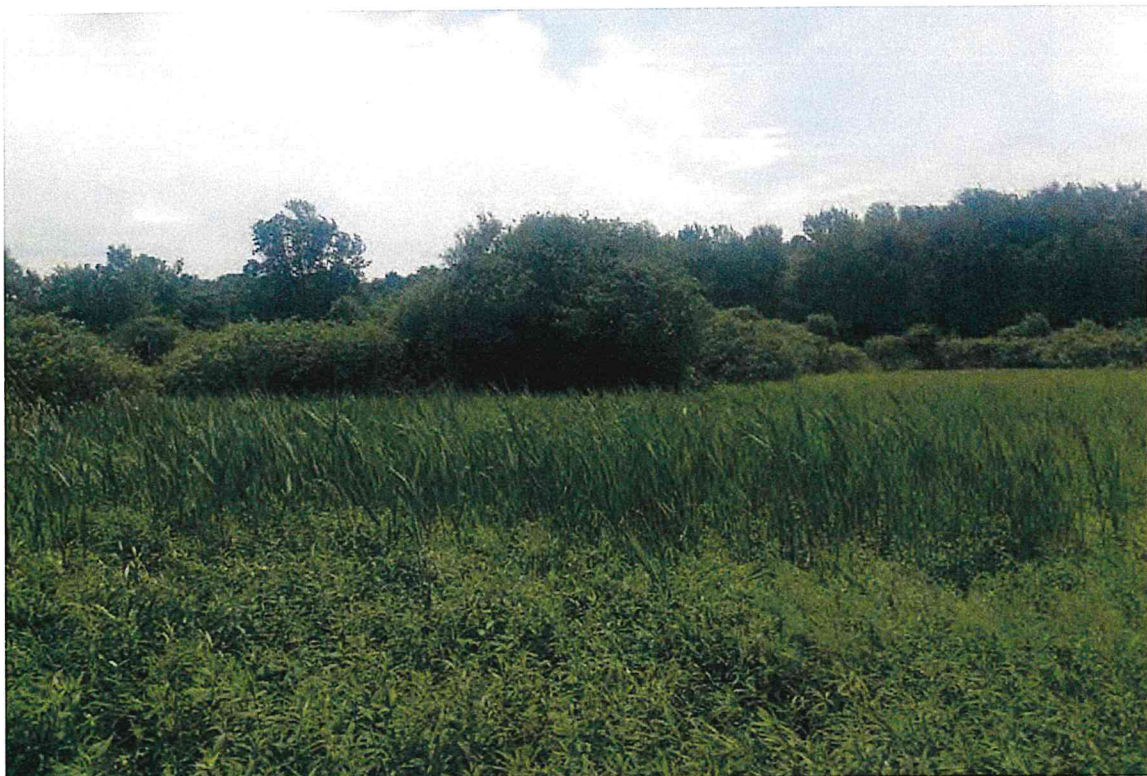
PHOTO 8 View of emergent and scrub-shrub communities in Wetland 2.

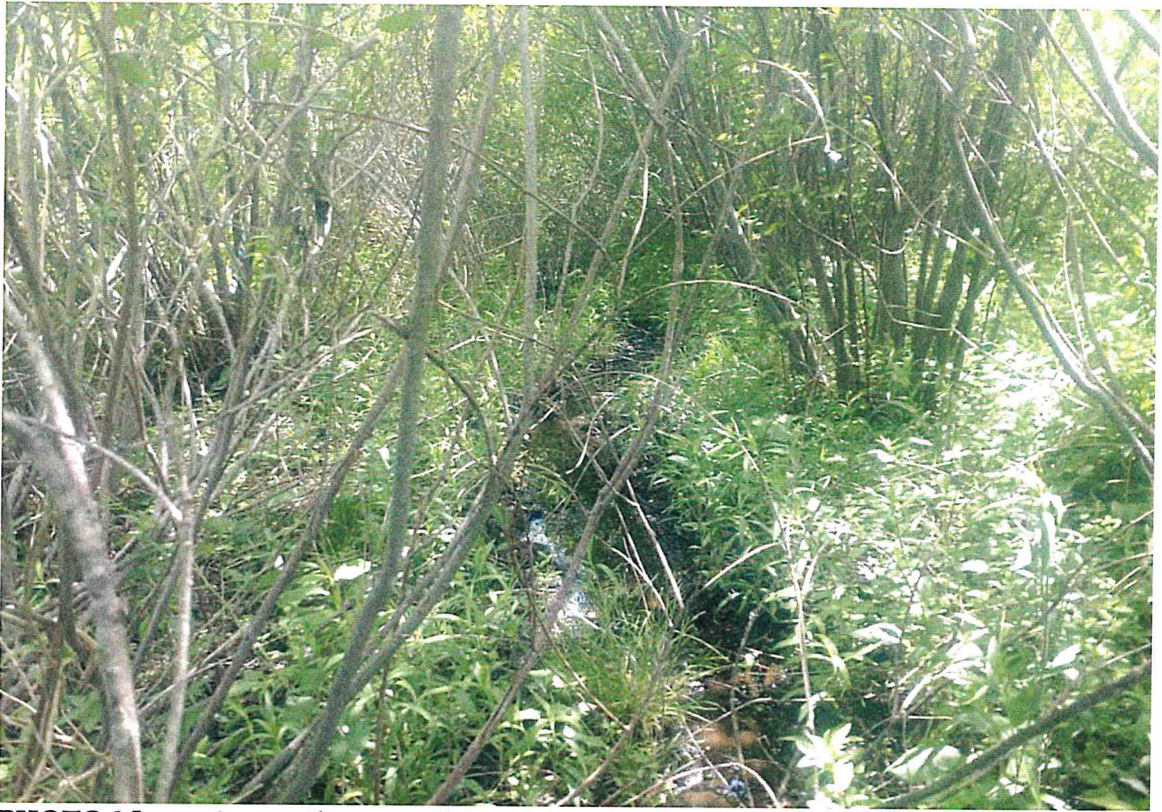
**PHOTO 9** Intermittent tributary to Stream B1 (Stream B3) located in Wetland 2. View is looking southward from path over a culvert crossing.

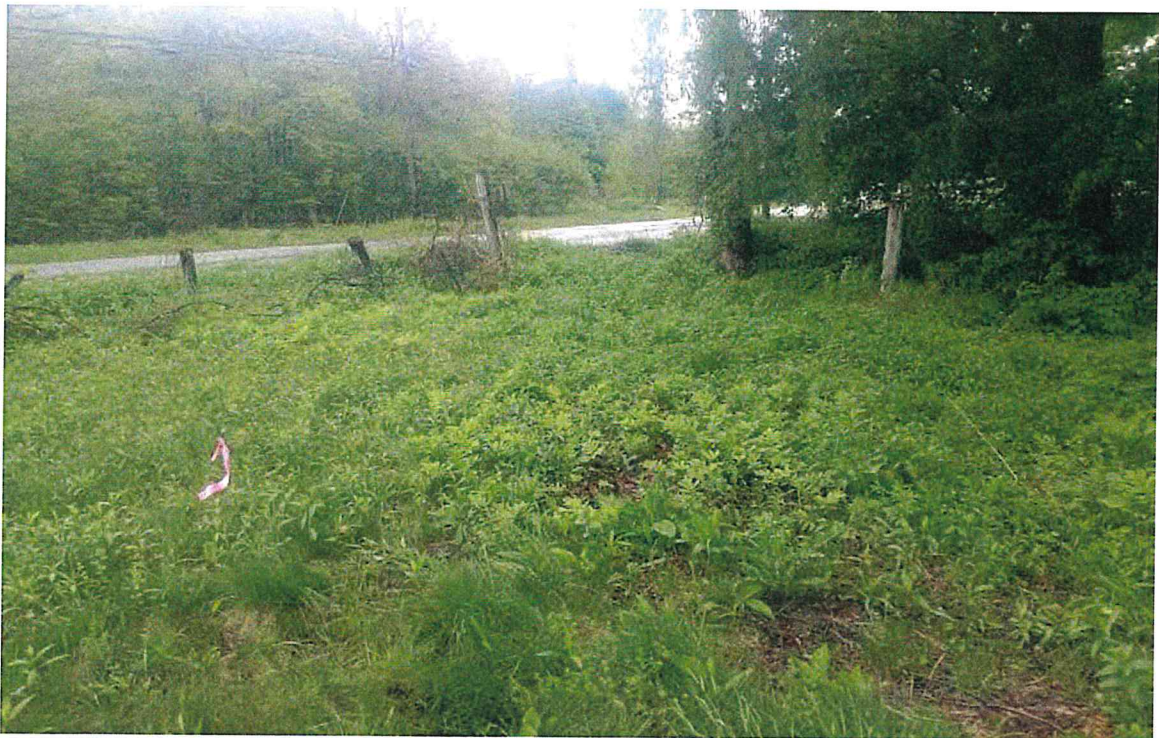
**PHOTO 10** Wetland 3 (emergent) along Stream B1 in southeastern corner of the Site.

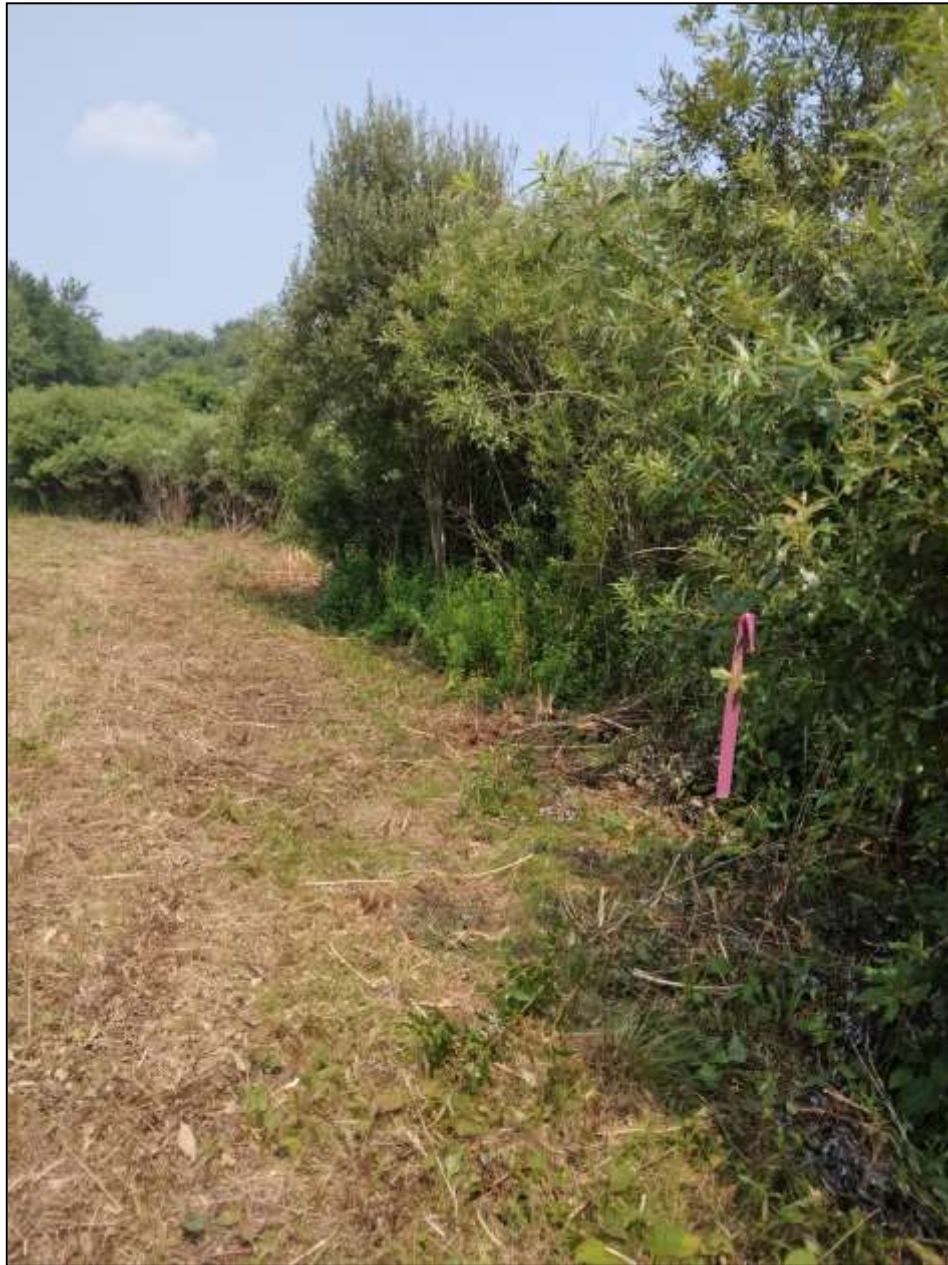
Existing wetland/upland meadow boundary.

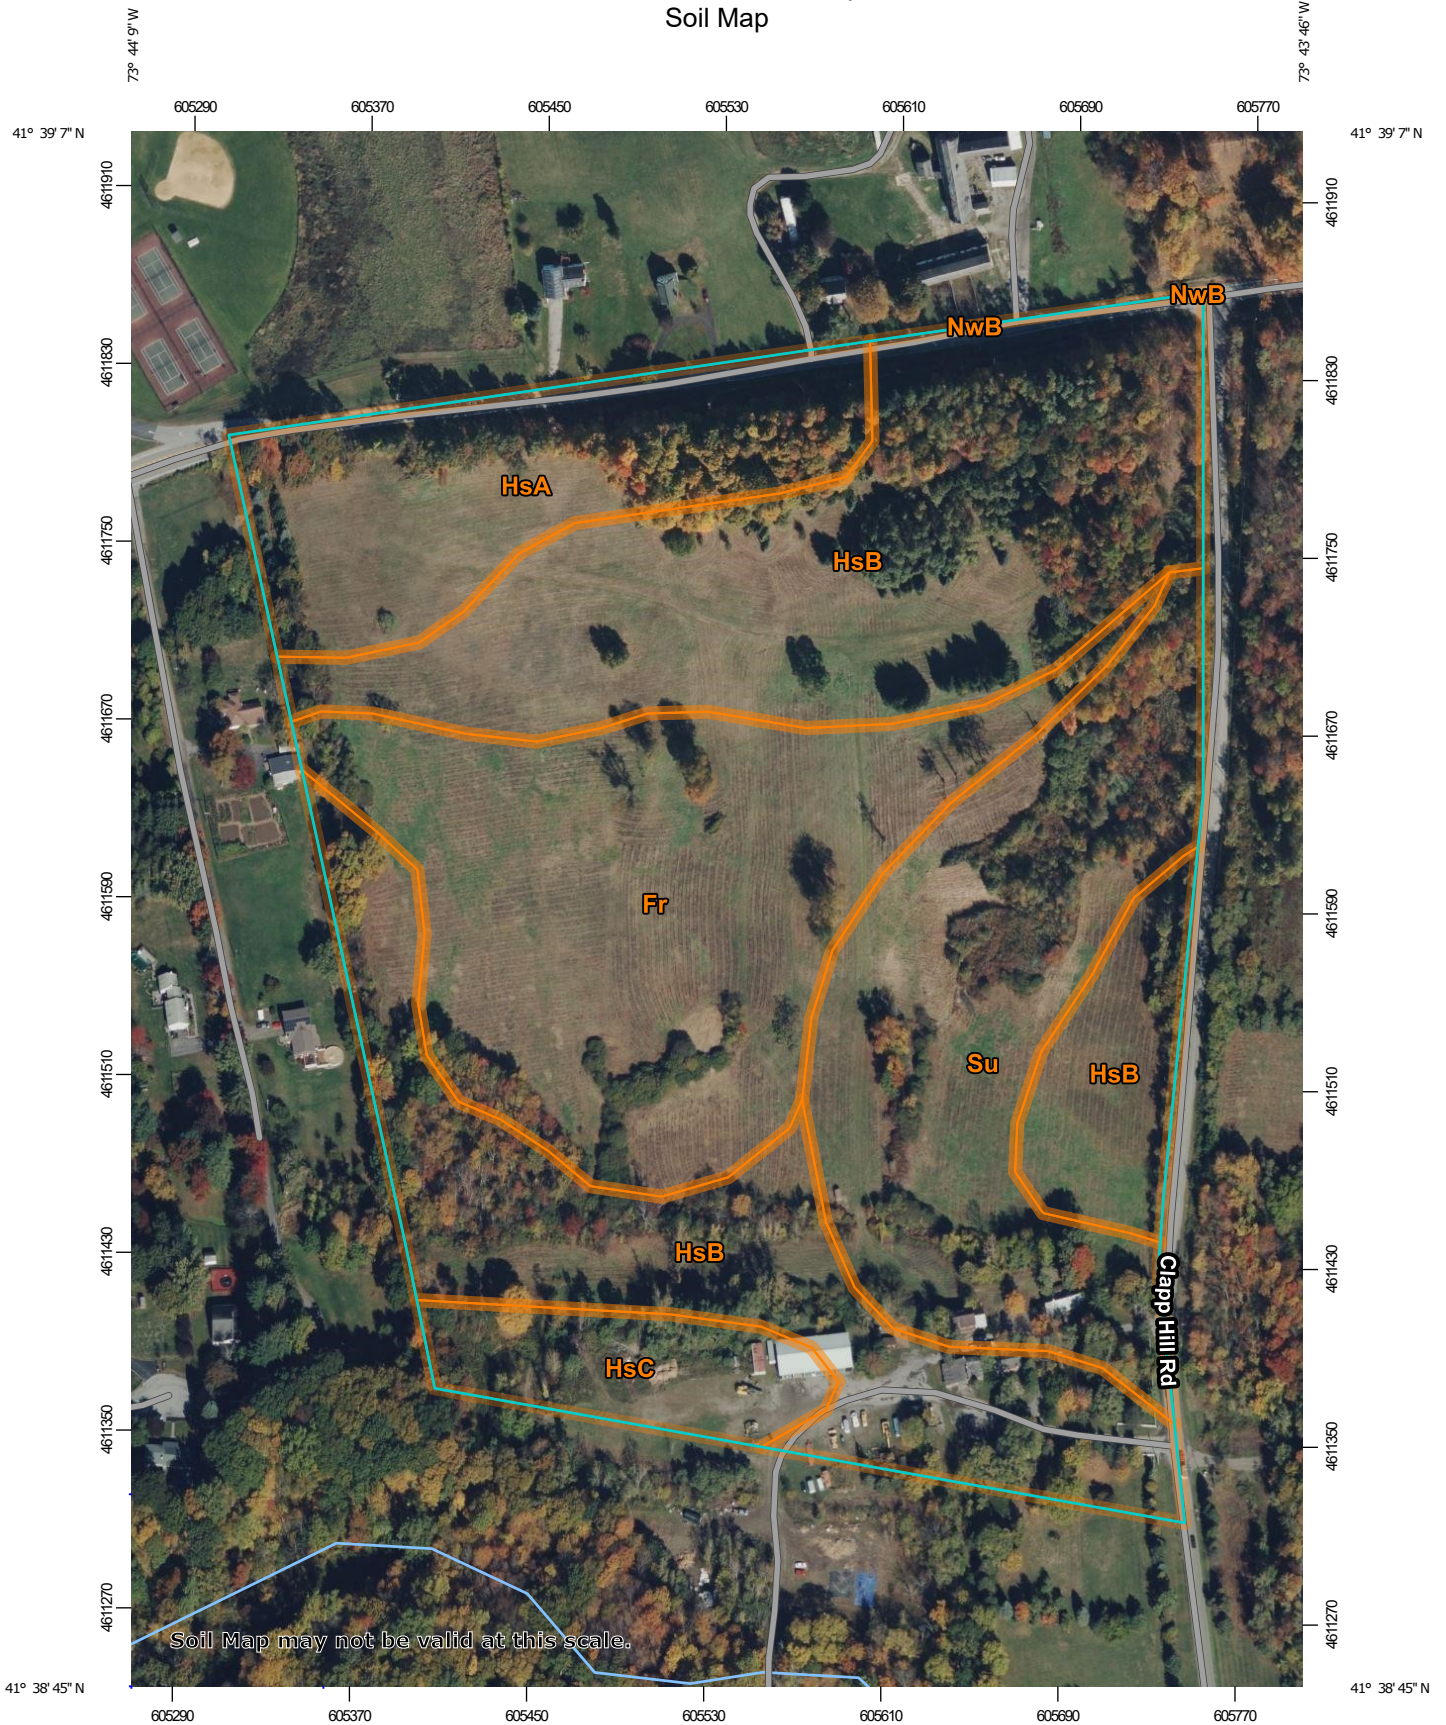
# Custom Soil Resource Report Soil Map

The soil map section includes the soil map for the defined area of interest, a list of soil map units on the map and extent of each map unit, and cartographic symbols displayed on the map. Also presented are various metadata about data used to produce the map, and a description of each soil map unit.

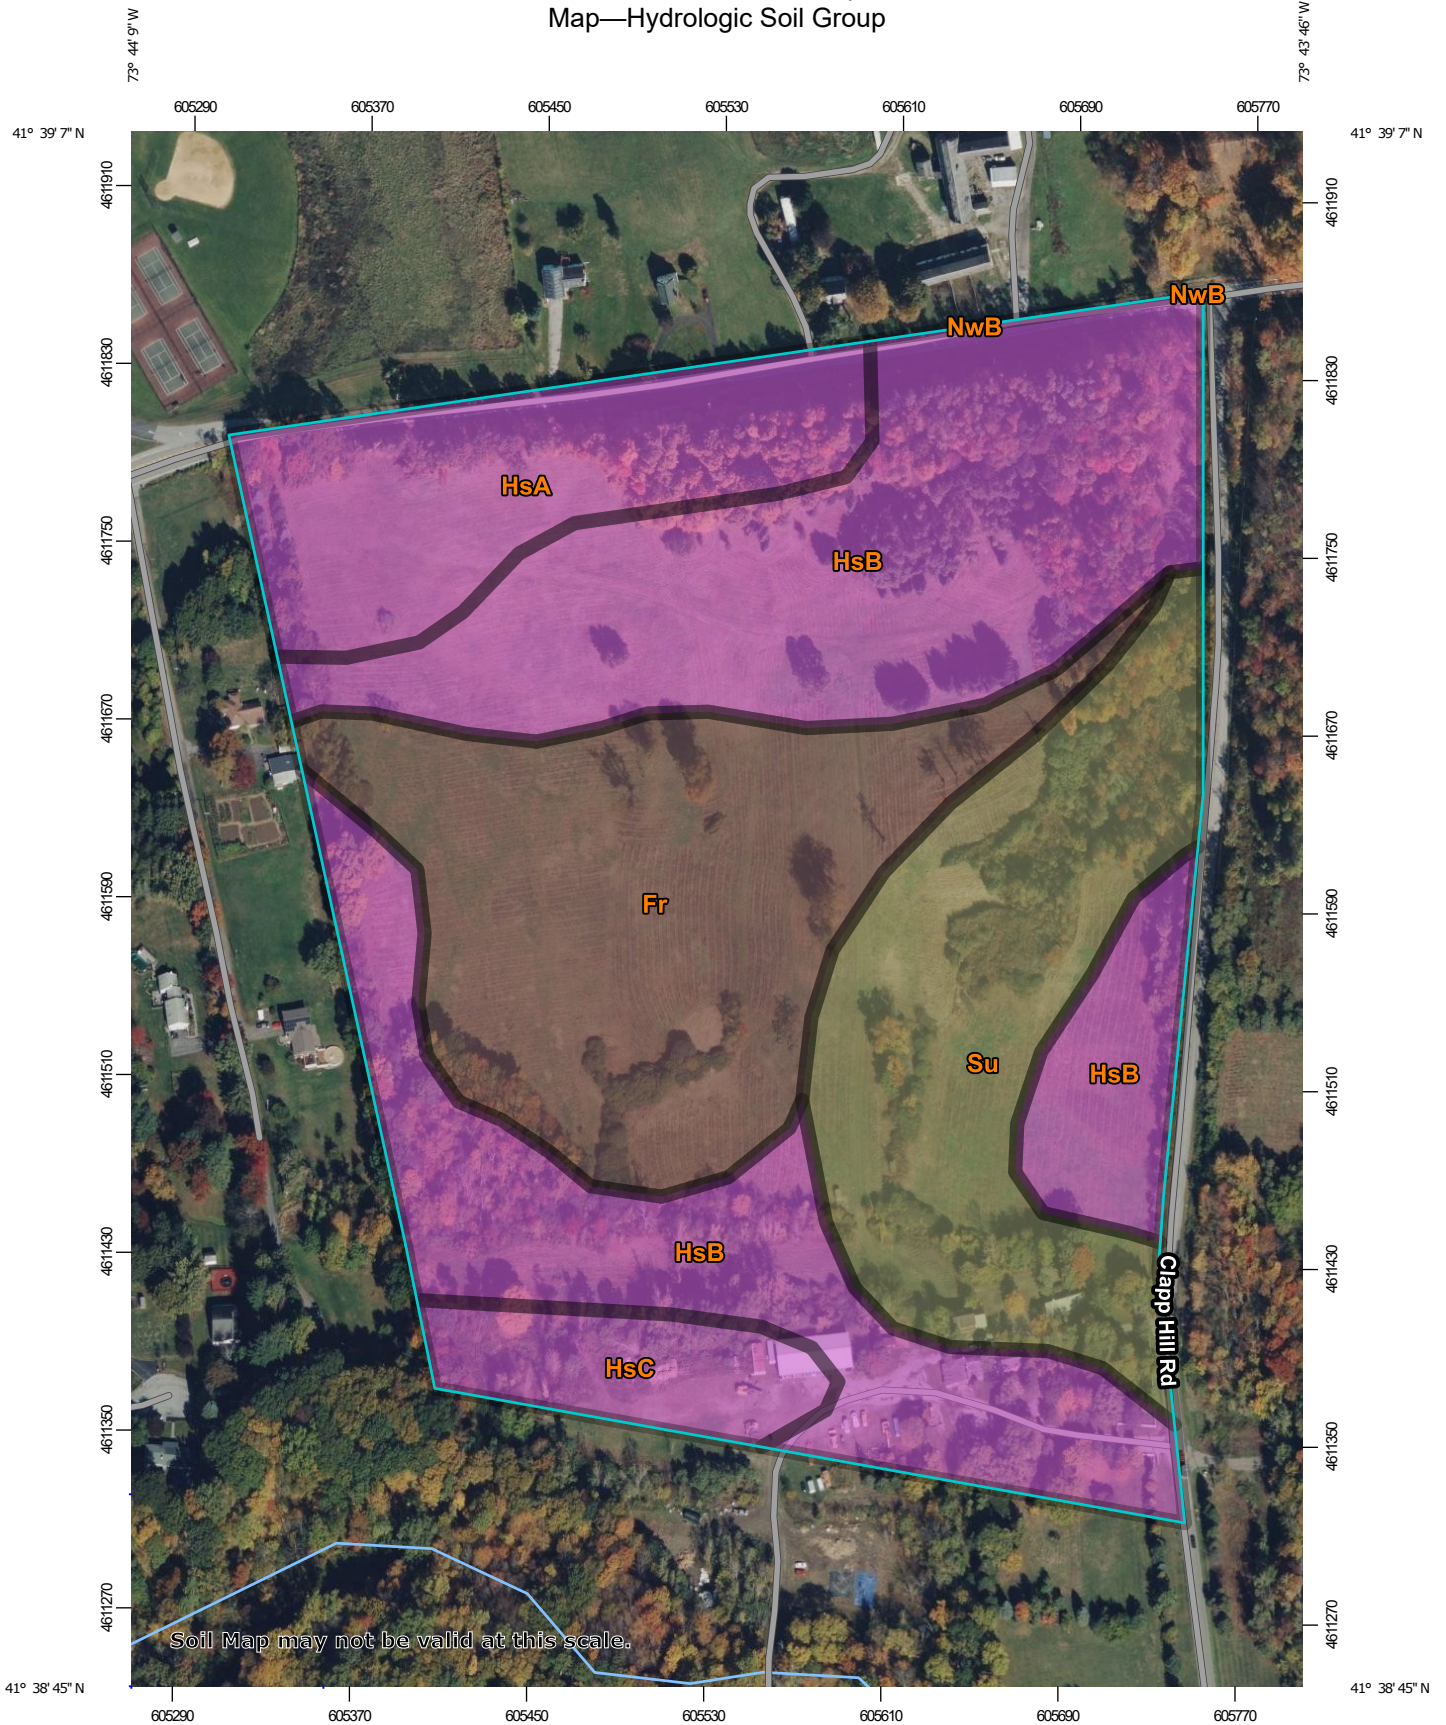
# Custom Soil Resource Report Map—Hydrologic Soil Group

If a soil is assigned to a dual hydrologic group (A/D, B/D, or C/D), the first letter is for drained areas and the second is for undrained areas. Only the soils that in their natural condition are in group D are assigned to dual classes.
