Attic Knee Walls

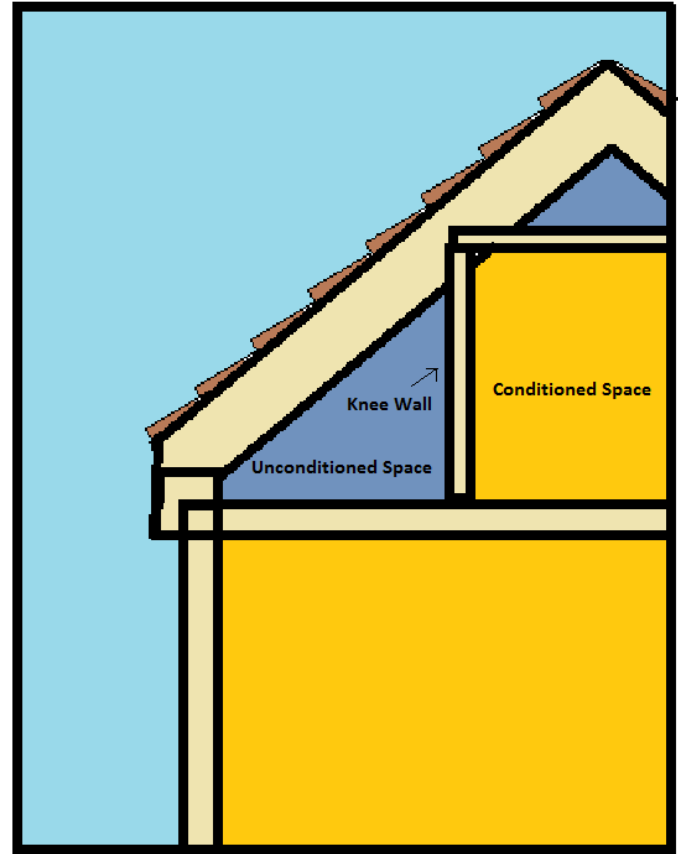
Another approach to the knee wall area is to remove the existing fiberglass insulation and install 2" polyiso foam board to the 2X4 framing. We would then dense pack cellulose insulation behind the foam board. The combined R-value is greater than the fiberglass and in turn the living space buffering the knee walls are much more comfortable.
