RE: Sunnyside Cogeneration Associates  
Annual Inspection Report, #2 Ash Landfill  
CCR Rule 257.84(b)

**CCR Unit: SCA #2 Ash Landfill**

**Owner: Sunnyside Cogeneration Associates**

**Annual Inspection: January 2017**

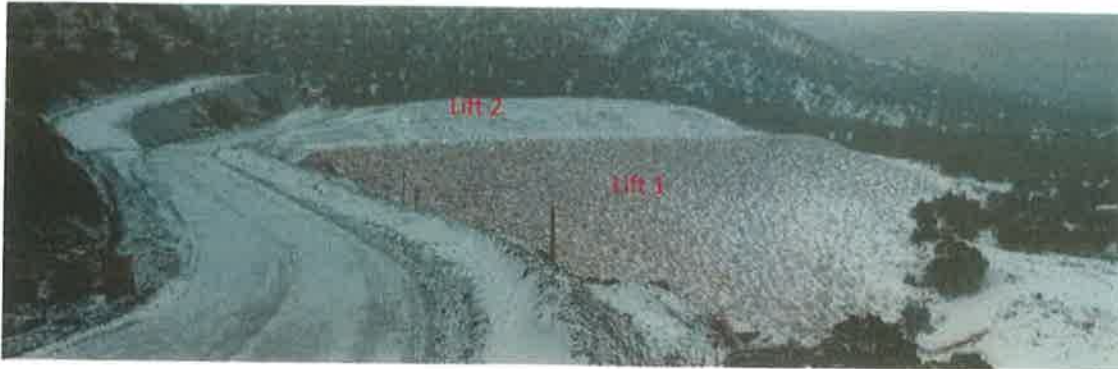
- i. Additional CCR materials have been added to the Ash Landfill in accordance with approved design parameters
    - ii. First lift, terrace and access road constructed across landfill. Now filling on second lift. First lift has been covered, surface roughened and seeded.

SCA#2 Ash Landfill – lower face looking easterly

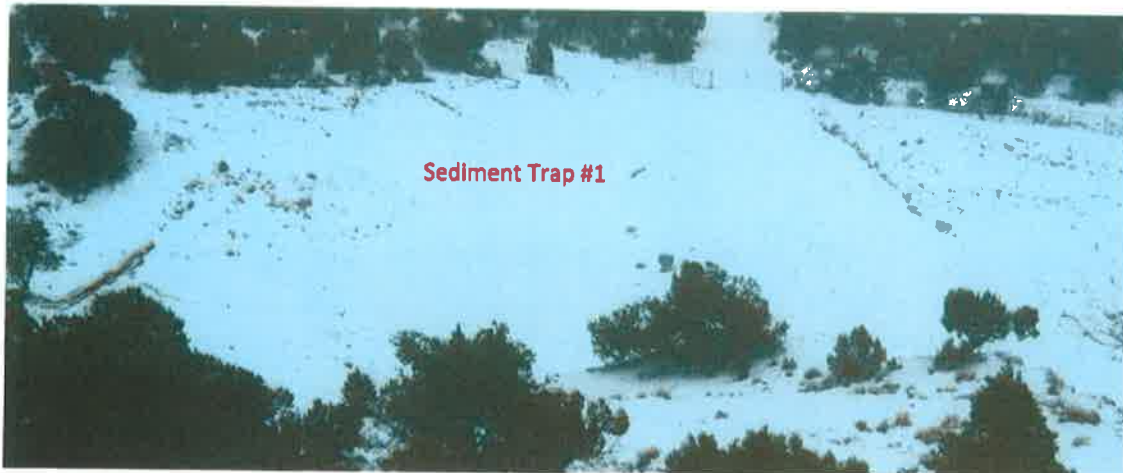
- iii. Run-off control ditch is in place along south side of landfill. Surface of landfill slopes to prevent run-on.
    - iv. Sediment Trap #1 and Sediment Pond 018 are in operation west of the landfill. No discharge recorded in 2016.

Sediment Trap #1, located immediately west of landfill – photo looking southerly

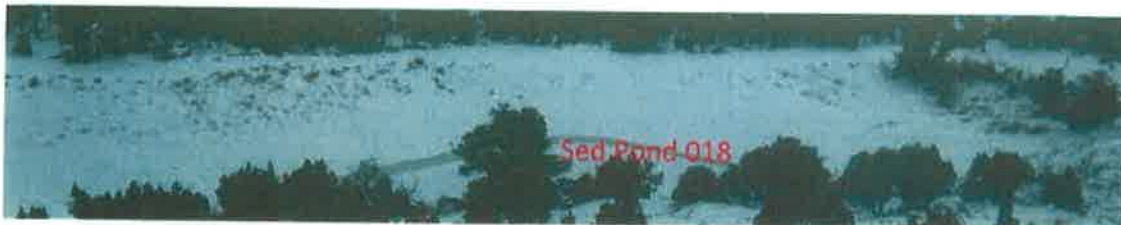
Sediment Pond 018, located west of Sed Trap #1 – photo looking southwesterly
