PRIMARY RECORD

*Resource Name or # (Assigned by recorder) 446 Second Street, Yuba City

P1. Other Identifier: Sutter County Courthouse

*P11. Report Citation: (Cite survey report and other sources, or enter "none.") Sutter County Historic Survey (Galvin Preservation Associates, 2005-2007)

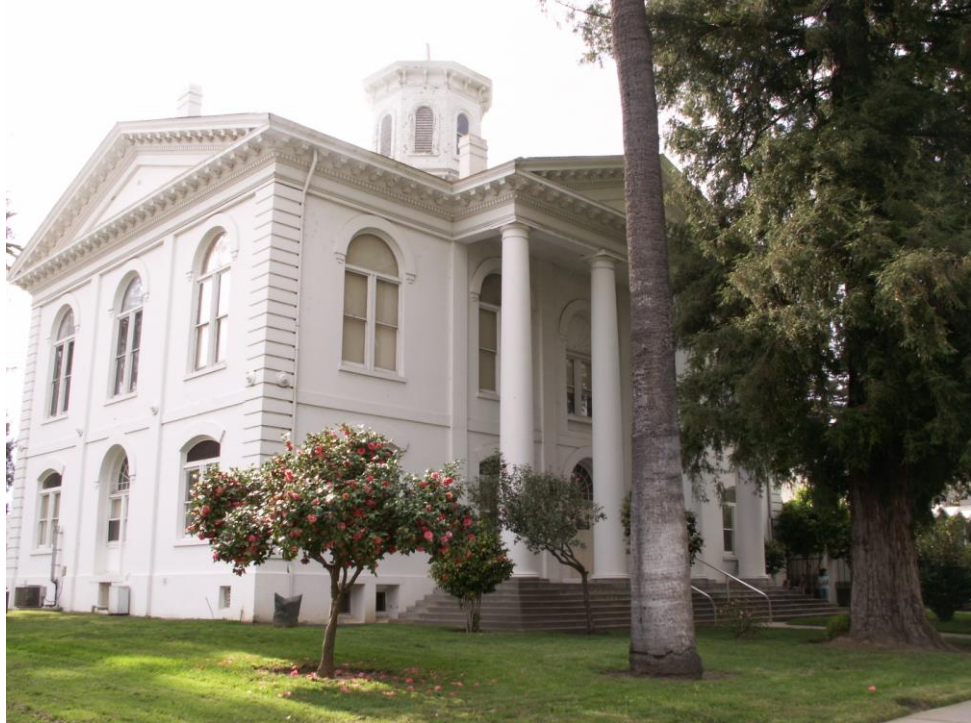
P5b. Description of Photo: (view, date, accession #) View looking northwest at the façade and south elevation, July 18, 2006

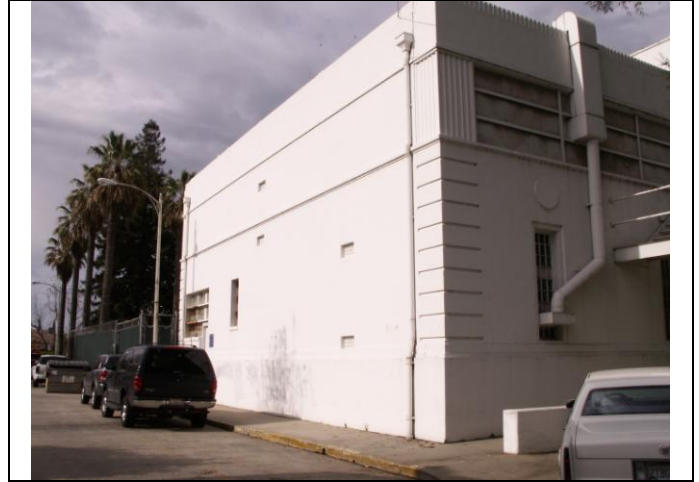
View looking southeast at the west elevation

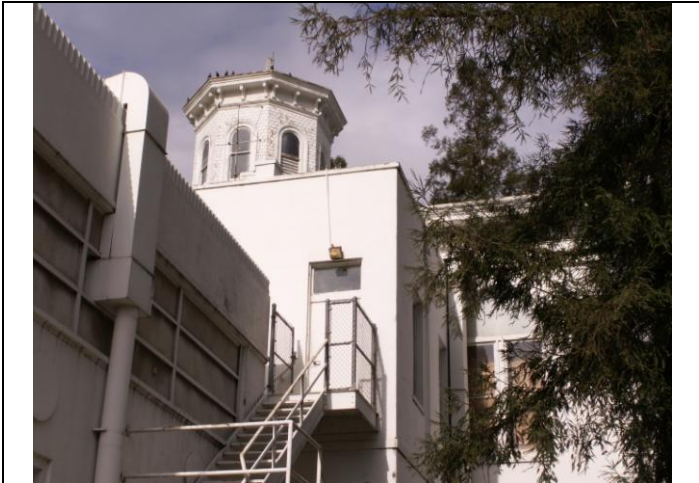
View looking northwest at the south elevation detail and cupola

The cupola, like the reticular framework, is an element of the building which defies precise classification. It repeats the Gothic fenestration in the body of the building. It contains brackets rather than modillions under the cornice. A fact indicative of the gradual dissolution of the more correct Classic and Gothic forms. Originally it was covered with clapboards, but sometime between the original construction and the fire these were replaced with shingles. It occupies the place a Classical dome would occupy, it serves no real purpose, and in fact, it creates a certain special discrepancy in the unity of the building. It is not unique for similar octagonal structures are found perched on the tops of many of the buildings of this period throughout the Valley and Foothills.

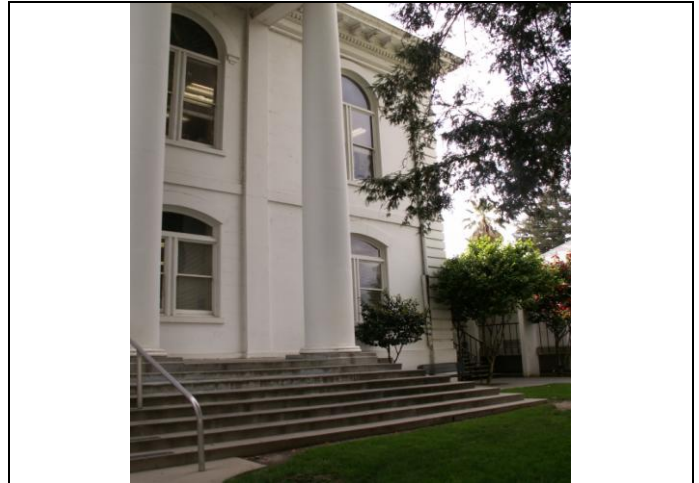
View looking southeast at the façade steps

The primary entry is located at the façade. It consists of a partial-width porch located beneath the intersecting pediment, supported by four Doric columns. The steps and landing are concrete with metal handrails leading to double metal doors. Other entrances to the building are visible on the south elevation. The entry to the south elevation is not visible but is accessible via a concrete stair and landing. There are nine windows on the façade and they are asymmetrically spaced. Five of the nine windows are located beneath the porch. Four windows are doubles consisting of double-hung wood-sash windows with half-moon windows over the top. The fifth window is located directly above the front door and consists of a pair of double-hung wood-sash windows with a half-moon indentation above. Other windows throughout the building consist of paired double-hung wood-sash windows with half-moon windows above. All of the windows throughout the courthouse have arched lintels.
