# Venice Beach Community Shoreline Study

## Beach Assessment and Shoreline Intervention Report

February 2015

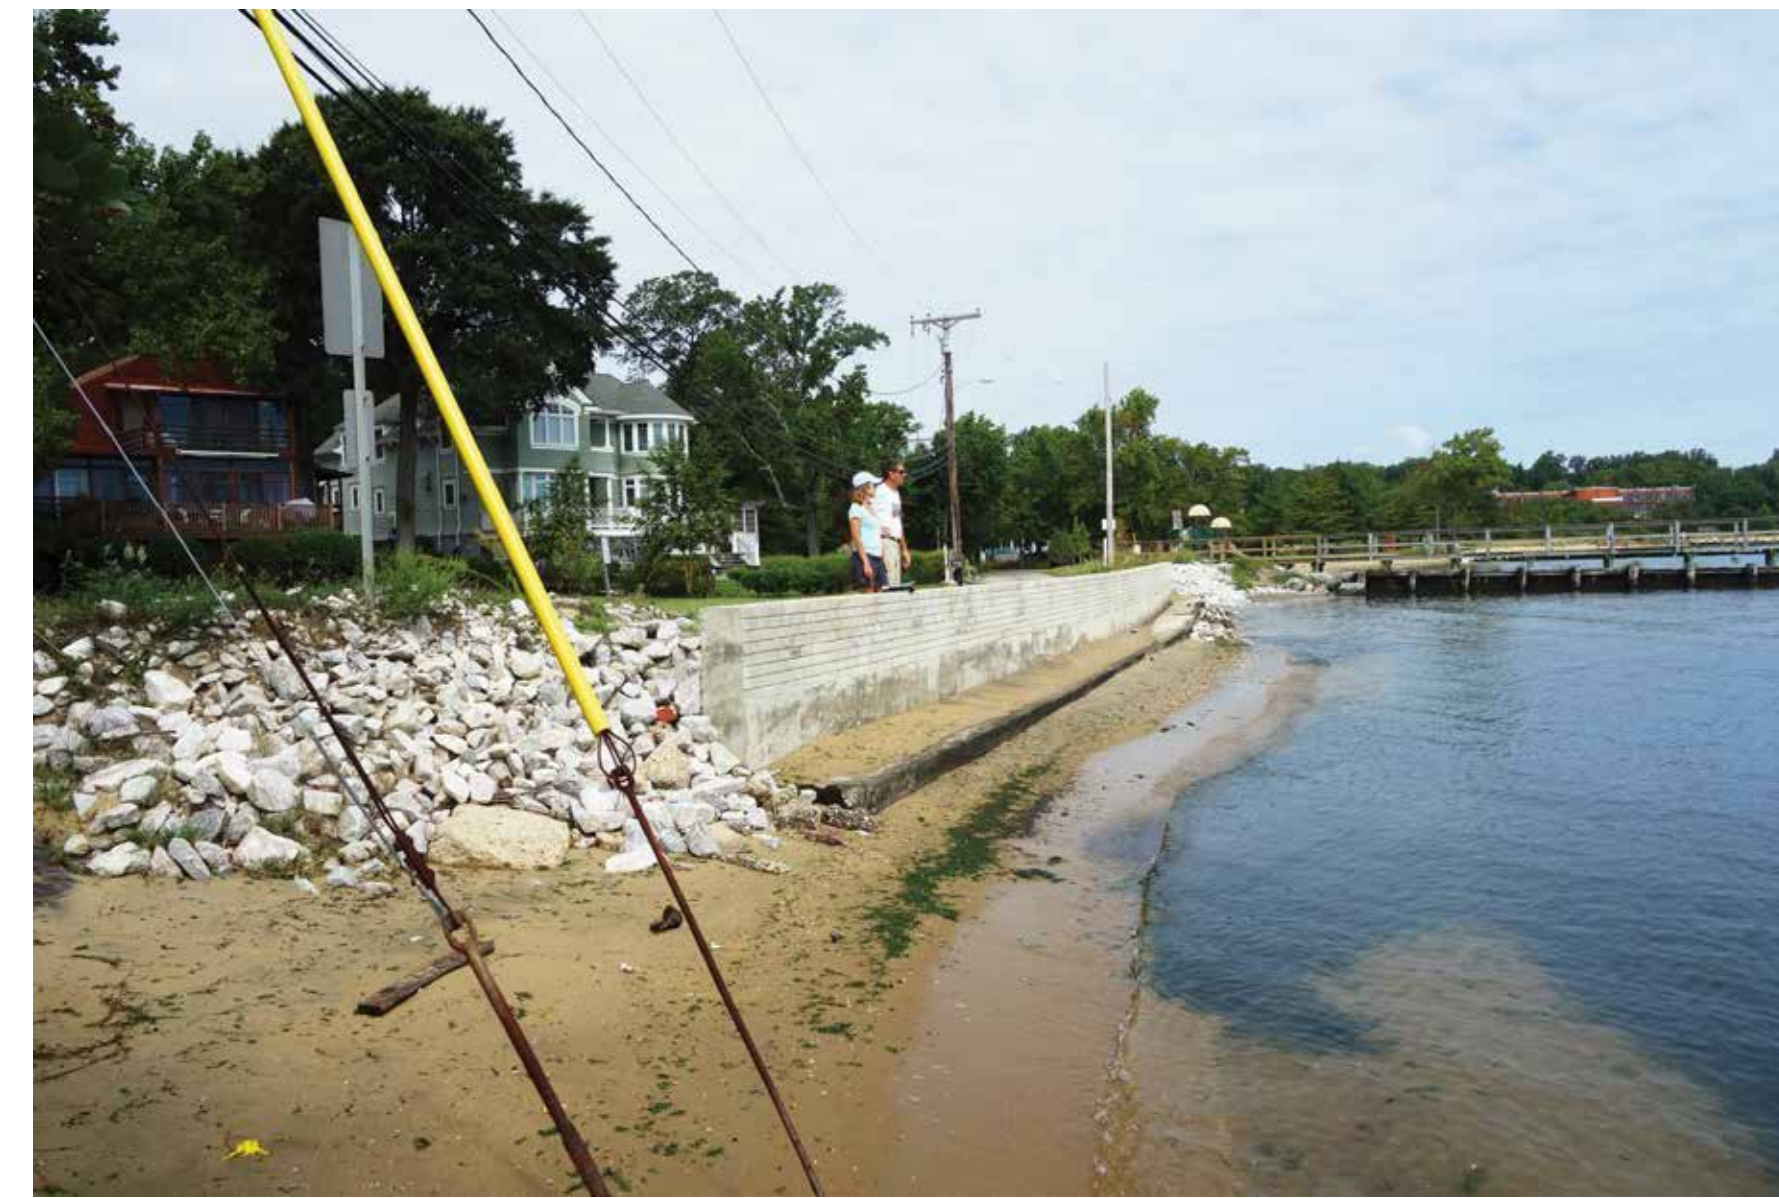
1

1. View of vertical bulkhead looking up the Bay.
2. View of vertical bulkhead with protective toe looking down the Bay.
3. View of wooden groin looking up the Bay.
4. View of wooden groin (foreground) and vertical bulkhead (background).
5. View of bed sill (left), wooden groin (right), stone jetty (left background), and vertical bulkhead (right background).

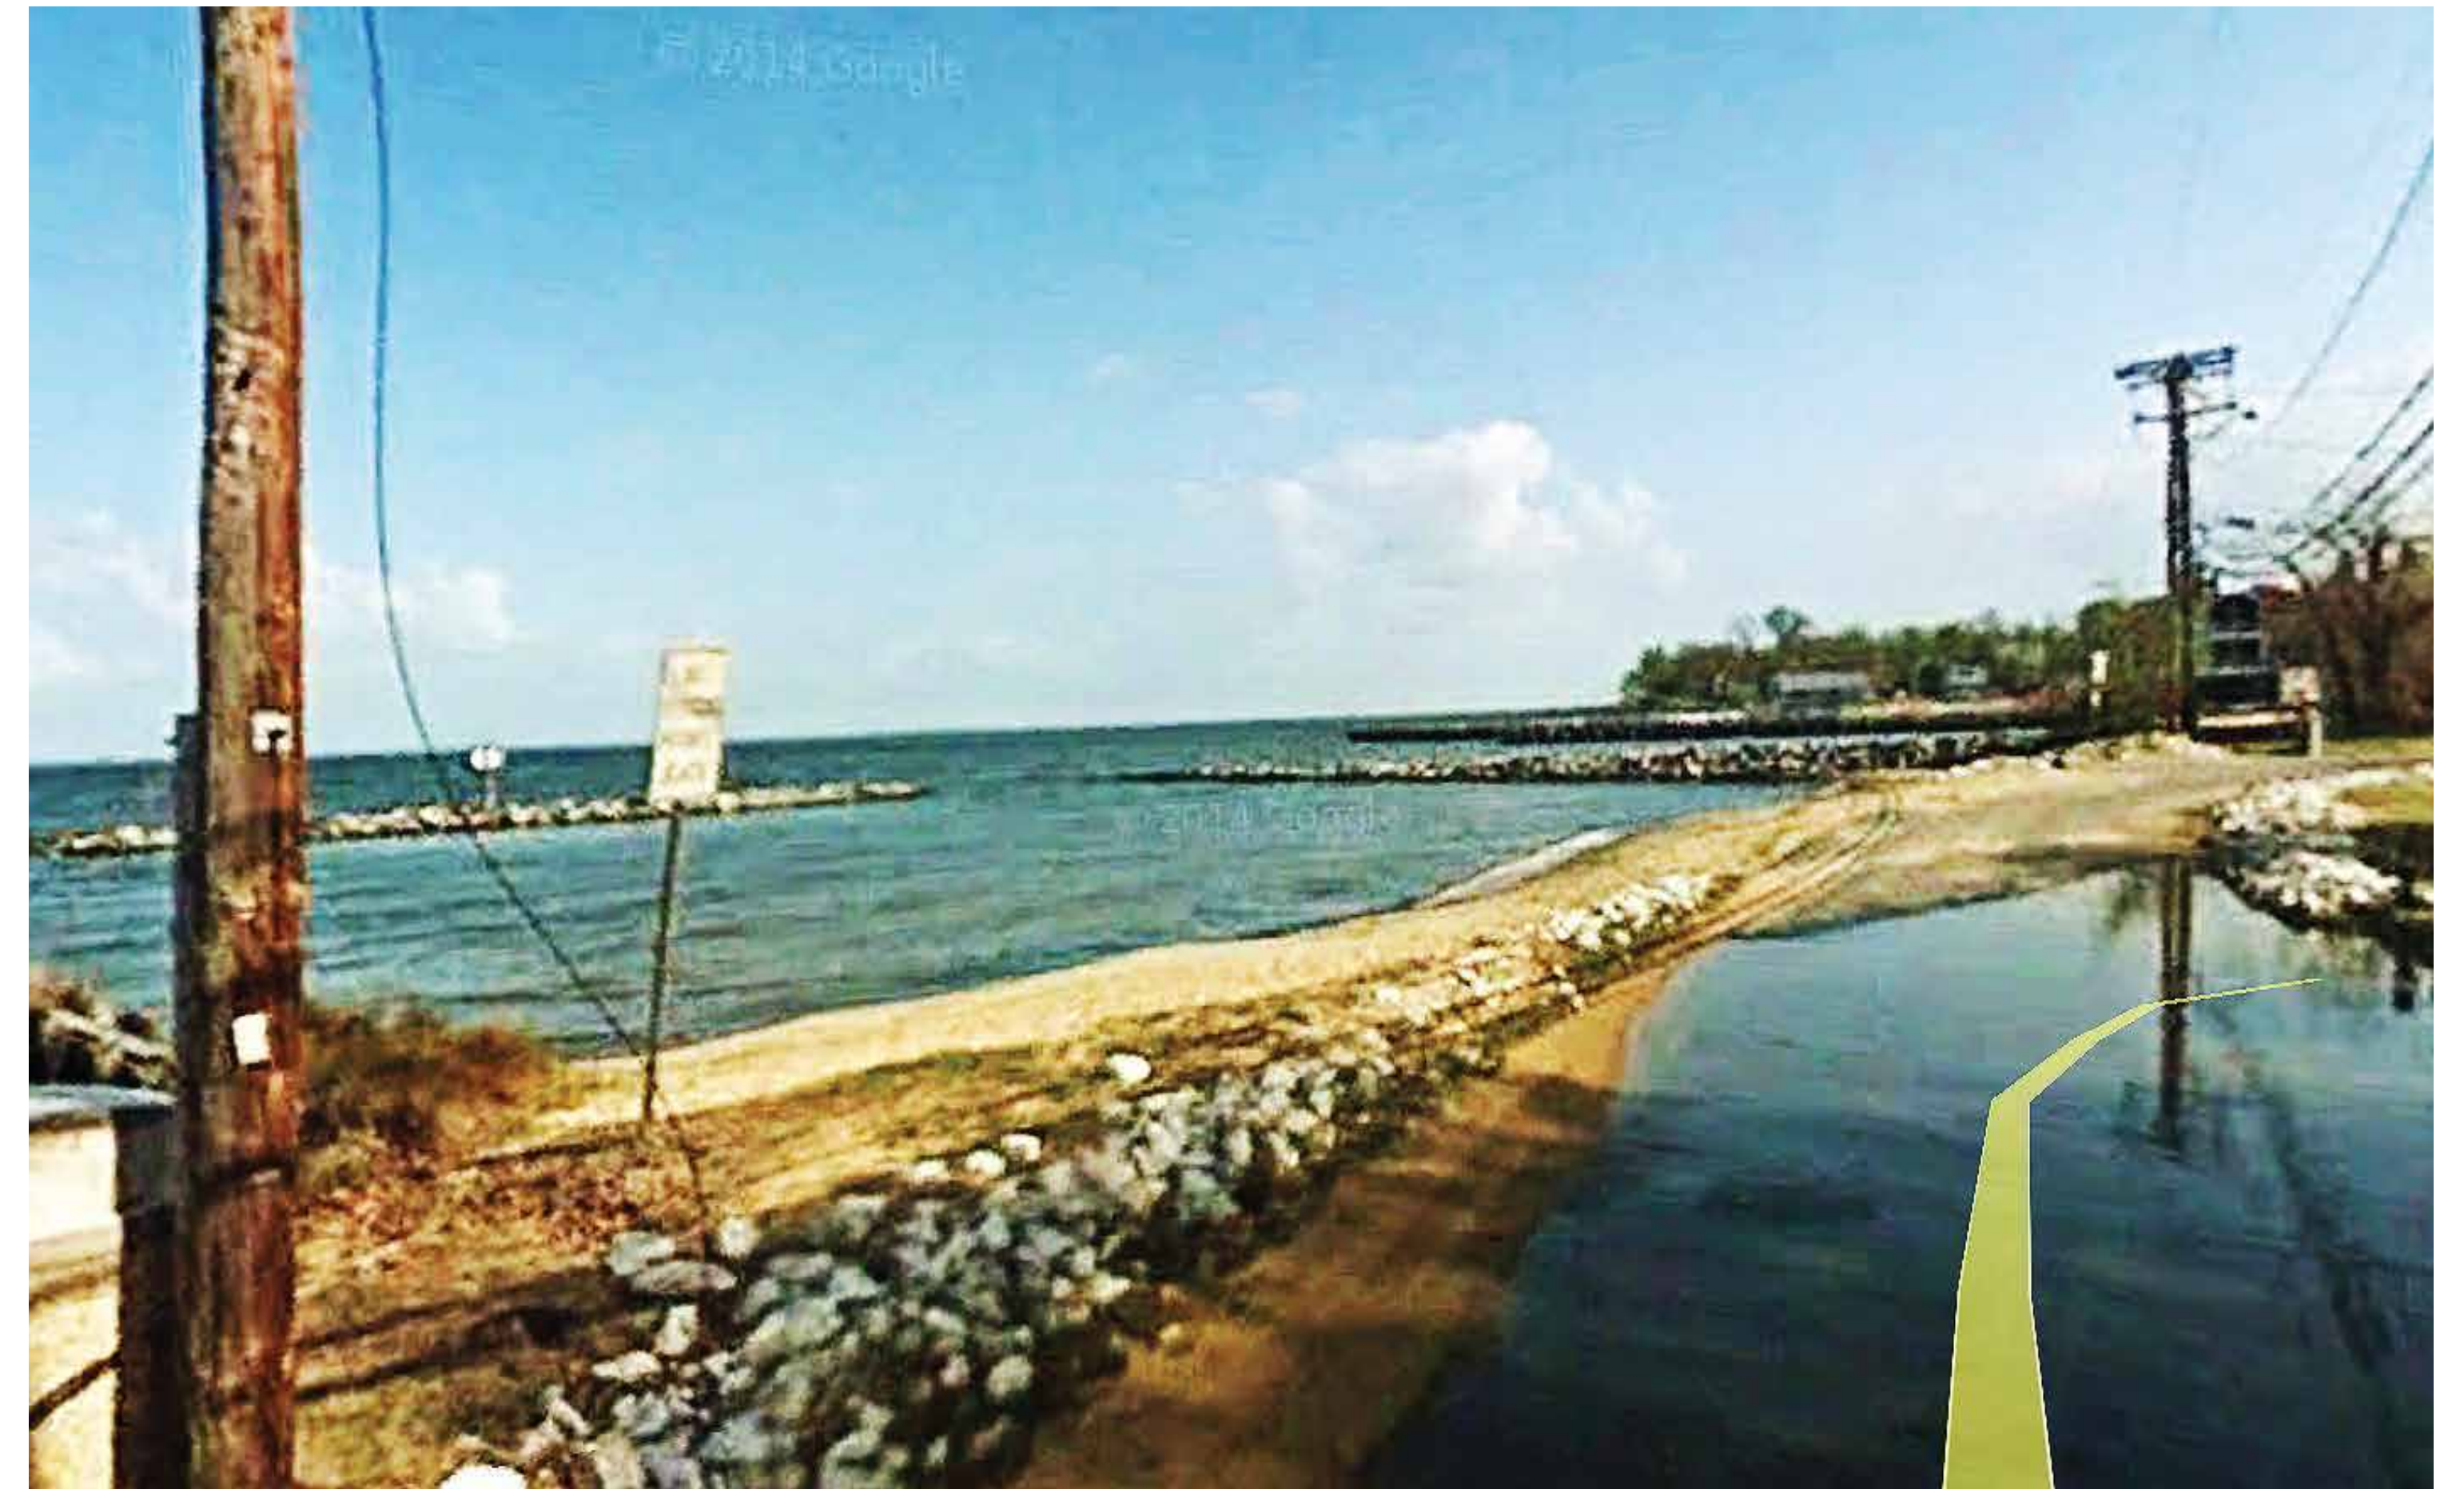
1

1. View from the waterfront (from North) before vertical bulkhead was constructed, notice the gradual sloping beach before the bulkhead was in place.
2. View from the waterfront (from South) before vertical bulkhead was constructed, notice the gradual sloping beach before the bulkhead was in place.
