NRCS LITTLE RIVER WATERSHED DAM NO. 25

**Watershed Dam Rehabilitation
Public Engagement Meeting
March 29, 2017**

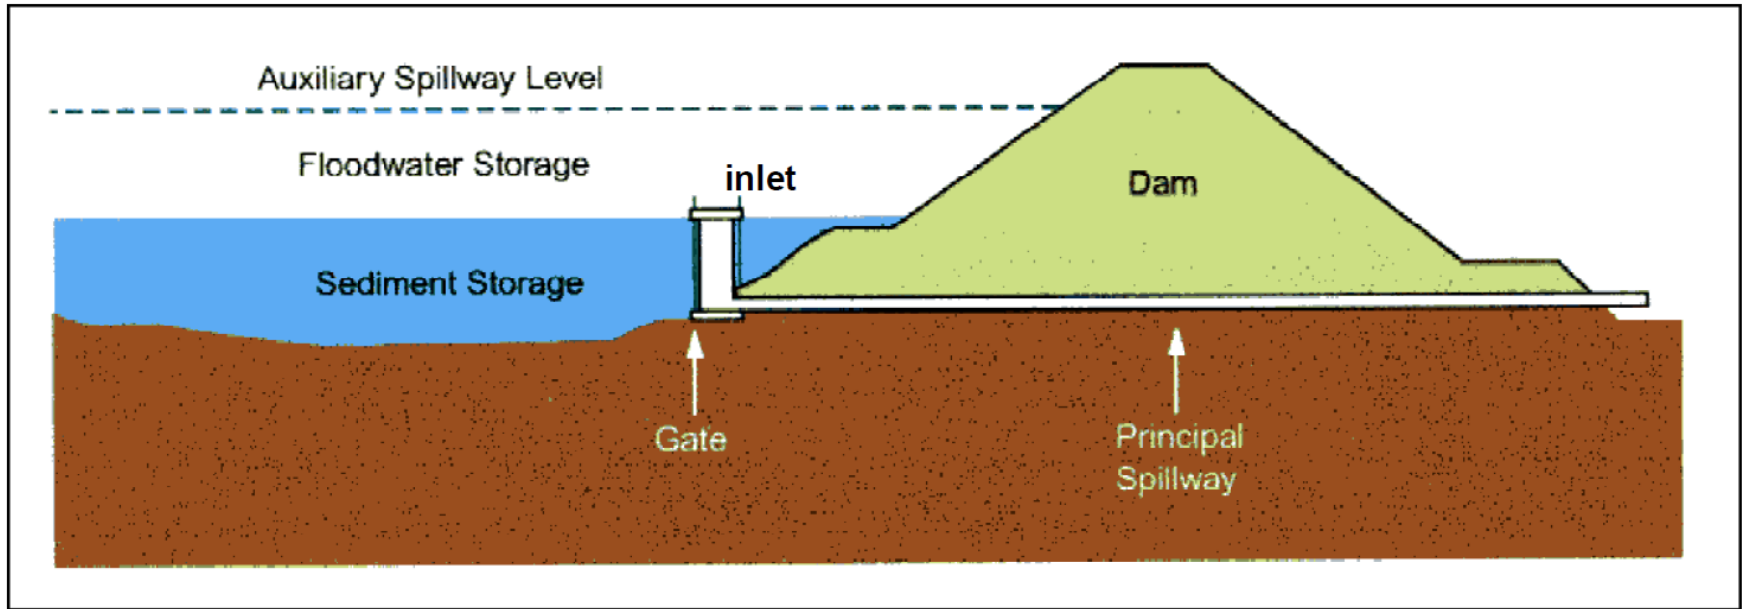
Cross Section of a Watershed Dam

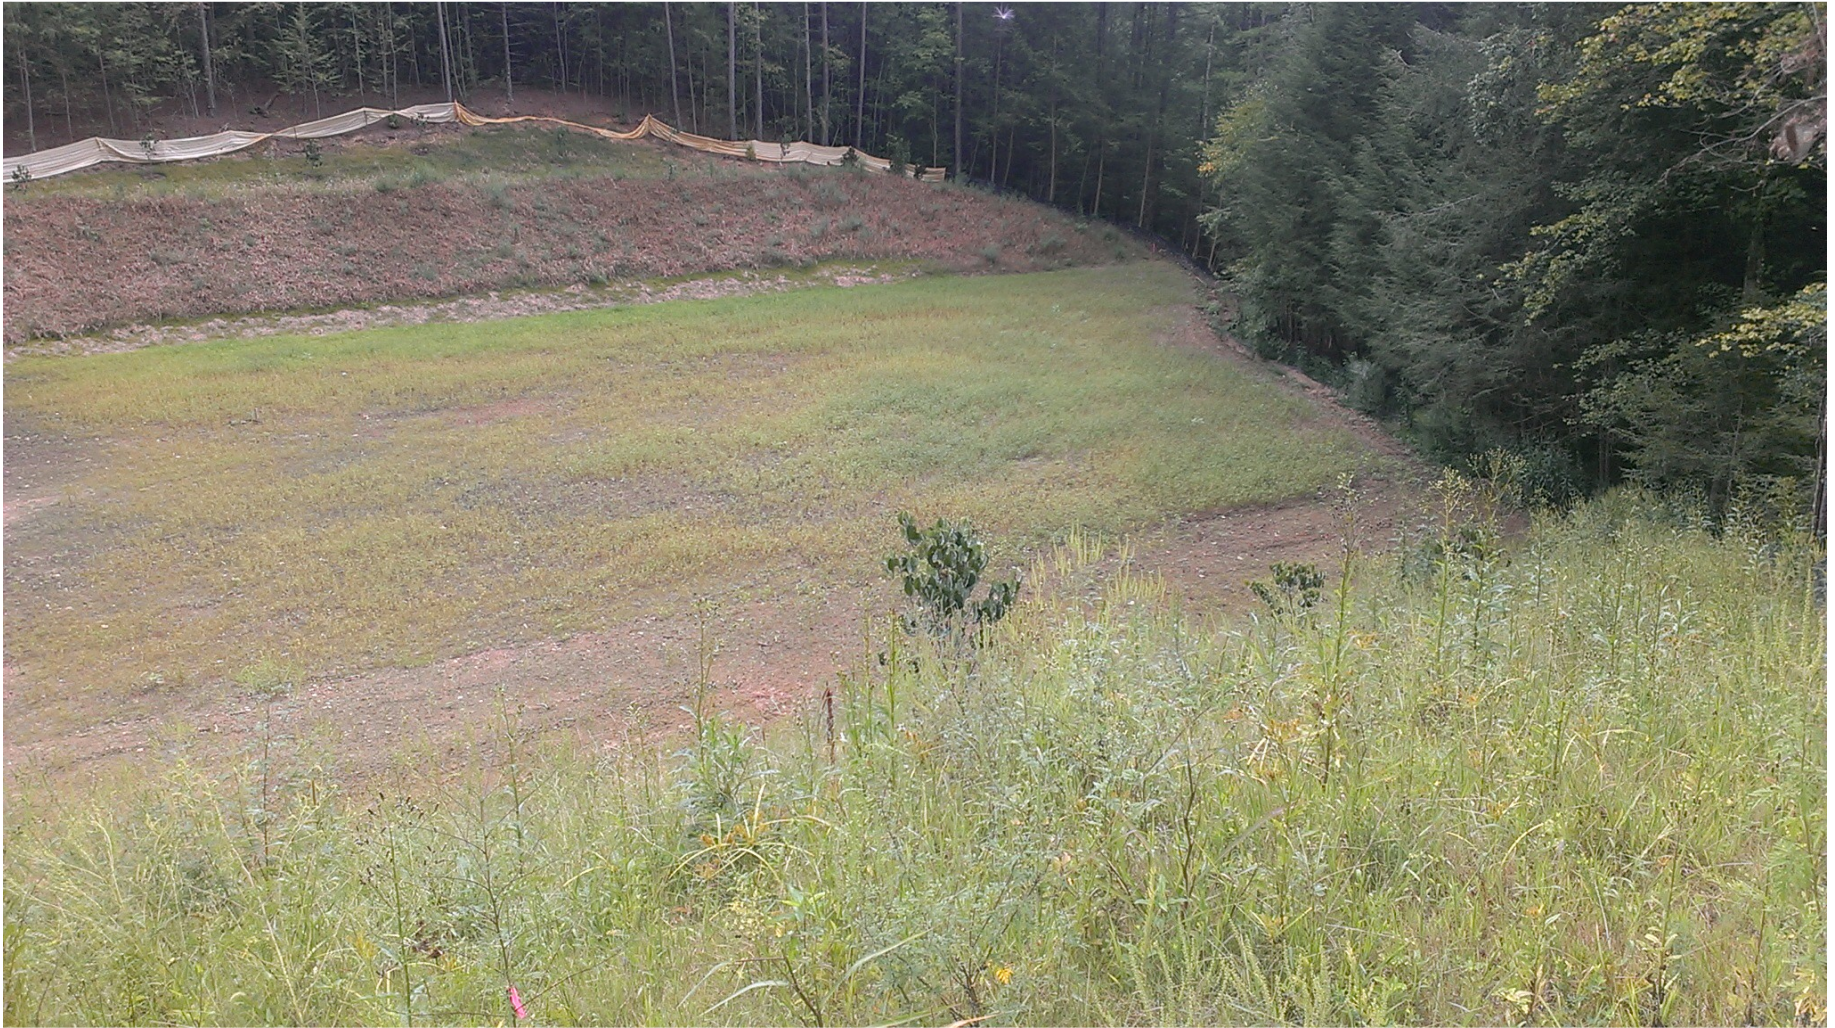
TYPICAL STRUCTURAL ALTERNATIVES

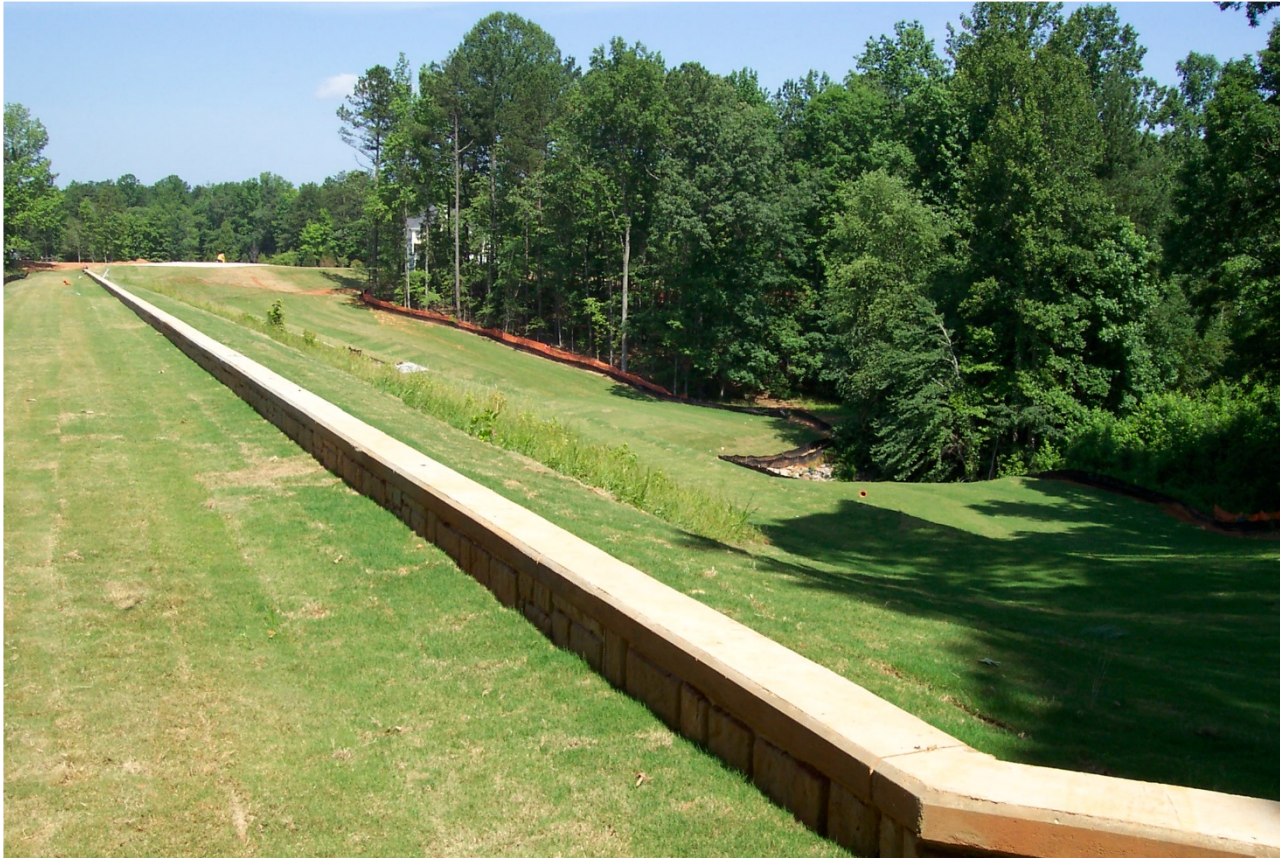
TYPICAL STRUCTURAL ALTERNATIVES

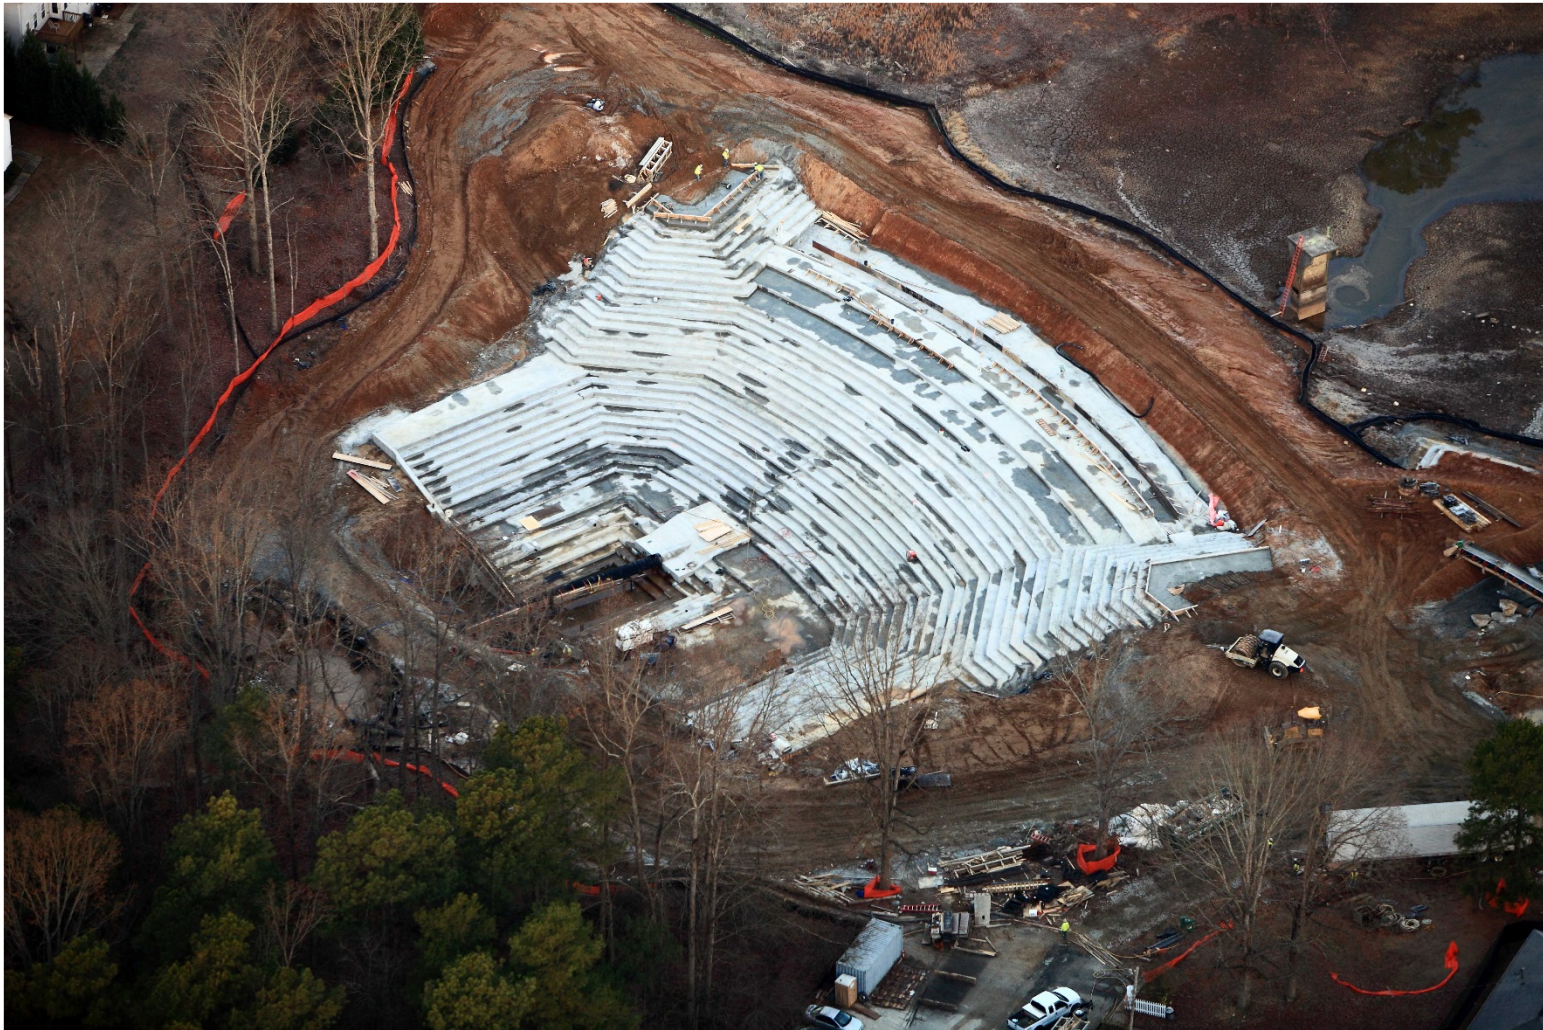
TYPICAL STRUCTURAL ALTERNATIVES

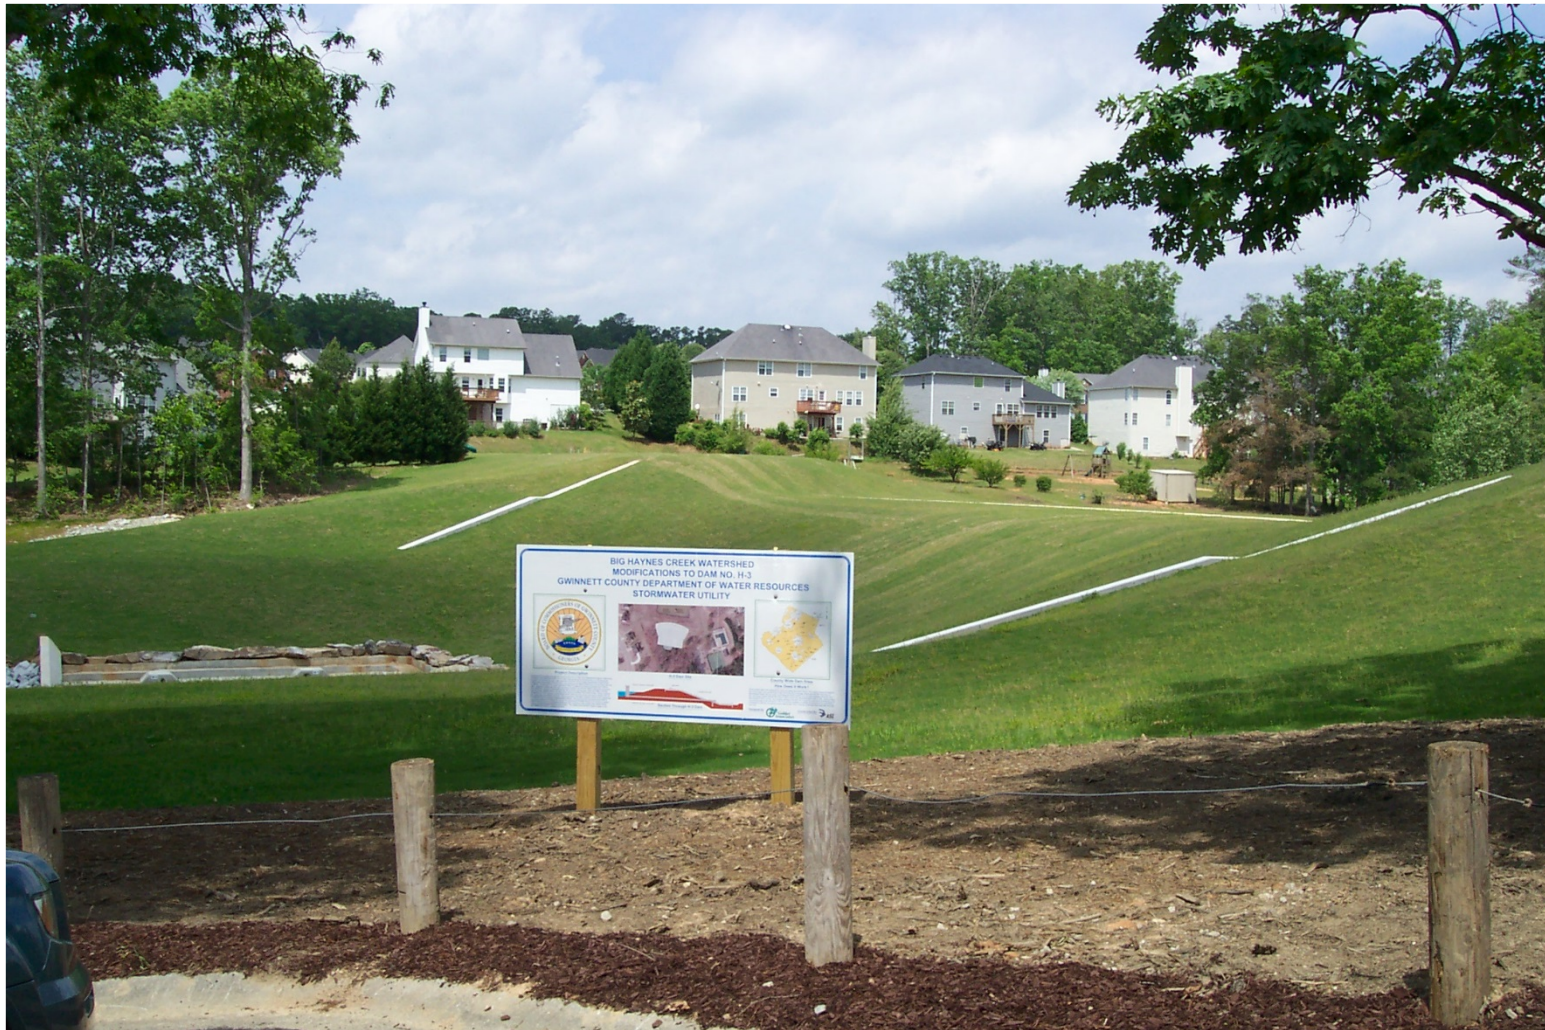
TYPICAL STRUCTURAL ALTERNATIVES

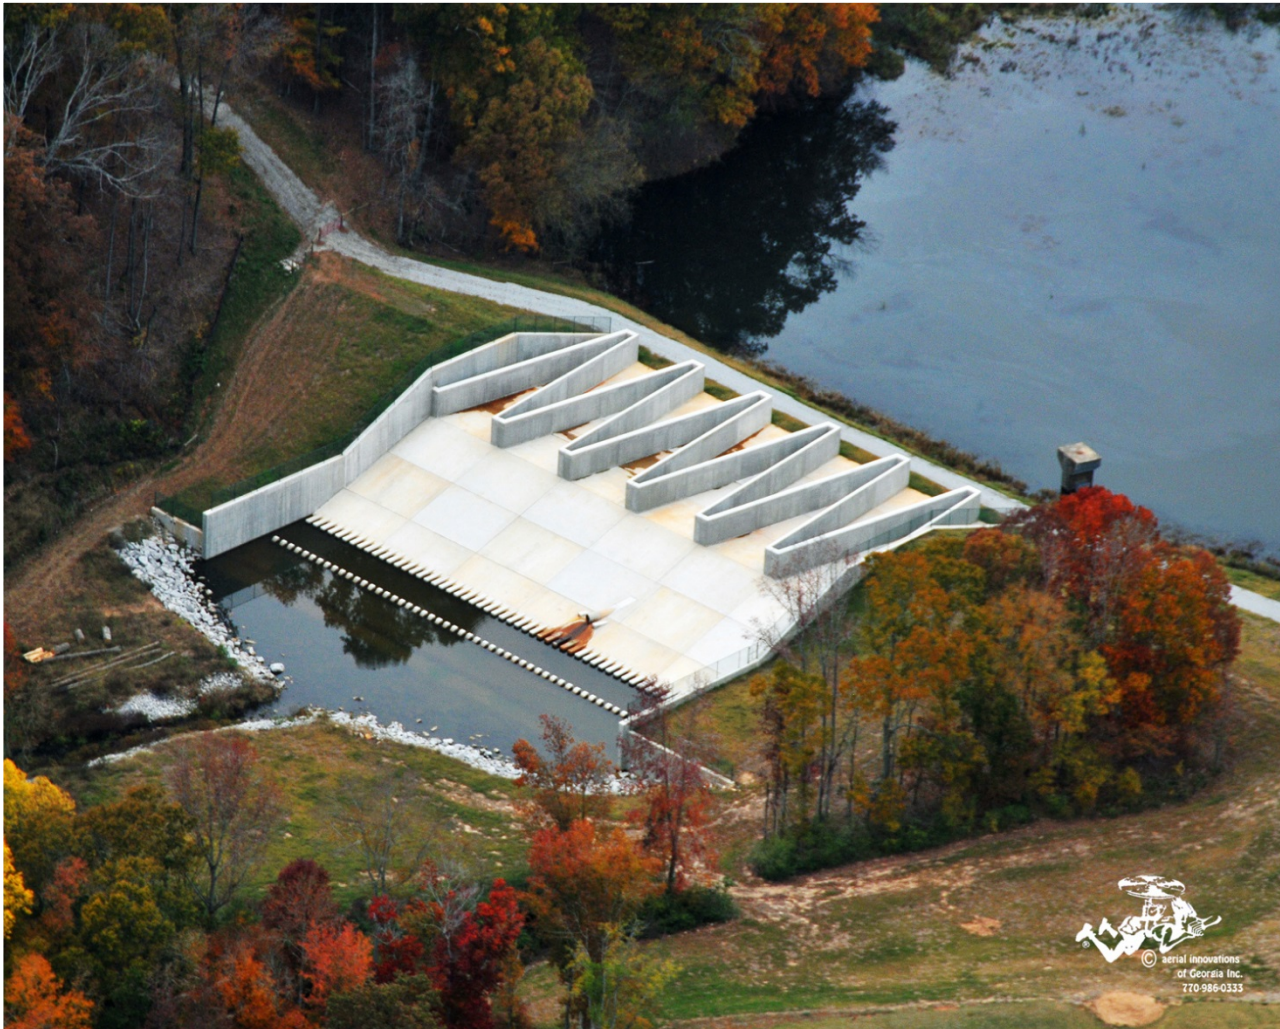
TYPICAL STRUCTURAL ALTERNATIVES
