LEVEL 2 REPLACEMENT RESERVE REPORT FY 2021 CORROTOMAN BY THE BAY ASSOCIATION

REPLACEMENT RESERVE REPORT

CORROTOMAN BY THE BAY ASSOCIATION

MOLLUSK, VIRGINIA
July 22, 2020
Revised November 23, 2020
Revised December 1, 2020

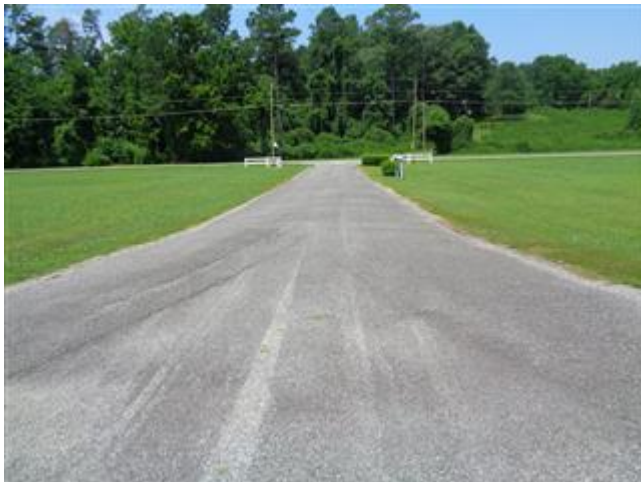
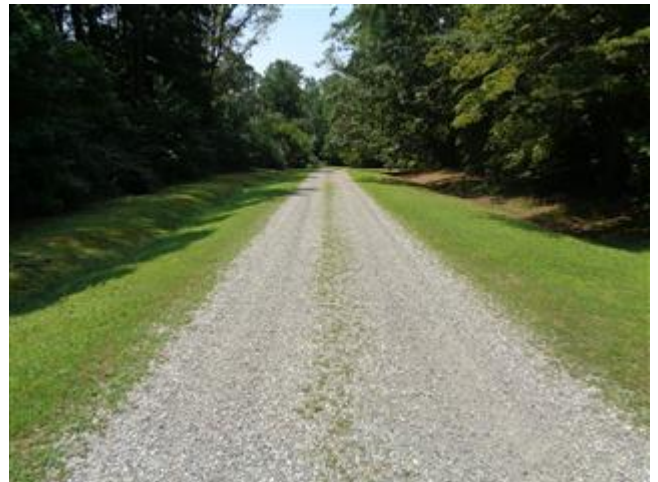
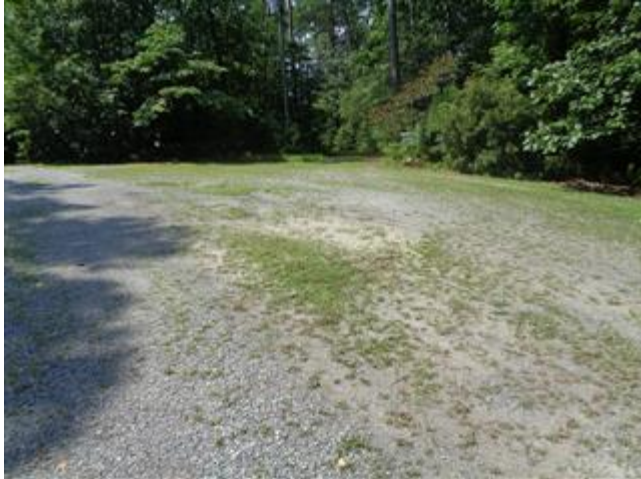
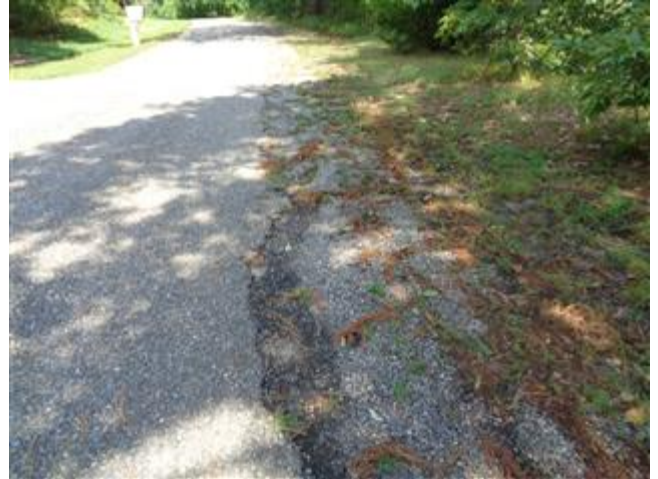
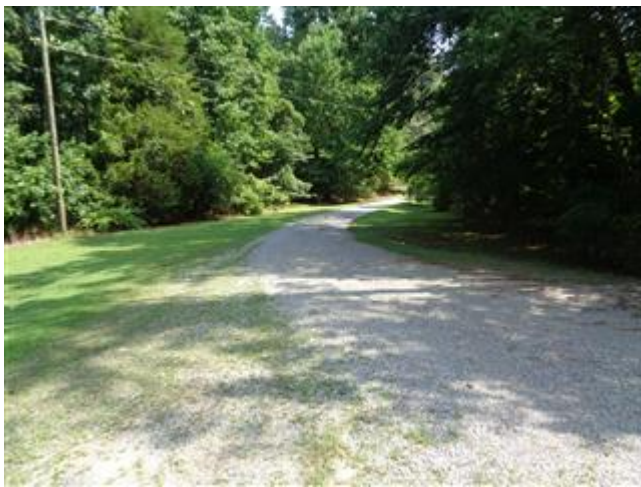
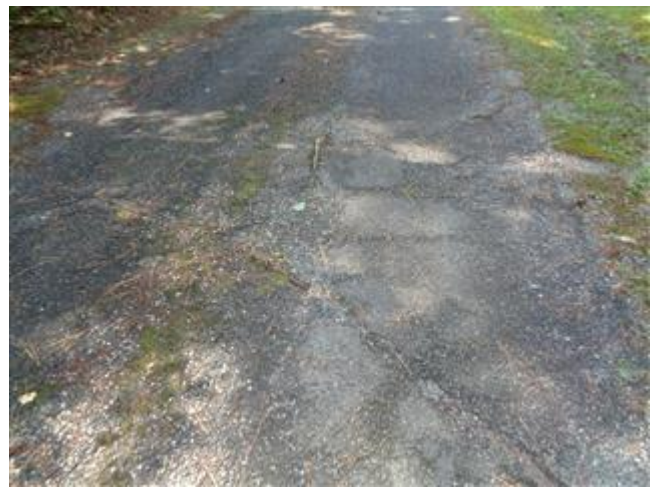
Road Pavement. The Association is responsible for the roadways and parking areas within the community. In general, the Association's roads are in good to fair condition. Some edge deterioration, ponding, vegetation, and drainage issues were noted. The gravel roads are in the process of being replenished at this time. We have continued to allocate \$6,000.00 every two years for paved road repairs and \$4,000.00 every two years for gravel road replenishment.

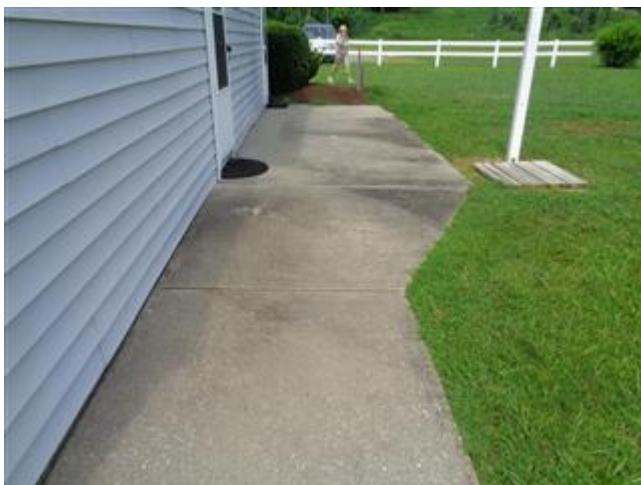
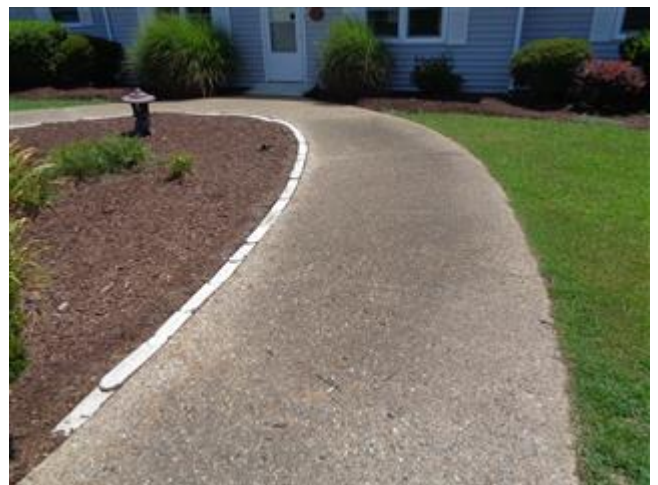
Concrete Work. The concrete work includes the community sidewalks and other flatwork at the clubhouse area. The overall condition of the concrete work is good with some cracking noted. There were no trip hazards.

The standards we use for recommending replacement are as follows:

- Trip hazard, ½ inch height difference.
- Severe cracking.
- Severe spalling and scale.

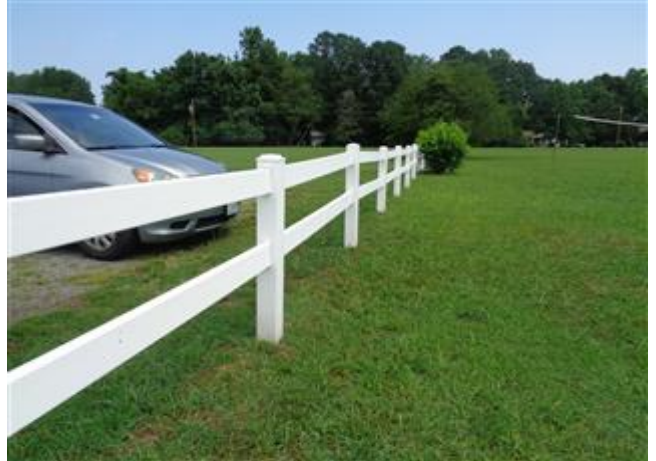
Vinyl fencing made of 100% virgin material can last 30 to 35 years, and periodic cleaning will keep the fence looking attractive.

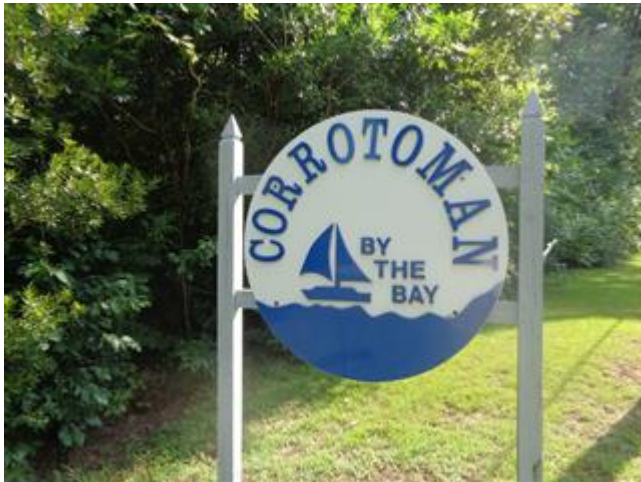
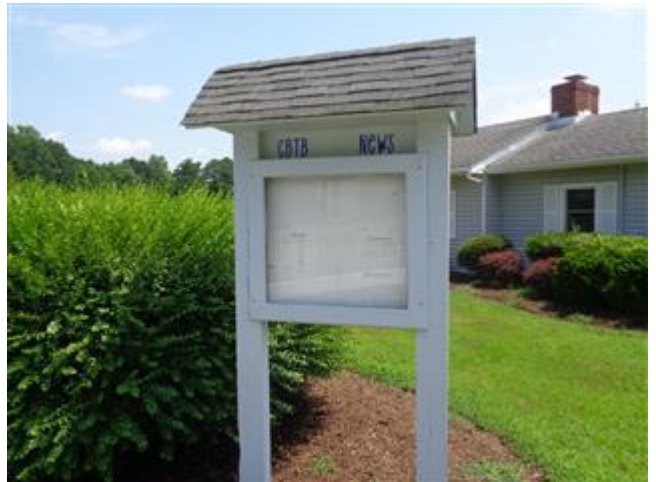
Signage and message board. The community signage and message board were in good condition.

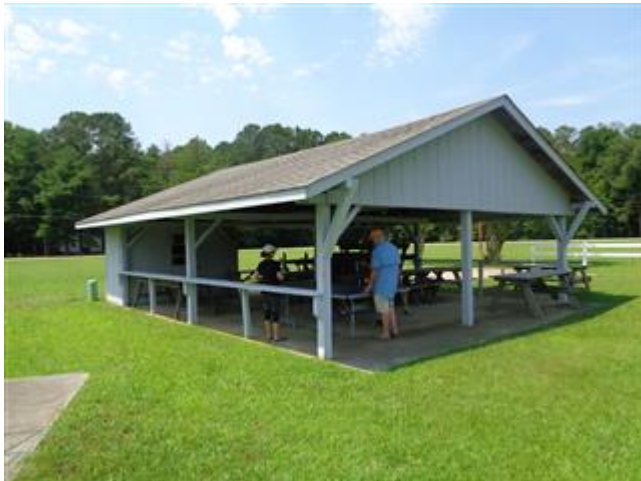
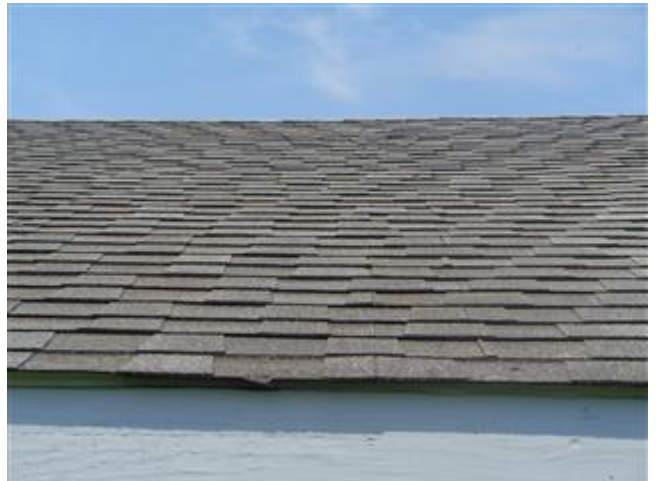
Building Roofing. The asphalt shingle roofing on the common area buildings appeared to be in good condition and no leaking was reported. We could not access or see the flat roofing on the rear of the clubhouse.

Asphalt shingle roofs can have a useful life of 20 to 40 years depending on numerous factors. Flat roofing systems typically have a useful life of 15 to 25 years.

Annual inspections are recommended, with cleaning, repair, and mitigation of vegetation performed as needed. Access, inspection, and repair work should be performed by contractors and personnel with the appropriate access equipment who are experienced in the types of roofing used for the facility.

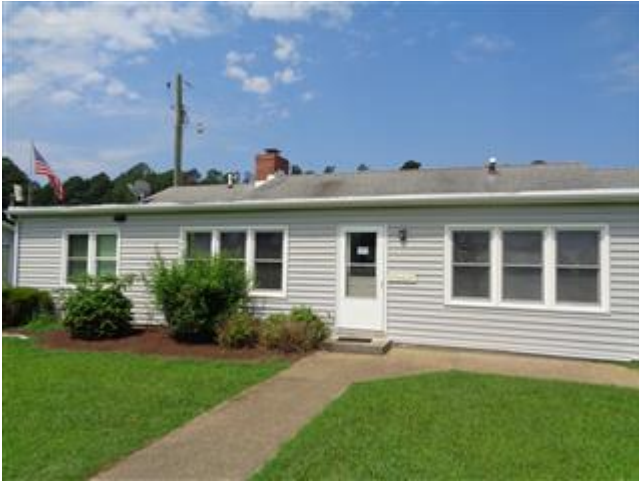
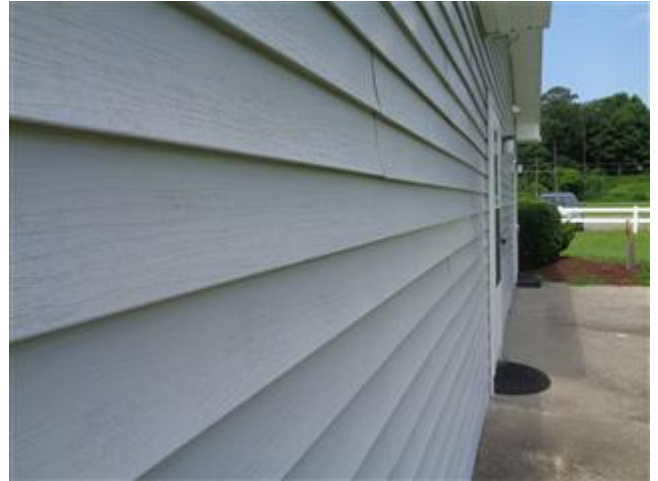
Siding and Trim. The siding and trim on the buildings was in good condition.

Wooden exterior materials are typically repaired as needed during normal painting cycles. Painting cycles for wooden exteriors vary between five and ten years depending on the grade of wood and the quality of the materials and finish work. In this study, we have modeled for an incremental wood material replacement to coincide with the painting cycle of the facility.

Vinyl/Aluminum Siding and Trim can have an extended useful life if not damaged by impact, heat, or other physical reasons. However, the coatings and finishes typically have a useful life and over time begin to weather, chalk, and show their age. For these reasons, we have modeled for the replacement of the siding and trim every 35 years.

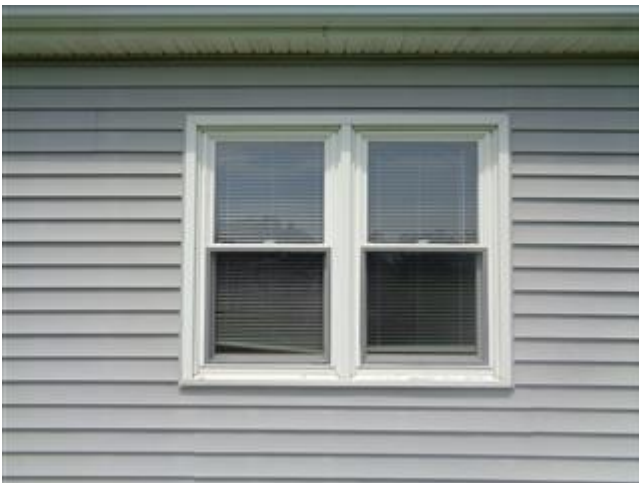
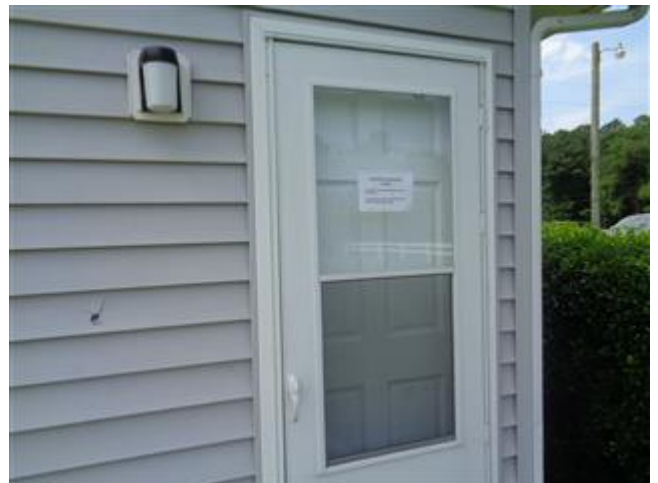
Windows and Doors. The Association is responsible for the common windows and exterior doors of the facility. The windows and doors are in generally good condition.

In general, we recommend coordinating the replacement of these units with other exterior work, such as siding and roof replacements. The weather tightness of the building envelope often requires transitional flashing and caulking that should be performed in coordination with each other. Warranties and advantages in 'economy of scale' can often result in lower overall replacement costs and results that are more reliable. Lastly, coordinated replacements offer the opportunity to correct initial construction defects and improve the effectiveness of details with improved construction techniques and materials.

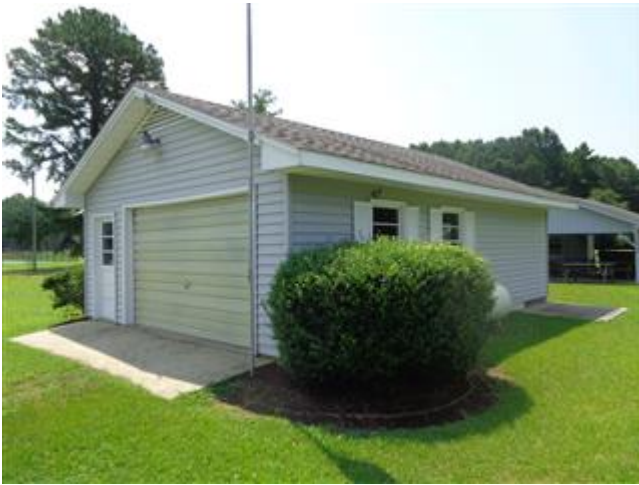
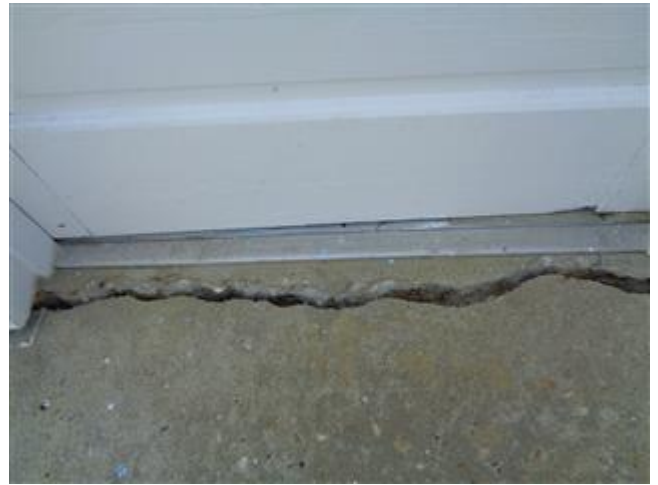
Storage building. We noticed a significant crack/opening at the concrete entrance to the storage building in front of the doors. This appears to be an old settlement and does not show evidence of recent movement. This opening should be sealed and covered to prevent water penetration below the slab causing further damage and to prevent a trip hazard.

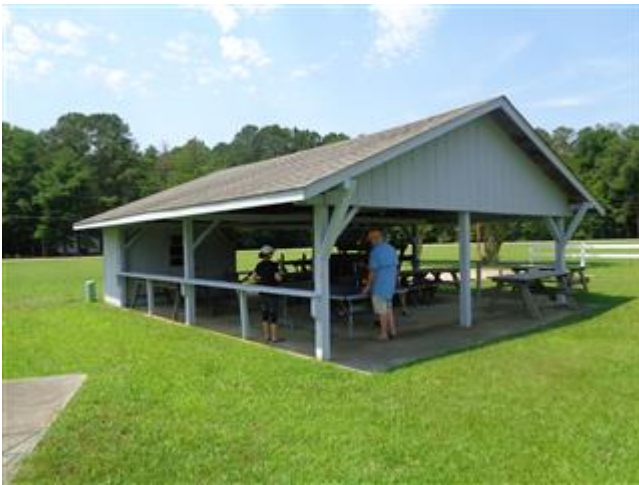
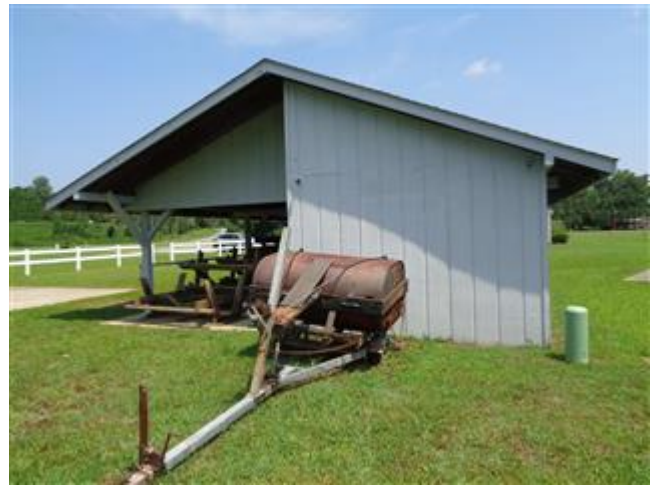
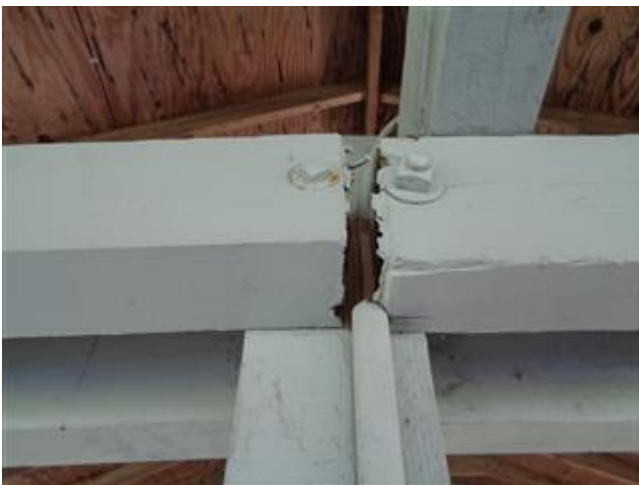
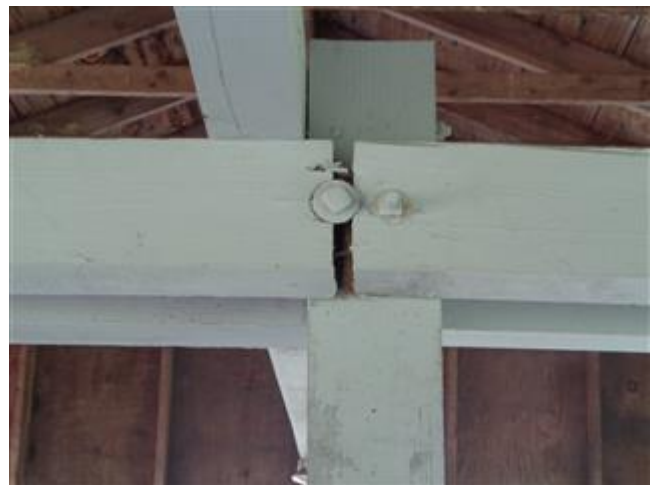
Picnic Shelter. The picnic shelter was in generally good condition with the exception of broken glass in a storage area door. We noted a structural issue that should be addressed. There is separation at the center posts where horizontal beams are bolted to the post. The bearing is inadequate. This is typically due to settlement/movement in the structure. We suggest repairs by a qualified contractor.

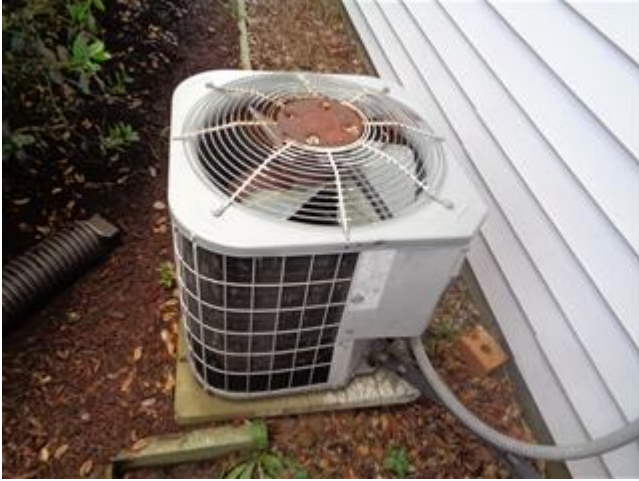
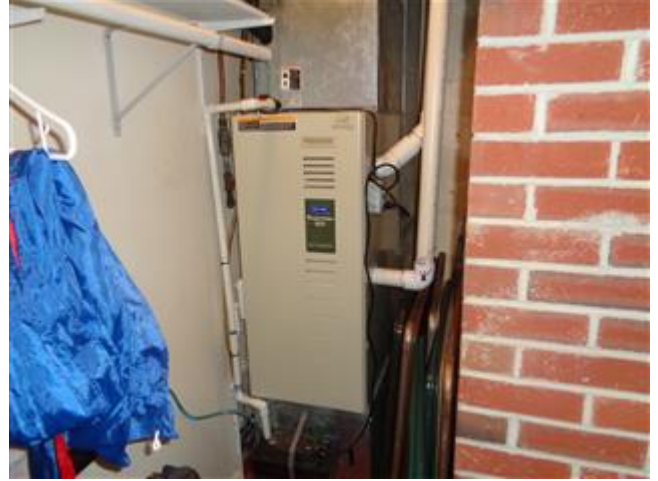
HVAC System The clubhouse heating and air conditioning system was not operating at the time of our visit. We understand it is scheduled for replacement in August 2020.

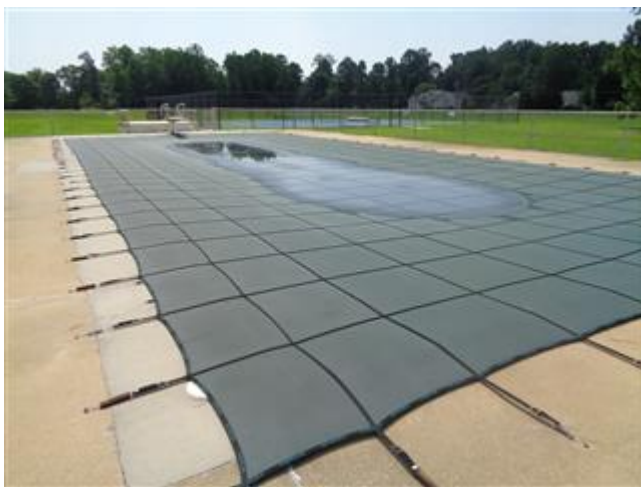
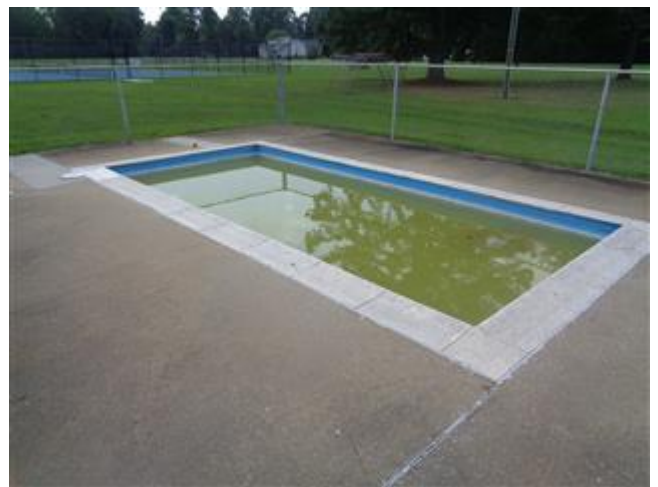
Pool Fence. The swimming pool is enclosed by a metal chain link fence that is in fair condition.

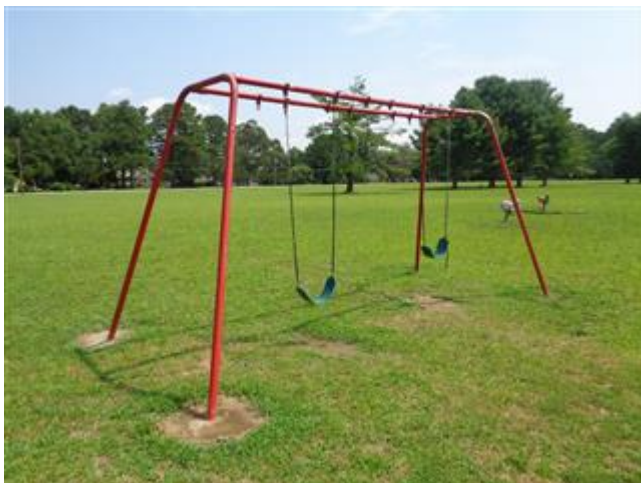
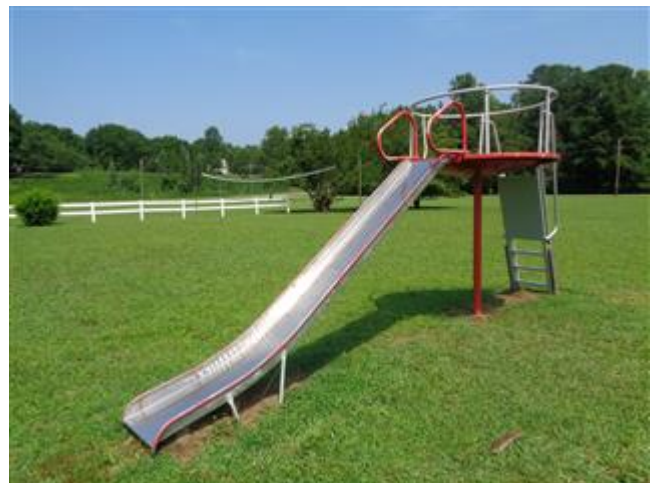
Basketball Court. The basketball court is older but remains in good to fair condition.

Tot Lots. The community maintains a playground spread over a large area. This includes play structures and miscellaneous play equipment. The facilities are outdated and in generally poor condition. There is no border around the area and no surface material. We understand the community plans to replace this with an updated tot lot in the near future. This report should be updated when actual replacement estimates are obtained.

The safety of each individual piece of playground equipment, as well as the layout of the entire play area, should be considered when evaluating a playground for safety. The installation and maintenance of the protective surfacing under and around all equipment are crucial. Please note that the evaluation of the equipment and these facilities for safety is beyond the scope of this work.

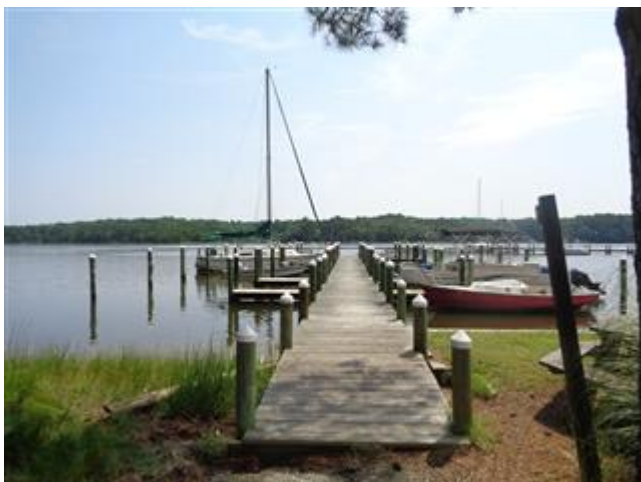
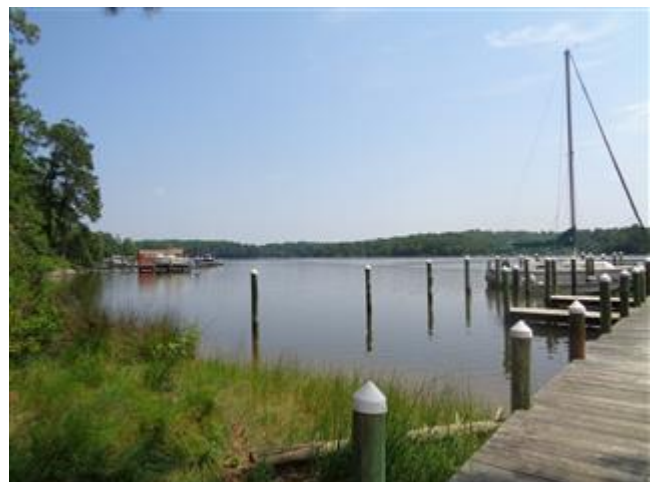
Waterfront/boating area. The Association maintains wood piers, boat slips, a boat ramp, and pilings on the Corrotoman River. The piers are constructed from pressure-treated lumber supported by wood pilings and were replaced in 2012. The piers, boat slips, pilings, and boat ramp are in good condition at this time. Bulkheads are also present.

Wood Pier Decking. The wood decking on the piers, the finger piers, and the wood walk is exposed to harsh extremes of sun and weather. It will typically require replacement before the heavier members of the underlying structure. This decking will also be removed and replaced in its entirety when the underlying structure is replaced. To model this replacement pattern, we have provided for a complete replacement incident to the replacement of the structure, and we have included an additional replacement interval for the wood pier decking at the midpoint of the service life of the underlying structure.

Pier Structure. The structure consists of pressure-treated woodpiles on 10-foot centers with stringers spanning the distance between piles. We have assumed that when the pier structure requires replacement, all pilings will also be replaced.

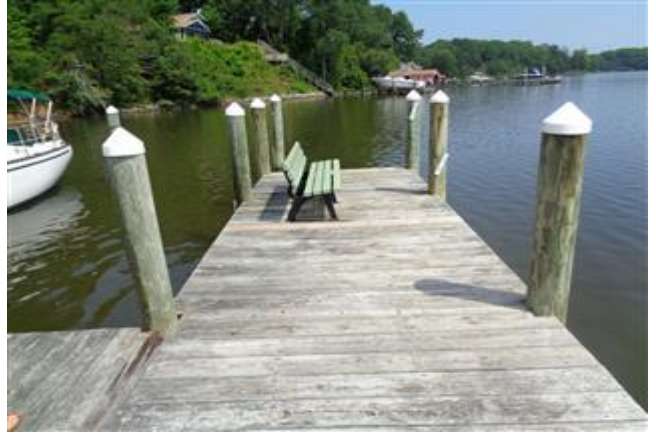
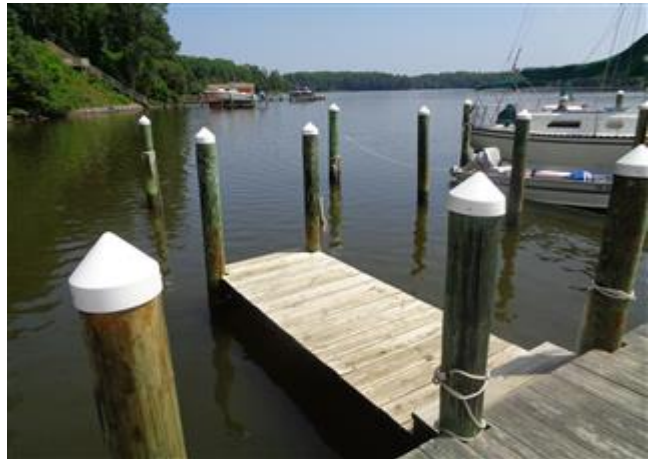
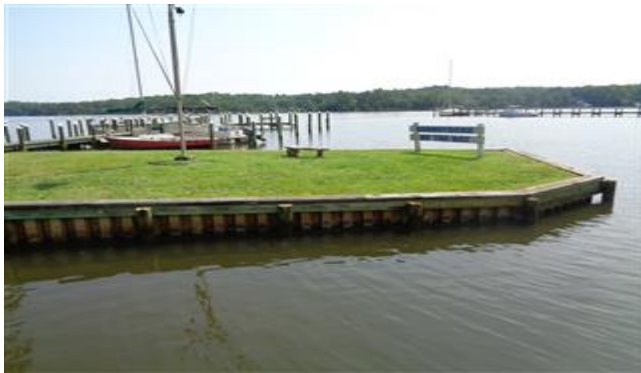
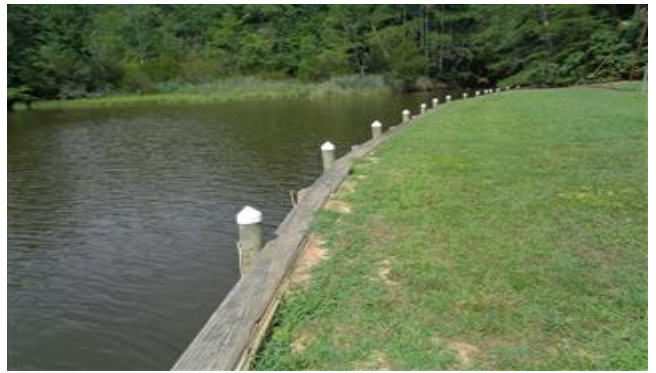
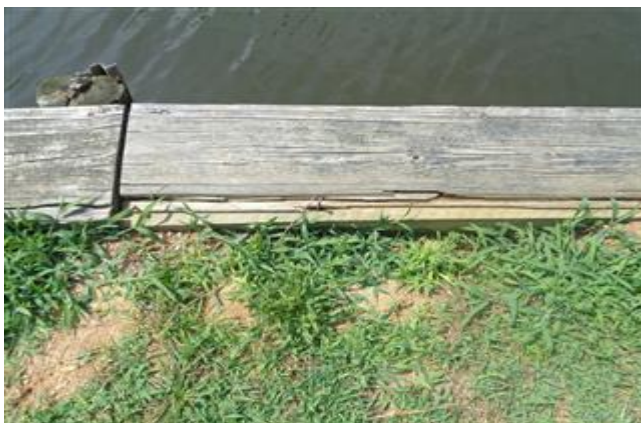
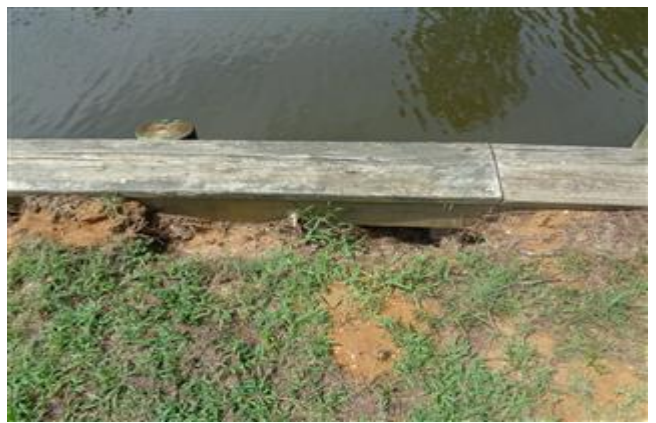
Bulkhead. The main bulkhead appears to be in good condition with the exception of some erosion taking place. The main bulkhead cap is showing wear. This item is usually the first to require replacement. There is a second bulkhead across the cove which is reportedly owned by the Association and is in disrepair. Quotes are being obtained for replacement costs. This report should be updated accordingly when the estimates are available.

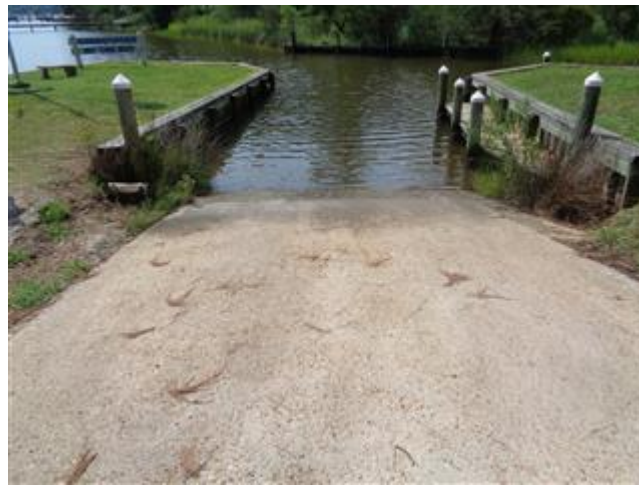
Boat Ramp. The concrete boat ramp appeared to be in good condition with no significant cracking or settlement noted.

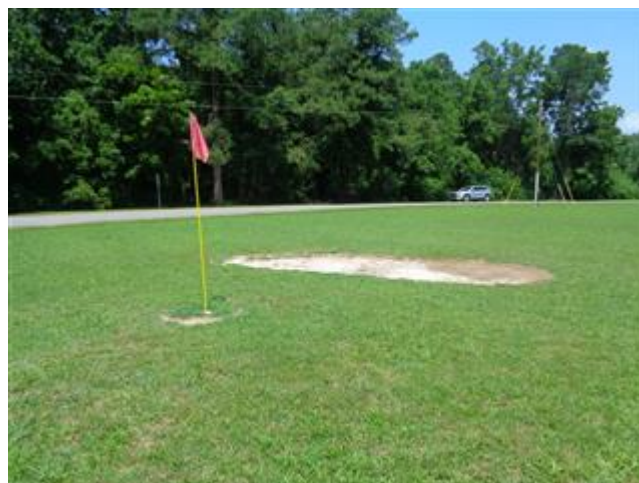
Golf area. The community maintains an area for golfing. This is primarily a large open grassy area suitable for some golf activities. We understand the community is considering an upgrade. We have continued the funding provided in the previous study for upkeep.
