# **Goliad County Recharge Evaluation**

## **Summary of Field Data Collection for September 2021**

Ken Rainwater, Ph.D., P.E., and Cade Coldren, Ph.D.

**Texas Tech University**

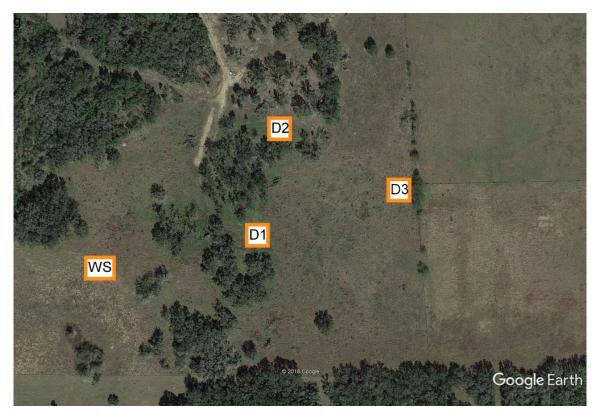
Figure 2. Approximate instrumentation sites at the Dohmann wooded location

Rainwater and Coldren (2018a,b, 2019, 2020a, b) previously reported the details of the instrumentation choices and site positions at the Landgrebe, Dohmann, and Fuller locations in Goliad County. Table 1 summarizes the details about the depths of the soil moisture sensor probes (P1-P5) at each of the datalogger sites (L1-L3, D1-D3, and F1-F3), as well as the coordinates of the datalogger sites and weather stations (WS). Aerial images (Google Earth) of the locations are shown in Figures 1, 2, and 3, respectively. Local soil conditions were presented in the previous reports.

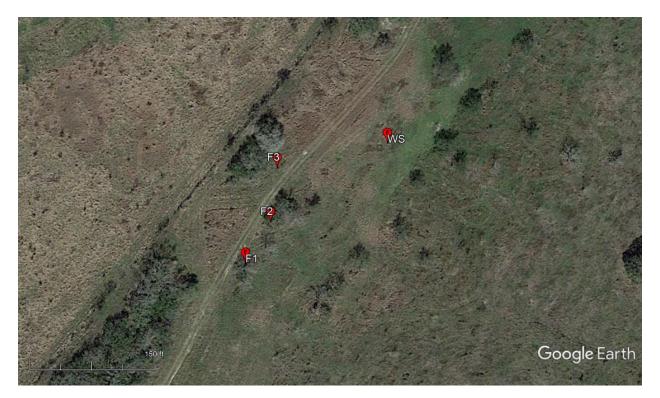
Figure 3. Approximate instrumentation sites at the Fuller location

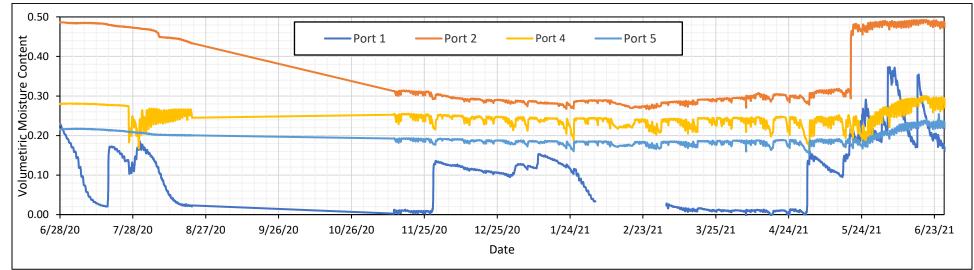
Figure 5. Landgrebe L1 soil moisture probes June 28, 2020 to June 27, 2021

Figures 4 to 13 display the Year 3 and early Year 4 observations for the Landgrebe locations, aligned vertically on tabloid-sized pages to allow visual comparison of the graphs while keeping the horizontal time axes aligned. Figure 4 is a bar chart that shows the daily values of RF and ET ref in in/d provided by the Landgrebe WS data. ET ref is calculated for a hypothetical reference grass as used in the Penman-Monteith approach, based on one of the most popular evapotranspiration formulas (Shuttleworth 1993). Figures 5 to 7 provide the variations in moisture content for the sensor probes at sites L1, L2, and L3, respectively, during Year 3. While the soil moisture data show decreased values in the summer months, responses to the winter and spring rainfall events were noted in the upper sensors. The three lower sensors at all three sites changed little over most of the year, then the P3 and P4 probes showed some response to the May and June rainfall events. Small increases in moisture content at the P5 probes were noted by the end of June. Figure 8 shows the cumulative depths of rainfall and ET ref for Year 4. Coupled with the large deficit between ET ref and RF, this dataset indicates that both evaporation from the soil and transpiration through the plants were drying the upper soils and limited downward migration of water. Figures 9 to 13 display the data from the first two months of Year 4. The upper three probes responded to the July rainfall events, then the moisture contents began declining. Unfortunately, only L1 still had the lowest P5 operating, and its moisture content was stable, indicating little arrival of water from above.
