Inspection Report

1500 Fair Street
Boise ID 83665

Inspection Services LLC

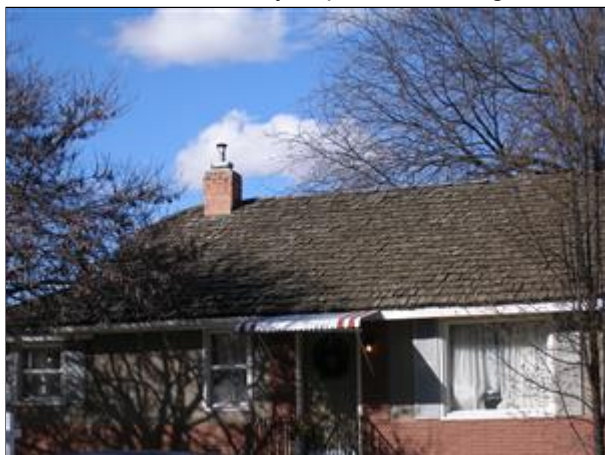
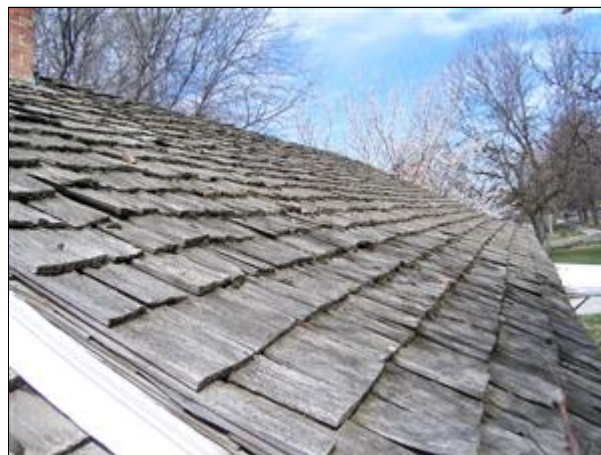
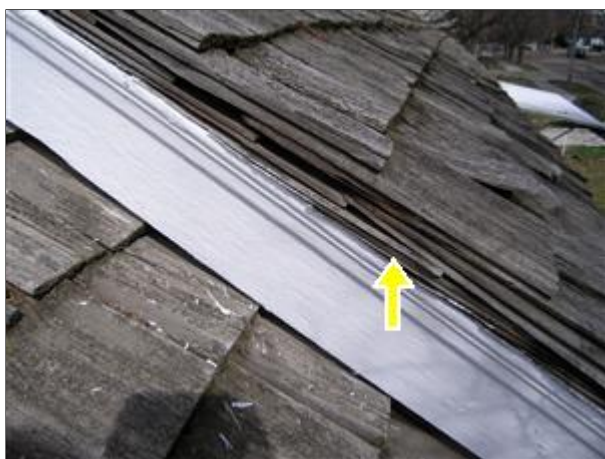
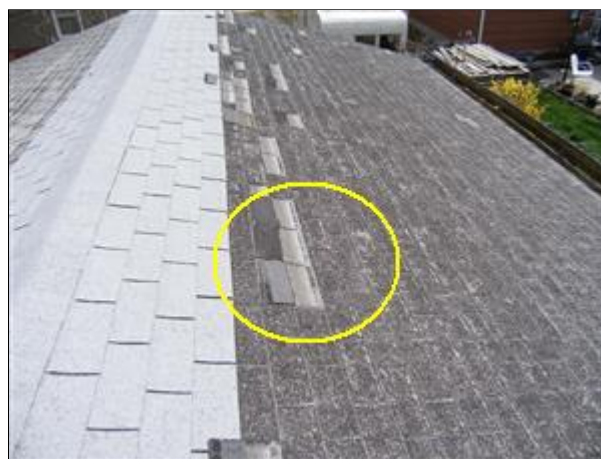
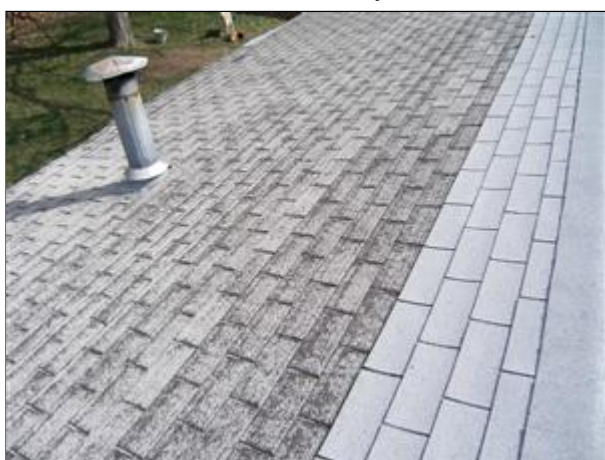
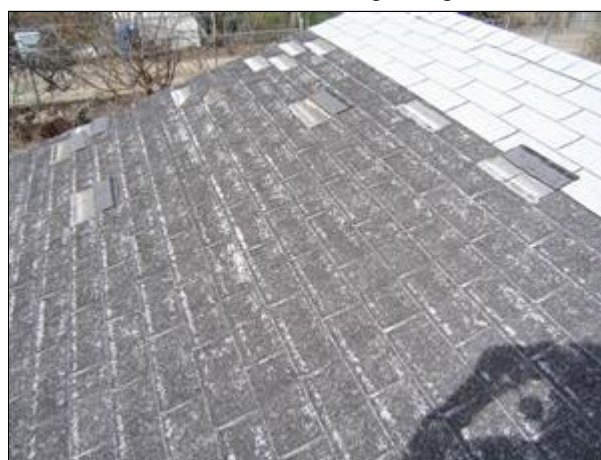
1.0 The roof has wood shakes that are old and weathered. The garage has asphalt shingles that have reached the end of life. Recommend evaluation by a qualified roofing contractor.

1.0 Picture 1 wood shakes

1.0 Picture 2 roof

1.0 Picture 3 layers

1.0 Picture 4 missing shingles

1.0 Picture 5 shingles

1.0 Picture 6 shingles

The roof has wood shakes that are old and weathered. The garage has asphalt shingles that have reached the end of life. Recommend evaluation by a qualified roofing contractor.

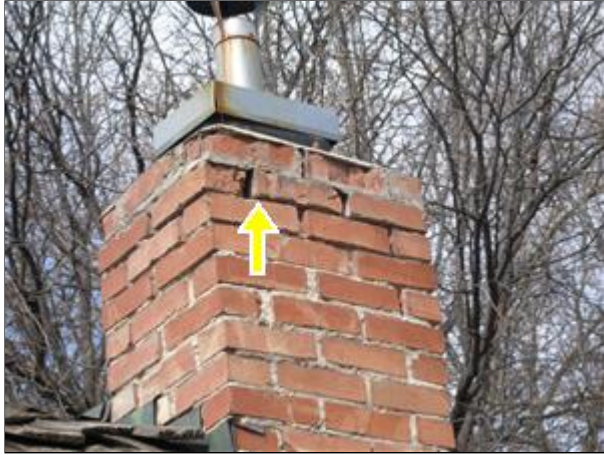
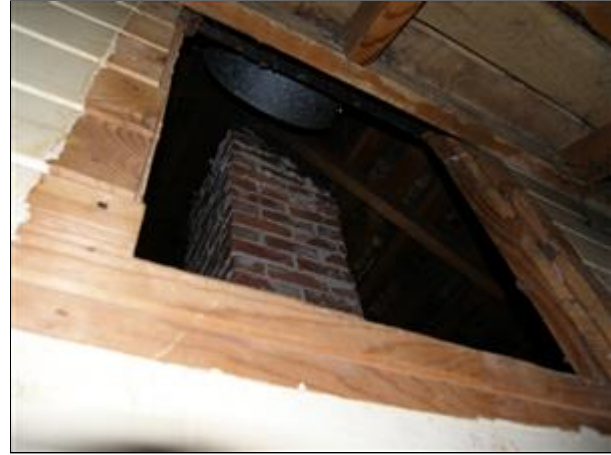
🏠 1.4 Bricks on the chimney are loose. Recommend evaluation by a qualified contractor.

1.4 Picture 1 loose block

1.4 Picture 2 chimney

Bricks on the chimney are loose. Recommend evaluation by a qualified contractor.

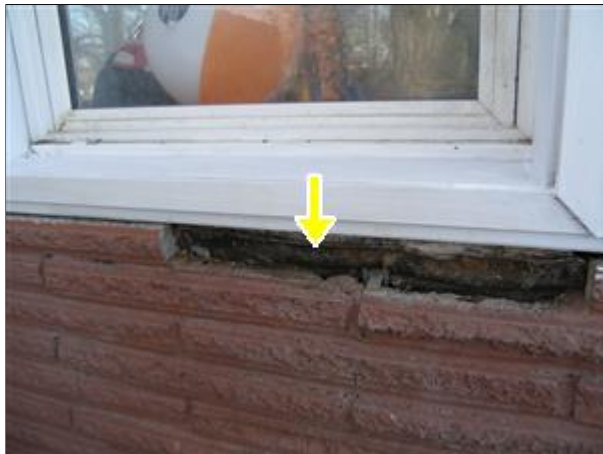
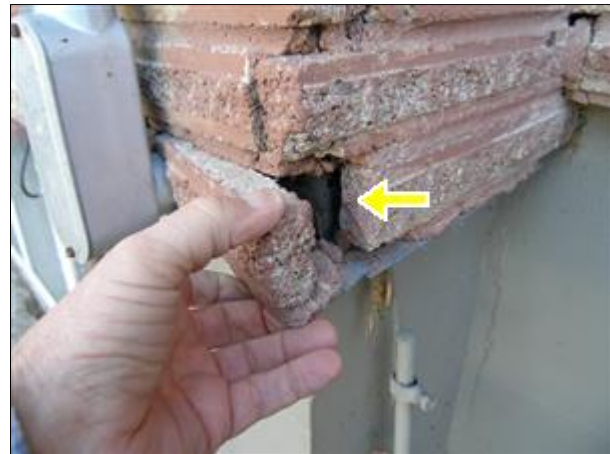
2.0 Picture 1

**2.0** The wood siding is weathered and splitting. Recommend budget to replace. Some of the block siding is loose or missing.

2.0 Picture 2 loose

The wood siding is weathered and splitting. Recommend budget to replace. Some of the block siding is loose or missing.

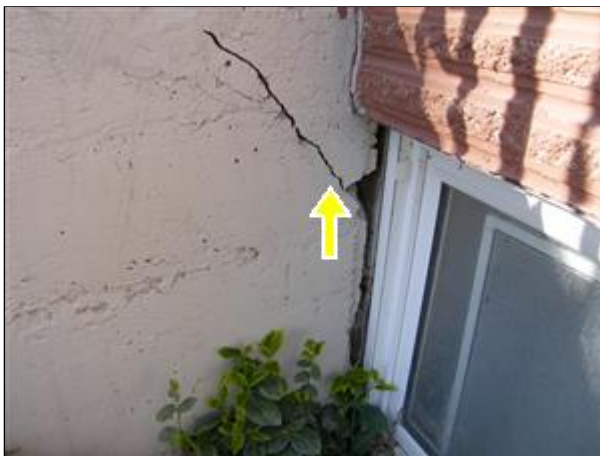
2.3 There is some cracking on the north side of the front porch stairs. Recommend continued monitoring and repair as necessary.

2.3 Picture 1 cracks

There is some cracking on the north side of the front porch stairs. Recommend continued monitoring and repair as necessary.
- 2.6 EAVES, SOFFITS AND FASCIAS**
Inspected

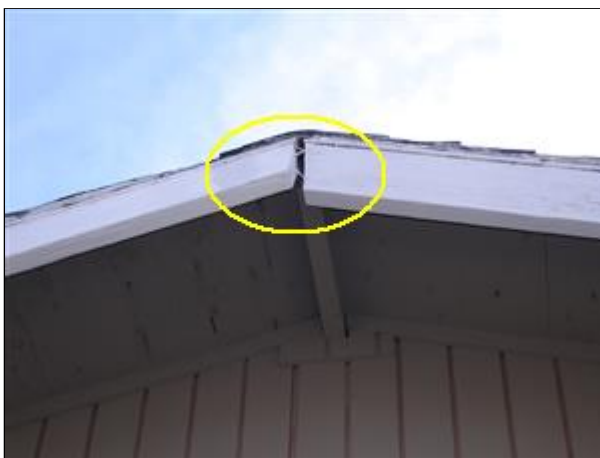
(2) The mitered joints on the fascia have separated at the back of the garage. Recommend repair and re-sealing to keep out moisture.

2.6 Picture 1 separated

(2) The mitered joints on the fascia have separated at the back of the garage. Recommend repair and re-sealing to keep out moisture.
- 2.7 GRADING AND DRAINAGE**
Repair or Replace

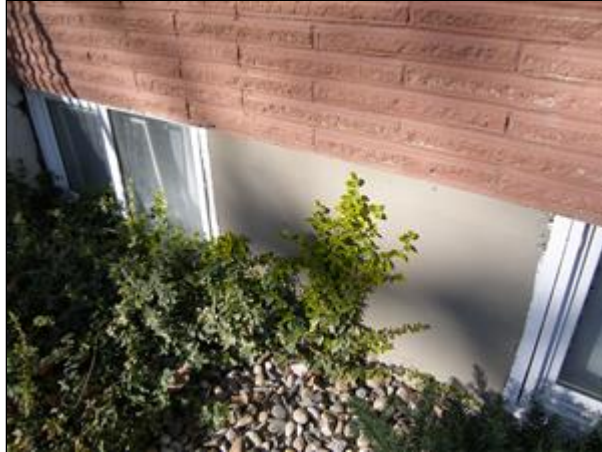
**2.9** The landscape bushes/trees are touching the house. Recommend they be trimmed back so they are not in contact with the wall cladding.

2.9 Picture 1 trim

The landscape bushes/trees are touching the house. Recommend they be trimmed back so they are not in contact with the wall cladding.

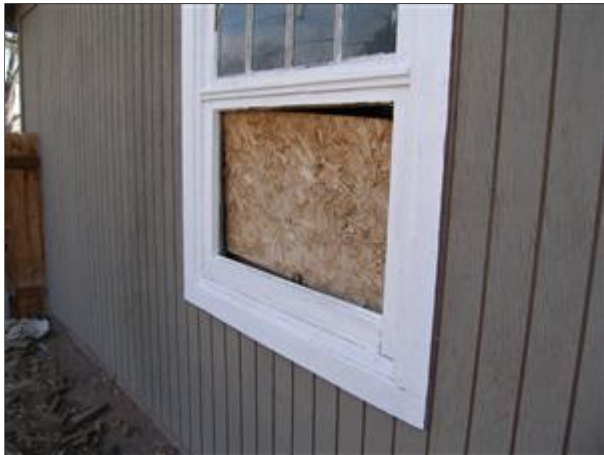
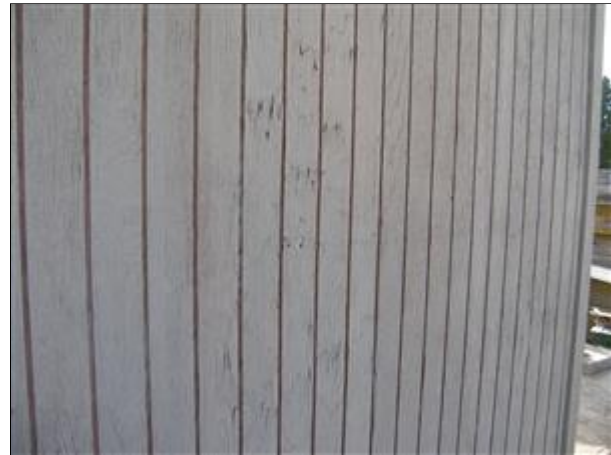
3.0 Picture 1

**3.0** Window at back of garage is damaged. Exterior sheeting is weathered and needs paint.

3.0 Picture 2 paint

Window at back of garage is damaged. Exterior sheeting is weathered and needs paint.
- 3.1 GARAGE FLOOR**
Repair or Replace
-

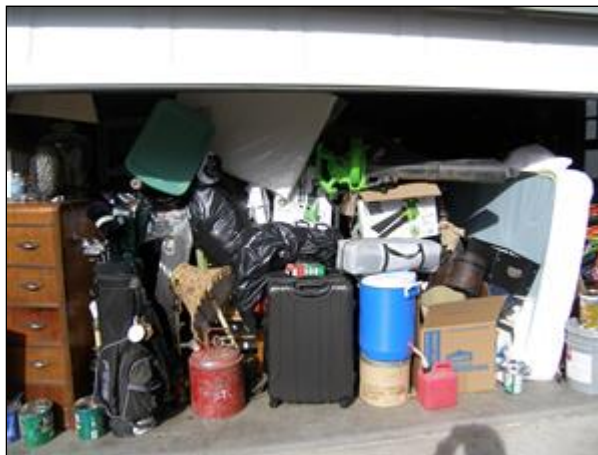
**3.1** The garage is full and inspection limited. The garage floor, where visible, was in good condition during today's inspection.

3.1 Picture 1 garage

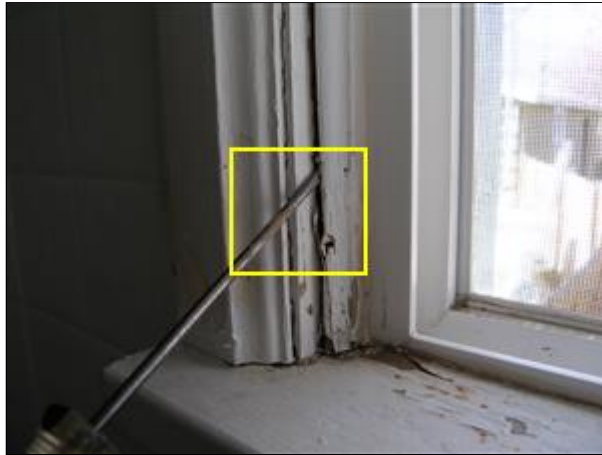
Casing for the window in the upstairs bath has moisture damage. Recommend repair by a qualified person.

4.6 Picture 1 moisture

Casing for the window in the upstairs bath has moisture damage. Recommend repair by a qualified person.

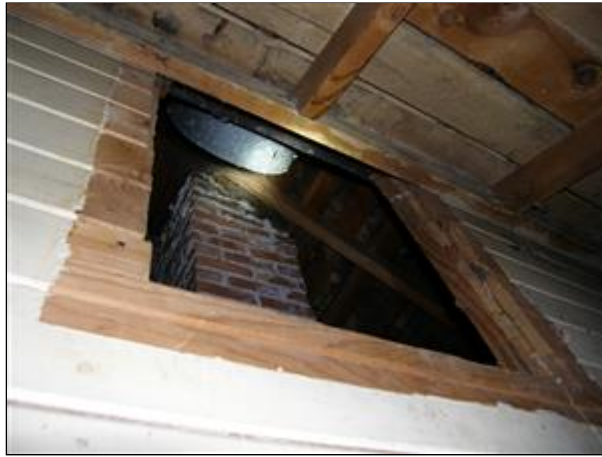
5.5 attic

5.5 Picture 1 attic

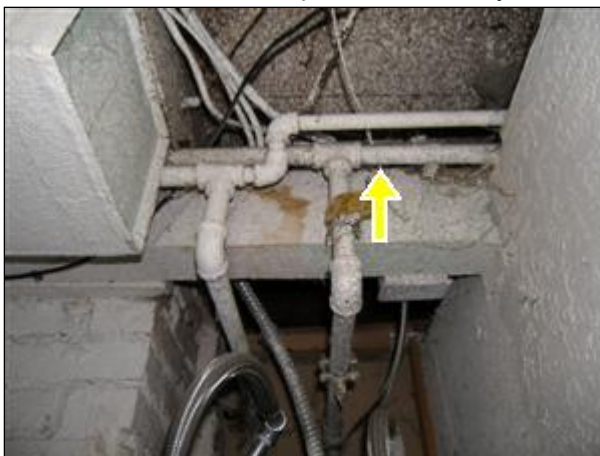
**6.1** The home has galvanized water supply piping. This style of pipe is known to corrode from the inside out and reduce water flow. Recommend continued evaluation and repair as necessary.

6.1 Picture 1 galvanized

The home has galvanized water supply piping. This style of pipe is known to corrode from the inside out and reduce water flow. Recommend continued evaluation and repair as necessary.

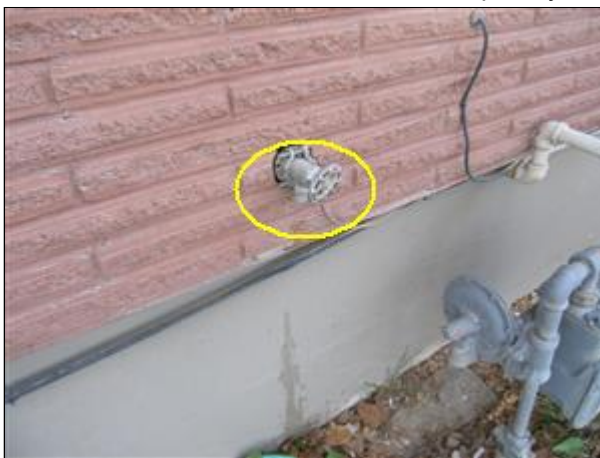
**6.4** The hose bib at the back of the house had no water. Recommend repair by a qualified person.

6.4 Picture 1 no water

The hose bib at the back of the house had no water. Recommend repair by a qualified person.

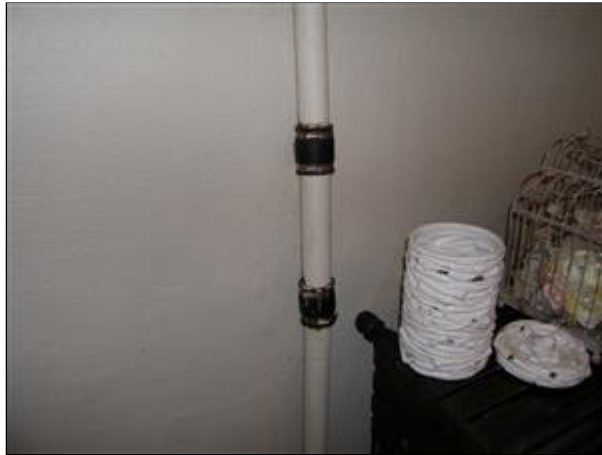
🏠 6.5 No hubs are present on the drain pipe downstairs. Recommend continued monitoring.

6.5 Picture 1 no hubs

No hubs are present on the drain pipe downstairs. Recommend continued monitoring.

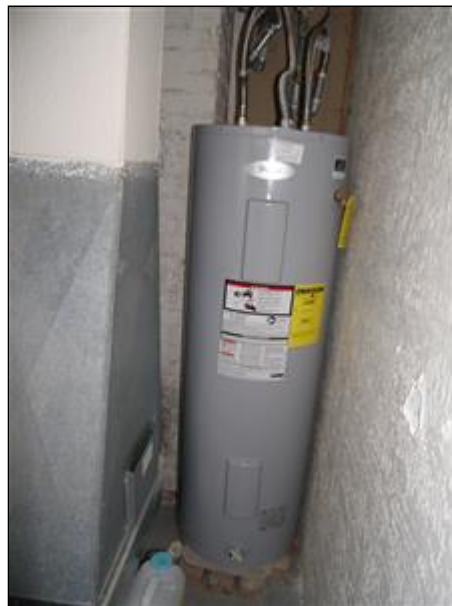
🏠 (2) The water heater is installed in the living area of the home. Recommend a galvanized secondary tank be installed around the heater with a bulkhead fitting and drain to the outside.

6.7 Picture 1 no containment

(2) The water heater is installed in the living area of the home. Recommend a galvanized secondary tank be installed around the heater with a bulkhead fitting and drain to the outside.

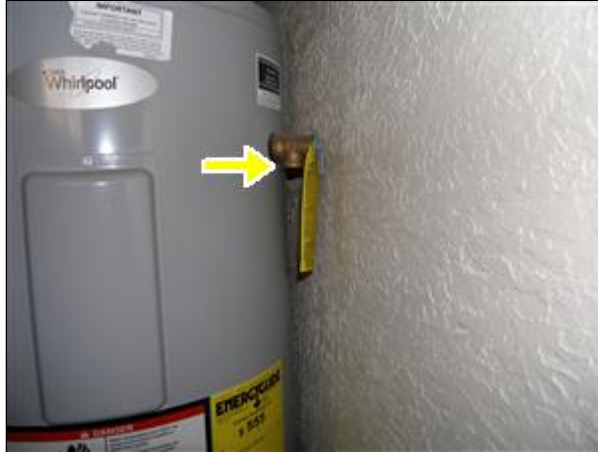
6.8 Picture 1

- 6.8** The Temperature and Pressure Relief valve on water heater needs a 3/4 pipe to extend within 6 inches of floor for safety. Recommend repair by a qualified plumber.

The Temperature and Pressure Relief valve on water heater needs a 3/4 pipe to extend within 6 inches of floor for safety. Recommend repair by a qualified plumber.

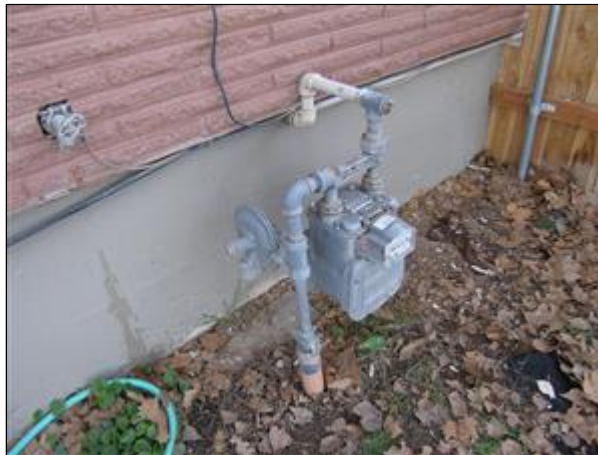
- 6.14** The main fuel shut off is outside in back of the house.

6.14 Picture 1 gas

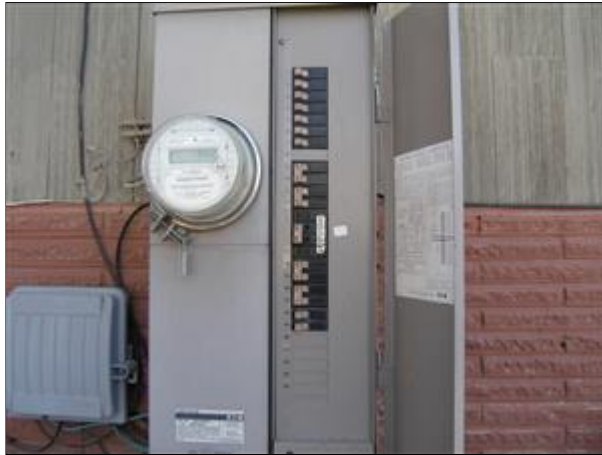
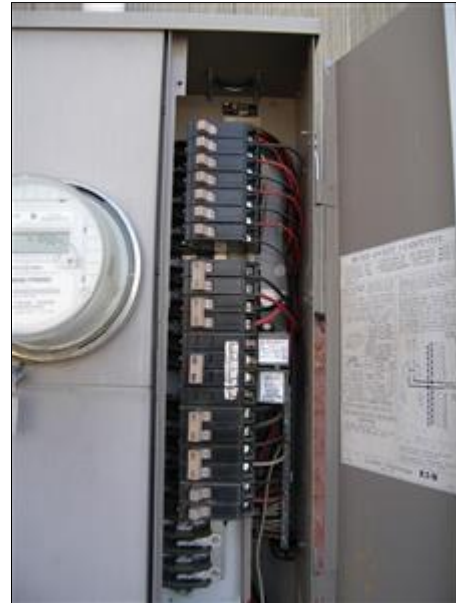
7.0 The main panel box is located at the back of the house.

7.0 Picture 1 main

7.0 Picture 2 main

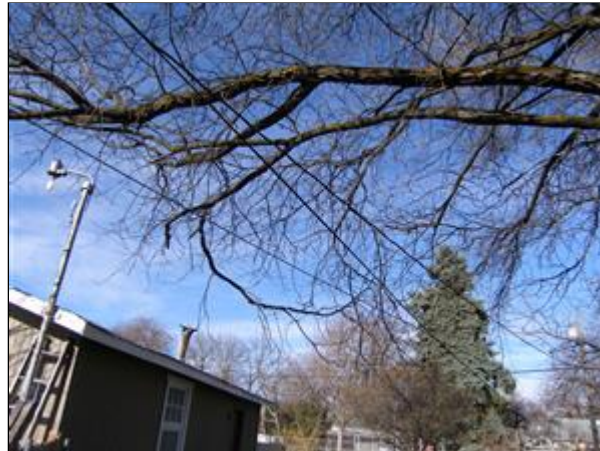
**7.1** The electrical service conductors are in the trees. This is a fire hazard. Recommend contacting the utility to have the tree trimmed.

7.1 Picture 1 trim

The electrical service conductors are in the trees. This is a fire hazard. Recommend contacting the utility to have the tree trimmed.

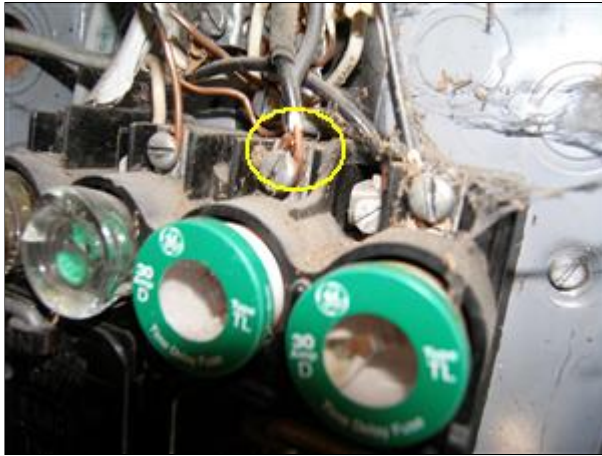
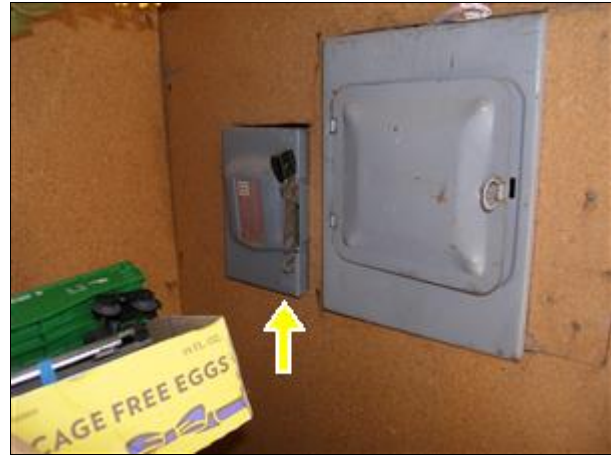
(2) The fused sub panel in the garage is double tapped and not properly labeled. There is an unidentified disconnect next to the panel. Recommend repair by a qualified electrician.

7.2 Picture 1 double tap

7.2 Picture 2 unidentified

(2) The fused sub panel in the garage is double tapped and not properly labeled. There is an unidentified disconnect next to the panel. Recommend repair by a qualified electrician.
-

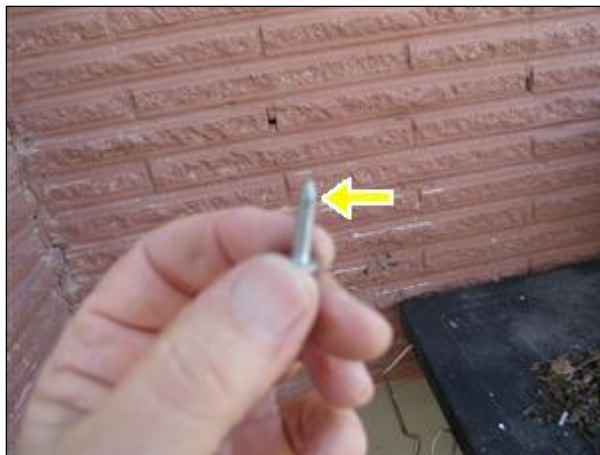
(3) Dead front for the main panel is secured by a sheet metal screw. Sheet metal screws are pointed at the end and can penetrate conductor insulation. Recommend changing screw to the proper style.

7.2 Picture 3 wrong screws

(3) Dead front for the main panel is secured by a sheet metal screw. Sheet metal screws are pointed at the end and can penetrate conductor insulation. Recommend changing screw to the proper style.

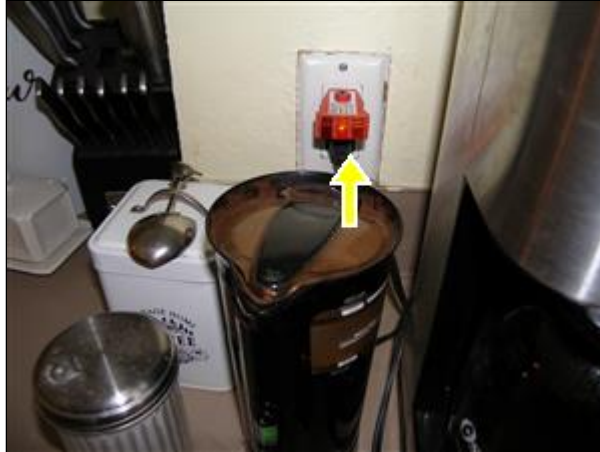
**7.9** (1) The GFCI outlet at the coffee pot in the kitchen has an open ground and will not trip. Recommend repair by a qualified electrician.

7.9 Picture 1 open ground

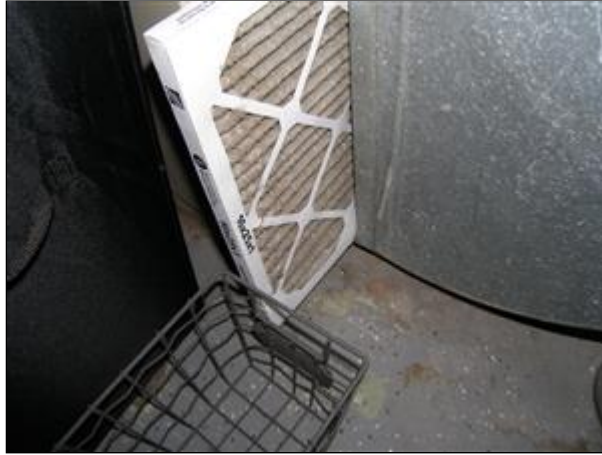
- 🏠 8.5 The return air filter is dirty and needs to be replaced. Recommend replacing filters every 30 to 60 days.

8.5 Picture 1 dirty

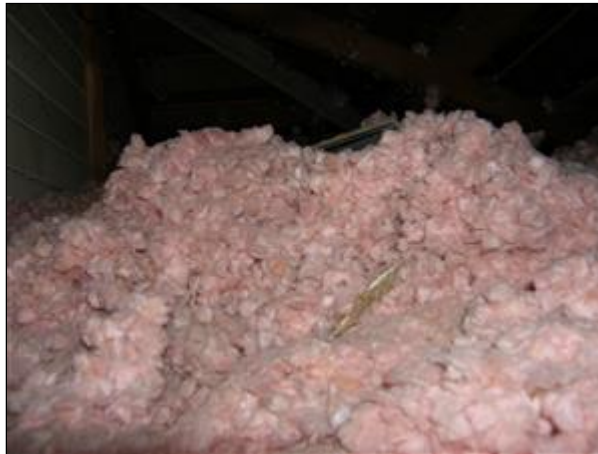
**9.0** The insulation is at about 6 inches in depth and where visible, was in good condition during todays inspection. Inspection was limited.

9.0 Picture 1 insulation

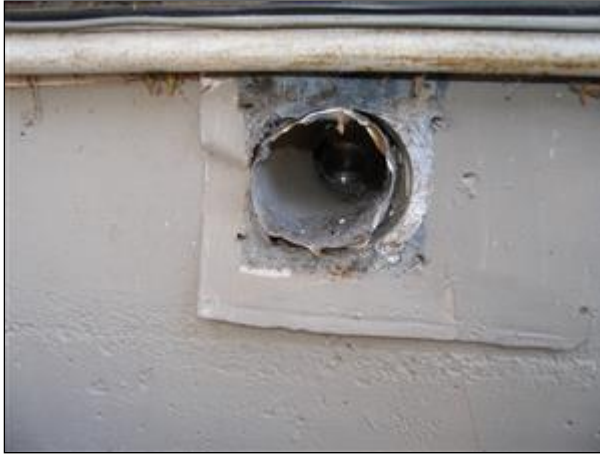
9.5 The dryer vent is missing a cover. Recommend repair by a qualified person.

9.5 Picture 1 no cover
