# RSM Inspections

## Property Inspection Report

123 Smith Street, Coto de Caza, CA 92679  
Inspection prepared for: I.M. Homebuyer  
Real Estate Agent: I.M. Seller - Top Sales Group

Date of Inspection: 3/1/2015 Time: 2:00 PM  
Age of Home: 1991 /approx 24 years Size: approx 3,200 sft  
Weather: 80° / Sunny

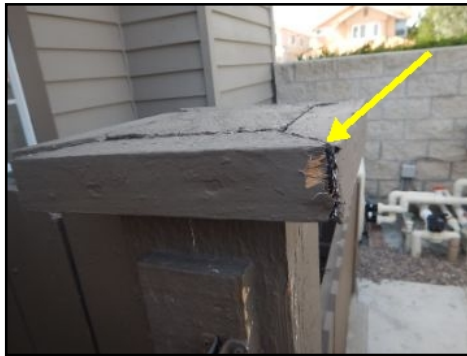
Page 8 Item: 5	Fence Condition	<ul style="list-style-type: none"> <li>• Wood deterioration observed. Suggest repairs/replacement as needed.</li> <li>• *Refer to termite report for any possible presence of dry rot or wood destroying organisms.</li> </ul>
----------------	-----------------	--

Possible dry rot

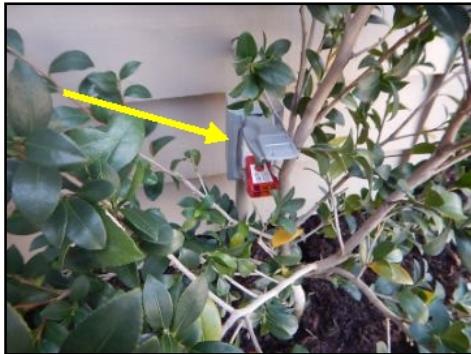
Page 10 Item: 9	Receptacle Condition	<ul style="list-style-type: none"> <li>• Outdoor receptacles appear to have no power. Recommend correction by a licensed electrician.</li> </ul>
-----------------	----------------------	--

No power to receptacle on porch

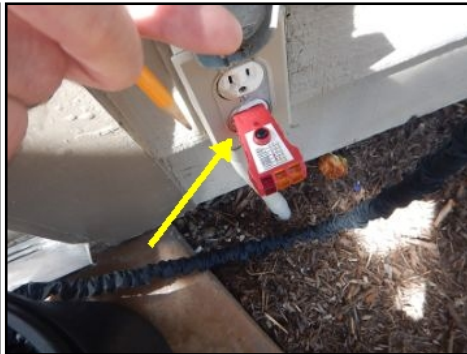
No power to receptacle on patio

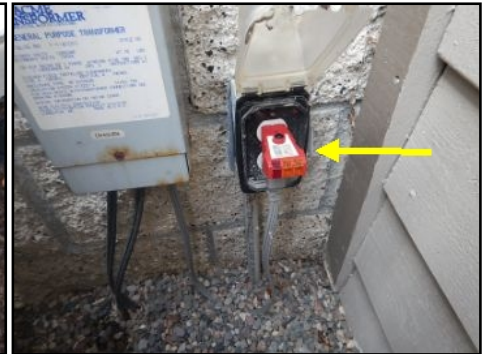
No power to receptacle behind pool equipment

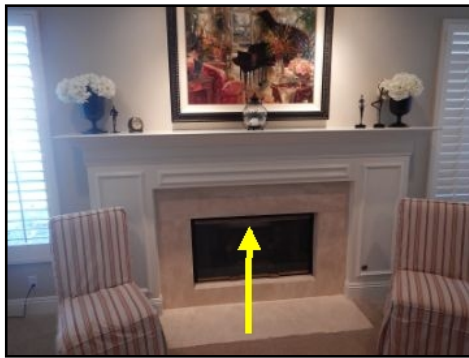
Page 15 Item: 2	Damper Condition	<ul style="list-style-type: none"> <li>• Damper not in a fixed open position where a gas fire is present. No damper clamp installed. This is an important safety feature that helps ensure that gases will be vented into the atmosphere instead of being trapped in the fireplace. An approved damper clamp should be installed for safety. A "Fireplace Damper Stop Clamp" can be purchased at a place like Amazon for around \$6.</li> </ul>
-----------------	------------------	---

Damper Clamp missing.

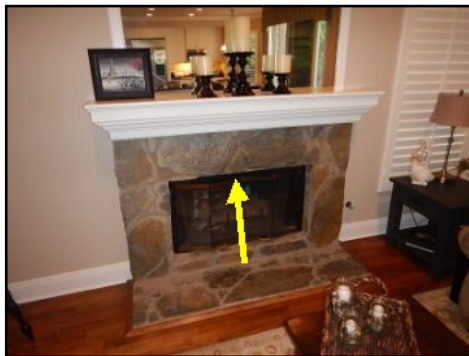
Page 15 Item: 2	Damper Condition	<ul style="list-style-type: none"><li>• Damper not in a fixed open position where a gas fire is present. No damper clamp installed. This is an important safety feature that helps ensure that gases will be vented into the atmosphere instead of being trapped in the fireplace. An approved damper clamp should be installed for safety. A "Fireplace Damper Stop Clamp" can be purchased at a place like Amazon for around \$6.</li></ul>
-----------------	------------------	---

Damper Clamp missing.

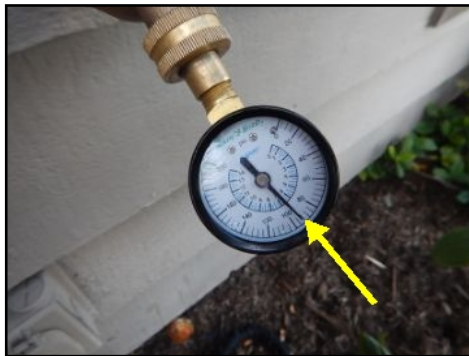
Page 18 Item: 6	Water Pressure Condition	<ul style="list-style-type: none"><li>• Water pressure from the street is approximately 95 psi. This pressure is too high. Fittings and hoses could fail at this high of a setting. Recommend a Licensed Plumbing Contractor further evaluate for correction.</li></ul>
-----------------	--------------------------	---

Water pressure is 95 psi

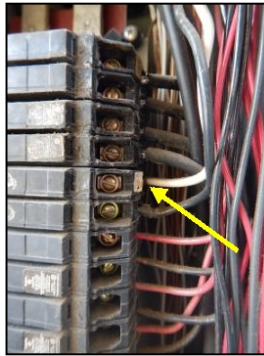
Page 20 Item: 6	Wiring Condition	<ul style="list-style-type: none"><li>• White wires used as "hot" wires should be marked with black tape. Recommend contacting a licensed electrician to repair the issues.</li></ul>
-----------------	------------------	---

White wire not marked as "hot"

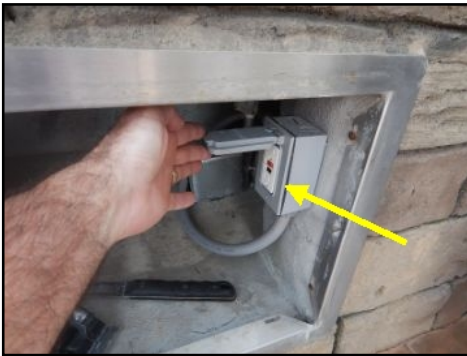
- GFCI protection is missing at on all receptacles on the kitchen counter, laundry, bathrooms, outside receptacles and receptacles the garage. Recommend protection be corrected by a licensed electrician.

GFCI receptacle not working properly under grill

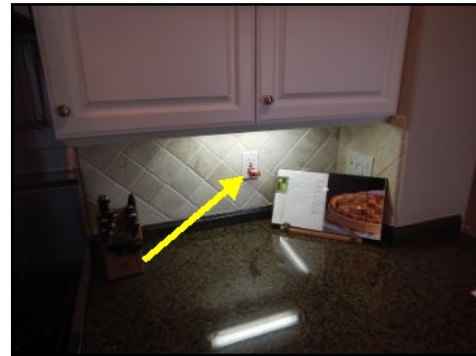
Faulty GFCI receptacle on kitchen countertop

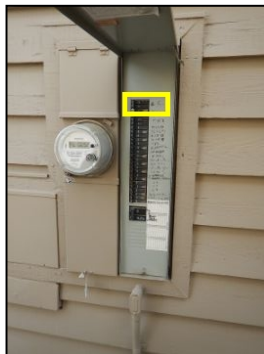
- Circuit breaker, in the main service panel, for the A/C Compressor is 50 Amps. This is not acceptable, according to the manufacturer.

Improper 50 amp fuse for A/C

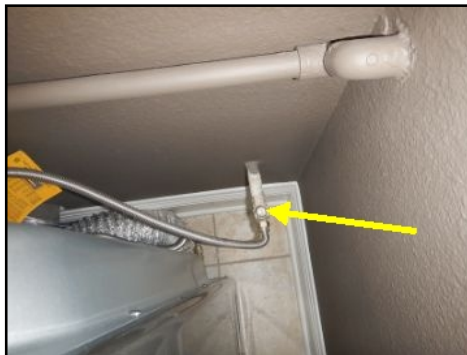
Page 29 Item: 12	Gas line Condition	<ul style="list-style-type: none"><li>• Old style gas valve. Could not turn valve by hand. Recommend having a new gas valve installed by a licensed plumber.</li></ul>
------------------	--------------------	--

Improper gas valve in laundry room

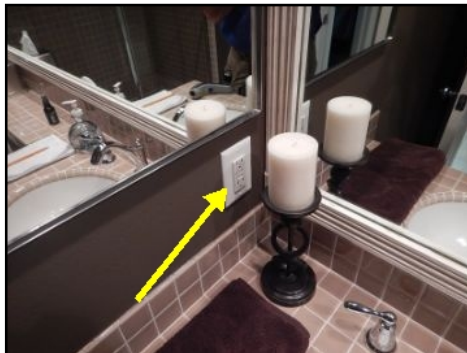
Page 31 Item: 5	Receptacle Condition	<ul style="list-style-type: none"><li>• Receptacles in the bathrooms has no power. May be faulty GFCI. Recommend correction by a licensed electrician.</li></ul>
-----------------	----------------------	--

No power to all receptacles in the bathrooms

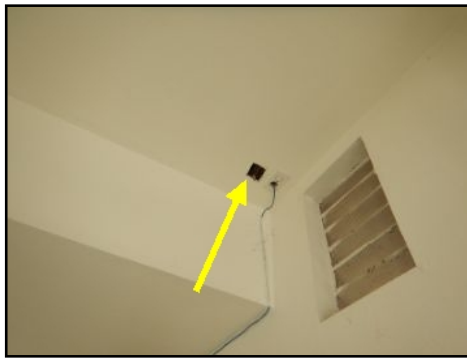
Page 32 Item: 2	Ceiling Condition	<ul style="list-style-type: none"><li>• Hole in the ceiling is a breach in the fire protection. Recommend patching the hole with 5/8 drywall.</li></ul>
-----------------	-------------------	---

Hole in ceiling

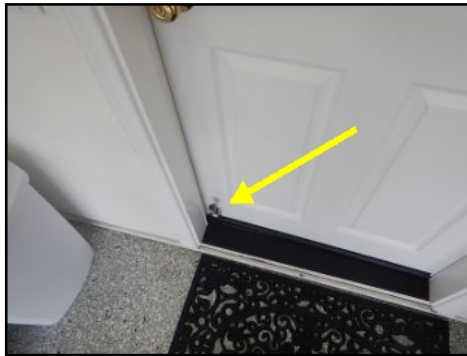
- Door stop mounted on the door from the house leading to the garage. This is a fire hazard. It is strongly recommended that this be removed to protect the residence against garage originated fires.

Door stop mounted on the door from the house leading to the garage. This is a fire hazard. It is strongly recommended that this be removed to protect the residence against garage originated fires.

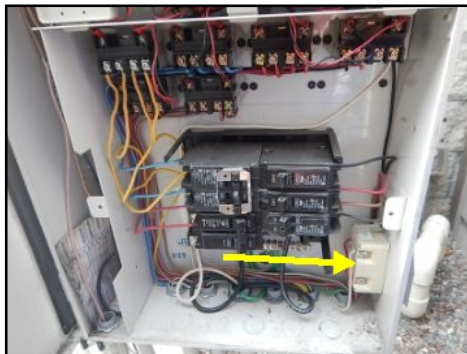
- All receptacles in the pool area do not work. Recommend correction by a licensed electrician.

Faulty GFCI receptacle in Pool Sub Panel

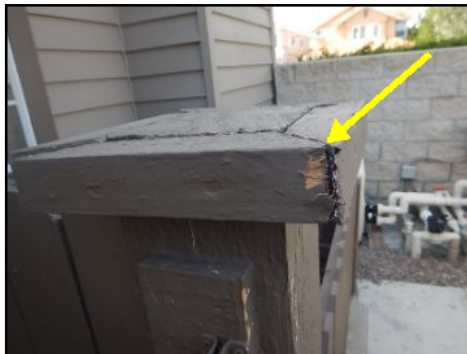
- Wood deterioration observed. Suggest repairs/replacement as needed.
- \*Refer to termite report for any possible presence of dry rot or wood destroying organisms.

Possible dry rot

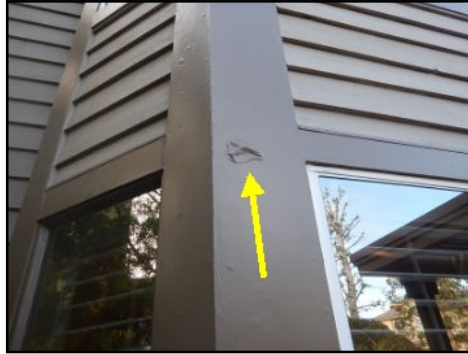
• Wood or wood-like materials present. These materials are subject to moisture damage and weathering to a greater extent than other siding materials, as well as infestation by wood-destroying pests and organisms. Notwithstanding anything noted in this report, recommend further evaluation by licensed pest control professional, repair or replacement as needed, and regular homeowner monitoring and maintenance thereafter

Numerous paint "blisters"

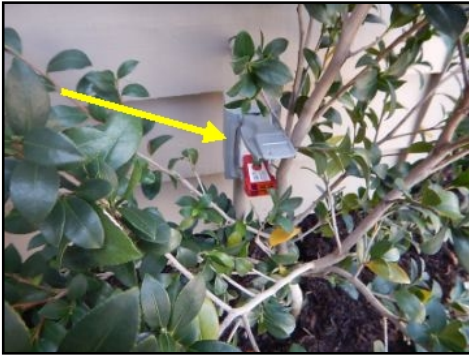
• Outdoor receptacles appear to have no power. Recommend correction by a licensed electrician.

No power to receptacle on porch

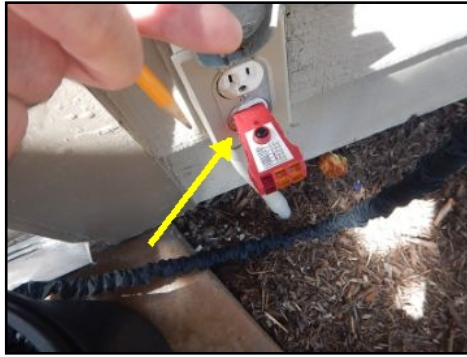
No power to receptacle on patio

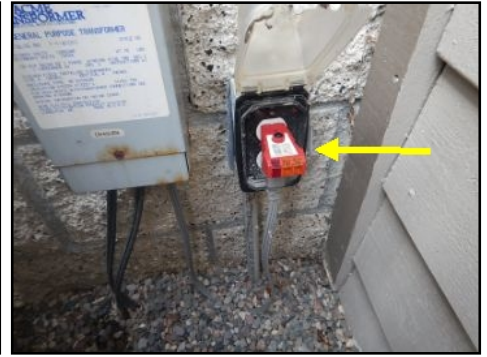
No power to receptacle behind pool equipment

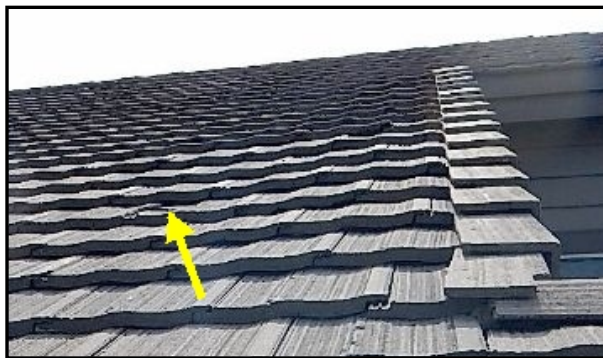
- A broken tile.

Cracked tile

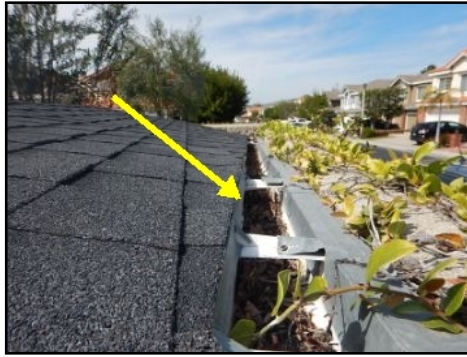
- Clean gutters: Significant amounts of debris evident.

Gutter on shed needs cleaning

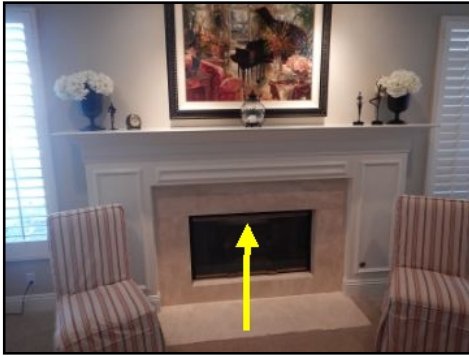
• Damper not in a fixed open position where a gas fire is present. No damper clamp installed. This is an important safety feature that helps ensure that gases will be vented into the atmosphere instead of being trapped in the fireplace. An approved damper clamp should be installed for safety. A "Fireplace Damper Stop Clamp" can be purchased at a place like Amazon for around \$6.

Damper Clamp missing.

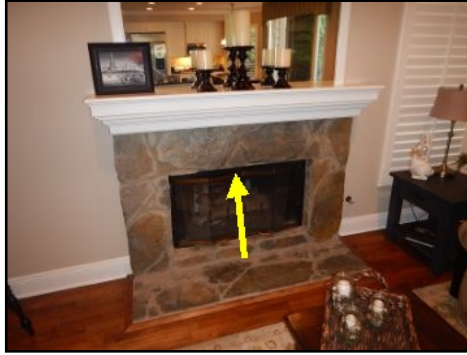
• Damper not in a fixed open position where a gas fire is present. No damper clamp installed. This is an important safety feature that helps ensure that gases will be vented into the atmosphere instead of being trapped in the fireplace. An approved damper clamp should be installed for safety. A "Fireplace Damper Stop Clamp" can be purchased at a place like Amazon for around \$6.

Damper Clamp missing.

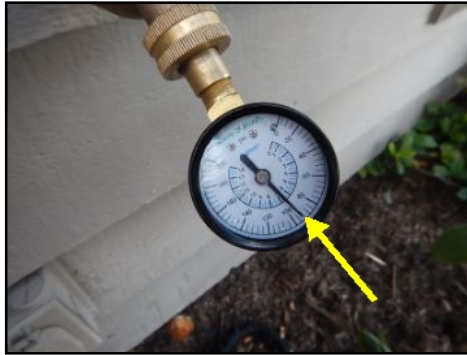
• Water pressure from the street is approximately 95 psi. This pressure is too high. Fittings and hoses could fail at this high of a setting. Recommend a Licensed Plumbing Contractor further evaluate for correction.

Water pressure is 95 psi

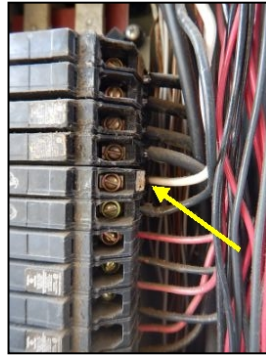
• White wires used as "hot" wires should be marked with black tape. Recommend contacting a licensed electrician to repair the issues.

White wire not marked as "hot"

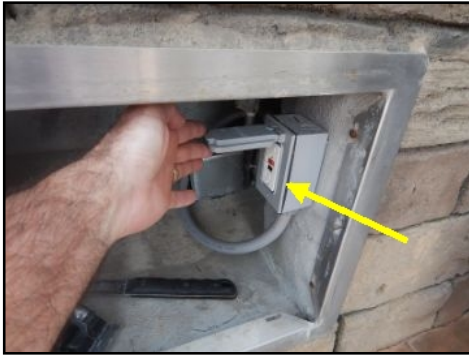
• GFCI protection is missing at on all receptacles on the kitchen counter, laundry, bathrooms, outside receptacles and receptacles the garage. Recommend protection be corrected by a licensed electrician.

GFCI receptacle not working properly under grill

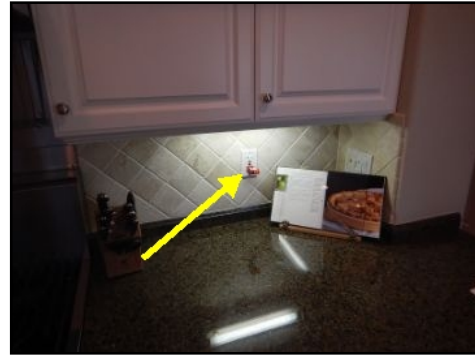
Faulty GFCI receptacle on kitchen countertop

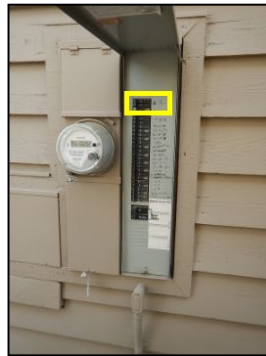
- **Circuit breaker, in the main service panel, for the A/C Compressor is 50 Amps. This is not acceptable, according to the manufacturer.**

Improper 50 amp fuse for A/C

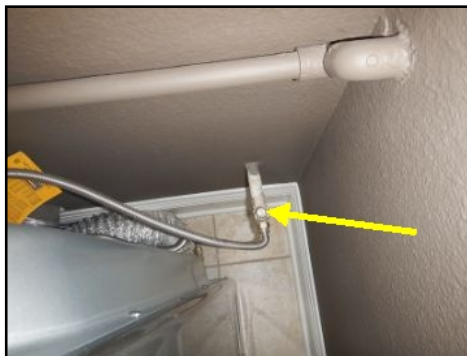
• Old style gas valve. Could not turn valve by hand. Recommend having a new gas valve installed by a licensed plumber.

Improper gas valve in laundry room

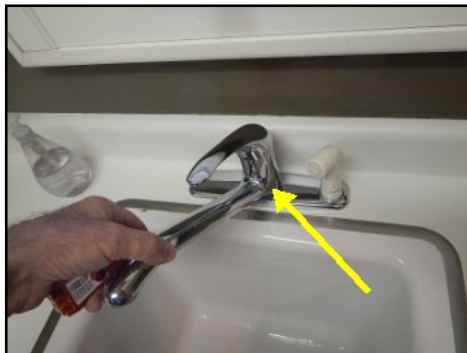
• Faucet loose.

Laundry sink faucet loose

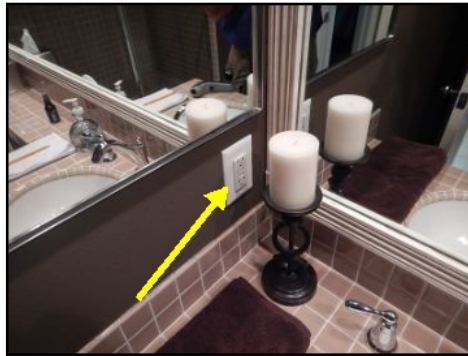
• Receptacles in the bathrooms has no power. May be faulty GFCI. Recommend correction by a licensed electrician.

No power to all receptacles in the bathrooms

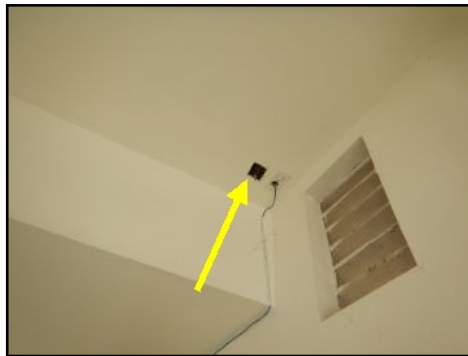
• Hole in the ceiling is a breach in the fire protection. Recommend patching the hole with 5/8 drywall.

Hole in ceiling

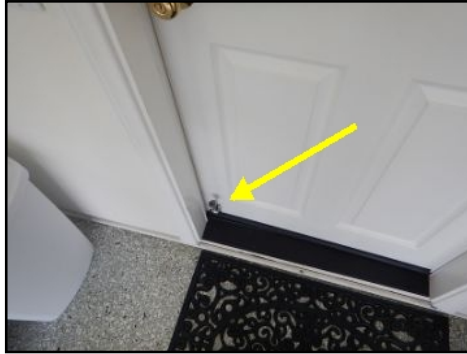
• Door stop mounted on the door from the house leading to the garage. This is a fire hazard. It is strongly recommended that this be removed to protect the residence against garage originated fires.

Door stop mounted on the door from the house leading to the garage. This is a fire hazard. It is strongly recommended that this be removed to protect the residence against garage originated fires.

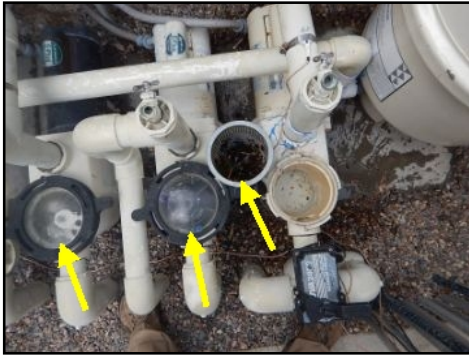
- Trap baskets needs cleaning.
- Recommend lubricating all orings once a year.

Pump Skimmer baskets dirty

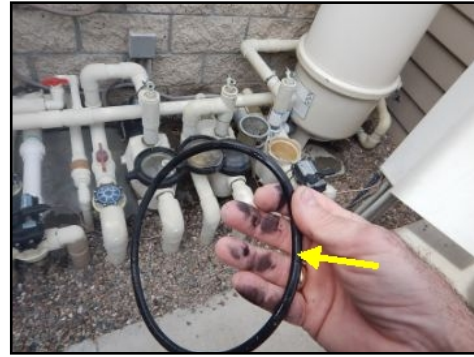
O-rings deteriorating

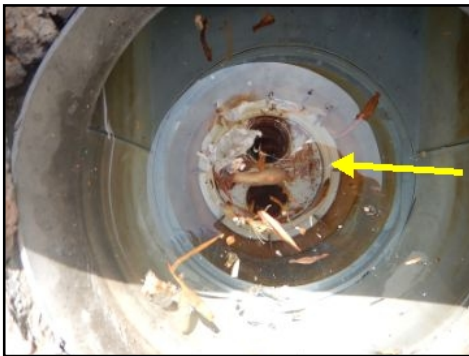
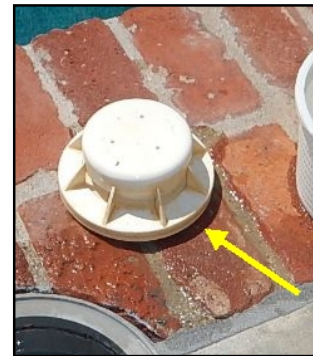
- 1 Skimmer. Current industry standards recommend 1 skimmer for every 800 square foot (sft) of pool surface area. The square foot of pool surface area is less than 800 sft. 1 skimmer is sufficient.
- Skimmer basket servicable.
  - Weir gate appears functional at skimmer opening.
  - Lintel over skimmer opening appears functional.
  - Float/diverter valve assembly under the skimmer basket is missing. This device draws water from the drain and the skimmer at the same time. If the water level drops below the skimmer line, this device closes and draws water from the the drain only. You should never let your water level drop below the skimmer. Recommend installing a new valve.
  - Missing required o-ring at the bottom of the skimmer.

Float/Diverter valve and oring missing in skimmer FYI - This is what a float/diverter valve looks like

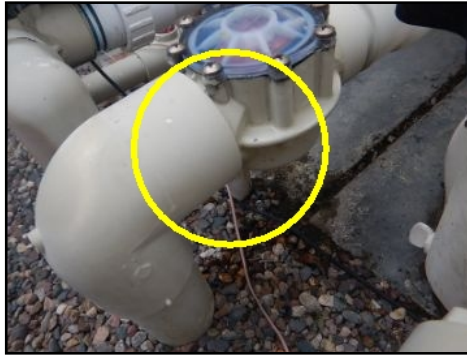
- Small leak at the check valve on the spa booster pump line.

Small leak at check valve in Spa booster pipe

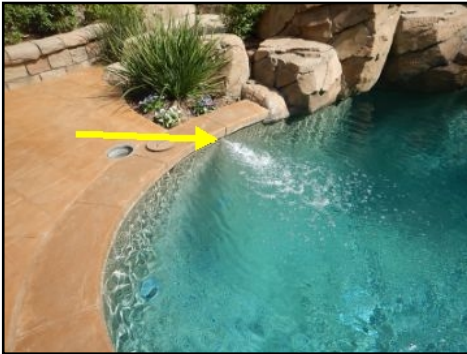
FYI - water fill location

- Recommend a timer be put on this line. You wouldn't want to leave this line running and forget to shut it off.

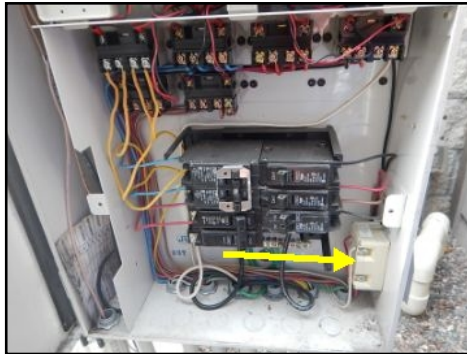
• All receptacles in the pool area do not work. Recommend correction by a licensed electrician.

Faulty GFCI receptacle in Pool Sub Panel

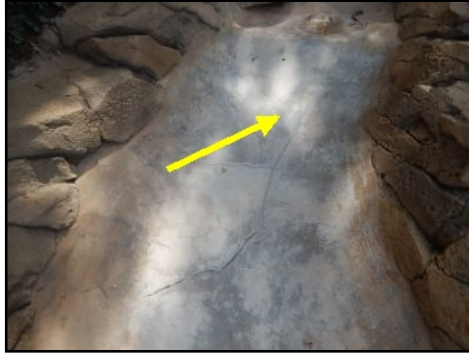
• Cement slides has what appears to be minor shrinkage cracks. Monitor these cracks.

Minor shrinkage cracks on pool slide

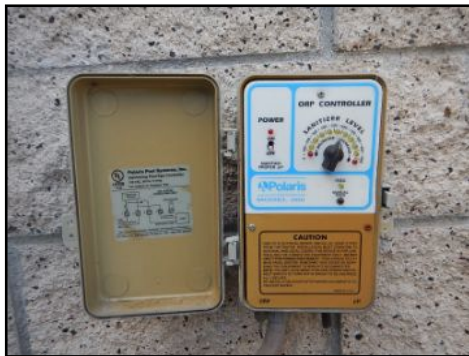
Abandoned Oxidation Reduction Potential (ORP) device in the pool equipment area. This device was used to approximate the disinfectant level in automatic chemical feed systems. Recommend you ask the seller about this device.

Abandoned "ORP" device
