Gitzlaff Stewardship Plan

Somers, WI

March, 2014

**Stewardship Plan for
Gitzlaff Park, Somers, WI**

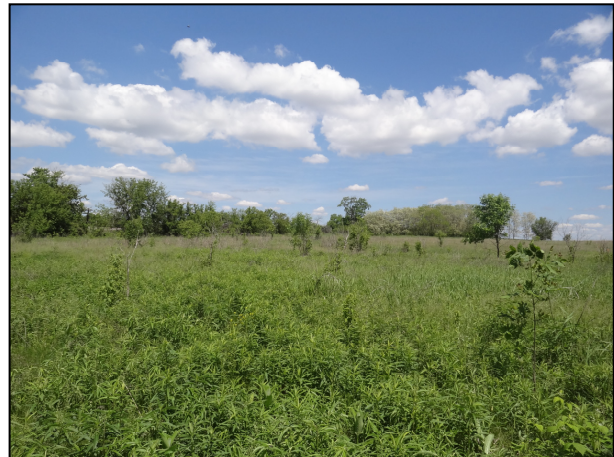
North field at Gitzlaff Park- old field vegetation

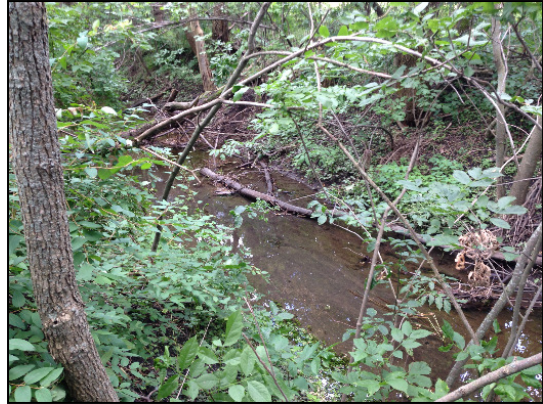
Somers branch flows through Gitzlaff Park

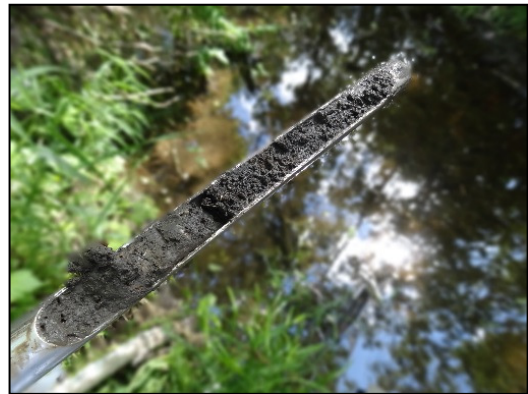
Very black clay rich soils found on site

A series of soil pits were dug in 2013 in the north and south field and the locations of the pits are shown on Figure 6. The soil data is found in Appendix 3. On the south side of the stream (data points 1-8) the soils varied from 12 to 15 inches of black silty clay loam or black silty clay overlying at least one foot of clay (silty clay or sandy clay), with those layers depleted of oxygen in the areas closest to the stream. These depleted areas indicate that water perches long enough to drive out oxygen and create wetland soil conditions. These features remain in the soil despite the presence of subsurface drain tiles.

The soils on the north side of the stream varied from 9-15 inches of black silty clay loam on the stream edge with clay located below. Many of the soil samples had redoximorphic features in the upper 12 inches, which indicates water perching seasonally in the root zone, again indicating the presence of historic hydric (wetland) soils in the lowland areas adjacent the stream.

The black soils indicate that prairie plants once dominated the landscape and are conducive to re-introducing prairie species.

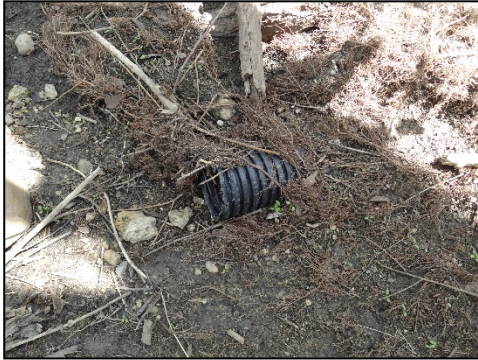
Drain tile outlet into Somers Branch from the south field at Gitzlaff,

Sub surface drain tiles are visible in the south field of Gitzlaff on the Kenosha County 2005 aerial (Figure 9). Drain tiles are characteristic on aerial photos as regularly spaced white lines running perpendicular to the stream as an artifact of winter frost heave in a plowed field. They are not noticeable on the north field as there is permanent plant cover by 1990. Rachel Samerdyke of the U.S. Fish and Wildlife Service assisted us in locating tile outlets entering into the stream on November 13, 2013. Seven tile locations were found on the south side of the stream, and one tile on the north side of the stream. Some are newer plastic pipe as shown on the photo to the left, others were clay tile that would be an older installation. There were multiple other suspicious areas that appeared as washout areas

We found multiple drain tiles entering into the stream on the south bank, indicating that the south field has sub surface drainage. These tiles matched the drain tile shadow on the 2005 aerial photo (Figure 9). We only found one active drain tile on the north bank of the stream, however there were multiple seeps that may indicate buried tile, or may be groundwater seeps.

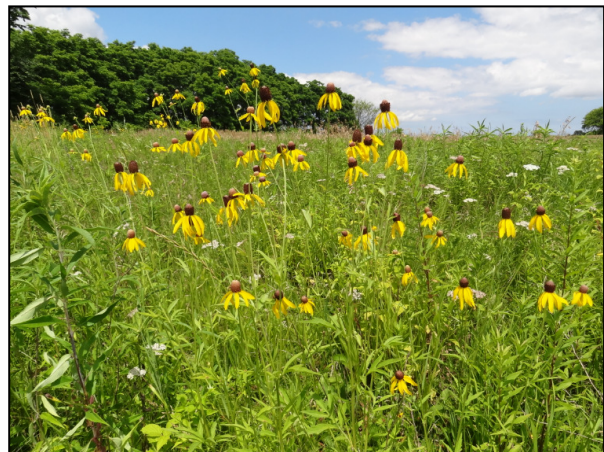
Relic prairie plants include native yellow coneflowers mixed within the old field vegetation north of the stream

North of the stream the uplands are presently old field vegetation as described in the section on existing Gitzlaff vegetation above. Some prairie species are already colonizing the site including evening primrose, yellow coneflower, ironweed and Indian hemp. Instead of destroying the current vegetation to plant prairie species we recommend the site be burned and then overseeded with native species. Alternately the site could be mowed closely followed by native seed however this may not be as effective as a burn. Seeding in late fall would allow the frost action to work the seeds into the soil. The prairie area that potentially could be restored is 10 acres.

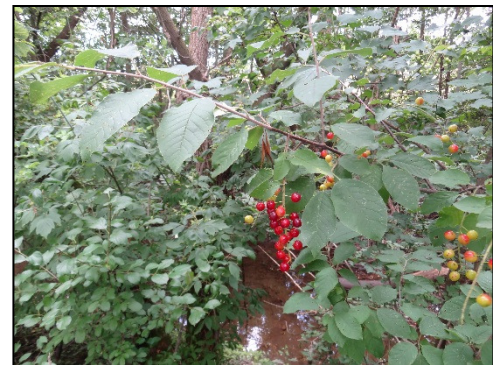
Native choke cherry shades the stream at Gitzlaff

The *shrub layer* is dominated by native shrubs including choke cherry, highbush cranberry, gray dogwood, wahoo, black raspberry, hawthorn and elderberry. These shrubs provide shelter, shade, and wildlife food. Non-native shrubs include honeysuckle and common buckthorn, which are present but not dominant at this time.

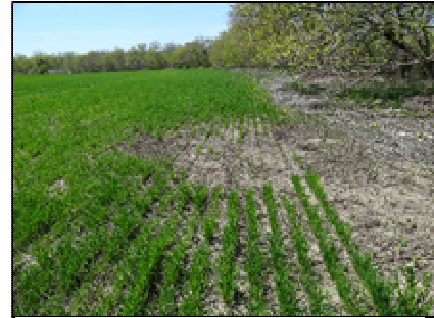
Winter wheat planted in agricultural field south of the stream at Gitzlaff

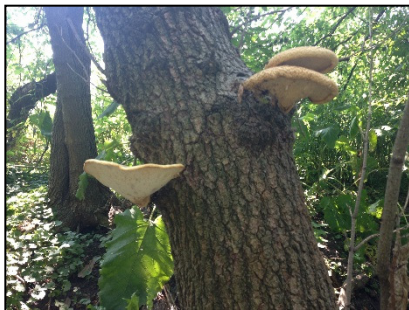
Chimney crayfish burrow to right
Shelf fungi on box elder to left

Chimney crayfish burrows were found on the north side of the stream. Chimney crayfish burrow to the groundwater table, often many feet below the soil surface, and these burrows are important to other wildlife including resident snakes that overwinter in the burrows.

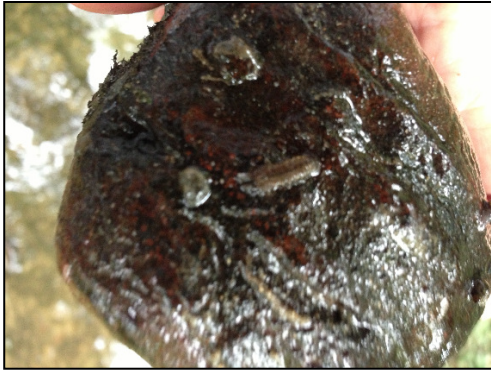
Sowbugs and other invertebrates on rock in stream adjacent Gitzlaff

Stream macroinvertebrates provide an indicator for water quality and stream habitat, and in addition to providing a food source for other animals (fish, birds, amphibians) they are an essential ecological connection for recycling nutrients and energy from plant material that falls into in the stream back into the ecosystem. Kick samples taken along the Somers branch indicate that the stream invertebrate community is typical for an intermittently flowing stream, dominated by taxa with high tolerance for low oxygen levels such as blood worm midgets (family Chironomidae) and sow bug isopods (family Asellidae). In areas of flowing water over rocks and gravels, taxa of higher sensitivity were found such as common net spinner caddisflies (family Hydropsychidae) and small minnow mayflies (family Baetidae).

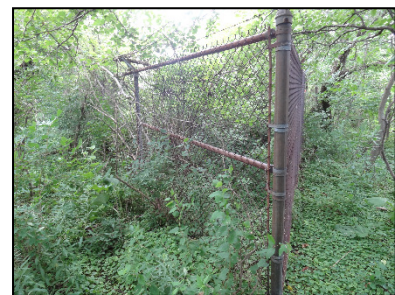
Maintenance yard fence blocks equipment access to north side of stream

There is a former sewer treatment building on the west side of Gitzlaff that is now a Town of Somers Maintenance Building/yard. Storage of Town materials is behind a locked gated yard and accessed by a culvert over the stream. This culvert and access road is the only way to access the north portion of the site. Creating a gate on the north side of the yard would allow for restoration and maintenance vehicles to access the north side.

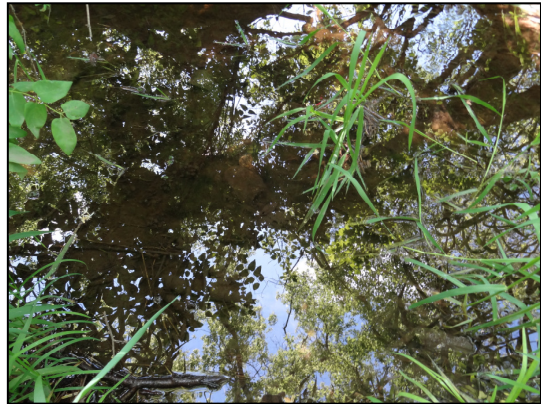
Somers Branch of the Pike River at Gitzlaff
