Pipeline Corrosion – Issues, Causes, some failure case histories

A.S.Khanna

Indian Institute of Technology, Bombay

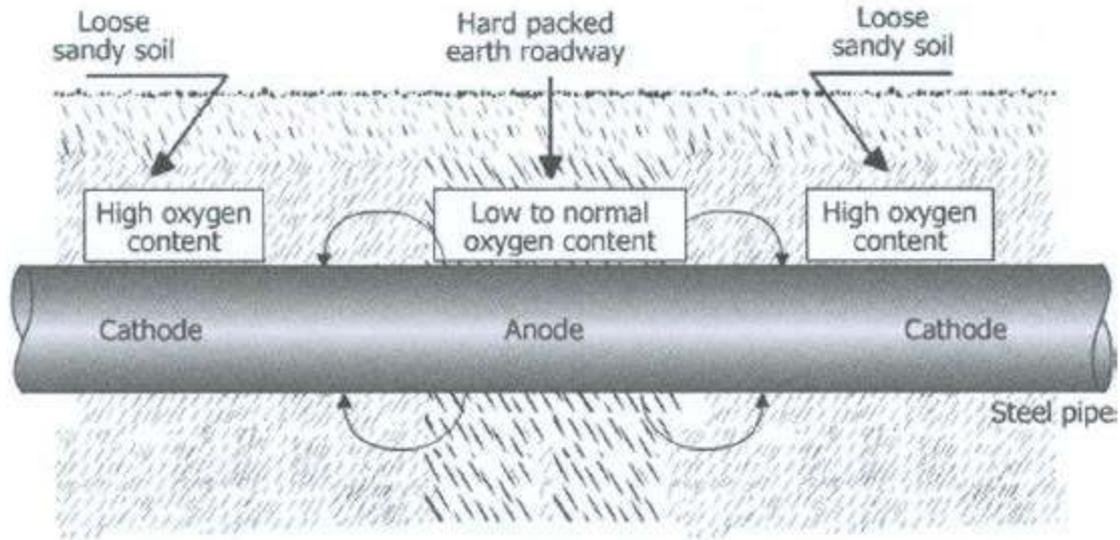
Formation of Differential Oxygen Cells due to variation in soil type around the pipe

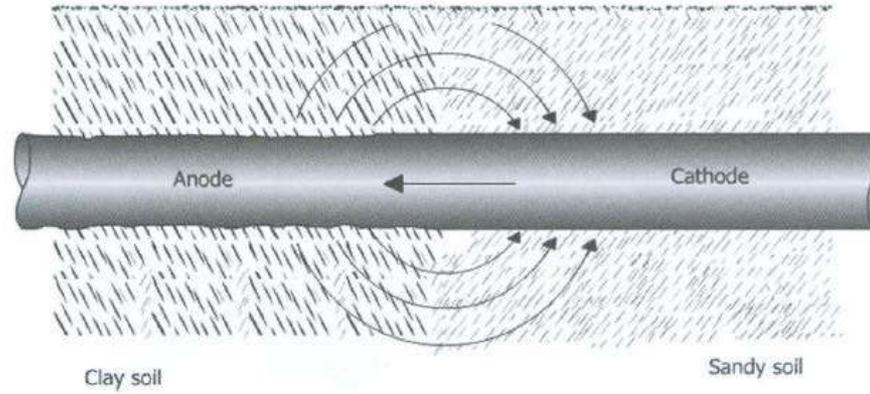
Formation of Differential Concentration Cells

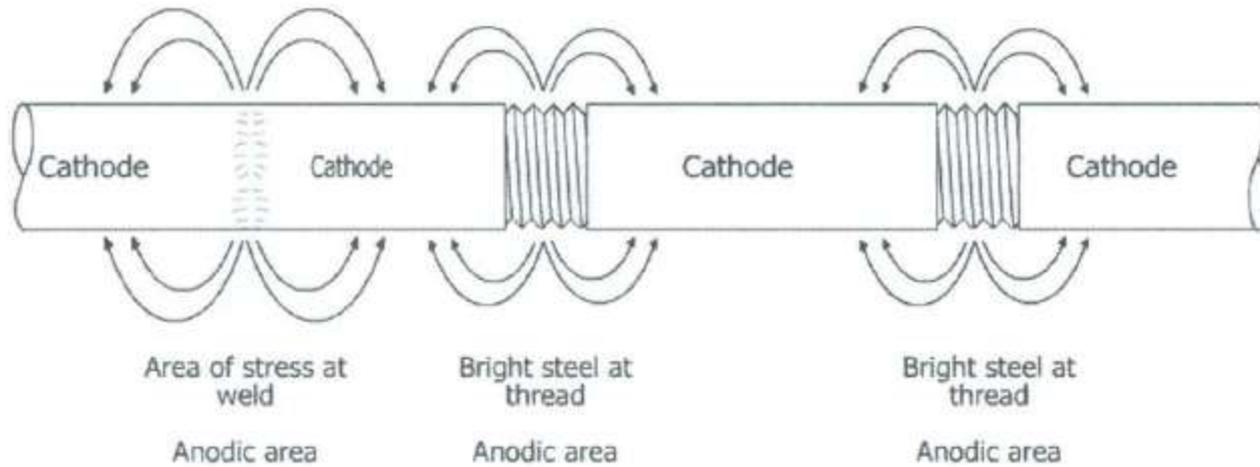
Formation of Corrosion Cells with stressed and unstressed portion

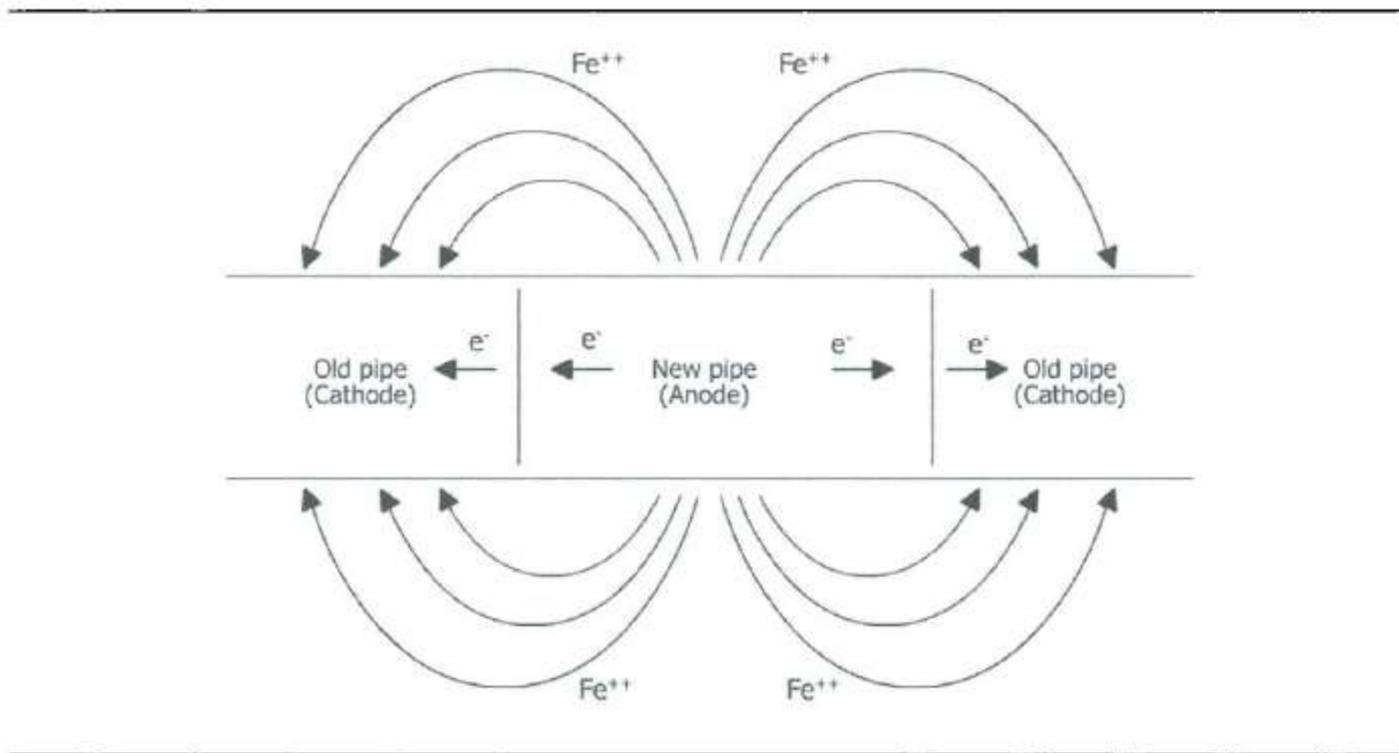
Dissimilar anode cell formation by joining of an old Pipe with a new pipe

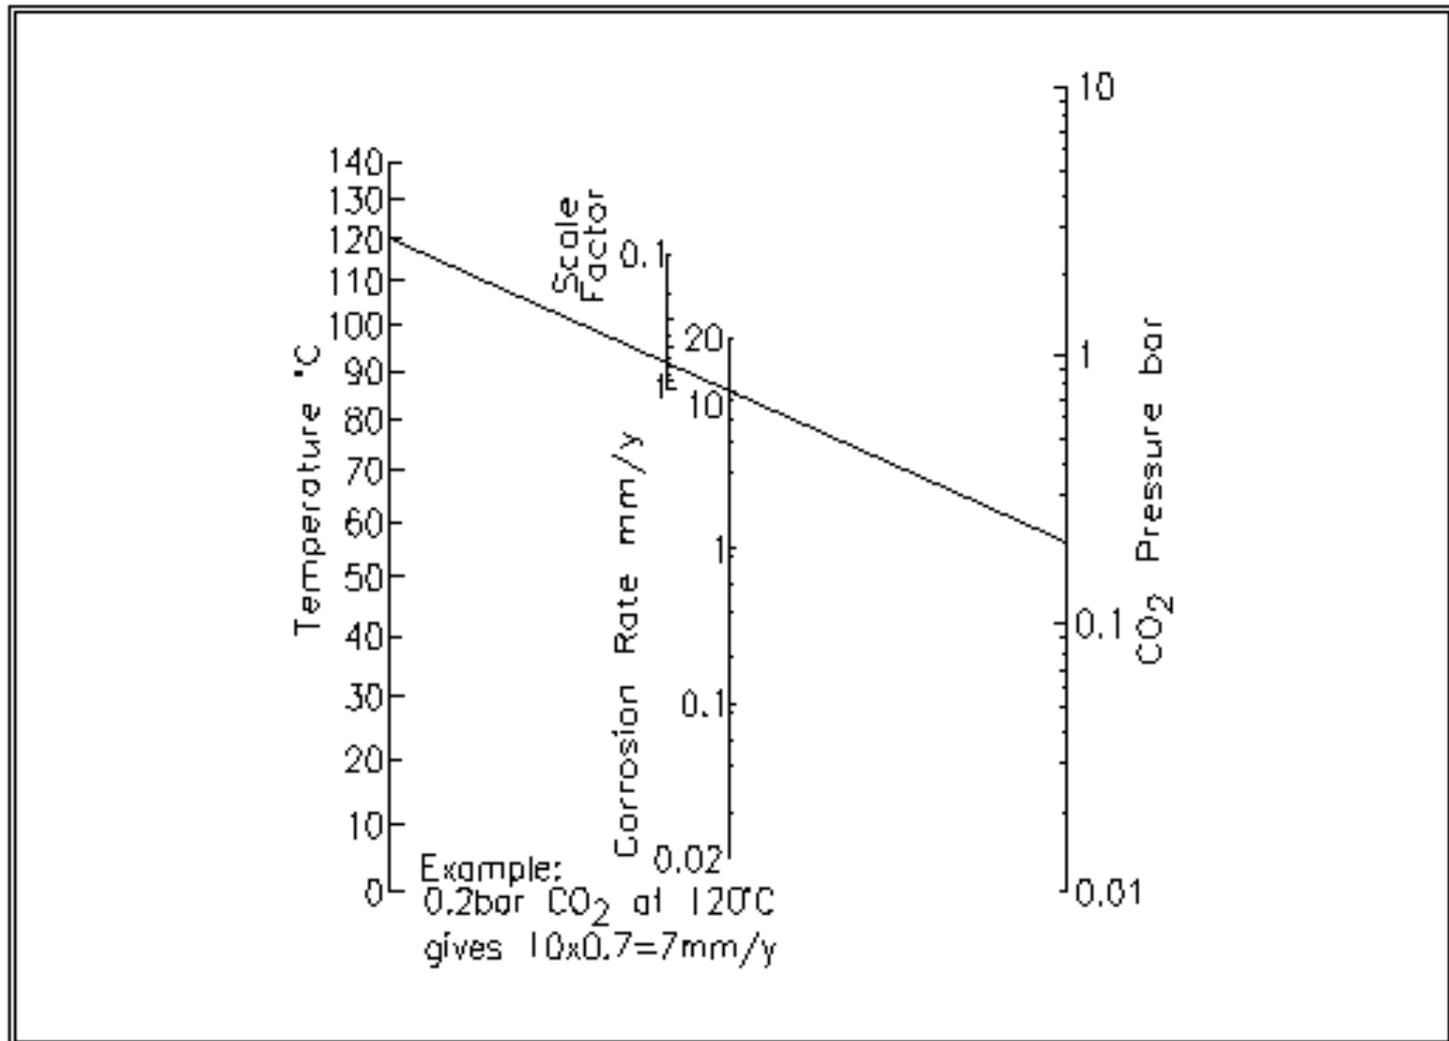
Effect of Temperature and partial Pressure of CO₂ on Corrosion of Steel

$$\log (V_{\text{cor}}) = 5.8 - 1710/T + 0.67 \log (p\text{CO}_2) \text{ ----- (1)}$$

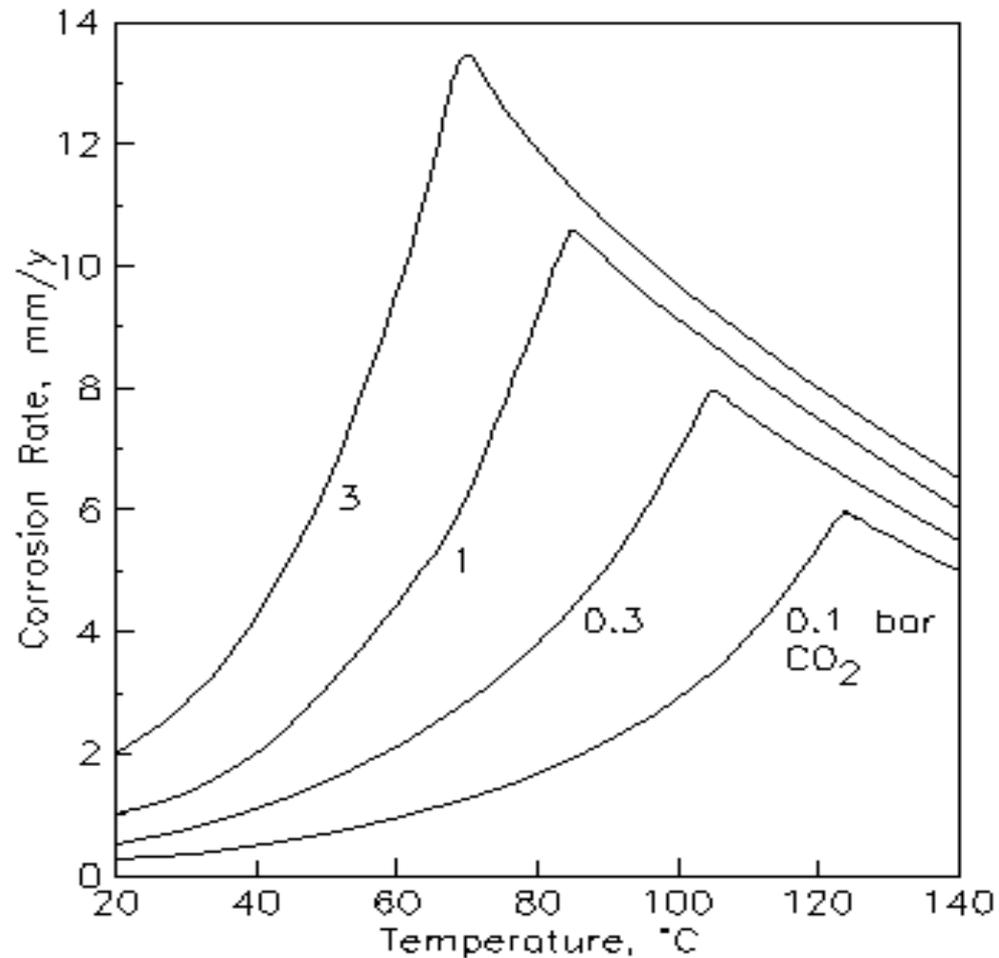
Effect of temperature on the corrosion rate of steel in CO₂ atmosphere.

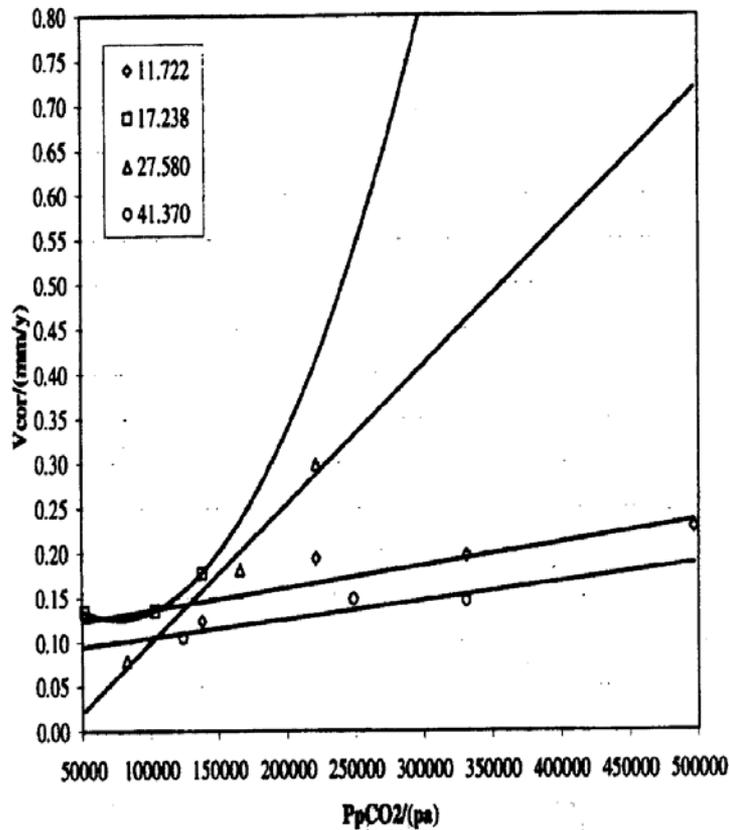
Corrosion rate as a function of CO₂ partial pressure at four different H₂S level at 38°C

API 5L grade B Steel

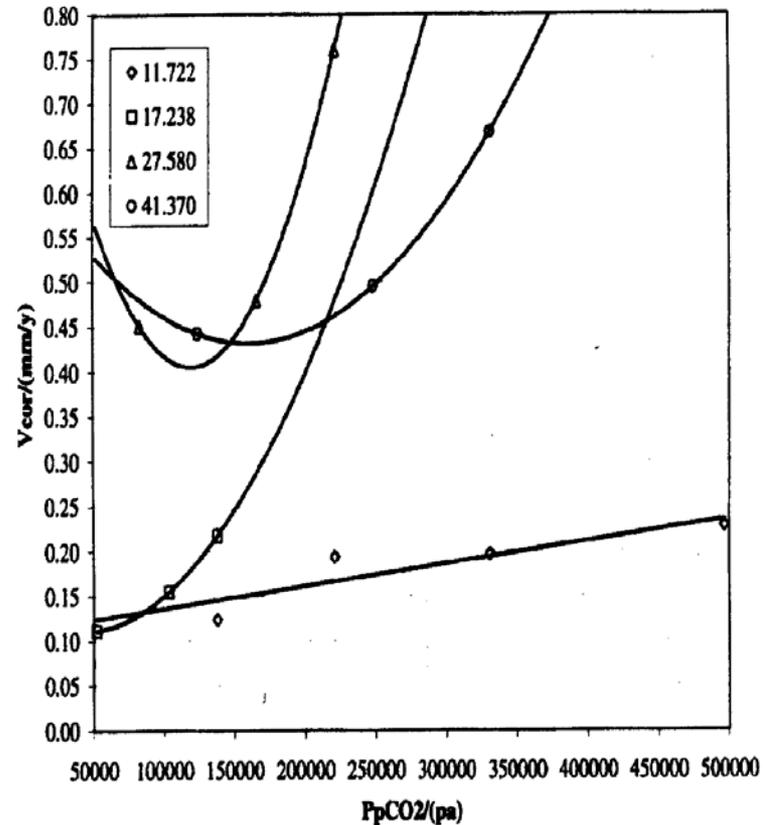
API 5L grade 52 Steel

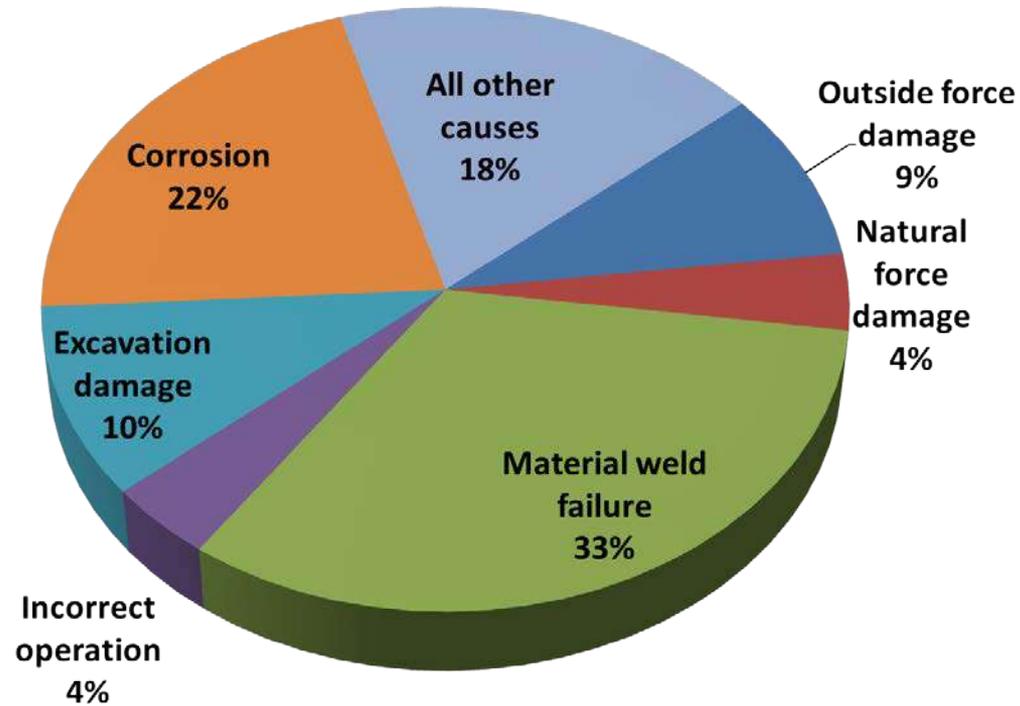
Causes of Pipeline Failure

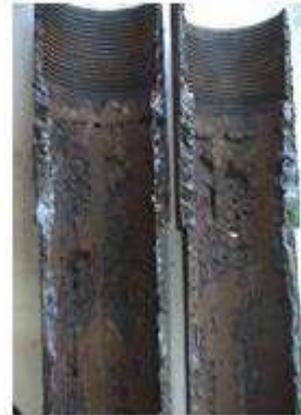
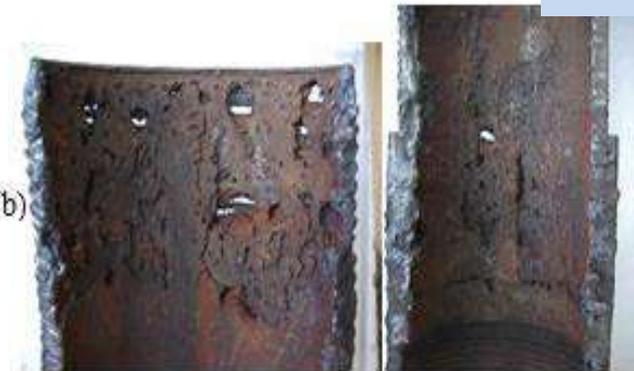
Severe Pitting Corrosion was observed many Of them opened to outer side.

High CO₂ partial pressure, flow velocity, water content and sand in the fluid caused Corrosion

The failure of the core pipes is due to severe corrosion attack estimated to be **3 – 8 mm/yr**, which necessitates replacement of the pipelines.

Pipeline material is not suitable to combat the aggressive condition of the well fluid. It is only good for its mechanical properties to withstand the operating pressure.

It is recommended to use another grade of steel that contain Cr content higher than 3% (compared to 0.23% of the failed steel).

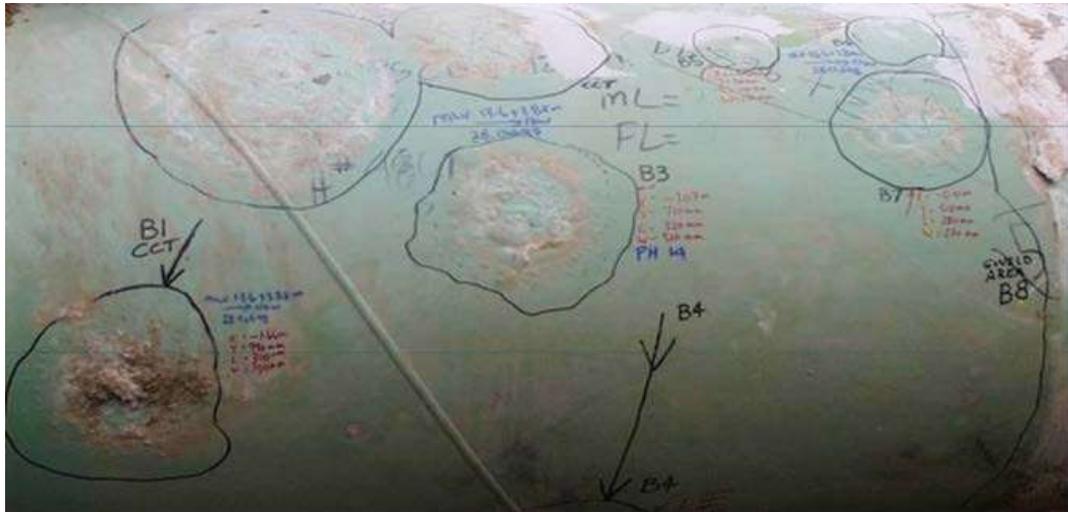
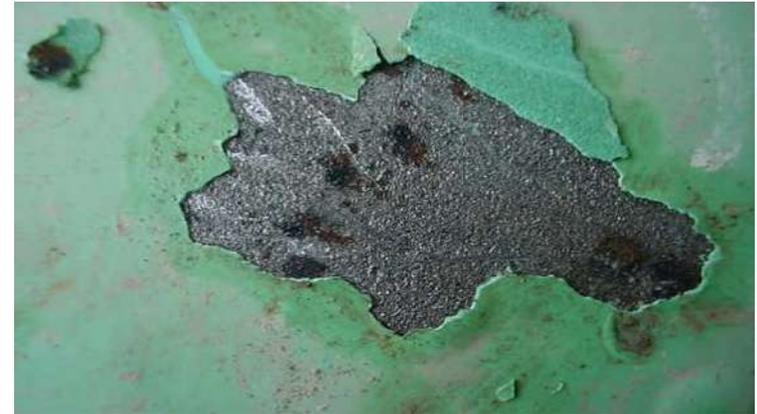
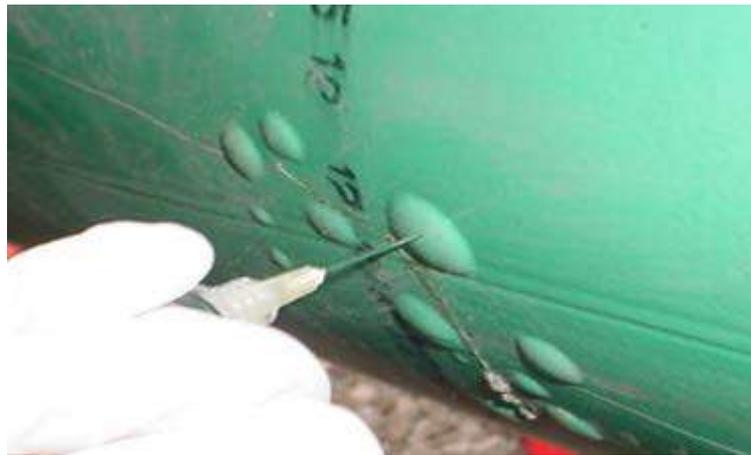
Failure Analysis of Fusion Bonded Epoxy Pipeline Coating

1-Extensive disbondment after 15 years

2-Corrosive soil

3-Poor cathodic disbondment resistance

4-Presence of high amounts of negatively charged ions, Cl^- , NO_3^-

5-Surface contamination prior to coating

6-Root Cause –Inadequate OC/OA prior and during coating process

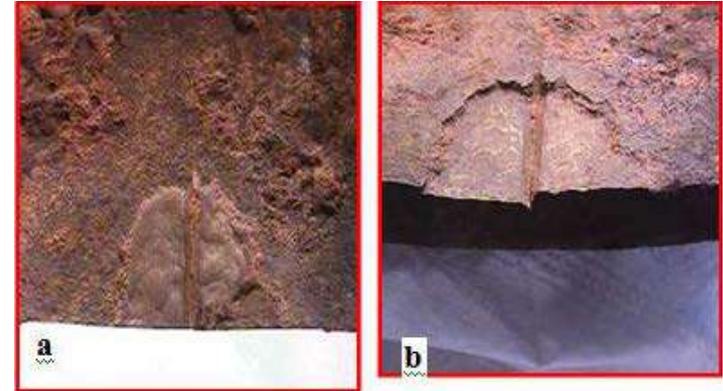
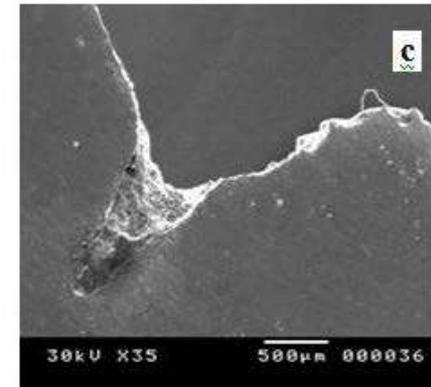
Cut piece showing
 (a) severe pitting corrosion
 (b) close-up of corrosion around seam welding groove.
 (c) Electron micrograph of the V groove with oxide deposits at the root.

Failure occurred in one badly fabricated seam welded pipe. Internal pitting corrosion, due to sour oil, during 25 years of service was a trigger of cracking in the infused weld grooves which ended to complete rupture of the pipe.

positioning of the weld (seam) line at the bottom (6 o'clock position where water accumulated, and stagnated during long shut down periods.

Remedial action: levelling of the pipes at the low lying areas should be carried out using concrete or sand bags as supports.

Any pipe having the seam weld line in the 6 O' clock position should be accurately inspected for the remaining wall thickness.
