# *Ridgeline Home Inspection Services, LLC*

## Property Inspection Report

123 Pine Ave, Greenbay, Wi 54313  
Inspection prepared for: Rodger Jones  
Real Estate Agent: Russel Smith - ABC Realty

Date of Inspection: 1/8/2014 Time: 8:00 AM  
Age of Home: 15 yrs Size: 2450 sq ft  
Weather: 30 degrees clear

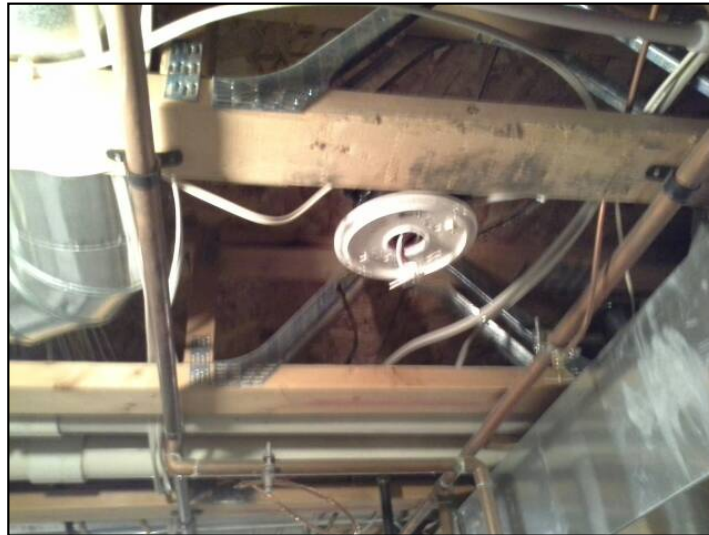
- Operated when tested.
- Smoke detector missing in basement furnace area.

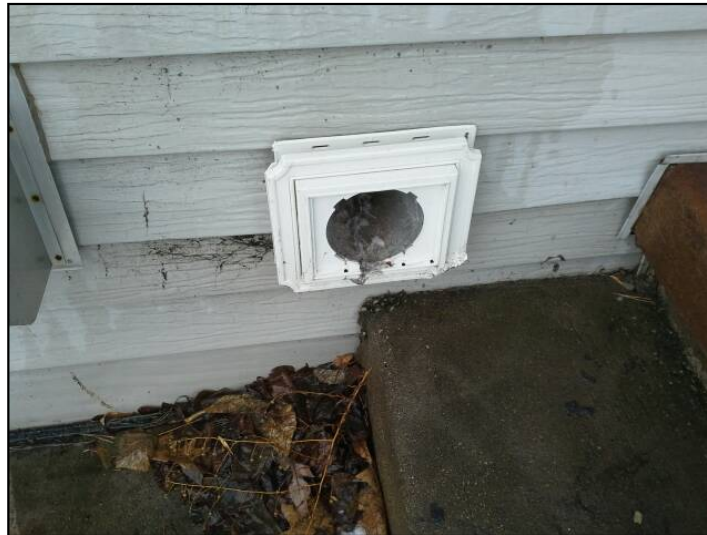
Observations:  
 • The dryer vent has a damaged exterior cover.

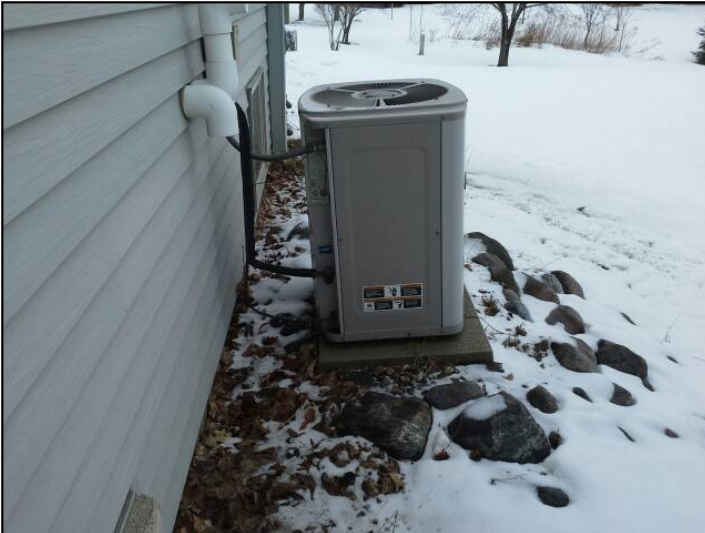
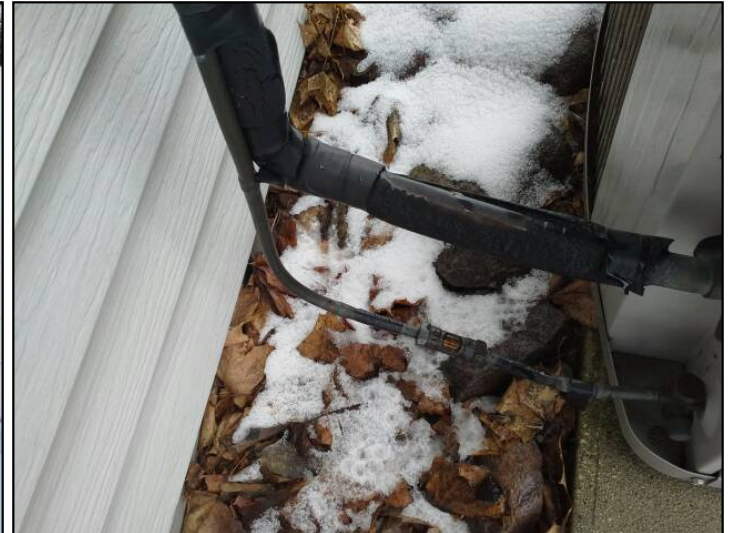
- Air Conditioning mounting pad not level; this may shorten motor life. Suggest leveling pad or unit.
- Air Conditioning line set has missing or damaged insulation; have HVAC tech repair.

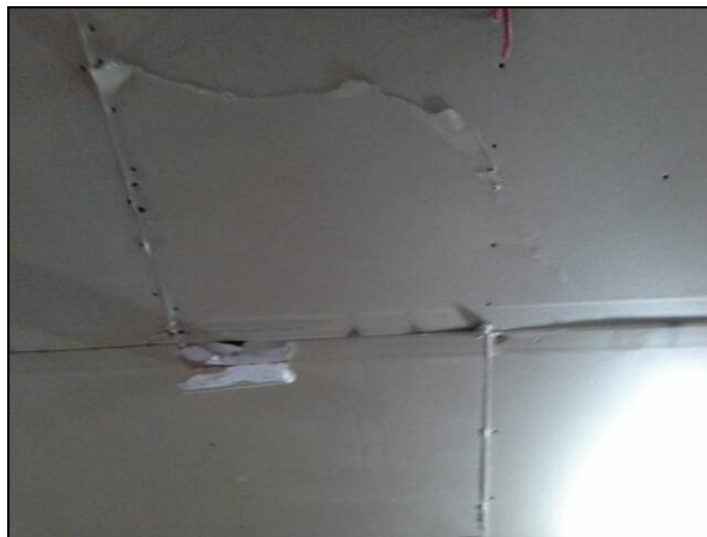
Observations:  
 • Engineered wood roof truss framing noted.  
 • Plywood Sheathing noted.  
 • **Hole in the ceiling is a breach in the fire protection.**

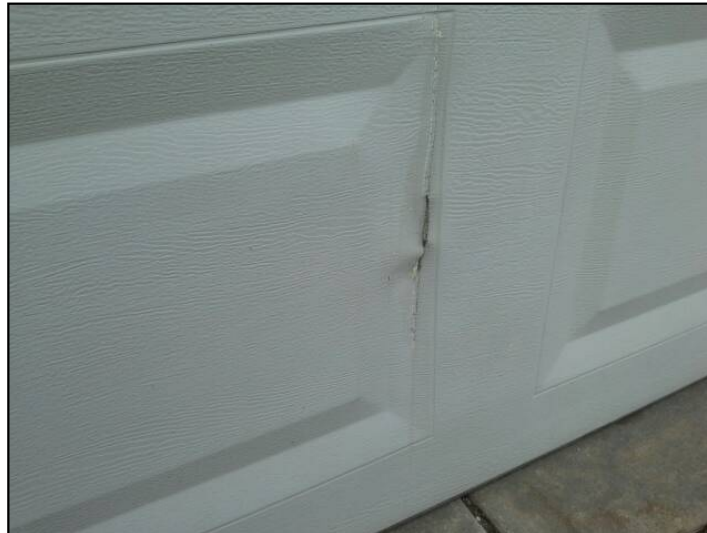
- Garage vehicle door panels damaged.
- dented

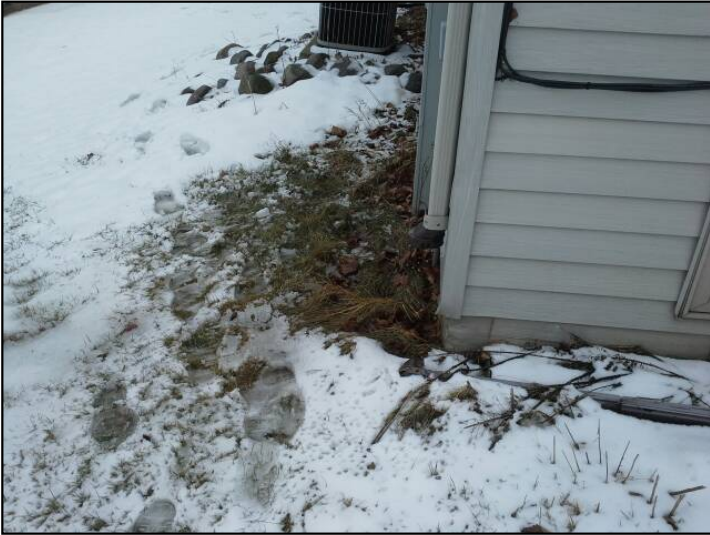
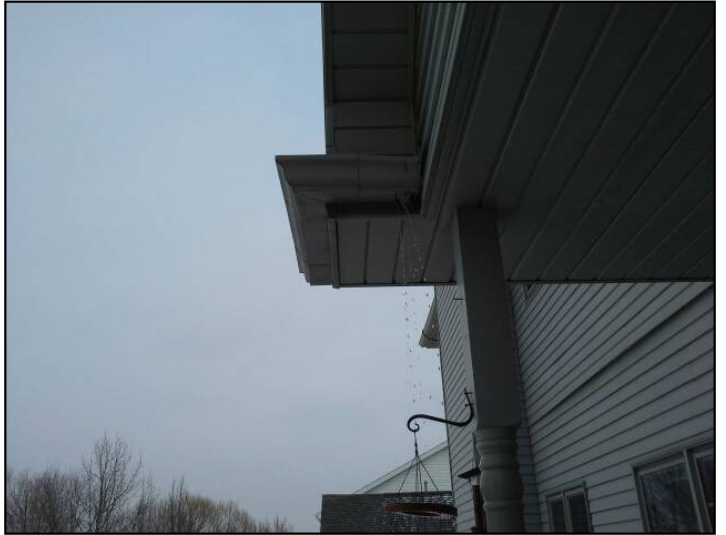
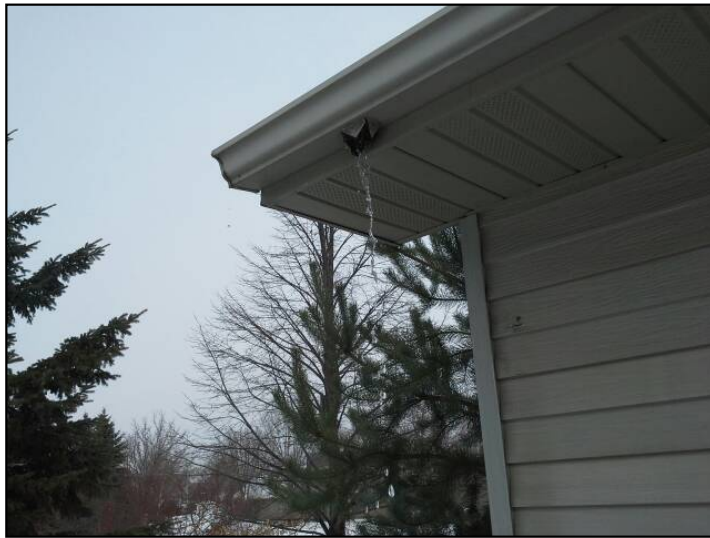
- Downspouts missing; recommend installation.
- No major system safety or function concerns noted at time of inspection. Gutter extension missing on north east corner of home

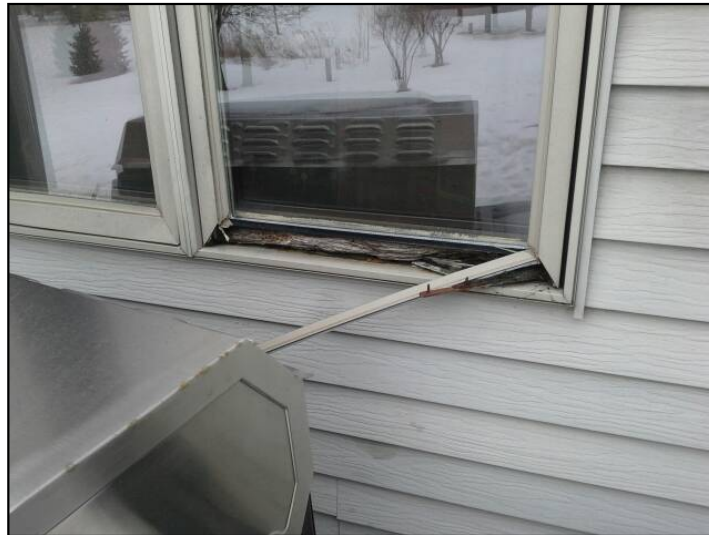
- Frame separating from glass. Sash needs to be replaced.

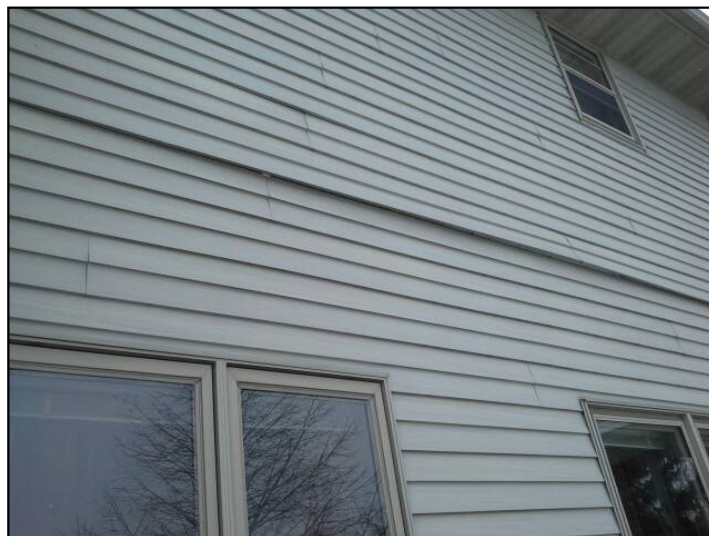
- . Siding needs to be refastened.

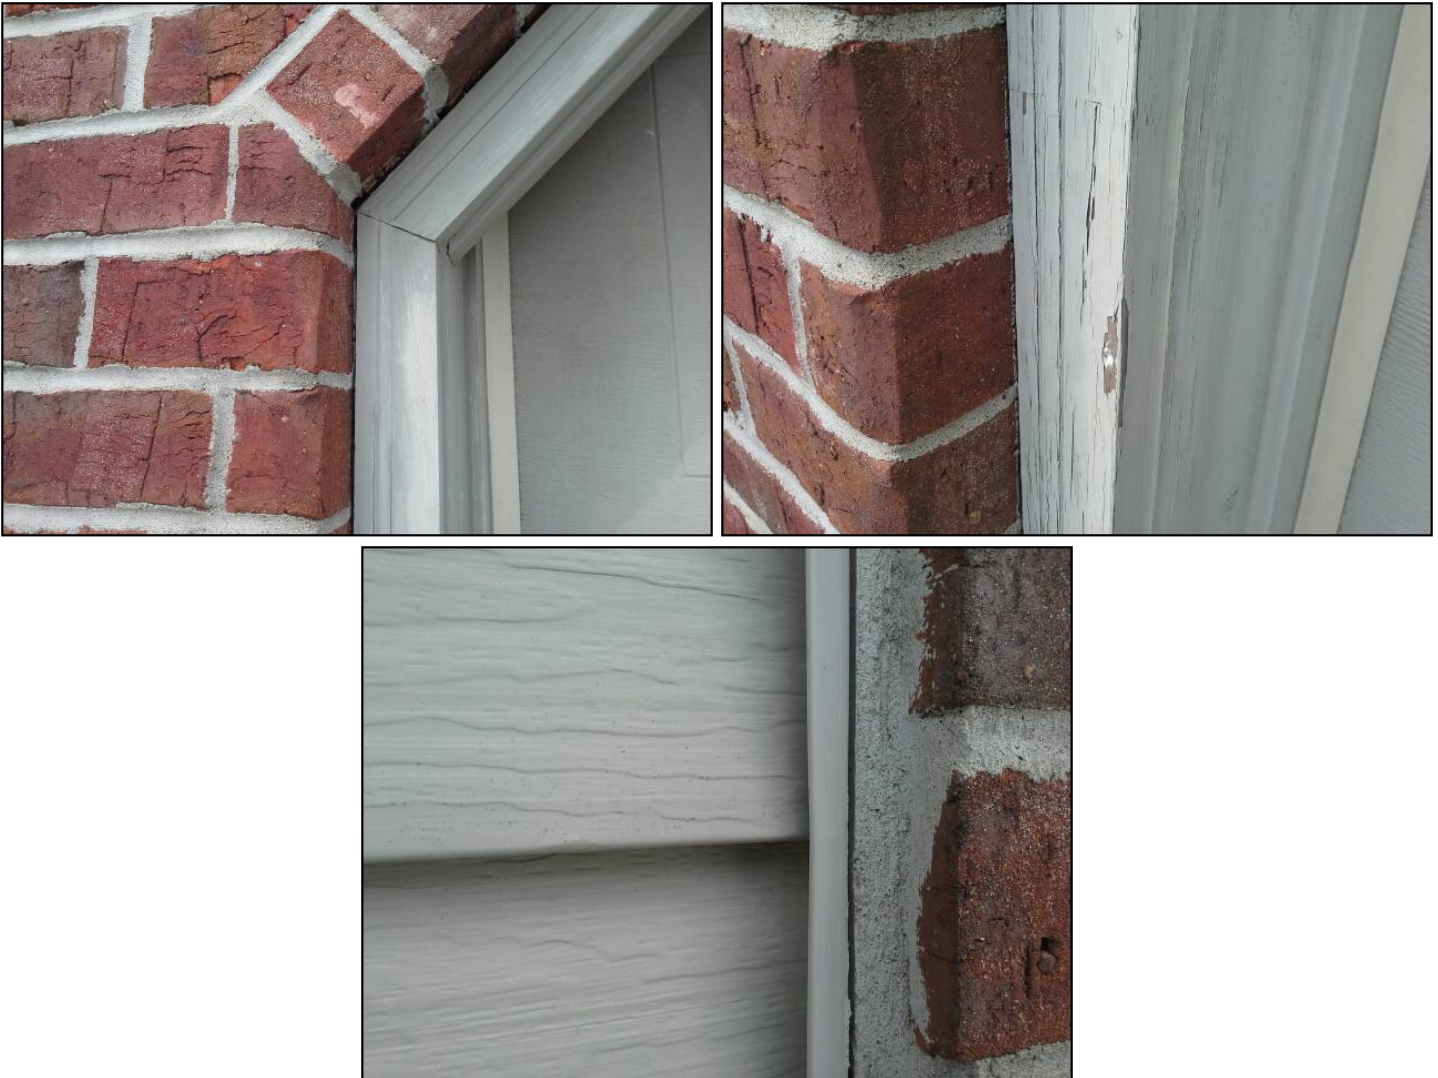
- Suggest caulking around doors and windows as necessary.
- Peeling paint observed, suggest scraping and painting as necessary.

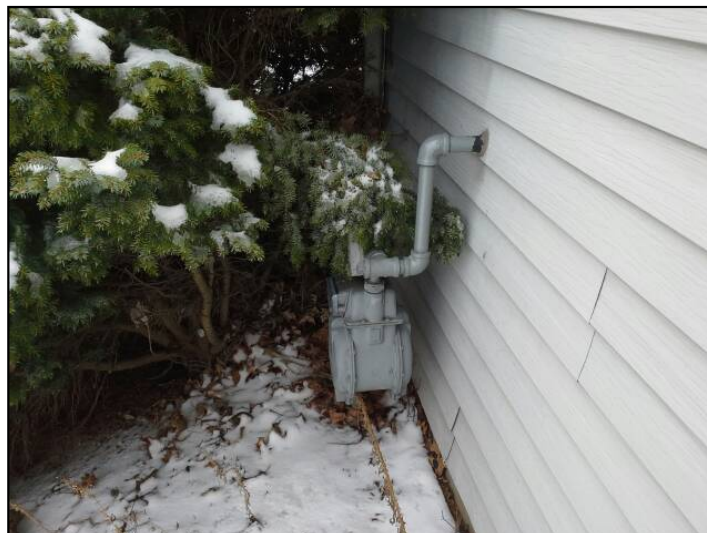
- Maintenance Tip: When landscaping, keep plants, even at full growth, at least a foot (preferably 18 inches) from house siding and windows. Keep trees away from foundation and roof. Plants in contact or proximity to home can provide pathways for wood destroying insects, as well as abrade and damage siding, screens and roofs.

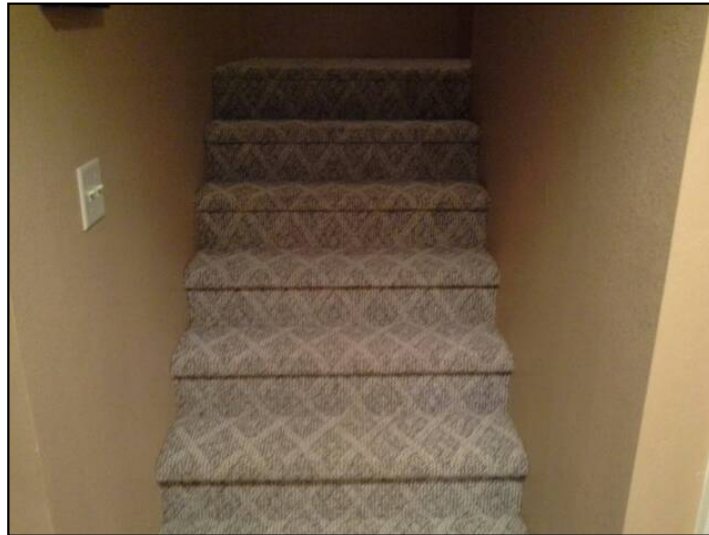
- Whenever three or more stairs are present a handrail is usually required.
