Case 18-T-0604 - Application of Deepwater Wind South Fork, LLC
 for a Certificate of Environmental Compatibility and Public Need for the Construction of Approximately 3.5 Miles of Submarine Export Cable from the New York State Territorial Waters Boundary to the South Shore of the Town of East Hampton in Suffolk County and Approximately 4.1 Miles of Terrestrial Export Cable from the South Shore of the Town of East Hampton to an Interconnection Facility with an Interconnection Cable Connecting to the Existing East Hampton Substation in the Town of East Hampton, Suffolk County.

Interrogatory/Document Request

Request Number:	Si Kinsella #12
Request Title:	PFAS Contamination – Griffiths Carpet
Addressed To:	NYS Dept. of Environmental Conservation
From:	Simon Kinsella
Date of Request:	January 13, 2020

Site Characterization Report

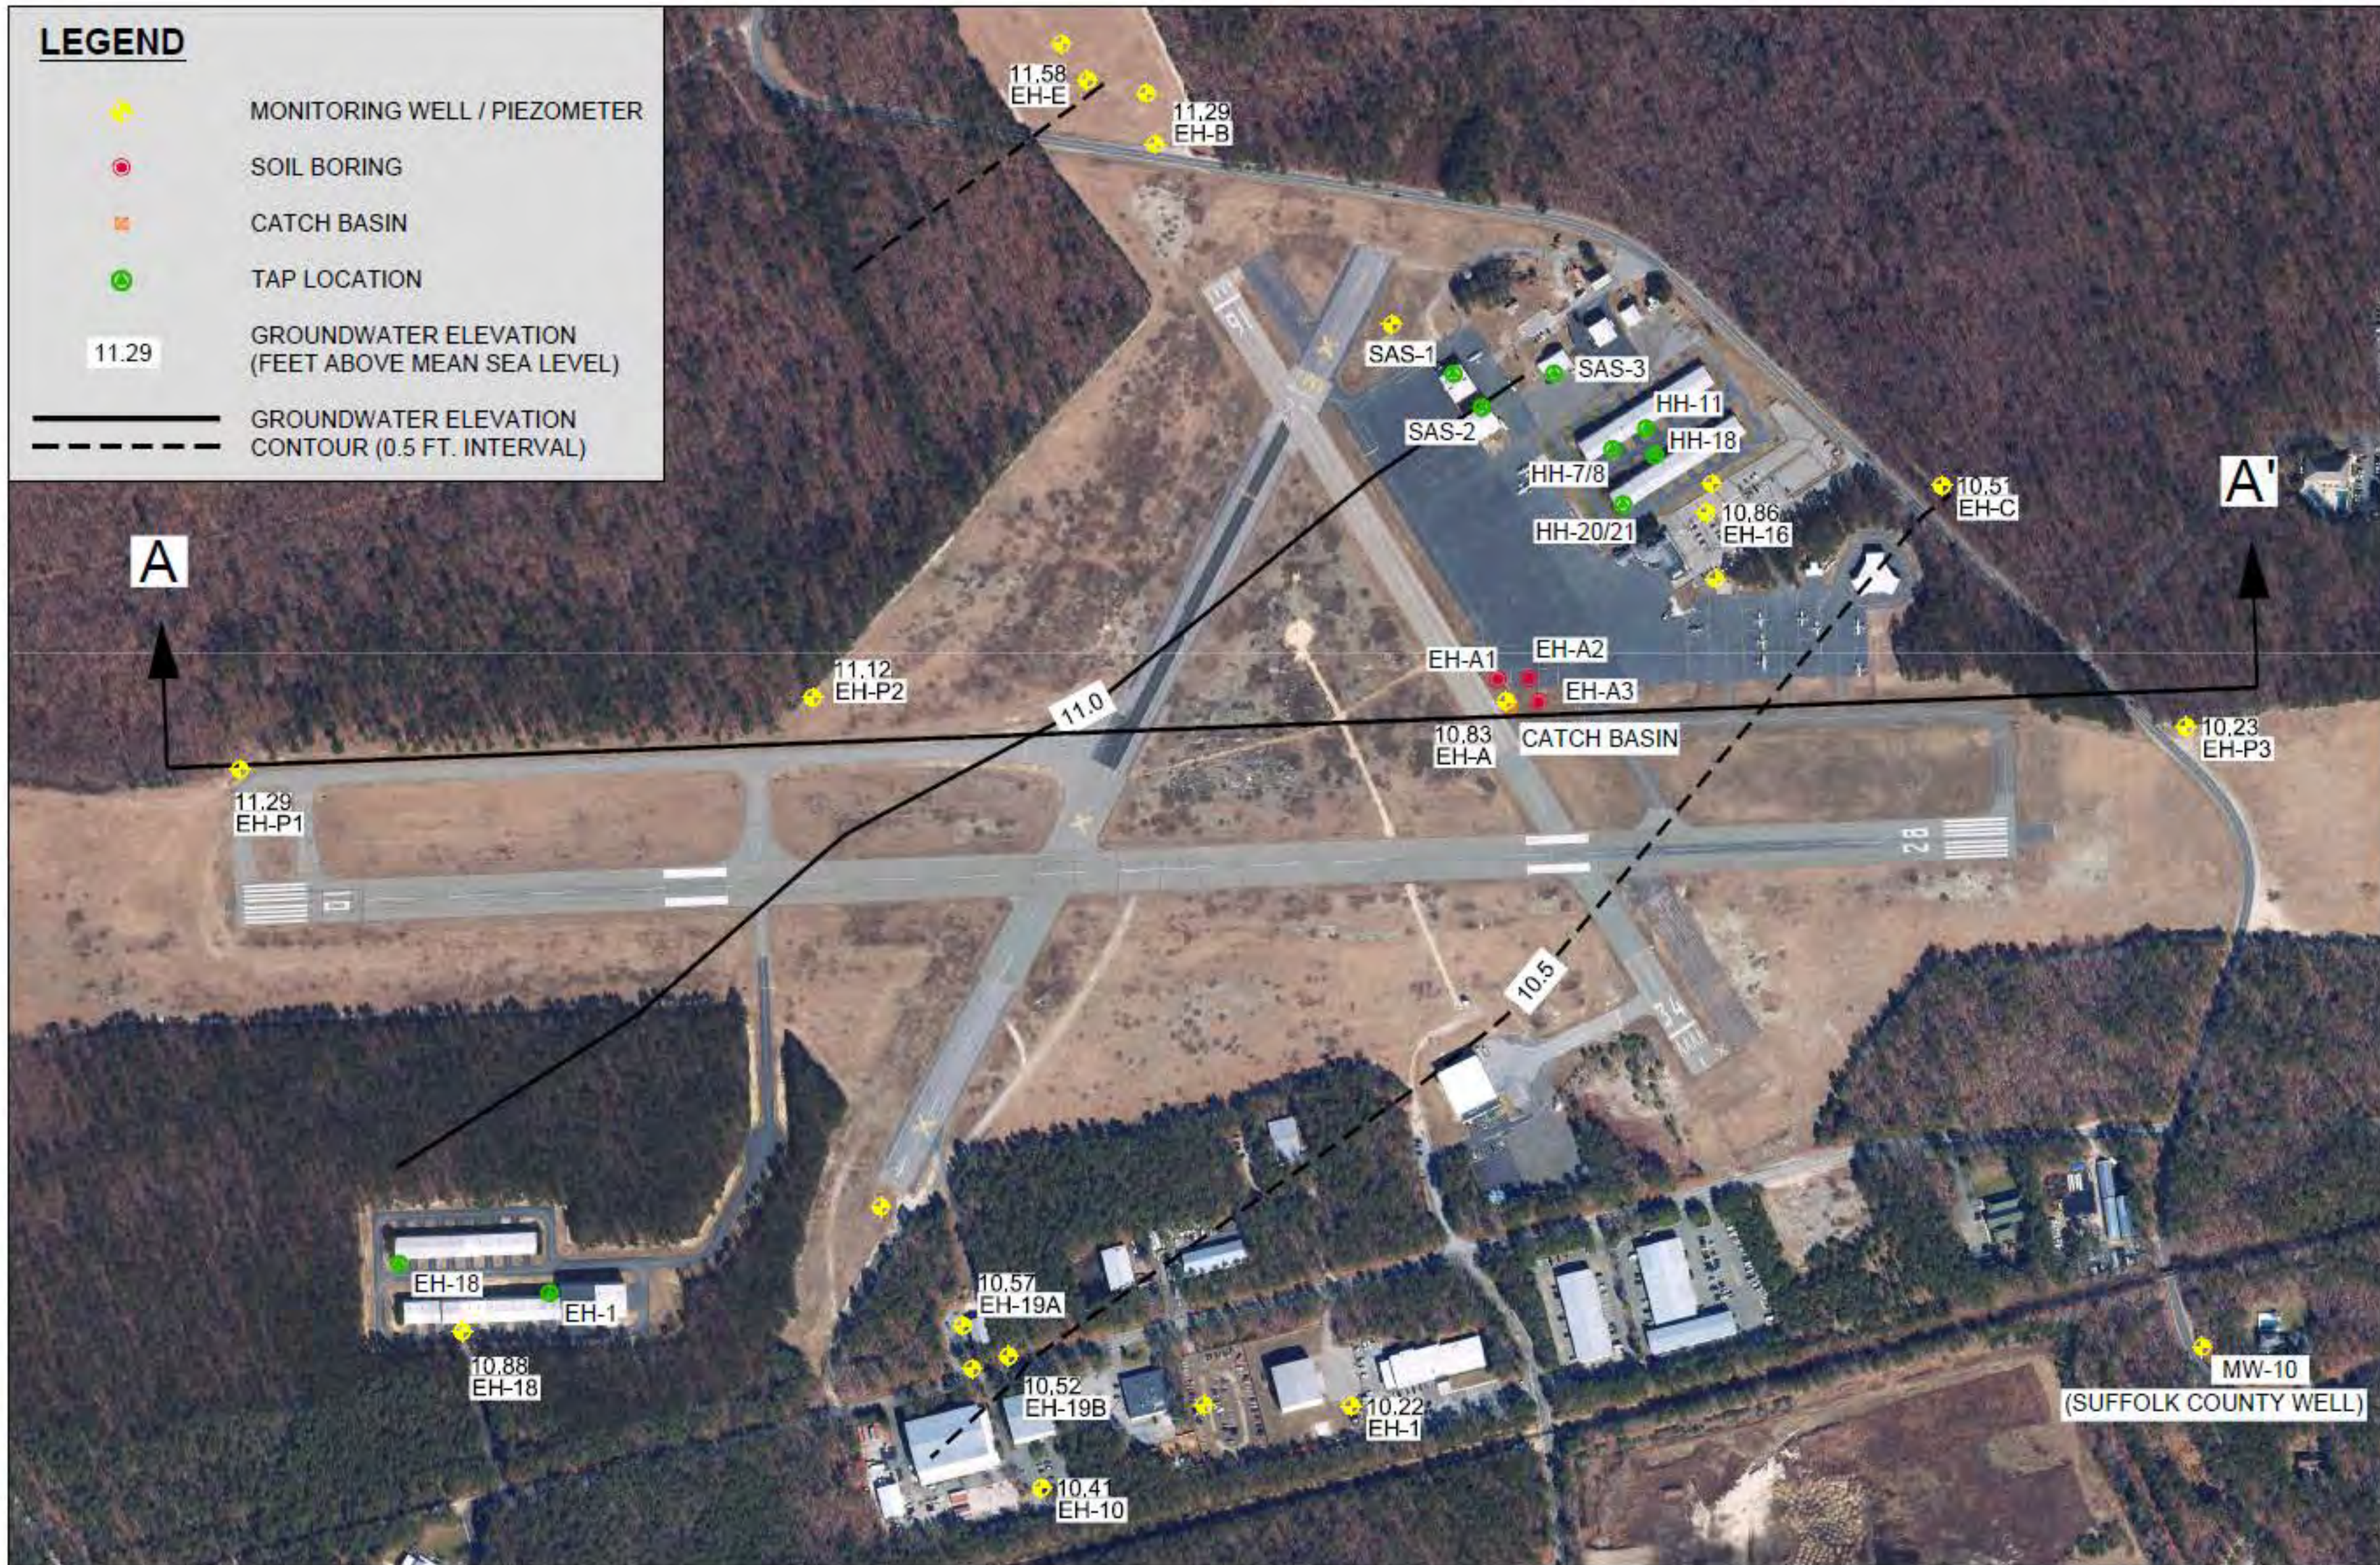
GROUNDWATER ELEVATION CONTOUR (0.5 FT. INTERVAL)

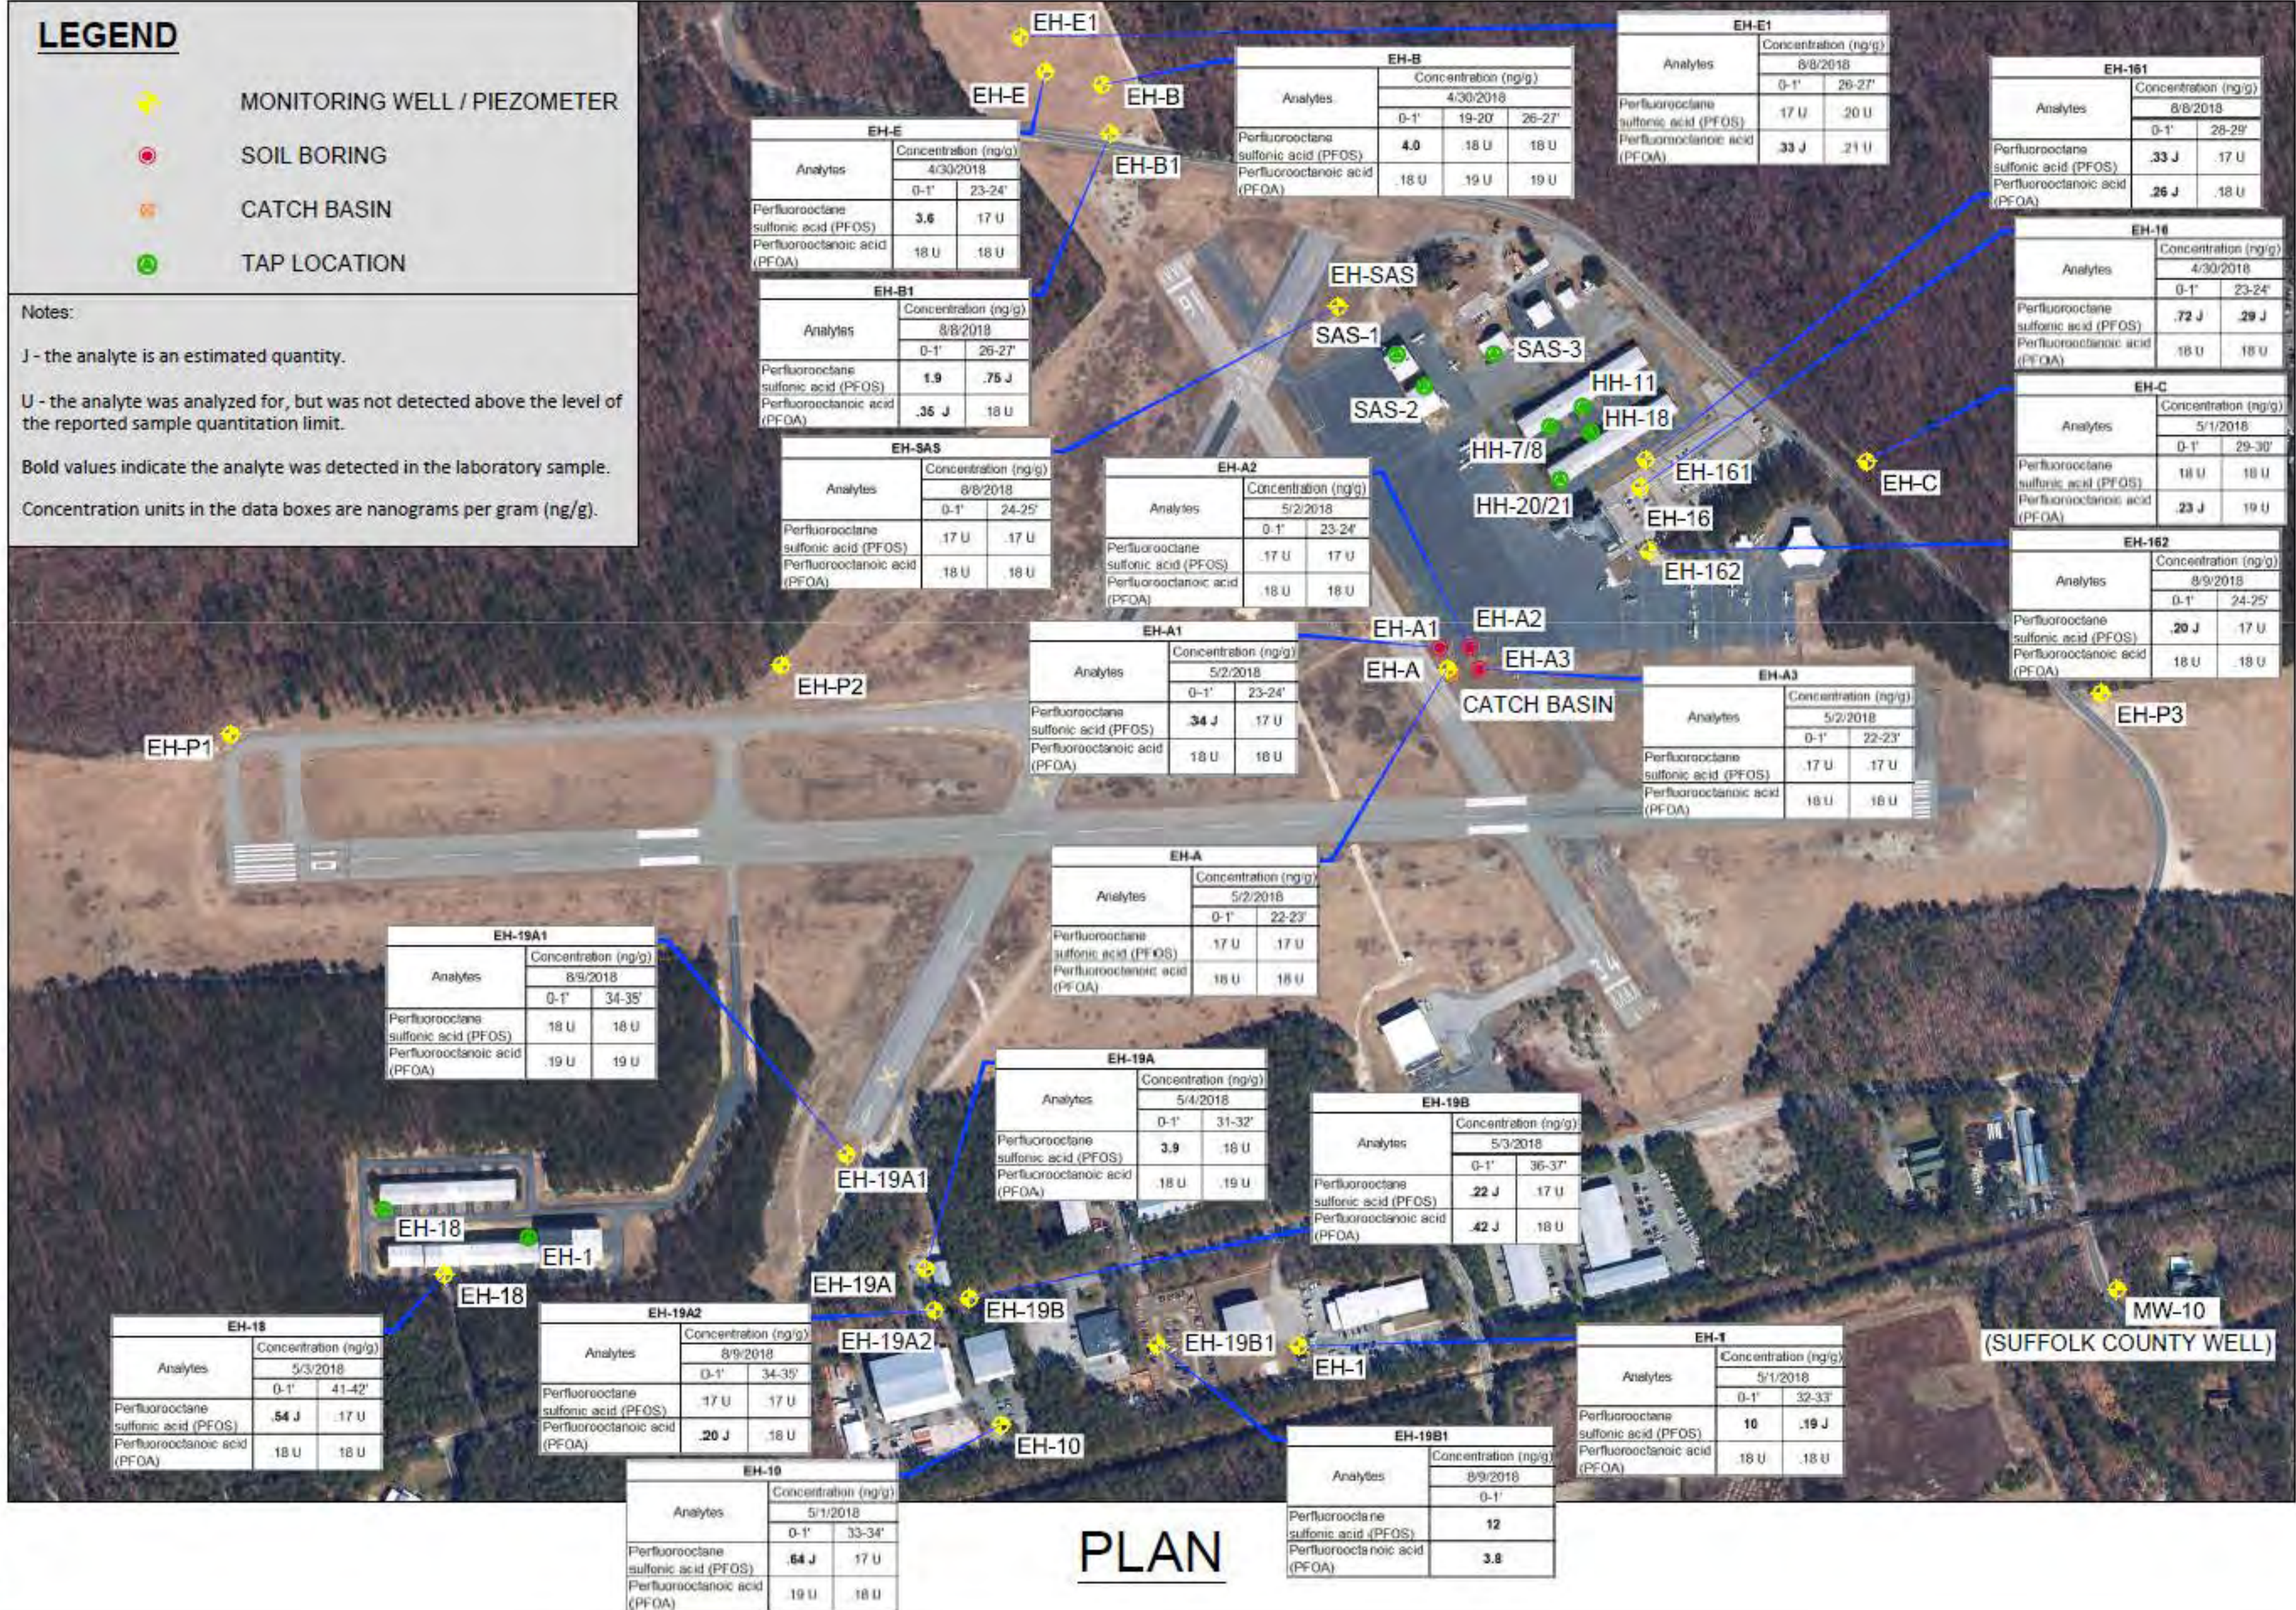
SOIL ANALYTICAL RESULTS

J - the analyte is an estimated quantity.
 U - the analyte was analyzed for, but was not detected above the level of the reported sample quantitation limit.
 Bold values indicate the analyte was detected in the laboratory sample.
 Concentration units in the data boxes are nanograms per gram (ng/g).

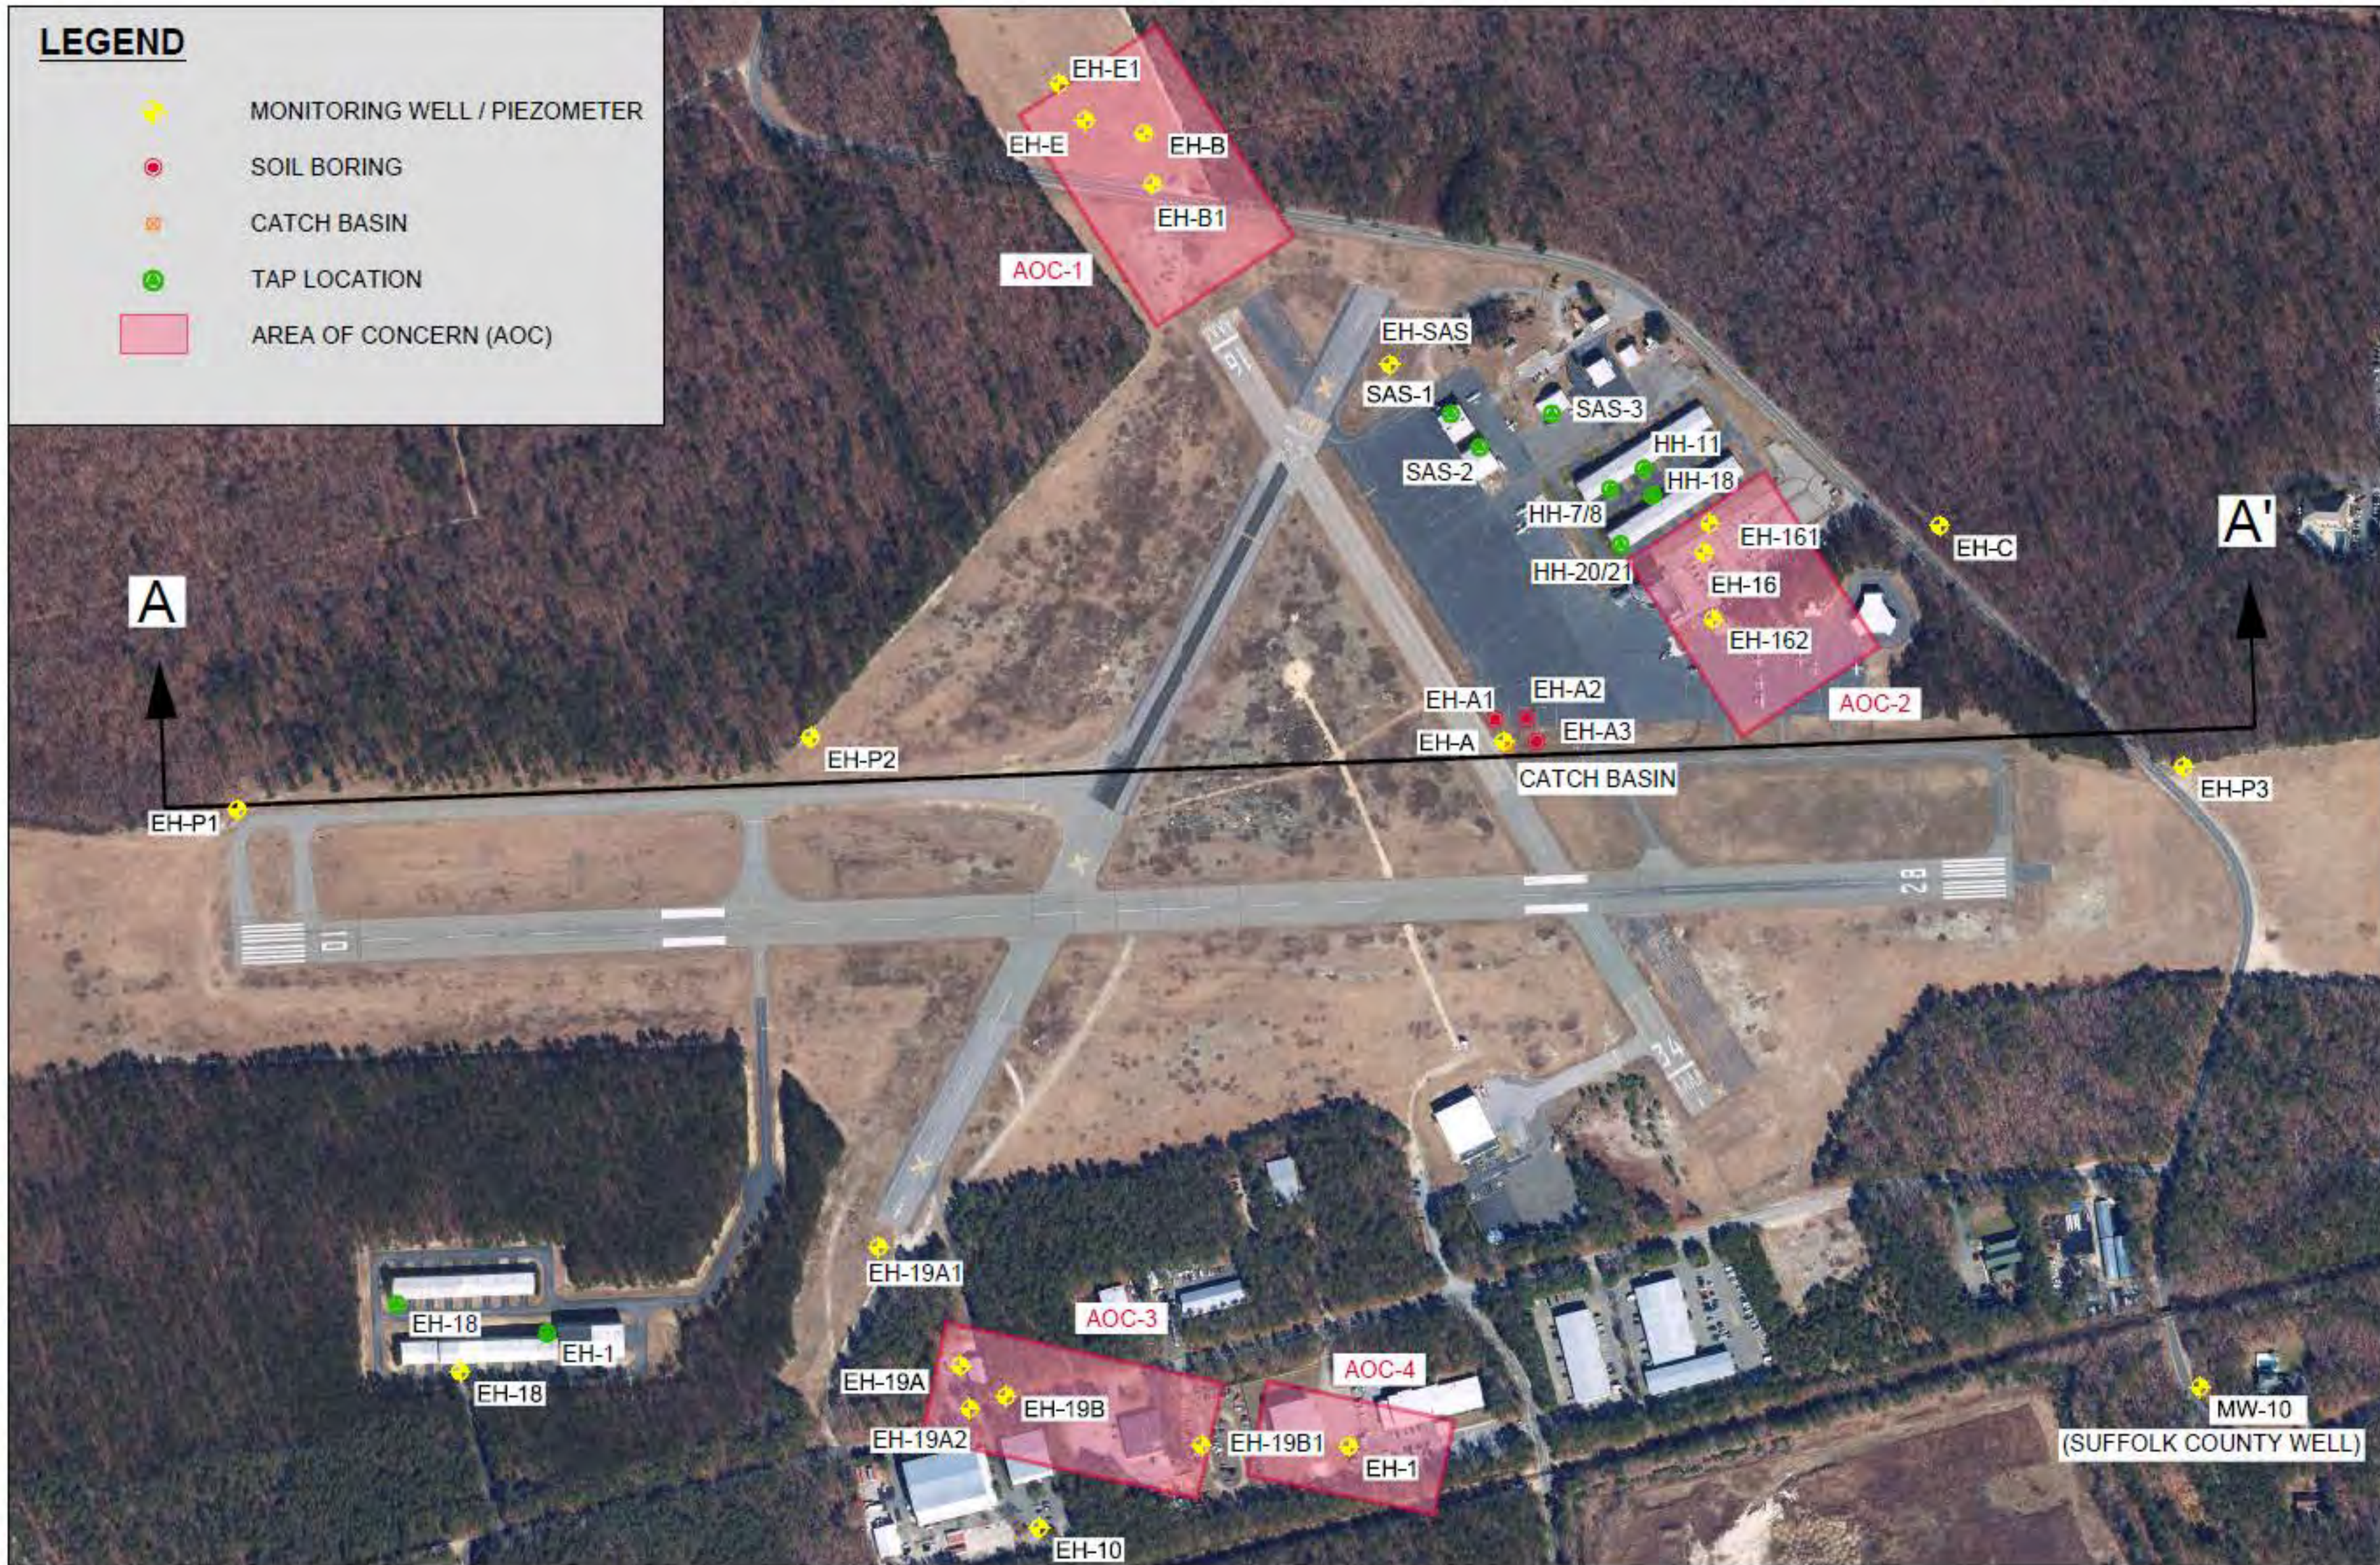
IDENTIFIED AREAS
OF CONCERN

Appendix A – Info Graphic based on NYS DEC’s Site Characterization Report on East Hampton Airport prepared by AECOM, published November 30, 2018 (see Fig 8) prepared by Si Kinsella (Jan 12, 2020).
Page 4

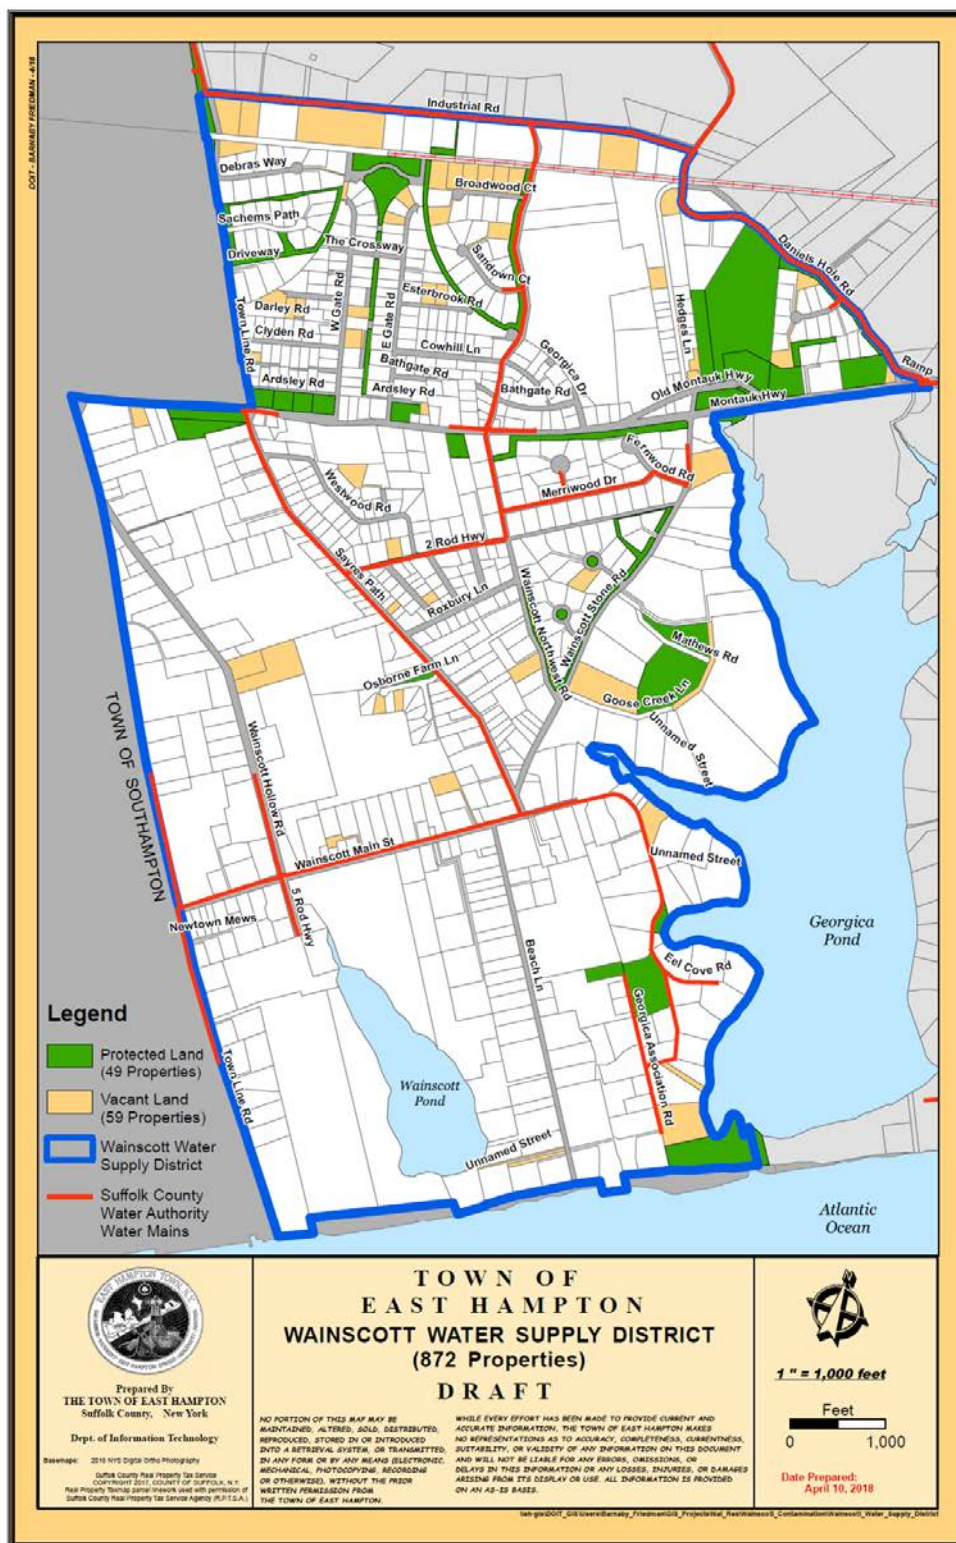
Figure 7 Town of East Hampton Wainscott Water District with existing Suffolk County Water Authority Water Main

As part of the plan to fund the project the Town of East Hampton will create the Wainscott Water Supply District. Figure 7 shows the boundaries of the district, parcels (872 properties), as well as existing SCWA water main. The Wainscott Water Supply District is the hamlet of Wainscott, in the Town of East Hampton, south of East Hampton Airport. Such area is delineated on the north by Industrial Road, on the west by Town Line Road and the East Hampton Town line and eastern boundary of the Incorporated Village of Sagaponack, south by the Atlantic Ocean and east by Georgica Pond and Daniels Hole Road.
