U.S. v. Brace et al. - Expert Report: Ecological Functions and Connections of Marsh Site Wetlands
Prepared by: Robert P. Brooks, Ph.D., Brooks Consulting

United States v. Brace et al., 17-cv-06, W.D. Pa.
Expert Report: Ecological Functions and Connections
of Wetlands and Waters at the Marsh Site,
Waterford, Erie County, Pennsylvania

Prepared for:
U.S. Department of Justice

18 December 2017

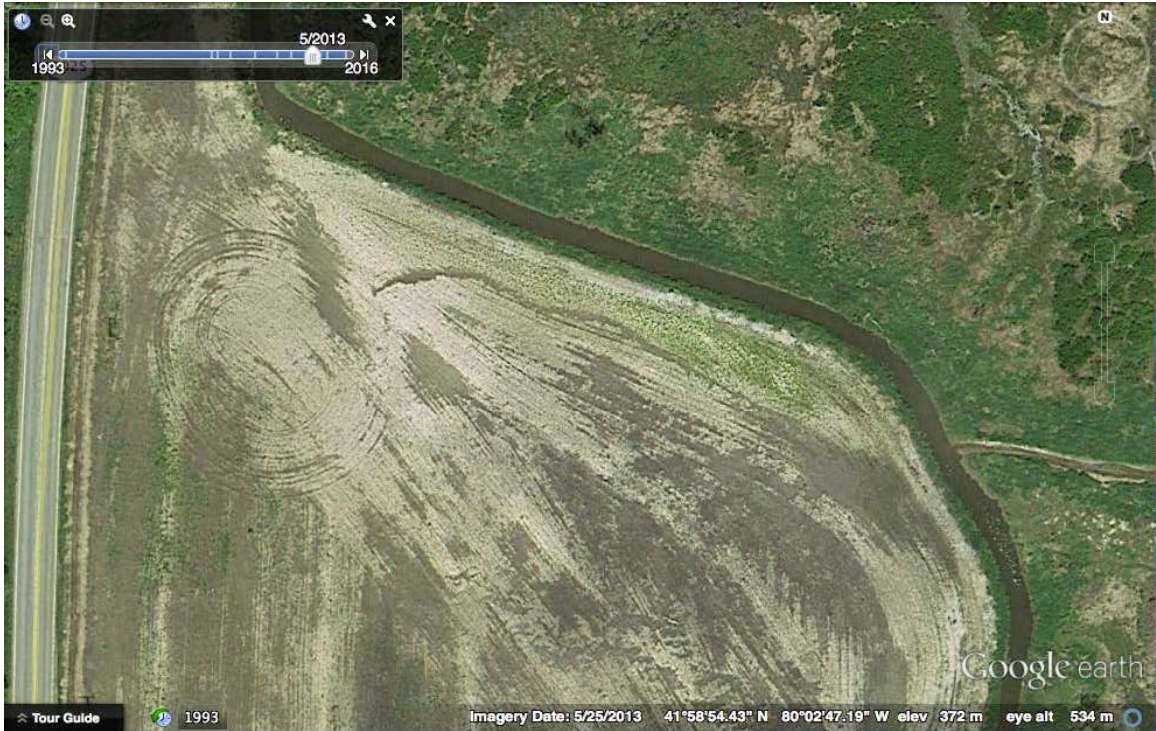
Figure 12. May 2013 aerial photograph of the Marsh Site (natural color, Google Earth) close-up showing extensive disturbance of vegetation throughout site to bare soil, plow and grading lines, and alterations to the morphometry of Elk Creek.

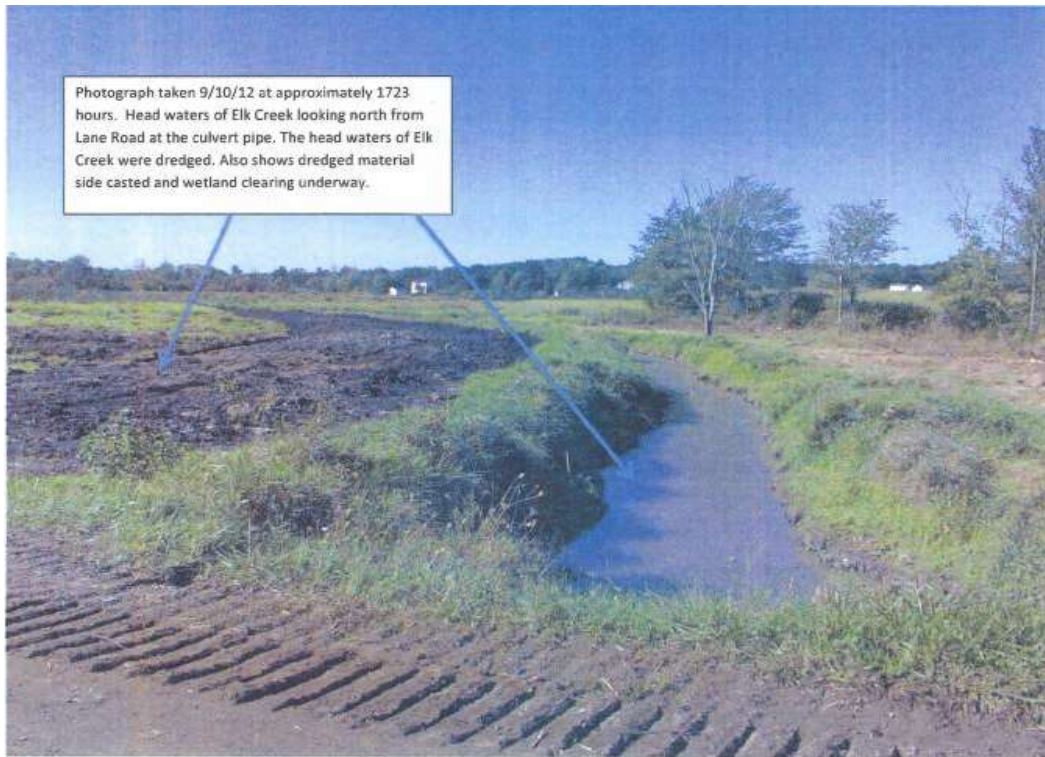
Figure 14. September 2012 photograph from Marsh Site inspection by Smolko; Elk Creek from Lane Road looking downstream (north) showing disturbed soils and side-casting from dredging Elk Creek.

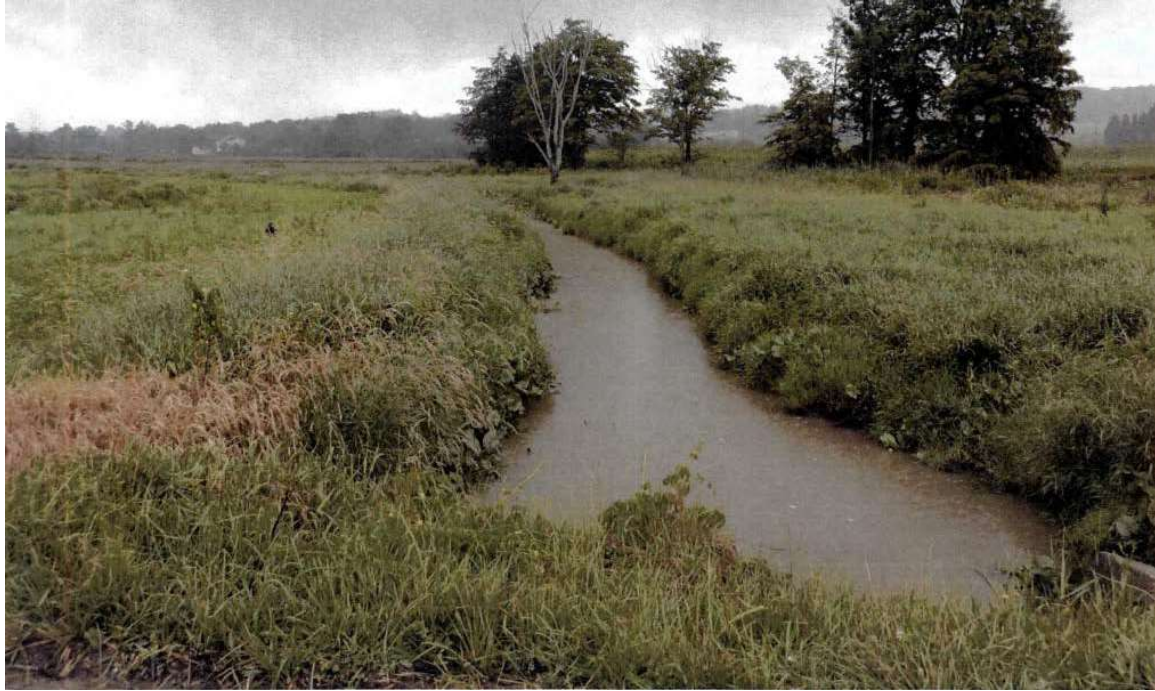
During the June 2013 inspection, new growth of hydrophytic vegetation was observed in portions of the site previously disturbed (Figures 15, Lane Road bridge). Based on the wetland delineation data sheets from three sample points, all located on the Marsh Site, hydrophytic plants were dominant, and soils showed hydric characteristics (i.e., chroma of 1 or 2, gleyed matrix, mottles). Surface hydrology was observed, so evidence of all three wetland parameters was present, indicating the presence of wetlands on the Marsh Site. Their Sample Point #1 was located near my Sample Point #6. Their other two points were located in the middle area of the Marsh Site. Heavy rains made obtaining additional soil samples difficult, and obscured some of the natural surface hydrology. A site inspection report from the same visit prepared by Scott Dudzic of the Pennsylvania Department of Environmental Protection (PADEP) dated 27 June 2013 described similar findings.

Figure 15. June 2013 photograph from Marsh Site inspection by EPA; Elk Creek from Lane Road looking downstream (north) showing recovering herbaceous vegetation after soil disturbance in 2012, and channelized reach of Elk Creek.

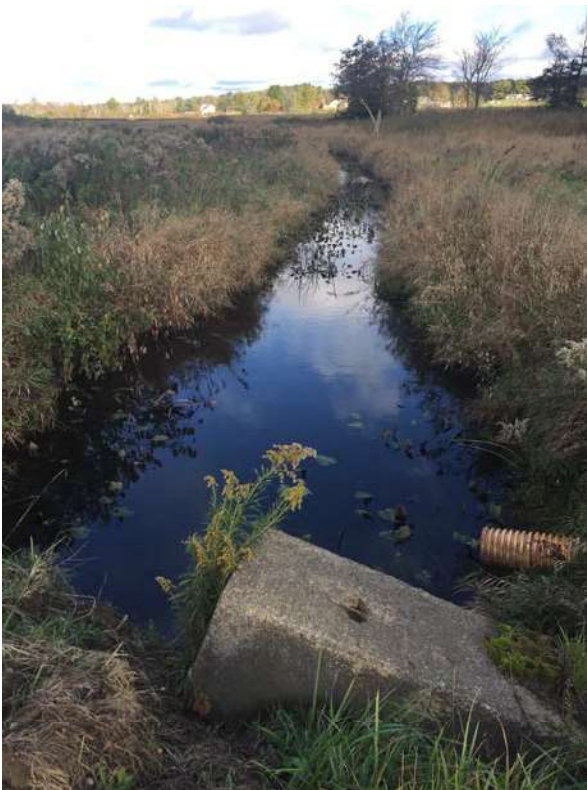
Figure 16. October 2017 photograph from Marsh Site inspection by Brooks; Elk Creek from Lane Road looking downstream (north) showing recovering herbaceous vegetation after soil disturbance in 2012, and channelized reach of Elk Creek.

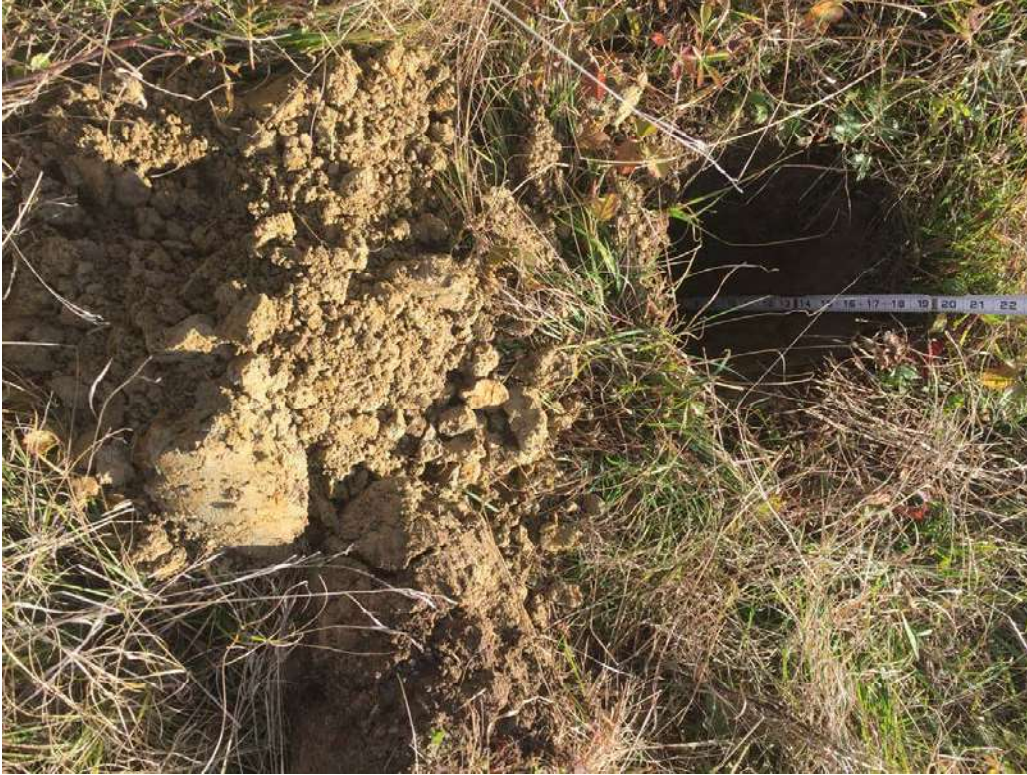
increasing to about 30% from 5-18 inches, with color of 7.5YR6/8. Soil texture from 0-5 inches was smooth, and an extended ribbon of 2.0 inches, indicating this is a silty clay loam. From 5-18 inches the soil had slight grit, and after moistening, a ribbon extended to 1.5 inches, indicating a texture of clay loam. Based on later laboratory analysis, the organic matter content from a sample taken at a depth of about 8-12 inches was quite low at 0.9% (Table 3). In summary, the soil at Sample Point #1 showed hydric characteristics (i.e., low matrix chroma, the presence of redoximorphic features; Figures 19 & 20).

Figure 19. Marsh Site Sample #1 soil pit with profile (see text for description).

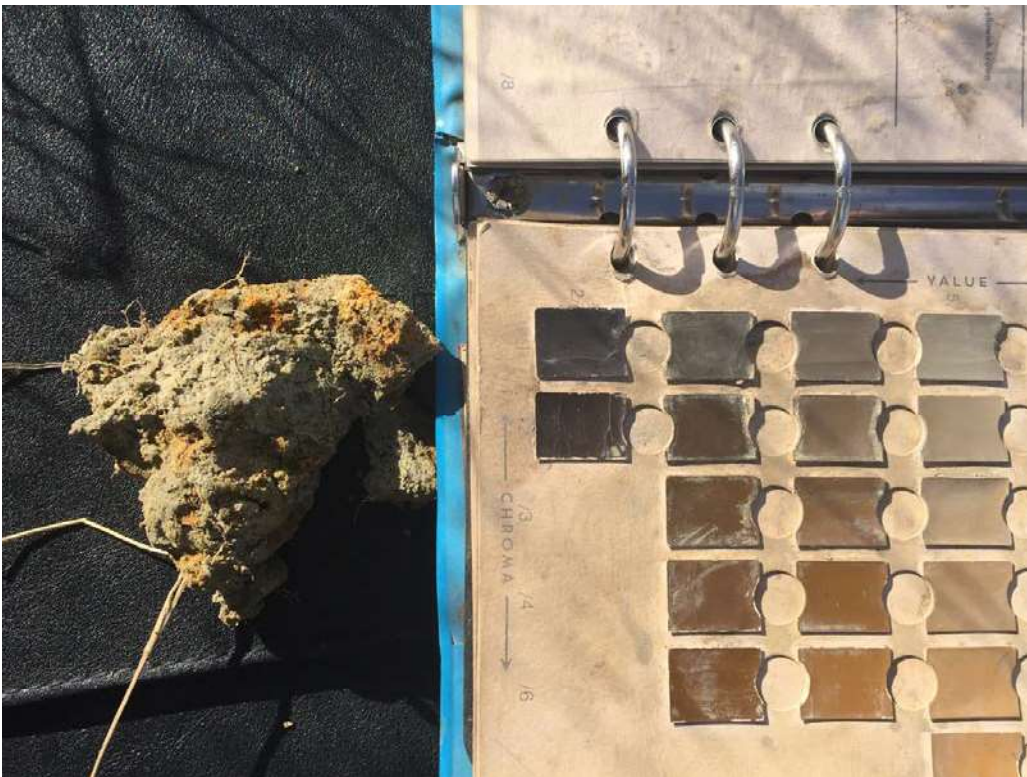
Figure 20. Munsell soil colors for Sample #1 showing hydric matrix, brighter mottles and oxidized rhizospheres (see text for discussion).

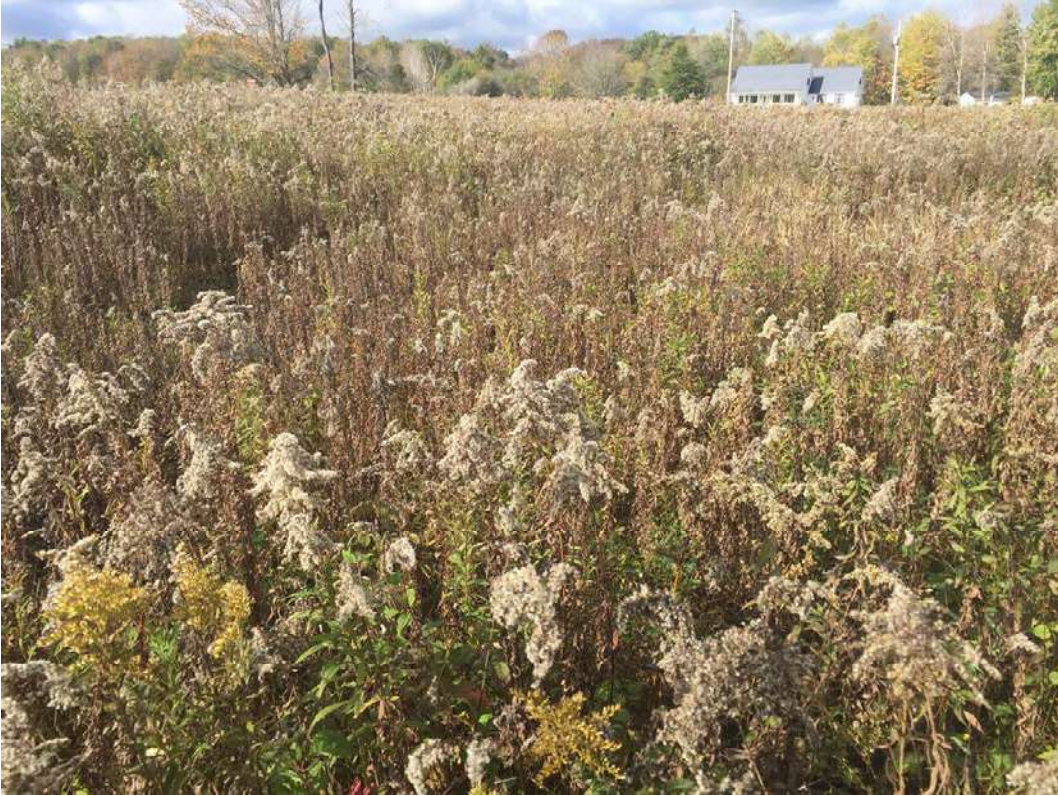
The vegetation in the vicinity of Sample Point #2 consisted of a combination of herbaceous and shrub species (Figure 23). The Dominance Test was positive for hydrophytic vegetation at 67% wetland species. There were no definitive hydrologic indicators at this point. Since normal circumstances do not exist at Sample Point #2, due to site alterations of hydrology and vegetation, the presence of all three wetlands indicators is not necessary to determine if the site is a wetland where a plausible explanation for the unconfirmed indicator is found. There was not sufficient detail available for the layout of the tile drainage and ditch network to estimate quantitative impacts on the Marsh Site, nor are there any known hydrologic measuring devices on site. The presence of a histosol (highly organic hydric soil), however, is a strong indicator that hydric conditions are present, especially when a viable hydrophytic plant community is present. Based on observations and the presence of a histosol, which develops over extensive time periods when conditions are sufficiently wet, there is active hydrology on this portion of the Marsh Site. Therefore, in my opinion wetlands are present at Sample Point #2 at the present time, despite efforts to alter the hydrology and vegetation in 2012.

Figure 23. Marsh Site Sample#2 vegetation (looking west) (see text for description).

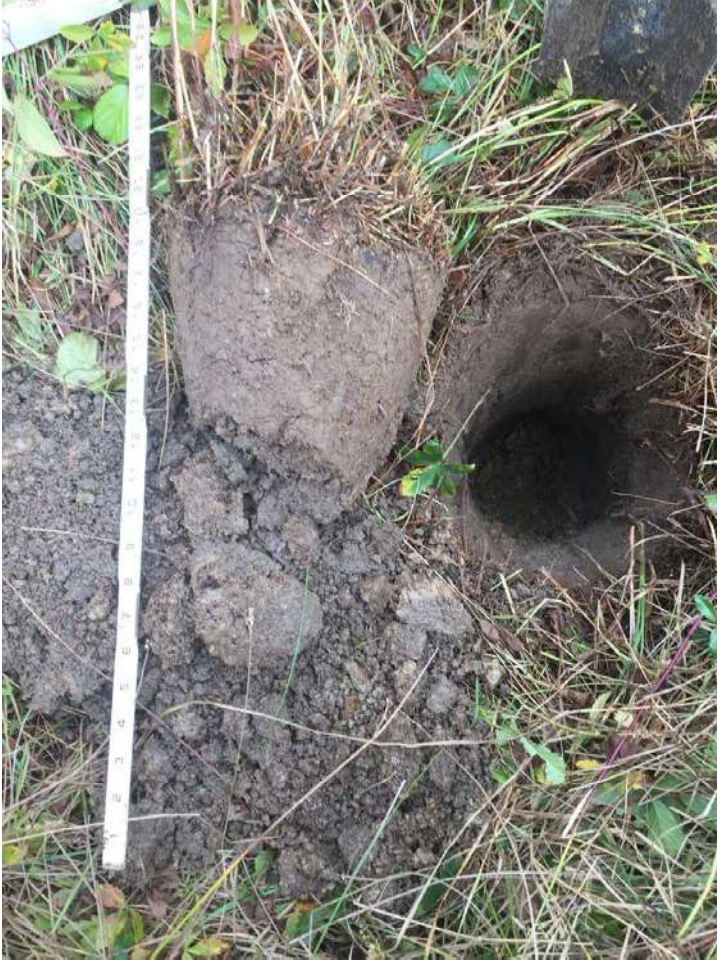
Sample Point #3 – Located at (41.9806992, -80.0470911) in a level area about 200 feet off Sharp Road. According to the Erie County Soil Survey, this point is located near the transition between Canandaigua mucky silt loam, which is listed as a strongly hydric soil in this county, and Red Hook silt loam (along Sharp Road), which is listed as a non-hydric soil (Figures 17 & 18). The soil pit suggested this is a transition area, with 5YR5/1 matrix from 0-10 inches, and mottles occupying 10% with a color of 75YR5/6. Oxidized rhizospheres were observed (and photographed, Figure 25) in the upper 9-10 inches. The soil texture was not gritty, and produced a ribbon of 1.5 inches, indicating this is a silty clay loam. From 10-18 inches the matrix color was a mixture of 10YR6/2 and 10YR4/4, with small areas (2%) of mottles of 5YR4/4 presenting redoximorphic features (Figure 24 & 25).

Figure 24. Marsh Site Sample #3 soil pit and profile, (see text for description).

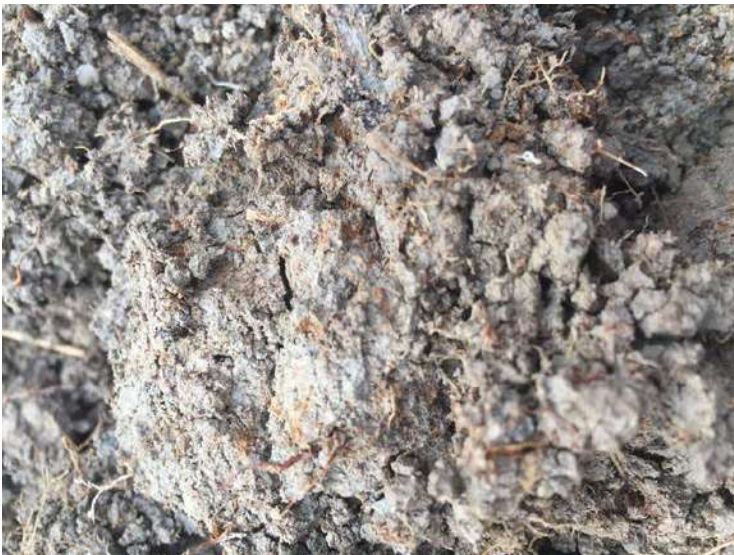
Figure 25. Marsh Site Sample #3 oxidized rhizospheres, 9-10 inches depth (see text for description).

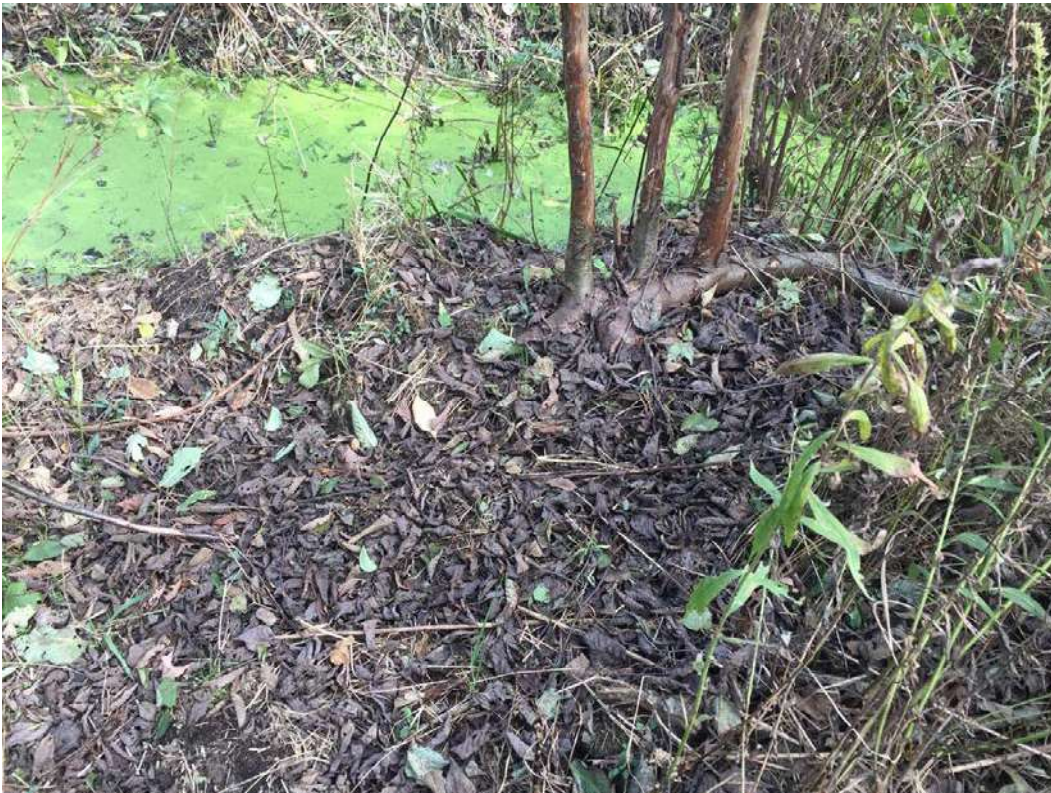
Figure 31. Marsh Site Sample #5 next to auxiliary duckweed-covered ditch flowing into Elk Creek.

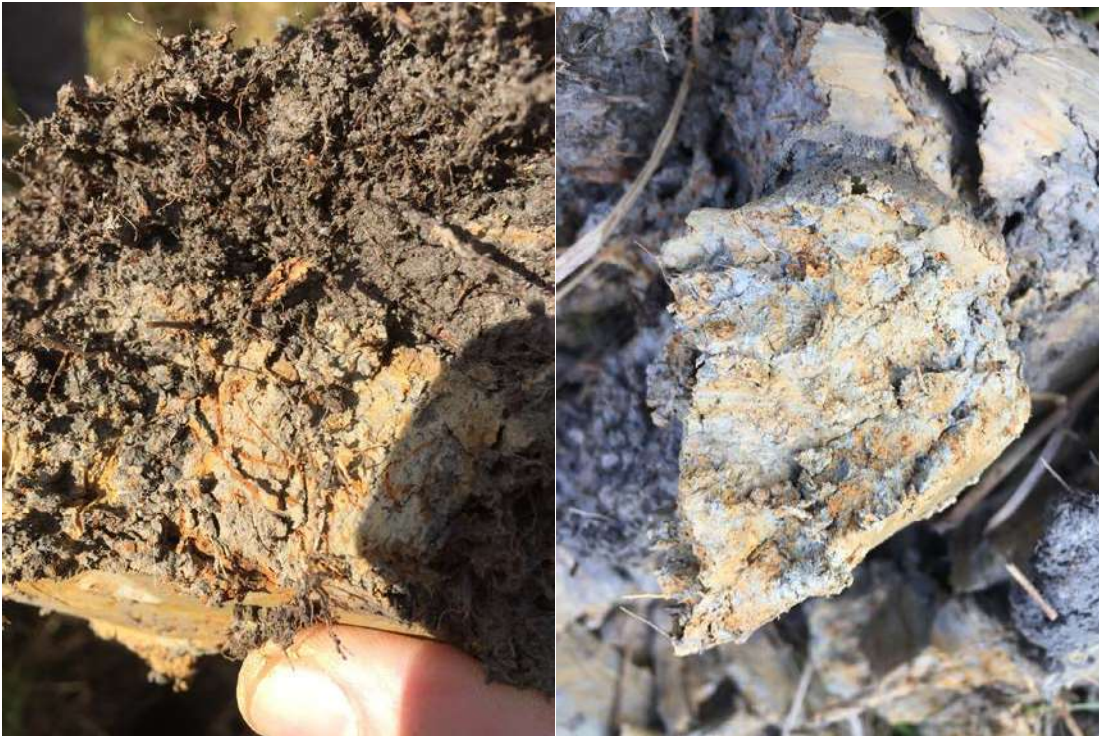
Figure 35. Marsh Site Sample #6 hydric soils: left – oxidized rhizospheres near surface; right – gleyed soil with mottles in lower portion of soil pit.

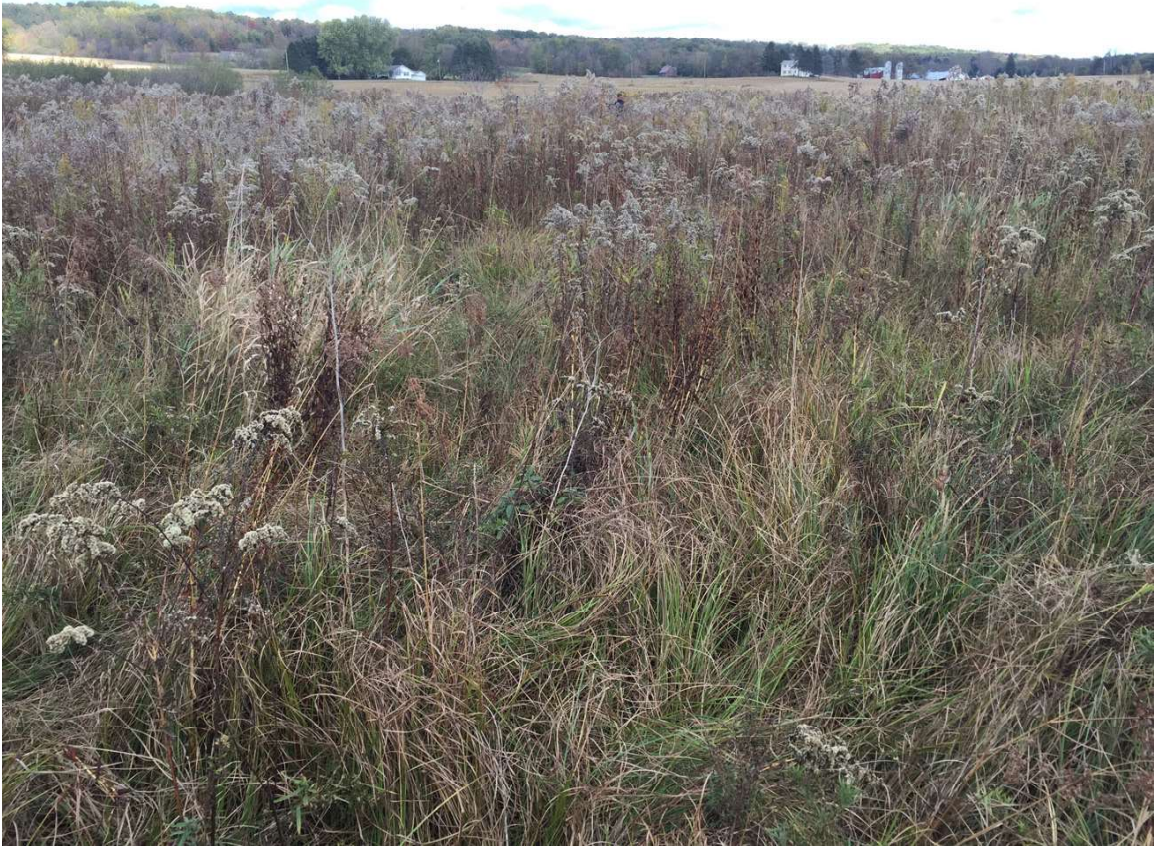
Figure 36. Marsh Site Sample Point #6 vegetation dominated by wetland plant species.

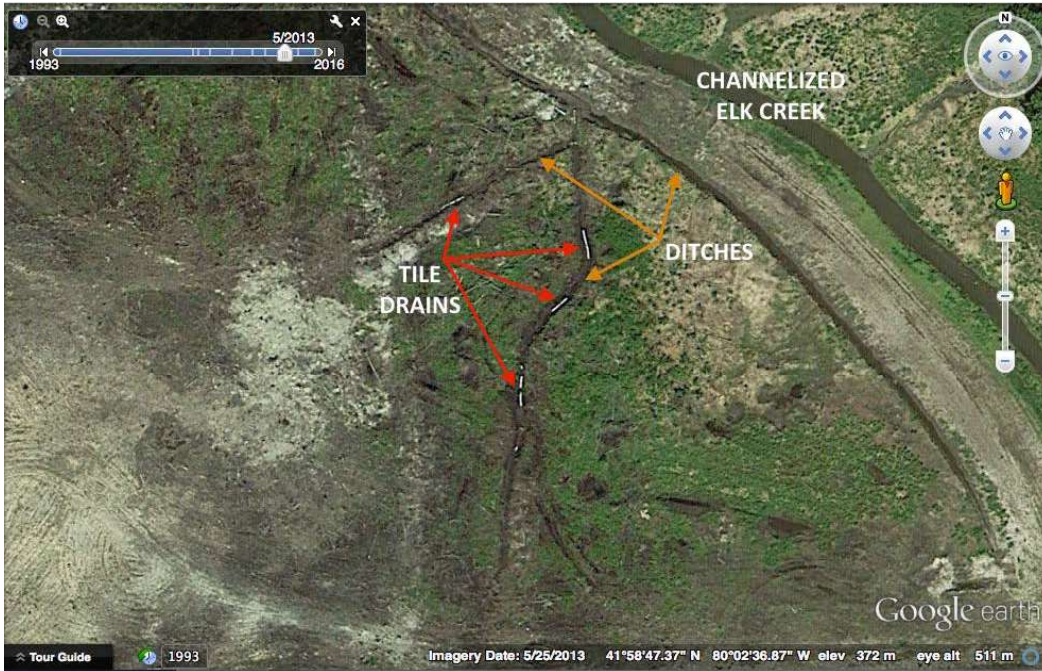
Figure 47 (close-up Figure 11). May 2013 aerial photograph of the Marsh Site (natural color, Google Earth) showing extensive disturbance of vegetation throughout site to bare soil, scattered logs and branches on the ground, plus labeled hydrologic alterations of tile drains (red arrows) and ditches (orange arrows) causing changes to wetlands in the floodplain of Elk Creek (near Sample Point #5).

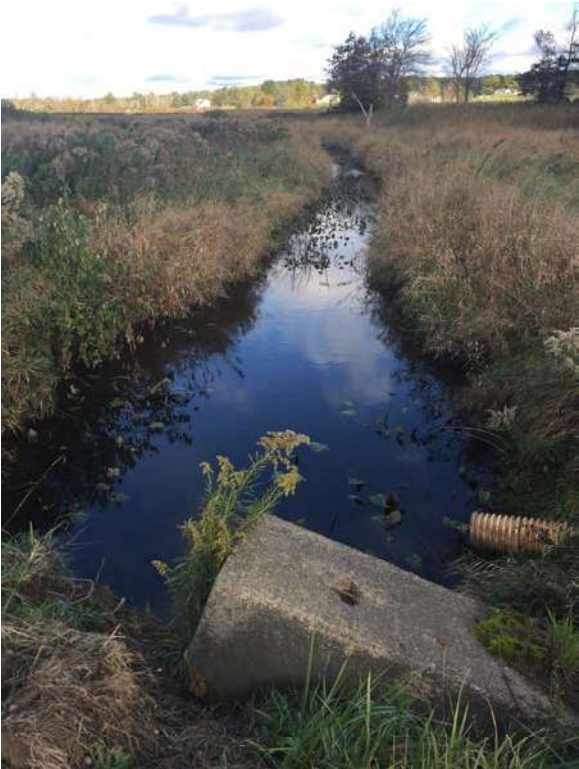
Figure 49. October 2017 photograph from Marsh Site inspection by Brooks; Elk Creek from Lane Road looking downstream (north) showing recovering herbaceous vegetation after soil disturbance in 2012, and channelized reach of Elk Creek.

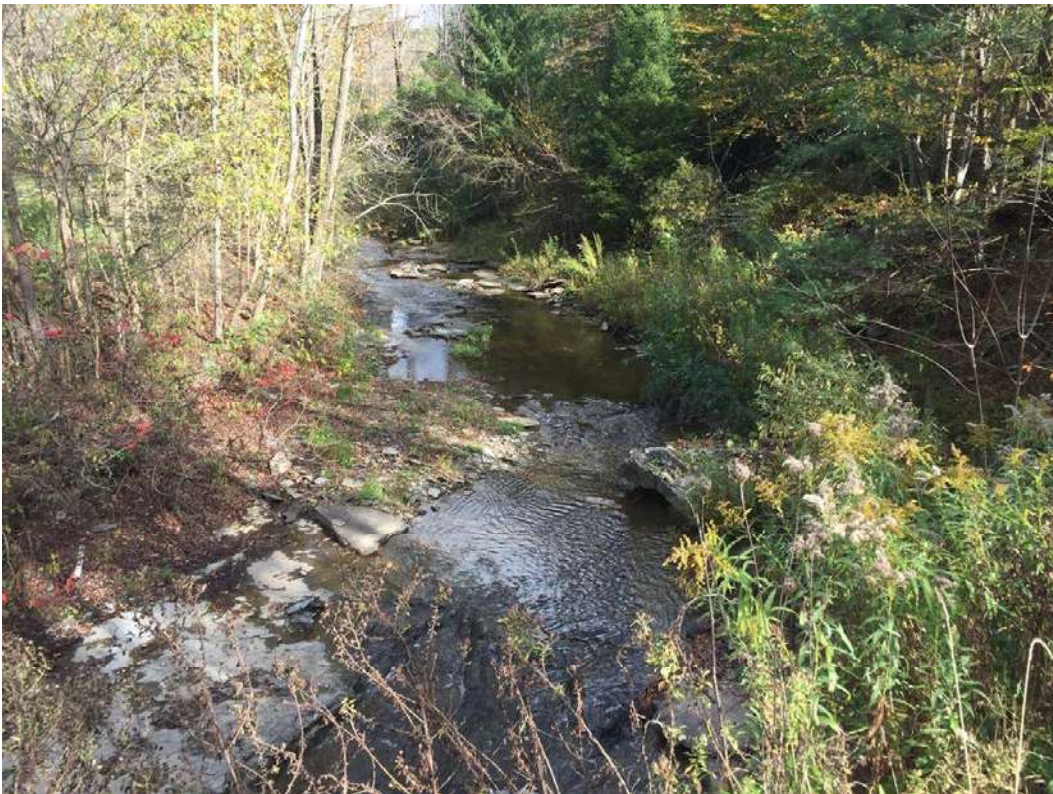
Figure 52. Hamot Road bridge looking upstream; stream bed rocky and relatively steep-sided, more incised than upstream portions of Elk Creek.

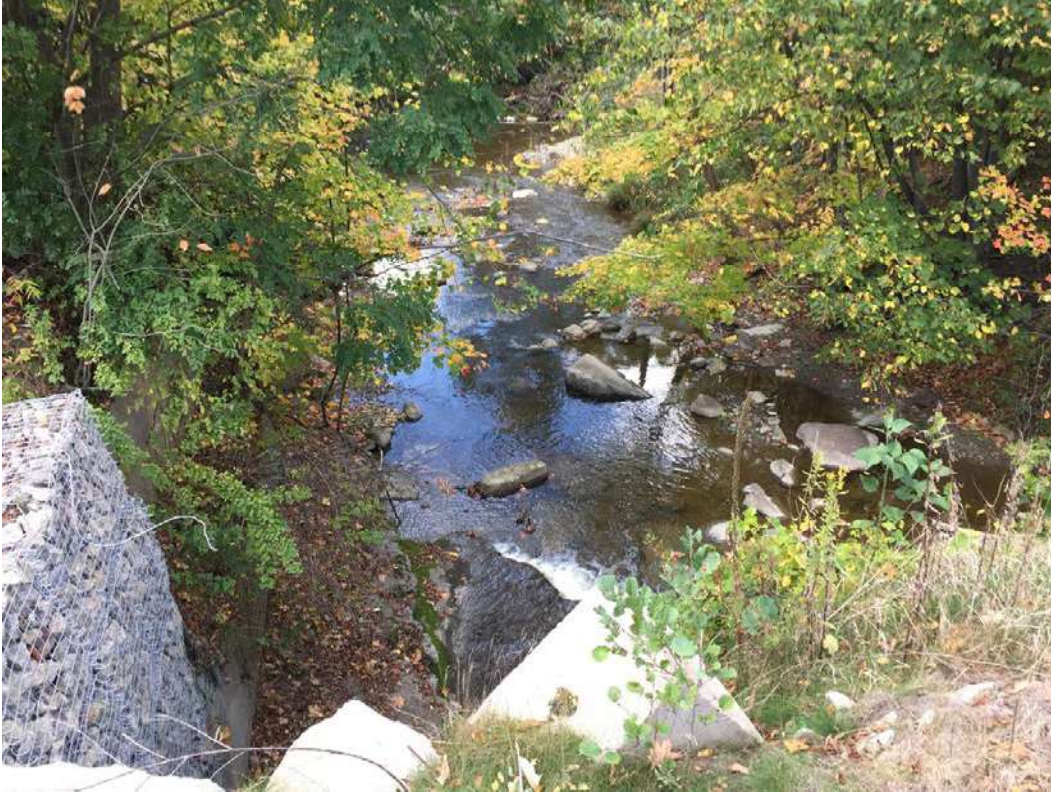
Figure 53. Elk Creek crossing under Oliver Road, steep-sided gorge; bridge supported by gabions.

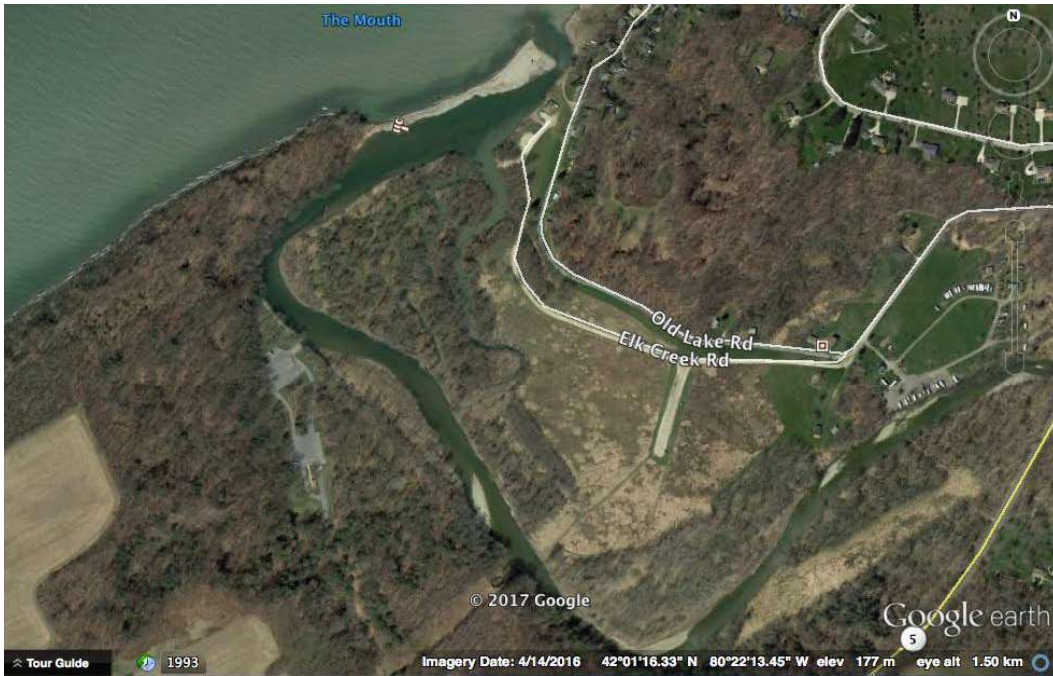
Figure 57. This reach connects directly to Lake Erie in about 500 feet along a sand spit referred to as “The Mouth”, establishing permanent connectivity to a TNW (Google Earth image).

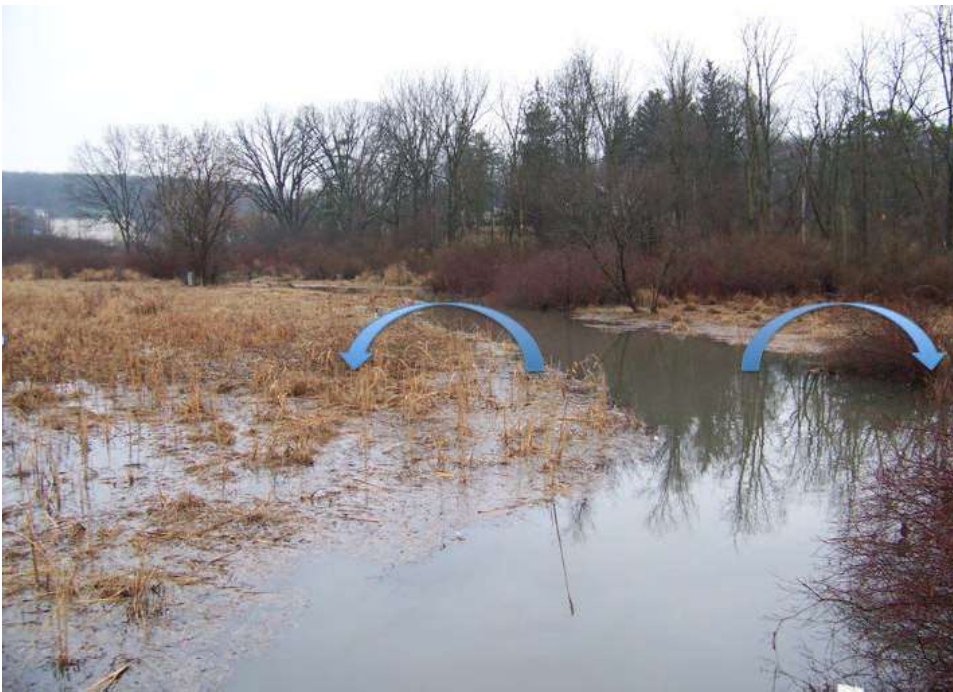
Figure 58. Example of overbank flooding of a similar sized stream where the stream is connected to the floodplain allowing frequent movement of water from the stream to the floodplain and from the floodplain back to the stream channel (Photograph by R. Brooks from central Pennsylvania).

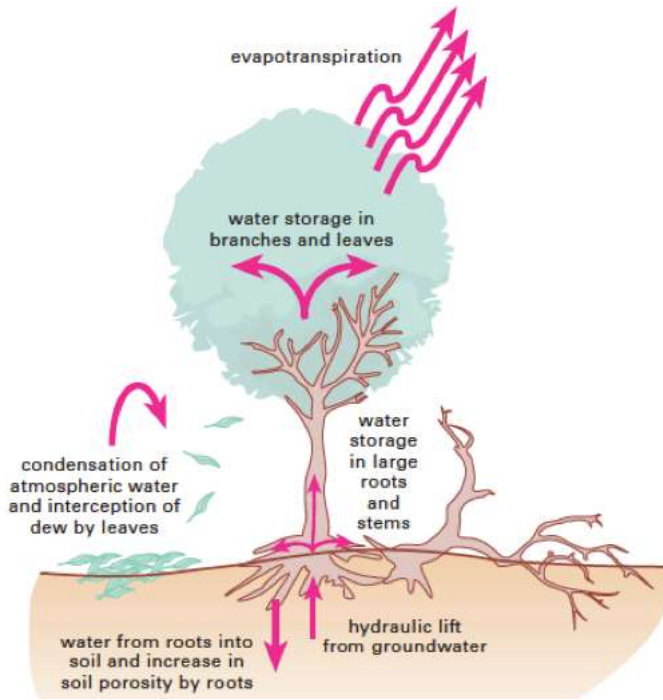
Trees are very important for maintaining the hydrology and function of floodplain forests.

Figure 65. Diagram of ecological processes associated with trees in forested wetlands and floodplains.

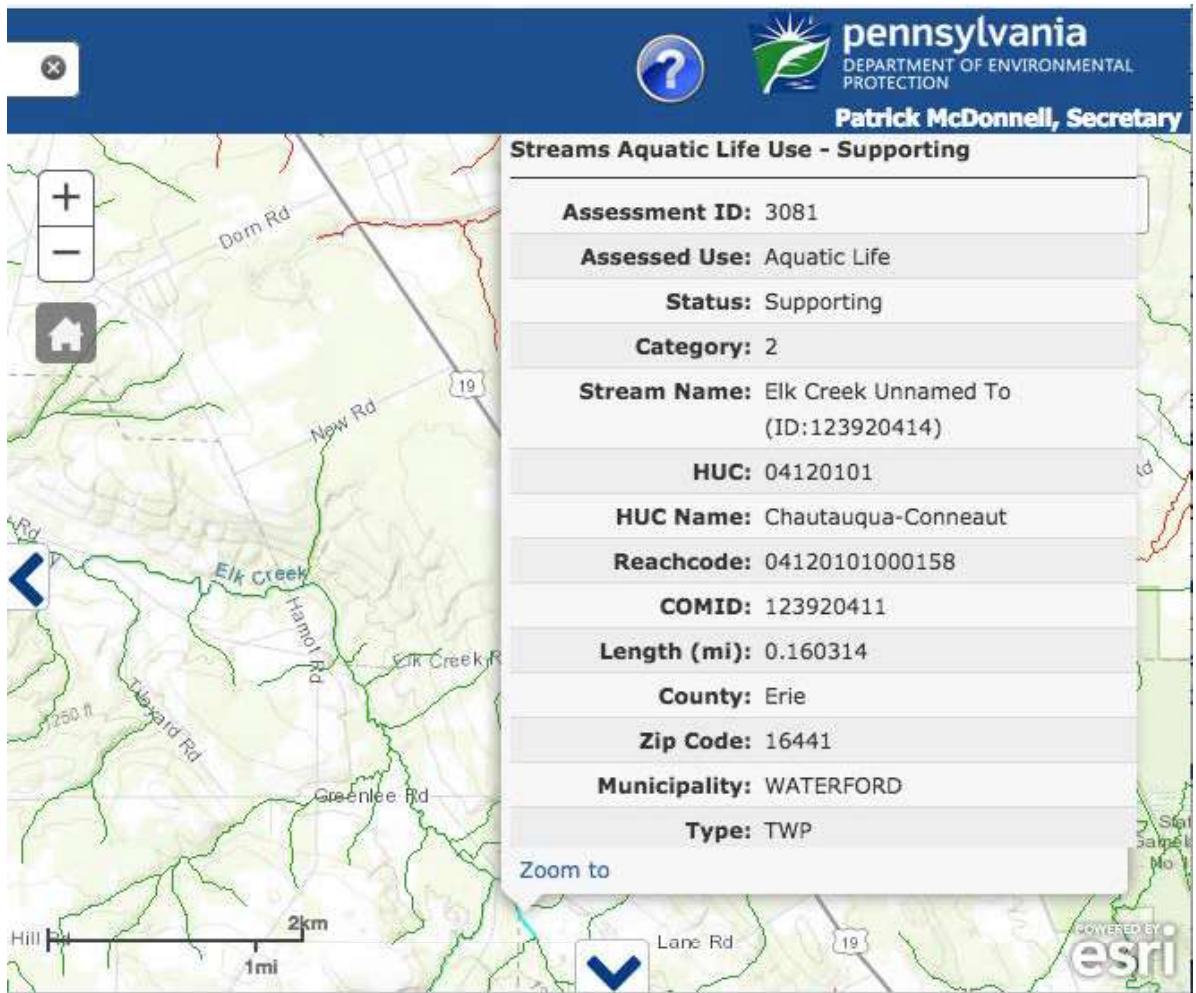
Figure 67. Elk Creek reach along the Marsh Site (see Zoom to arrow above) assessed by PADEP as Supporting Aquatic Life Use for the 2016 Triennial Integrated Water Quality Monitoring and Assessment Report (303(d) list). All streams of Elk Creek watershed appear to be in the same category.

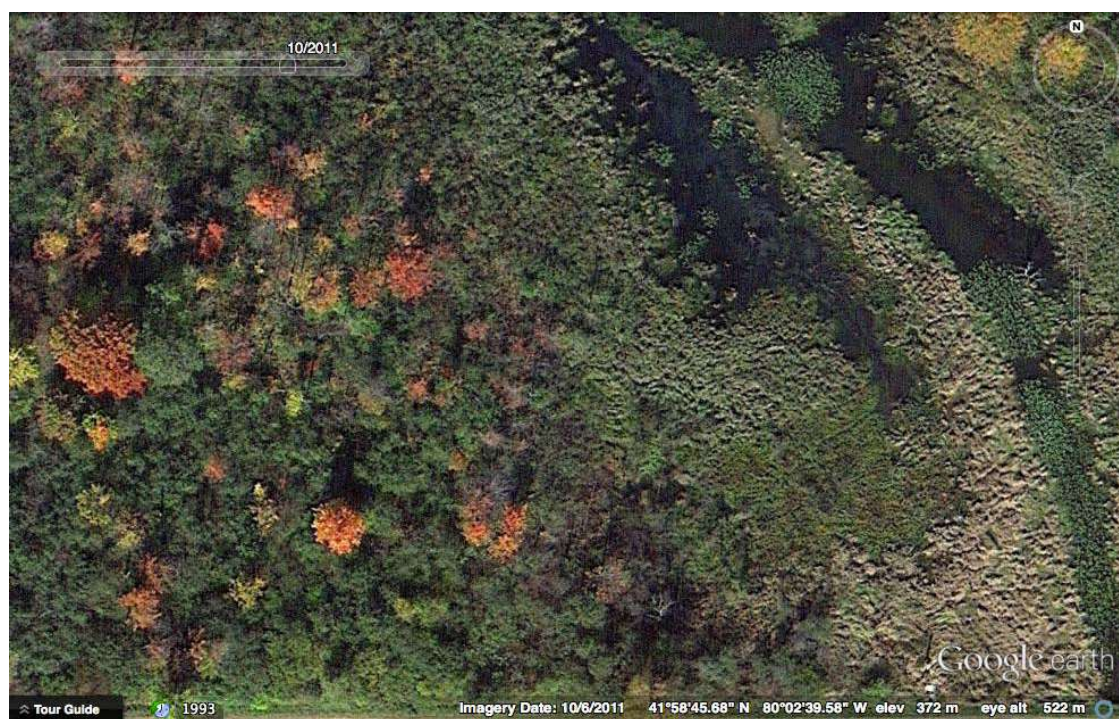
Figure 68. Conceptually, wetland and stream restoration of the Marsh Site should be designed and constructed to reach vegetation communities and hydrologic regimes comparable to the pre-disturbance condition of the site (2011 aerial photograph – close-up of southeast corner of the Marsh Site (Google Earth)).
