HISTORICAL, ARCHITECTURAL AND ARCHAEOLOGICAL  
INVESTIGATIONS AT THE STEINER-SCHOB COMPLEX  
VICTORIA COUNTY, TEXAS

Center for Archaeological Research  
The University of Texas at San Antonio  
Archeological Survey Report, No. 52

1. Historical, architectural and archaeological investigations at the Steiner-Schob Complex;
2. Coleto Creek Project, Steiner-Schob Complex;
3. Victoria County, Texas;
4. Thomas R. Hester, Principal Investigator; Anne A. Fox, Field Director and co-author; Katherine Livingston, Project Manager for the office of Eugene George, AIA Architect and co-author;
5. Guadalupe-Blanco River Authority;
6. Texas Historical Commission Antiquities Permit No. 80;
7. Published by the Center for Archaeological Research, The University of Texas at San Antonio, San Antonio, Texas 78285; June 1979.

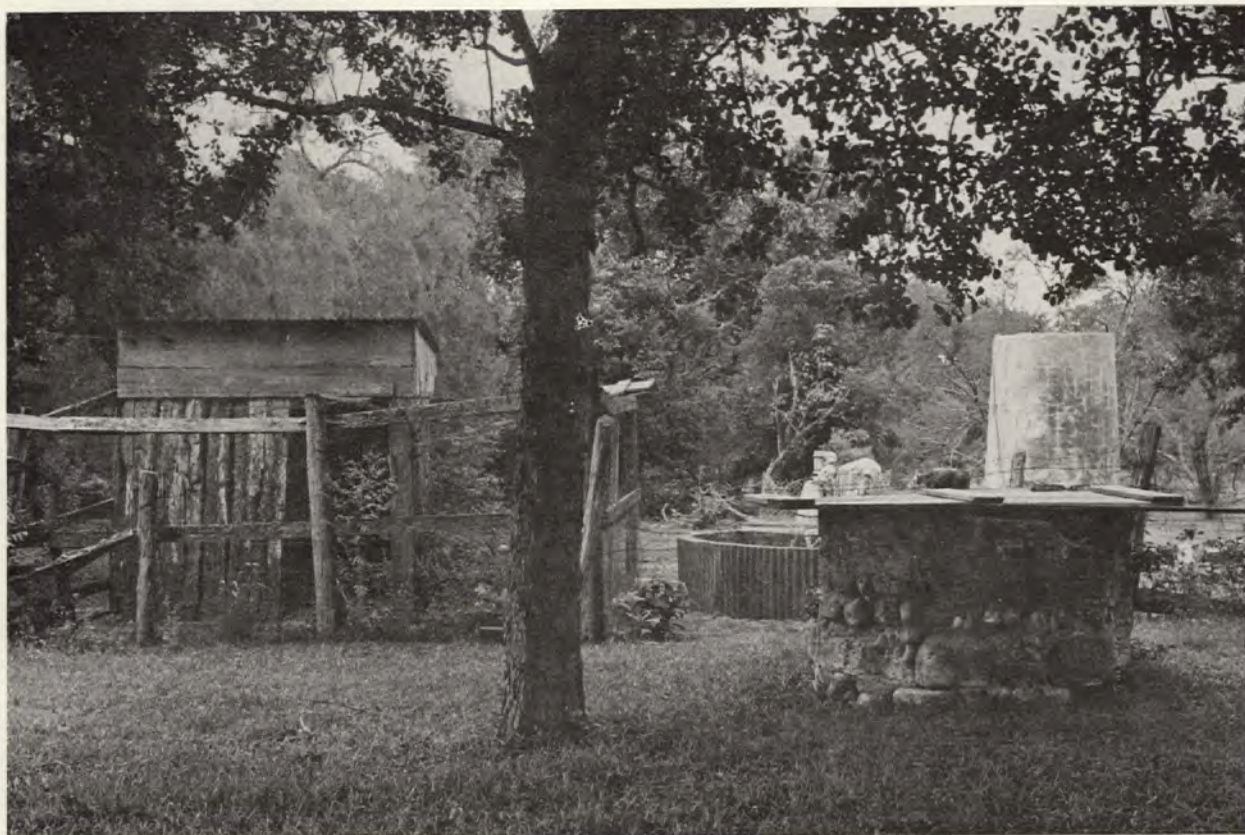
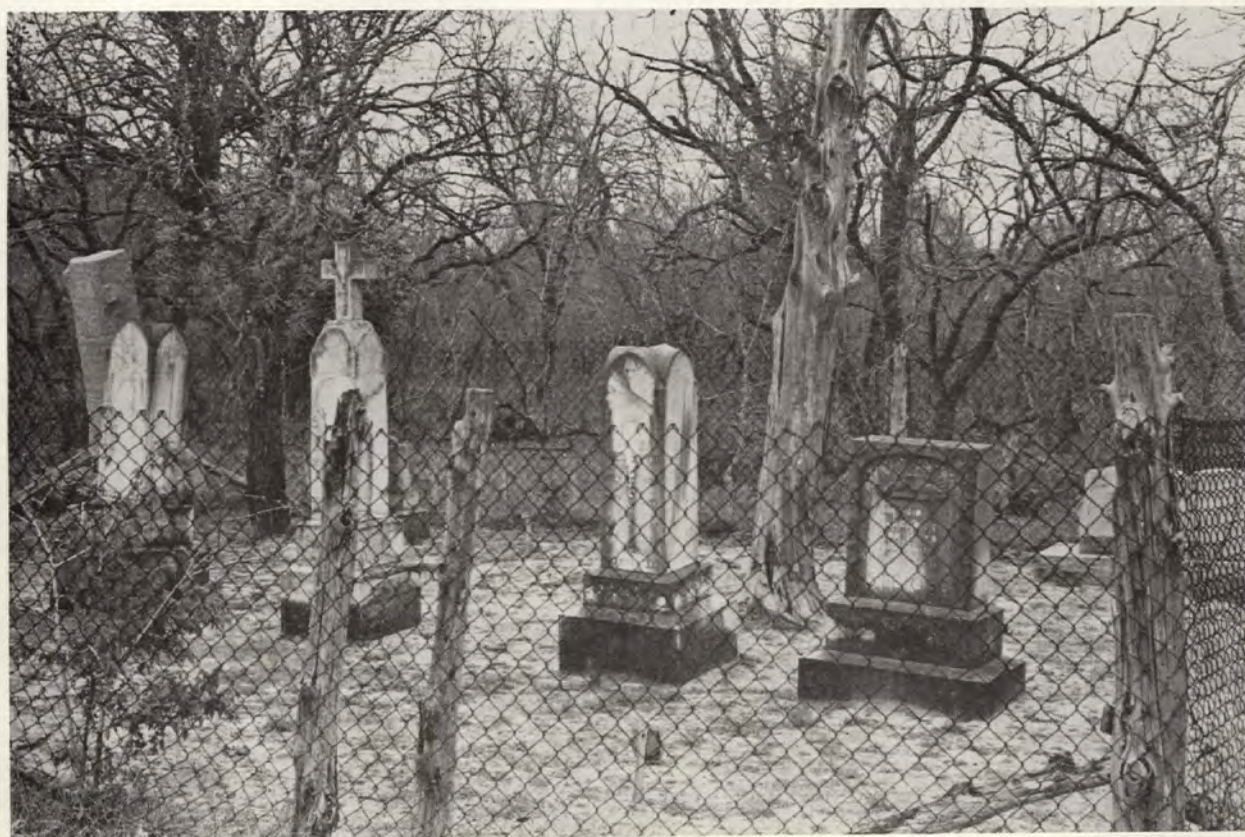
Figure 4. *Outbuildings*. a, Guinea house (old smokehouse?) on the left and well on the right; b, cemetery.

Family tradition relates that the small building last used as a guinea house was the smokehouse that had been brought up from the Steiner site. The archaeologists uncovered foundations that roughly approximate the size of the existing smokehouse; however, a connection between the two cannot be ascertained. The existing smokehouse had its shingled roof removed and a flat roof installed ca. 1969 (Fig. 4,a).

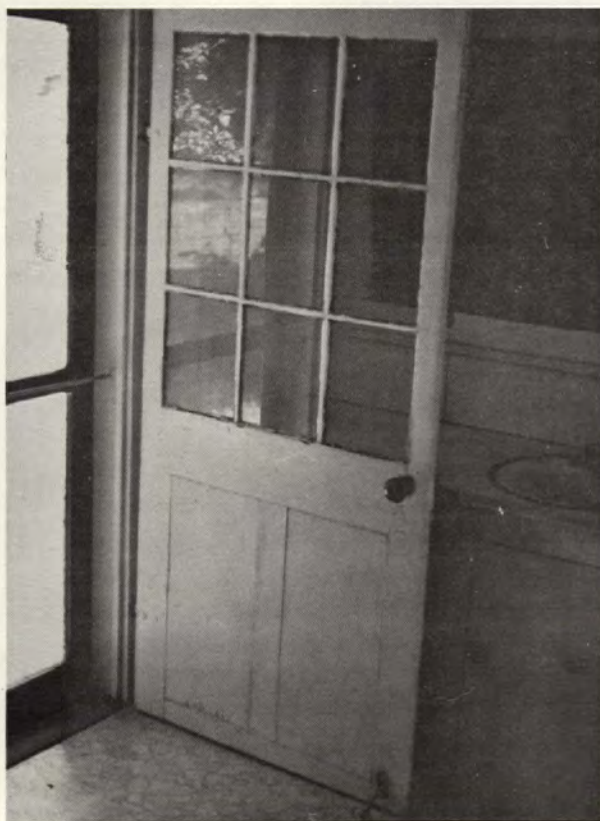
Figure 5. *Steiner House Photographs*. a, Steiner House at Schob site; b, door reported to have been used in the Steiner House; c, detail of hinge.

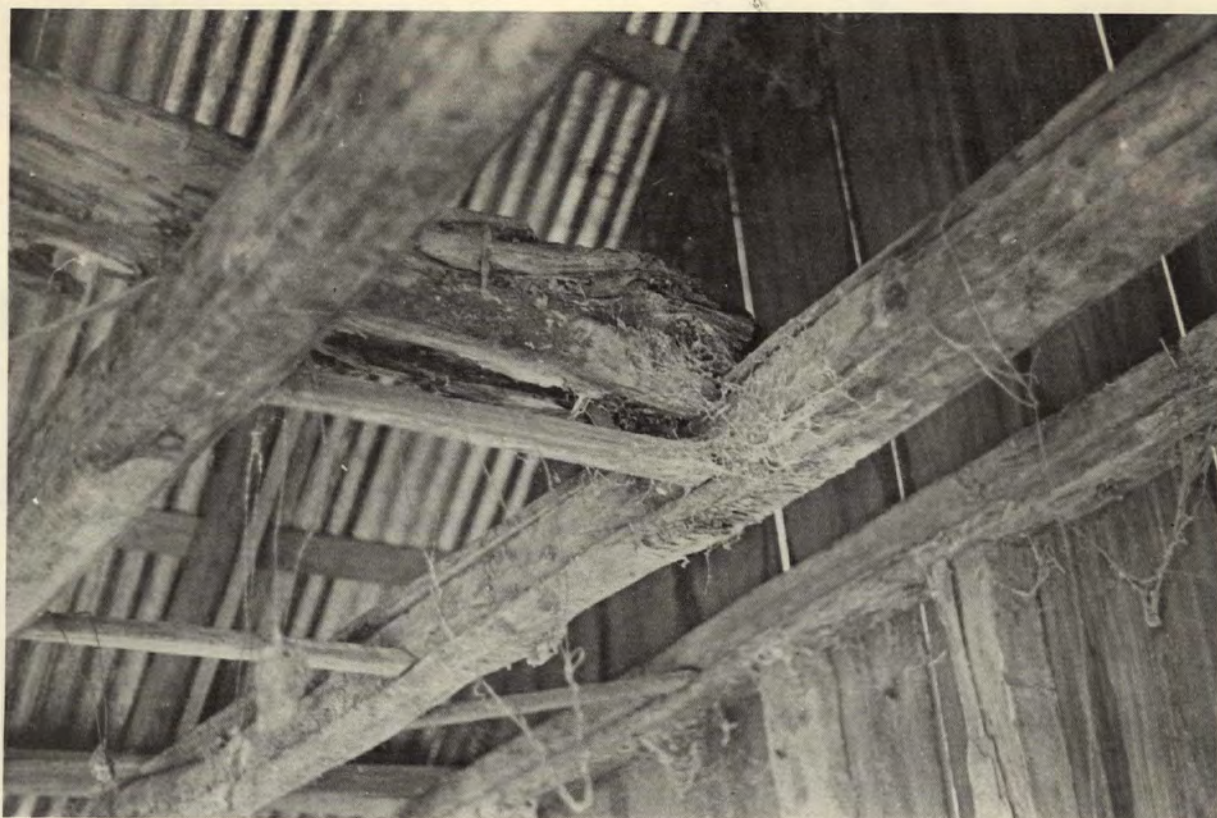
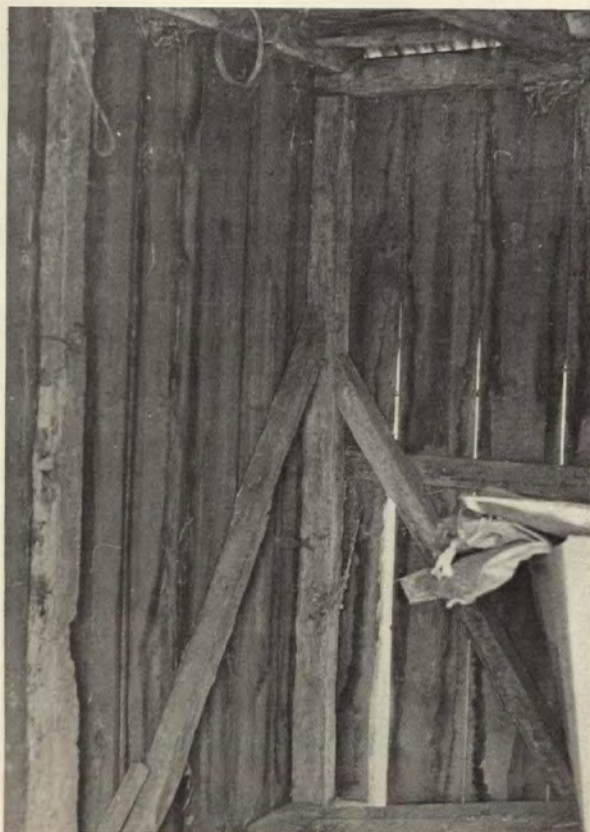
Figure 7. *Steiner House Details.* a, Detail of grooved ceiling joists; b, c, hewn structural members, note corner bracing.

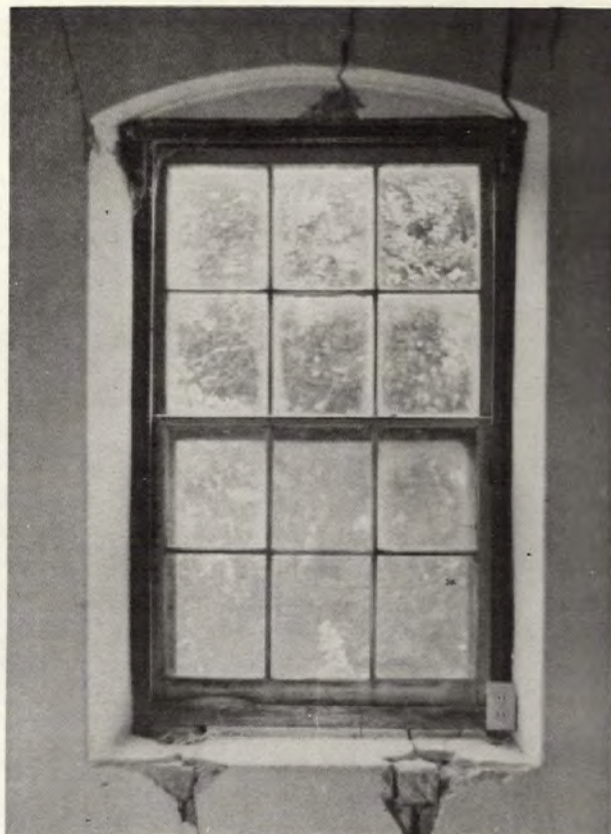
Figure 9. *Architectural Details.* a, typical window; b, window, second floor; c, doorway, second floor; d, window, first floor.

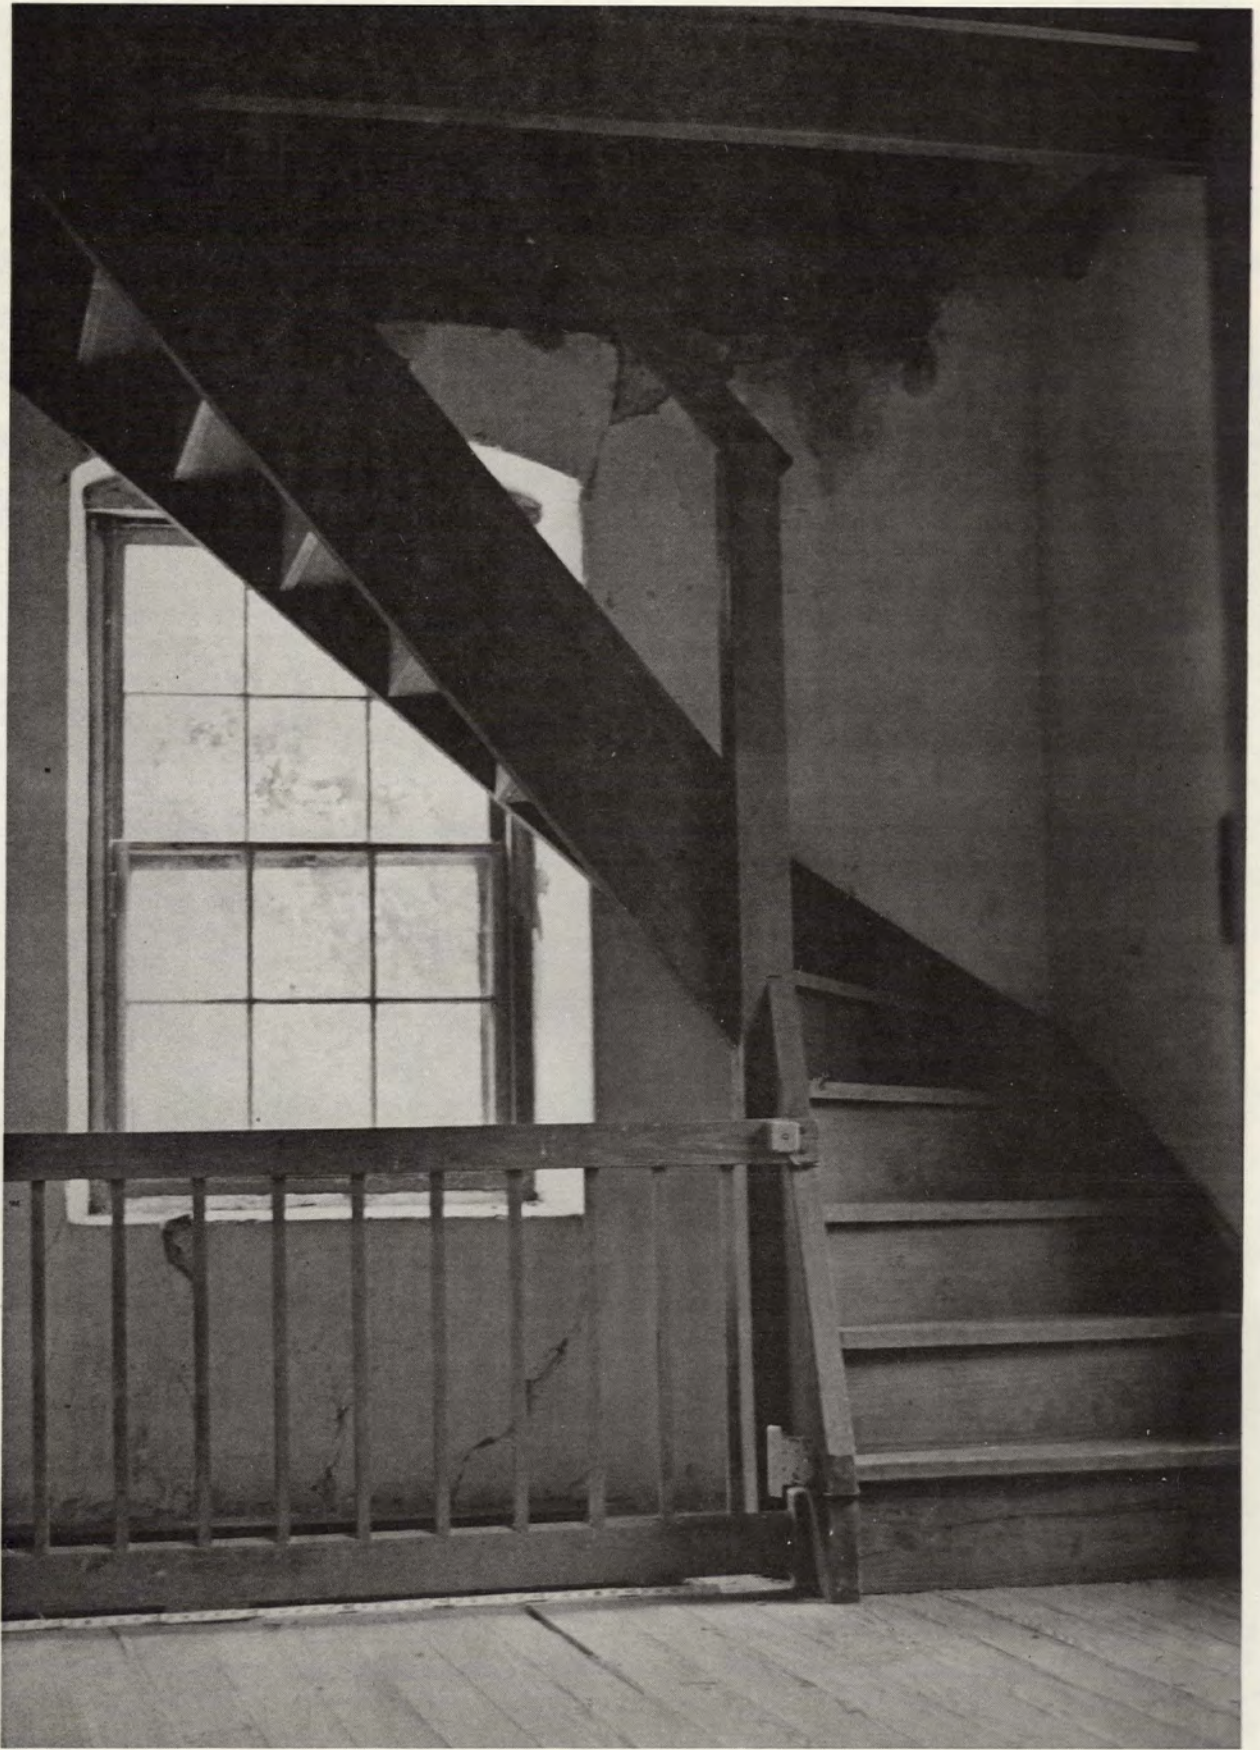
Figure 11. *Interior Stairs, Second Floor.*

The stairs to the second floor lead into a room 12 ft 8 in x 17 ft 2 in which contained a roller organ Steiner brought from Germany and a great pipe organ bought in 1885 from a Lutheran church. The ceiling and joists in this room were painted green. The stairway continues from this room to the attic space (Fig. 11). On the second floor was the Schob's bedroom in the adjacent room. Mrs. Augusta Sandhop remembers that the room contained a four-poster bed and two dressers. A rocking chair which the Steiners brought over from Germany also was used in this room. The ceiling is painted blue. The flooring throughout the second floor is pine, 4-1/2 x 3/4 inches, matched.

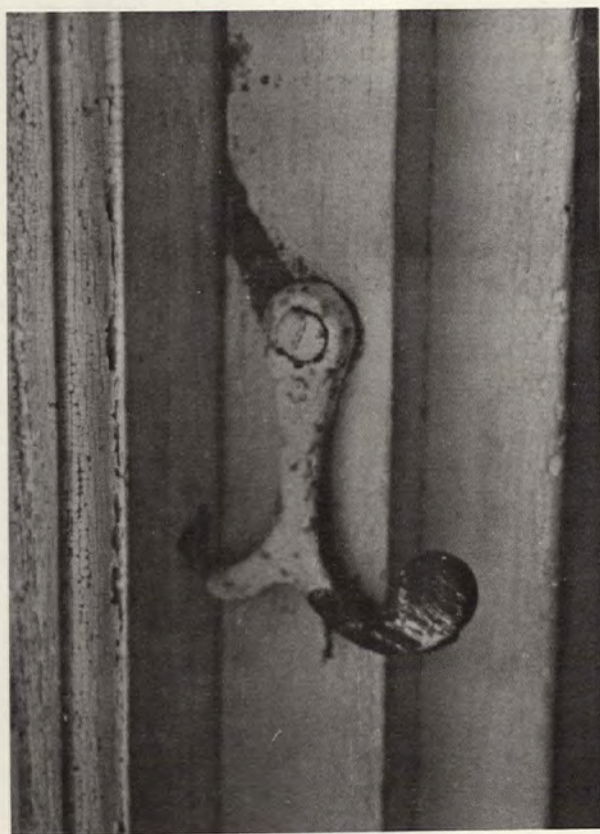
Figure 12. *Hardware.* a, front door latch, from exterior, 7-3/4 inches long; b, front door latch, interior; c, device to hold open bottom sash of the window; d, typical door lock.

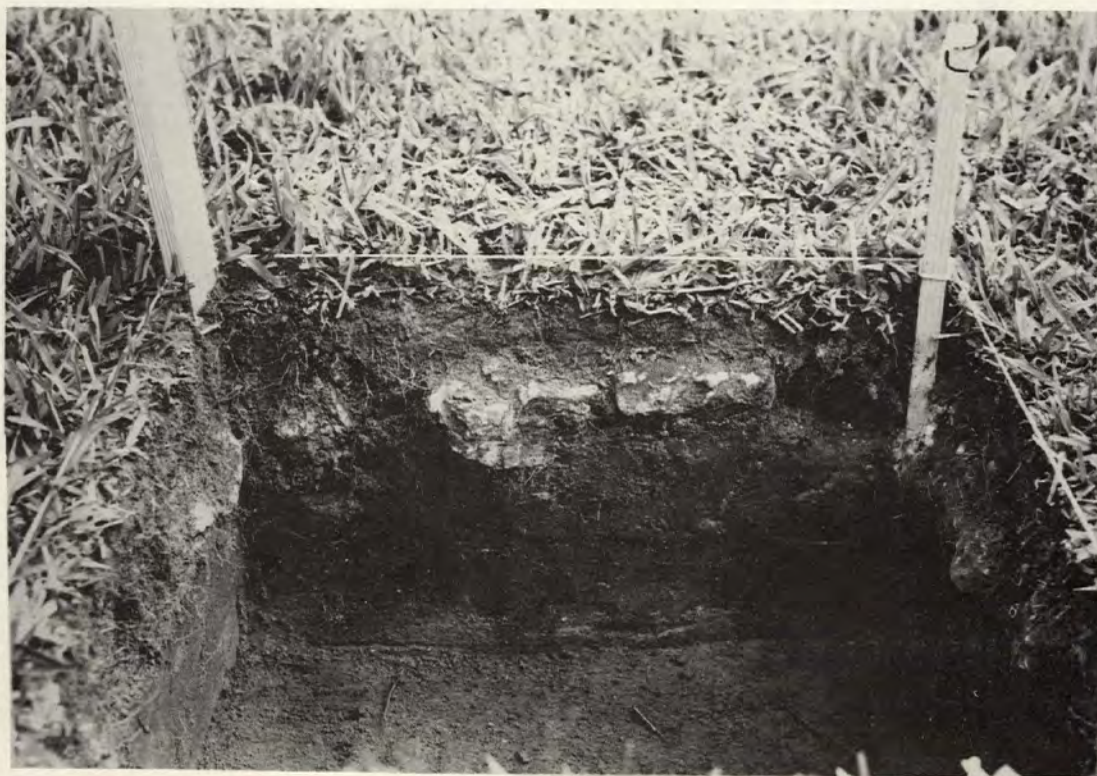
Figure 17. *Excavations at the Schob House, Photographs.* a, test trenches in kitchen area, outhouse-tool shed in background, present kitchen to left; b, stratigraphic test in front yard, showing cobblestone paving beneath the grass.

A series of test trenches was laid out over the area (Figs. 17,a and 18,a) and two-inch levels were excavated with trowels, screening all soil through 1/4-inch mesh to obtain maximum recovery of artifacts. In this manner it was hoped to discover any remaining traces of drip lines from the roof, or architectural features such as pier bases or post holes, steps or walks, or a chimney foundation. Artifact distribution could also be plotted to determine possible location of the building through concentrations of small articles and fragments which would have fallen through cracks in the floor of the kitchen.

A test excavation just southeast of the present kitchen revealed a layer of cobblestones at four inches below the surface, beneath which the soil was sterile (Figs. 17,b and 18,b). In a subsequent interview, Mrs. Augusta Sandhop recalled that a large portion of the yard around the house had been paved in this manner. (A similar custom can still be observed in the older German settlements in the

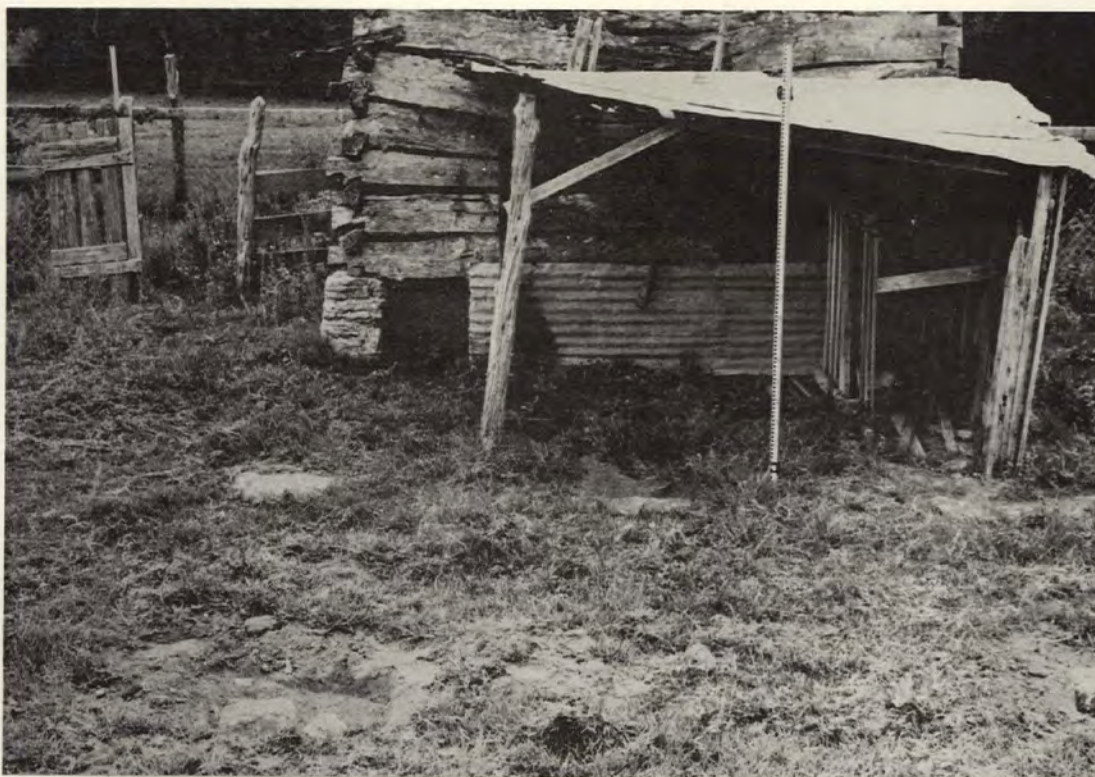
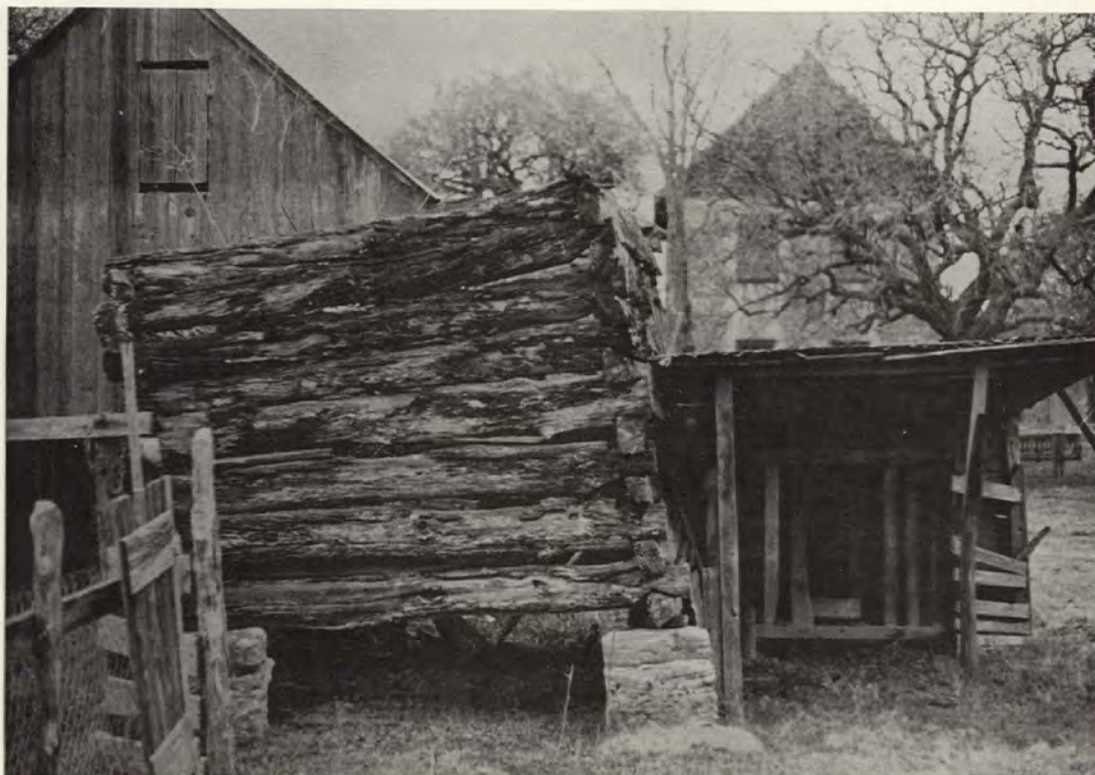
Figure 21. *Log Shed at Schob Farm.* a, shed from southeast, showing locations of stone piers for the missing section in foreground; b, shed from southwest, note half-dovetail notching. Barn made from Steiner house to the left. Schob house in the background.

The construction of the barn of hewn logs with half-dovetail corner notching bears witness to its mid-19th century origin (Jordan 1972:59-76). Identical construction has been found on other early German sites in Texas, such as the Legler and Polasek sites in Fayette County (Carter and Ragsdale 1976:33-34, 37). It seems likely that this was one of the first buildings on the Steiner place and was, indeed, moved to its present site at a later date.

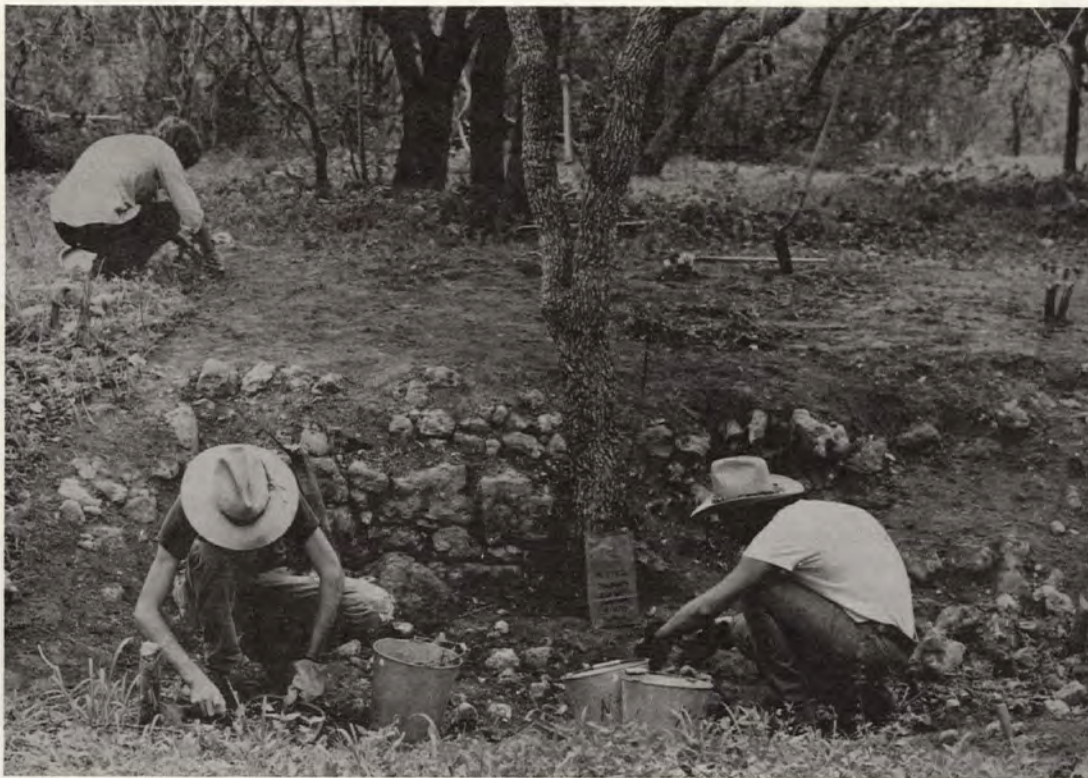
**a**

Figure 23. *Excavations at Steiner House, Structure 1.* a, cleaning the surface in preparation for laying out the grid. Cellar depression is in the foreground; b, start of excavation within grid units.

The first problem in beginning excavations was to determine the precise orientation of the walls of the collapsed cellar in order not to waste time in exploratory excavations. To accomplish this, the crew worked with trowels to clear the cellar surface of debris and loose rocks, making a controlled artifact collection and continual observations of the wall lines as they appeared. Within a short time, the line of the southwest cellar wall began to emerge (Fig. 23,a).

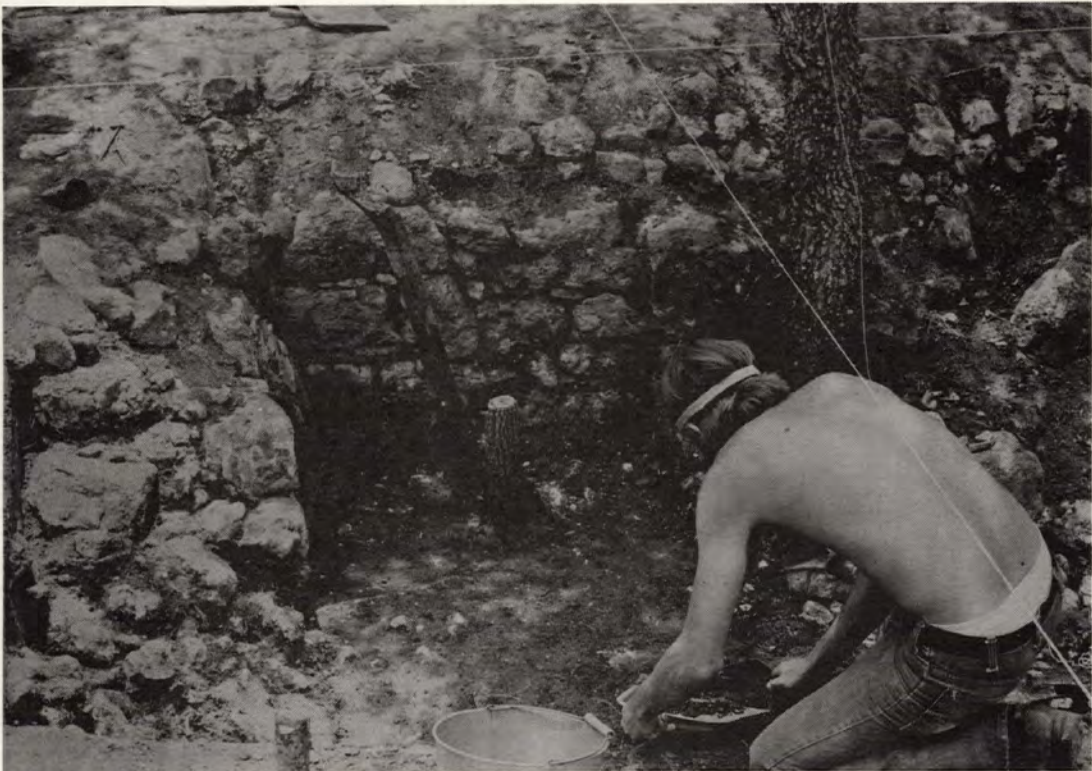
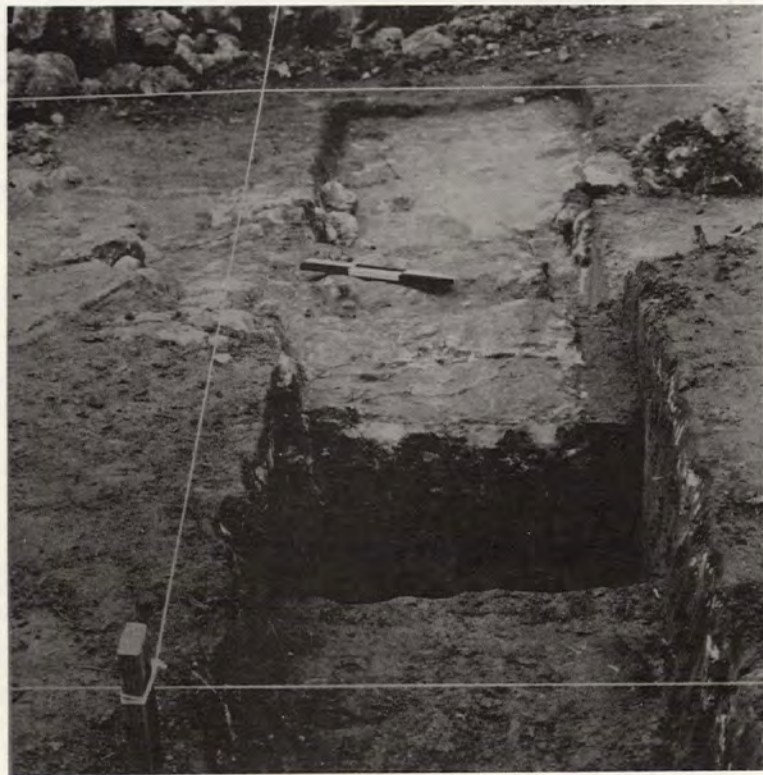
Figure 26. *Excavations at Steiner House, Structure 1.* a, Unit C in corner of cellar; b, Unit D from northeast, showing depth of chimney footing.

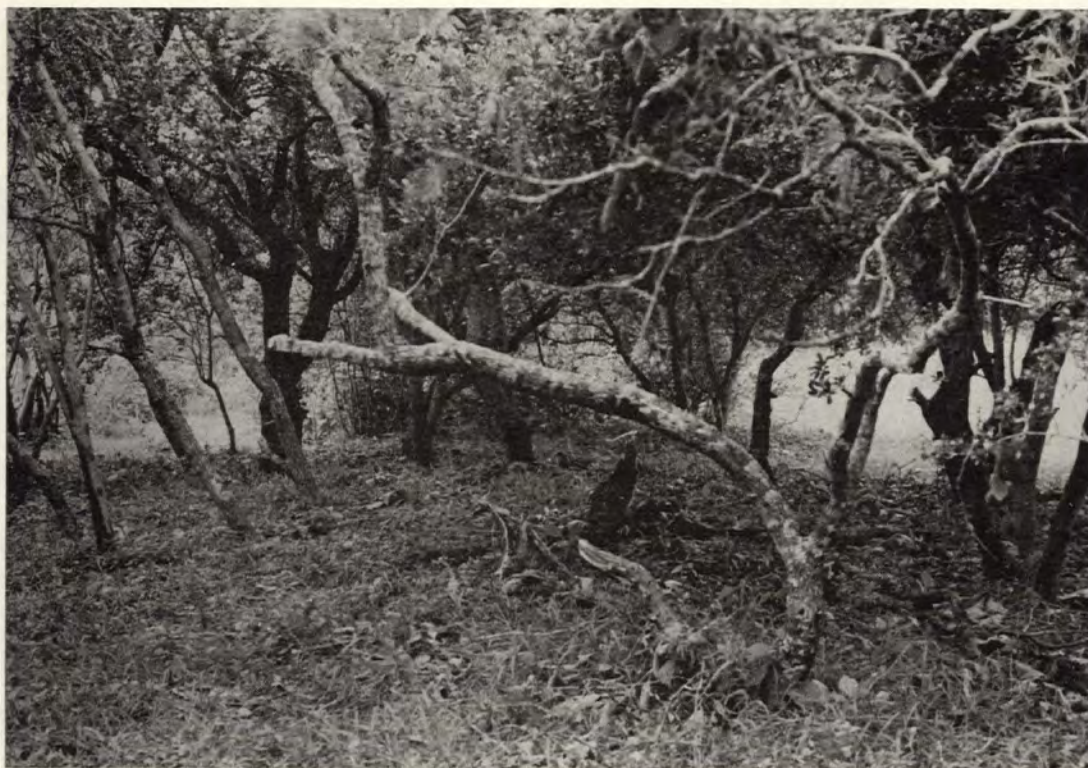
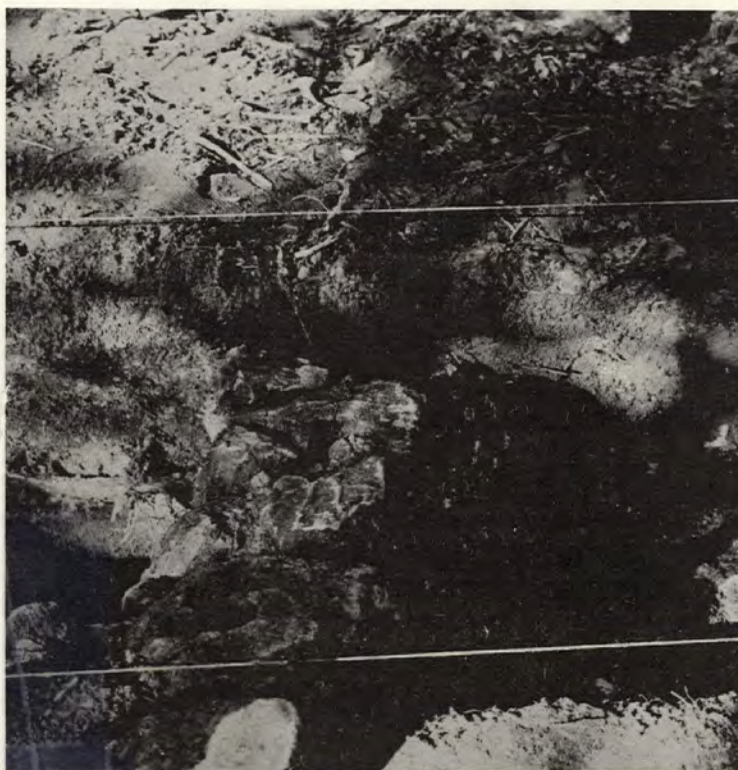
Figure 27. *Excavations at Steiner Site, Structure 2.* a, area before excavation, from the east; b, Unit A, showing construction of wall footing.

An area to the northwest of Structure 1 was designated Structure 2. When first cleared, this feature consisted of a low mound of earth (Fig. 27,a) in the surface of which were several groups of shaped sandstone blocks that appeared to be wall foundations. A trench designated Unit A (Fig. 28) was excavated into the center of the mound in hopes of locating a wall line and determining the content of the mound. After the surface humus was removed, a sterile yellow/tan clay deposit was encountered. Below this clay cap was a darker deposit of gray and tan clay containing numerous artifacts and animal bones. Near the north end of

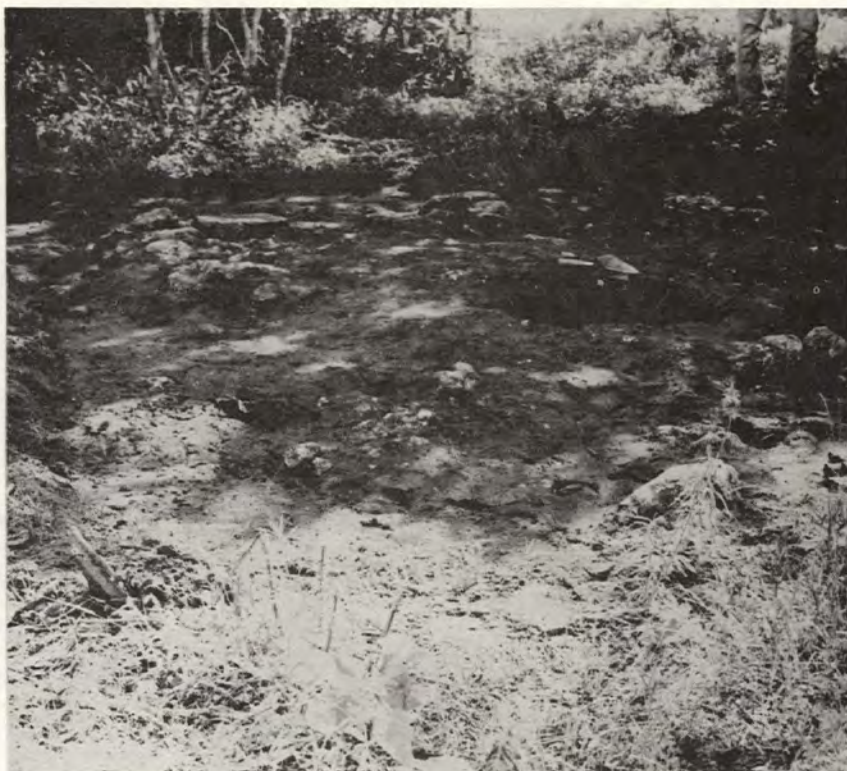
**a**

Figure 30. *Views of Steiner Site Features.* a, Structure 3, showing footing remnants and test pit in center; b, the well, covered with hewn logs from the old log barn; picture taken from the house site (Structure 1).

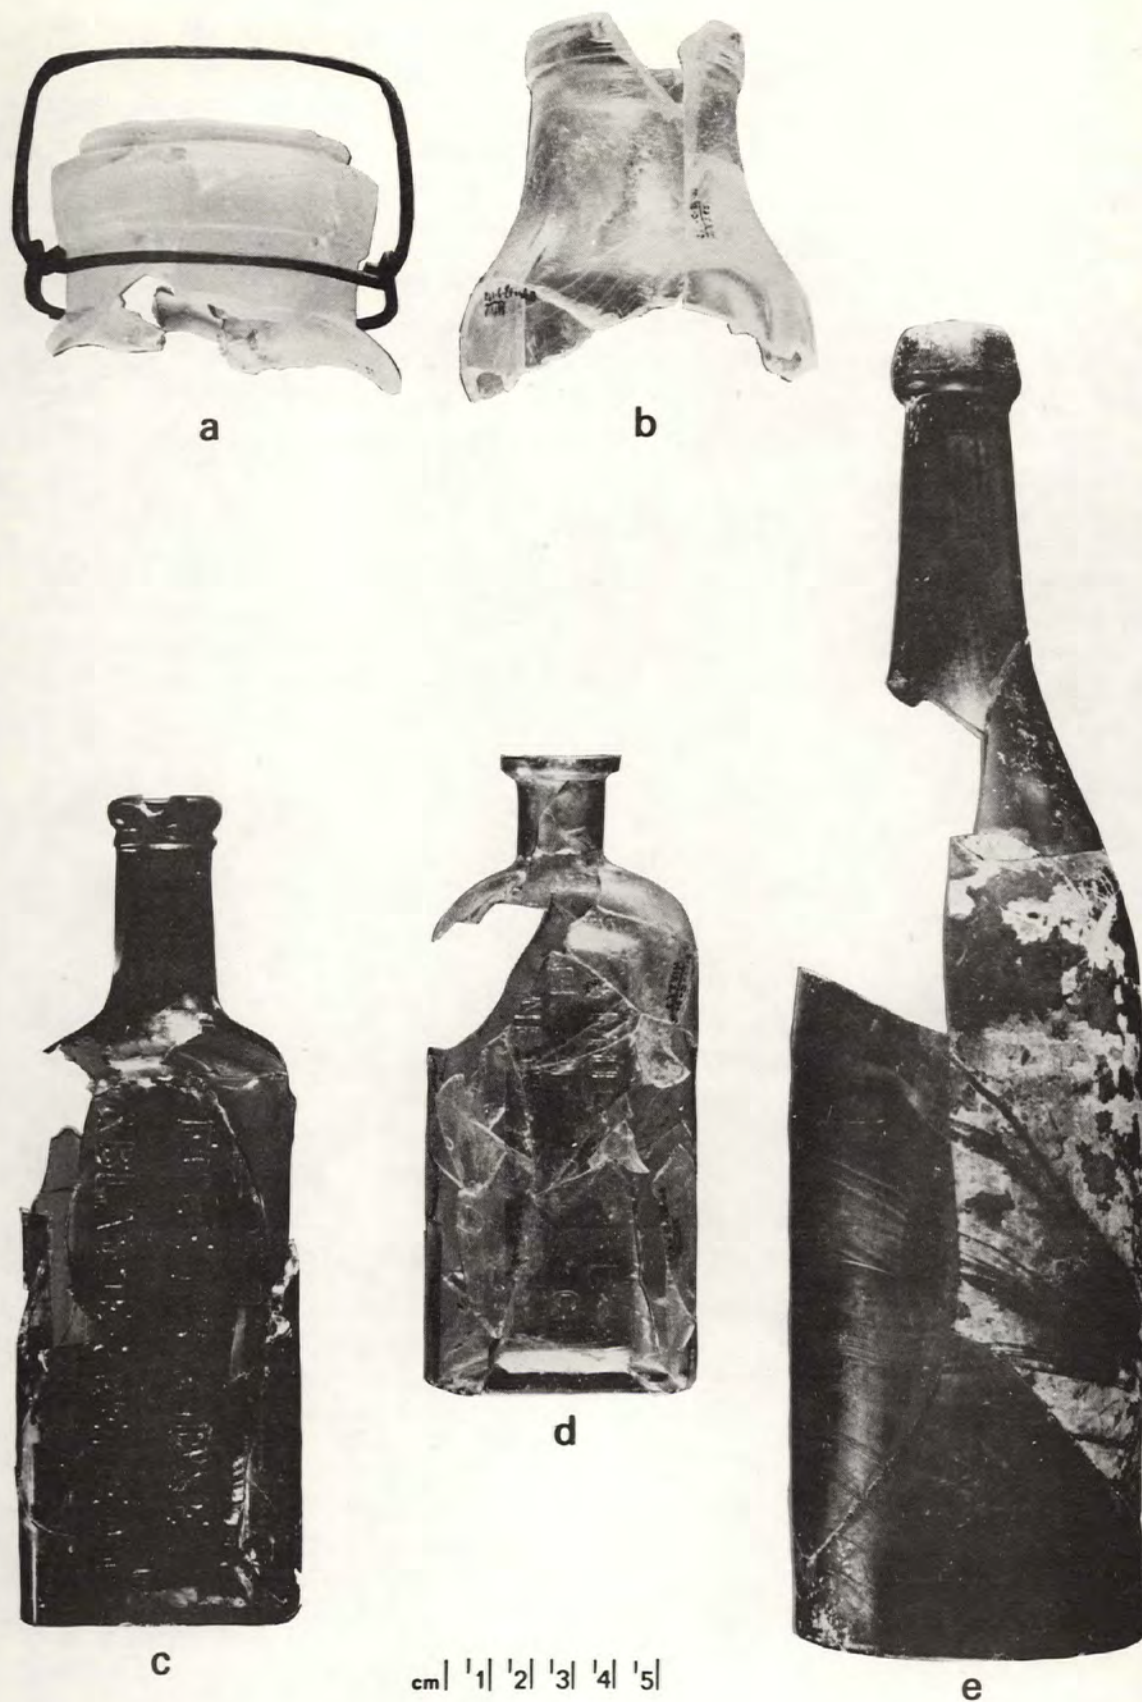
Figure 35. *Bottles from Steiner Site, Structure 1.* a, canning jar neck; b, heavy molded clear glass bottle, hand-tooled lip; c, brown panel bottle, "FOLEY'S KIDNEY & BLADDER REMEDY/FOLEY & CO./CHICAGO, U.S.A."; d, amber panel bottle, "MUL-EN-OL"; e, olive wine bottle.

Neck and shoulder of heavy blown-in-mold jar with round neck and octagonal body, machine-finished rim. A similar documented jar is 7-1/8" high (Adams 1971:76), 1860-1880 (Fig. 35,b)

Neck and base of canning jar with metal clamp, 3-1/2" diameter at base, Owens ring on bottom, after 1903 (Fig. 35,a)

Restorable bottle, turn mold finish, tooled lip, made ca. 1880-1890 (Fig. 35,e)

Restorable panel bottle, "FOLEY'S KIDNEY & BLADDER REMEDY/FOLEY & CO./CHICAGO, U.S.A." on three sides. Identical bottle advertised in *Emporia* (Kansas) *Daily Gazette*, April 6, 1897 (Baldwin 1973:185) (Fig. 35,c)

Restorable panel bottle, "MUL-EN-OL" embossed on front, 1870-1900 (Fig. 35,d)
