“Full” Reserve Study

Fiesta Gardens Homes Association

San Mateo, CA

Report #: 25308-0
For Period Beginning: January 1, 2014
Expires: December 31, 2014

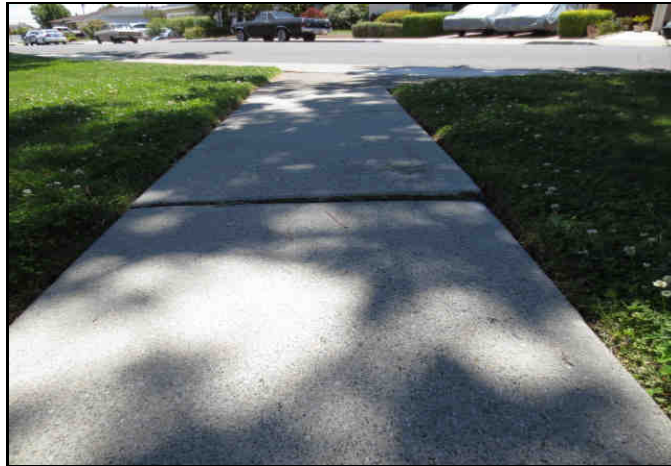
Evaluation: Generally good condition with no significant cracking, lifting, settling or other indications of problems at this time. Inspect periodically and perform any needed minor repairs as a maintenance project. Large-scale or complete repairs should not be anticipated, but moderate sized projects should be as the concrete ages. Although difficult to predict timing, cost and scope, we suggest setting aside a repair/replacement allowance to supplement the operating budget in future years. Adjust as conditions dictate in future years. Avoid adjacent over-watering of landscape and monitor any tree roots nearby.

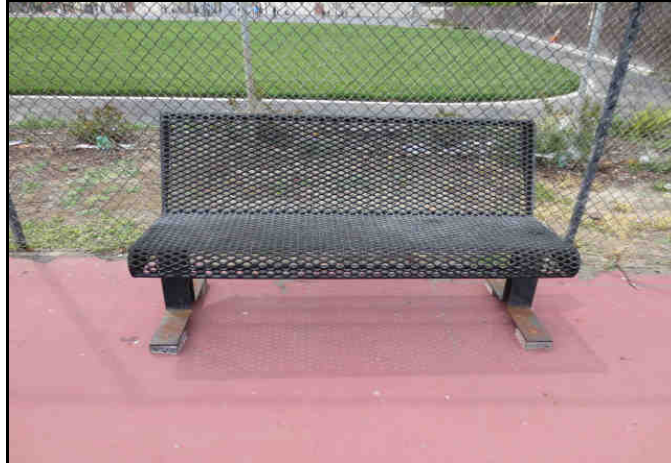
Evaluation: Metal coated benches at the tennis court area. Benches are sturdy and firmly secured in to the ground. Isolated areas where the metal coating is worn and minimal rust noted mainly at the base. Functional.

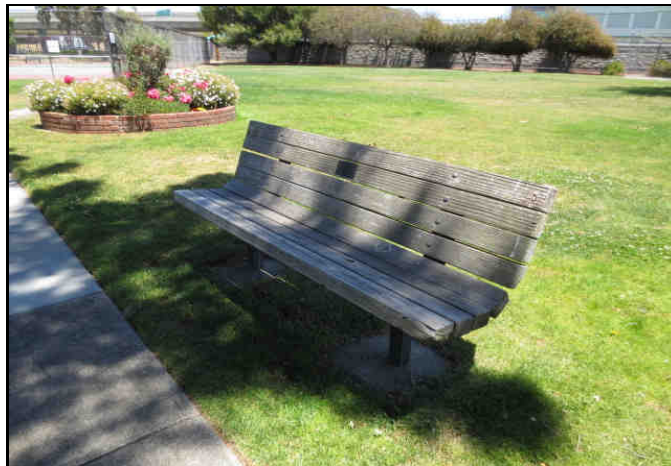
Evaluation: Wooden benches with metal frames and support posts. All are intact with no significant warping, cracking, or deterioration noted. Sturdy and functional.

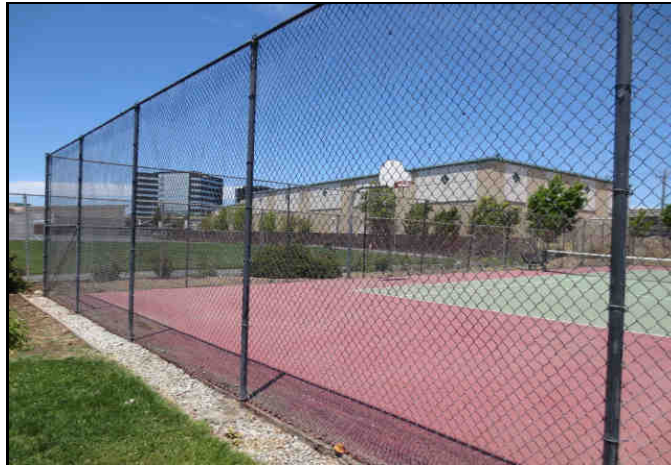
Useful Life:
28 years

Remaining Life:
12 years

Best Case: \$16,200.00

\$36/LF; Lower estimate to replace

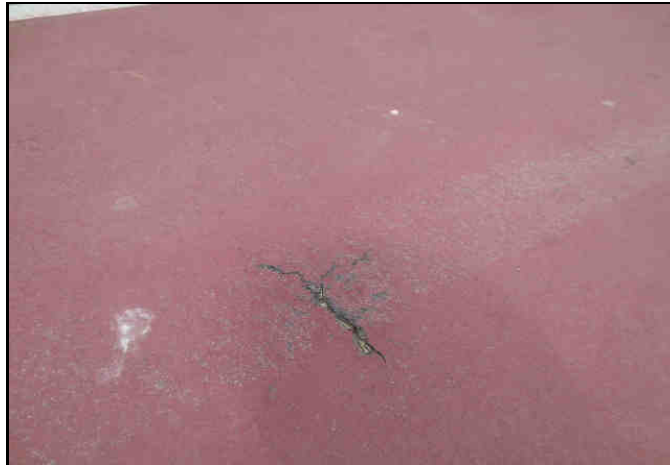
Useful Life:
7 years

Remaining Life:
0 years

Best Case: \$11,000.00
\$5,500/court; Lower estimate to resurface

Worst Case: \$15,000.00
\$7,500/court; Higher estimate to resurface

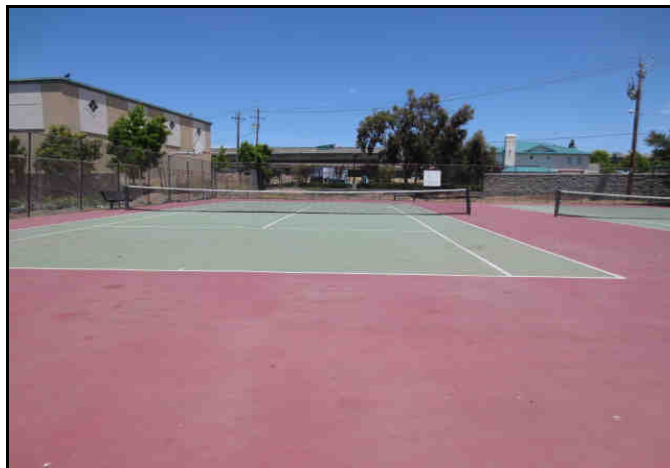
Useful Life:
28 years

Remaining Life:
14 years

Best Case: \$30,000.00
\$15,000/Court; Lower estimate to resurface

Worst Case: \$40,000.00
\$20,000/Court; Higher estimate to resurface

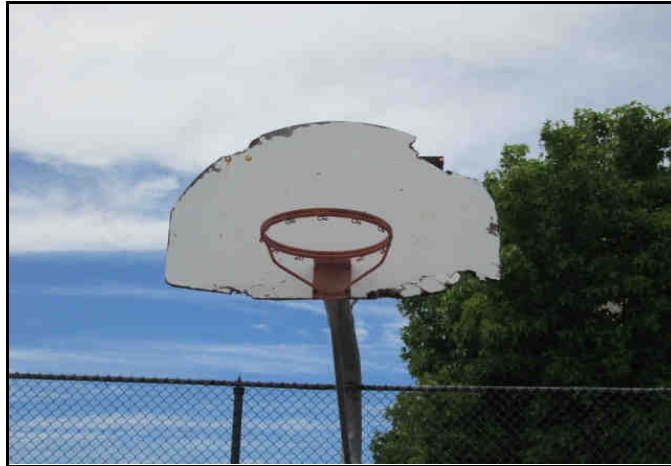
Evaluation: Basketball hoops are mounted on metal poles above the tennis courts. The backboards show significant deterioration with pieces chipped and broken. Consider replacement to allow for proper use. No expectation to replace the metal support pole. Basketball back boards are economical in cost and fall below the threshold to be deemed a reserve component. Fund out of operating. No reserve funding necessary.

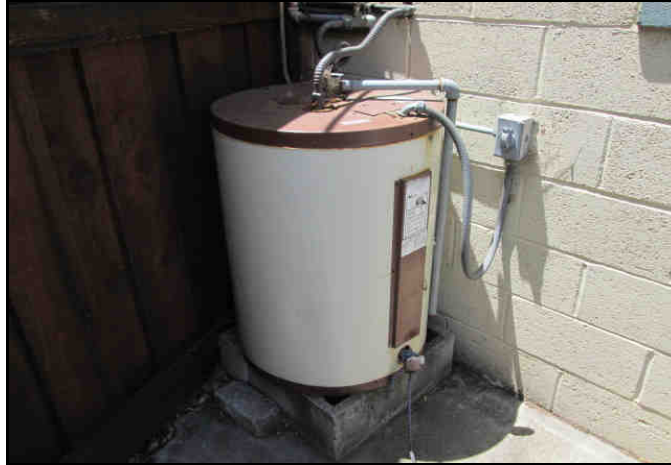
Useful Life:
15 years

Remaining Life:
1 years

Best Case: \$1,200.00
Estimate to replace

Worst Case: \$1,500.00
Higher estimate

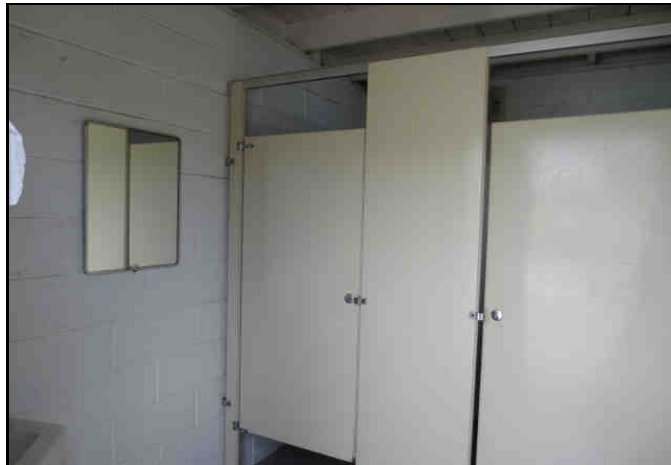
Useful Life:
15 years

Remaining Life:
3 years

Best Case: \$7,000.00
\$3,500/Bathroom; Lower estimate to refurbish

Worst Case: \$10,000.00
\$5,000/Bathroom; Higher estimate to refurbish

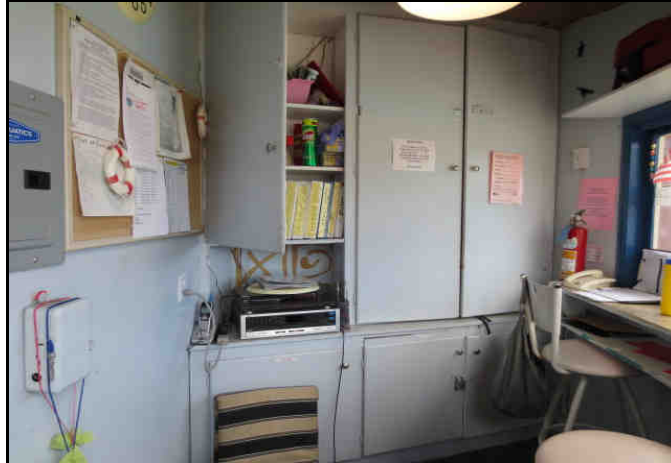
Useful Life:
15 years

Remaining Life:
6 years

Best Case: \$2,000.00
Lower estimate to refurbish

Worst Case: \$3,000.00
Higher estimate to refurbish

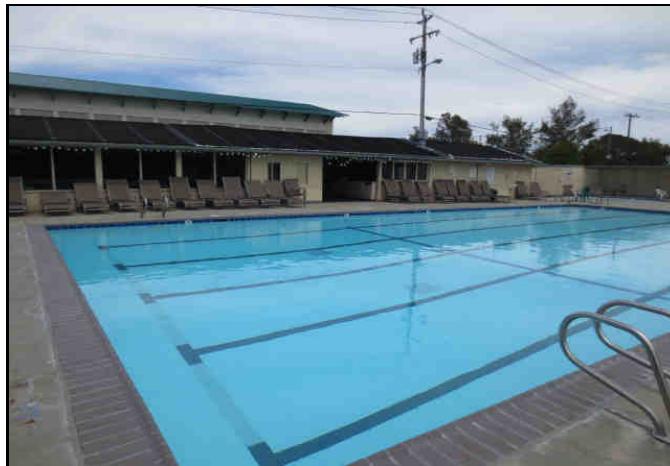
Useful Life:
12 years

Remaining Life:
8 years

Best Case: \$32,000.00
Lower estimate to resurface

Worst Case: \$40,000.00
Higher estimate to resurface

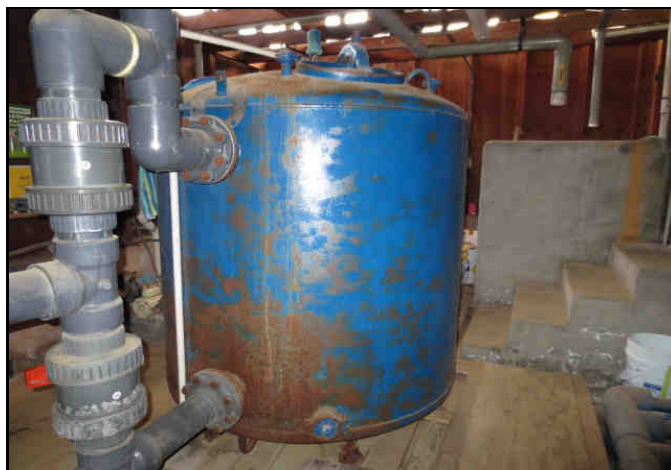
Useful Life:
30 years

Remaining Life:
15 years

Best Case: \$15,000.00
Lower estimate to replace with multiple sand filters

Worst Case: \$20,000.00
Higher estimate to replace

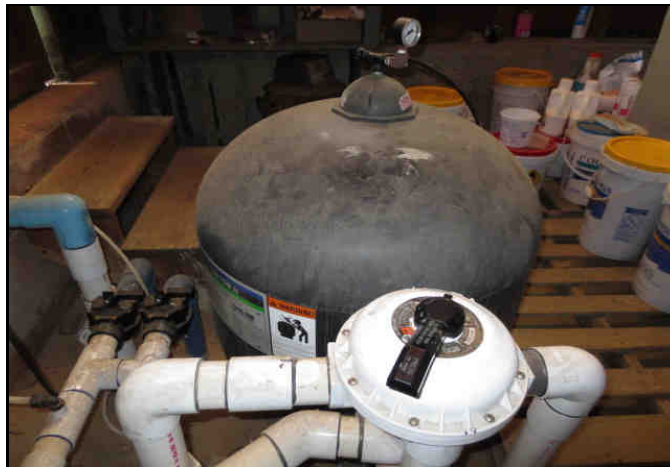
Evaluation: (1) Triton II Sand Filter, Model TR-100. No signs of leaking or issues at the time of the site visit. Sand filters will need to have the sand replaced periodically. Sand replacement is economical in cost and should be handled out of the operating budget. This component funds for complete replacement in the future.

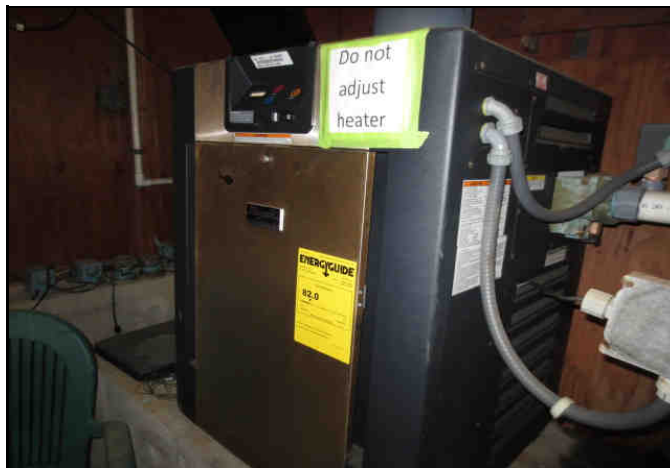
Evaluation: (1) Raypak Rheem Professional Heater model B-R408-EN-X-ASME S/N 1205339850 item #013731. Newer model. Functioning properly with no problems reported.

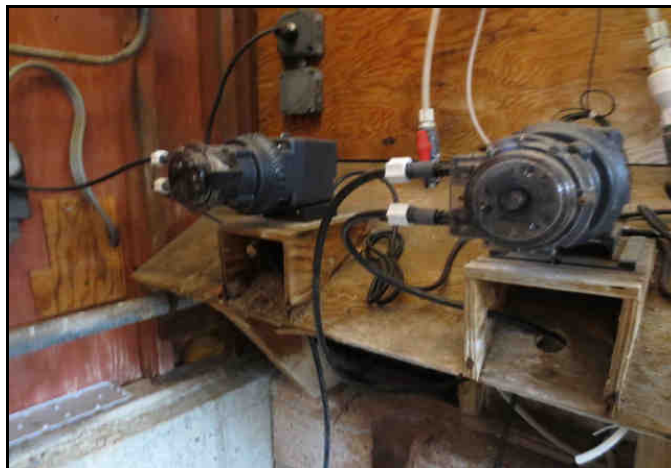
Useful Life:
10 years

Remaining Life:
6 years

Best Case: \$2,800.00
\$700/Chlorinator; Lower estimate to replace

Worst Case: \$3,400.00
\$850/Chlorinator; Higher estimate to replace

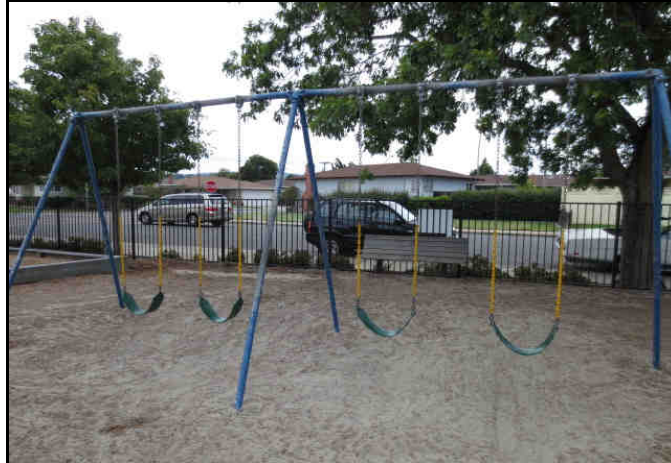
Useful Life:
20 years

Remaining Life:
5 years

Best Case: \$24,000.00
\$12,000/Swing Set; Lower estimate to replace

Worst Case: \$32,000.00
\$16,000/Swing Set; Higher estimate to replace

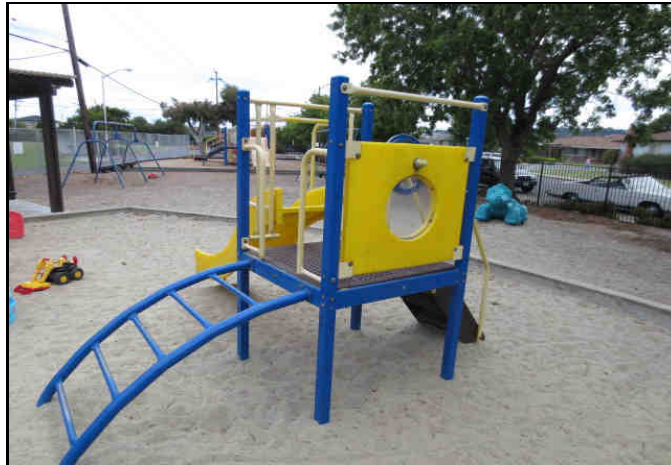
Evaluation: (1) Kid Builders small play structure. Structure has (1) slide and no moving parts. All pieces are intact with no paint chipping, rust, or abuse noted. Inspect periodically to ensure the play structures remain intact and area a safe play environment for children.

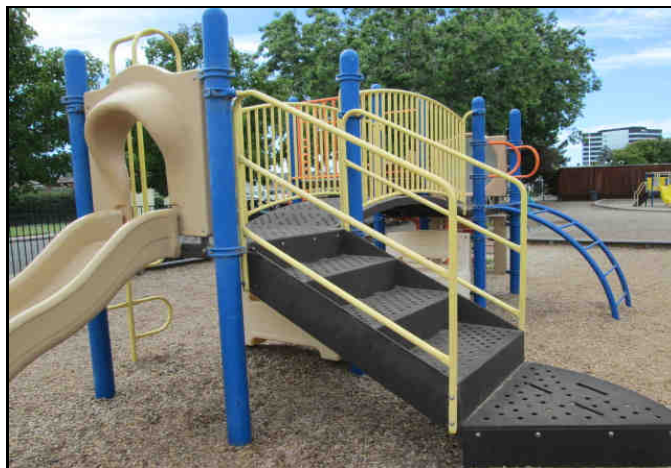
Evaluation: Larger structure has moderate rusting at the tallest platform and is held together by duct tape in isolated areas. We recommend replacement in the near future. Inspect periodically to ensure the play structures remain intact and a safe play environment for children.

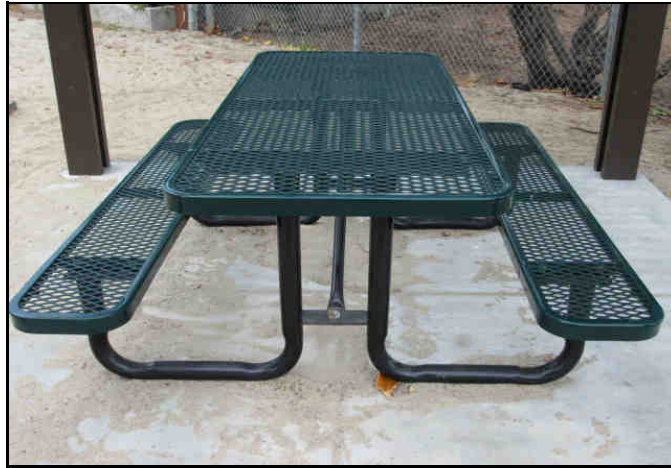
Evaluation: Metal-coated picnic bench in good condition. No signs of deterioration at this time.

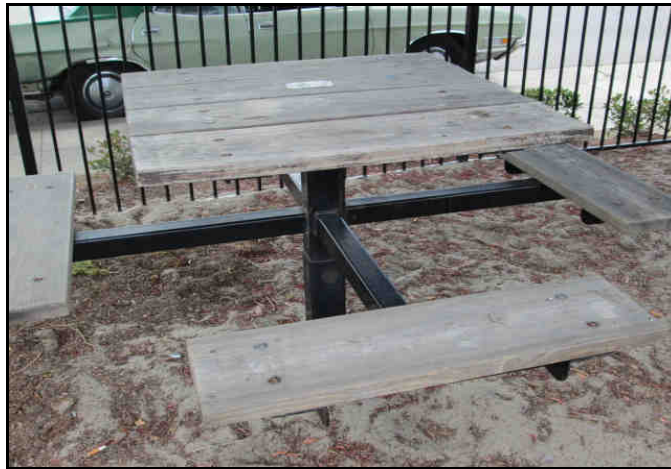
Evaluation: (1) Picnic table with a metal base and wood table and seats. (2) Wooden benches with metal frames and supports. Wood seats and tables are intact with no significant warping, cracking, or deterioration noted. Metal base is sturdy with no rust or corrosion noted.

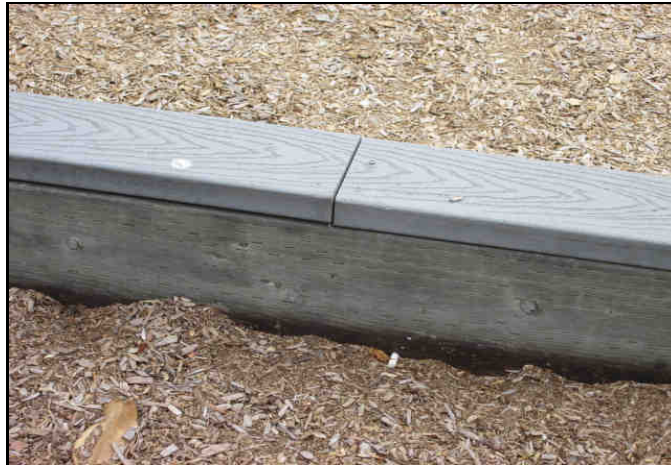
Useful Life:
15 years

Remaining Life:
8 years

\$26/LF; Lower estimate to replace

\$32/LF; Higher estimate to replace

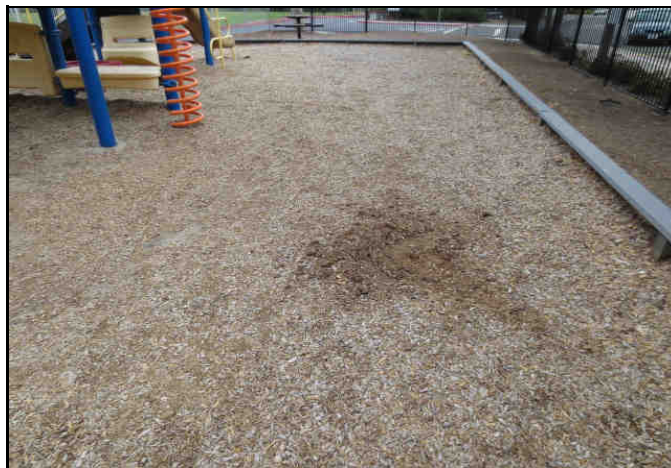
Useful Life:
2 years

Remaining Life:
1 years

Lower estimate to replenish tan bark

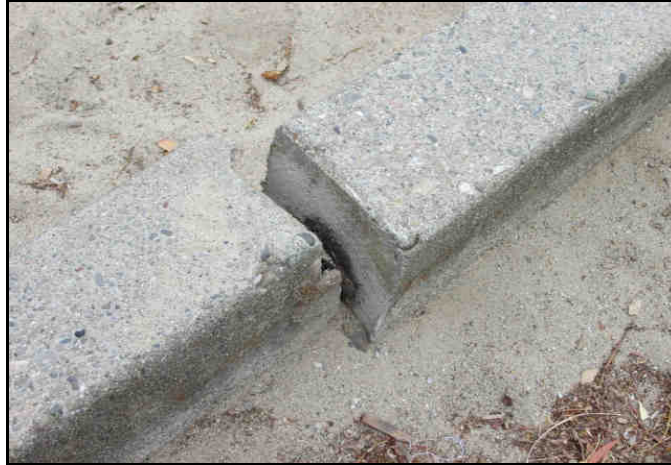
Comp #: 414 Sand Box - Repair/Replace

Useful Life:
15 years

Remaining Life:
0 years

Allowance for repair/partial replacement

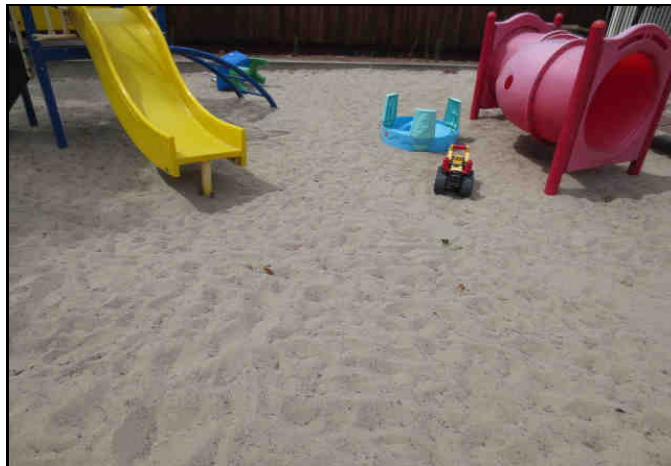
Useful Life:
2 years

Remaining Life:
1 years

Lower estimate to replenish sand

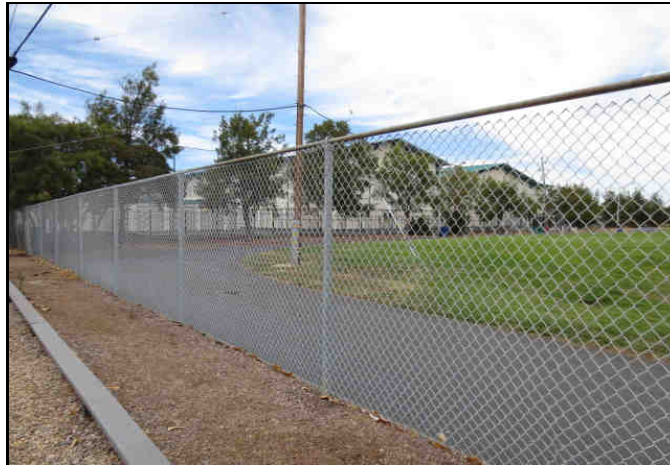
Comp #: 503 Chain Link Fence - Replace

Evaluation: Chain link fences is in good condition. Upright with no stretched links or bend areas. Durable and typically long lived component with ordinary care and maintenance, however, we recommend setting aside funding for eventual replacement at the interval indicated below.

Useful Life:
25 years

Remaining Life:
18 years

\$24/LF; Lower estimate to replace

\$28/LF; Higher estimate to replace

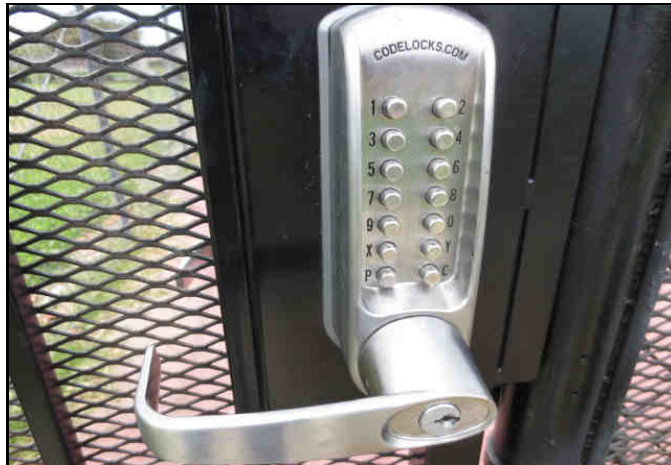
Comp #: 720 Push Button Entry System - Replace

Evaluation: (1) CodeLock electronic push button entry system at the tennis court entrance. Good condition no scratches or scuffs. Exterior location exposed to the elements. Currently functional with no problems reported.

Useful Life:
10 years

Remaining Life:
6 years

Best Case: \$1,200.00
Lower estimate to replace including installation

Worst Case: \$1,800.00
Higher estimate to replace

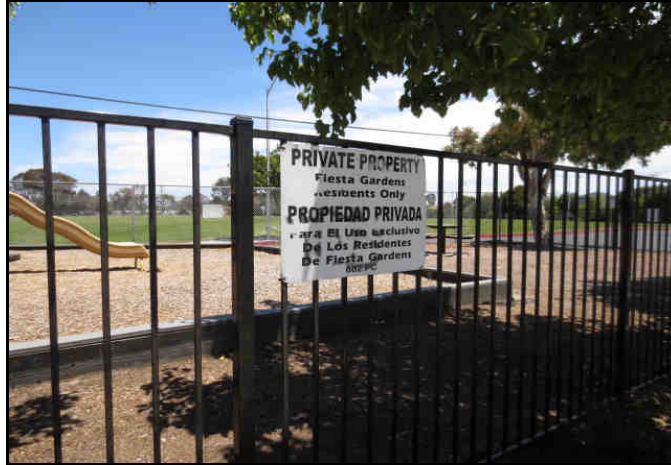
Evaluation: Paint is in fair condition. No significant chipping or peeling evident. Plan on painting every 4-5 years to keep well protected from costly repairs and/or replacement.

Useful Life:
5 years

Remaining Life:
2 years

\$8/LF; Lower estimate to repaint

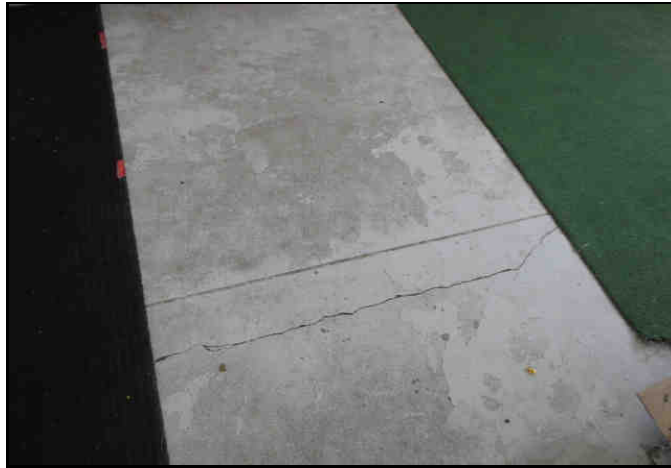
Evaluation: Concrete seal is aged and chipping in most areas. Aged appearance. We recommend resealing the concrete to establish an attractive appearance and to prevent water penetrating into the base and causing premature damage

Useful Life:
8 years

Remaining Life:
0 years

\$1.50/GSF; Lower estimate to repair

\$2.00/GSF, Higher estimate to repair

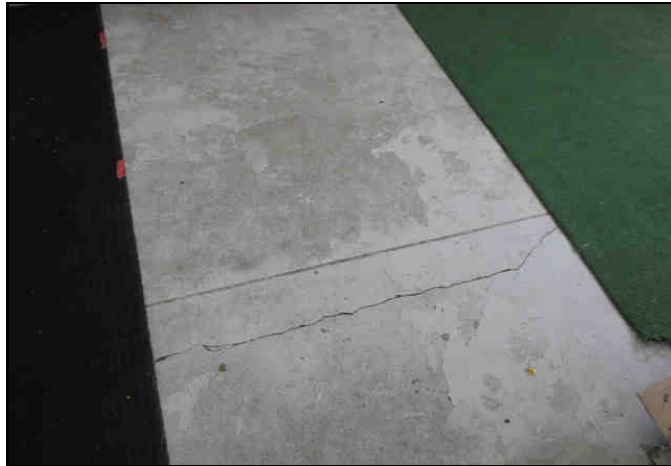
Comp #: 207 Concrete Floor - Repair

Evaluation: Concrete floor shows hairline cracks. No significant movement, lifting or settling noted. Floor covering is laid over a majority of the ground. Generally concrete surfaces were noted to be intact and in good condition. Repair any trip and fall hazards immediately to ensure safety. As routine maintenance, inspect regularly, pressure wash for appearance and repair promptly as needed. With proper installation and minimal damage due to shifting soil and/or tree root intrusion, there is no predictable cycle for long-term replacement. No reserve funding allocated. If predictable patterns of repairs do become the norm, track and include in future Reserve Study

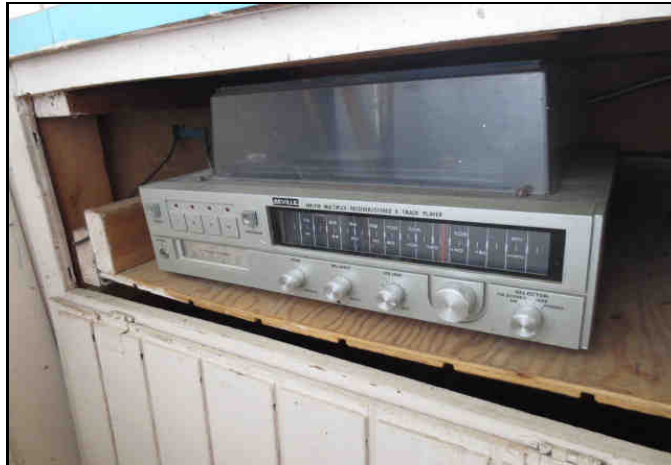
Evaluation: Various audio pieces in the cabinet in the kitchen as well as in the life guard office. System appears to be a compilation of multiple brands and various ages. Pieces appear to be replaced on an as-needed basis. Fund for repairs and replacement as needed out of the operating budget.

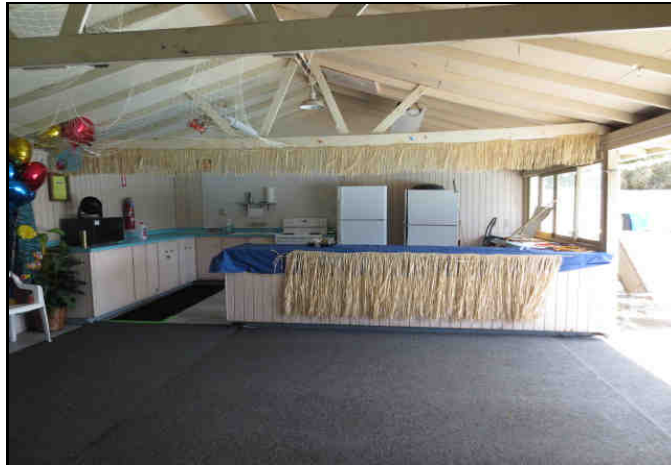
Comp #: 601 Carpet - Replace

Evaluation: Fair quality carpet. Carpet is intact but shows wear by being stained and worn, especially in high traffic areas. No seam exposure or fraying noted. Replace in the near future to maintain an attractive aesthetic appearance. As part of ongoing maintenance program, and vacuum regularly.

Useful Life:
12 years

Remaining Life:
5 years

\$35/GSY; Lower estimate to replace

\$40/GSY; Higher estimate to replace

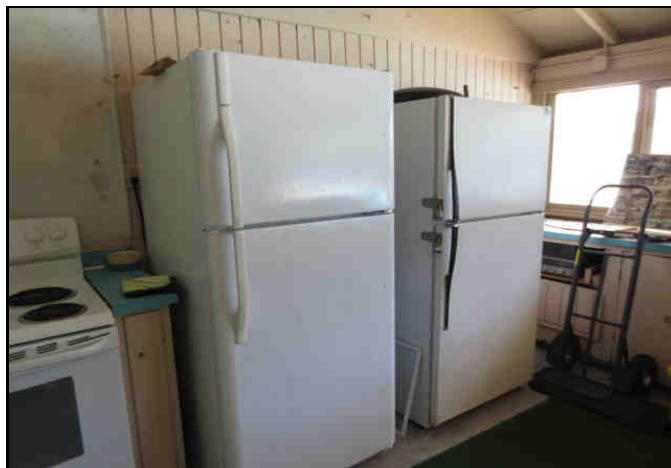
Comp #: 901 Appliances - Replace

Useful Life:
20 years

Remaining Life:
5 years

Lower allowance to replace

Higher allowance to replace

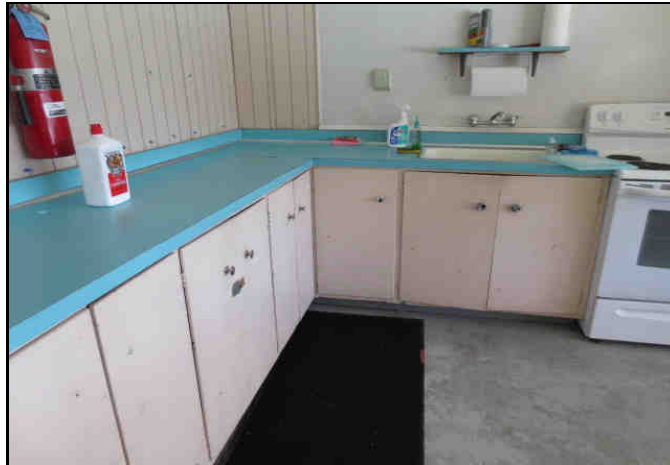
Evaluation: Basic kitchen counters with wooden cabinets below. Drawer near the auto equipment is broken. Some doors are harder to open and close but all appear functional. Plan on replacing in the next few years to maintain an attractive appearance.

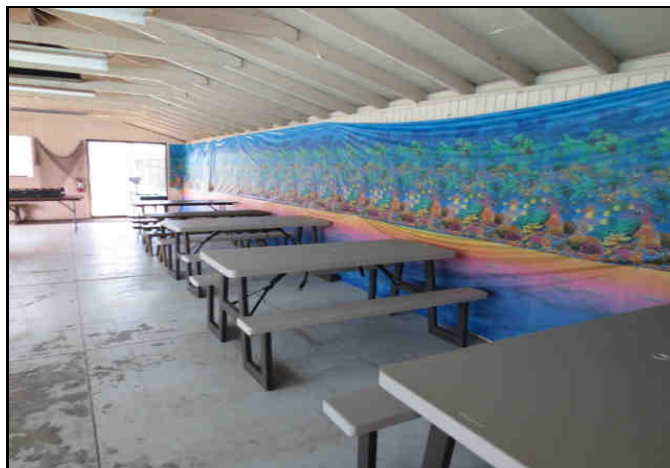
Evaluation: (6) Plastic tables newer, good condition, (3) Picnic tables older, dated appearance, (8) Benches older, dated appearance, consider upgrading all wood furniture to plastic for consistently attractive aesthetic appearance (1) Foolsball table functional, (1) Small ping pong table that wasn't set up. Assuming functional.

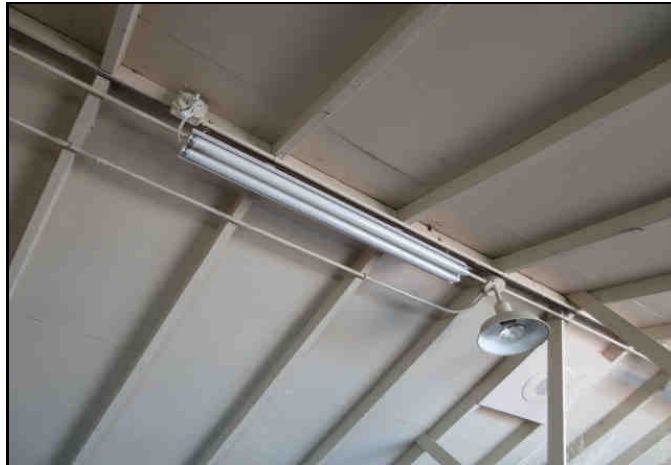
Useful Life:
10 years

Remaining Life:
2 years

\$1.00/GSF; Lower estimate to repaint

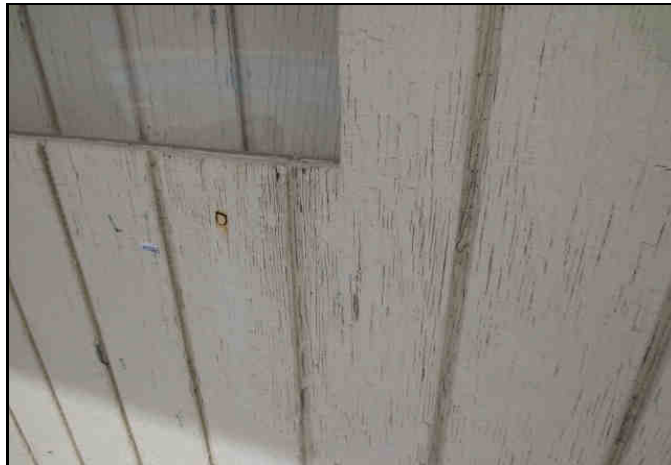
Useful Life:
5 years

Remaining Life:
0 years

\$2.25/GSF; Lower estimate to repaint

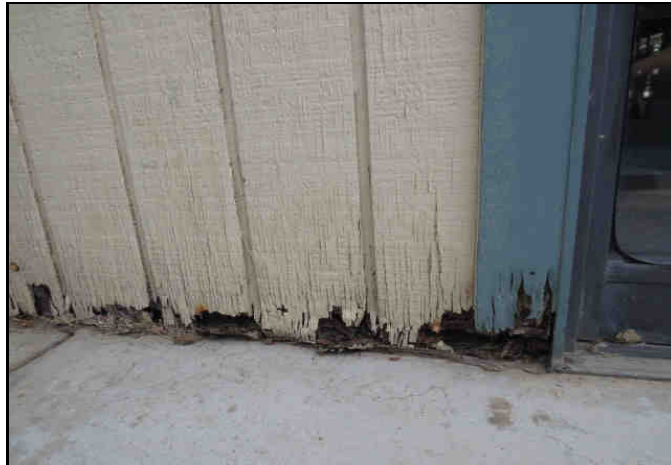
Evaluation: Isolated areas of significant wood rot and deterioration noted, especially at the base of the exterior walls and top of the exterior walls that is exposed to the elements. Funding for partial replacement of wood due to severe wood rot near base of the building. Coordinate with future painting.

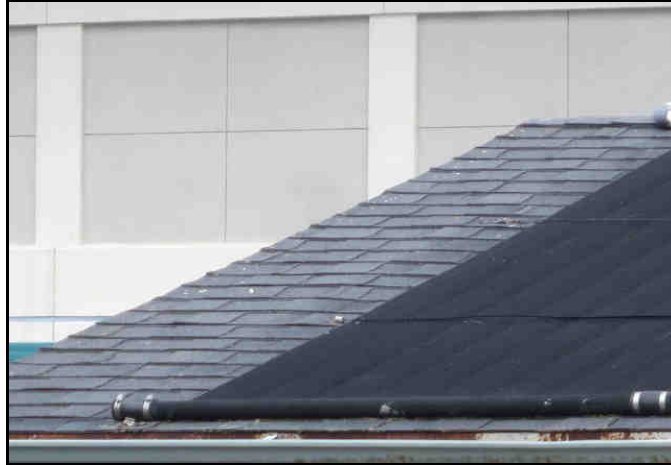
Useful Life:
25 years

Remaining Life:
10 years

\$8/GSF; Lower estimate to replace

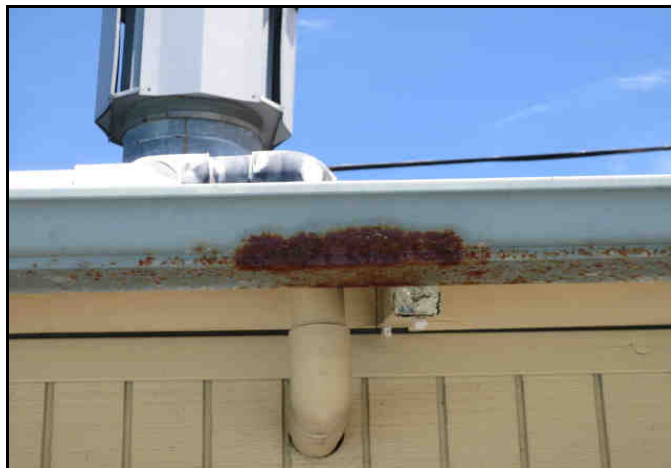
Useful Life:
25 years

Remaining Life:
2 years

\$10/LF; Lower estimate to replace
