# Palmer Lake

## Aquatic Vegetation and Water Quality Study

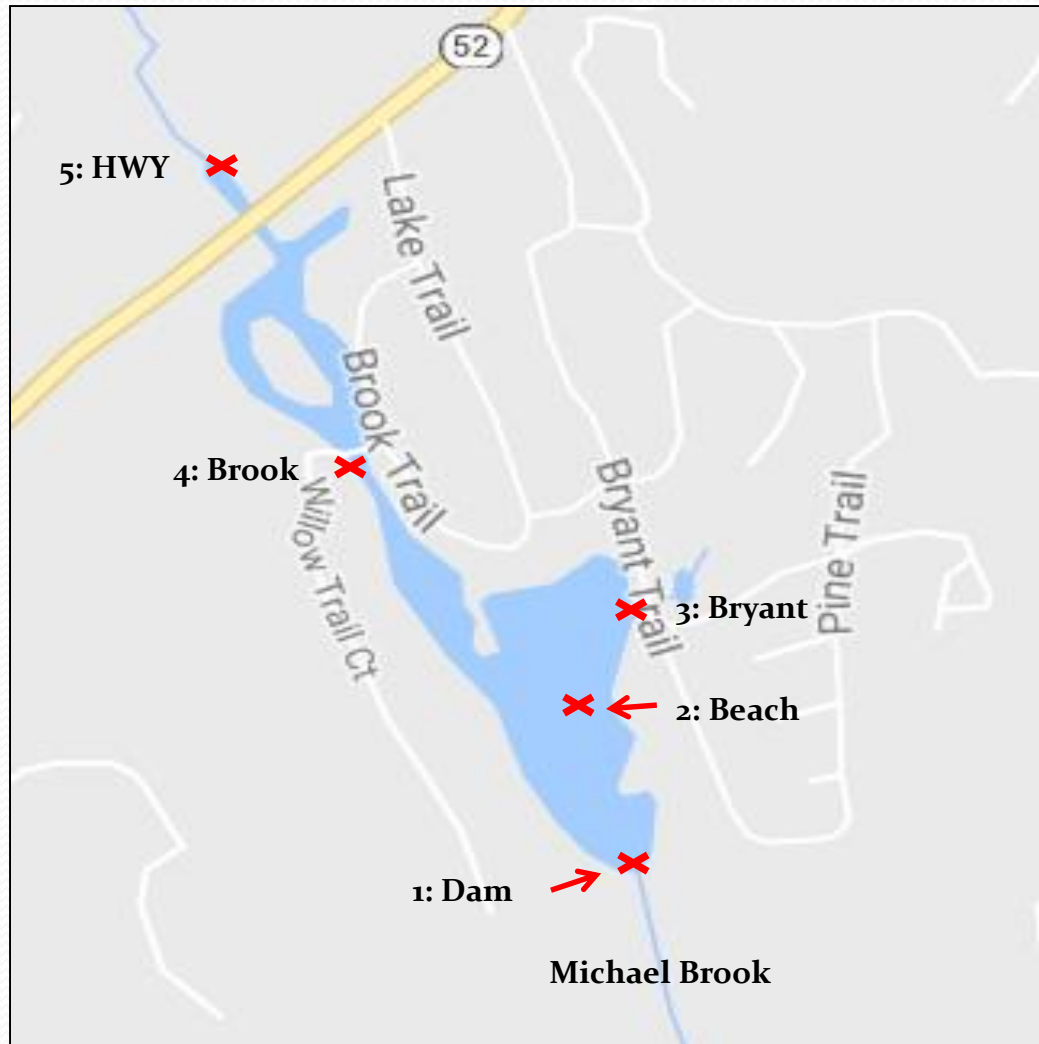
# Water Quality Sampling

- How often and where we will sample?
  - **Water Quality**
    - Seasonal sampling (summer 2016, fall 2016, and spring 2017)
      - better picture of the lake's ecological health throughout the year.
    - Five sites
      - Provides us with a proper representation of the lake's water quality
      - Aids us in monitoring possible water quality issues stemming from the tributaries that are entering the lake.

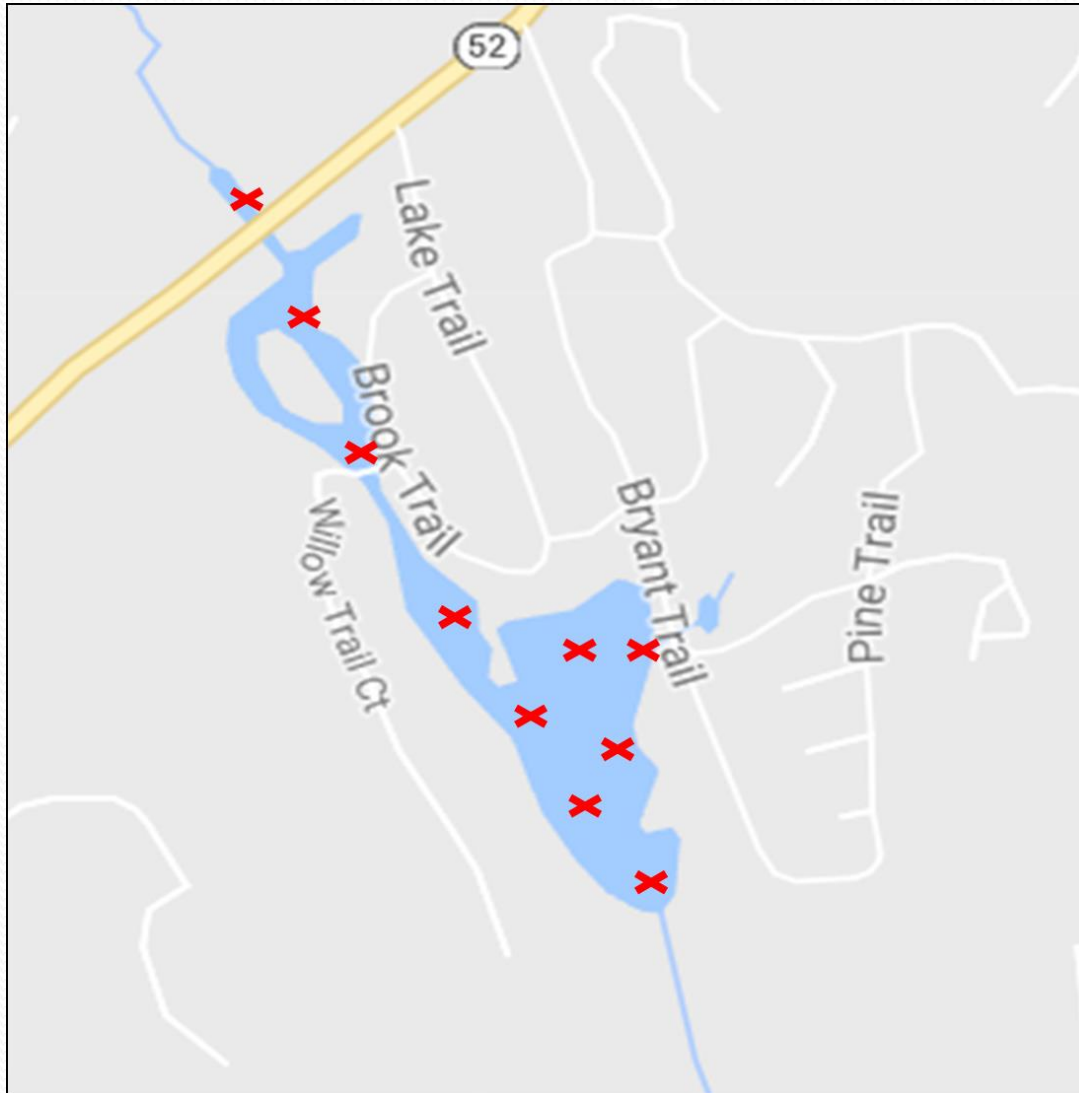
# Vegetation Study

- How often and where we will sample?
  - **Vegetation Study**
    - Annually (summer)
    - Ten sites – plant identification and biomass
      - Best representation of plants species in the entire lake (invasives present?)
    - Whole lake – percent cover
      - More accurate percent coverage analysis (required by DEC for carp permit)
  - Furthermore, sampling multiple sites at different times of the year will provide us with a larger dataset by which to guide our management recommendations

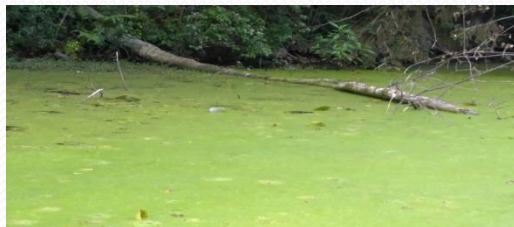
- 88% of lake covered in aquatic plants
- Four species of plants found
  - Eurasian Milfoil (*Myriophyllum*)\*
  - Coontail (*Ceratophyllum*)
  - Waterweed (*Elodea*)
  - Brittle Waterlily (*Najas*)\*
- 40% Eurasian Milfoil
- Duckweed present at 70% of sites

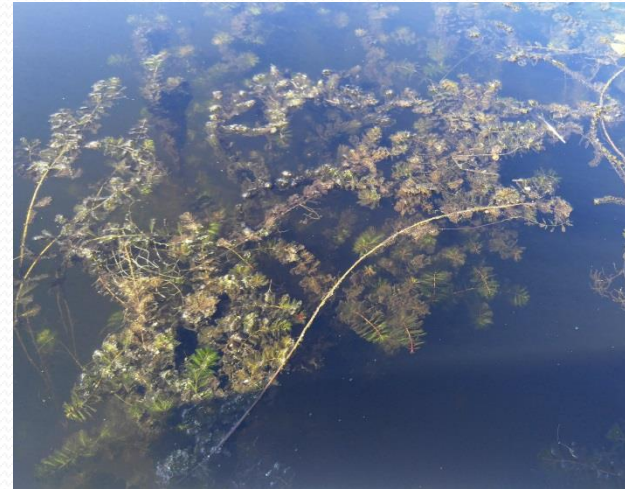
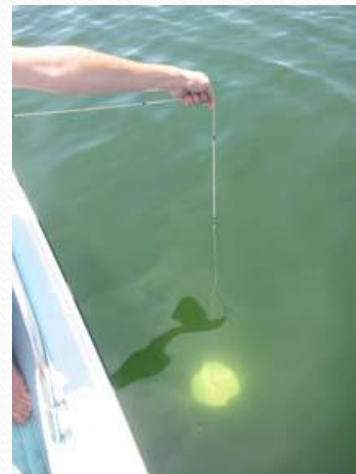
- Low levels of oxygen; 4 of 5 sites
  - Dense plant canopy leads to low oxygen
  - Effects game fish populations
- Water clarity is fair
  - Secchi depth – 7 feet
- Lake exhibits stratification
  - Higher O<sub>2</sub> vs other sites; fewer plants
- Conductivity and alkalinity within normal range

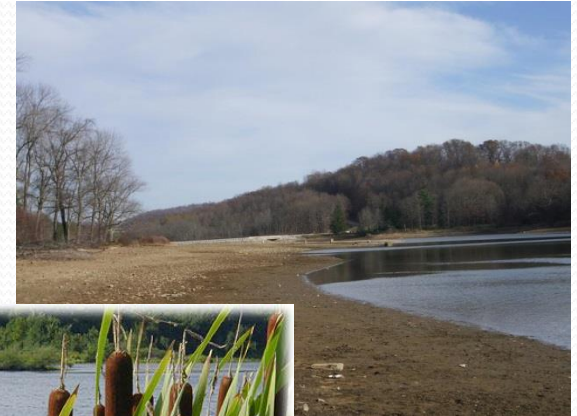
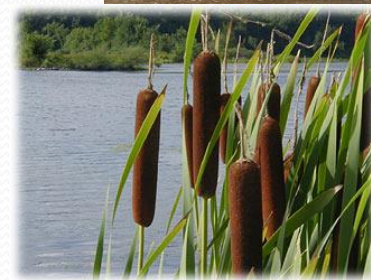
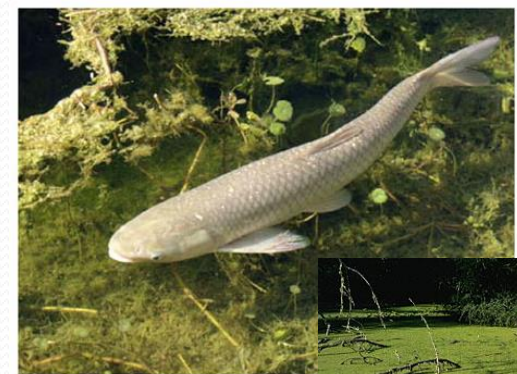
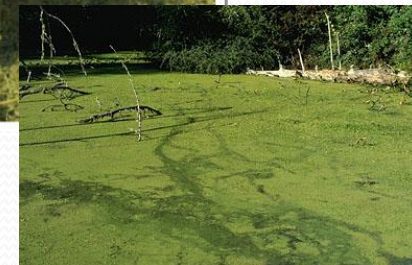
- Phase I: In-lake; Integrated Plan
  - **Aquatic vegetation**
    - Lake drawdown - late fall 2016
      - Exposure to freezing kills seeds and root systems
      - **Not the only answer**
      - Can promote other species (i.e. cattails, phragmites)
    - Stocking sterile triploid carp
      - Carp will eat vegetation (body weight each day)
      - Last about 8 – 12 years
      - Can cause algae blooms if carp overgraze
      - May lead to required algaecide treatment

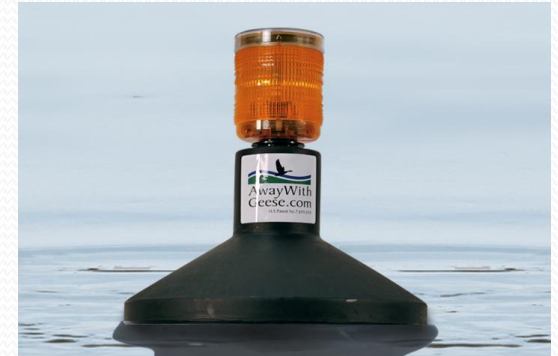
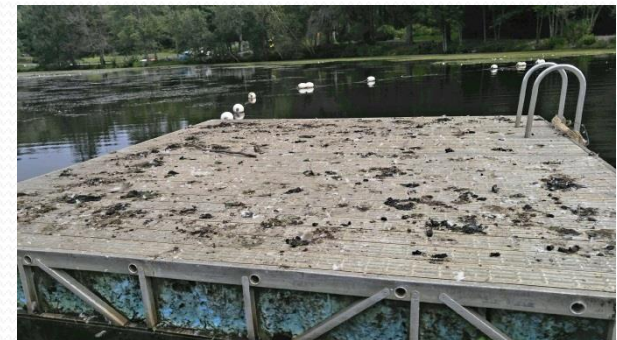
- **Nuisance waterfowl deterrent**
  - “Away with geese” lights
    - Only effective ~10m radius (need 8-10 lights around beach)
  - Goose barrier around dock
    - Sticks at each corner with rope attached
    - Prevents geese from roosting/defecating on dock/beach area

Reducing geese will result in less exceedances in fecal coliform counts; fewer interruptions in swimming
