Delta Ponds Restoration Project

From Opportunity to Completion

An Overview of the Vision, Accomplishments, Management, and Lessons Learned

February 2014

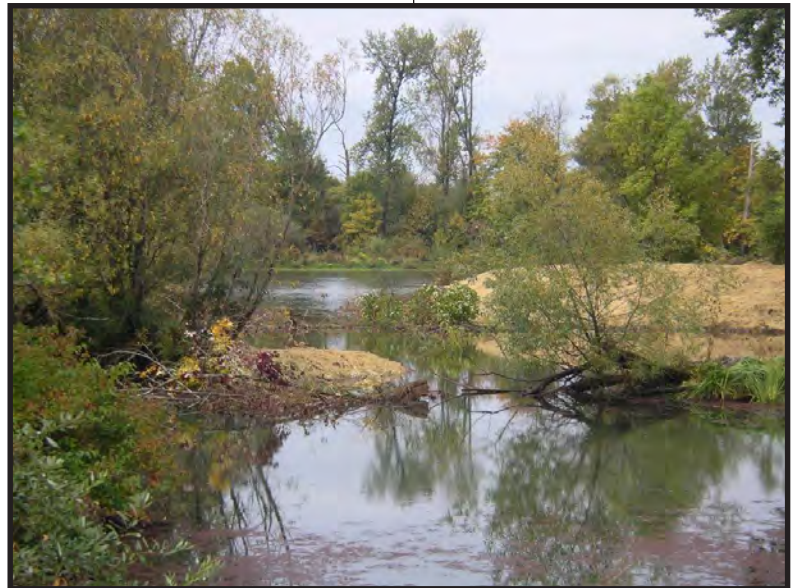
The weir, or inlet, from the Willamette River was cut in 2005, allowing flow to enter the southernmost pond.

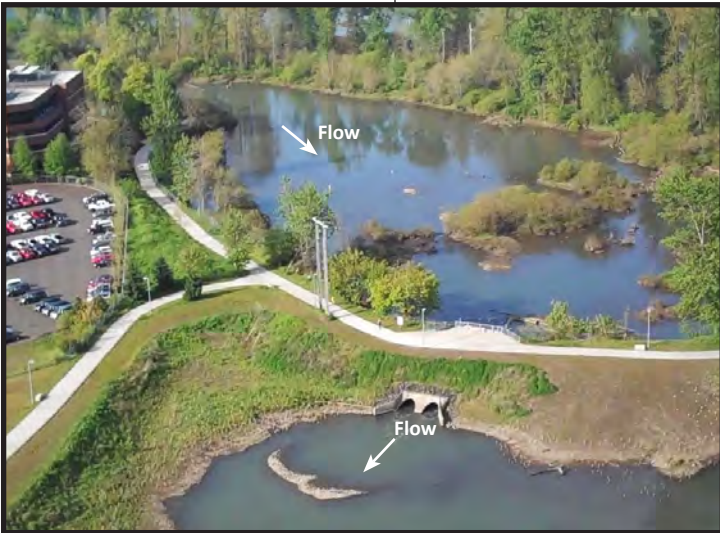
Gated culvert under the levee and multi-use path

barrier was at the levee that carried supported the newly installed multi-use path and the second barrier was Goodpasture Island Road. At this time, river flows that entered the southern ponds were diverted back to the river less than a quarter mile downstream.

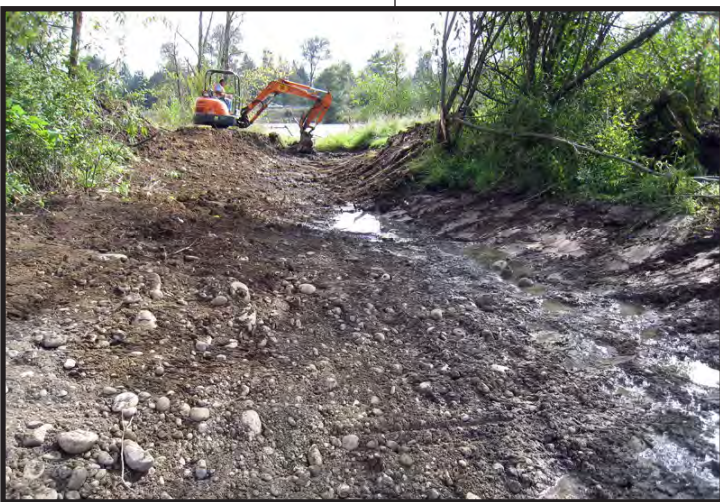
Excavation of the northernmost channel near the Dedrick Slough outlet

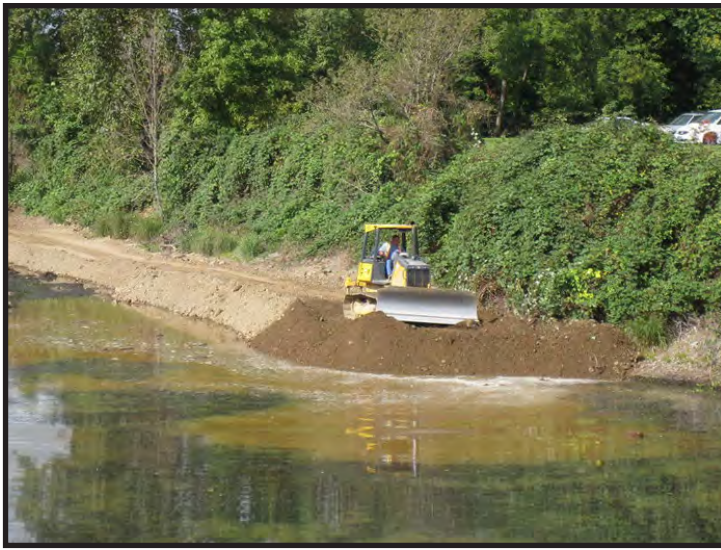
Grading riparian bench

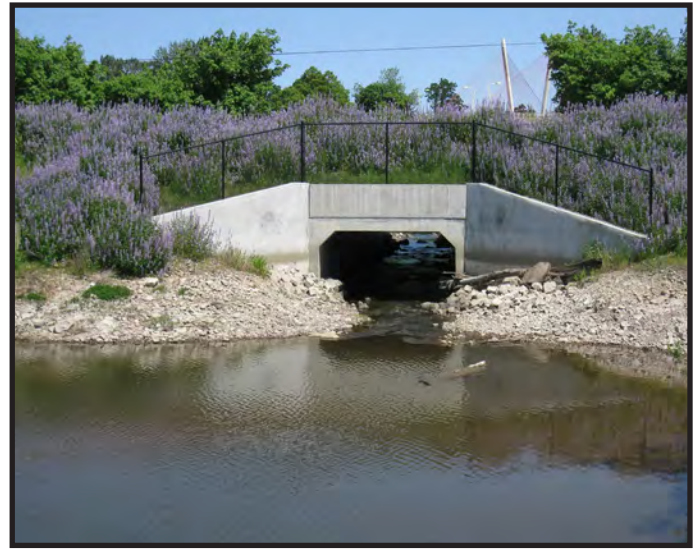
Box culvert under Goodpasture Island Road

- **Culvert Constructed Under Goodpasture Island Road:** In 2010, the final barrier to flow was removed with the installation of a 12-foot wide fish friendly box culvert.

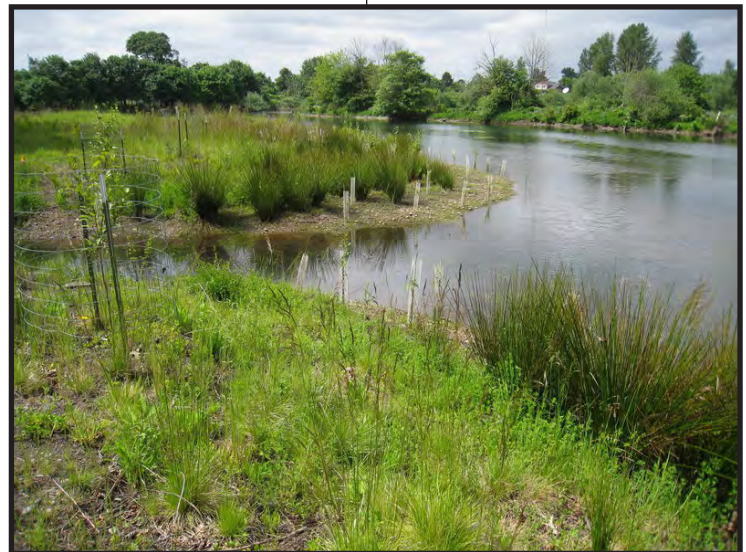
Protective tubes and fencing to limit herbivory

The City had thought that trees and shrubs planted densely enough the loss from herbivory would not be significant. Unfortunately, the damage by beaver and nutria was extremely high. After that experience the City required all willows and dogwoods to be protected with 24-30” tall rigid seedling protection tubes that were staked in

place with 30-36” bamboo stakes. These were removed after two years, once the plants had established healthy root systems and could better withstand herbivory. All trees were protected with metal fencing secured with metal t-posts. These fence rings were large enough to allow for a decade or more of growth and have been left on site indefinitely.

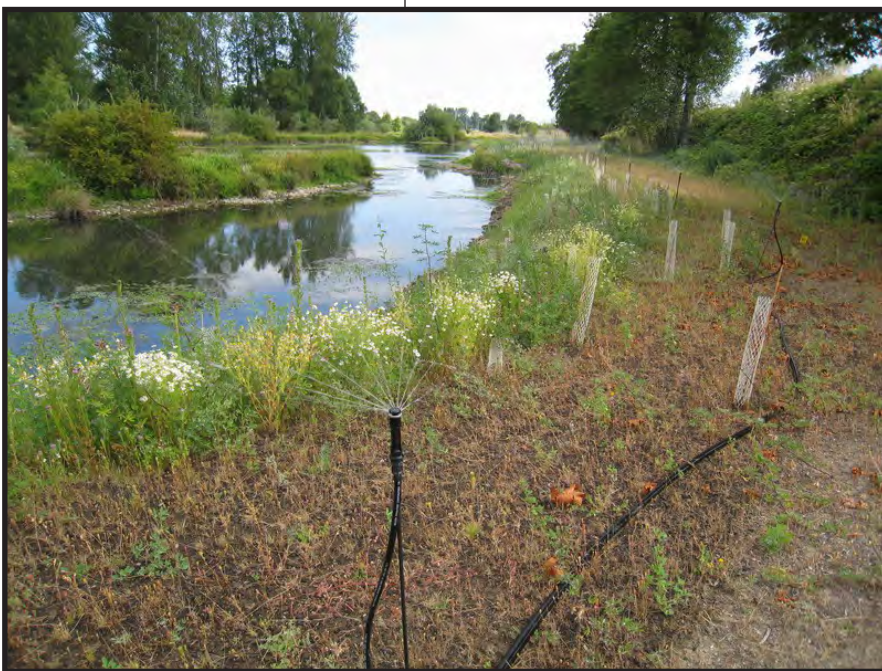
Temporary irrigation was used to water trees and shrubs for the first two years following planting.

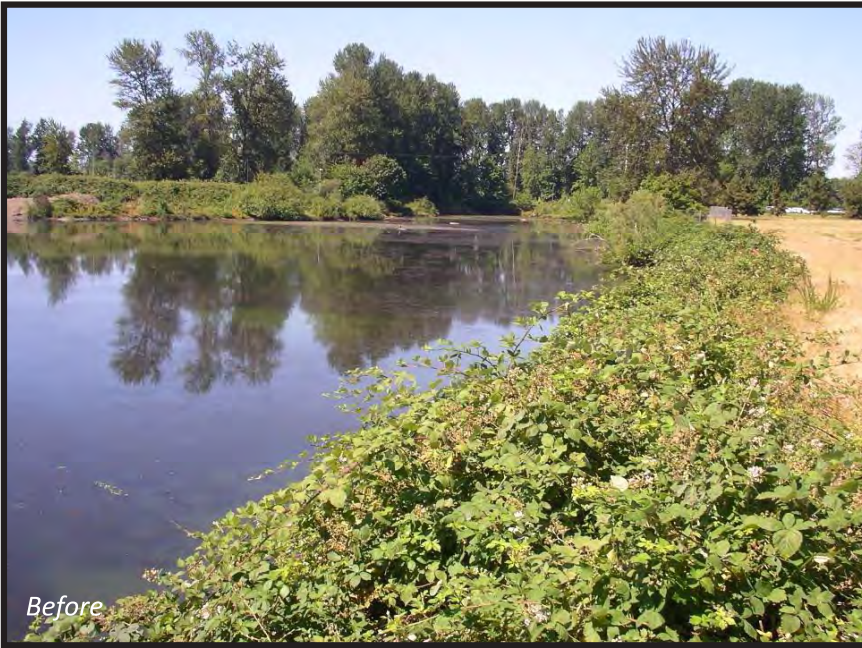
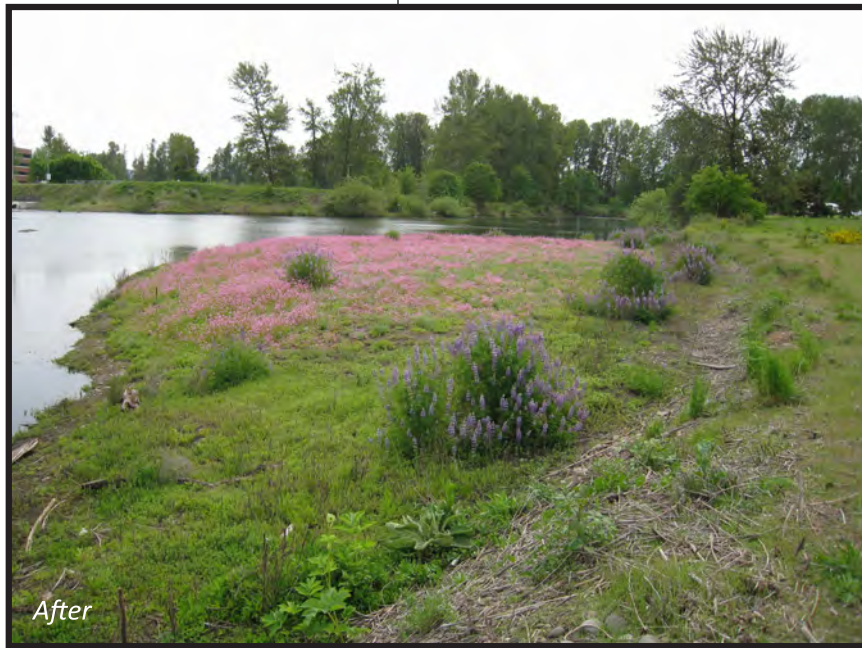
Photomonitoring showing pre- and post-construction conditions of riparian bench

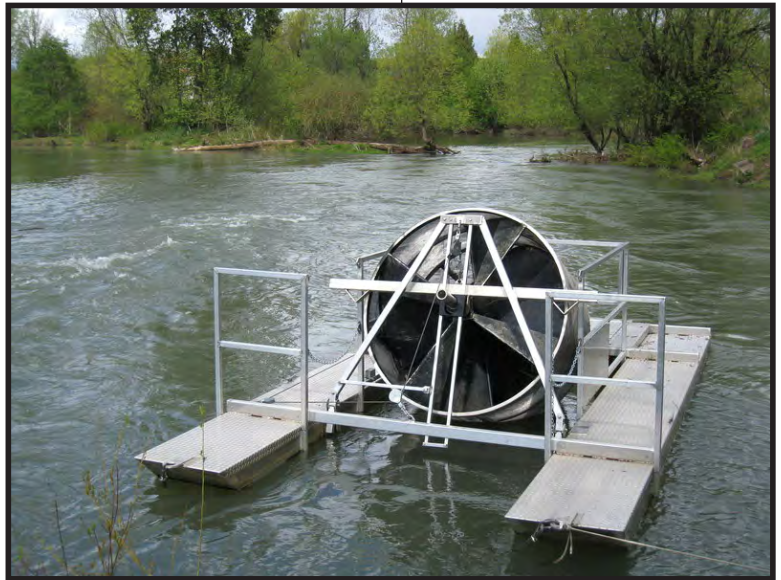
Rotary screw trap located just downstream of the weir

In 2011, with the hydrological connections fully completed, the City hired Cramer Fish Sciences to conduct fish monitoring at Delta Ponds and Heron Slough with the goal of determining species composition, relative abundance, and the timing of juvenile salmonid use of Delta Ponds and Heron Slough. Methods used included the placement and monitoring of a rotary screw trap
