# REBUILDING SITE ALTERNATIVES AND GENERAL DESIGN RECOMMENDATIONS FOR DOWNTOWN ANTHONY

ANTHONY, KANSAS

For:  
CITY OF ANTHONY, KANSAS

Prepared By:  
FRAZIER ASSOCIATES  
ARCHITECTURE ■ URBAN PLANNING ■ WAYFINDING

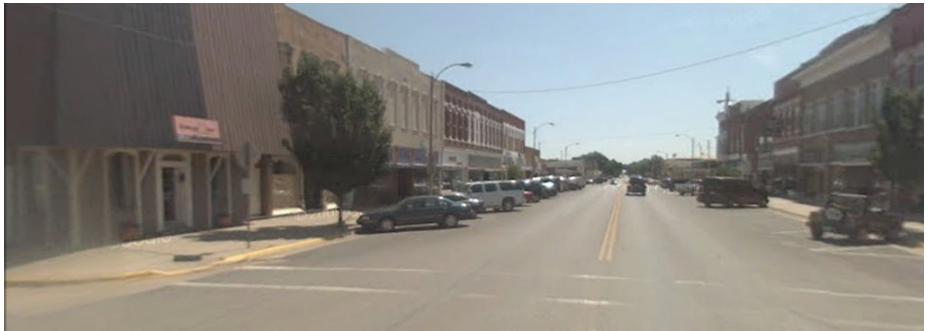
View looking east on Main Street. The buildings on the left burned down on July 8, 2009.

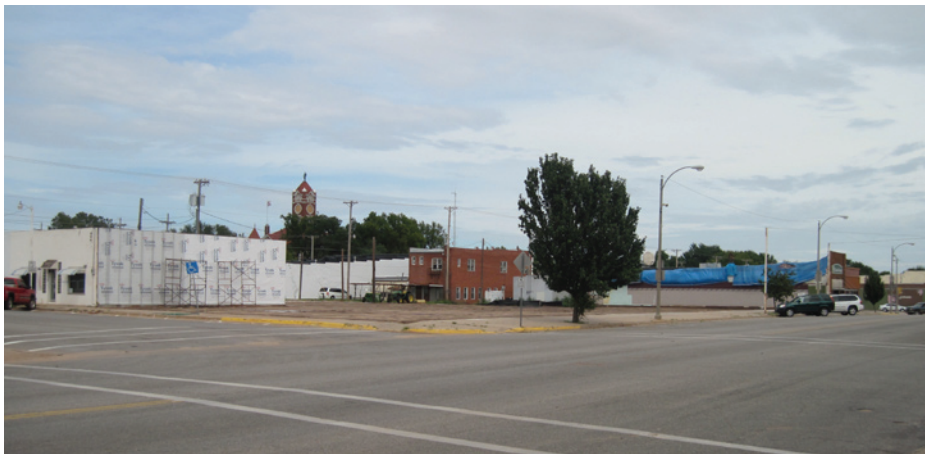
The site as it appeared in August 2010.

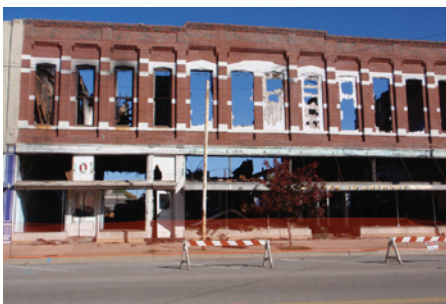
One of the facades of the burned buildings.

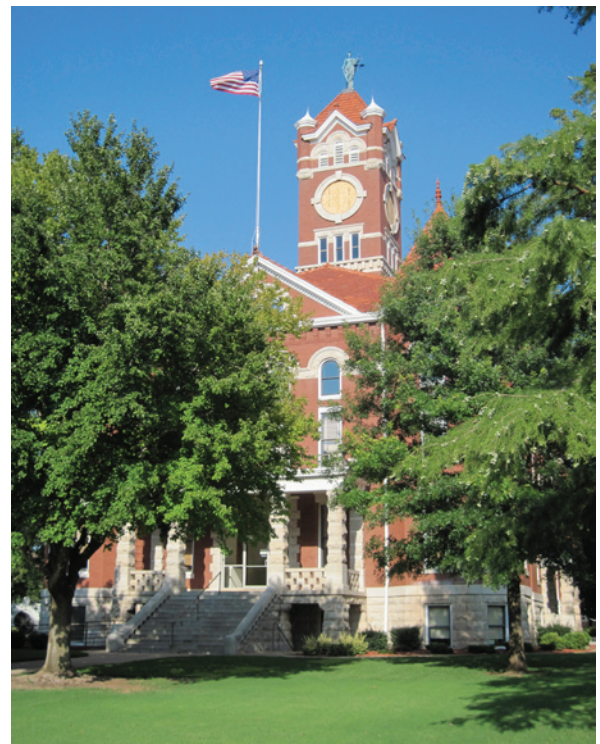
The Harper County Courthouse clocks were undergoing restoration during the site visit thus this image shows plywood in the cupola where the clocks are housed.

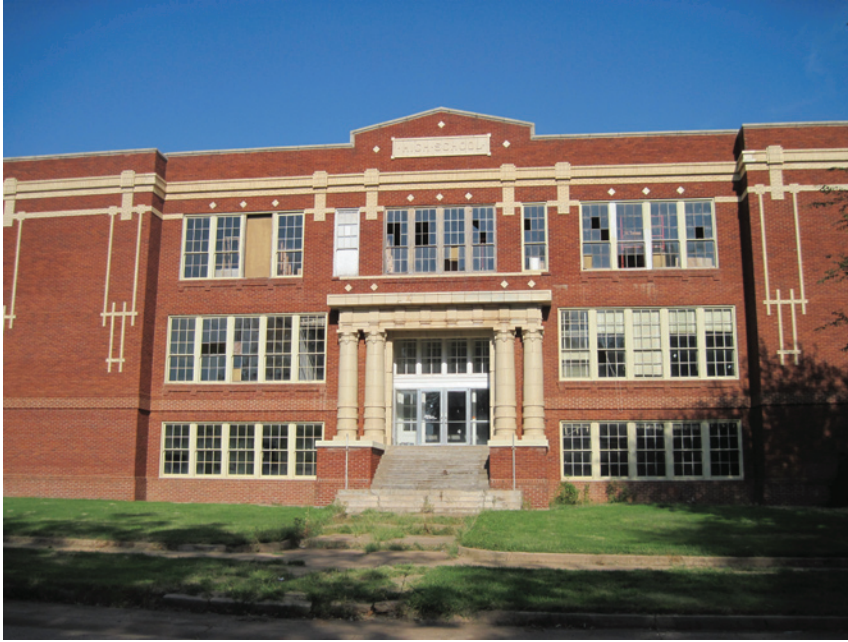
The historic high school sits vacant with broken windows.

The first key property is the vacant Anthony High School. We learned, while on site, that the property had had several owners with proposed plans but all have fallen through. The property sits vacant with broken windows that only invite more vandalism. The second property is the Carnegie Library building adjacent to Main Street also appeared to be vacant.

In the short term, it is recommended that steps be taken to secure and “mothball” these facilities. Losing them either in part or in whole to fire or other vandalism would be tragic. See <http://www.nps.gov/history/hps/tps/briefs/brief31.htm>

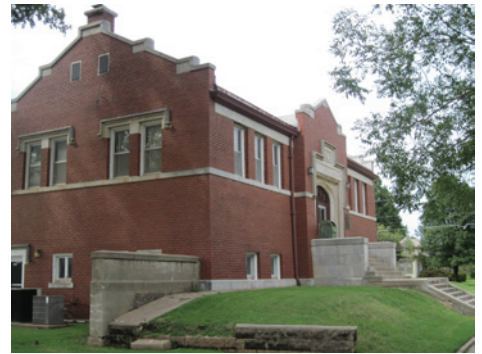
The Jacobethan-style Carnegie Library, listed on the National Register of Historic Places, was built in 1911. It is currently vacant.

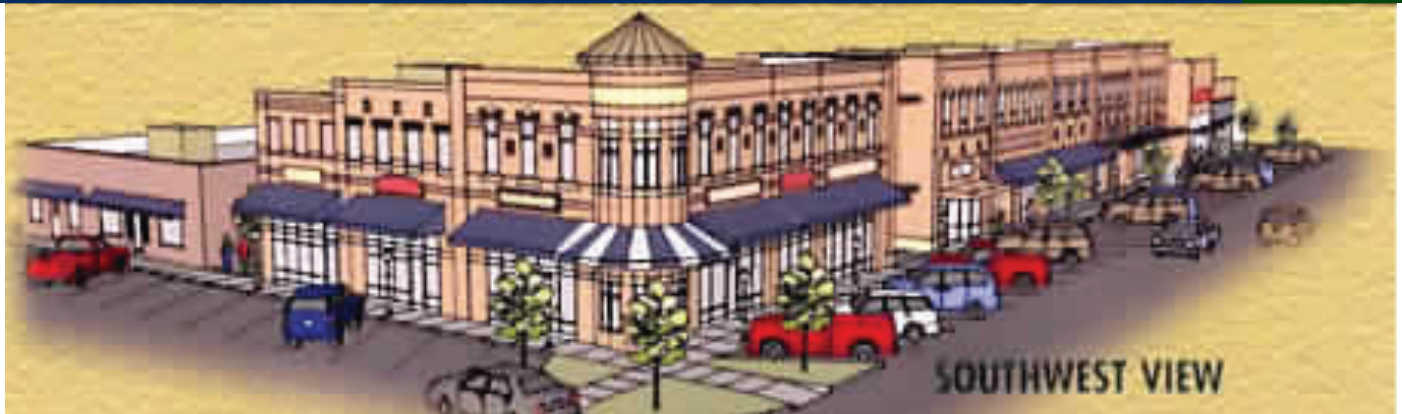
Our understanding is that the currently proposed rebuilding project consists of two, two-story buildings of approximately 30,000 square feet total; and that the project is designed to be mixed-use with retail on the first floor and offices on the second floor. The site is located on the north side of Main Street between Jennings and Bluff Avenue. We understand that the project as planned includes parking for thirty cars. As presented, the project is very attractive and fits the character of downtown and appears to meet historic guidelines for new infill construction in Anthony.

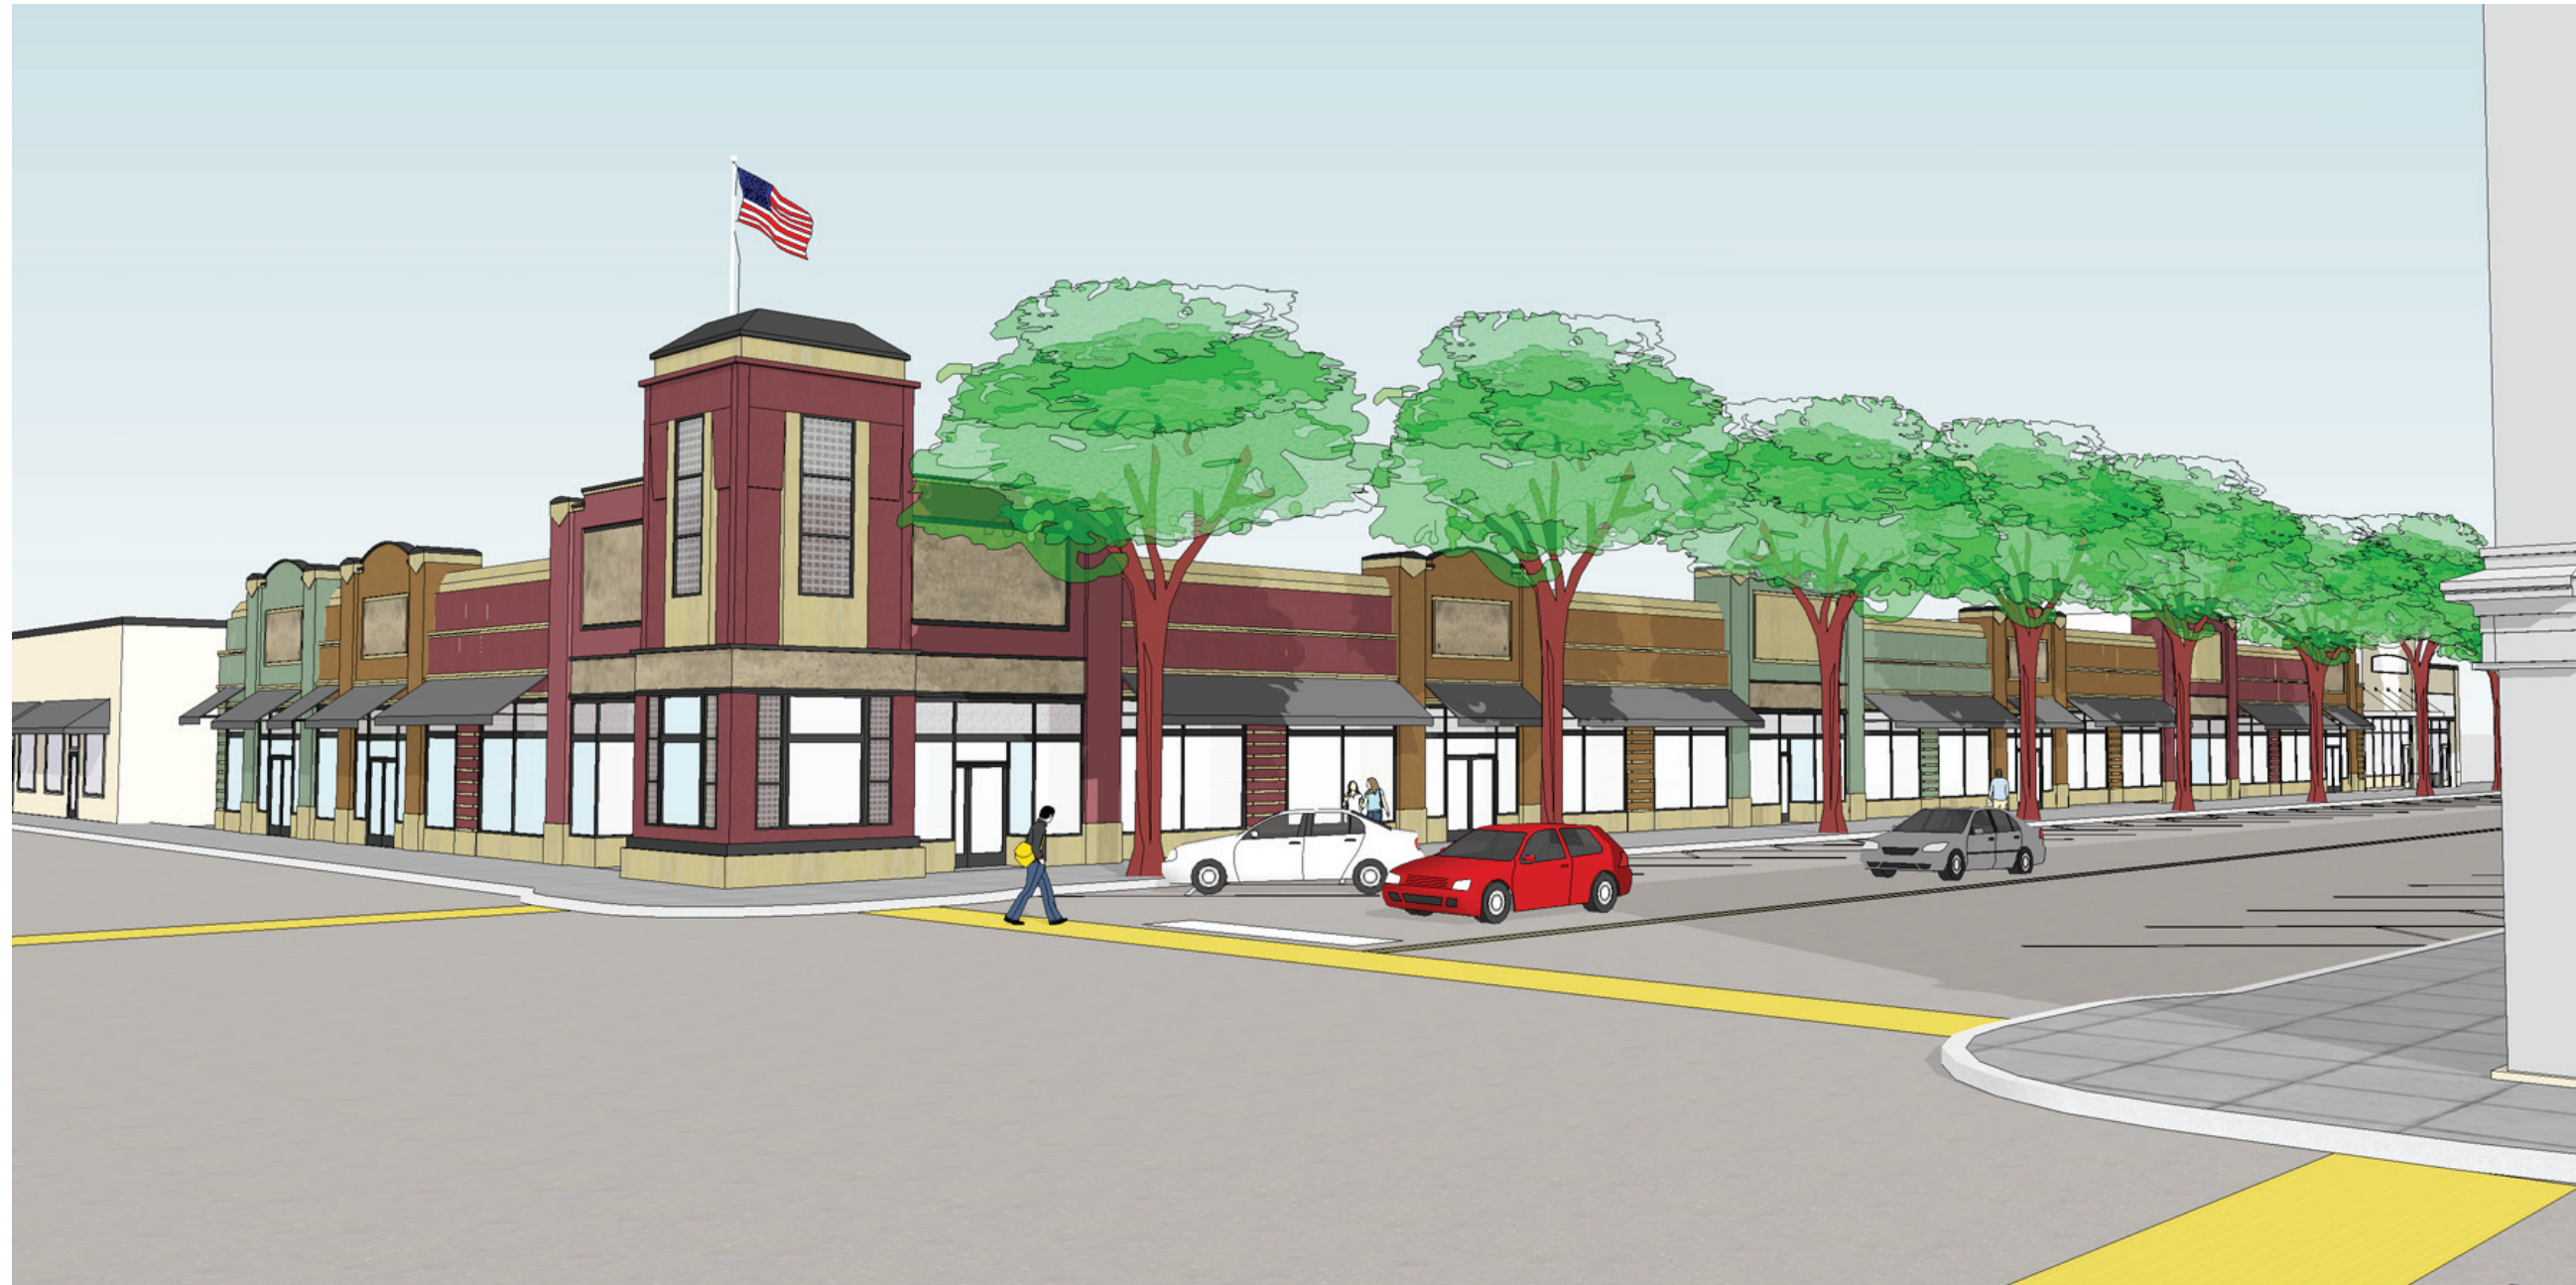
One-Story Option

This option suggests a variety of color and form in the facade and has vertical elements that strengthens the corner. Large street trees also help to create shade and provides scale that matches the scale of the historic buildings on the south side of Main Street.

The first alternate explored constructing only a one-story project, which would eliminate a portion of construction costs associated with two-story buildings. This type of project may be more feasible given the economic report and could be developed much like a one-story strip commercial project, typically built outside of downtown areas. Parking on-site could also be included. For the purposes of planning, the lot was estimated to be 150 feet deep by 275 feet wide minus 3000 square feet of property owned by others. Allowing for the parking area, the net buildable area ranges between 18,000 and 22,000 square feet. Using a lower cost per square foot (ranging from \$87-85/square foot) due to the project being only one-story, this project cost could range from \$1.6 to 1.9 million. (Costs are derived from RS Means Square Foot Costs 2010.)

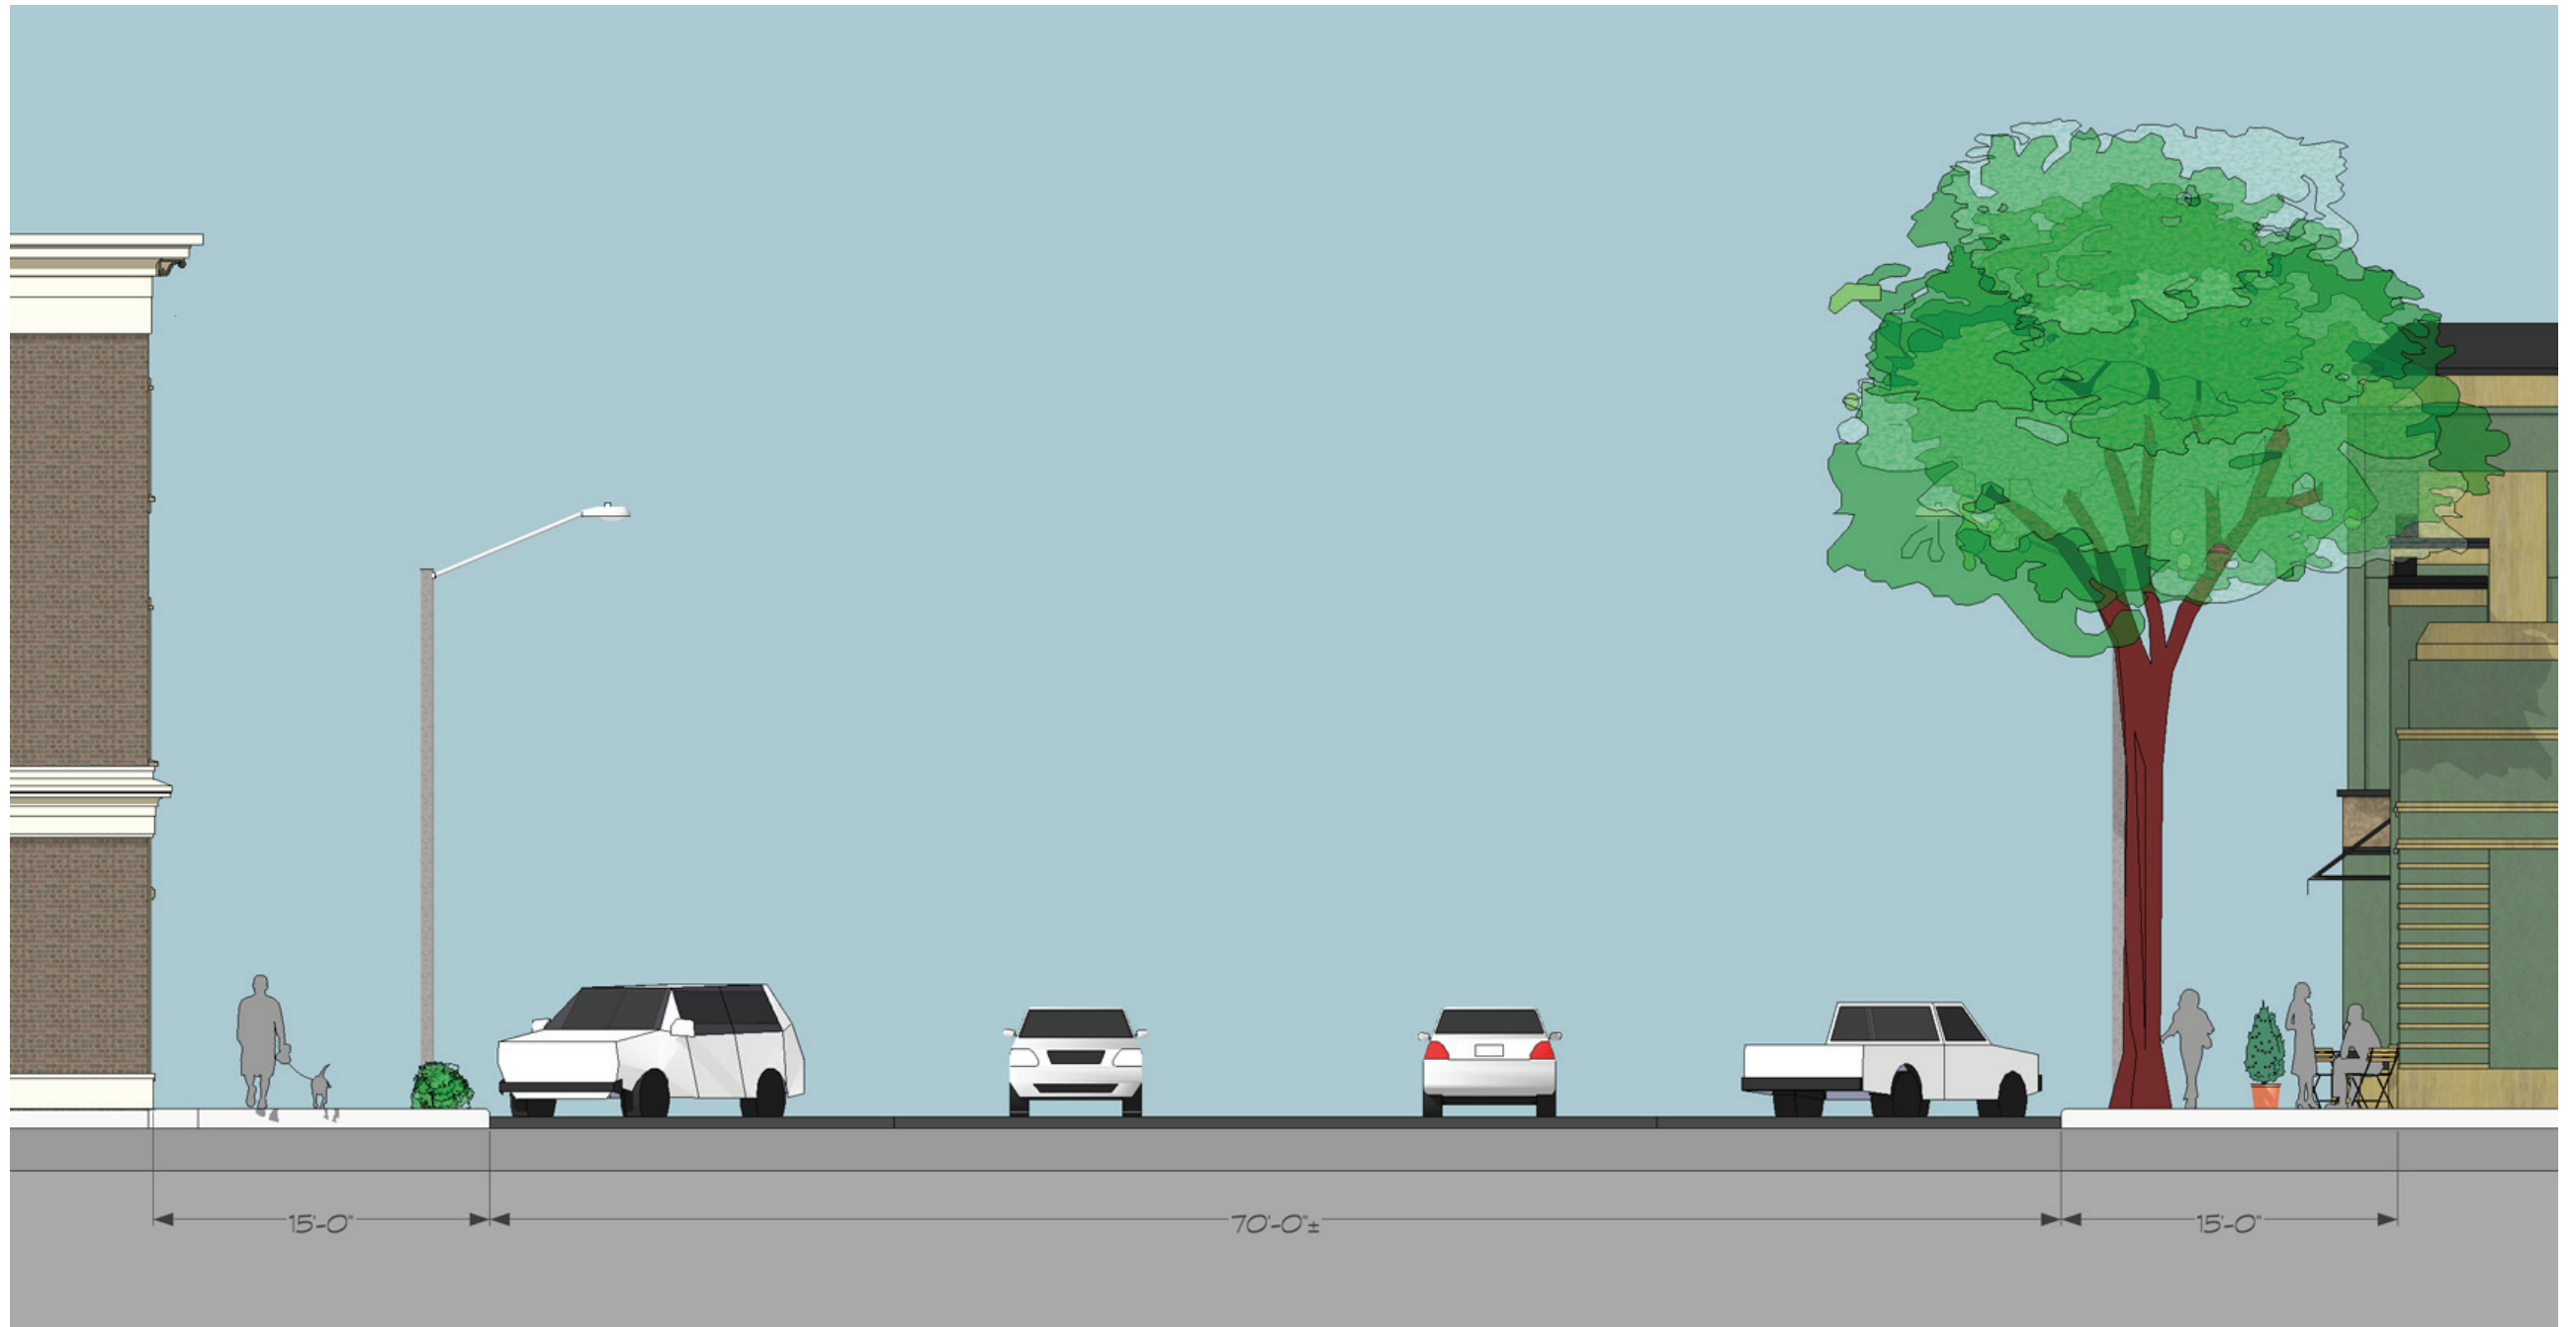
One-Story Option

This street section shows how large street trees on the north side can eventually provide scale that matches the scale of the historic buildings on the south side of Main Street.

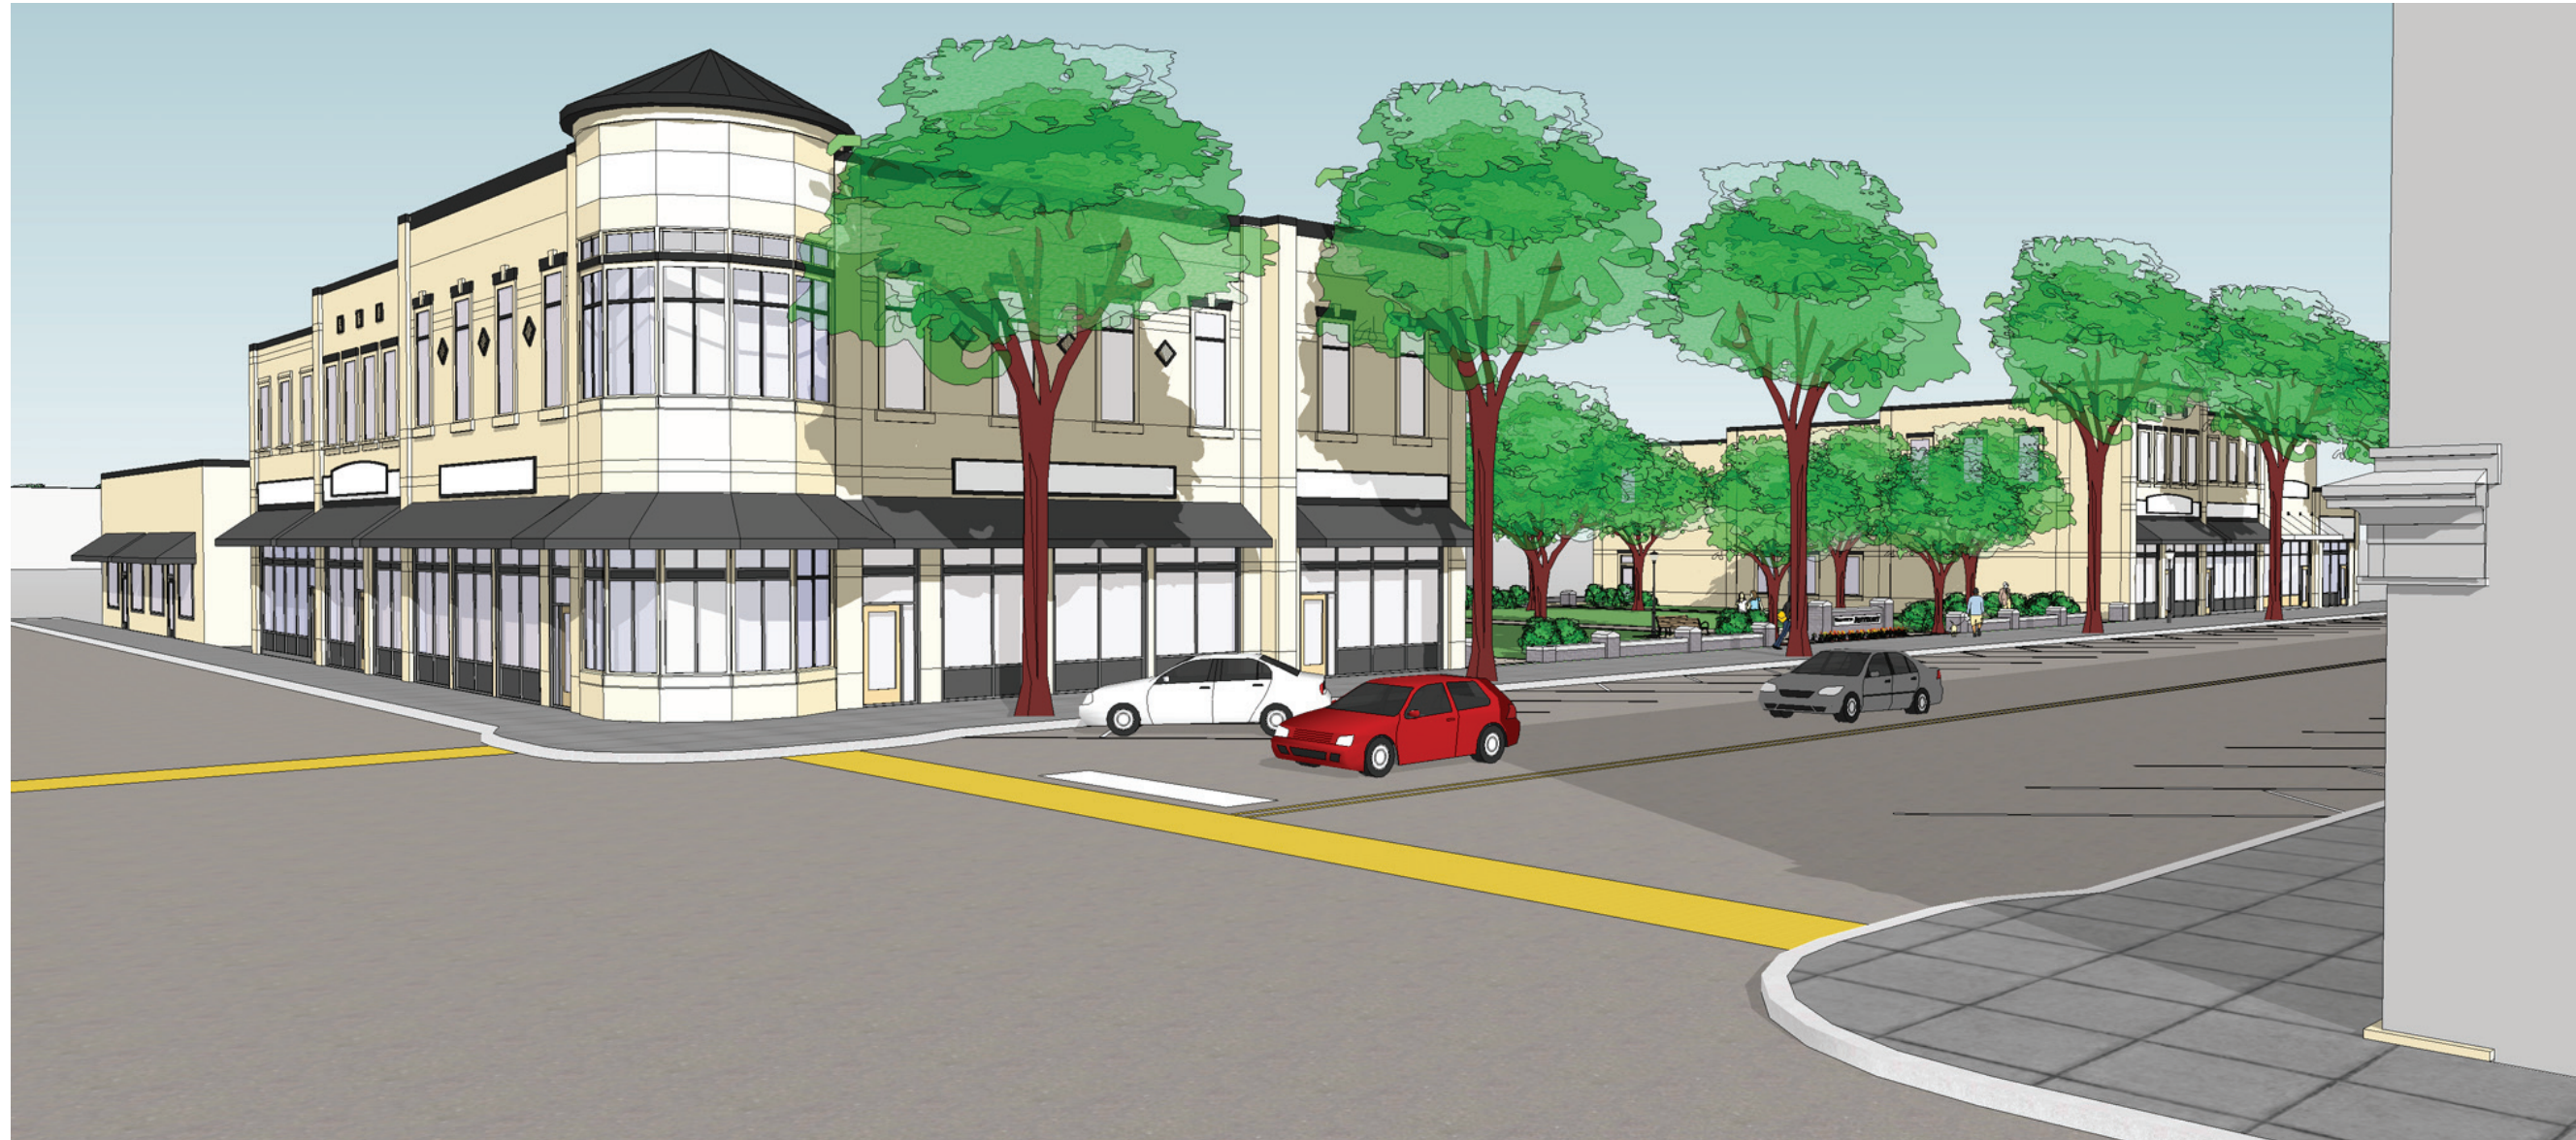
Two-Story Option

This option suggests building the proposed scheme in two phases with the first phase being the building on the corner. The empty lot could be converted into an outdoor event space for the heart of downtown.

The second scheme allows for building the corner building of the original project as a first phase of a longer-term project. The remaining area could be converted into a park for events in the heart of downtown. Shown in the rendering is the concept of using blank walls for showing movies outdoors in the summertime. Realizing that eventually the Anthony Theater would be restored for this use, the park could be used in the interim as a fundraising opportunity for the theater. Live music events could also be hosted in the space.

The two-story building was estimated to range in size from 12,000 to 16,000 square feet with a budget of \$1.8 to 2.2 million (\$153 – \$144 a square foot). A park area could be approximately 15,000 square feet at a cost starting at \$200,000. A parking lot with approximately 30 spaces would also be a part of the plan.

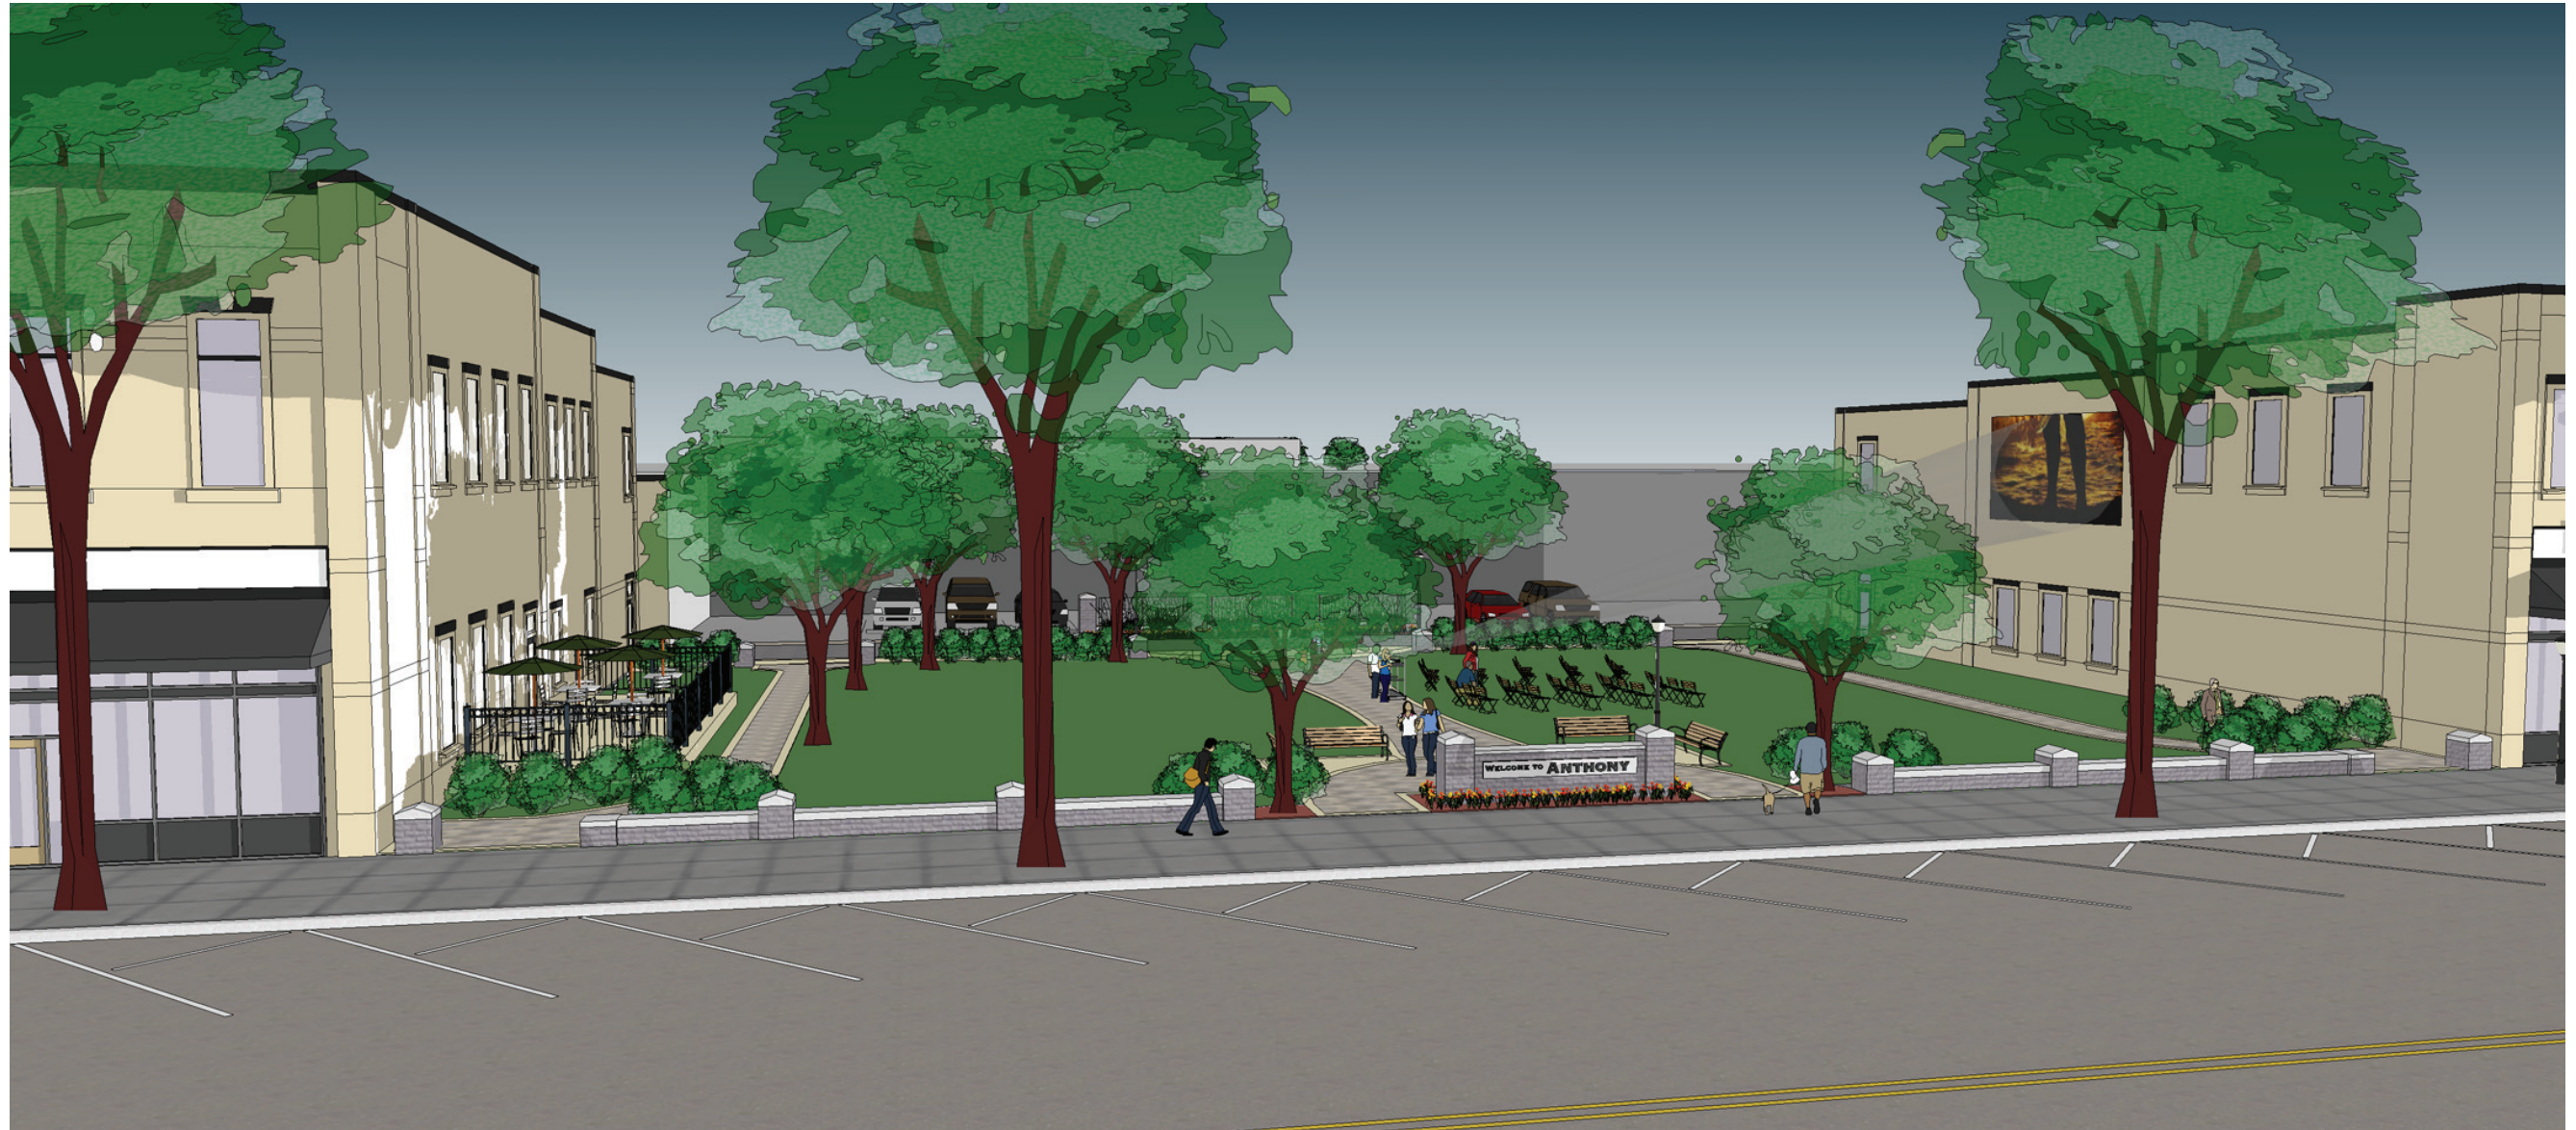
Two-Story Option

This view shows how the empty lot could be converted into an outdoor event space and used, in this case, to show movies.

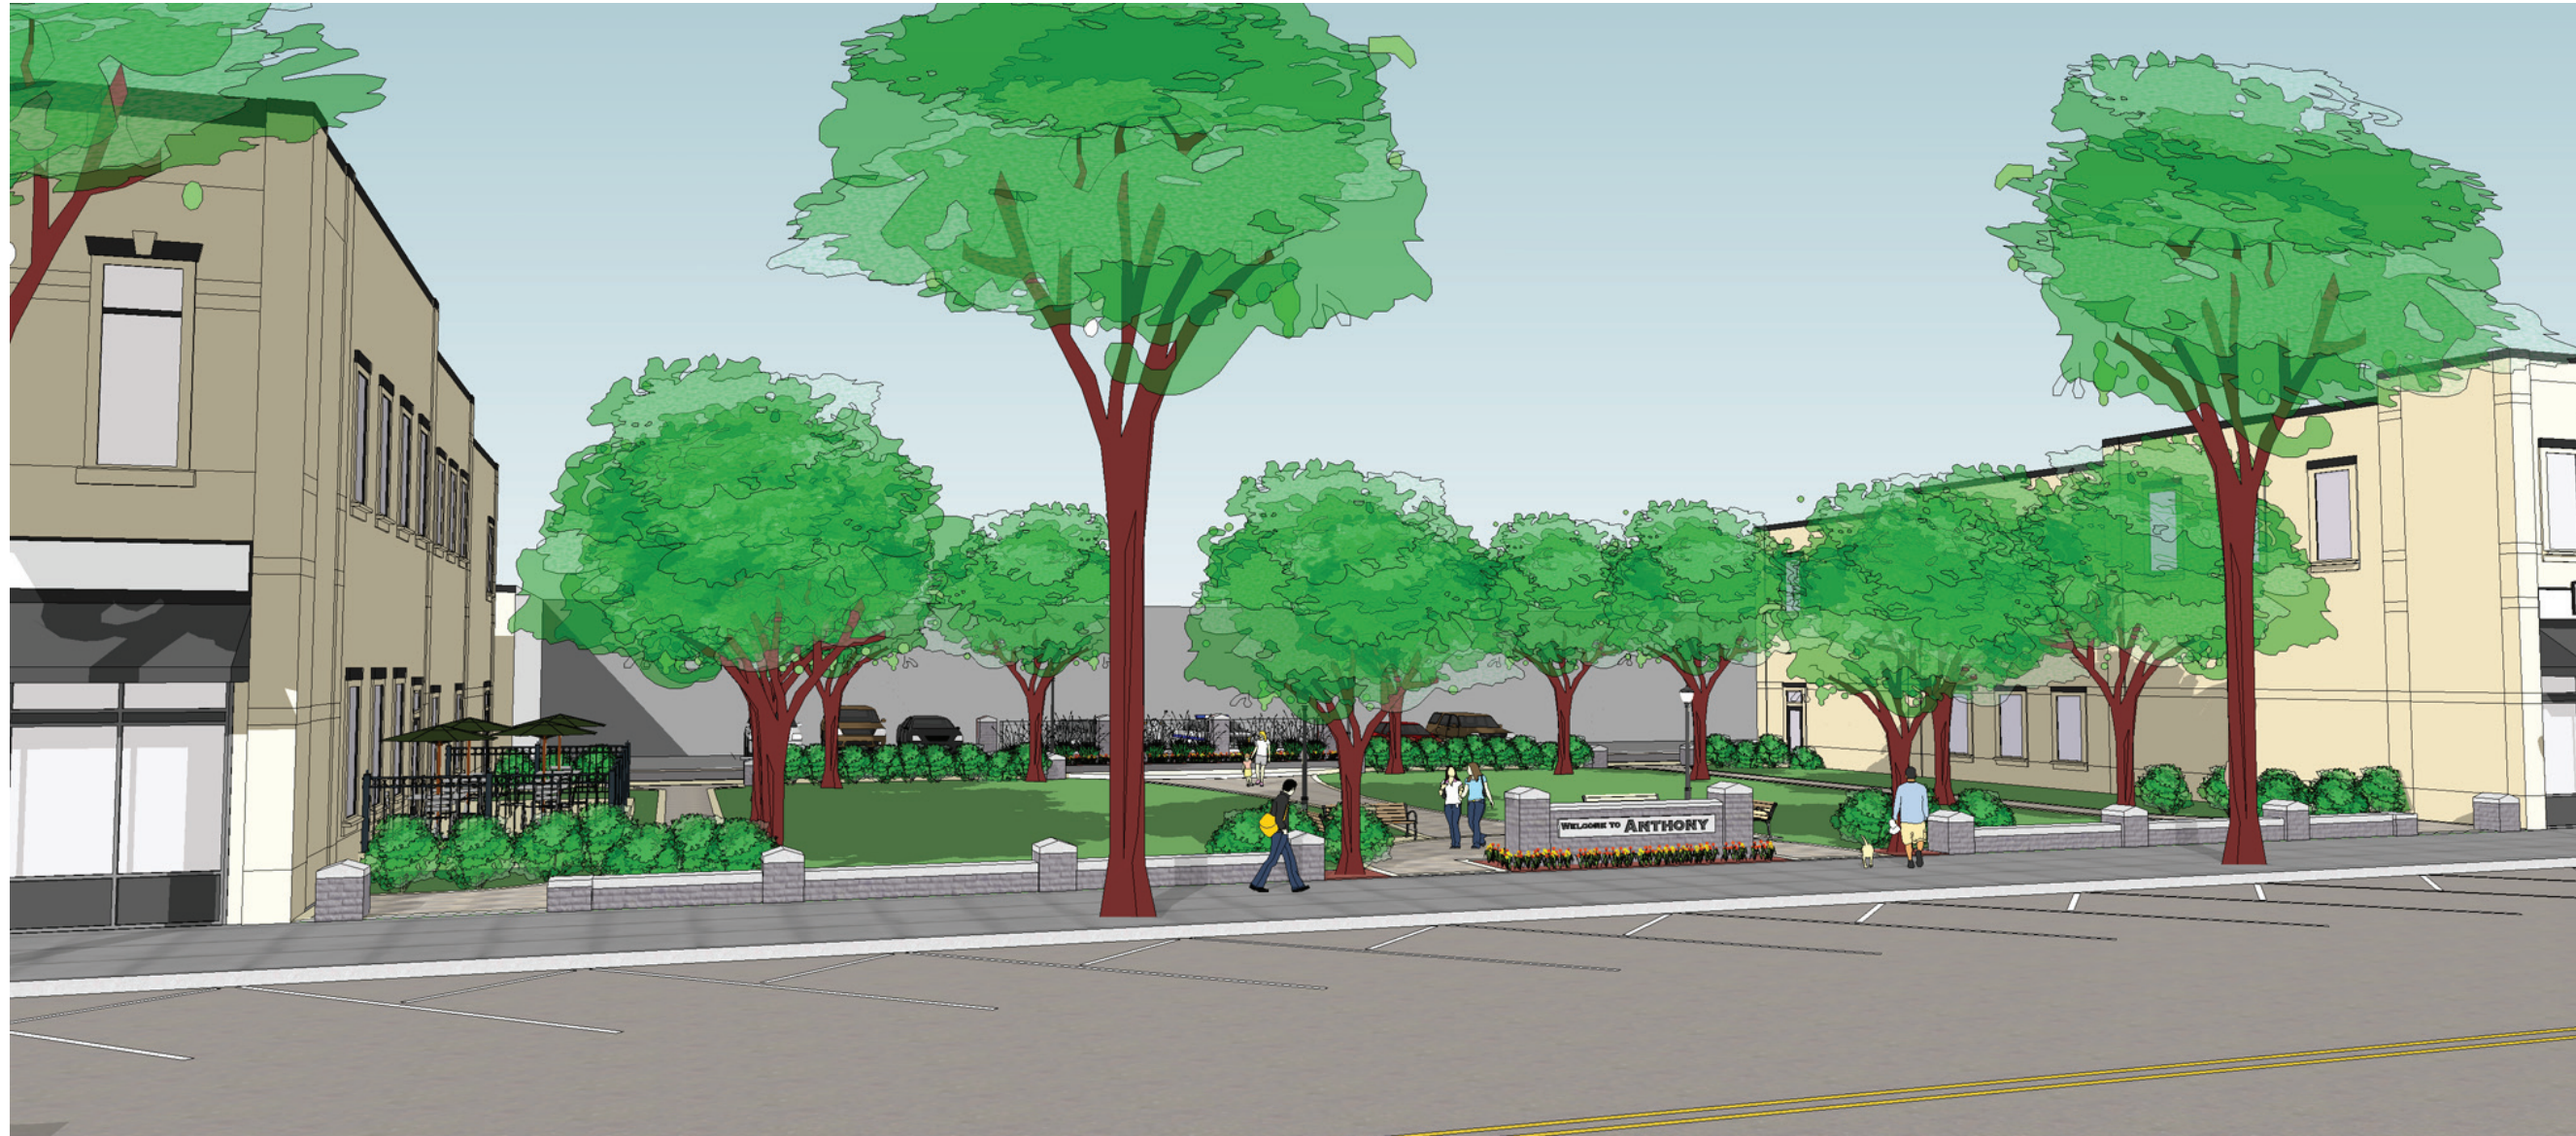
Two-Story Option

This view shows the empty lot planted with trees and used for outdoor dining.

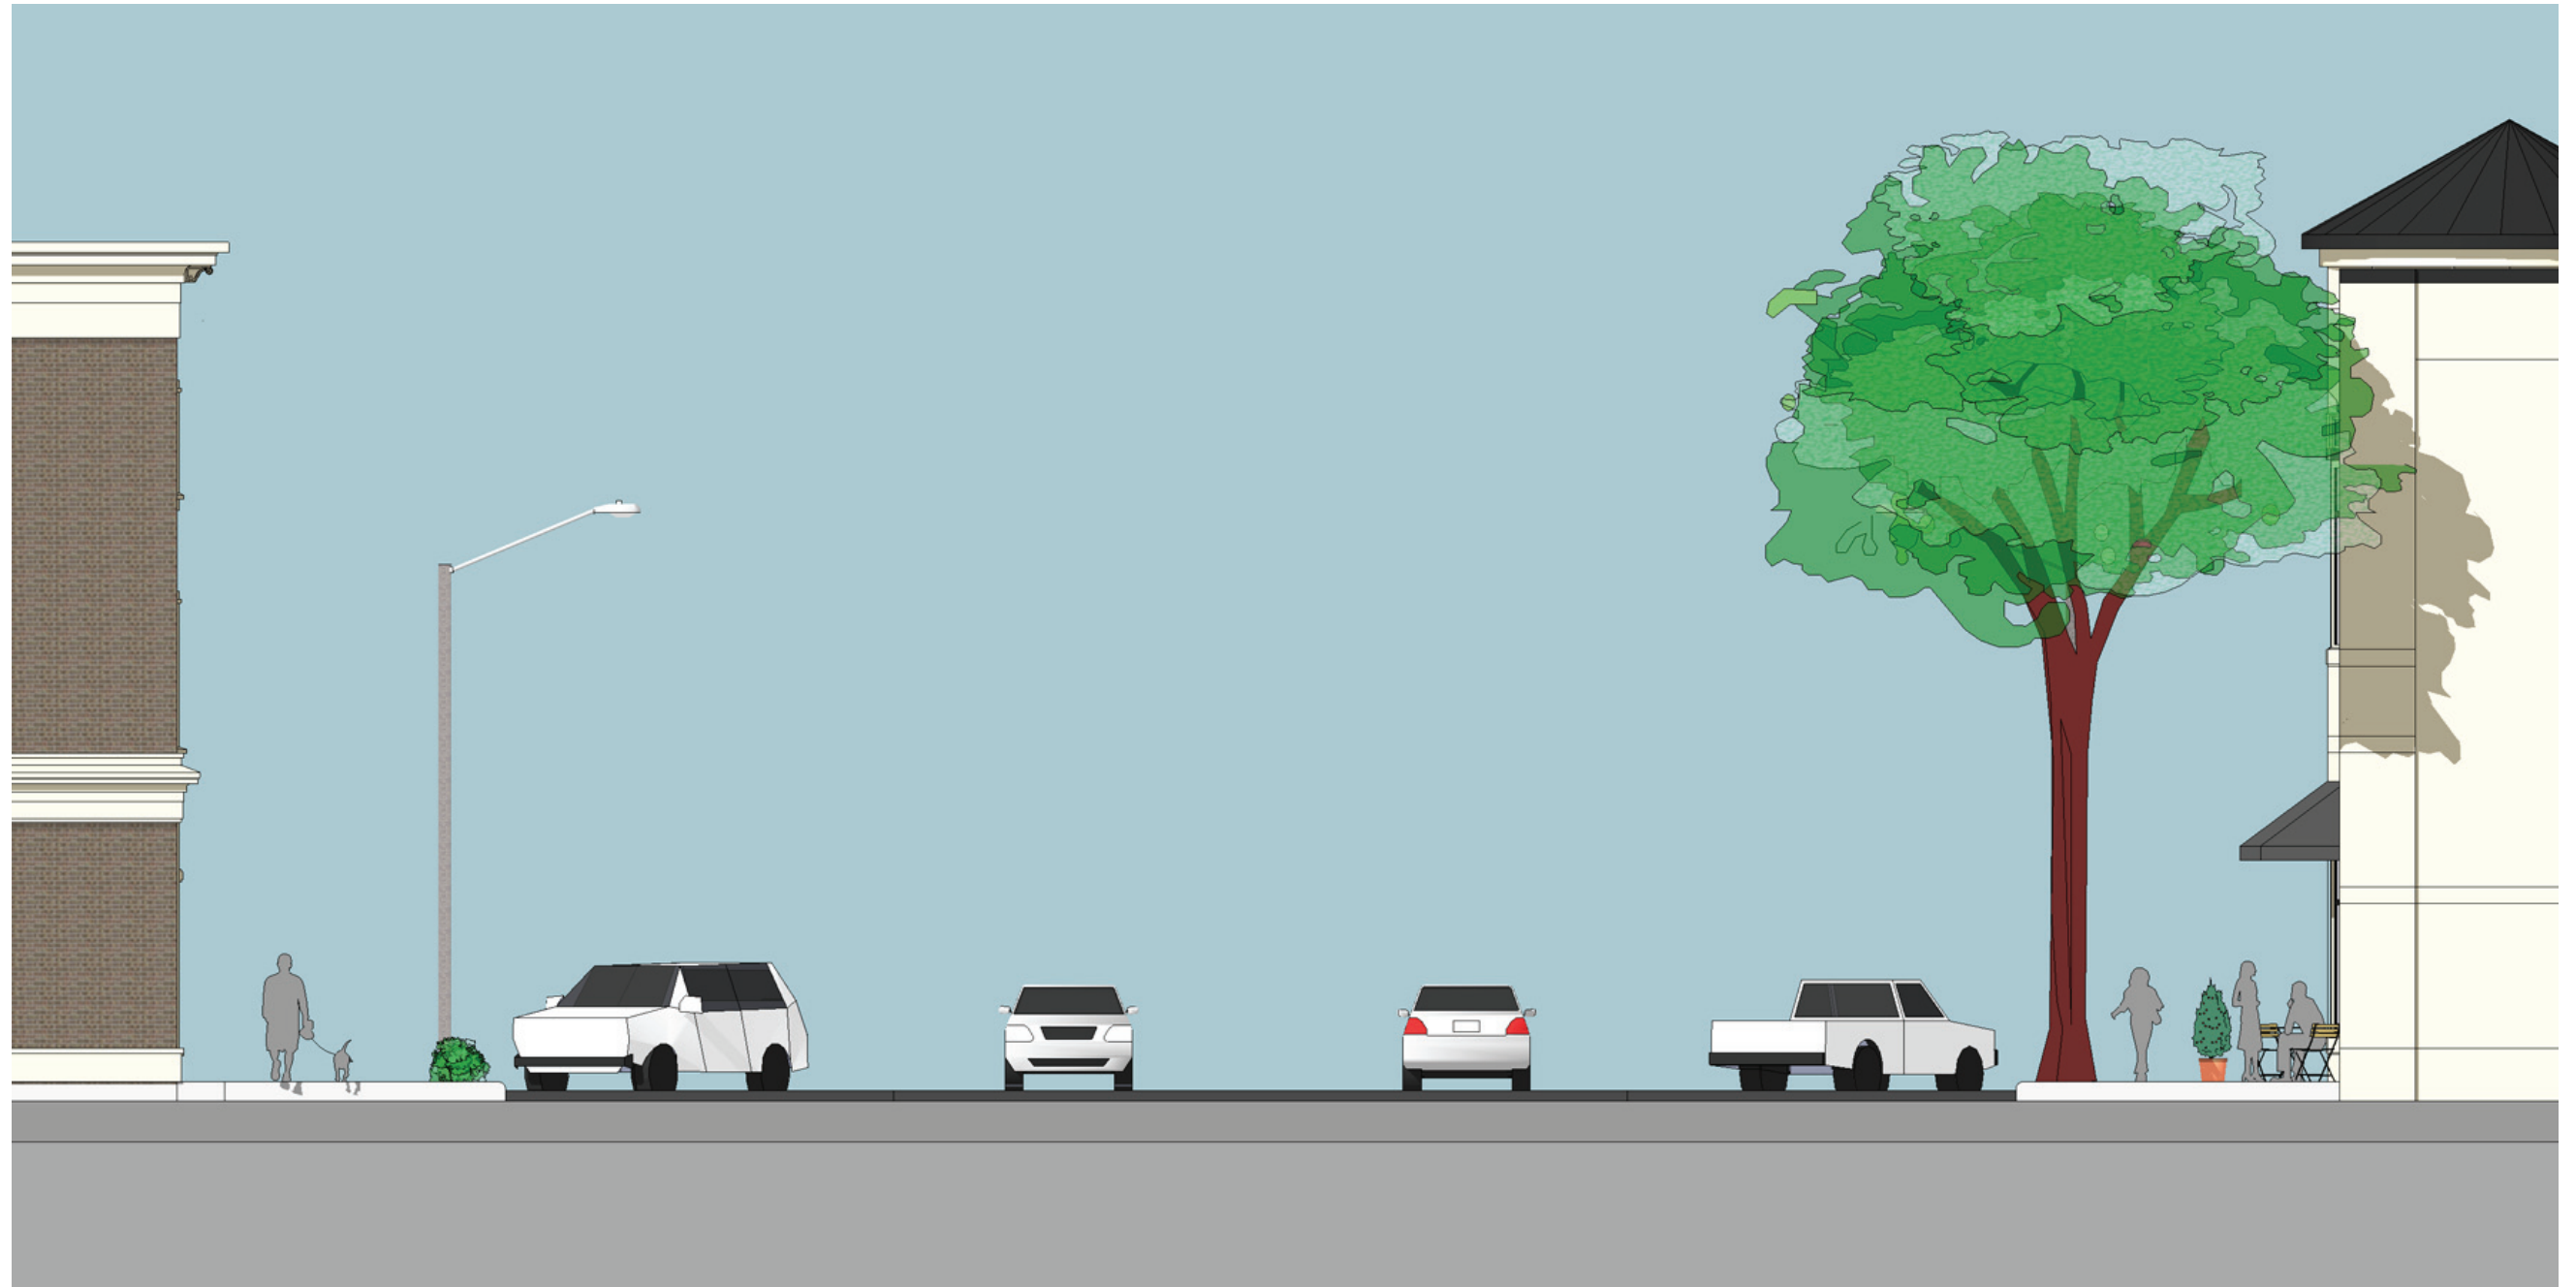
Two-Story Option

This street section shows the relationship of the new buildings (right) in relationship to the existing historic buildings (left).
