# REBUILDING SITE ALTERNATIVES AND GENERAL DESIGN RECOMMENDATIONS FOR DOWNTOWN ANTHONY

ANTHONY, KANSAS

For:  
CITY OF ANTHONY, KANSAS

Prepared By:  
FRAZIER ASSOCIATES  
ARCHITECTURE ■ URBAN PLANNING ■ WAYFINDING

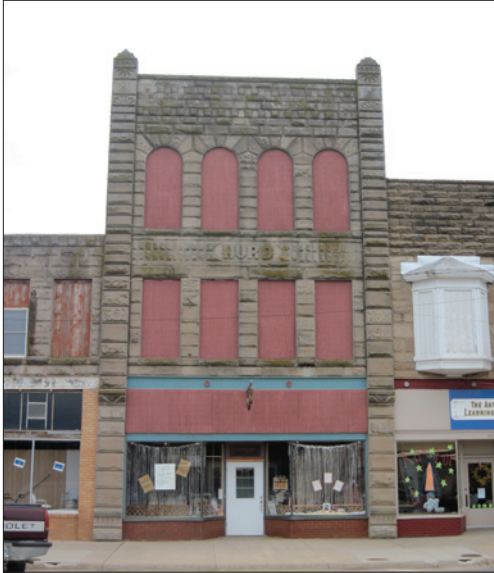
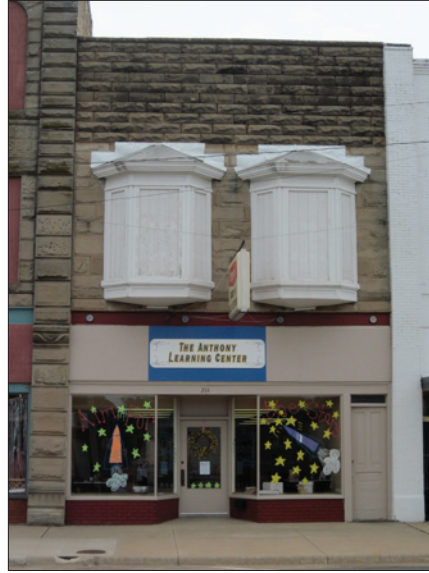
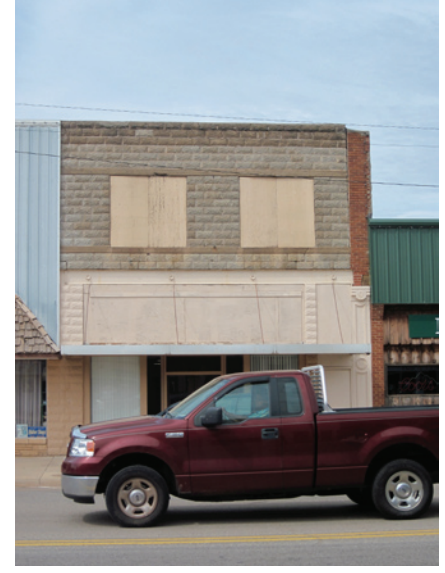
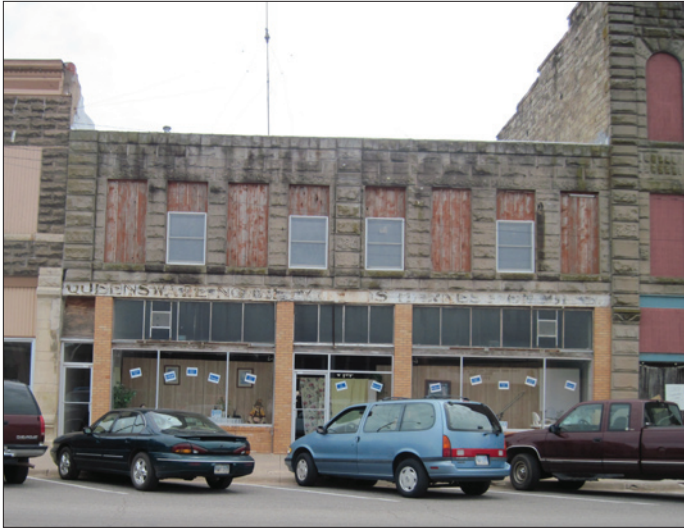
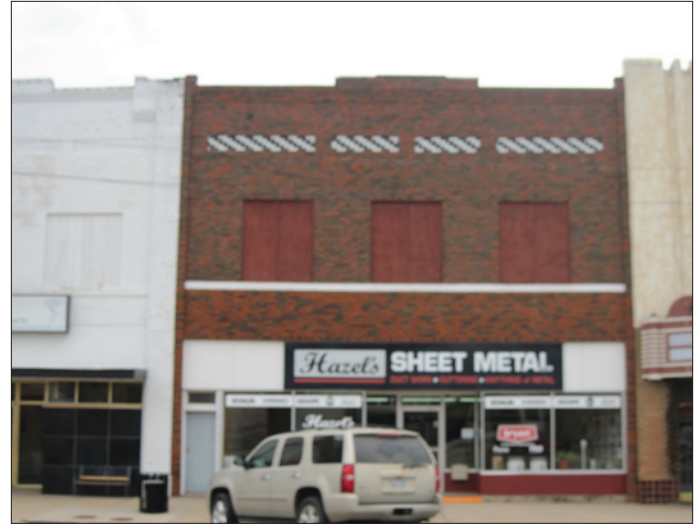
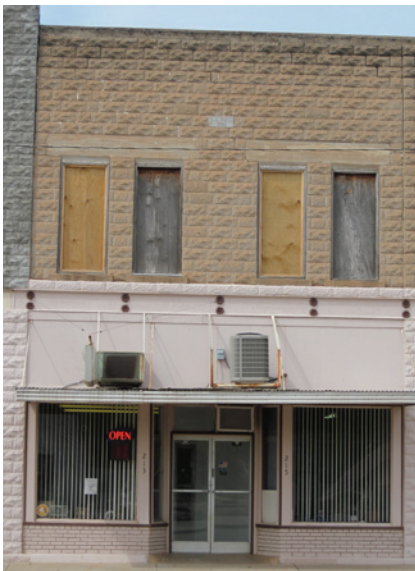
Anthony has many handsome historic commercial buildings that would benefit from facade improvements, ranging from opening second floor windows, adding awnings and signs, to fresh paint schemes.

During the site visit, the wide variety and quality of historic downtown buildings was noted along with the opportunity for economical improvements that will enhance the appeal of the district. One of the key issues noted was blocked up second floor windows. This appearance gives a vacant and abandoned appearance to downtown, even though most of the first floors of these buildings were occupied with viable businesses. The program could focus on reopening and repairing these historic wood windows and show the community that downtown is open for business – even on the second floor. In some cases, if the improvements reach a certain cost threshold, then owners would be eligible for historic tax credits. See above. In addition, Anthony has had a facade improvement program in place since early 2000 that provides economic incentives to fix up the exterior of buildings. Design Guidelines are in place for this program. This program could be promoted more actively and possibly packaged with the historic tax credits. Design assistance would be beneficial to aid owners in visualizing the impact of improvements.

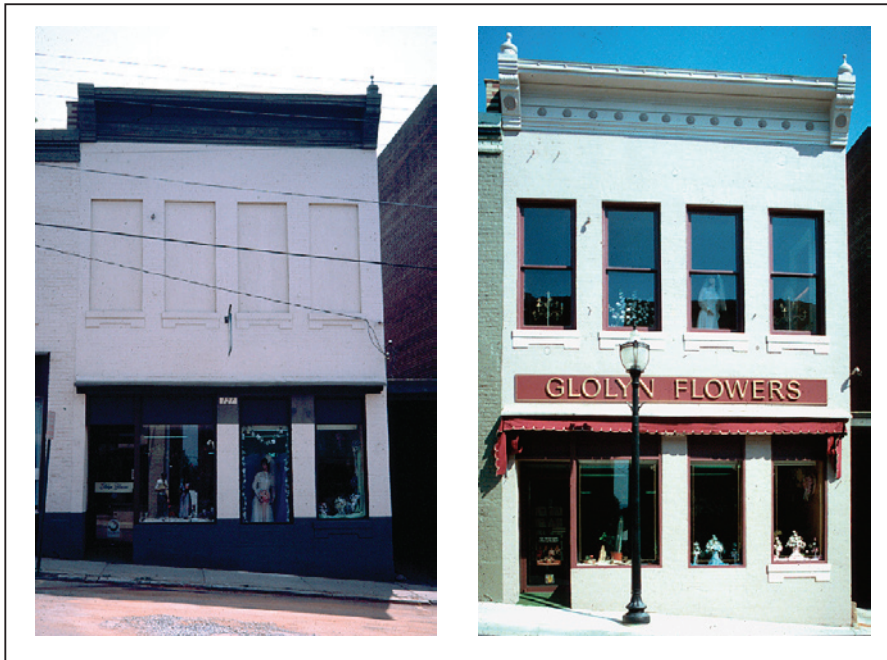
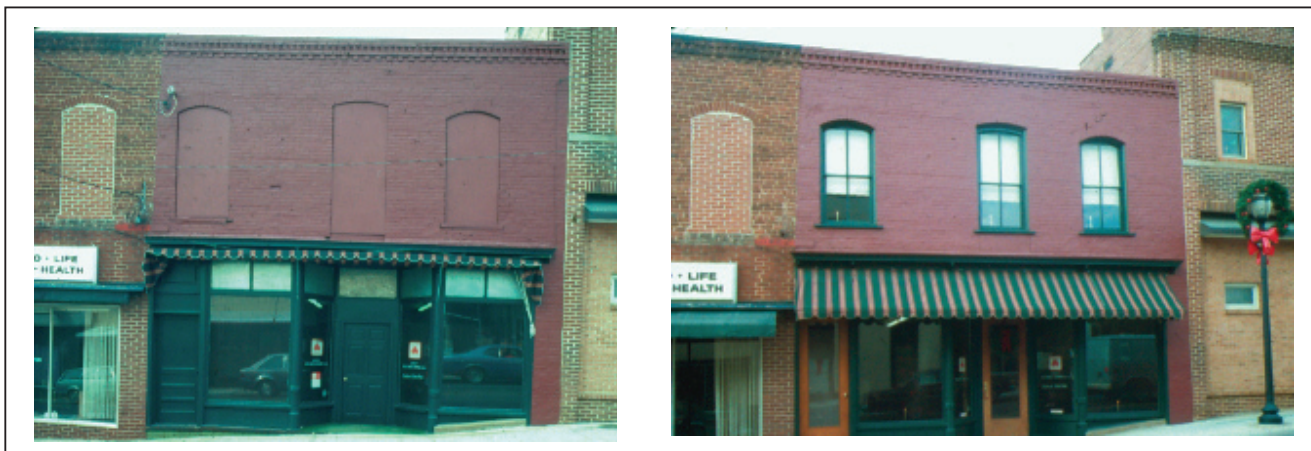
The illustrations on this page are examples of facade improvements that included opening second floor windows, new paint schemes, awnings and signs.

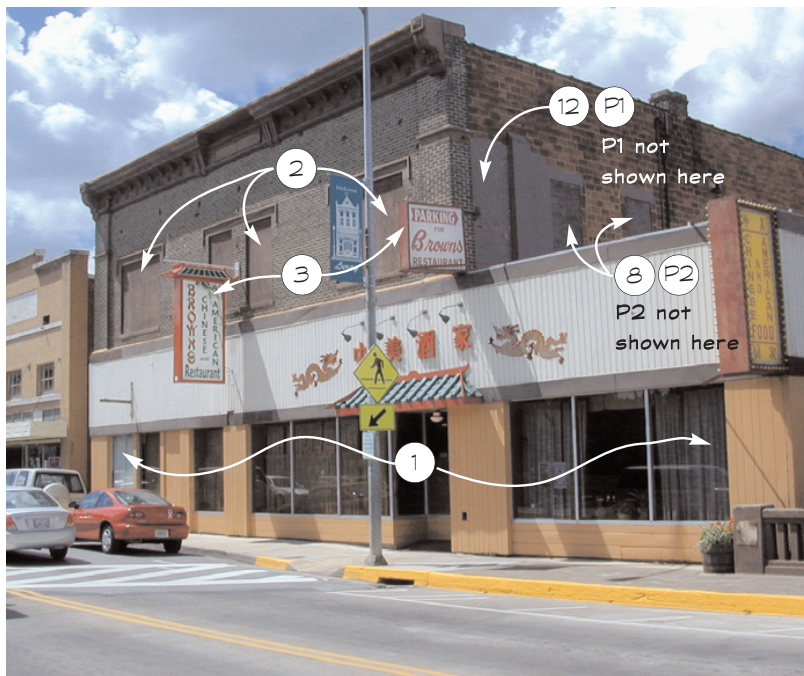
**EXISTING FRONT FACADE**  
NOT TO SCALE

1. Remove metal siding, wood panels, storefront, lattice screen and support system from the front and side facades to expose the original building fabric. Repair damage to the masonry with materials to match existing in color, texture and size. If the original lower facade structure is different and/or cannot be re-built as illustrated, contact the Main Street Architect for recommendations prior to proceeding with work.

2. Remove panels from upper facade window openings. Repair any damage to masonry with materials to match existing in color, texture and size. Repair windows to operable condition. Provide new windows where existing windows are missing to match existing design and materials of remaining windows.

3. Remove the existing signs, and salvage as per owner's instructions. Repair any damage to masonry with materials to match existing in color, texture and size.  
(NOTES 4-7 not used on this sheet.)

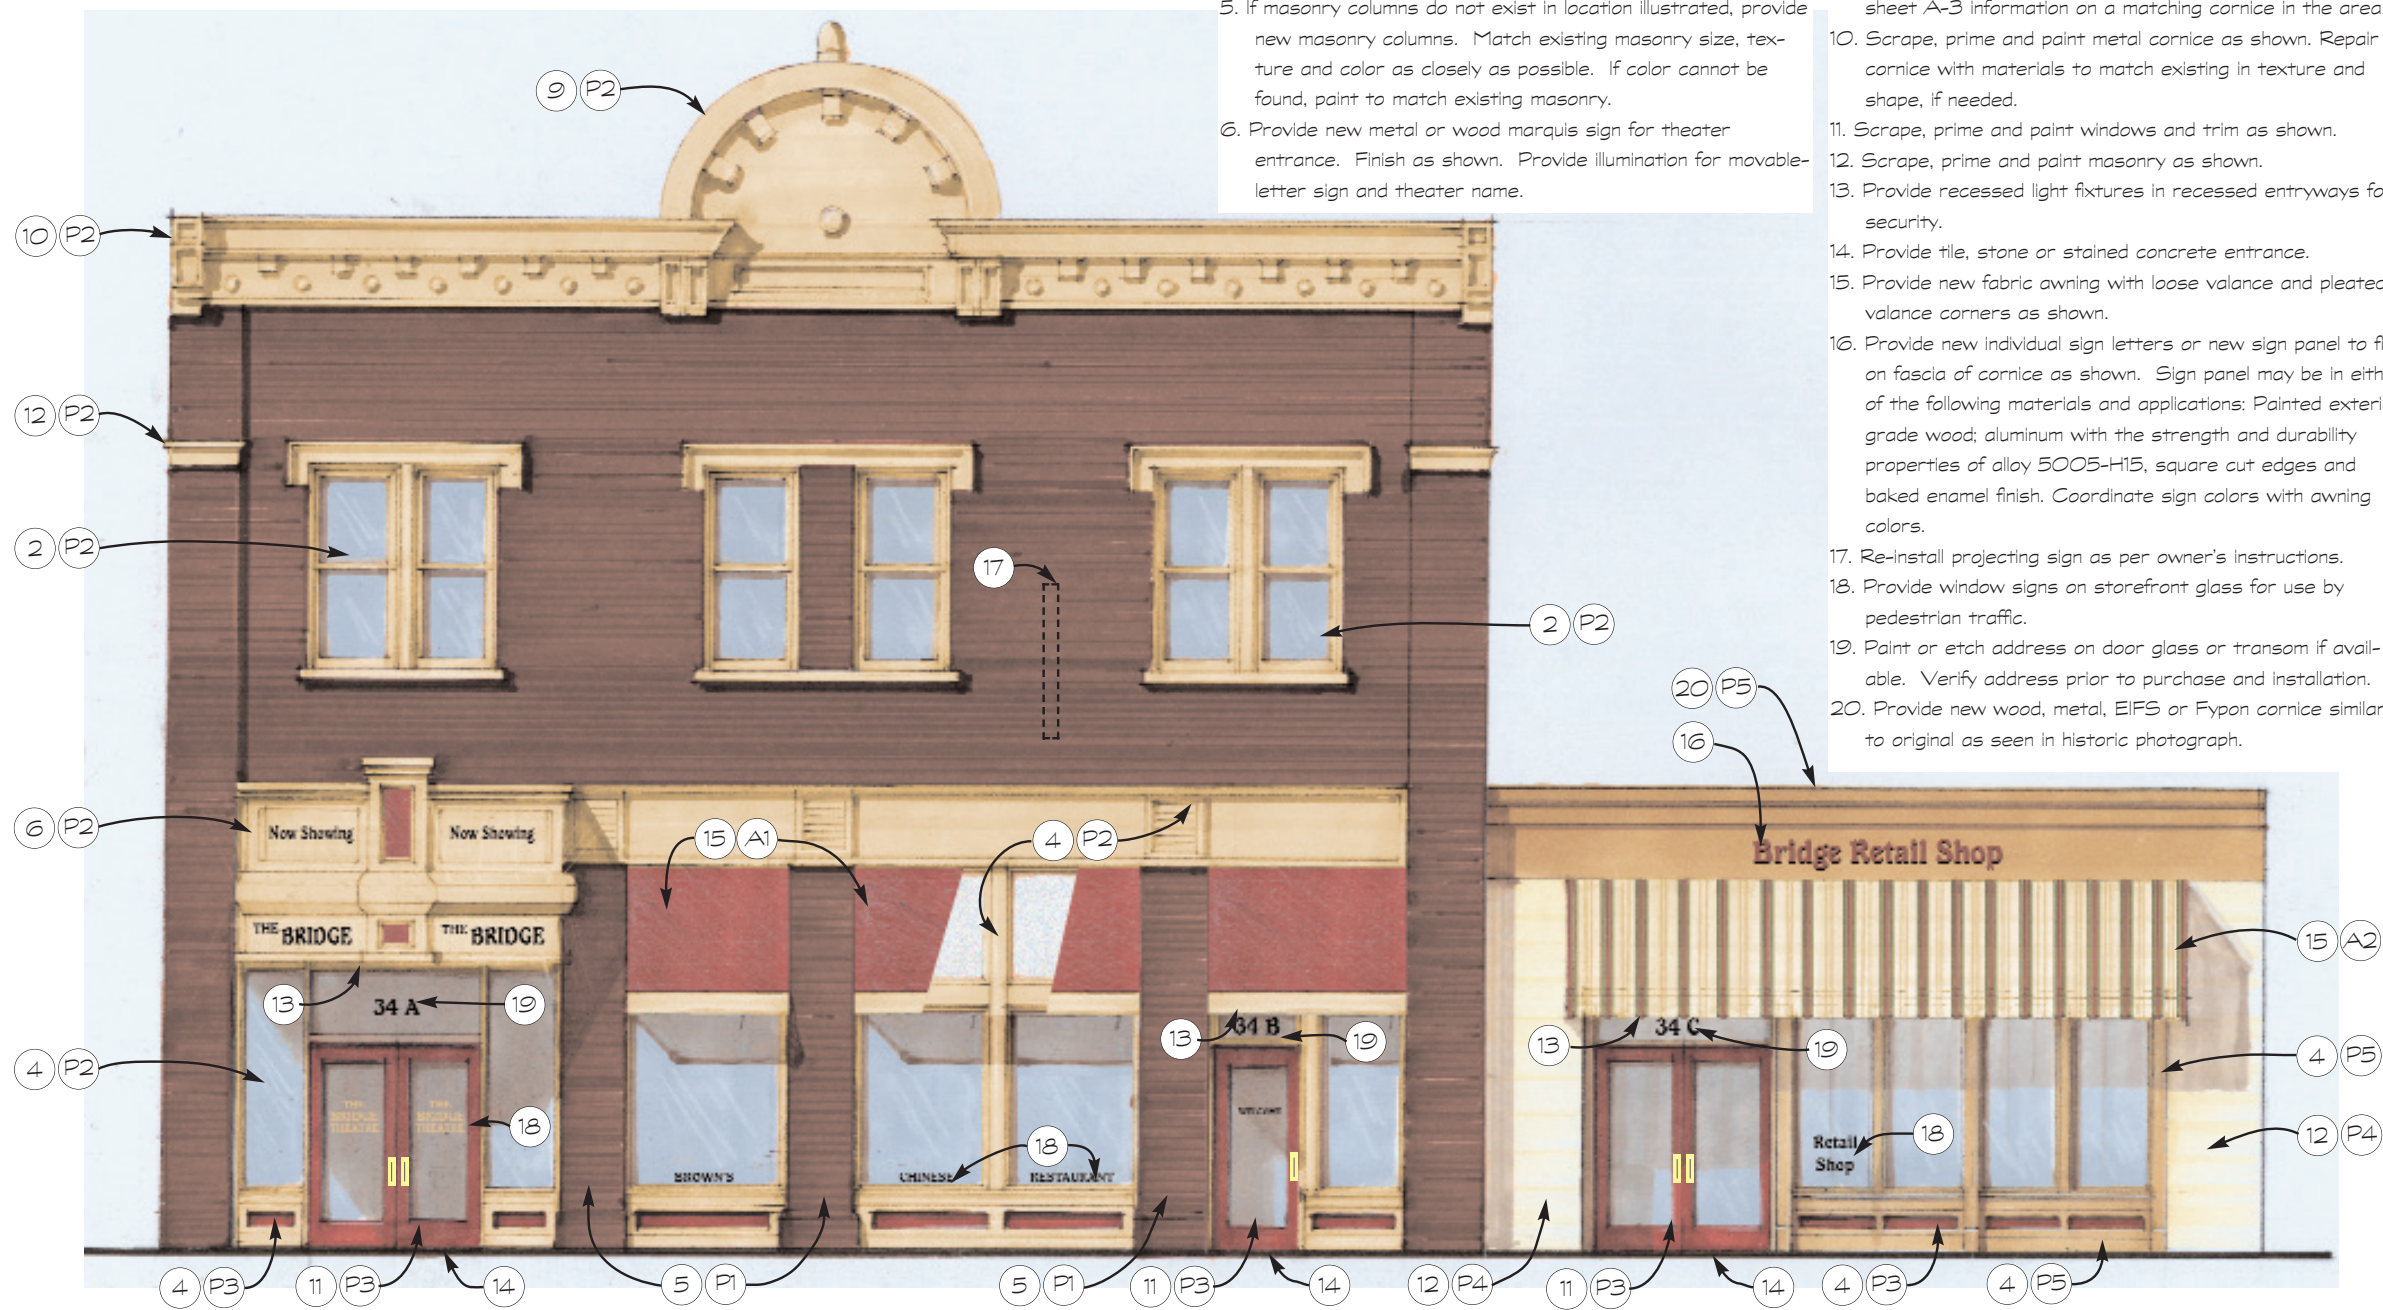
**FRONT FACADE**  
NOT TO SCALE

1. Remove metal siding, wood panels, storefront, lattice screen and support system from the front and side facades to expose the original building fabric. Repair damage to the masonry with materials to match existing in color, texture and size. If the original lower facade structure is different and/or cannot be re-built as illustrated, contact the Main Street Architect for recommendations prior to proceeding with work.

2. Remove panels from upper facade window openings. Repair any damage to masonry with materials to match existing in color, texture and size. Repair windows to operable condition. Provide new windows where existing windows are missing to match existing design and materials of remaining windows.

3. Remove the existing signs, and salvage as per owner's instructions. Repair any damage to masonry with materials to match existing in color, texture and size.

5. If masonry columns do not exist in location illustrated, provide new masonry columns. Match existing masonry size, texture and color as closely as possible. If color cannot be found, paint to match existing masonry.

9. Provide new metal cornice arch. Paint as shown. See sheet A-3 information on a matching cornice in the area.
10. Scrape, prime and paint metal cornice as shown. Repair cornice with materials to match existing in texture and shape, if needed.

14. Provide tile, stone or stained concrete entrance.
15. Provide new fabric awning with loose valance and pleated valance corners as shown.
16. Provide new individual sign letters or new sign panel to fit on fascia of cornice as shown. Sign panel may be in either of the following materials and applications: Painted exterior grade wood; aluminum with the strength and durability properties of alloy 5005-H15, square cut edges and baked enamel finish. Coordinate sign colors with awning colors.

20. Provide new wood, metal, EIFS or Fypon cornice similar to original as seen in historic photograph.

Sample Facade Improvement Drawing

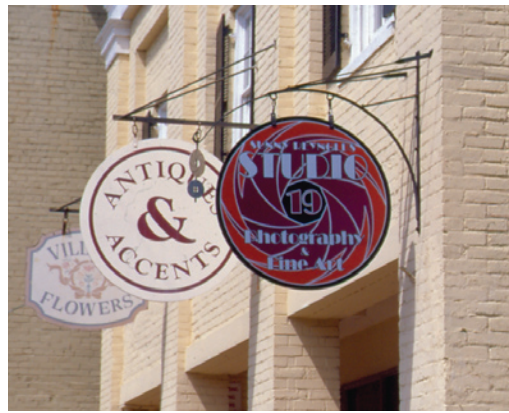
Samples of attractive wall mounted, window and projecting signs found on historic downtown buildings.

Businesses in downtown could benefit from improved signs and graphics. Design and fabrication of these elements should be included in facade improvements. Because downtown businesses are viewed both from the car and by a pedestrian, different types of signs and placement locations are usually recommended. See illustration. For instance, signs on storefront glass are easily read by the passing pedestrian; flat wall signs above the storefront are seen from across the street; projecting signs are useful to those viewing from the automobile and as a pedestrian.

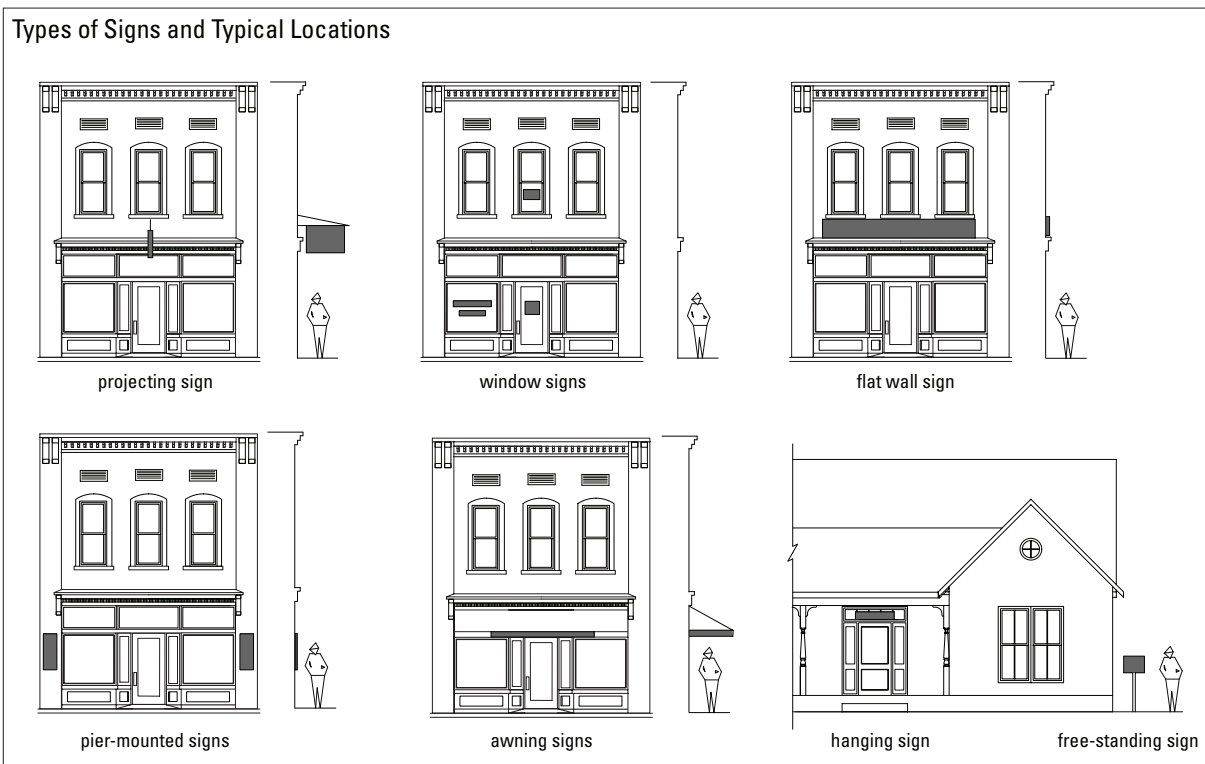
Types of Signs and Typical Locations

This graphic shows typical locations for signs on historic commercial buildings as well as residences used for businesses.

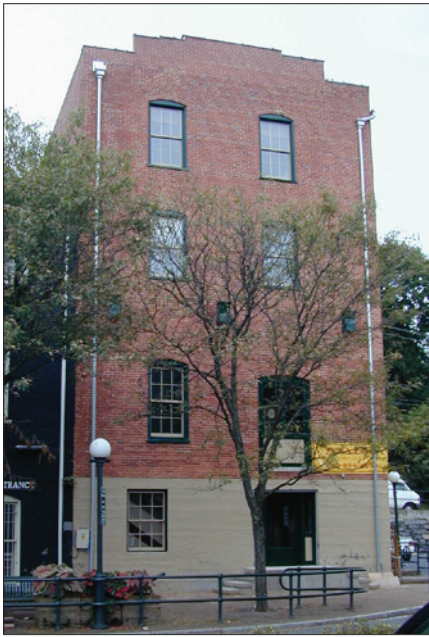
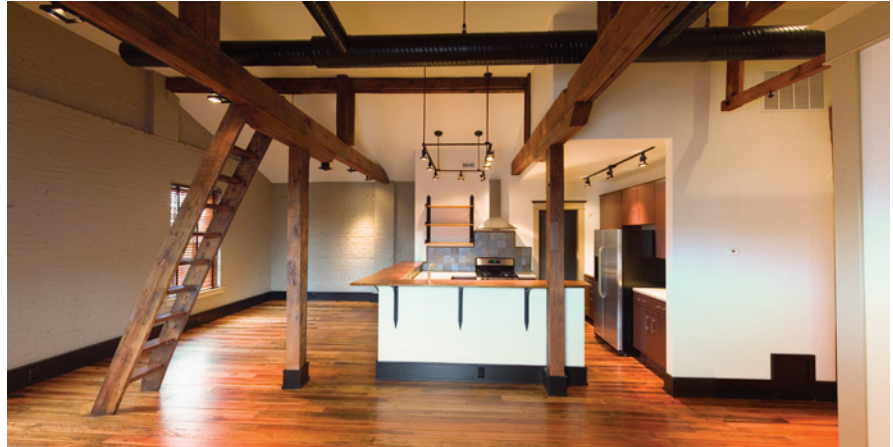
The upper floors of this building were used for grain storage and was never finished. The new apartment featured painted brick walls, refurbished wood floors and exposed wood beams.

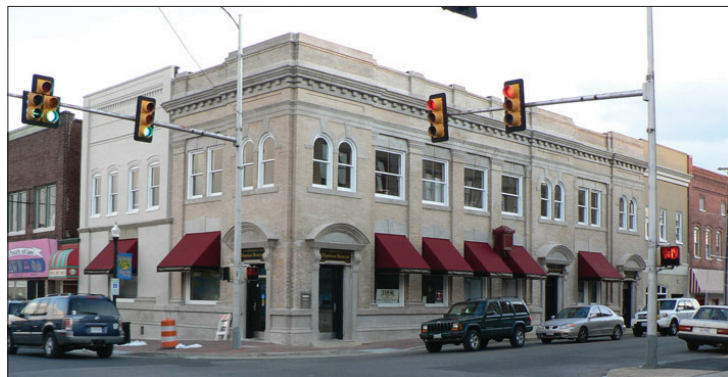
This building had a more finished second floor, so the rehabilitation included refinishing floors, painting walls and refurbishing trim while adding new kitchens and bathrooms.

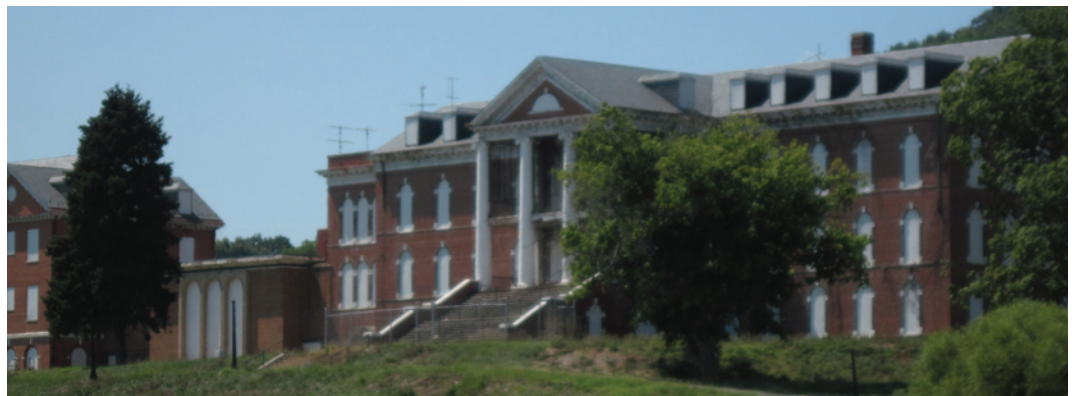
The high school, like this building, is waiting to be redeveloped. To ensure that vandalism is minimized, the windows were secured with plywood and painted.

In the short term, it is recommended that steps be taken to secure and “mothball” these facilities. Losing them either in part or in whole to fire or other vandalism would be tragic. See <http://www.nps.gov/history/hps/tps/briefs/brief31.htm>

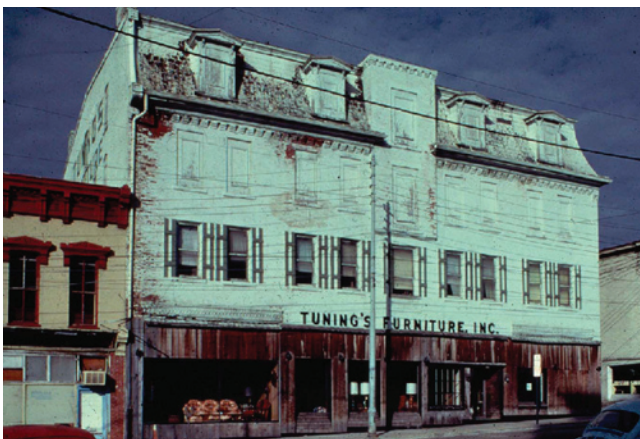
Many communities have large “white elephant” buildings (above) that remain vacant due to obsolete uses. However, many are converted (right) to new uses like this old hotel that is now a community center for history and art.

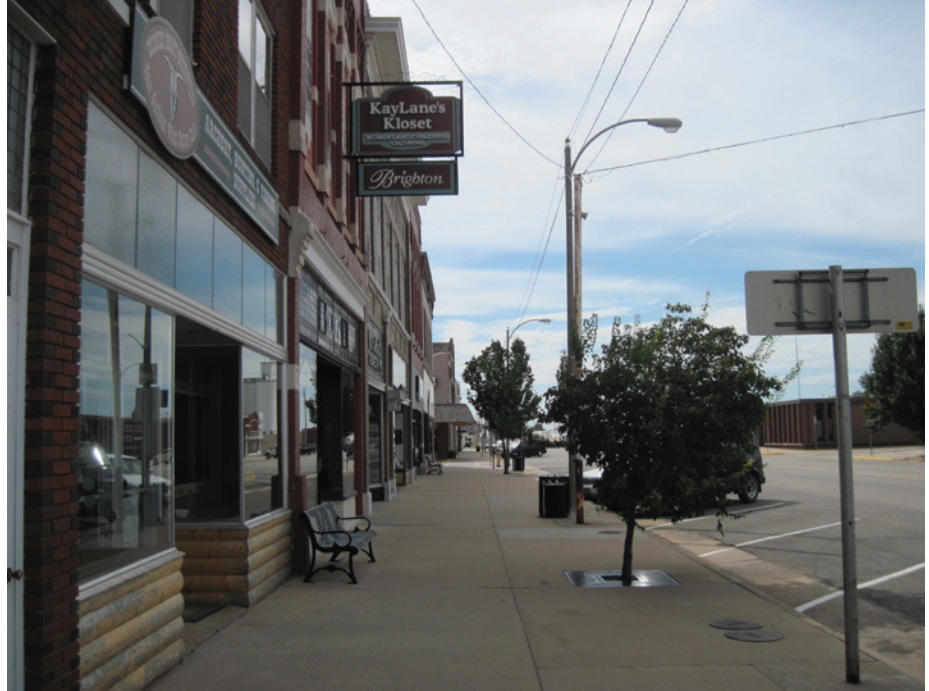
The south side of Main Street benefits from the shadow cast by the buildings on Anthony's wide downtown sidewalks, making the area ideal for events and outdoor dining.

Downtown is a pedestrian-oriented place. Downtown Anthony already has several key amenities that make for a positive outdoor pedestrian environment. Some of these amenities include wide sidewalks, ample lighting, and buildings in the core area with zero front setback from the sidewalk. The south side of Main Street has two-story buildings, and these buildings cast shade on the sidewalk all day, making that area a wonderful opportunity for outdoor seating, dining and events.

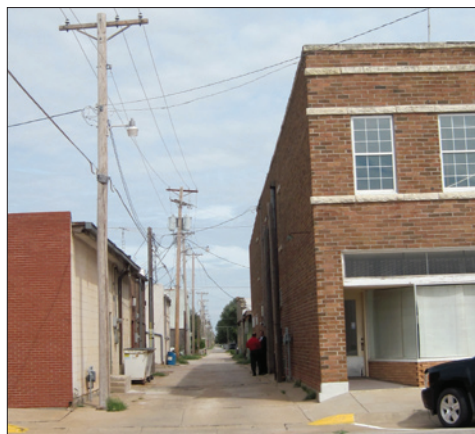
View of alley behind Main Street that carries utilities.

Anthony is fortunate that all utilities run in the alleys behind the buildings on Main Street giving the street a very clean and uncluttered appearance. This also makes adding amenities such as street trees easier to accomplish.

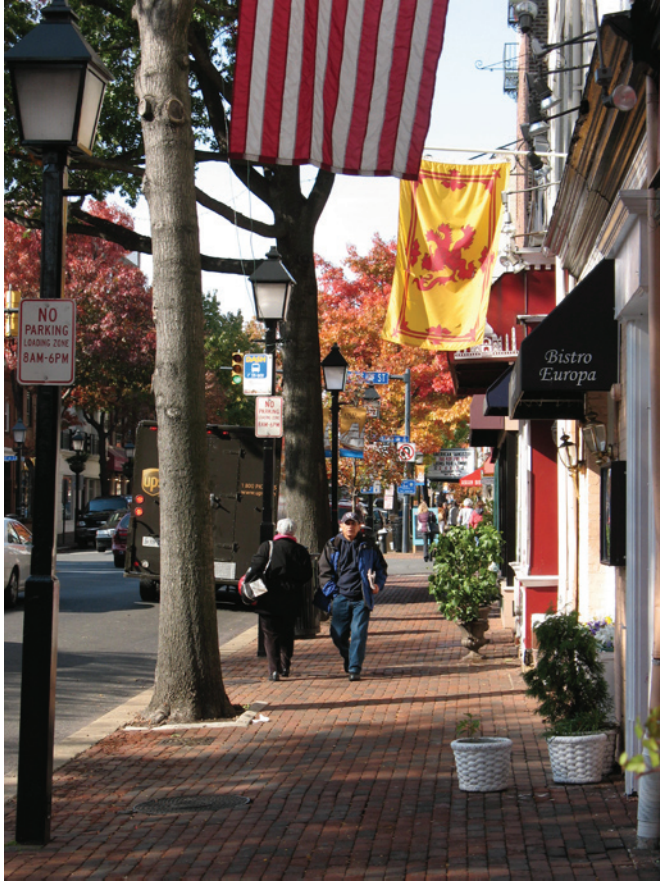
This view of a historic downtown street shows an ideal pedestrian environment provided by shade trees, awnings and banners.

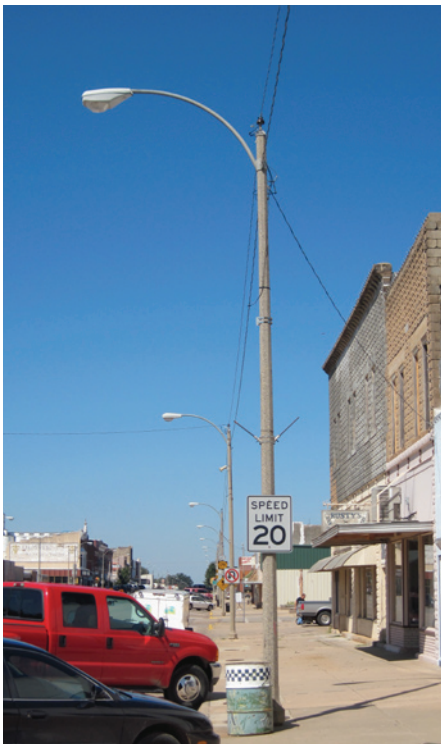
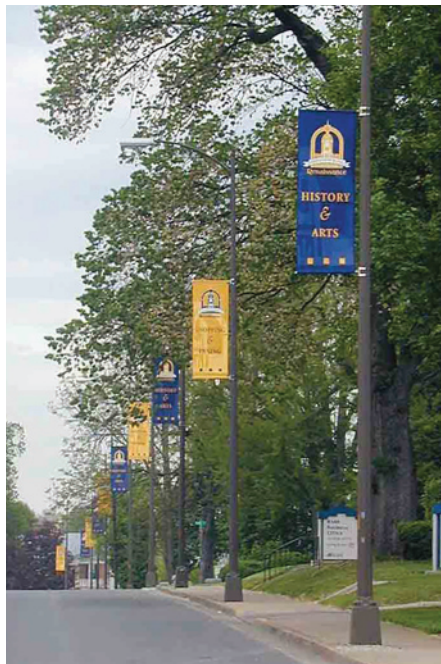
These photographs show Anthony's light poles (left) and an example of colorful banners on similar poles (right) that help to identify this downtown district.

- Anthony's tall concrete streetlights in the downtown provide an opportunity for banners to further define downtown and create a celebratory feel in the district. (There are some metal poles, as well, that require painting.) Banners should be colorful, reflect the character of the community and be changed seasonally to remain fresh. (Placing banners on the poles may have already been explored in Anthony. If not, the design and mounting will need to be coordinated with the design of the poles and, particularly, wind loads.)
