# RANCHO LA QUINTA COUNTRY CLUB

INITIAL REVIEW OF EXISTING GOLF COURSE CONDITIONS

Submitted by:  
Michael D. Vogt, CGCS, CGIA, LLC on behalf of:

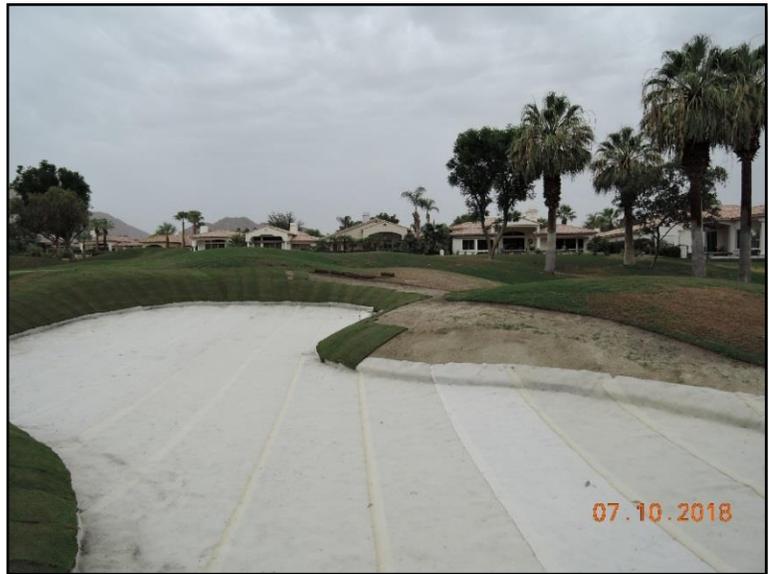
Photo 1 renovation of #15 green side bunker, Jones Course

- Sand bunkers throughout the two courses require renovation due to sand soil contamination and poorly defined hazard edges. Several renovations are being completed, methods appear to be in keeping with best practices, illustrated in Photo 1.

- It was mentioned that 6 sand bunkers are scheduled for in-house renovation this off-season. Renovation costs may range from approximately \$9.50 to \$12.00 per square foot. We estimate an approximate total of \$1,300,000 for the Jones Course and \$1,550,000 for the Pate course if a qualified golf course contractor is used to complete a total renovation. Under the current approach the Club will allocate a cost of approximately \$25,000 per year for at least 10 years. For quality reasons, the members may want to do a total upgrade sooner. Using a reputable golf course architect and golf course construction contractor is recommended. There is a total of 79 sand bunkers on the two courses. To arrive at an exact cost, a golf course architect and contractor should be consulted.

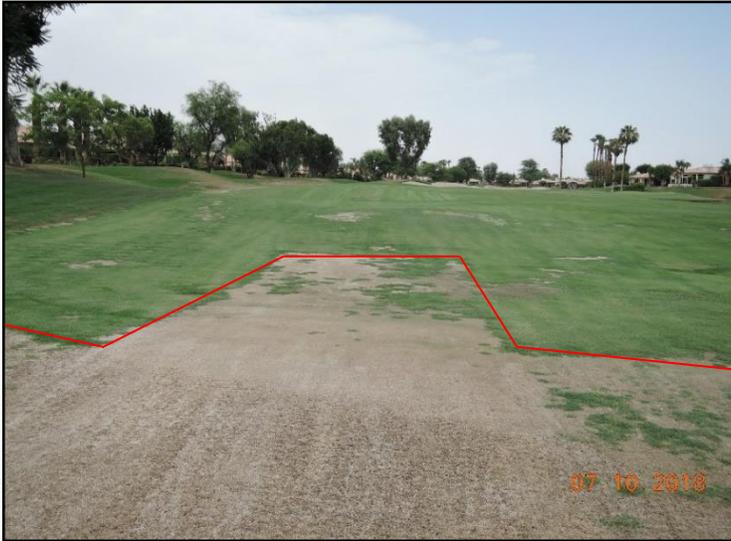
Photo 2 Turfgrass voids, #3 fairway, Jones Course

- Photo 2 illustrates a predominantly dead turfgrass patch on a fairway. I believe during the past, repairs were made, and the new turf apparently did not survive the winter overseed process. These voided areas, mostly on fairways and rough, are consistent throughout the two courses.
- If the desire is to focus fully on the in-season (winter) play conditions these summertime conditions are relatively inconsequential. I can only surmise with a minimum community population of 50% year-round residents, it may be advantageous to market and prepare the club for golf events throughout the year.

- Sod or sprig repairs on fairways and rough should occur during early summer.
- Fairway sprig renovation using 419 Bermuda turf is approximately \$3,000 per acre, if work is accomplished by an outside contractor. I recommend a three-year program to re-establish these sprigs as required in thin areas. Certain areas common to this type of renovation will not yield satisfactory results in one season due to pressure from the overseed process. Multiple renovation may be required.

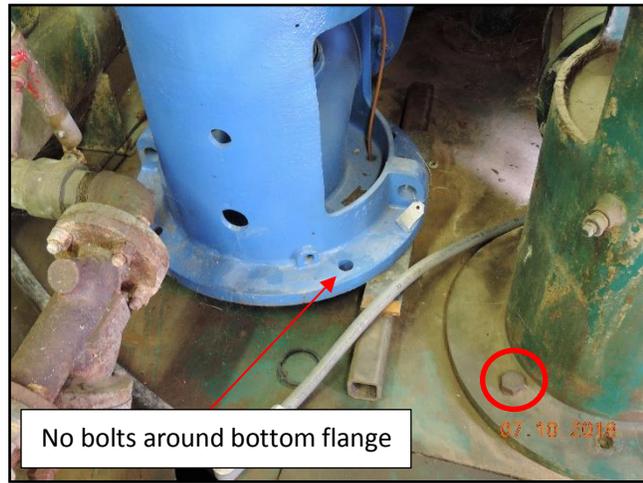
Photo 3 Pump station well heads on Jones Course

- A cursory inspection of the irrigation system revealed several problems. In Photo 3, the pump head (blue cast iron) is not attached to the deck plate like the other pump head, that's just adjacent (green cast iron, red circle, bolted to deck plate). It is my belief that these vertical turbine pump heads should be attached to a firm metal deck plate. Unfortunately, the metal deck plate on this pump station is rusted, nearly completely through in several areas. As the metal pump deck plate loses its integrity the components and employees are in jeopardy of falling into the wet well.

- Both pump stations have suffered from deferred maintenance and are in less than average condition for the vintage. A repair-when-broke philosophy has been standard operating procedure in the past. A pre-engineered pump station replacement with comparable components is valued at approximately \$250,000 each.

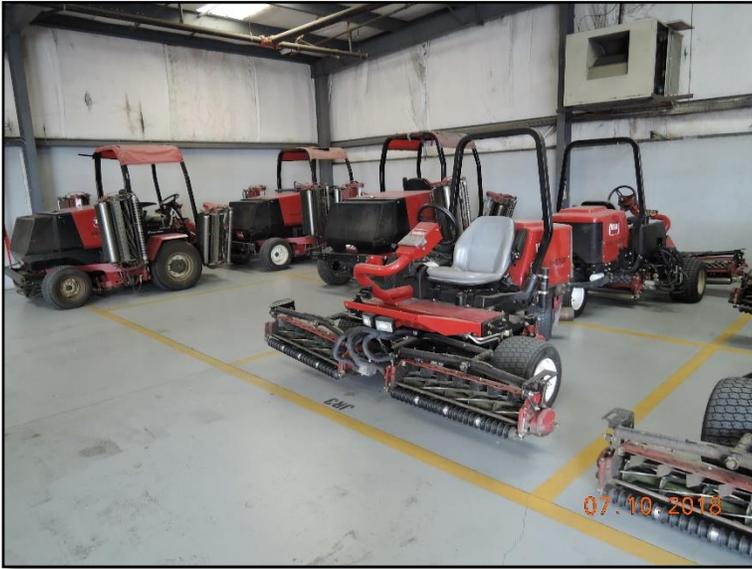
Photo 4 Equipment at storage area at maintenance facility

- Equipment accounts for a large part of the courses capital assets. It was mentioned, with exception of a turf sprayer, that the current fleet is at least 8 years old (no replacements since 2010).
- Normally, golf businesses have a staggered equipment replacement schedule based on age, hours of service and expense to keep in service.
- Although the equipment fleet is 8 years or older the condition appears to be better than average for the age (Photo 4).
- An annual amount based on fleet size and retirement of equipment in an orderly manner should be estimated at \$175,000
