Operation Outward

Britain's World War II offensive balloons

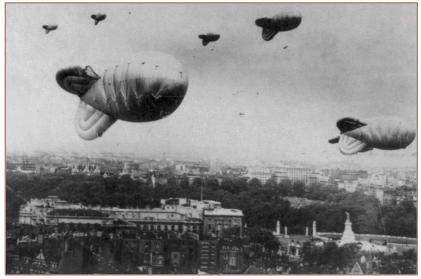
figure 1. Barrage balloons over Buckingham Palace, London, during World War II (from Air Publication 3003–A Brief History of the Royal Air Force, 2004).

That history, including the iconic photographs of barrage balloons deployed near Tower Bridge, the Houses of Parliament, and other strategic structures and installations is well known (see Figure 1). What is less well known is what happened next.

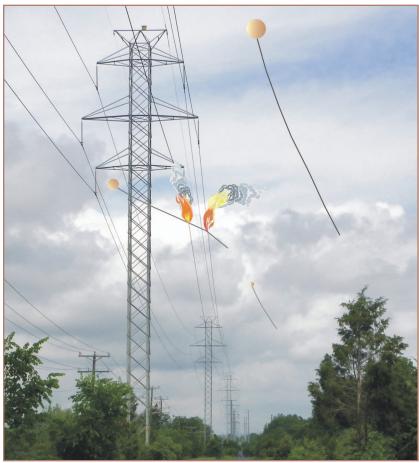
figure 2. Artist's conception of what a fleet of balloons might have looked like as it encountered an overhead power line (image courtesy of Raoul E. Drapeau).

Surprisingly, the trials showed that even a thin steel wire (much thinner than that used to tether the static barrage balloons), when drawn in sliding contact across two or more phases, could cause an arc as long as 15 ft (4.6 m) that would be maintained until the circuit breaker opened. In some cases, the arc's heat melted the aluminum outer layers and then the reinforcing steel center strands of the conductors. Further, even if not severed, the conductors would be so weakened by the arc that they would be susceptible to breaking due to increased load demands or even normal weather events such as wind, snow and ice. Then, even if the trailing wire was severed by the arc, the balloon with the remaining portion of the wire could be carried along with the wind to engage yet another electric line (see Figure 2).

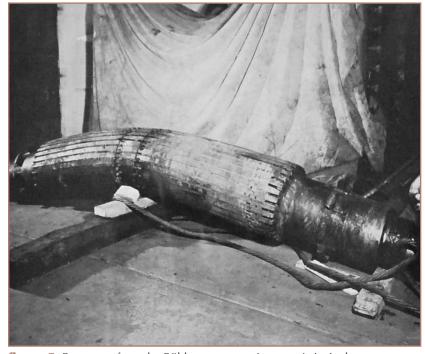
figure 5. Bent rotor from the Böhlen power station near Leipzig that was destroyed by an Operation Outward balloon on 12 July 1942 (from The National Archives of the United Kingdom, folder #ADM 199–848).

One of the most important instances of damage was the 12 July 1942 complete destruction of a power plant at Böhlen near Leipzig due to an Outward balloon that had been launched on 11 July 1942. A phase-to-phase short on a 110-kV overhead transmission line caused the circuit breakers to malfunction, causing one of the 16.5-MW generators to be thrown out of synchronism and begin to vibrate. Its rotor shaft bent, causing mechanical interference with the fixed stator, followed by an explosion and a fire that destroyed the power station. This event put 250 MW of generating capacity out of operation for an extended period. The value of that material loss was estimated by the team at £1,000,000 (US\$4,250,000) in 1942 currency, not including the value of production time lost (see Figures 5 and 6).

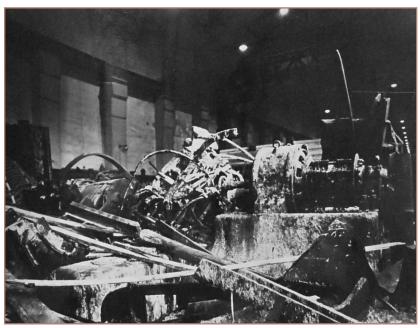
figure 6. Interior of the Böhlen power station near Leipzig after the explosion and fire that destroyed the power station on 12 July 1942 (from The National Archives of the United Kingdom, folder #ADM 199–848).
