# Precision 20/20 Full Reserve Study for The Creekside Crossing Homeowners Association Plainfield, Illinois April 22, 2014

**Client:** The Creekside Crossing Homeowners Association (Creekside Crossing)

Location: Plainfield, Illinois

**Inspection Date:** April 22, 2014

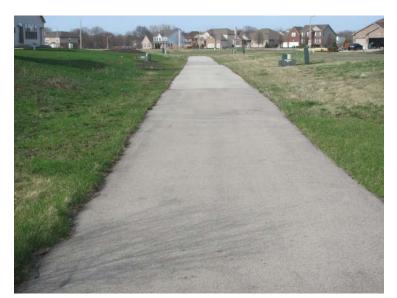
Asphalt Pavement, Crack Repair, Patch and Seal Coat - Asphalt pavement comprises 1,070 square yards of walking paths from Drauden Road to Portage Lane and on to Creekview Drive. The pavement is original and in good overall condition. We note an isolated crack. To maximize the life of the pavement, the Association should plan for seal coat applications and repairs every three- to five-years. These activities reduce water infiltration and the effects of inclement weather. We elaborate on solutions and procedures necessary for the optimal maintenance of asphalt pavement in the following discussion.

Asphalt walking path west of Portage Lane overview

We recommend periodic seal coat applications, crack repairs and patching to maintain the pavement. These activities minimize the damaging effects of vehicle fluids, maintain a uniform and positive appearance, and maximize the useful life of the pavement. Asphalt pavement is susceptible to isolated areas of accelerated deterioration in areas that experience freeze-thaw cycles, at the centerlines of streets and at high traffic areas such as intersections. Depressions often appear at areas where vehicles park such as driveways and parking areas. Isolated areas of

We recommend that Creekside Crossing plan the next application of seal coat by 2017 and subsequent applications every four years thereafter except when repaving occurs. Line Item 4.020 of *Reserve Expenditures* notes our estimate of future costs and anticipated times of these activities.

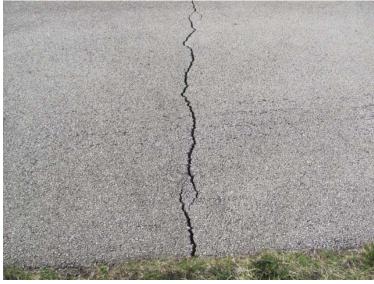
depressions, cracks and deterioration indicate the need for crack repairs and patching. The contractor should patch areas that exhibit potholes, alligator or spider web pattern cracks, and areas of pavement that are severely deteriorated from oil and gasoline deposits from parking vehicles. Area patching requires total replacement of isolated areas of pavement. The contractor should mechanically rout and fill all cracks with hot emulsion. Crack repair minimizes the chance of the cracks transmitting through the pavement.

Path crack

Creekside Crossing should repair any isolated areas of deteriorated pavement prior to seal coat applications. Proposals for seal coat applications should include crack repairs and patching. The contractor should only apply seal coat applications after repairs are completed. A seal coat

does not bridge or close cracks, therefore, unrepaired cracks render the seal coat applications useless. Our future estimates of cost include an allowance for repair activities.

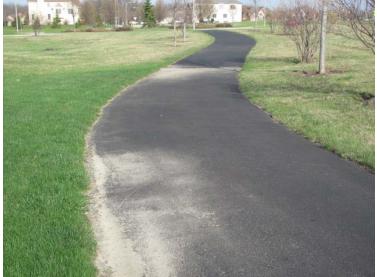
Asphalt Pavement, Repaving, Walking Paths – As state above, the Association maintains 1,070 square yards of asphalt walking paths from Drauden Road to Portage Lane and on to Creekview Drive. These paths are original and in good overall condition. We note an isolated crack as shown on Page 5.2 of *Photographs*. Walking path asphalt pavement is typically not as thick as parking area or street asphalt pavement. This type of pavement application has the potential for deterioration from tree roots, settlement and development of cracks. The need to maintain a safe pedestrian surface results in a useful life of 12- to 18-years for walking path asphalt pavement. We recommend the Association budget for total replacement by 2021 and again by 2037. We anticipate total replacement is likely to maintain a safe pedestrian walking surface. We include this information on Line Item 4.080 of *Reserve Expenditures*.

Walking path east of Portage Lane overview

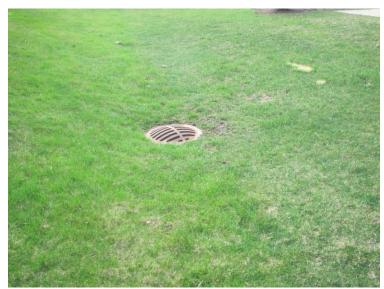
Catch Basins - The Association maintains the landscape catch basins throughout the property that collect storm water from the lots and conduct it into the storm water system. The overall condition of the catch basins is good without settlement visually apparent. The useful life of catch basins is up to 60 years. However, achieving this useful life usually requires interim capital repairs or partial replacements every 15- to 20-years.

Typical landscape catch basin

The Association should anticipate the occasional displacement or failure of a catch basin and the surrounding soil from erosion. Erosion causes settlement around the collar of catch basins. Left unrepaired, the *entire catch basin* will shift and need replacement. The exact times and amount of capital repairs or replacements are dependent upon variable natural forces. Based on the age and condition of the catch basins, we recommend the Association anticipate the inspection, capital repair or partial replacement of the catch basins by 2023 and again by 2041. Our allowance on Line Item 4.100 of *Reserve Expenditures* includes an inspection of the catch basins and resetting of up to 10 catch basins.

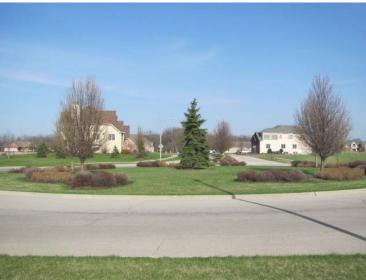
Landscape, Partial Replacements - The Association contains a large quantity of trees, shrubbery and other landscape elements. Replacement of these elements is an ongoing need. We have also conducted a Transition Study, issued under separate cover, identifying specific design, construction and condition defects with the landscape.

Creekview Drive landscape

Many associations budget for these replacements as normal maintenance. Other associations fund ongoing replacements from reserves. Large amounts of landscape may need replacement due to disease, drought or other forces of nature. If the cost of removal and replacement is substantial, funding from reserves is logical. The Association may also desire to periodically update the appearance of the community through major improvements to the landscape. In consideration of these factors and at the request of Management and the Board, we include a landscape allowance every five years beginning by 2019 to ensure the accumulation of sufficient reserves for partial replacements of the landscape. The times and costs of these replacements may vary. However, we judge the amounts shown on Line Item 4.500 of *Reserve Expenditures* sufficient to budget appropriate reserves.

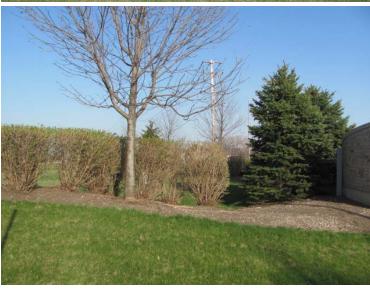
Entrance area landscape

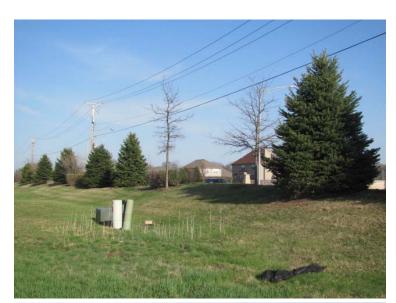
Landscape along Renwick Road

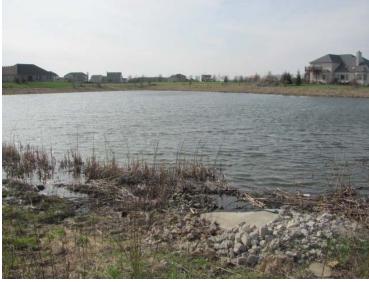
**Ponds** - The Association maintains four ponds. Refer to Section 5 of the narrative: *Photographs* for specific names and locations of the ponds. The health or condition of a pond is reflected in the clarity of the water, balance of plant life, the ability of the water to retain life giving gases and the health of the fish in larger bodies of water. Three factors which affect the health of ponds are erosion, buildup of silt and algae blooms. We have also conducted a Transition Study, issued under separate cover, identifying specific design, construction and condition defects with the ponds. We include the following solutions and procedures as a summary of the minimum requirements for successful pond management for present and future board members.

Stormwater Management Area North overview

Based on the visual condition, visibly apparent erosion and natural buffer zones, we recommend the Association anticipate the need to remove pond sediment every 30 years. We recommend the Association anticipate sediment removal within the small section and neck of Stormwater Management Area South every 15- to 20-years. For reserve budgeting purposes, we estimate the need to remove the sediment at the small section and around the neck of Stormwater Management Area South, or approximately 800 square yards, by 2020 and again by 2035. We recommend the Association anticipate the need to remove the sediment at approximately 3,050 square yards, or eight percent (8%) of the surface area of the remaining three ponds an average depth of one yard. However, the actual volume of material to remove may vary dependent upon an invasive analysis at the time of removal. We conservatively recommend that the Association budget for this variable but probable activity by 2035. The time and cost of this maintenance activity may vary. However, we judge the amount shown on Line Items 4.730 and 4.731 of *Reserve Expenditures* sufficient to budget appropriate reserves. The Association should consider disposal of the sediment on-site to lower the cost of disposal.

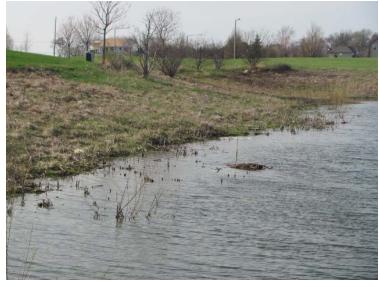
We note natural vegetation at the perimeter of the ponds. This condition suggests the Association should plan for eventual removal of sediment from the decay of seasonal vegetation at the pond perimeters.

Stormwater Management Area North shoreline

We recommend that the Association plan to fund shoreline erosion control through the operating budget.

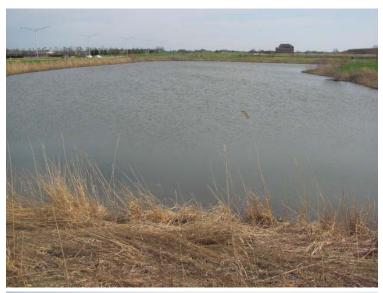
Stormwater Management Area South overview

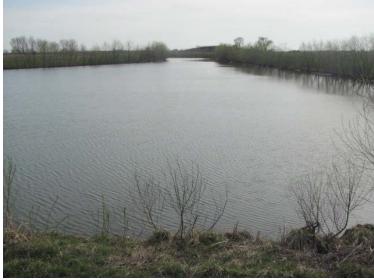
Stormwater Management Area A overview

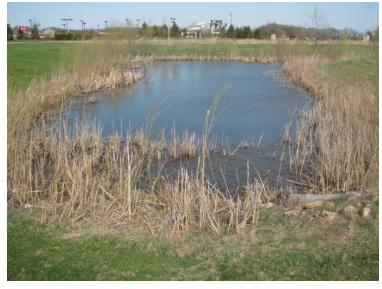
North portion of Stormwater Management Area B

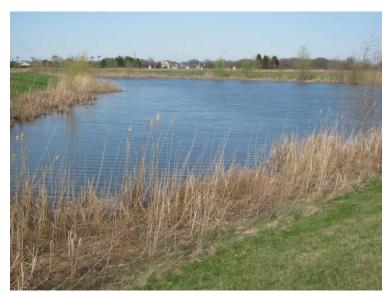
South portion of Stormwater Management Area B

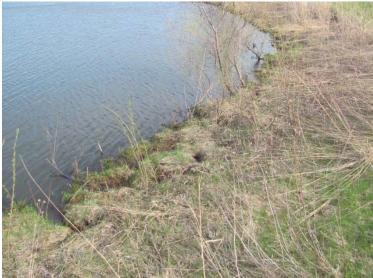
Stormwater Management Area B shoreline

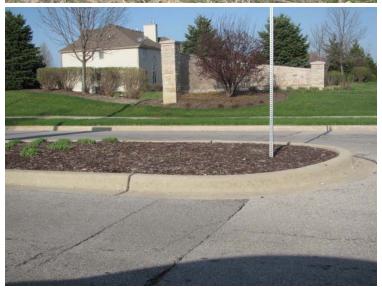
The signage is original and in good condition. Community signage contributes to the overall aesthetic appearance to owners and potential buyers. Renovation or replacement of community signs is often predicated upon the desire to "update" the perceived identity of the community rather than for utilitarian concerns. Therefore, the specific times for replacement or renovation are discretionary. We recommend the Association plan to renovate the signage every 15- to 20-years, or by 2027. Renovation should include the following work:

Typical entrance monument and landscape

- Repointing and repairs to the 2,400 square feet of masonry
- Replacement of the remaining components listed above

We note this information on Line Item 4.800 of *Reserve Expenditures*. The Association should fund interim repairs and replacements through the operating budget.
