COMPARISON OF DENTINAL DAMAGE INDUCED BY DIFFERENT NICKEL-TITANIUM ROTARY INSTRUMENTS DURING CANAL PREPARATION: AN IN VITRO STUDY

Aim:To compare dentinal damage caused by hand and rotary nickel-titanium instruments using Protaper Next, K₃XF, and M_{two} system after root canal preparation.

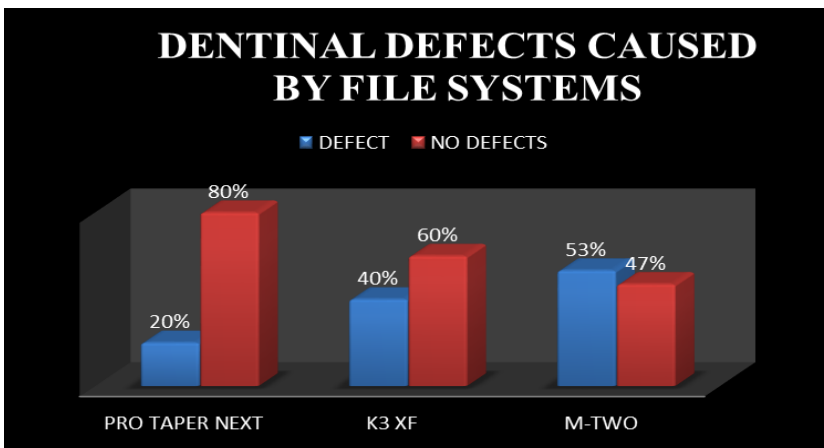
Figure 5- Dentinal defects caused by file system

(Figure.5) is a bar chart representing the number of root defects in each group. Group 1 and Group 2 showed no defects in

roots of unprepared group and K- file group respectively. Dentinal defects were seen in Group 3; Group 4; Group 5 i.e. Protaper next; K₃XF ; M_{Two}. Protaper next group showed least defects (3/15); k₃xf showed (6/15) and M_{two}showed highest defects (8/15). But the difference was not significant among all the rotary systems used in this study. Similarly the defects were compared at 9; 6 and 3mm sections. At 3mm no defect was observed in all groups. Highest defects were seen at 6mm section of all rotary system in comparison with 9 mm sections. (Figure.6) is bar chart showing comparison of defects at 6mm in all rotary systems. (Figure.7) is a bar chart representing defects at 9 mm in all rotary systems. Result showed that no statistical significant difference was seen for the presence of dentinal defects at coronal and middle thirds i.e at 9mm and 6mm.

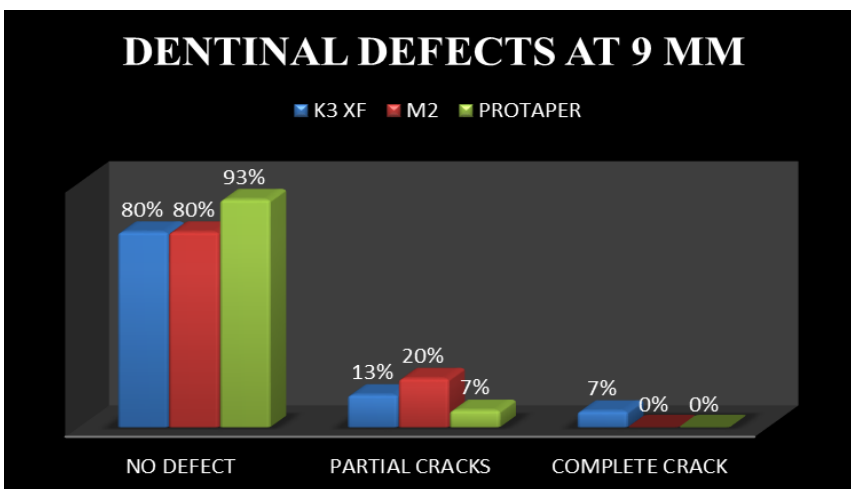
Figure 7- Dentinal defects at 9mm
