REPLACEMENT RESERVE REPORT FY 2016 CORROTOMAN BY THE BAY ASSOCIATION

CORROTOMAN BY THE BAY ASSOCIATION

LANCASTER, VIRGINIA

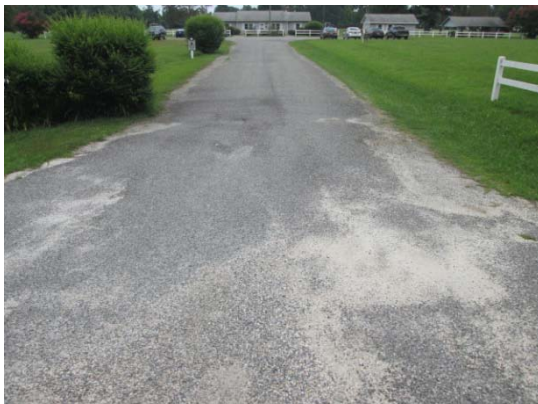
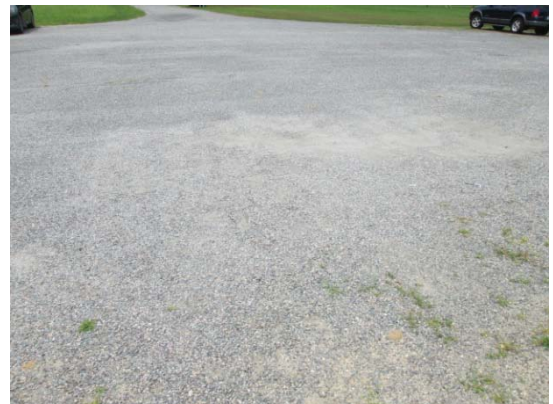
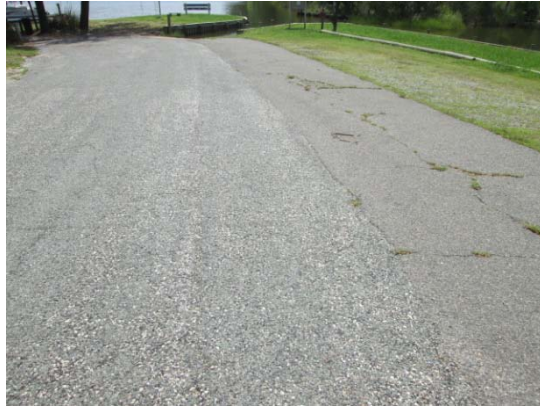
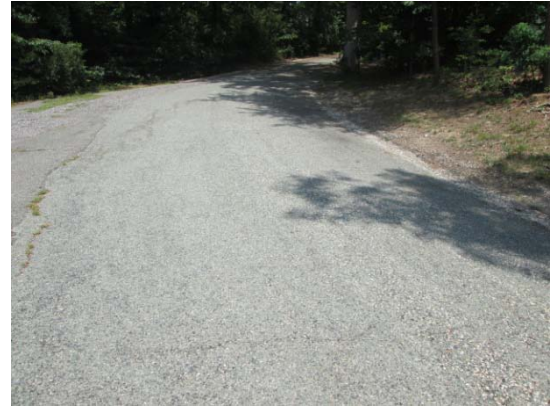
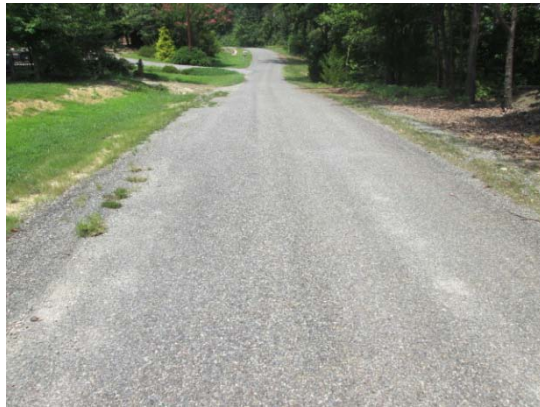
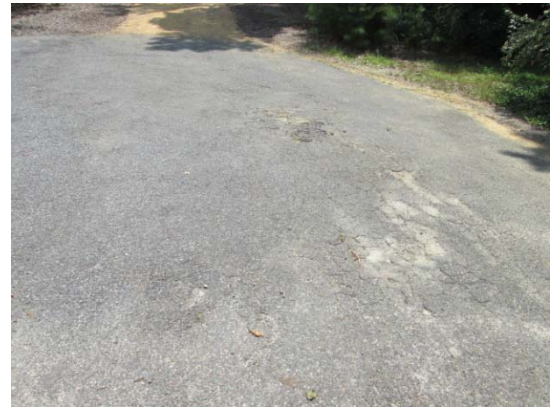
Asphalt Pavement. The asphalt paved roads are being maintained by as-needed patching and periodic chip seal applications. The average life of a chip seal coating is about 7 to 10 years. The Association reported spending between \$4,000 and \$5,000 per year on both the asphalt and the gravel roads to patch and chip seal asphalt roads and refurbish the gravel roads. We have allocated \$3,000 per year to the asphalt road repair and \$2,000 per year to the gravel road repair for a total of \$5,000 per year.

Areas of vegetation growing into the paving should be removed to prevent root damage to the asphalt. In addition, cracks should be filled between chip seal applications to prevent water penetration and further damage during freeze/thaw cycles.

As a rule of thumb, asphalt should be overlaid when approximately 5% of the surface area is cracked or otherwise deteriorated. The normal service life of asphalt pavement is typically 18 to 20 years.

In order to maintain the condition of the pavement throughout the community and to ensure the longest life of the asphalt, we recommend a systematic and comprehensive maintenance program that includes:

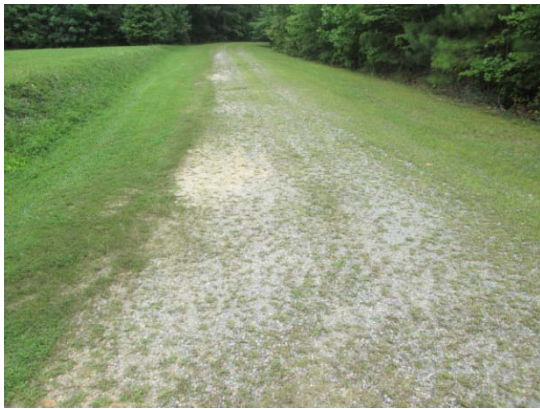
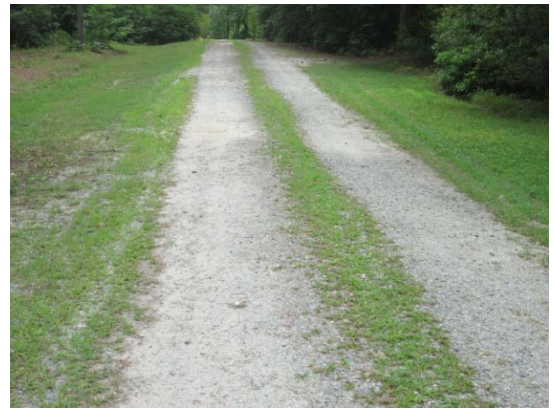
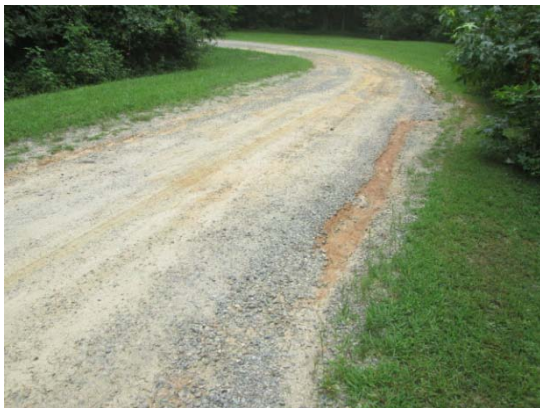
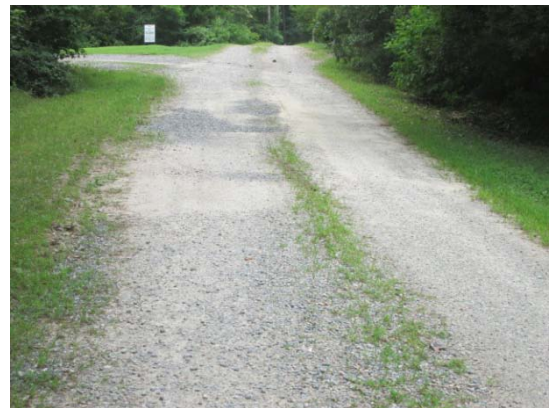
Gravel Roads. The gravel roads are in overall fair to good condition with several areas of erosion and loss of gravel. The roads were power raked and supplemented in early 2015. This operation should take place every year to keep the roads in good condition. About every 20 years, we anticipate the roads will need a more thorough “reshaping” with a motor grader to remove deep wheel ruts, high and low spots, and restore proper camber for drainage.

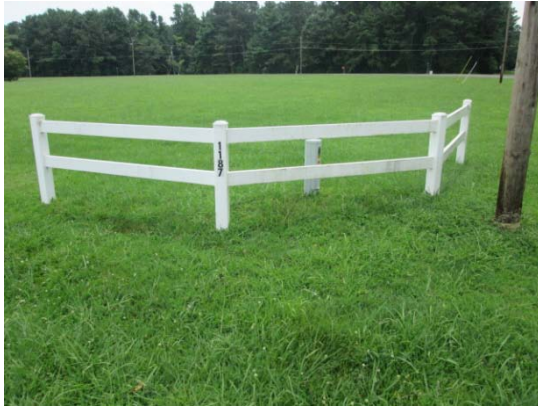
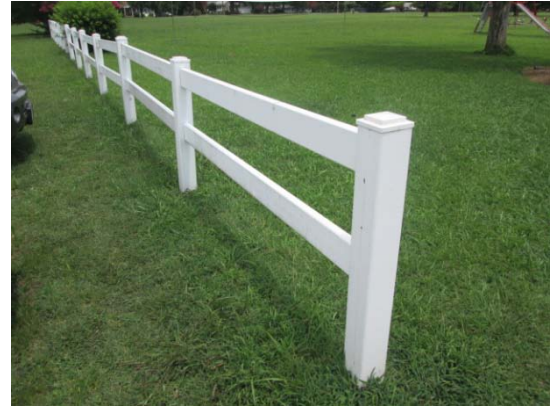
Fencing. The vinyl fencing at the clubhouse remains in overall good condition. Fencing systems have a large number of configurations and finishes that can usually be repaired as a maintenance activity by replacing individual components as they become damaged or weathered.

Protection from string machine damage during lawn maintenance can extend the useful life of some fence types. Protection from this type of damage is typically provided by applying herbicides around post bases or installing protective sheathing.

Vinyl fencing made of 100% virgin material can last 30 to 35 years, and periodic cleaning will keep the fence looking attractive. Vinyl components with ticker walls can provide a longer useful life.

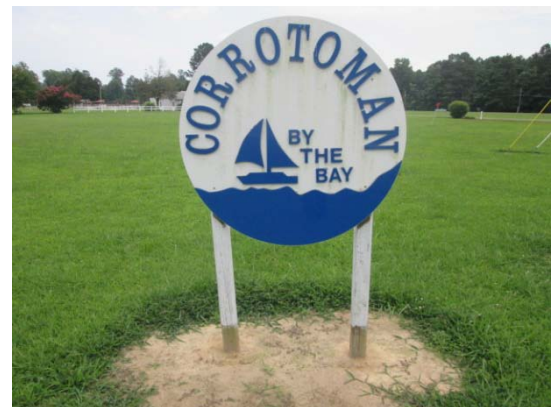
Entry Sign. The wood entry sign has been relocated to the clubhouse area. The sign is in good condition and can be touch-up painted to extend its economic life.

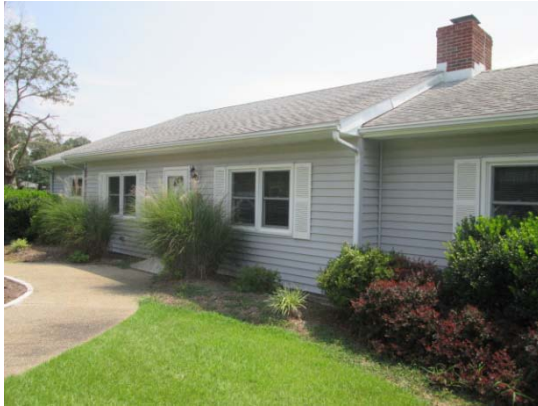
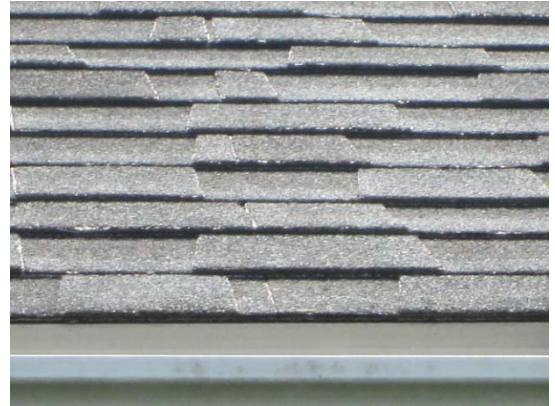
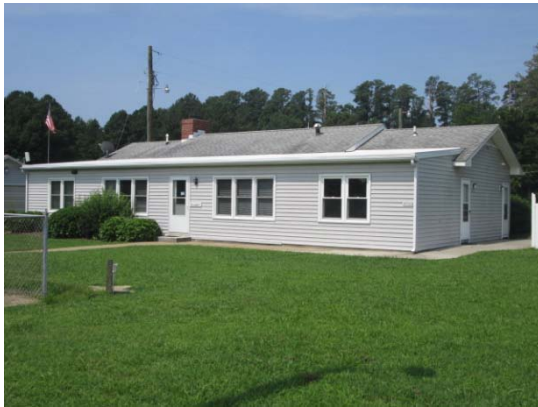
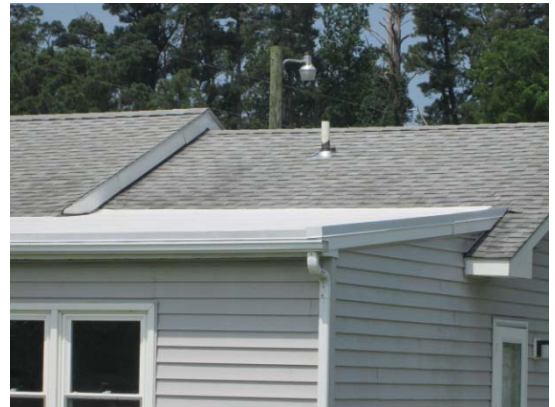
Building Roofing. The clubhouse asphalt shingle roofing is approximately 9 years old and remains in good condition with normal aging noted. Over time, the shingles will lose the granular protective surface and we observed this has happened along the shingle edges. Asphalt shingle roofs can have a useful life of 20 to 50 years depending on the weight and quality of the shingle. Weathered, curled, and missing shingles are all indications that the shingles may be nearing the end of their useful life.

The low-slope asphalt roof on the rear of the building has been re-roofed with a membrane roof in excellent condition. Flat roofing systems typically have a useful life of 15 to 25 years.

Annual inspections are recommended, with cleaning, repair, and mitigation of vegetation performed as needed. Access, inspection, and repair work should be performed by contractors and personnel with the appropriate access equipment who are experienced in the types of roofing used for the facility.

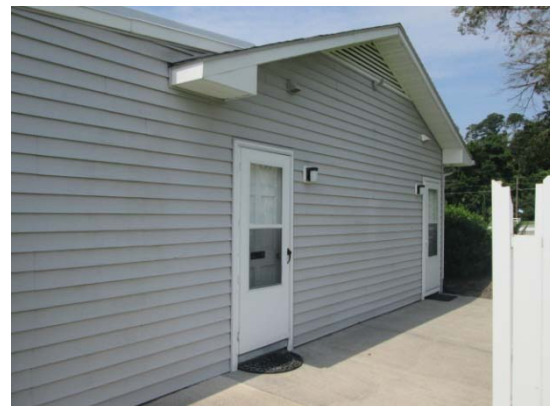
Vinyl siding and trim can have an extended useful life if not damaged by impact, heat, or other physical reasons. However, the coatings and finishes typically have a useful life and over time begin to weather, chalk, and show their age. For these reasons, we have modeled for the replacement of the siding and trim every 35 years.

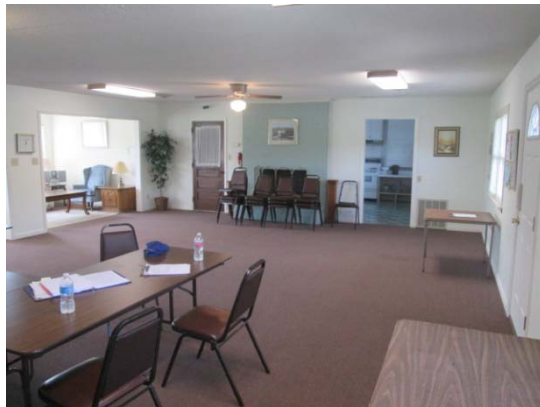
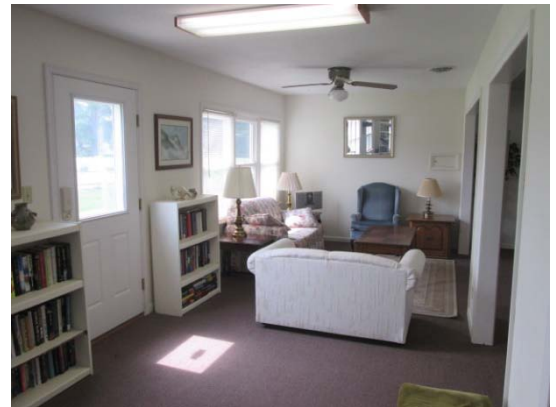
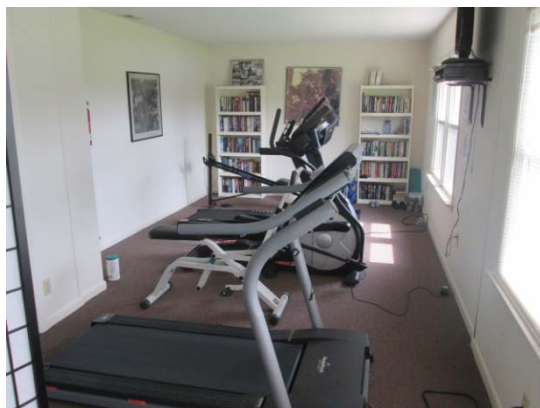
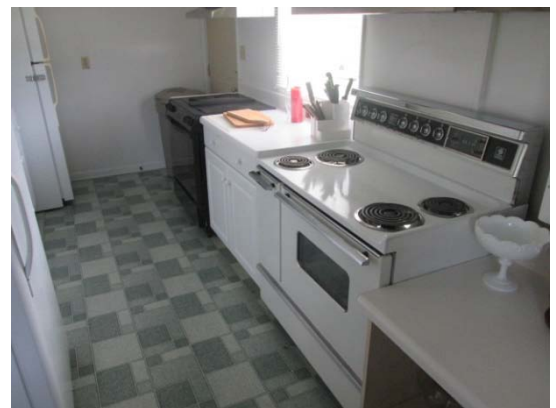
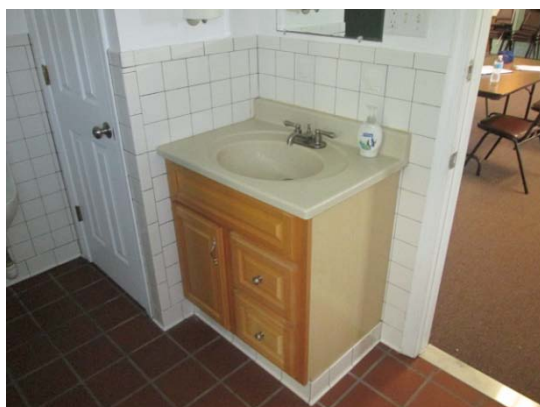
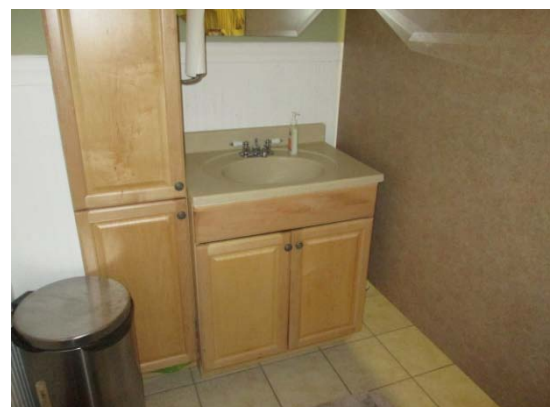
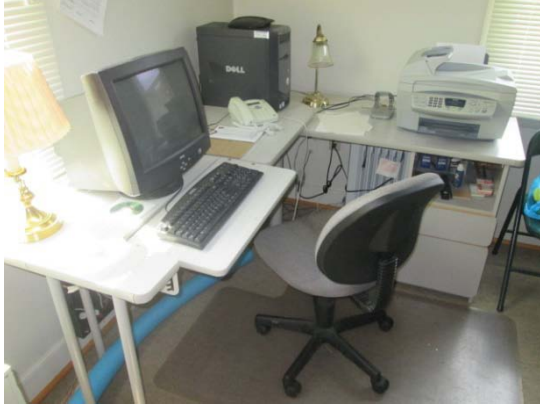
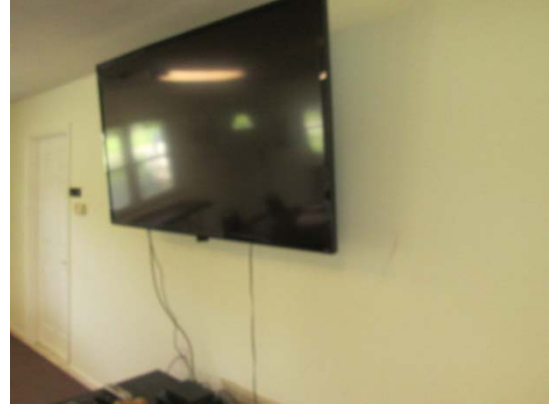
Interior. The clubhouse interior components remain in overall good condition. The carpet was replaced about three years ago and is in excellent condition. We have added the new TV and the existing water heater to the study. In addition, we have included painting of the interior on a 7 year schedule.

To extend the life of the carpet, it is important that the Association continue with a comprehensive maintenance program that includes regular vacuuming, spot and spill removal, interim cleaning of high traffic areas, and regular scheduled cleanings. It is also recommended that all entrances be fitted with walk-off mats to trap soil.

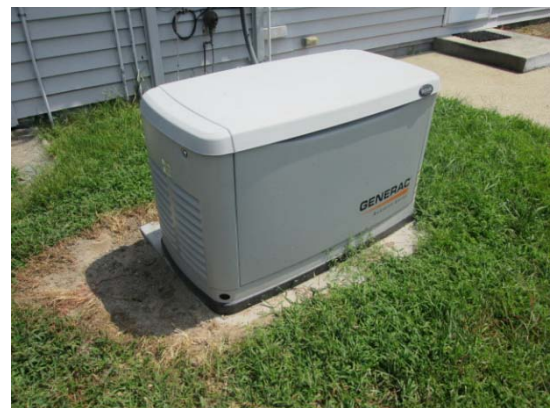
Emergency Generator. The Association installed a small emergency generator at the clubhouse building in 2012. We have included funding to replace the generator in approximately 30 years, which is the anticipated engine life given by the manufacturer.

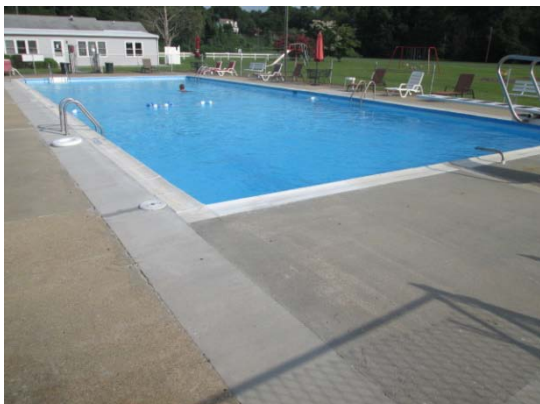
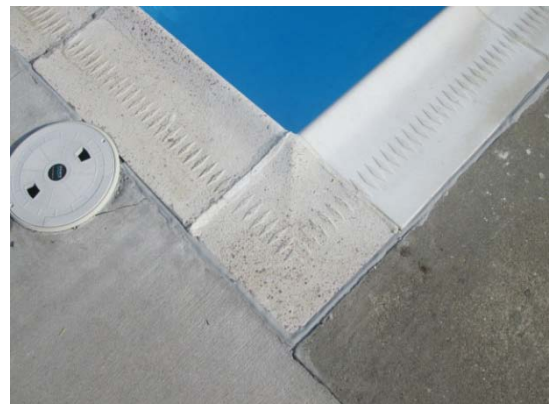
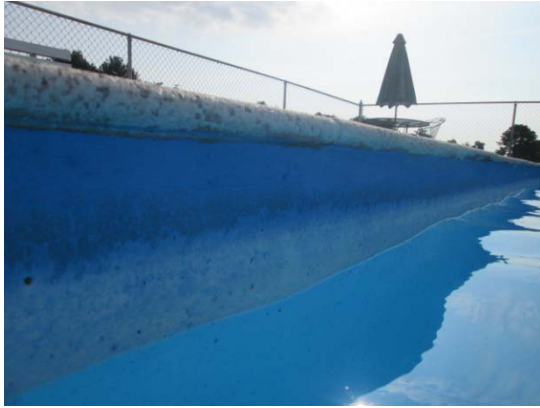
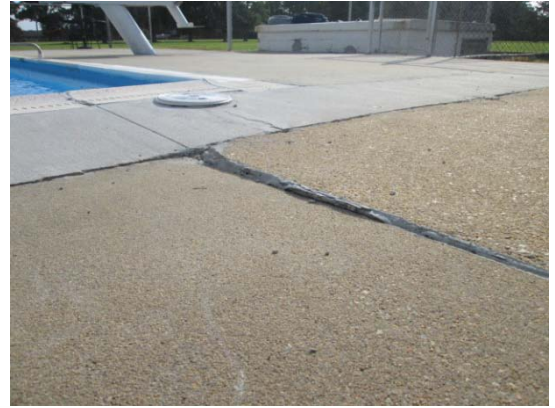
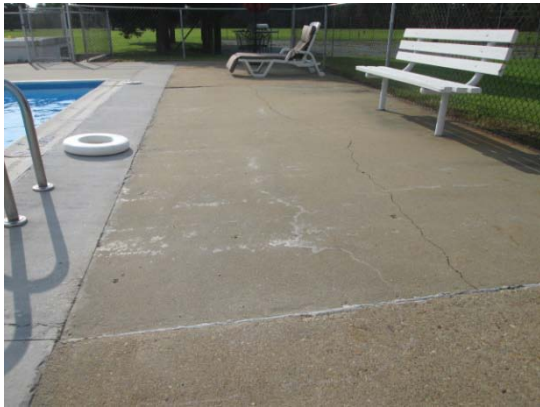
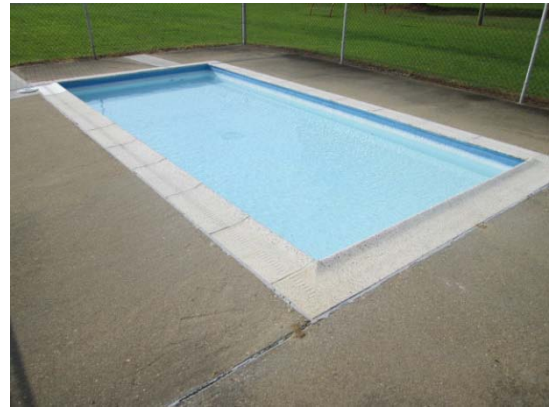
Swimming Pool. The community operates an outdoor pool and wading pool of concrete construction. Listed below are the major components of the pool facilities:

- Pool Shell. The shell for the swimming pool remains in good condition.
- Pool Deck. The pool concrete deck has been patched where the filter system piping was recently replaced. The patches are smooth and in good condition. The remaining concrete deck has several cracks that should be ground smooth, if needed, and filled to prevent water penetration. There is one tripping hazard at a corner on the diving board end that should be ground down.
- Pool Paint. The pool paint is in good condition. We have included funding to repaint the pool every 5 years.
- Coping. The pool precast coping remains in overall good condition. The caulk joint between the coping and the deck is in overall good condition, but a couple isolated areas need touch-up.
- Pump and Filter System. The filter system is new as of 2014 and in good operating condition.

- **Pool Fence.** The swimming pool is enclosed by a chain link fence that remains in fair condition with areas of rust.

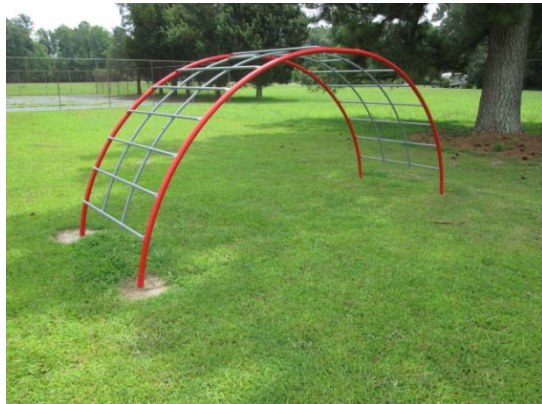
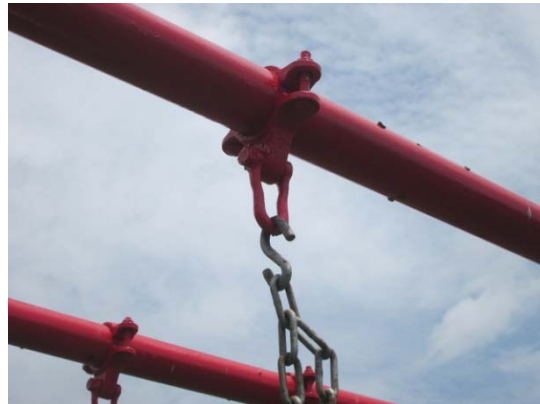
Tot Lot. The community maintains play equipment near the clubhouse, to include, a slide, monkey bars, spring toys and a merry-go-round. The equipment is older and does not meet current requirements for safety. For example, connections should be made with closed fasteners and not S-hooks. The facility facilities are in generally fair condition with minor wear and a few loose connections. The major defect is the lack of protective surfacing around and under the equipment. Adequate surfacing provides fall protection for the user. The "Public Playground Safety Handbook" listed below can provide guidance to the Association on what changes need to be made to make the equipment safe for use.

The safety of each individual piece of playground equipment as well as the layout of the entire play area should be considered when evaluating a playground for safety. The installation and maintenance of the protective surfacing under and around all equipment is crucial. Please note that the evaluation of the equipment and these facilities for safety is beyond the scope of this work.

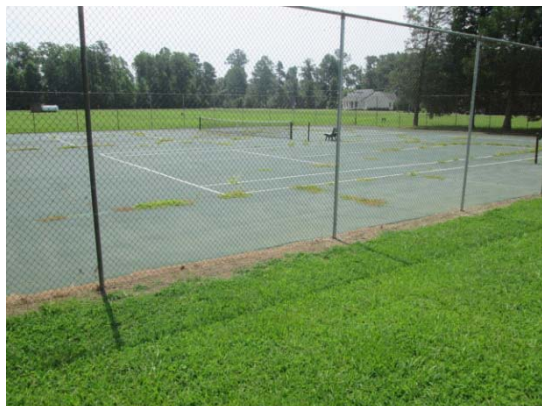
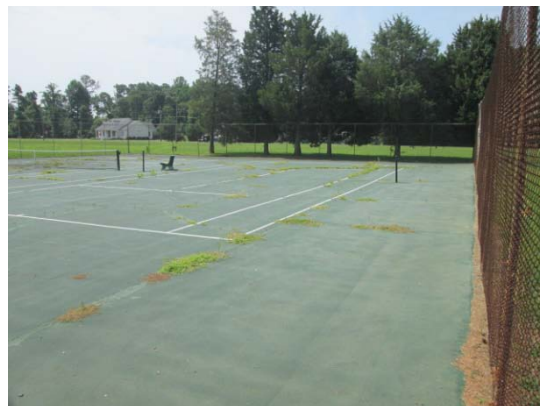
Tennis Courts. The community maintains two tennis courts. The overall condition of these courts is poor with severe cracking. The existing courts were installed at too low a grade and are frequently flooded during heavy rains. The Association is planning to totally replace the courts in 2016, to include, raising the court level to allow for proper drainage.

- Asphalt Pavement (base layer). Once replaced, we have assumed a service life of 20 to 30 years for the asphalt base layer.
- Color Coat (surface layer). Annual cleaning is recommended to maintain the surface of the court. The base of a tennis court is subject to cracking and low spots known as “birdbaths” that can occur from weather and earth movement. A program to address cracks as they appear will help to prolong the useful life of the color coat. We have assumed a service life of five to ten years for the color coat.

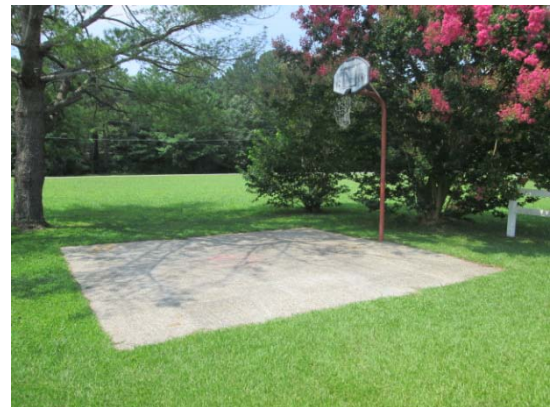
Basketball Court. The community maintains a small basketball court. The asphalt court remains in good condition with minor cracking. Cracks should be filled with an elastomeric sealant to prevent water penetration and further damage during freeze/thaw cycles. The goal has been bent and will need to be replaced and we assume this will be funded through the operating budget.

Wood Pier. The wood pier remains in overall good condition with no significant defects noted. The pier is approximately 10 years old.

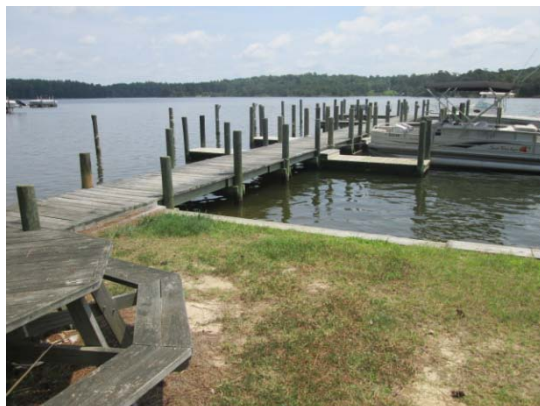
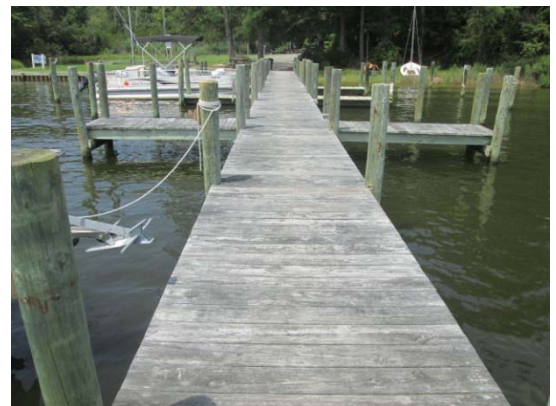
Wood Pier Decking. The wood decking on the main pier and the finger piers is exposed to harsh extremes of sun and weather. It will typically require replacement before the heavier members of the underlying structure. This decking will also be removed and replaced in its entirety when the underlying structure is replaced. To model this replacement pattern, we have provided for complete replacement incident to the replacement of the structure, and we have included an additional replacement interval for the wood pier decking at the midpoint of the service life of the underlying structure. The decking can be sealed every 2 to 3 years to protect the wood and extend its useful life.

The pier structure is in good condition.

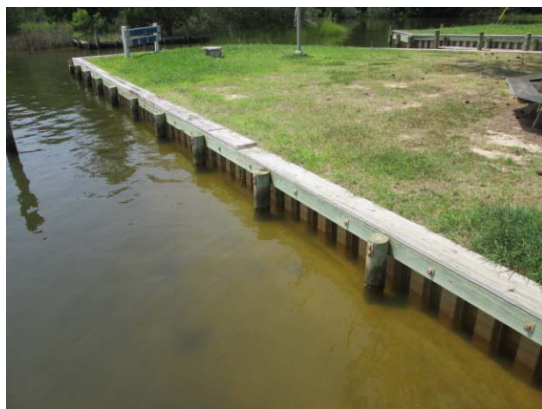
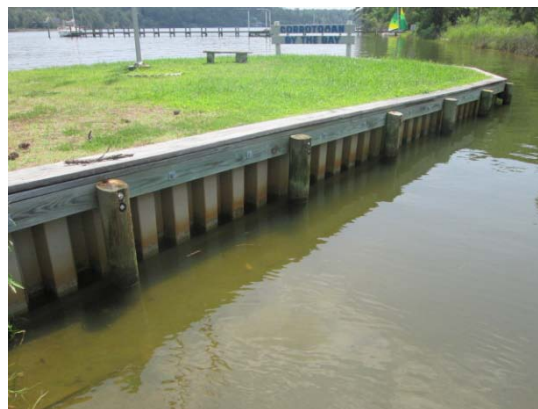
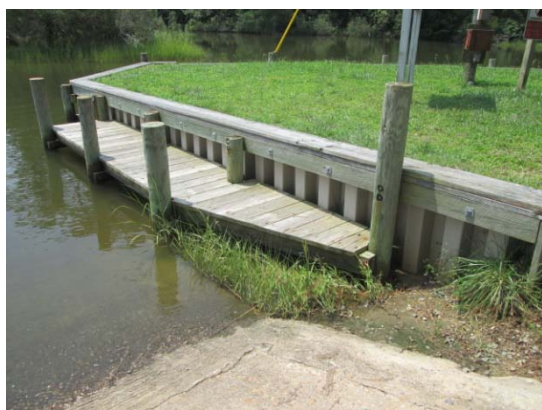
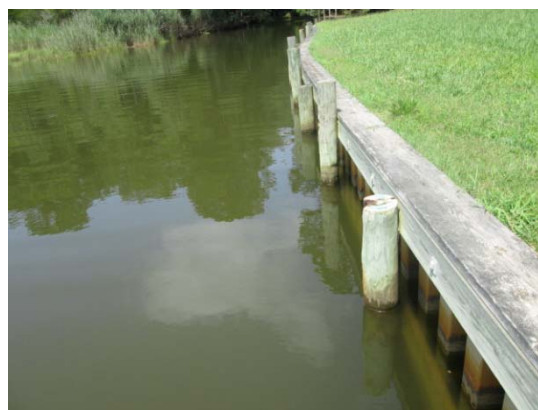
Bulkhead. The bulkhead remains in overall good condition. Because it is most exposed to weathering, we anticipate the cap board will require replacement several times over the life of the bulkhead. It remains in good condition at this time.

Boat Ramp. The boat ramp remains in good condition with no significant cracks or damage noted. It was mentioned that the ramp is not long enough to easily launch some boats. The ramp may need to be extended in the future.
