# Winters Putah Creek Park – Part 2 – Analysis of Project Failures

by Friends of Putah Creek - August, 2019

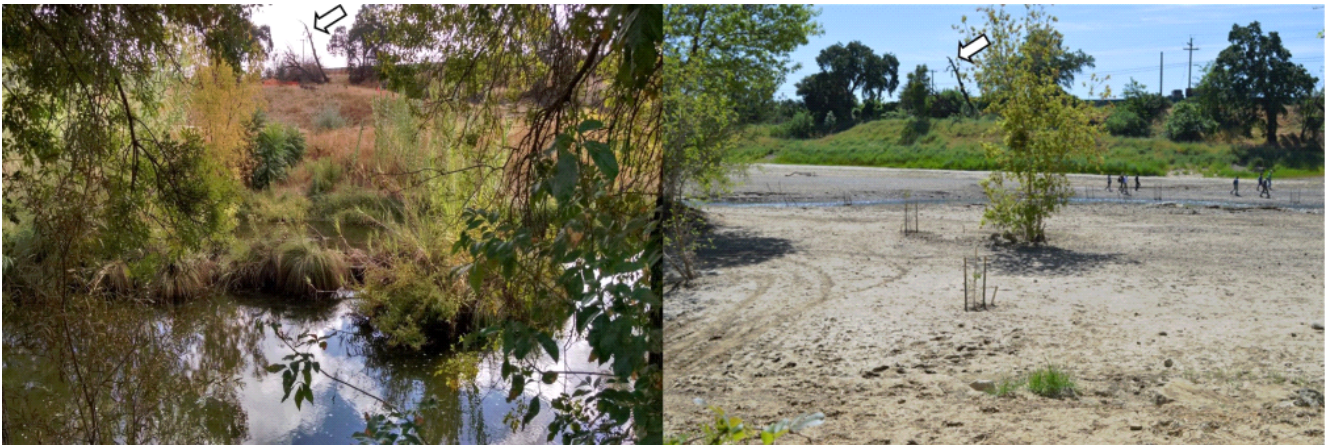
*All depressional features in Phases 1 and 2 of the floodplain landscape were eliminated including all ponds without “recognizing that depressional features such as ponds can be important refugia for species”. Rather than “Create higher ground in floodplains that can serve as refugia from floodwaters for wildlife species”, all such high ground was functionally eliminated when the floodplain was flattened and graded to a uniform slope.*

**Fig. 1** - Recent “Before and After” photos following bulldozing and leveling of a rich riparian floodplain habitat.

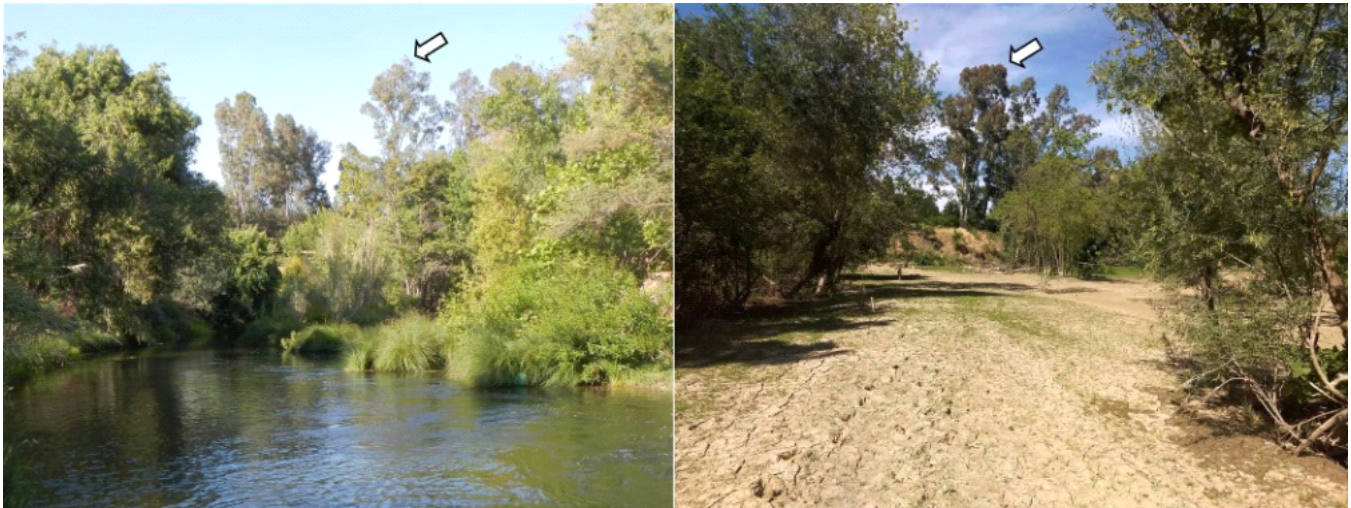
**Fig. 2** - Recent “Before and After” photos of a once vibrant beaver pool habitat in Winters

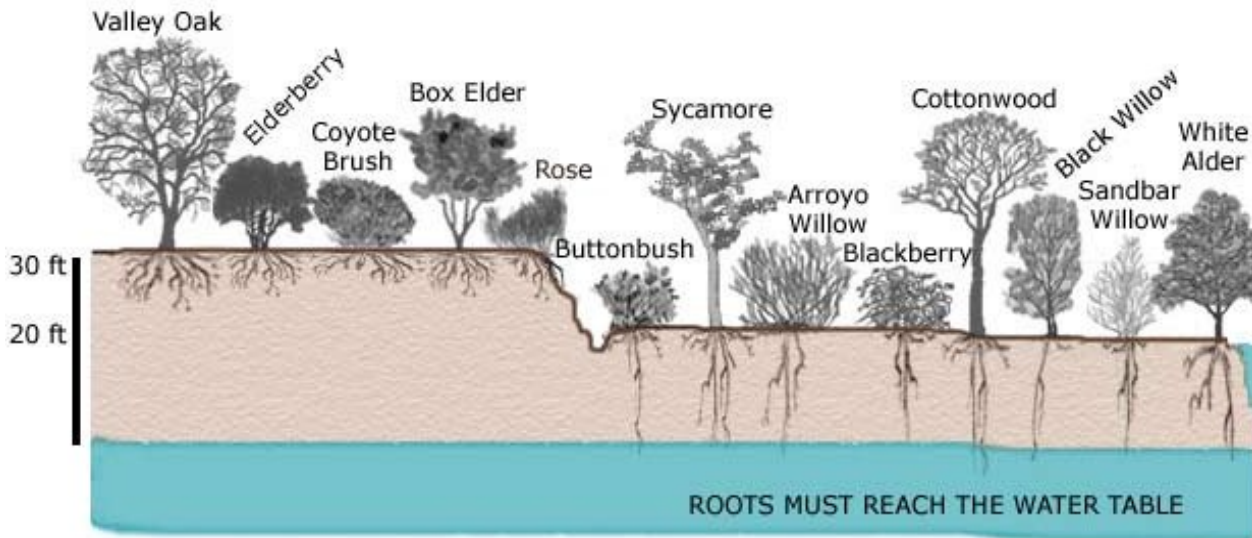
**Figure 7: Rooting Depth Requirements of Select Riparian Species**

Depth to water table is second in ecological importance behind soils for determining species survival, growth and the community structure of the vegetation. Depth to water table must be known for several points across a site, as it may vary by several feet. Deep soil-auger cores and soil pit samples taken on the site will allow the depth to water table to be measured if water is reached, or estimated if soil becomes moist at the bottom of the pit. Depth to the water table can also be measured with multiple piezometers placed into the ground that reach the ground water table. Cottonwood and willows absolutely must grow their roots into the upper portion of the water table within the three-year maintenance period, or they will die when irrigation is stopped. Other species of trees and shrubs will prosper by growing their roots into the water table, however, this is not a requirement for survival. Soil profile and depth to water table interact and can be a problem for root growth if the top of the water table is within a layer of cobbles or gravel where roots cannot grow well, making the water table functionally out-of-reach of the roots.

*Rooting depth requirements of riparian species must be known, along with the depth to the water table across the site, so that planted species will survive and thrive after irrigation is no longer applied.*
