Inspection Report

Property Address:
XXX
Denver CO 80203

Safeguard Inspection Services Inc.

Date: 7/18/2019	Time:	Report ID: 901
Property: XXX Denver CO 80203	Customer: John Doe	Real Estate Professional:

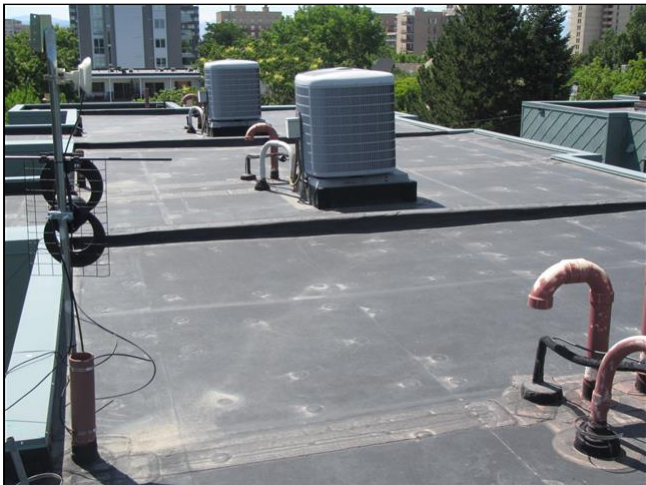
1.0 Item 1(Picture)

Comments: Action Recommended
(1) The EPDM (Ethylene Propylene Diene Monomer) roofing membrane present was in fair overall condition. Moderate cut observed in membrane near southwest corner allowing minor water intrusion. Numerous unsealed penetrations made by tenant on northeast corner present in parapet wall. Minor gaps and loose membrane/patches noted at seam tape, drains and corner details. Drain cover on southeast corner is not installed. Several uplifting screws noted below seam tape. Several prior repairs/patches observed. Poorly sloped/tapered sections on small flat roofs over stairwells. Recommend further evaluation, minor repairs and annual inspections by licensed roofing contractor.

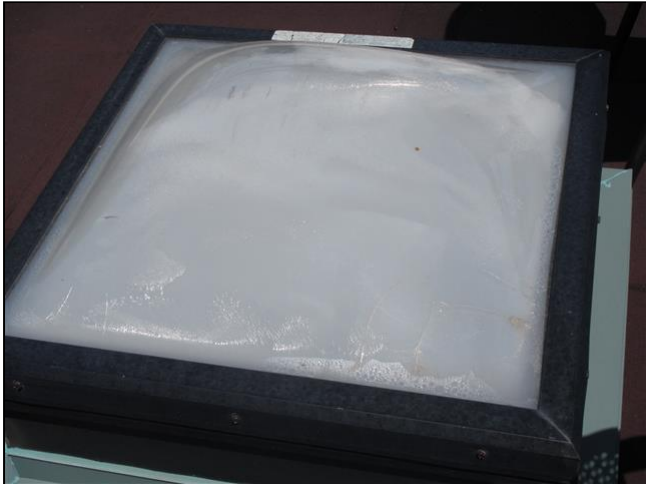
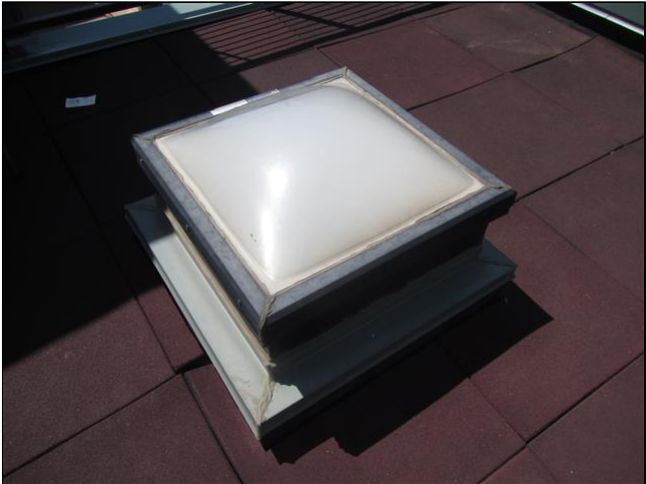
1.0 Item 17(Picture)

(2) Cracked/damaged skylight observed on deck of Unit 101 allowing water intrusion. Caulking at skylights and curbs is becoming weathered and deteriorated. Peeling paint and evidence of minor water intrusion noted below skylights in Units 101 and 106. Recommend further evaluation and repairs/replacement by licensed roofing contractor.

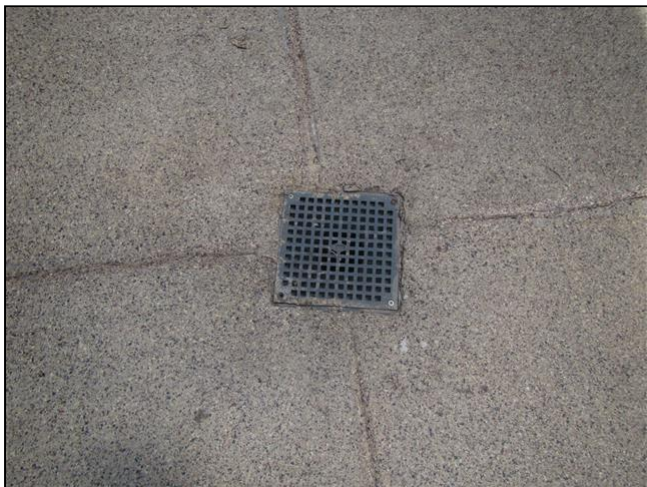
1.1 Item 1(Picture)

Recommend further evaluation to confirm underground drains are operating properly to direct water away from foundation. Monitor and maintain underground drains routinely.

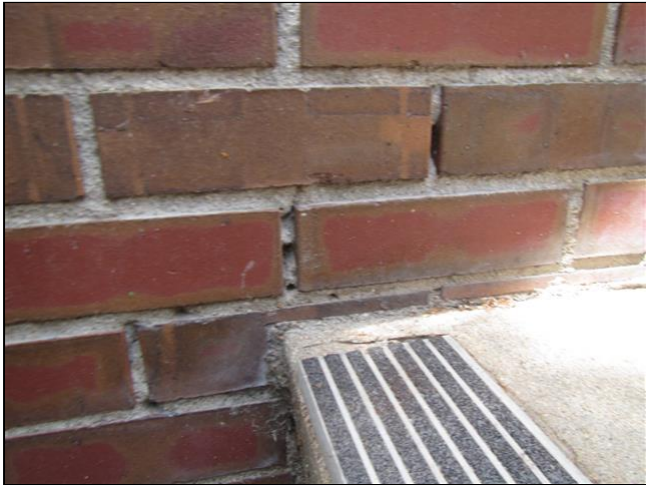
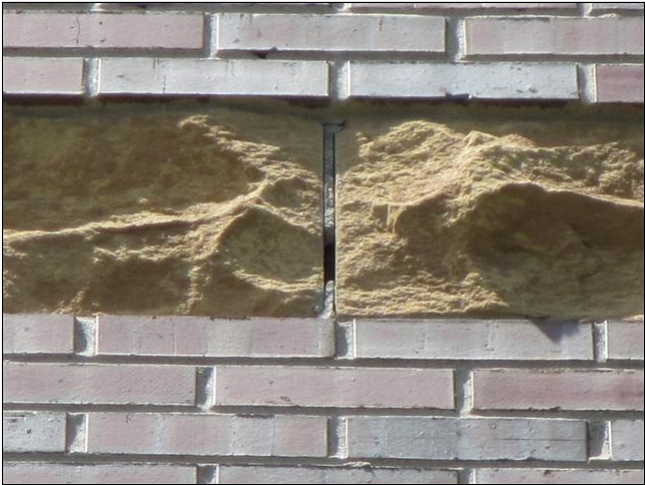
2.0 Item 1(Picture)

(1) Brick, stone and mortar were in good overall condition at time of inspection. Minor deterioration and gaps in mortar observed. Minor damage and small gap present on southeast outlet. Minor gap observed on upper west elevation vent cover. Several damaged columns present in courtyard. Unused scupper located on southwest corner and all penetrations should be properly sealed to prevent water intrusion. Recommend repairs by qualified contractor.

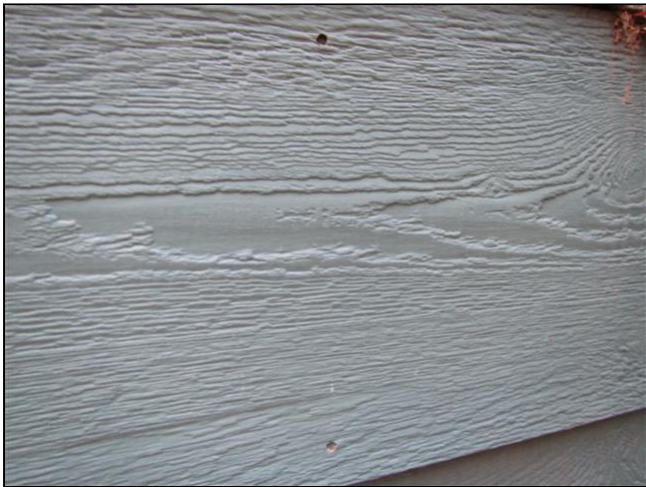
2.0 Item 11(Picture)

(2) The composite siding was in fair condition. Caulking is deteriorated at joints and terminations, minor water damage observed at grade. Several countersunk nails noted throughout. Properly seal all penetrations to prevent water intrusion. Recommend repairs by qualified contractor. Maintain painting and caulking to extend life.

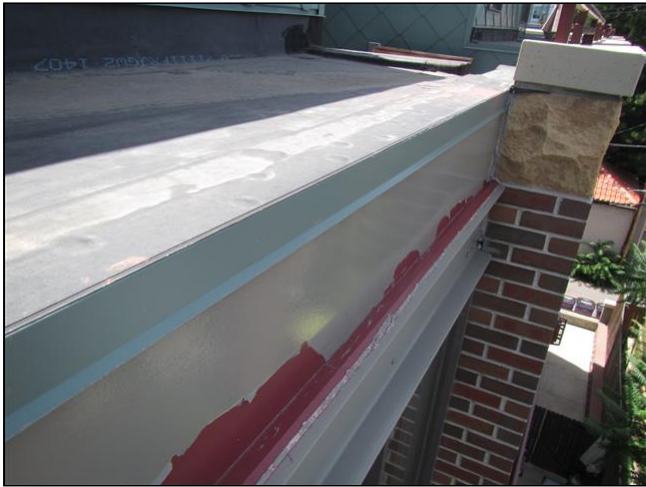
2.0 Item 16(Picture)

(3) Metal siding and flashing were in good overall condition. Several areas of peeling paint observed. Poorly sealed condensate lines and light fixtures noted. Minor damage and gaps observed at east deck intercom boxes. Confirm all penetrations are properly sealed to prevent water intrusion. Recommend repairs by qualified contractor and monitor condition.

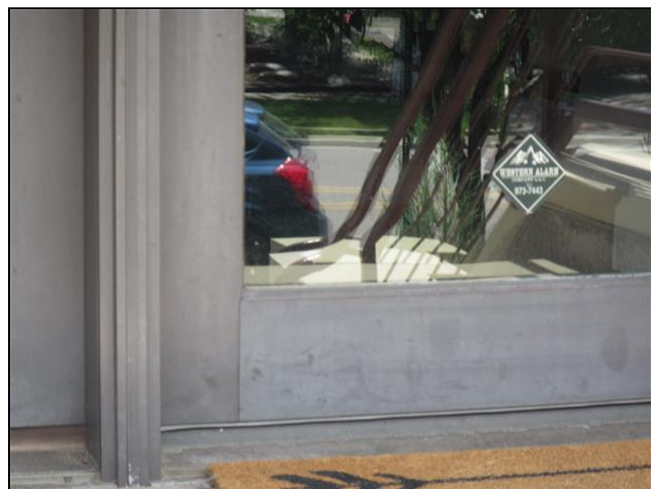
2.1 Item 1(Picture)

(1) Weathering/fading observed throughout exterior doors. The majority of balcony french doors are fogged and difficult to operate. Several doors rub on frames, peeling paint noted. Minor water damage observed at interior of doors in Units 108 and 109. Unit 105 door was inoperable. Moderate rust present on metal doors frames of Units 101 and 106 in

courtyard. Unit 104 screen door is damaged on balcony. Recommend further evaluation and repairs/replacement by qualified contractor.

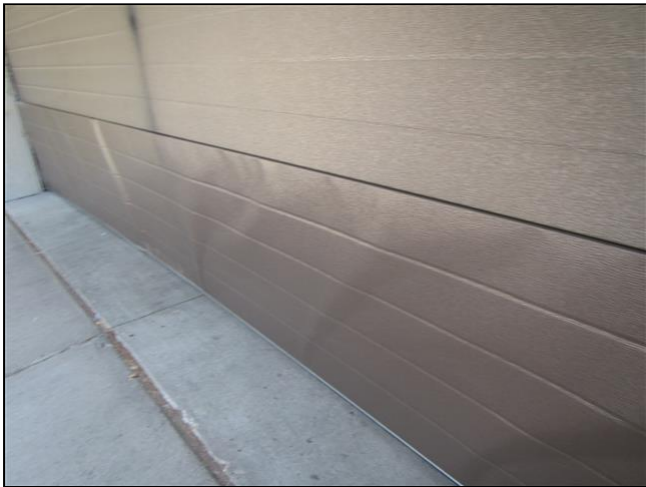
2.1 Item 12(Picture)

(2) Minor damage present on overhead garage door. Recommend replacement by qualified contractor.

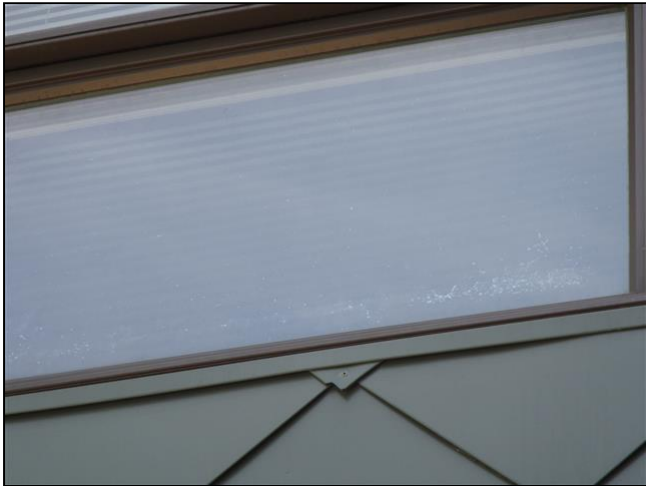
2.2 Item 1(Picture)

Windows appeared in good overall condition. Windows were excessively dirty at time of inspection. A couple windows appeared fogged. Recommend cleaning and repairs if necessary by qualified contractor. Keep all interior and exterior sills/seams caulked as part of routine maintenance.

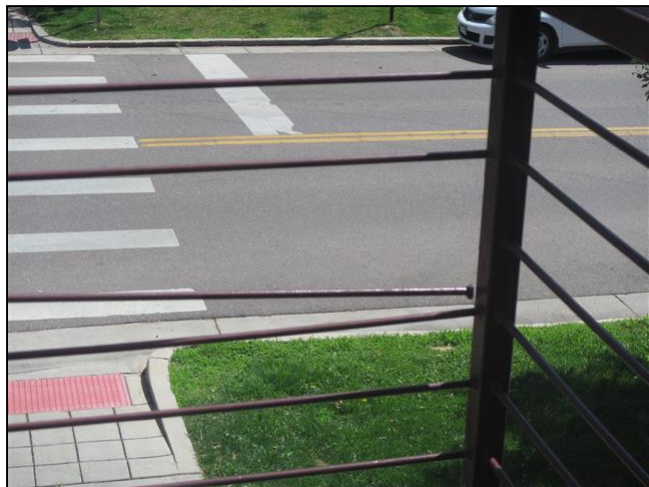
2.3 Item 1(Picture)

(1) Damaged railing observed on balcony of Unit 101. Support anchor on northeast entry roof is pulling away. Recommend further evaluation and repairs by qualified contractor.

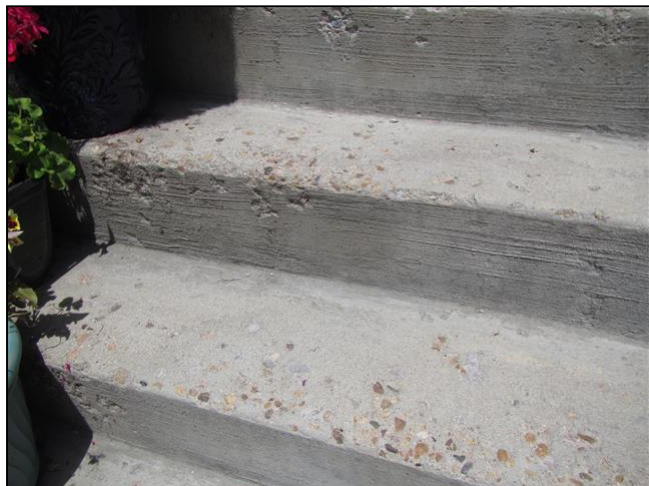
2.3 Item 4(Picture)

(2) Areas of minor spalling, cracks and deteriorated mortar noted on concrete stairs. Recommend repairs by qualified contractor.

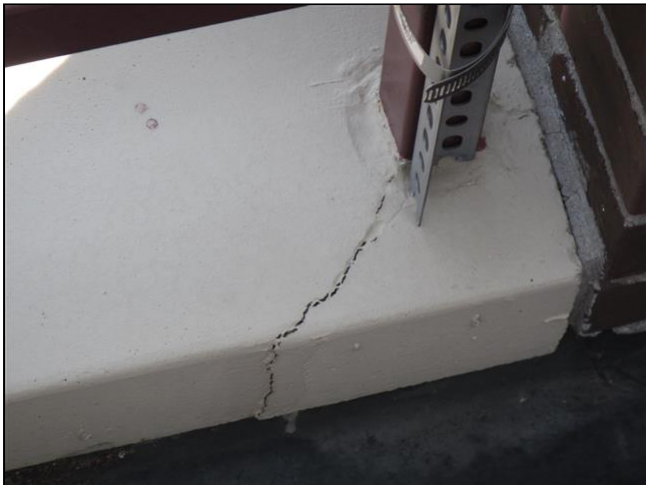
2.3 Item 8(Picture)

(3) Several small cracks observed on balcony stone caps. Uplifting screw present on railing of Unit 105. Minor gaps observed in EPDM seams/patches at corner and drain details. Drains are clogged and in need of cleaning. Note: Limited observation due to furniture and pavers. Recommend further evaluation and repairs by qualified contractor.

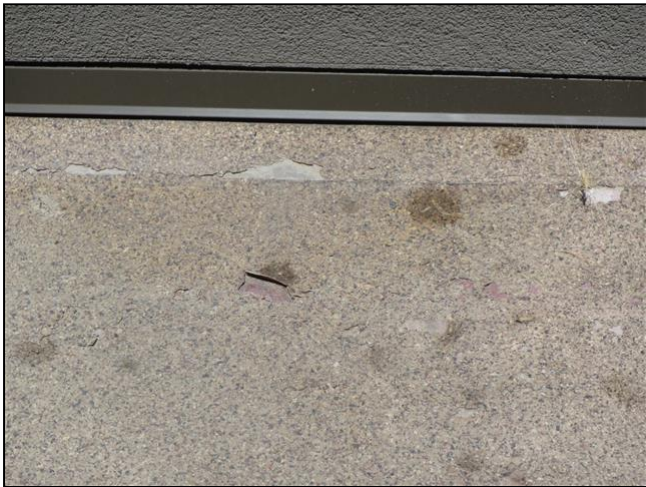
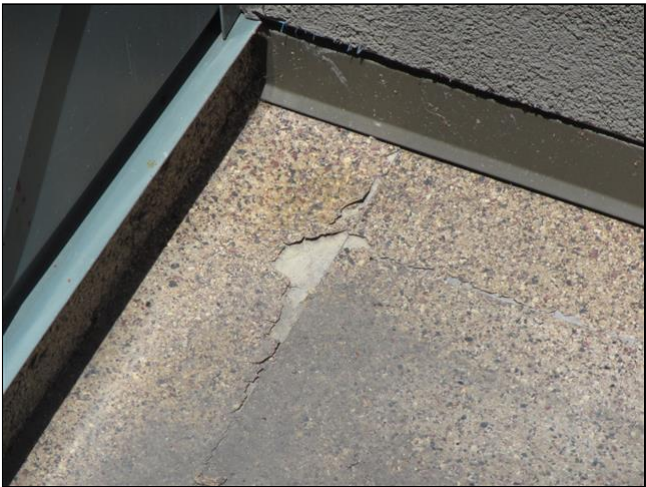
2.4 Item 1(Picture)

Peeling traffic coating observed in areas throughout courtyard. Recommend repair/replacement by a qualified contractor.

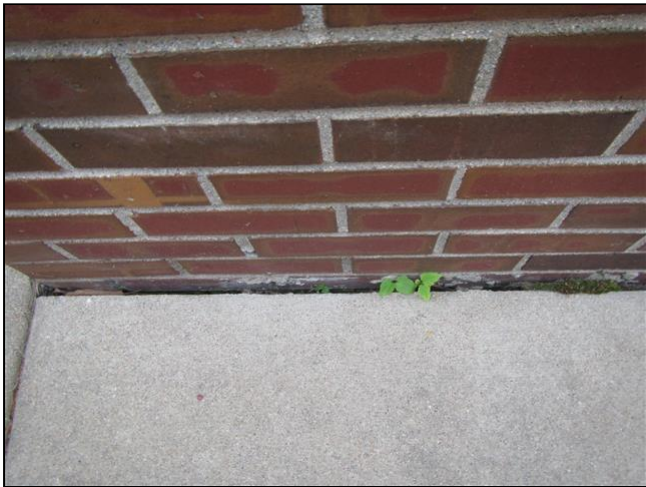
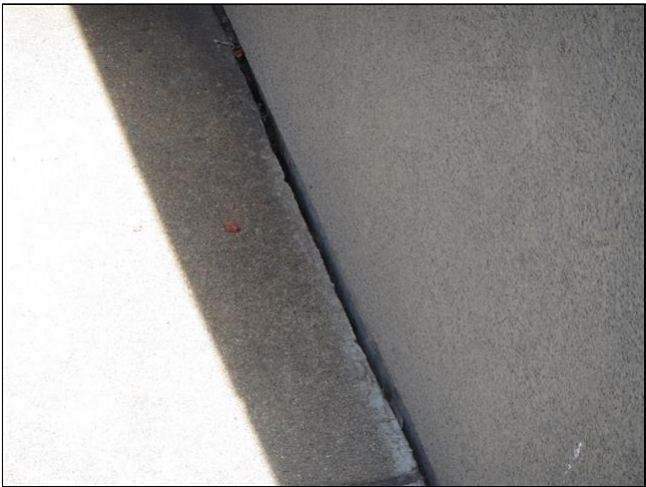
2.6 Item 1(Picture)

Near level grading present in areas around structure. Recommend monitoring during rainfall/wet conditions for possible ponding near the perimeter of the property. Confirm ground level patios are properly draining. Improve grading if necessary to prevent possible water intrusion problems that may effect the foundation system. Recommend sealing large gaps in concrete along grade to prevent water intrusion.

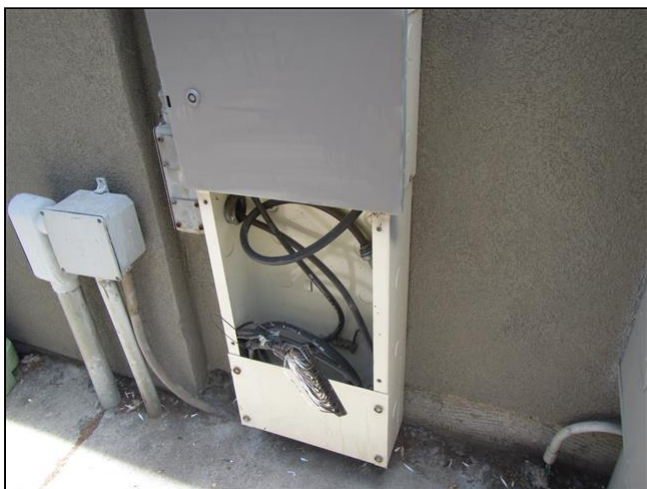
5.1 Item 1(Picture)

Note: Missing panel observed on low volt service entry panel. Recommend repairs by qualified contractor.

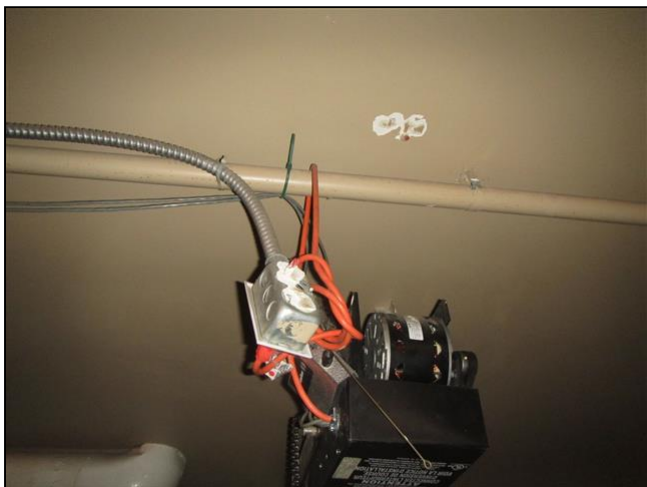
5.2 Item 1(Picture)

Garage door opener outlet is loose on ceiling. Recommend minor repairs by a licensed electrician.

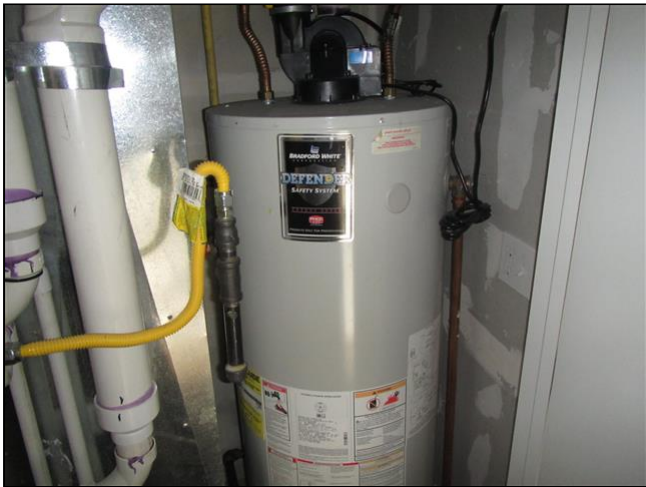
6.0 Item 1(Picture)

Comments: Action Recommended
All Units:
Manufacturer: Bradford White
Size: 48 gallon
Age: 12 yrs
Typical Life Expectancy: 10-14yrs
Condition: The water heaters in all units are at their design life. Unit 102 is slightly leaking from TRP valve. Unit 101 is missing the TPR valve extension. A discharge pipe should be installed and terminated near the floor for safety. Recommend replacement of units due to age by licensed plumber.

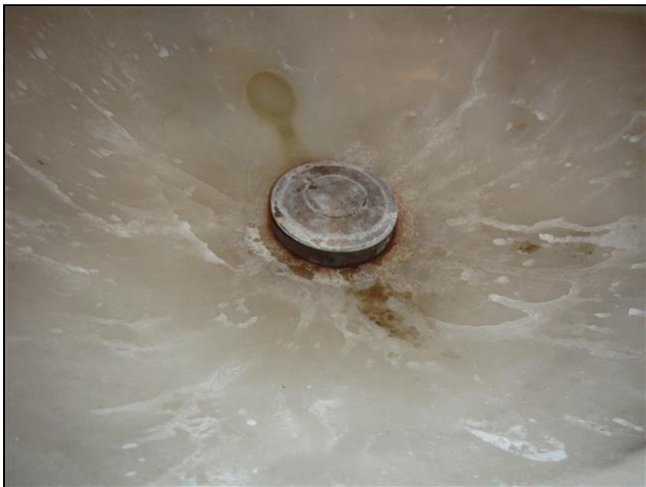
6.1 Item 1(Picture)

- (1) Note: Inspection of the main sewer line is outside of the scope of a this inspection, see additional report provided by Sewer Scope LLC.
- (2) Minor rust present on sink drain in Unit 104. Recommend repairs/replacement by licensed plumber.

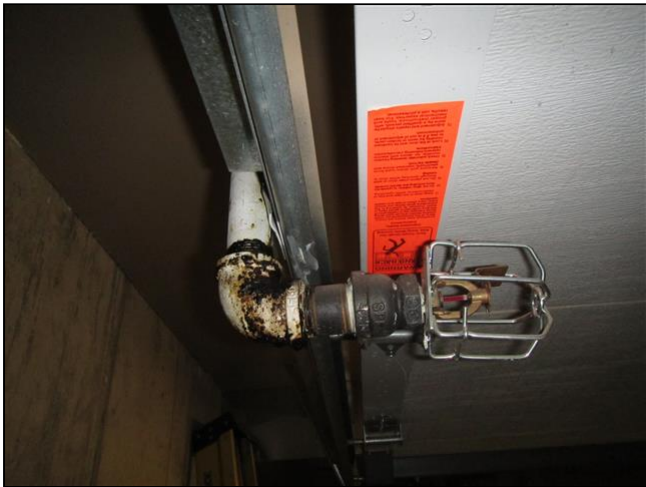
6.2 Item 1(Picture)

(1) Numerous small leaks observed in fire sprinkler lines throughout garage. Recommend repairs by qualified contractor.

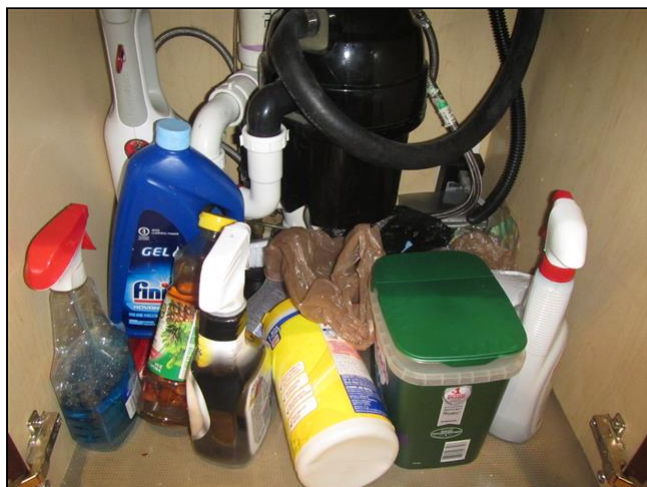
6.2 Item 7(Picture)

(2) No active leaks were observed below kitchen and bathroom fixtures. Note: Limited observation of multiple units due to stored items in cabinets. Maintain caulking around tub and sink areas to prevent water intrusion.

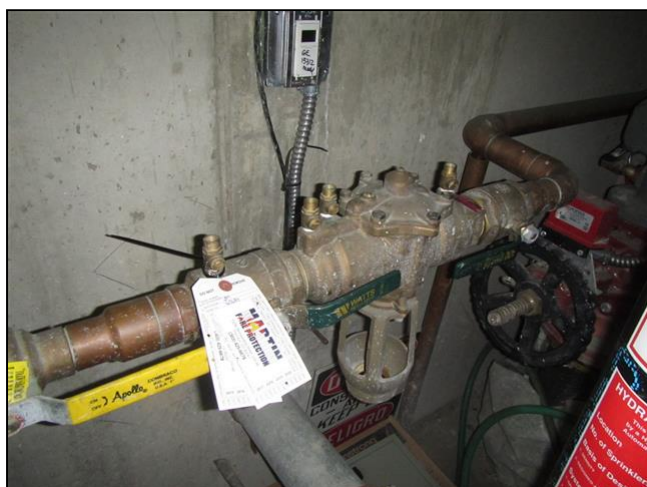
6.3 Item 1(Picture)

Note: Inspection for backflow device and operation of device is outside the scope of this inspection.

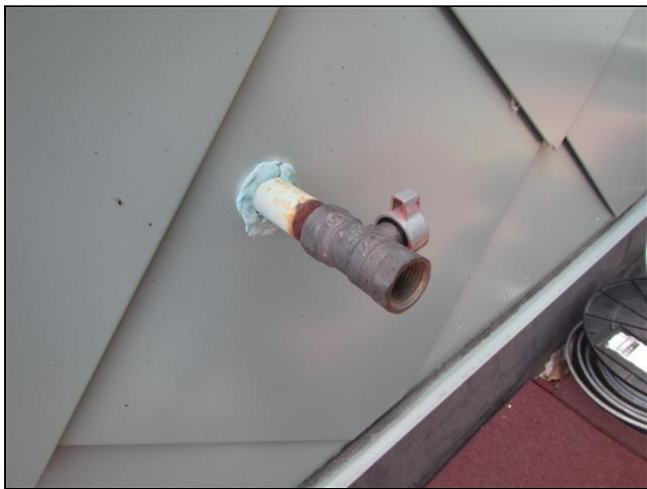
6.4 Item 1(Picture)

Recommend properly capping unused gas lines for safety.

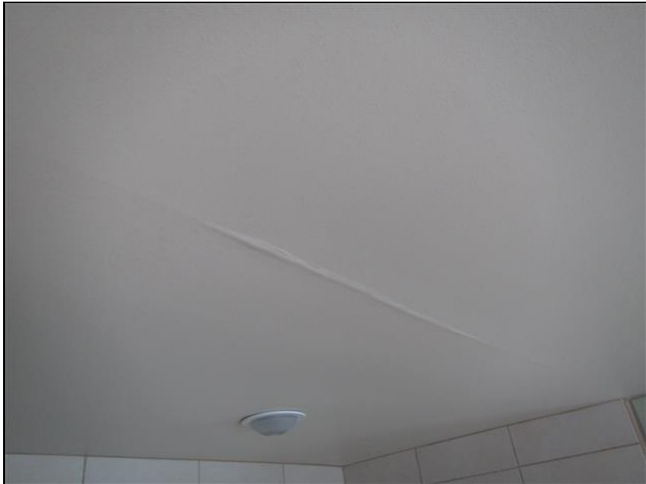
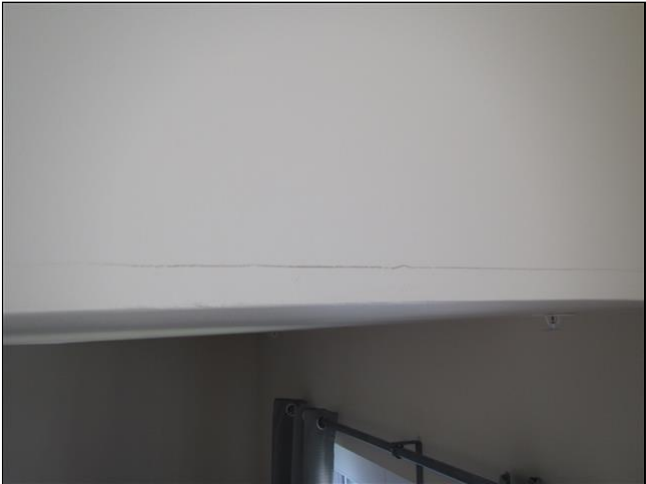
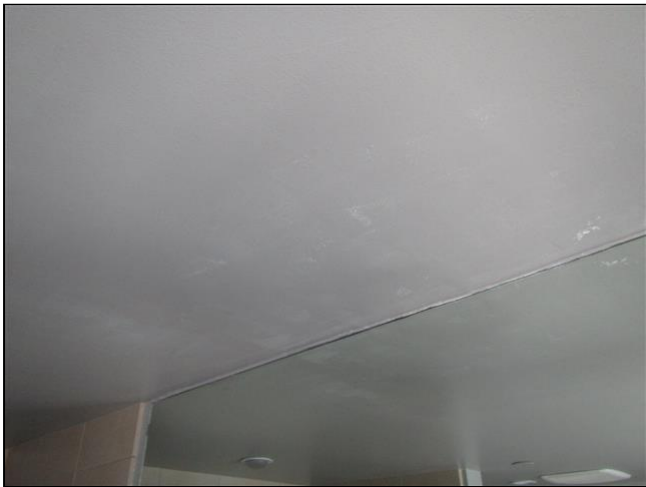
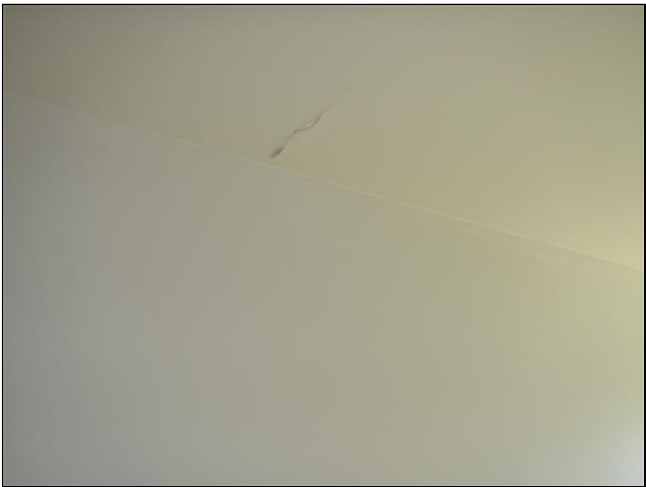
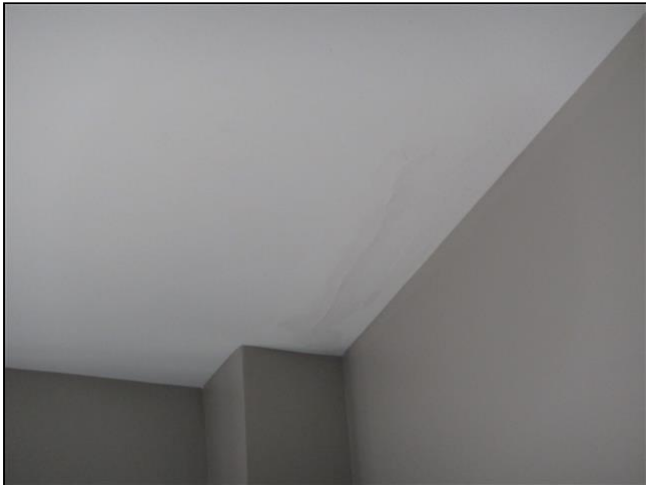
Peeling paint observed on bathroom ceiling of Unit 109 (see bathroom tile notes). Minor crack present on ceiling near stairwell. Prior damage/repairs noted on bathroom ceiling of Unit 108 (area was dry at time of inspection). Small area of peeling paint observed on ceiling of Unit 102. Stains noted in bedroom ceiling of Unit 101. Recommend further evaluation and repairs by qualified contractor.

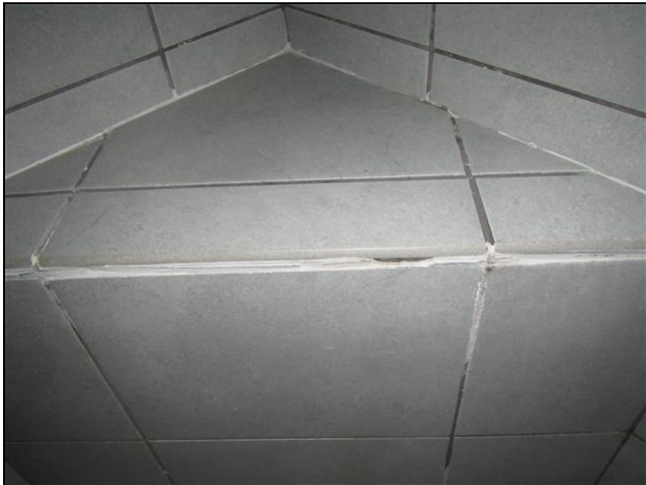
7.1 Item 1(Picture)

Minor deterioration and/or small gaps observed in bathroom tile grout of Units 106, 108, 109, 101. Recommend repairs by qualified contractor to prevent water intrusion.

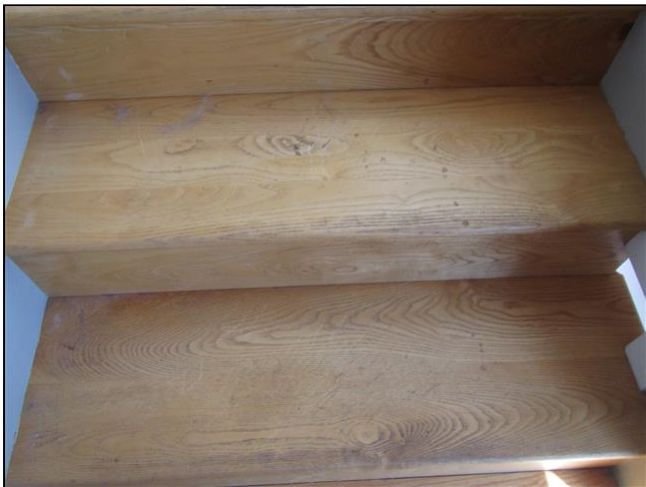
7.2 Item 1(Picture)

Significant damage to carpet and minor scratches in hardwoods observed in Unit 104. Water damaged flooring present at courtyard entry of Unit 101, several cracked tile noted at east entry. Recommend repairs/replacement by qualified contractor.

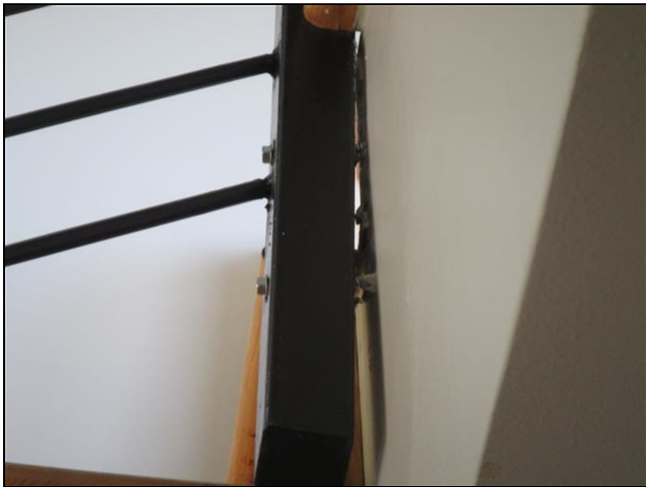
7.3 Item 1(Picture)

(1) Poorly installed railings present in Unit 101. Recommend repairs by qualified contractor.

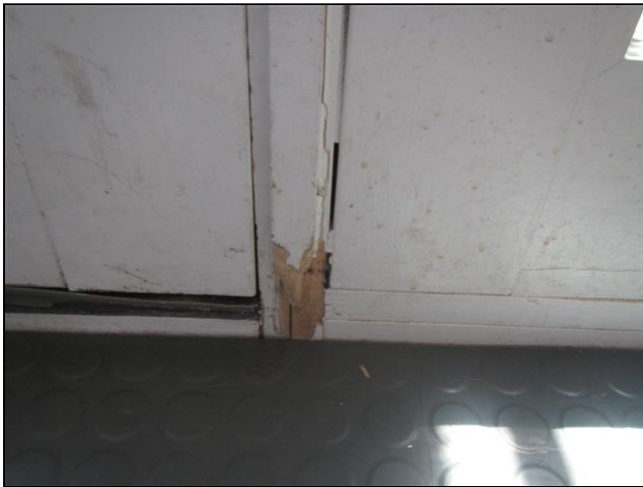
7.5 Item 1(Picture)

Door frame damage and missing strike plate observed in Unit 104. Recommend replacement by qualified contractor.

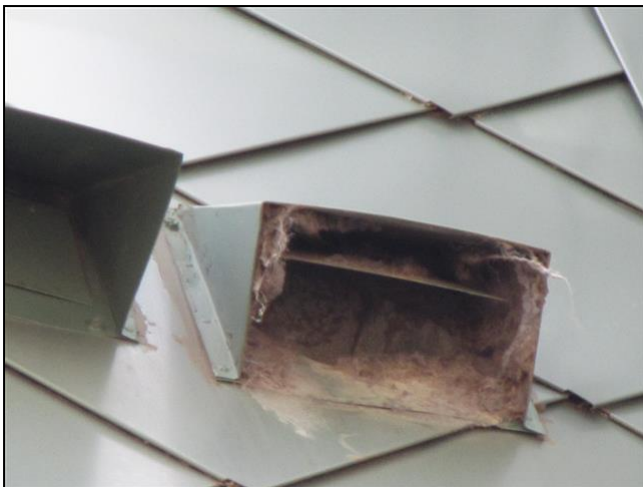
7.7 Item 1(Picture)

(2) Note: Clothes dryers are not inspected during property inspection. Recommend confirming dryer vent ducts are in good condition and discharging to the exterior of the building. Perform vent duct cleaning by qualified person.

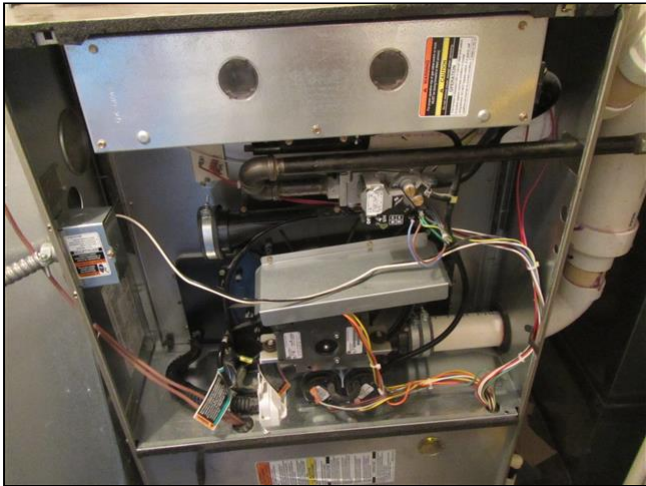
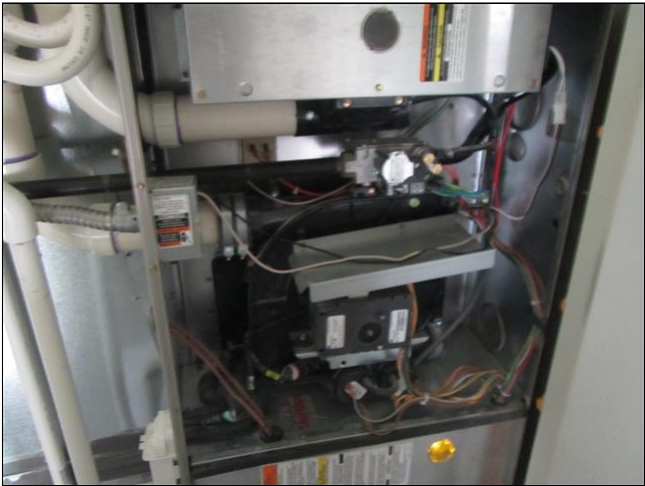
8.0 Item 1(Picture)

(1) All Units:
Manufacturer: Carrier
Size: 120,000BTU/hr
Age: 12yrs
Typical Life Expectancy: 20-25yrs
Condition: The furnaces are within their design life and appeared to be in good operating condition. Note: Excessive rust draining from condensate line of Unit 107. Recommend further evaluation, routine cleaning, maintenance and certification by a qualified HVAC technician.

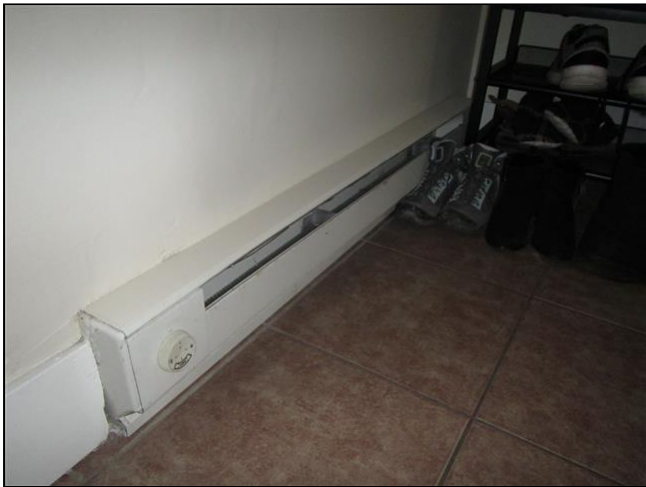
8.0 Item 5(Picture)

(2) Electric baseboard heaters present at lower entries were in good condition. Maintain proper clearances for safety.

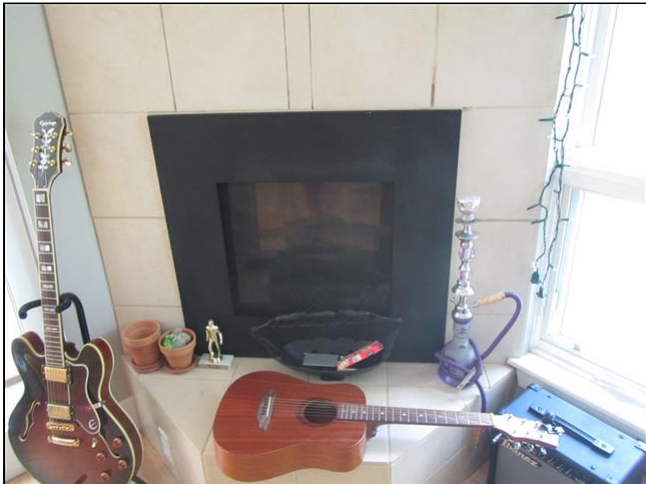
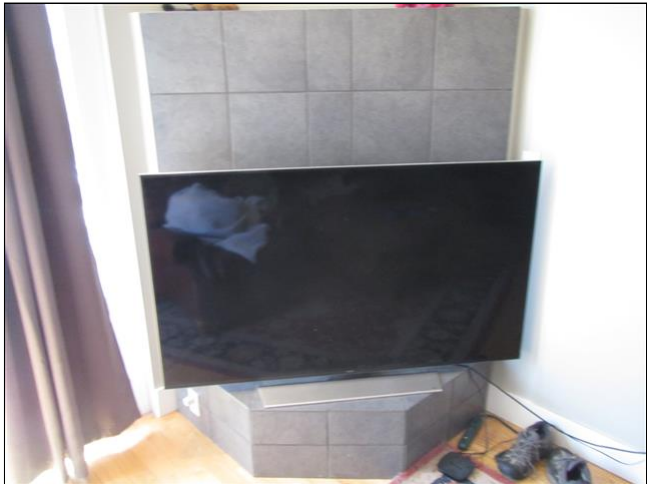
(3) Unit 108 gas fireplace was inoperable at time of inspection. Recommend further evaluation and repairs by qualified technician. Confirm all units are operating and venting properly prior to use. Note: Limited observation of some units to stored items.

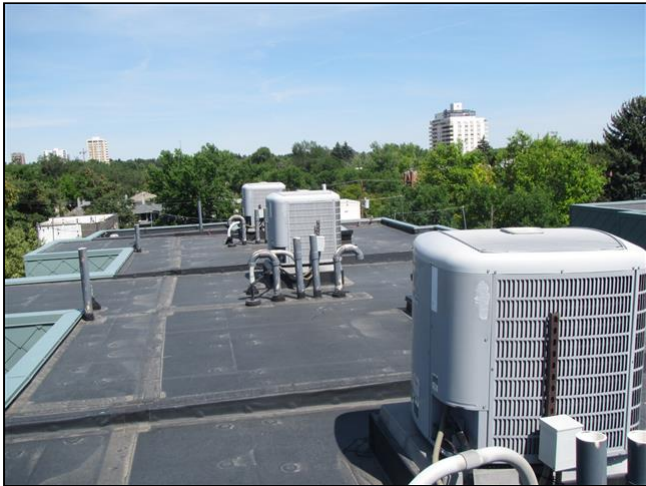
8.1 Item 1(Picture)

All Units:
Manufacturer: Carrier
Size: 4 & 5 Ton
Age: 12yrs
Typical Life Expectancy: 18-25yrs
Condition: The AC units are original and within their design life. Several rooftop units have moved on curbs, multiple damaged pads observed. Minor deterioration noted on line sets. Recommend minor repairs, routine cleaning and maintenance by a qualified HVAC technician.

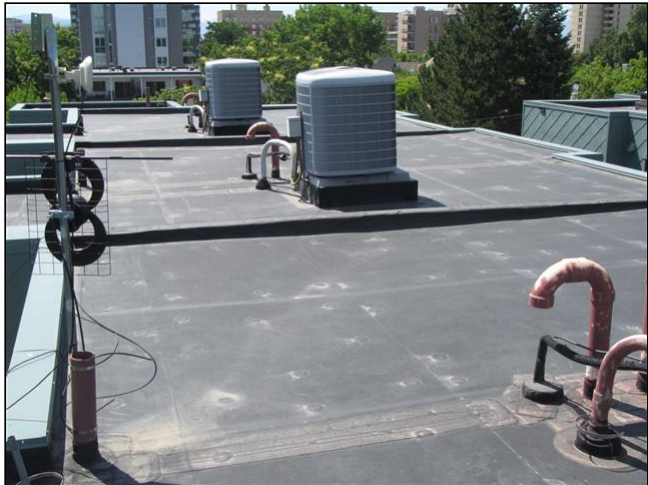
1.0 Item 1(Picture)

(1) The EPDM (Ethylene Propylene Diene Monomer) roofing membrane present was in fair overall condition. Moderate cut observed in membrane near southwest corner allowing minor water intrusion. Numerous unsealed penetrations made by tenant on northeast corner present in parapet wall. Minor gaps and loose membrane/patches noted at seam tape, drains and corner details. Drain cover on southeast corner is not installed. Several uplifting screws noted below seam tape. Several prior repairs/patches observed. Poorly sloped/tapered sections on small flat roofs over stairwells. Recommend further evaluation, minor repairs and annual inspections by licensed roofing contractor.

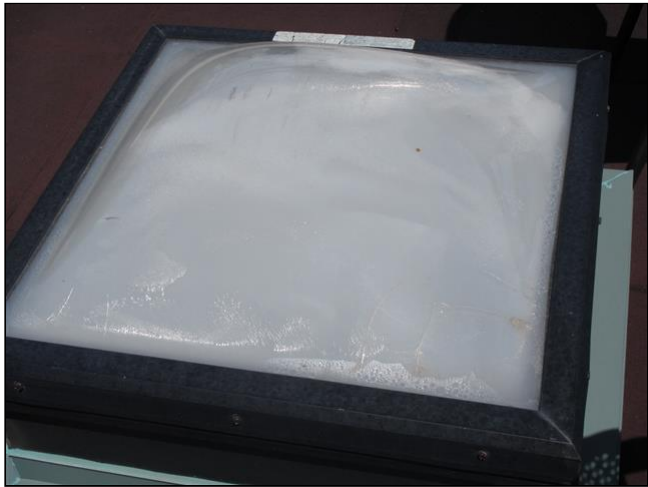
1.0 Item 17(Picture)

(2) Cracked/damaged skylight observed on deck of Unit 101 allowing water intrusion. Caulking at skylights and curbs is becoming weathered and deteriorated. Peeling paint and evidence of minor water intrusion noted below skylights in Units 101 and 106. Recommend further evaluation and repairs/replacement by licensed roofing contractor.

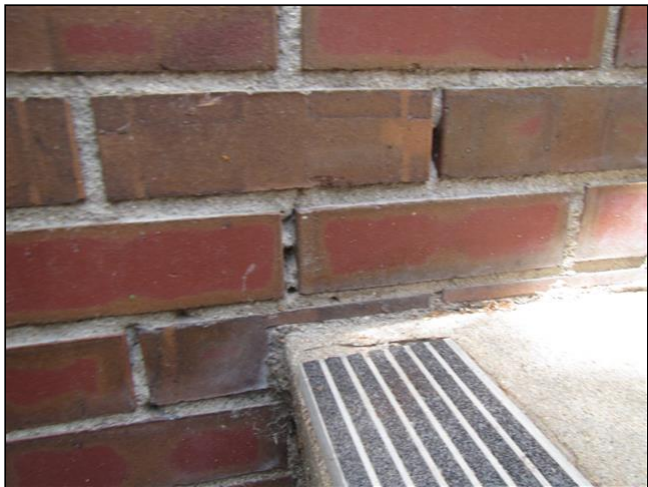
2.0 Item 1(Picture)

(1) Brick, stone and mortar were in good overall condition at time of inspection. Minor deterioration and gaps in mortar observed. Minor damage and small gap present on southeast outlet. Minor gap observed on upper west elevation vent cover. Several damaged columns present in courtyard. Unused scupper located on southwest corner and all penetrations should be properly sealed to prevent water intrusion. Recommend repairs by qualified contractor.

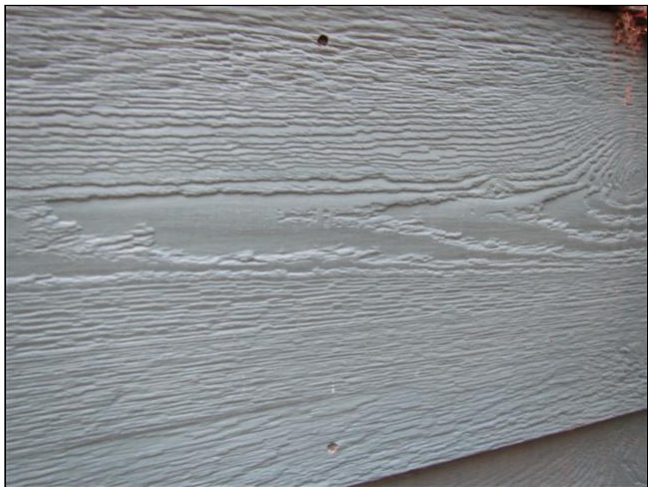
2.0 Item 11(Picture)

(2) The composite siding was in fair condition. Caulking is deteriorated at joints and terminations, minor water damage observed at grade. Several countersunk nails noted throughout. Properly seal all penetrations to prevent water intrusion. Recommend repairs by qualified contractor. Maintain painting and caulking to extend life.

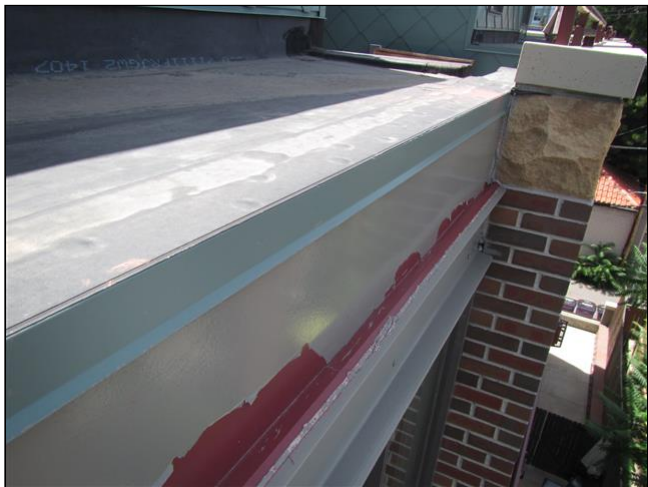
2.0 Item 16(Picture)

(3) Metal siding and flashing were in good overall condition. Several areas of peeling paint observed. Poorly sealed condensate lines and light fixtures noted. Minor damage and gaps observed at east deck intercom boxes. Confirm all penetrations are properly sealed to prevent water intrusion. Recommend repairs by qualified contractor and monitor condition.

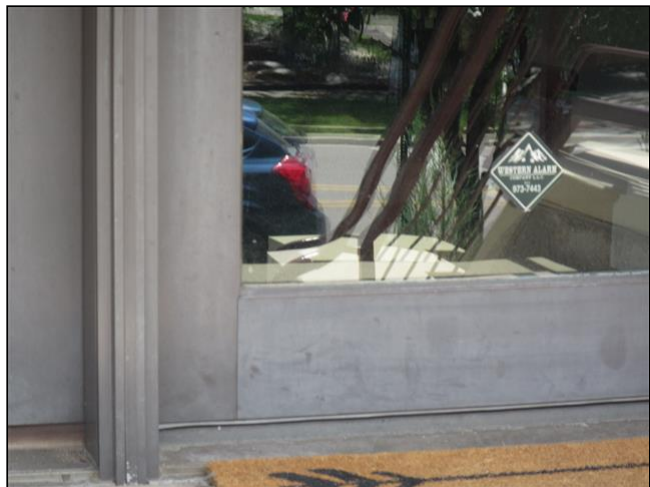
2.1 Item 1(Picture)

(1) Weathering/fading observed throughout exterior doors. The majority of balcony french doors are fogged and difficult to operate. Several doors rub on frames, peeling paint noted. Minor water damage observed at interior of doors in Units 108 and 109. Unit 105 door was inoperable. Moderate rust present on metal doors frames of Units

101 and 106 in courtyard. Unit 104 screen door is damaged on balcony. Recommend further evaluation and repairs/ replacement by qualified contractor.

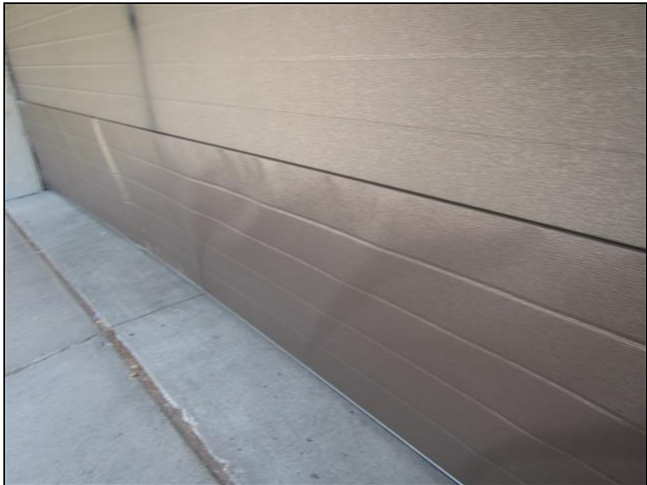
2.1 Item 12(Picture)

(2) Minor damage present on overhead garage door. Recommend replacement by qualified contractor.

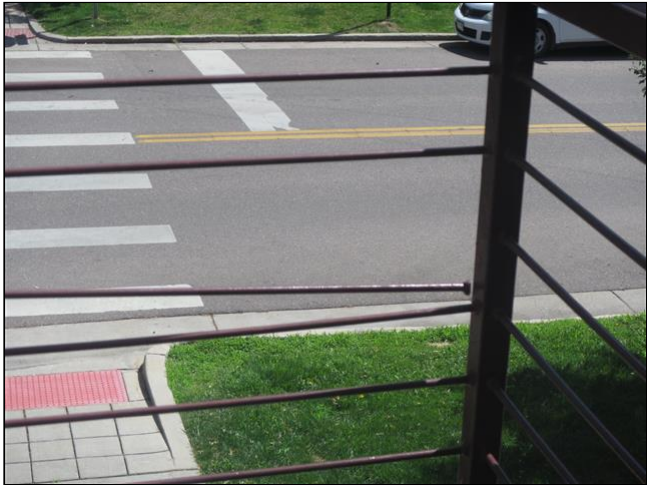
2.3 Item 1(Picture)

(1) Damaged railing observed on balcony of Unit 101. Support anchor on northeast entry roof is pulling away. Recommend further evaluation and repairs by qualified contractor.

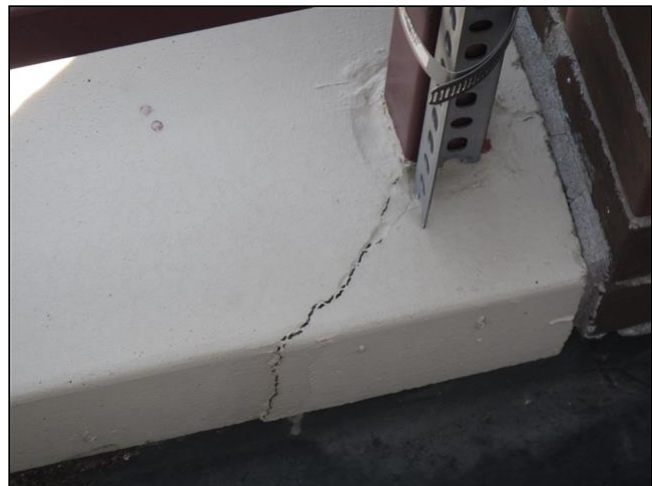
2.3 Item 8(Picture)

(3) Several small cracks observed on balcony stone caps. Uplifting screw present on railing of Unit 105. Minor gaps observed in EPDM seams/patches at corner and drain details. Drains are clogged and in need of cleaning. Note: Limited observation due to furniture and pavers. Recommend further evaluation and repairs by qualified contractor.

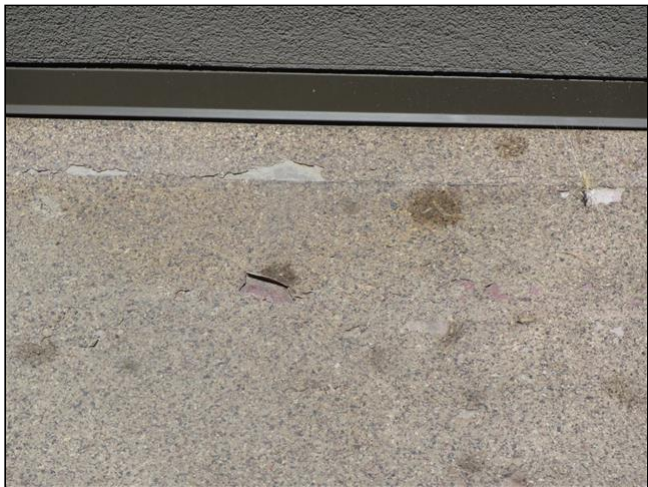
2.4 Item 1(Picture)

Peeling traffic coating observed in areas throughout courtyard. Recommend repair/replacement by a qualified contractor.

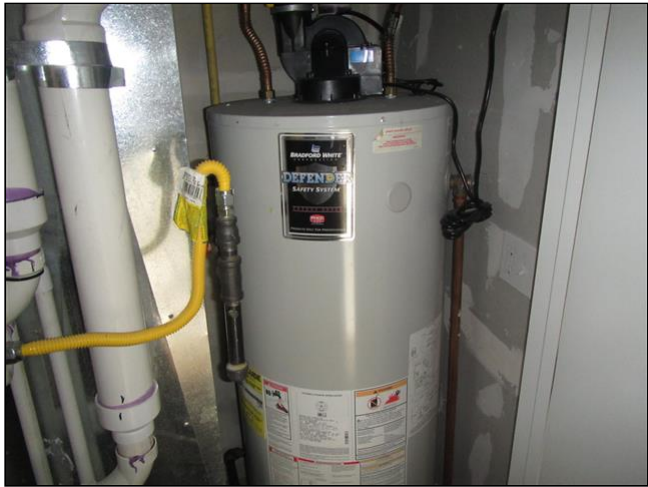
6.0 Item 1(Picture)

All Units:
Manufacturer: Bradford White
Size: 48 gallon
Age: 12 yrs
Typical Life Expectancy: 10-14yrs
Condition: The water heaters in all units are at their design life. Unit 102 is slightly leaking from TRP valve. Unit 101 is missing the TPR valve extension. A discharge pipe should be installed and terminated near the floor for safety. Recommend replacement of units due to age by licensed plumber.

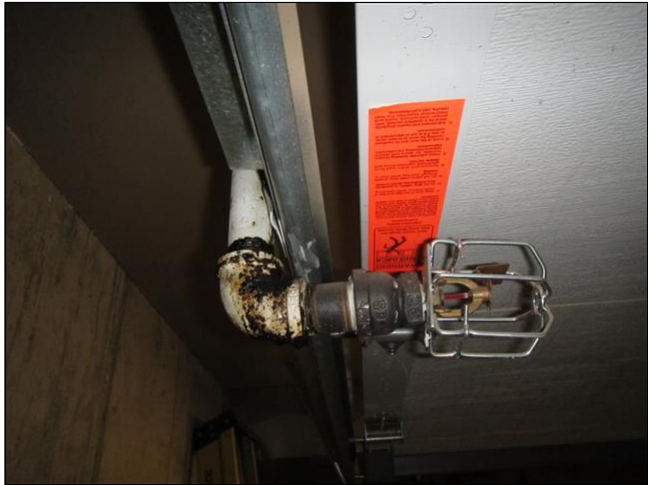
6.2 Item 1(Picture)

(1) Numerous small leaks observed in fire sprinkler lines throughout garage. Recommend repairs by qualified contractor.

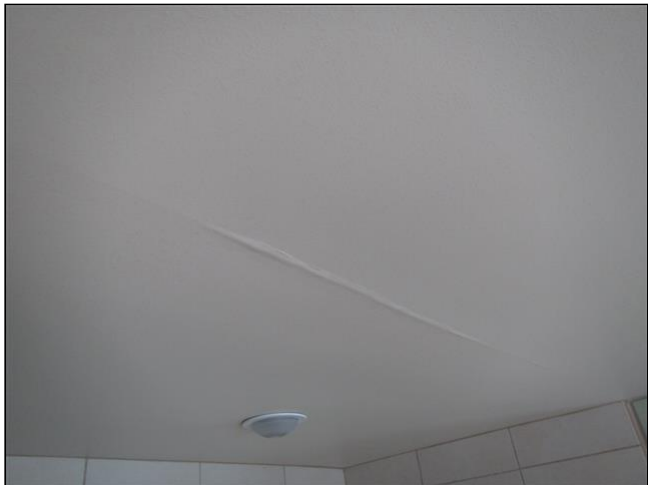
7.0 Item 1(Picture)

Peeling paint observed on bathroom ceiling of Unit 109 (see bathroom tile notes). Minor crack present on ceiling near stairwell. Prior damage/repairs noted on bathroom ceiling of Unit 108 (area was dry at time of inspection). Small area of peeling paint observed on ceiling of Unit 102. Stains noted in bedroom ceiling of Unit 101. Recommend further evaluation and repairs by qualified contractor.

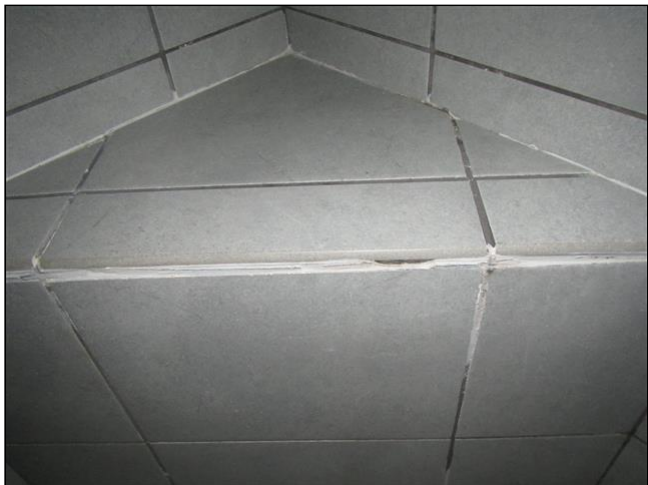
7.1 Item 1(Picture)

Minor deterioration and/or small gaps observed in bathroom tile grout of Units 106, 108, 109, 101. Recommend repairs by qualified contractor to prevent water intrusion.
