Inspection Report

Property Address:
XXX
Denver CO 80203

Safeguard Inspection Services Inc.

Date: 7/18/2019	Time:	Report ID: 901
Property: XXX Denver CO 80203	Customer: John Doe	Real Estate Professional:

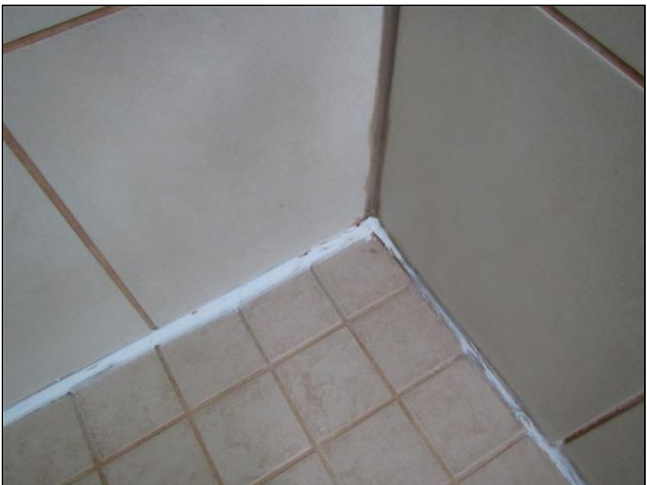
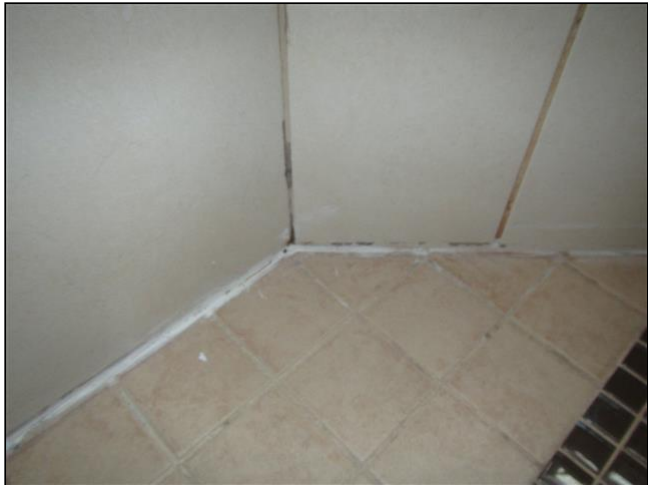
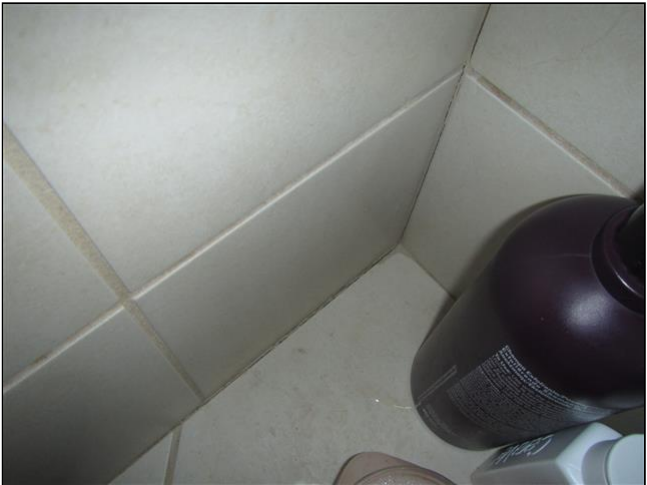
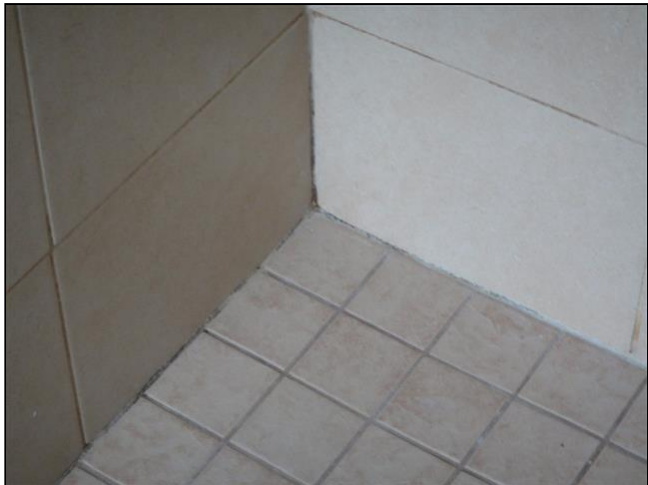
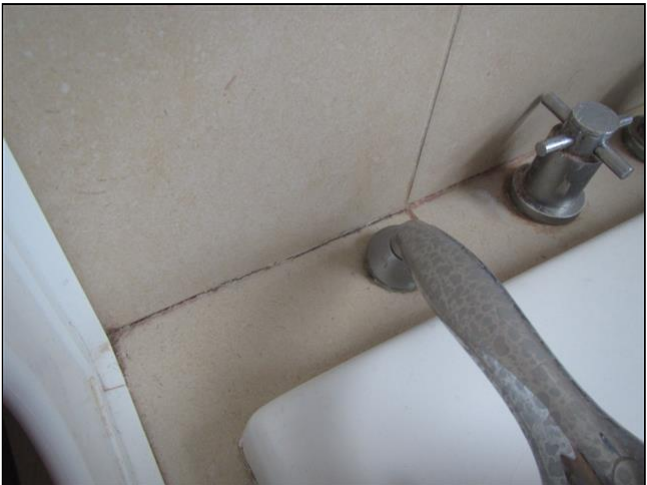
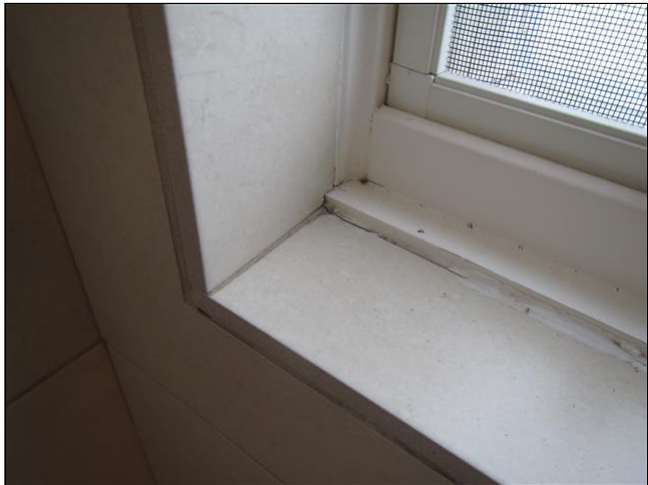
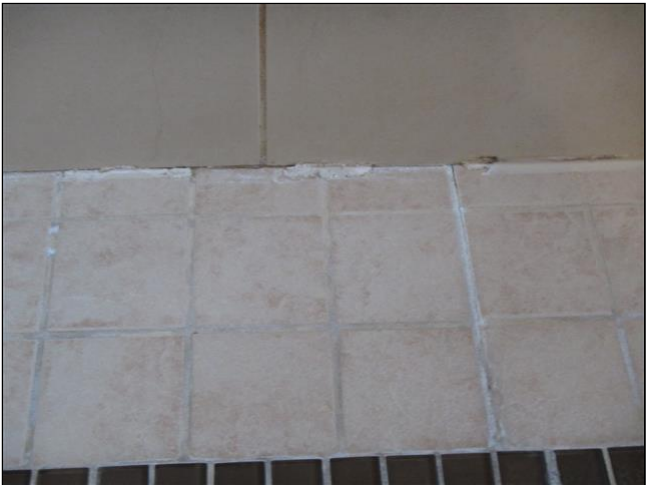
Minor deterioration and/or small gaps observed in bathroom tile grout of Units 106, 108, 109, 101. Recommend repairs by qualified contractor to prevent water intrusion.

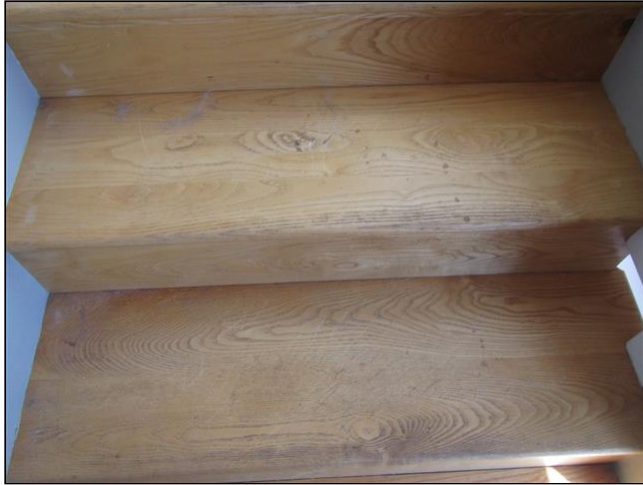
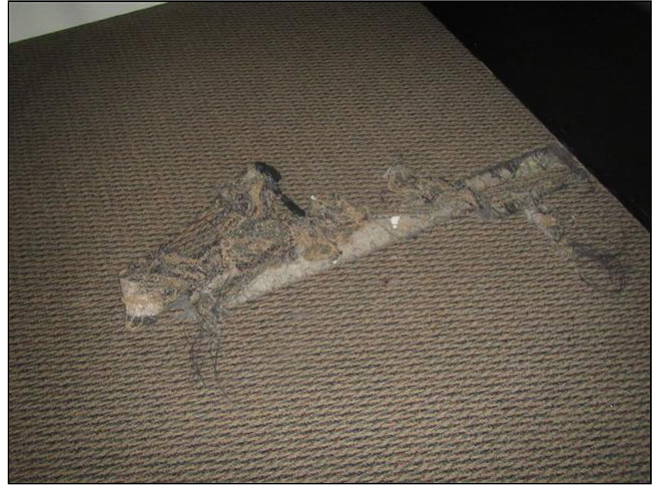
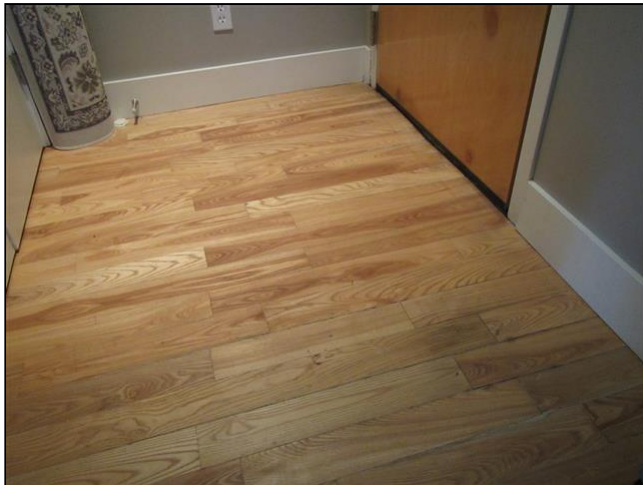
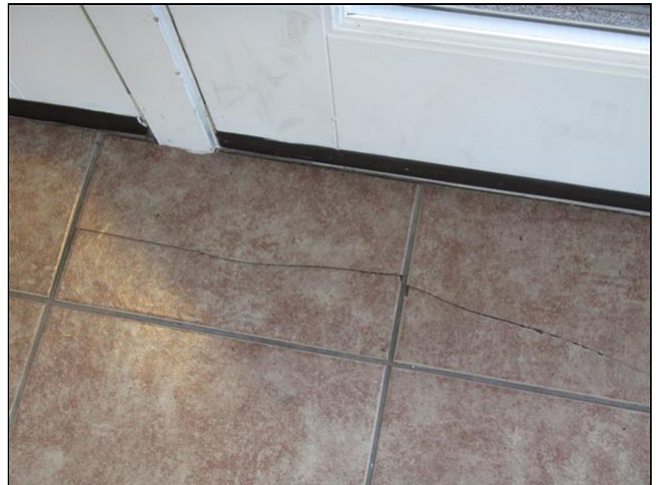
Significant damage to carpet and minor scratches in hardwoods observed in Unit 104. Water damaged flooring present at courtyard entry of Unit 101, several cracked tile noted at east entry. Recommend repairs/replacement by qualified contractor.

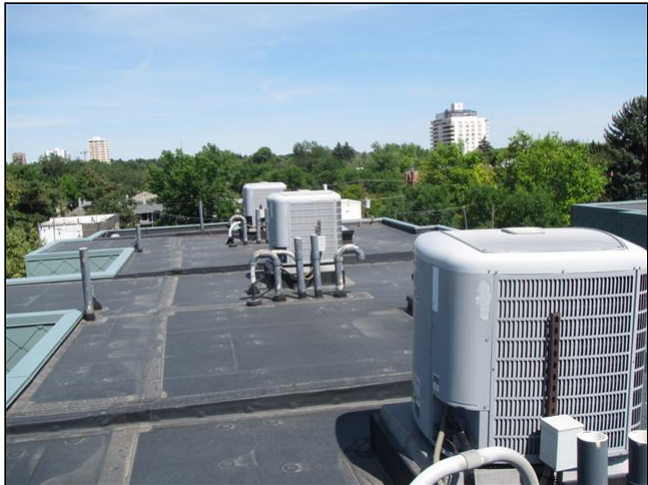
8.1 Item 1(Picture)

Condition: The AC units are original and within their design life. Several rooftop units have moved on curbs, multiple damaged pads observed. Minor deterioration noted on line sets. Recommend minor repairs, routine cleaning and maintenance by a qualified HVAC technician.
