1826 Eldon Way

PROPERTY ADDRESS: 123 ANY PLACE LANE

## RESIDENTIAL INSPECTION REPORT

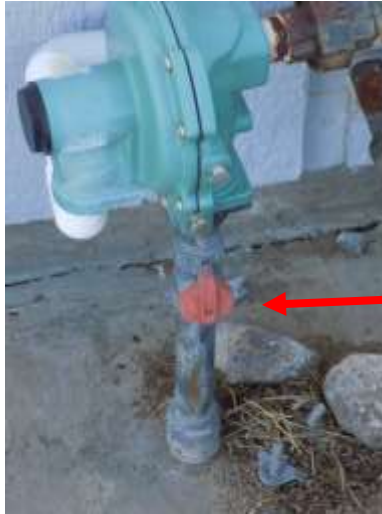
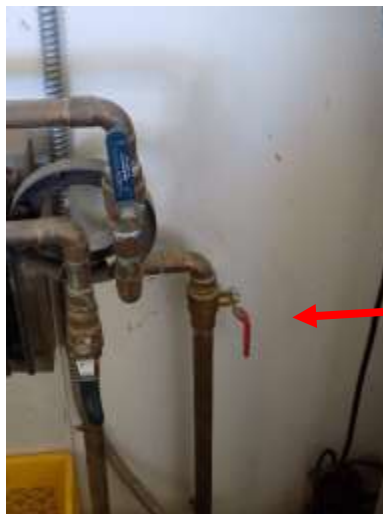
Utility	Location	Operation
LP Gas	Right side of home next to side entry on the garage next to the air conditioning unit.	To shut the main gas supply off, turn the red handle ¼ of a turn to the right.
Water Main	At the rear wall of the garage to the left of the well water pressure tank.	To shut down the main water supply to the home, turn the red handle ¼ of a turn to the right (pulling towards the body).

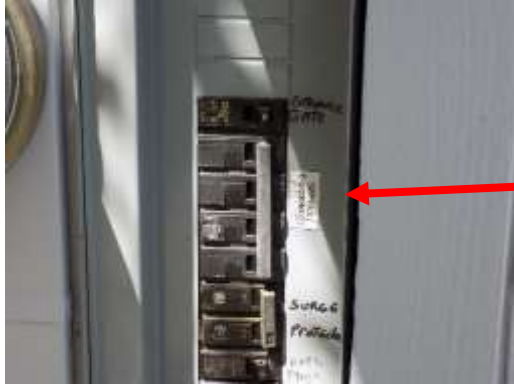
Electrical  
Service  
Disconnect

On the left side of the home near the front of the house.  
It is important to maintain 30 inches of clearance from the  
vegetation in order to have adequate access.

The main breaker is a 200 amp  
breaker labeled "Service Disconnect".  
This will disconnect the electrical  
service if the breaker switch is pulled  
to the left.

It is important to note, that electrical  
service should be shut down by a  
qualified professional since electrical  
panels have the ability to be  
energized.

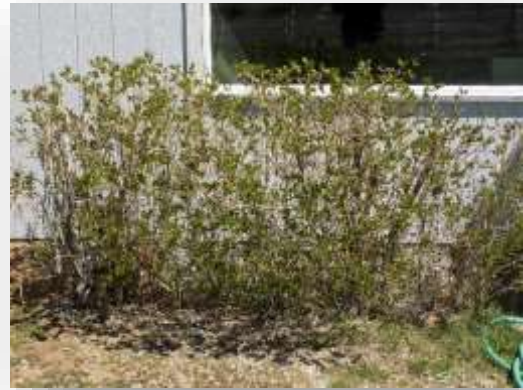
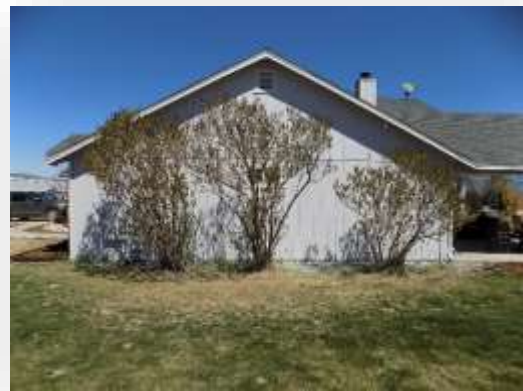
### ➡ VEGETATION

Mature vegetation is located on the left and rear of the home. While there was no evidence of transpiration and its impact on the foundation, it is recommended that periodic pruning and attention be paid to the area to avoid potential issues.

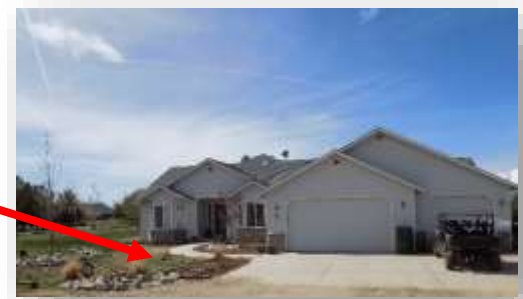
### ➡ NEGATIVE GRADE SLOPE

There is a slight negative slope at the front of the home. While this does not appear to have an impact on the foundation, it is likely that ponding may occur in the area identified in the picture.

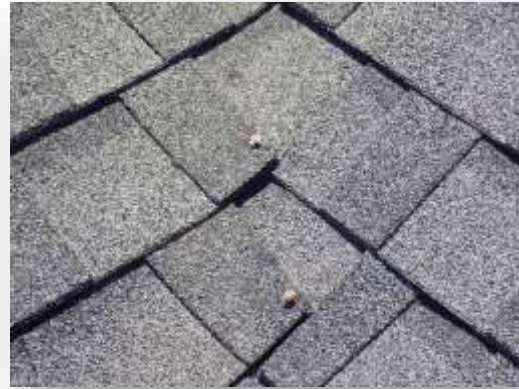
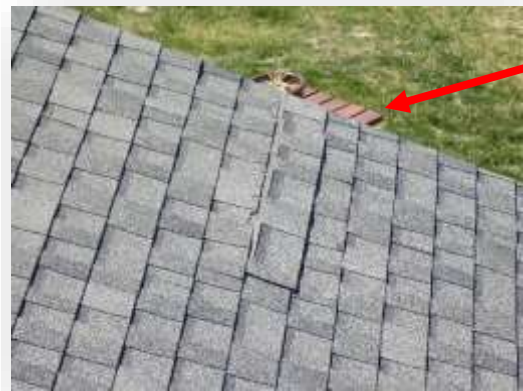
### ISSUE: IMPROPER ROOF REPAIRS

The roof showed evidence of improper repairs and a loose shingle. While there were no signs of water damage in the attic or the interior ceiling, the roof should be repaired by a qualified professional.

- **ISSUE: IMPROPER ROOF REPAIRS**
  - The roof showed evidence of improper repairs and loose shingles. While there were no signs of water damage in the attic or the interior ceiling, the roof should be repaired by a qualified professional.
- **ISSUE: RUBBER COLLAR ON PLUMBING VENT CRACKED/DETERIORATED**
  - The rubber collar on the plumbing vent is cracked and deteriorated due to UV damage. While it does not appear to be leaking, I recommend the collar be repaired or replaced by a qualified professional.

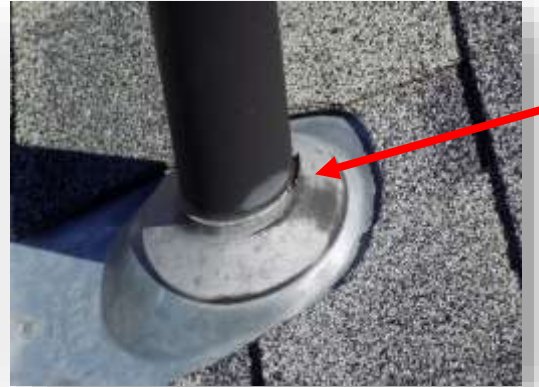
ISSUE: RUBBER COLLAR ON PLUMBING VENT  
CRACKED/DETERIORATED

The rubber collar on the plumbing vent is cracked and deteriorated due to UV damage. While it does not appear to be leaking, I recommend the collar be repaired or replaced, by a qualified professional.

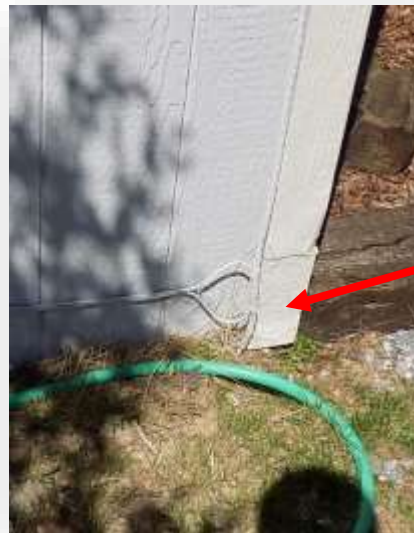
### IMITATION WOOD SIDING DELAMINATING/SWELLING/SHOWING SIGNS OF ROT

There is evidence of the siding showing signs of rot at the front left corner. I recommend repair/replacement by a qualified professional.

- **ISSUE: IMITATION WOOD SIDING DELAMINATING/SWELLING/SHOWING SIGNS OF WOOD DESTROYING ORGANISM**
  - There is evidence of the siding showing signs of rot at the front-left corner. I recommend repair/replacement by a qualified professional.

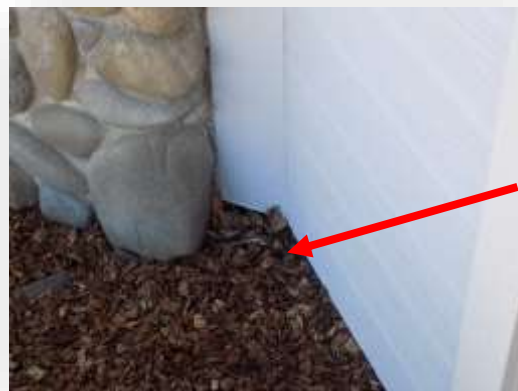
### SIDING TOO CLOSE TO GROUND

The siding located in various locations around the home is too close to the ground. Siding should stop 6" – 8" above ground. I recommend pulling the soil away from the foundation to meet the 6" – 8" clearance.

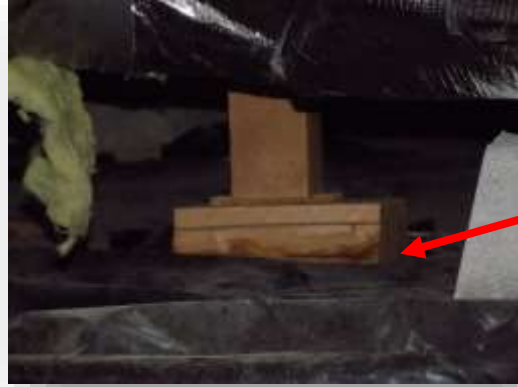
### ISSUE: POST HAS DIRECT CONTACT WITH GROUND

A post located in the crawlspace has direct contact with ground and is not resting on a concrete pier. I recommend having a licensed professional evaluate the need for this post since it is not a part of the main foundation.

- **ISSUE: POST HAS DIRECT CONTACT WITH GROUND**
  - A post located in the crawlspace has direct contact with ground and is not resting on a concrete pier. I recommend having a licensed professional evaluate the need for this post since it is not a part of the main foundation.
- **ISSUE: CELLULOSE DEBRIS IN CRAWLSPACE**
  - There is cellulose debris located in various locations throughout the crawlspace. I recommend having the debris removed to prevent infestation by wood destroying organisms.

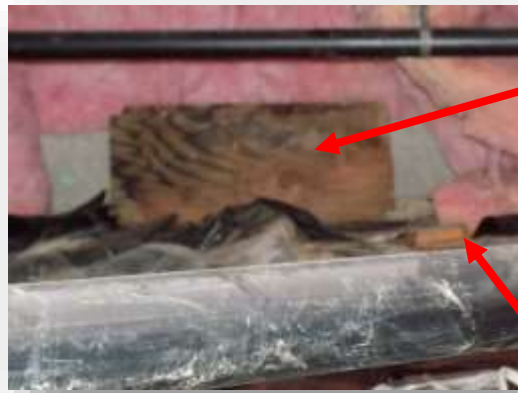
### ISSUE: CELLULOSE DEBRIS IN CRAWLSPACE

There is cellulose debris located in various locations throughout the crawlspace. I recommend having the debris removed to prevent infestation by wood destroying organisms.

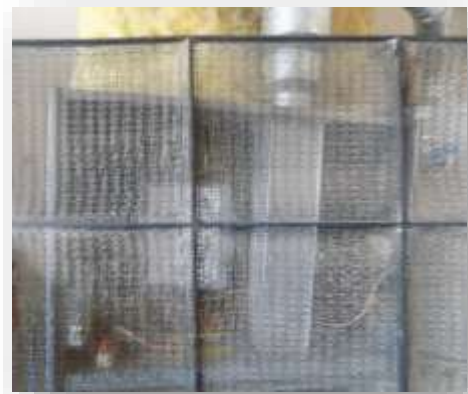
**AIR FILTER NEEDS CLEANING/REPLACEMENT**

The air filter for the cold air return is dirty and needs cleaning or replacement. Dirty air filters reduce airflow causing waste and inefficiency of the HVAC system. I recommend replacing/cleaning the air filter.

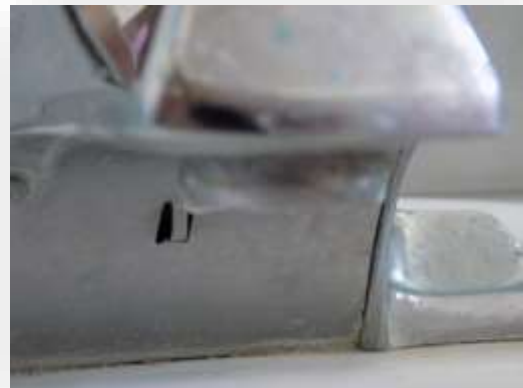
ISSUE: LEAKING FIXTURE

The plumbing fixture located in the master bath is leaking and corroded. I recommend repair/replacement by a qualified professional.

- **ISSUE: LEAKING FIXTURE**
  - The plumbing fixture located in the master bath is leaking and corroded. I recommend repair/replacement by a qualified professional.

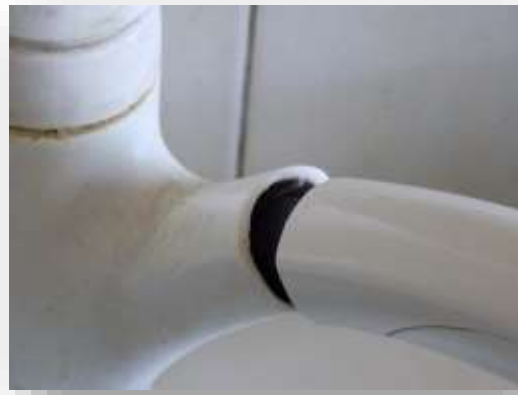
### SPRAYER ON KITCHEN SINK IS LOOSE

The sprayer on the kitchen sink does not seat properly. While it does not show signs of leaking, it could in the future. I recommend repair/replacement by a qualified professional.

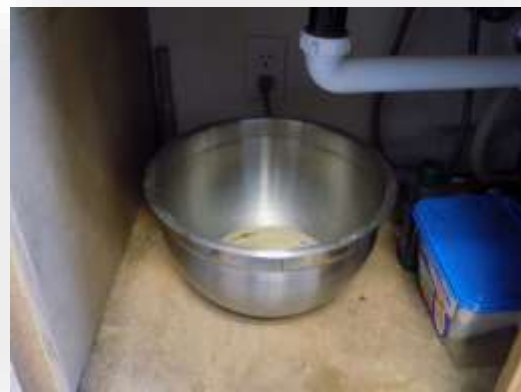
### ISSUE: HISTORICAL WATER DAMAGE UNDER SINK/POSSIBLE ACTIVE LEAK

There appears to be historical water damage under the sink located in the cabinets in the kitchen. While no active leaks were present, it should be noted that a pan was located under the drain pipe. I recommend repair/replacement by a qualified professional.

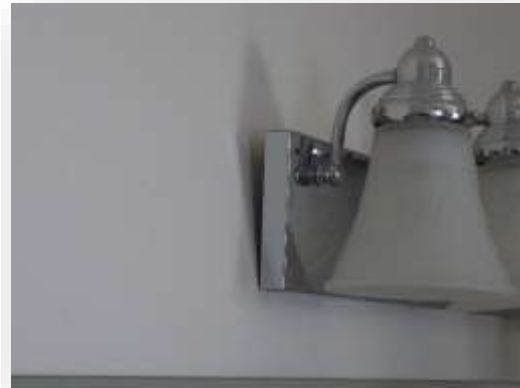
### SAFETY ISSUE: LOOSE ELECTRICAL FIXTURE

The electrical lighting fixture located in the master bathroom is not mounted properly and is loose. This could potentially lead to a fire hazard. I recommend having the fixture repaired/replaced by a licensed electrician immediately.

- **SAFETY ISSUE: LOOSE ELECTRICAL FIXTURE**
  - The electrical lighting fixture located in the master bathroom is not mounted properly and is loose. This could potentially lead to a fire hazard. I recommend having the fixture repaired/replaced by a licensed electrician immediately.

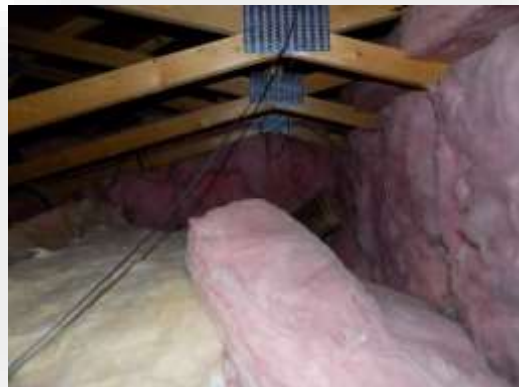
The insulation was inspected from the attic hatch. The insulation was present in both the attic and the crawlspace. Full inspection of the attic was limited due to the scissor trusses, but the insulation was installed correctly and largely intact from the point of observation.

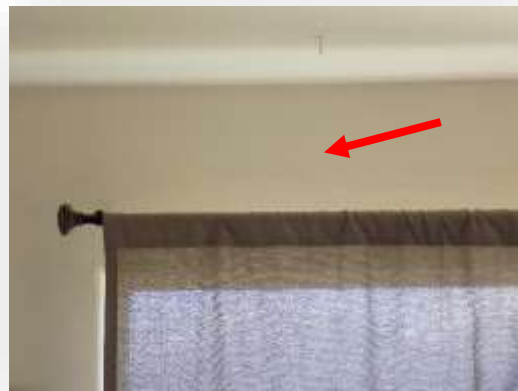
### ➡ HAIRLINE CRACK

There is a hairline crack above the window in the master bedroom. Cracks like this are cosmetic, but they should be evaluated by a qualified professional if they worsen or run diagonally from the corner of the window.

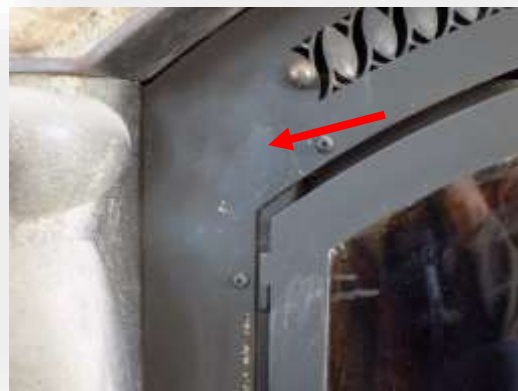
### 🚫 ISSUE: SOOT/CREOSOTE ON FIREPLACE

Upon inspecting the fireplace, there was soot/creosote on the edge of the door indicating leakage of heated gases. I recommend repair/replacement of the door gasket by a qualified professional.

- **ISSUE: SOOT/CREOSOTE ON FIREPLACE**
  - Upon inspecting the fireplace, there was soot/creosote on the edge of the door indicating leakage of heated gases. I recommend repair/replacement of the door gasket by a qualified professional.

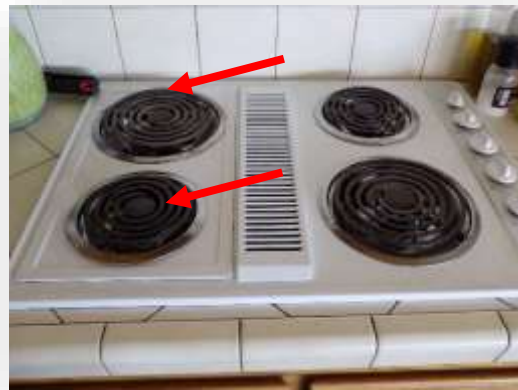
### ISSUE: ELEMENTS ON COOKTOP INOPERABLE

The elements on the left side of the kitchen cooktop are not heating. I recommend repair/replacement by a qualified professional.

- **ISSUE: ELEMENTS ON COOKTOP INOPERABLE**
  - The elements on the left side of the kitchen cooktop are not heating. I recommend repair/replacement by a qualified professional.

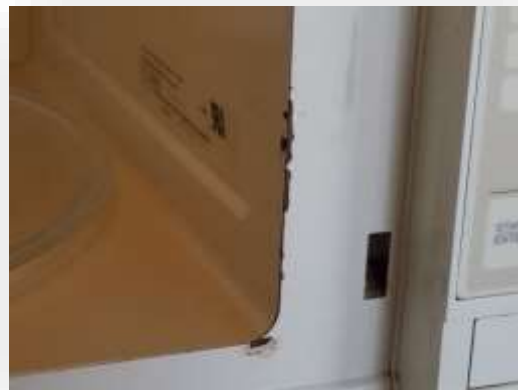
### ISSUE: CORROSION INSIDE MICROWAVE OVEN

There was some minor corrosion on the interior of the microwave. Upon inspection it was still functional, therefore I recommend monitoring the corrosion and functionality of the microwave.
