# **Marble Wetlands Management Plan**

## **December 2023**

**Prepared By:**  
Aspen Valley Land Trust

# DRAFT BASELINE DOCUMENTATION REPORT

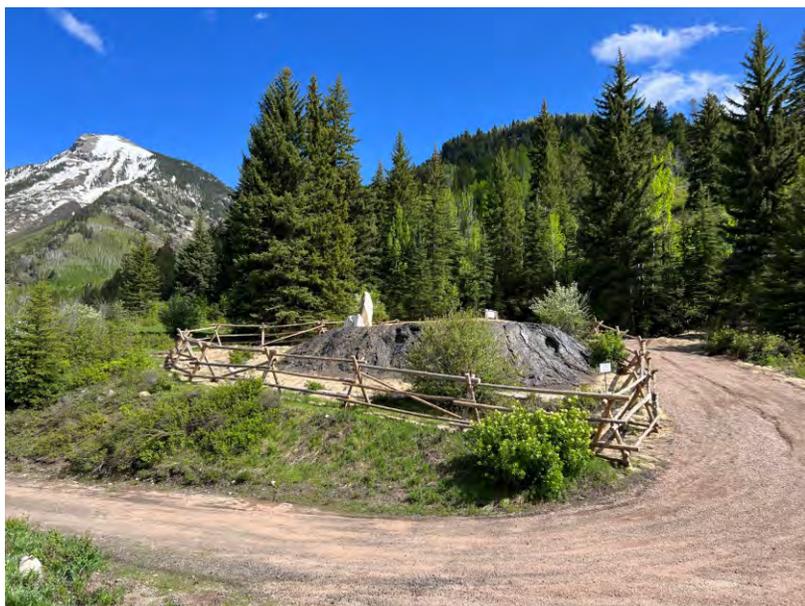
**Photopoint 1.** Looking south-by-southeast across the access road toward the slag pile restoration area in the northwest part of the Property (6/4/23).

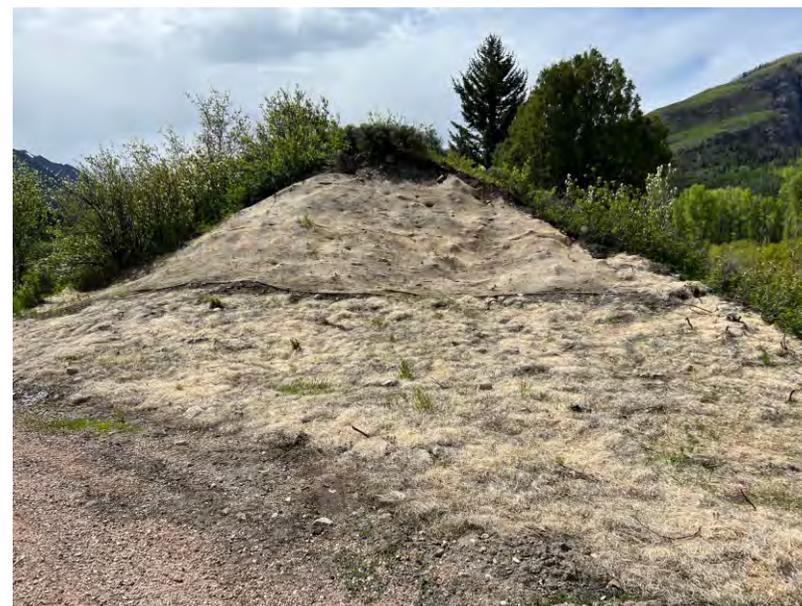
**Photopoint 2.** Looking northwest at the stabilized slope opposite the slag pile restoration area (6/4/23).

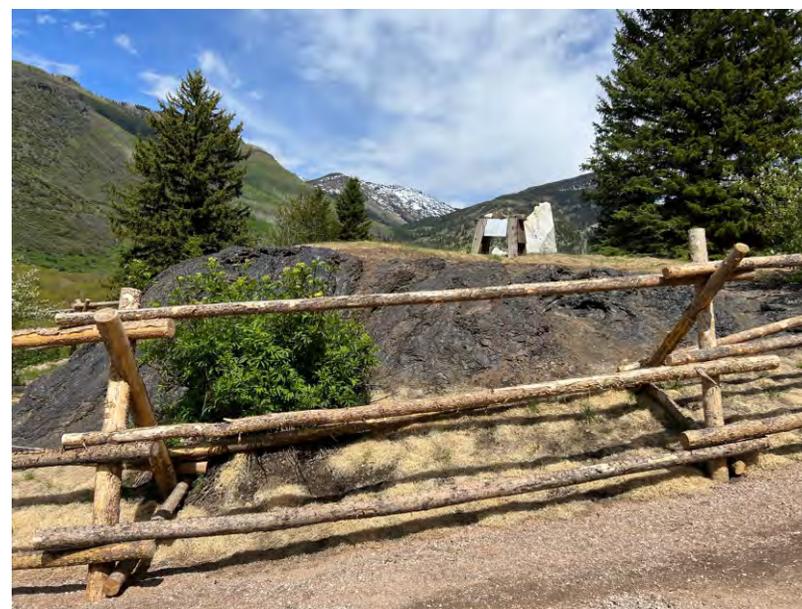
**Photopoint 4.** Looking east-by-northeast at the west side of the slag pile from the access road (6/4/23).

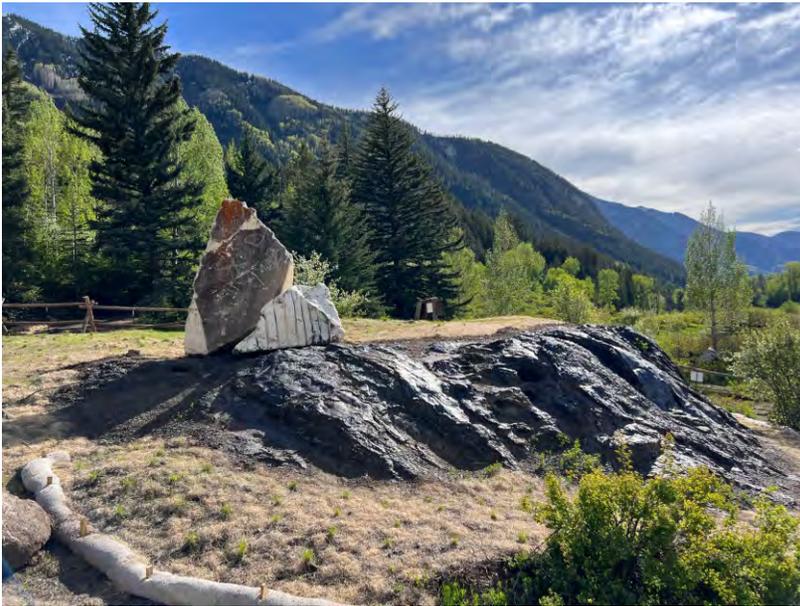
**Photopoint 5.** Looking west-by-southwest across the fenced slag pile restoration area from its east boundary (6/4/23).

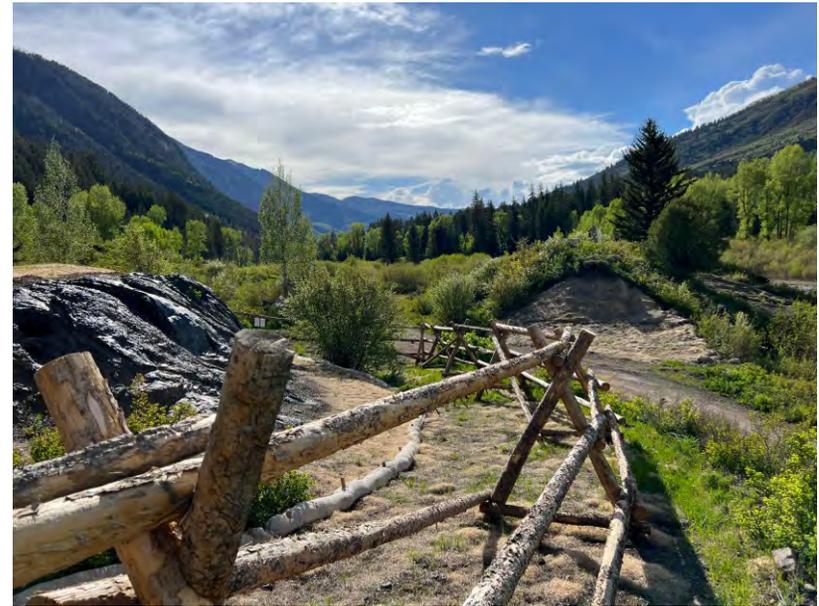
**Photopoint 5.** Looking west-by-northwest along the east boundary of the fenced slag pile restoration area 6/4/23).

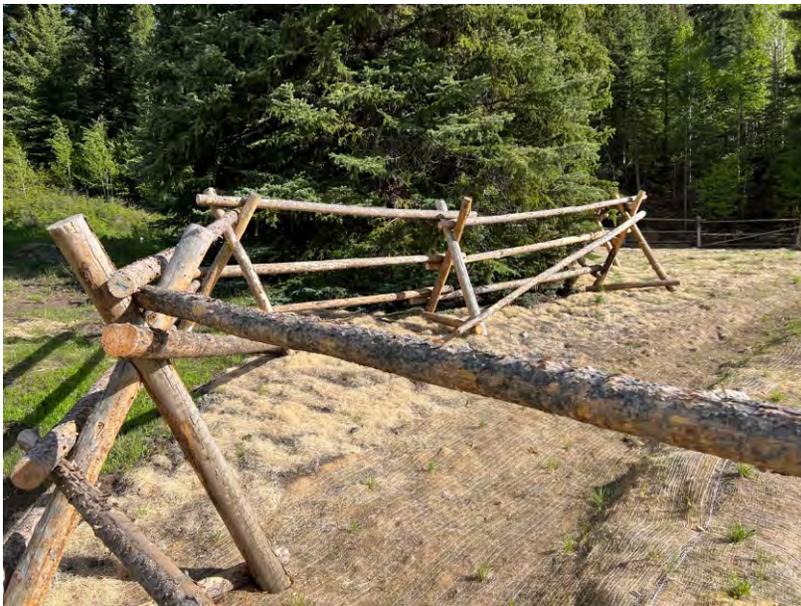
**Photopoint 5.** Looking south along the east boundary of the fenced slag pile restoration area (6/4/23).

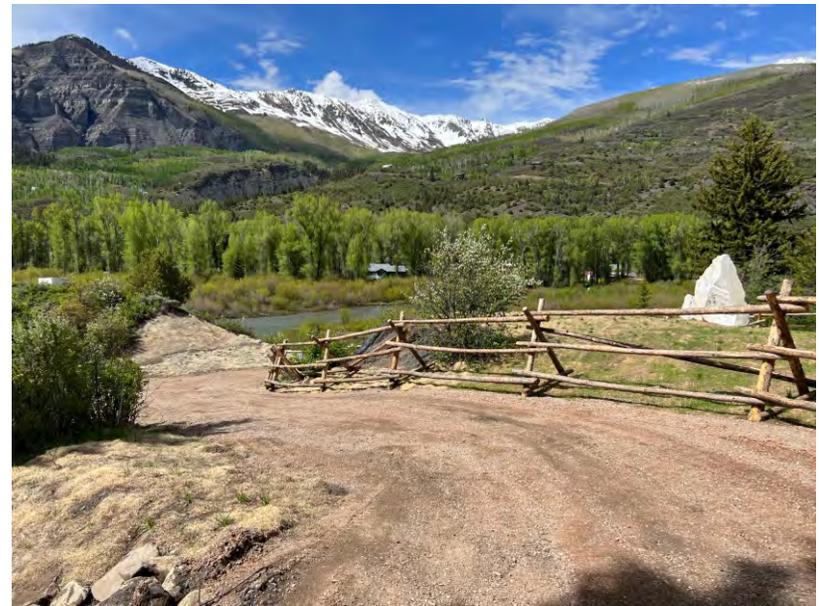
**Photopoint 6.** Looking north-by-northeast from the access road toward the north end of the slag pile restoration area and stabilized slope (6/4/23).

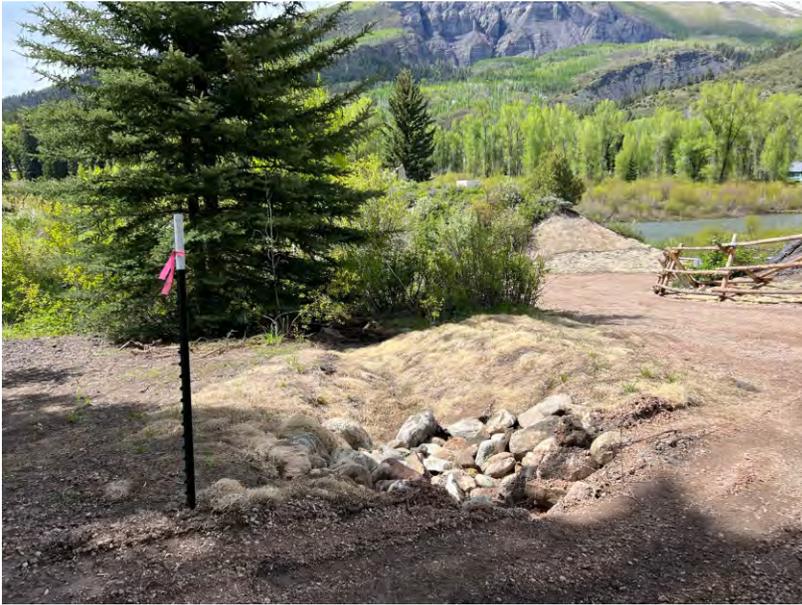
**Photopoint 6.** Looking north-by-northwest at a restored drainage pattern and culvert crossing on the access road upgradient of the slag pile (6/4/23).

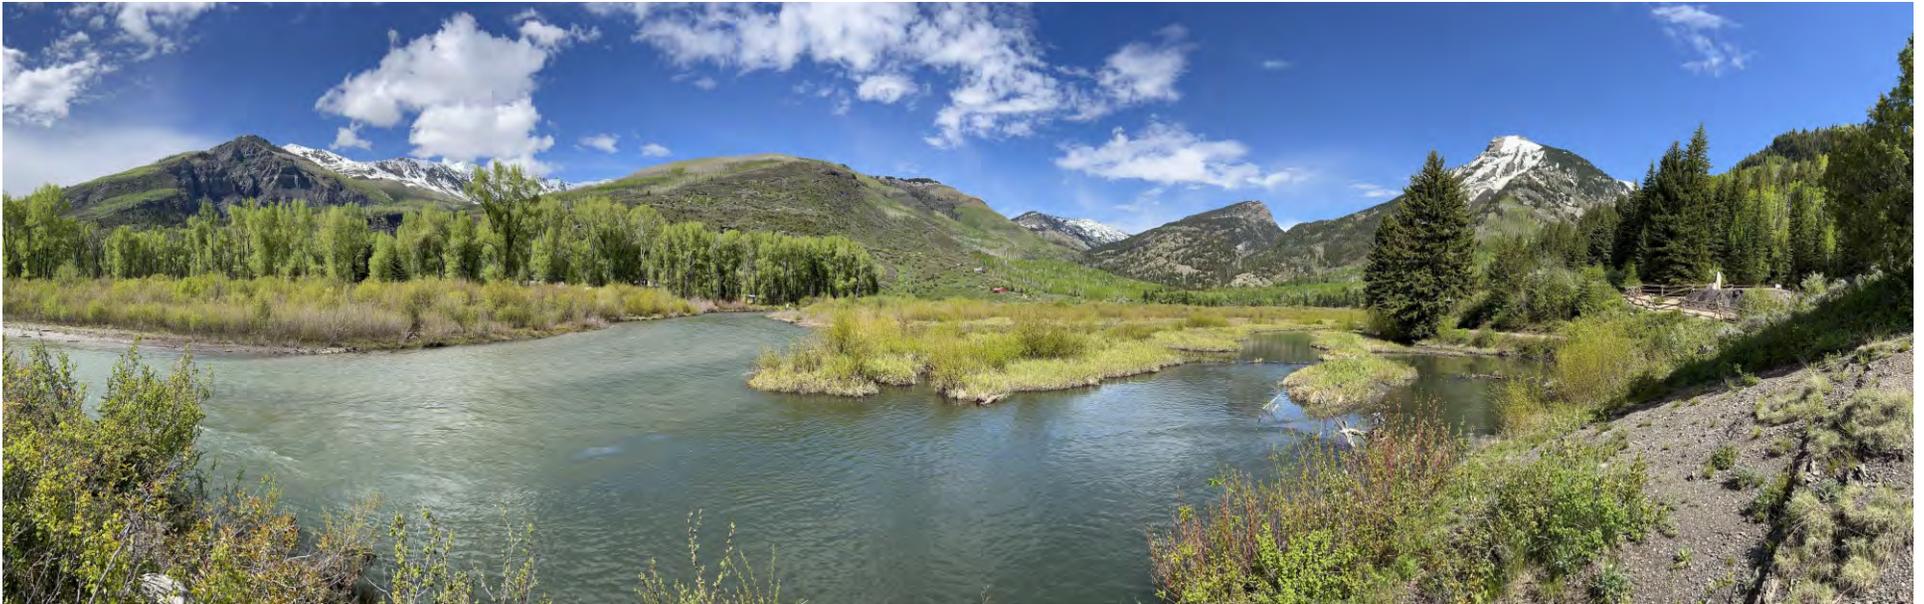
**Photopoint 7.** Looking north-by-northwest across the fenced repository area (6/4/23).

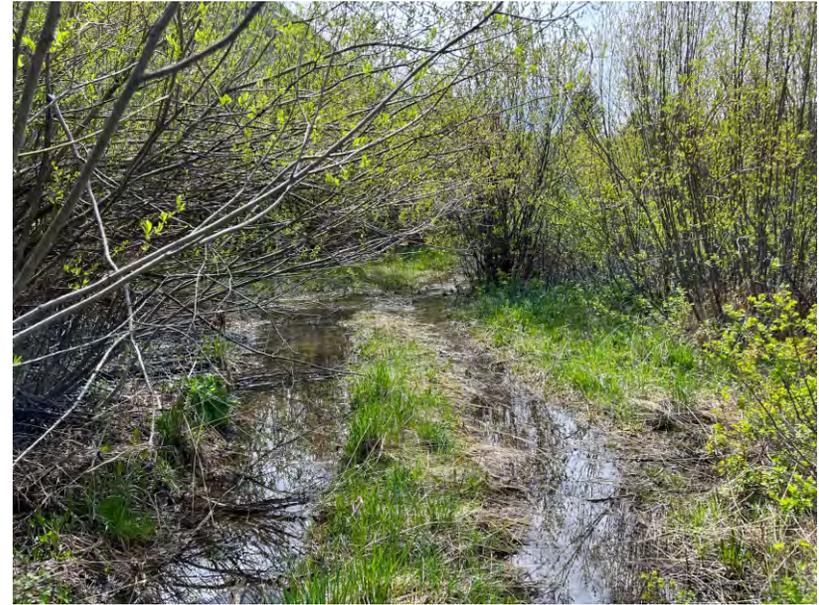
**Photopoint 10.** Looking west at a two-track trail in the northwest part of the Property, which was inundated from here westward (6/4/23).

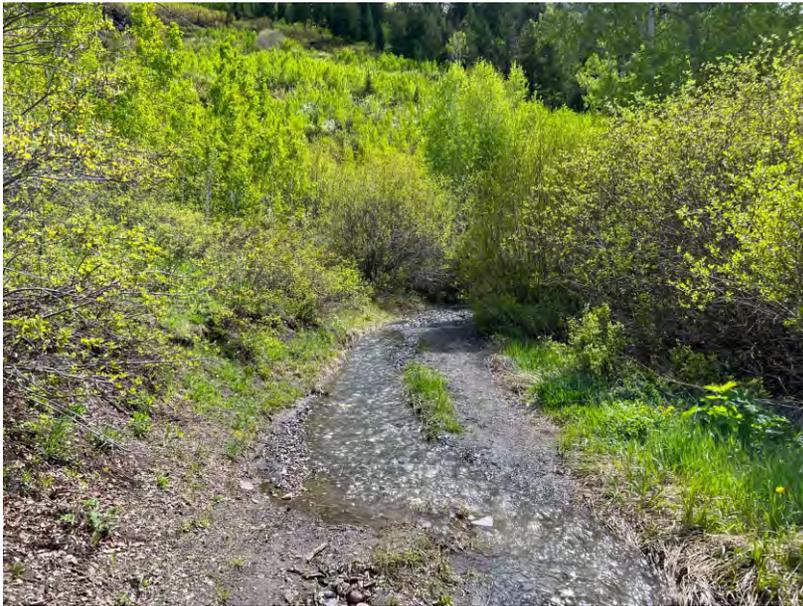
**Photopoint 11.** Looking southwest along the same two-track trail, which was inundated southwesterly from this point (6/4/23).

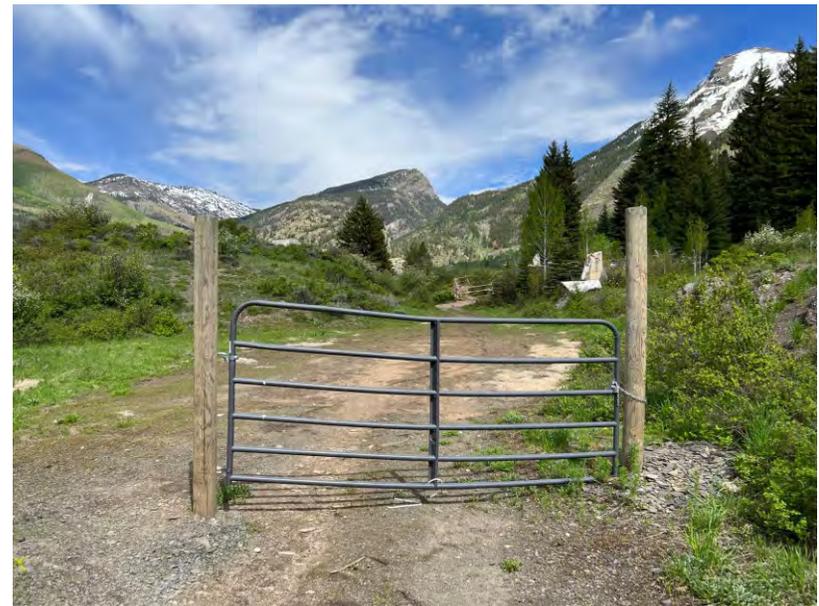
**Photopoint 12.** Looking east at a gate where the improved road leading west from the slag pile/repository area ends (6/4/23).

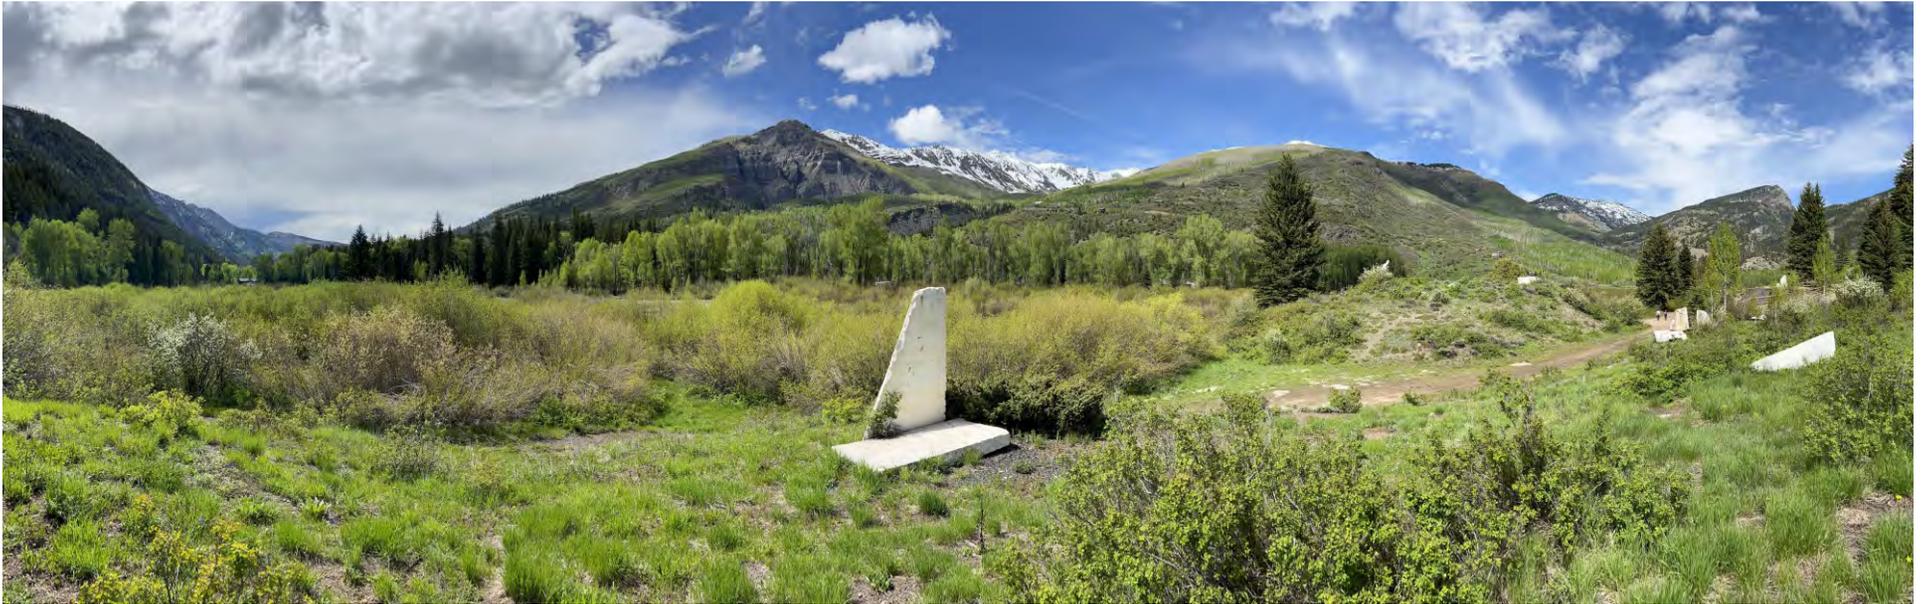
**Photopoint 13.** Continuing panorama, looking west through east (left to right) in an upland meadow area in the northwest part of the Property. Note the scattered slabs of marble, which are present in a few locations in the northwest and east parts of the Property (6/4/23).

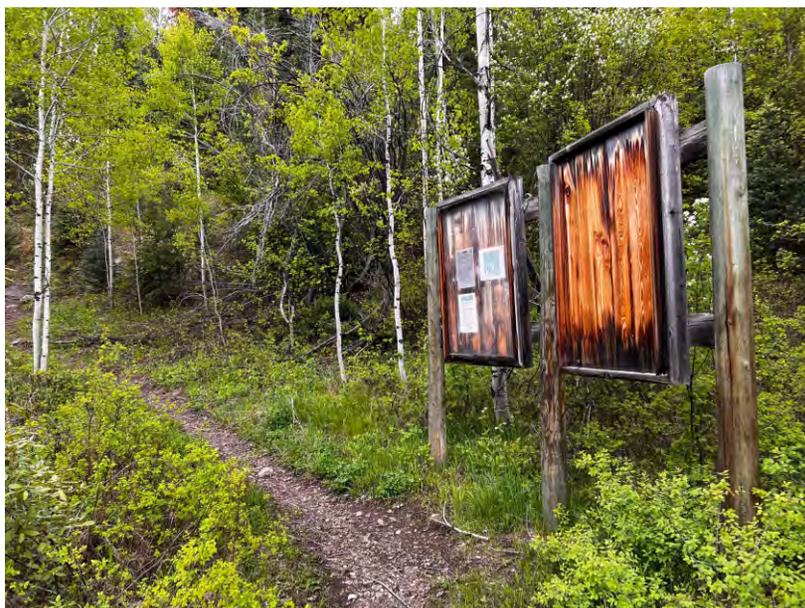
**Photopoint 18.** Looking south at the Raspberry Creek Loop Trail and signage on the southwest part of the Property (6/4/23).

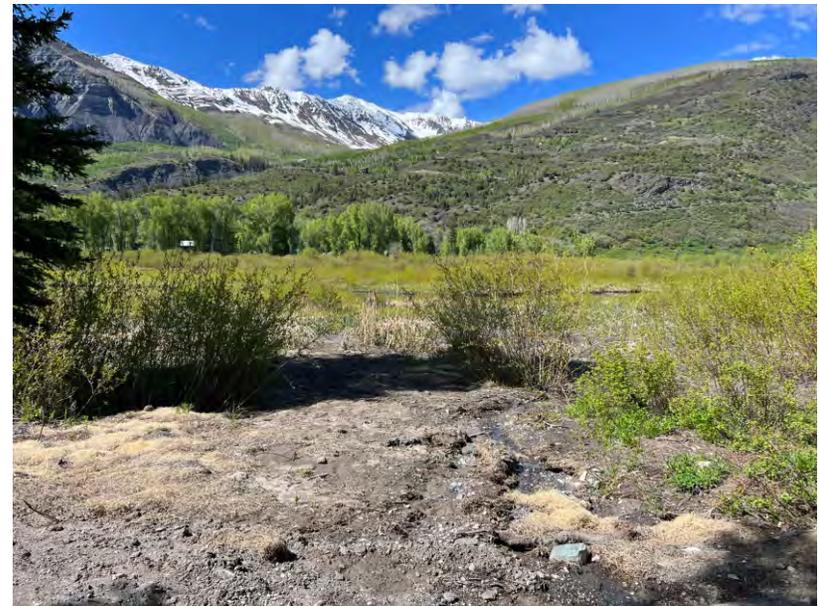
**Photopoint 24.** Looking south-by-southwest at erosion control measures on a seasonal drainage intersecting the main access road (6/4/23).

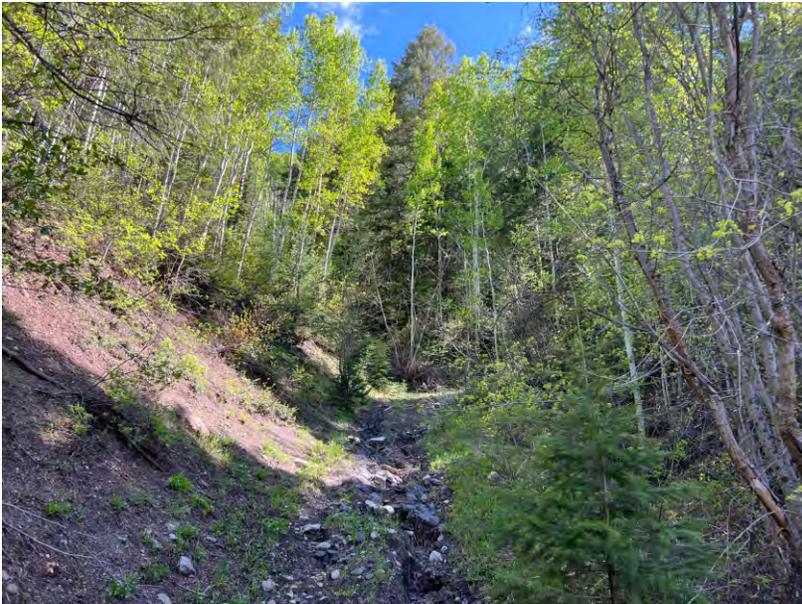
**Photopoint 32.** Looking south along the improved road (note erosion damage) leading from the main access road to the south boundary (6/4/23).

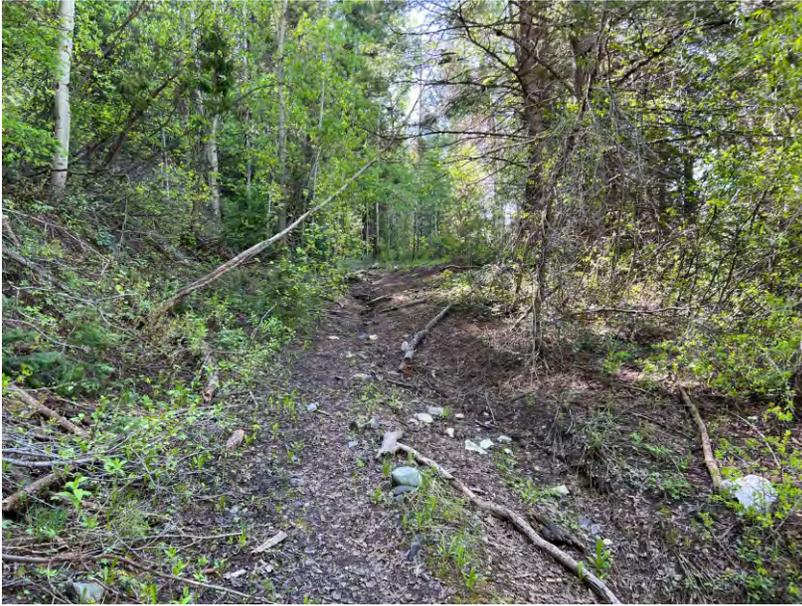
**Photopoint 33.** Looking west-by-northwest along the improved road (note erosion damage) off the main access road to the south boundary (6/4/23).

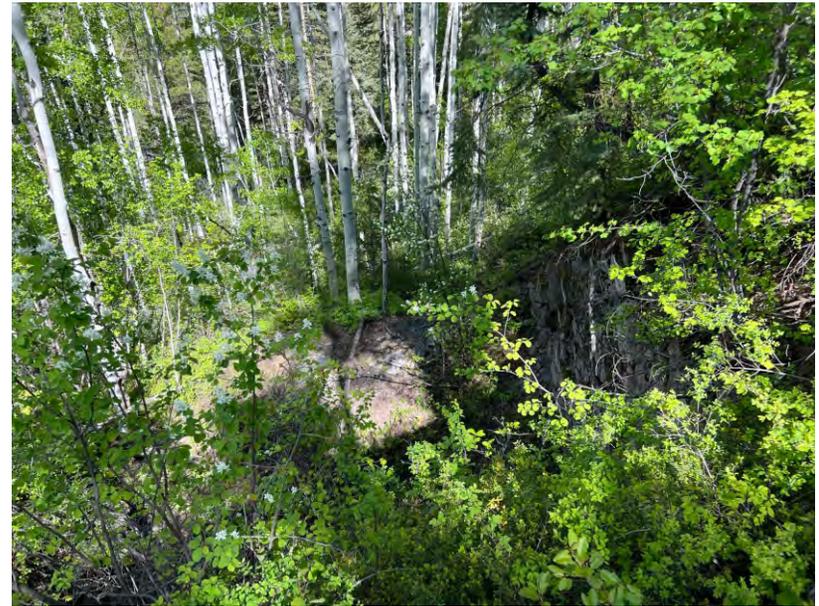
**Photopoint 36.** Looking south at what appears to be an old “discovery cut” on or near the southeast part of the Property (6/4/23).

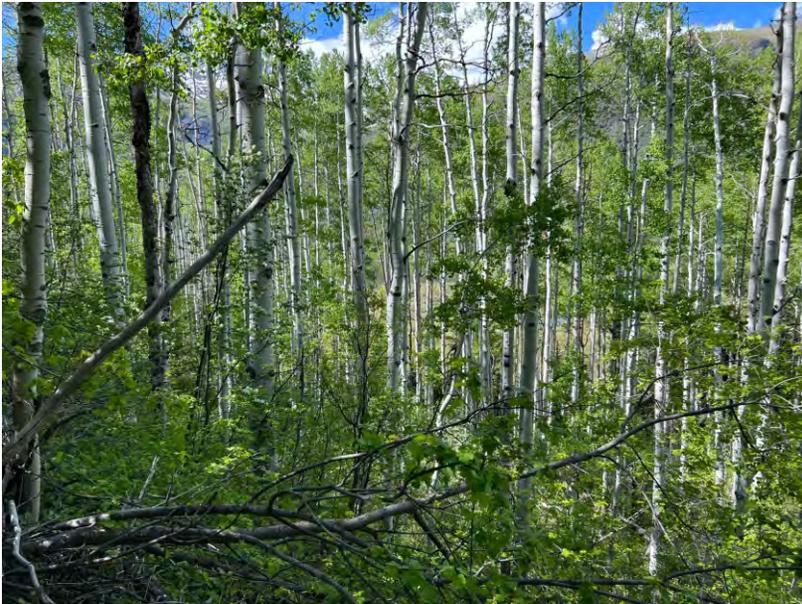
**Photopoint 37.** Looking east-by-southeast at a second apparent discovery cut in the southeast part of the Property (6/4/23).

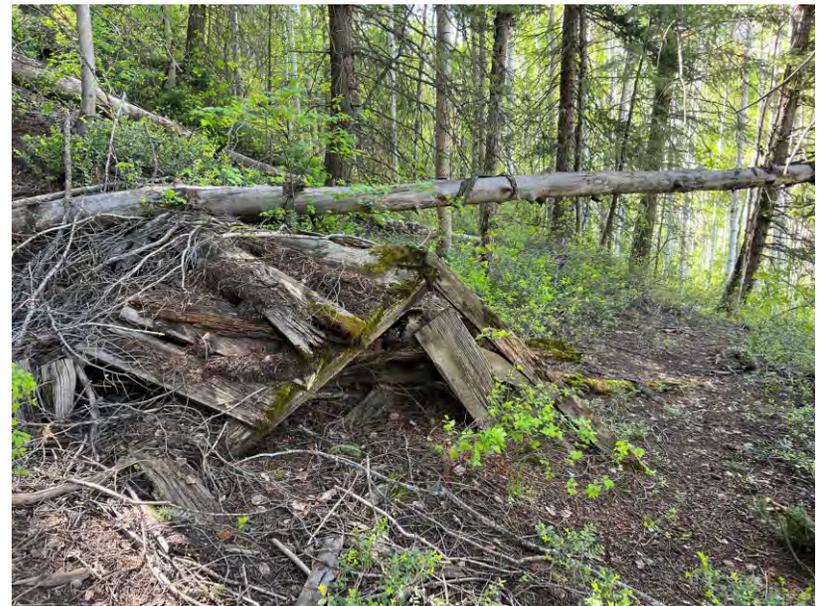
**Photopoint 39.** Looking northwest at old lumber debris in the southeast part of the Property (6/4/23).

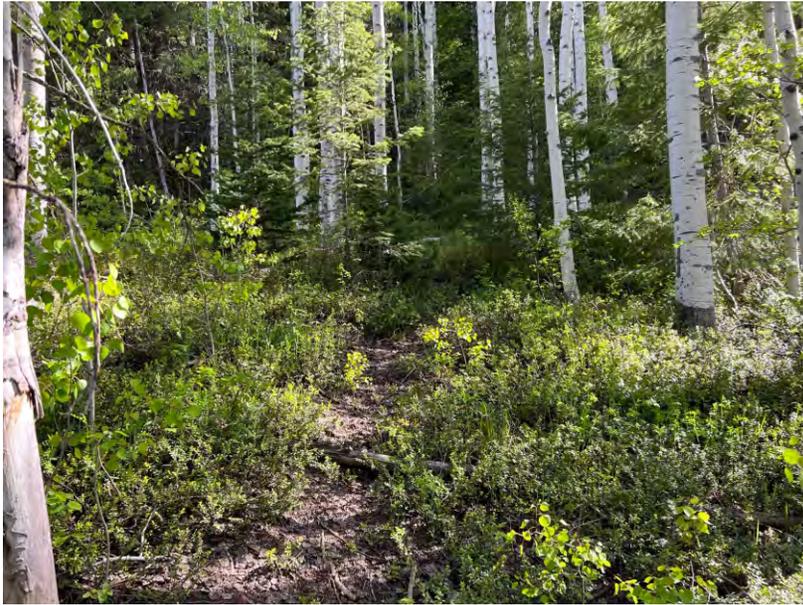
**Photopoint 40.** Looking west at a third discovery cut observed in the southeast part of the Property (6/4/23).

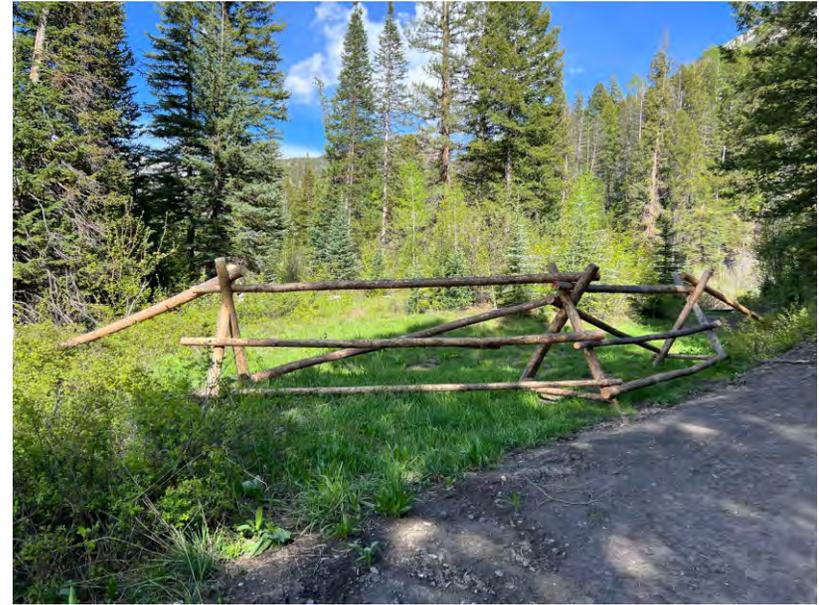
**Photopoint 44.** Looking west at a buck rail fence blocking access to old two-track trails leading east from the main access road (6/4/23).

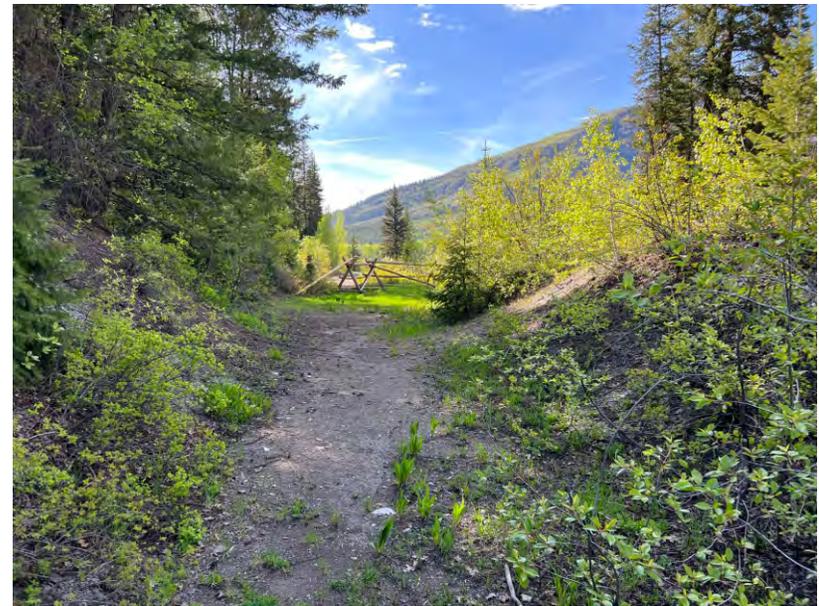
Property includes an entrance sign and a “no camping” sign posted on the main access road (Photopoints 14, 15), signs posted at the slag pile/repository area (Photopoints 3, 4), and signage related to the USFS Raspberry Creek Loop Trailhead (Photopoints 17, 18). Some old lumber that was potentially a small dilapidated shack was observed in the southeast part of the Property (Photopoint 39). An old bathtub is near the defunct irrigation headgate (Photopoint 45).

**Photopoint 45.** Looking southeast at an old bathtub and old irrigation headgate on the west bank of Yule Creek near the south boundary (6/4/23).

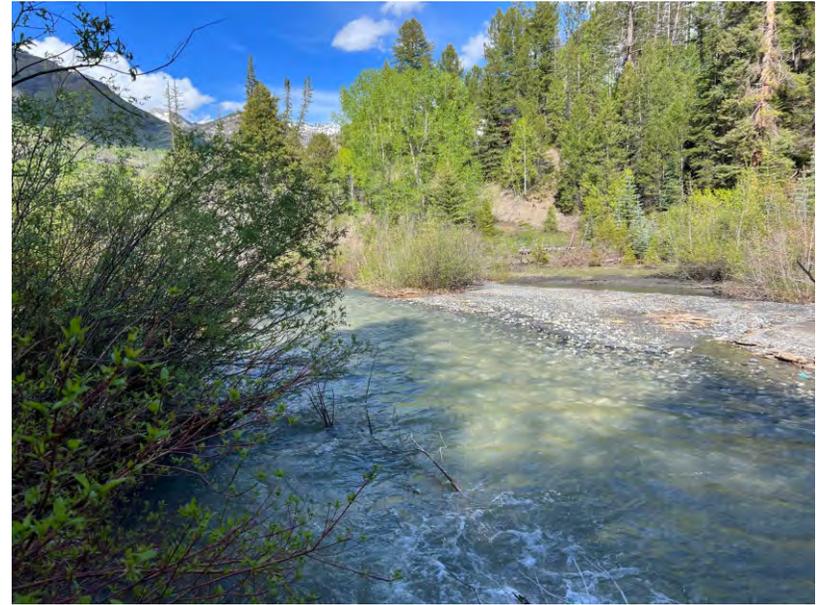
**Photopoint 46.** Looking south-by-southeast at detail of the old irrigation headgate structure on Yule Creek near the east Property boundary (6/4/23).

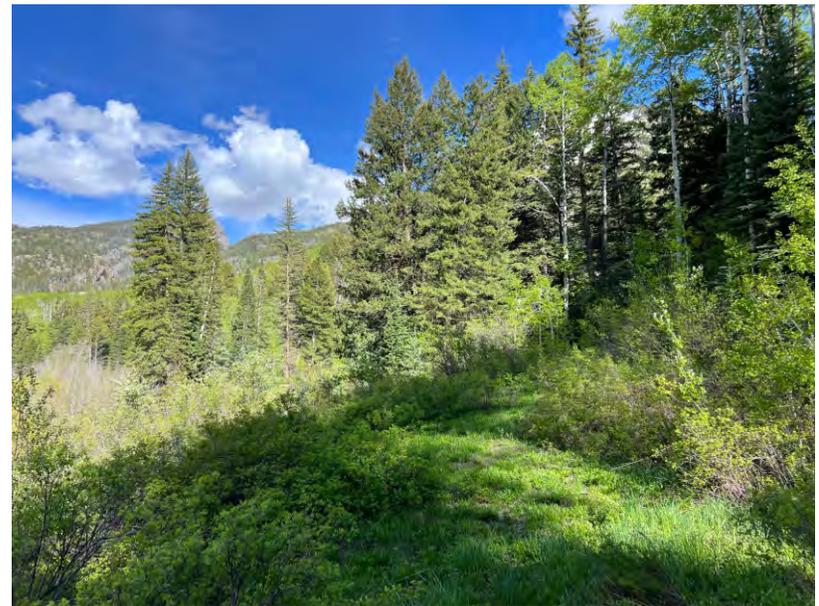
**Photopoint 48.** Looking northwest at the location of the old irrigation ditch and Parshall flume (arrow) in the east part of the Property (6/4/23).
