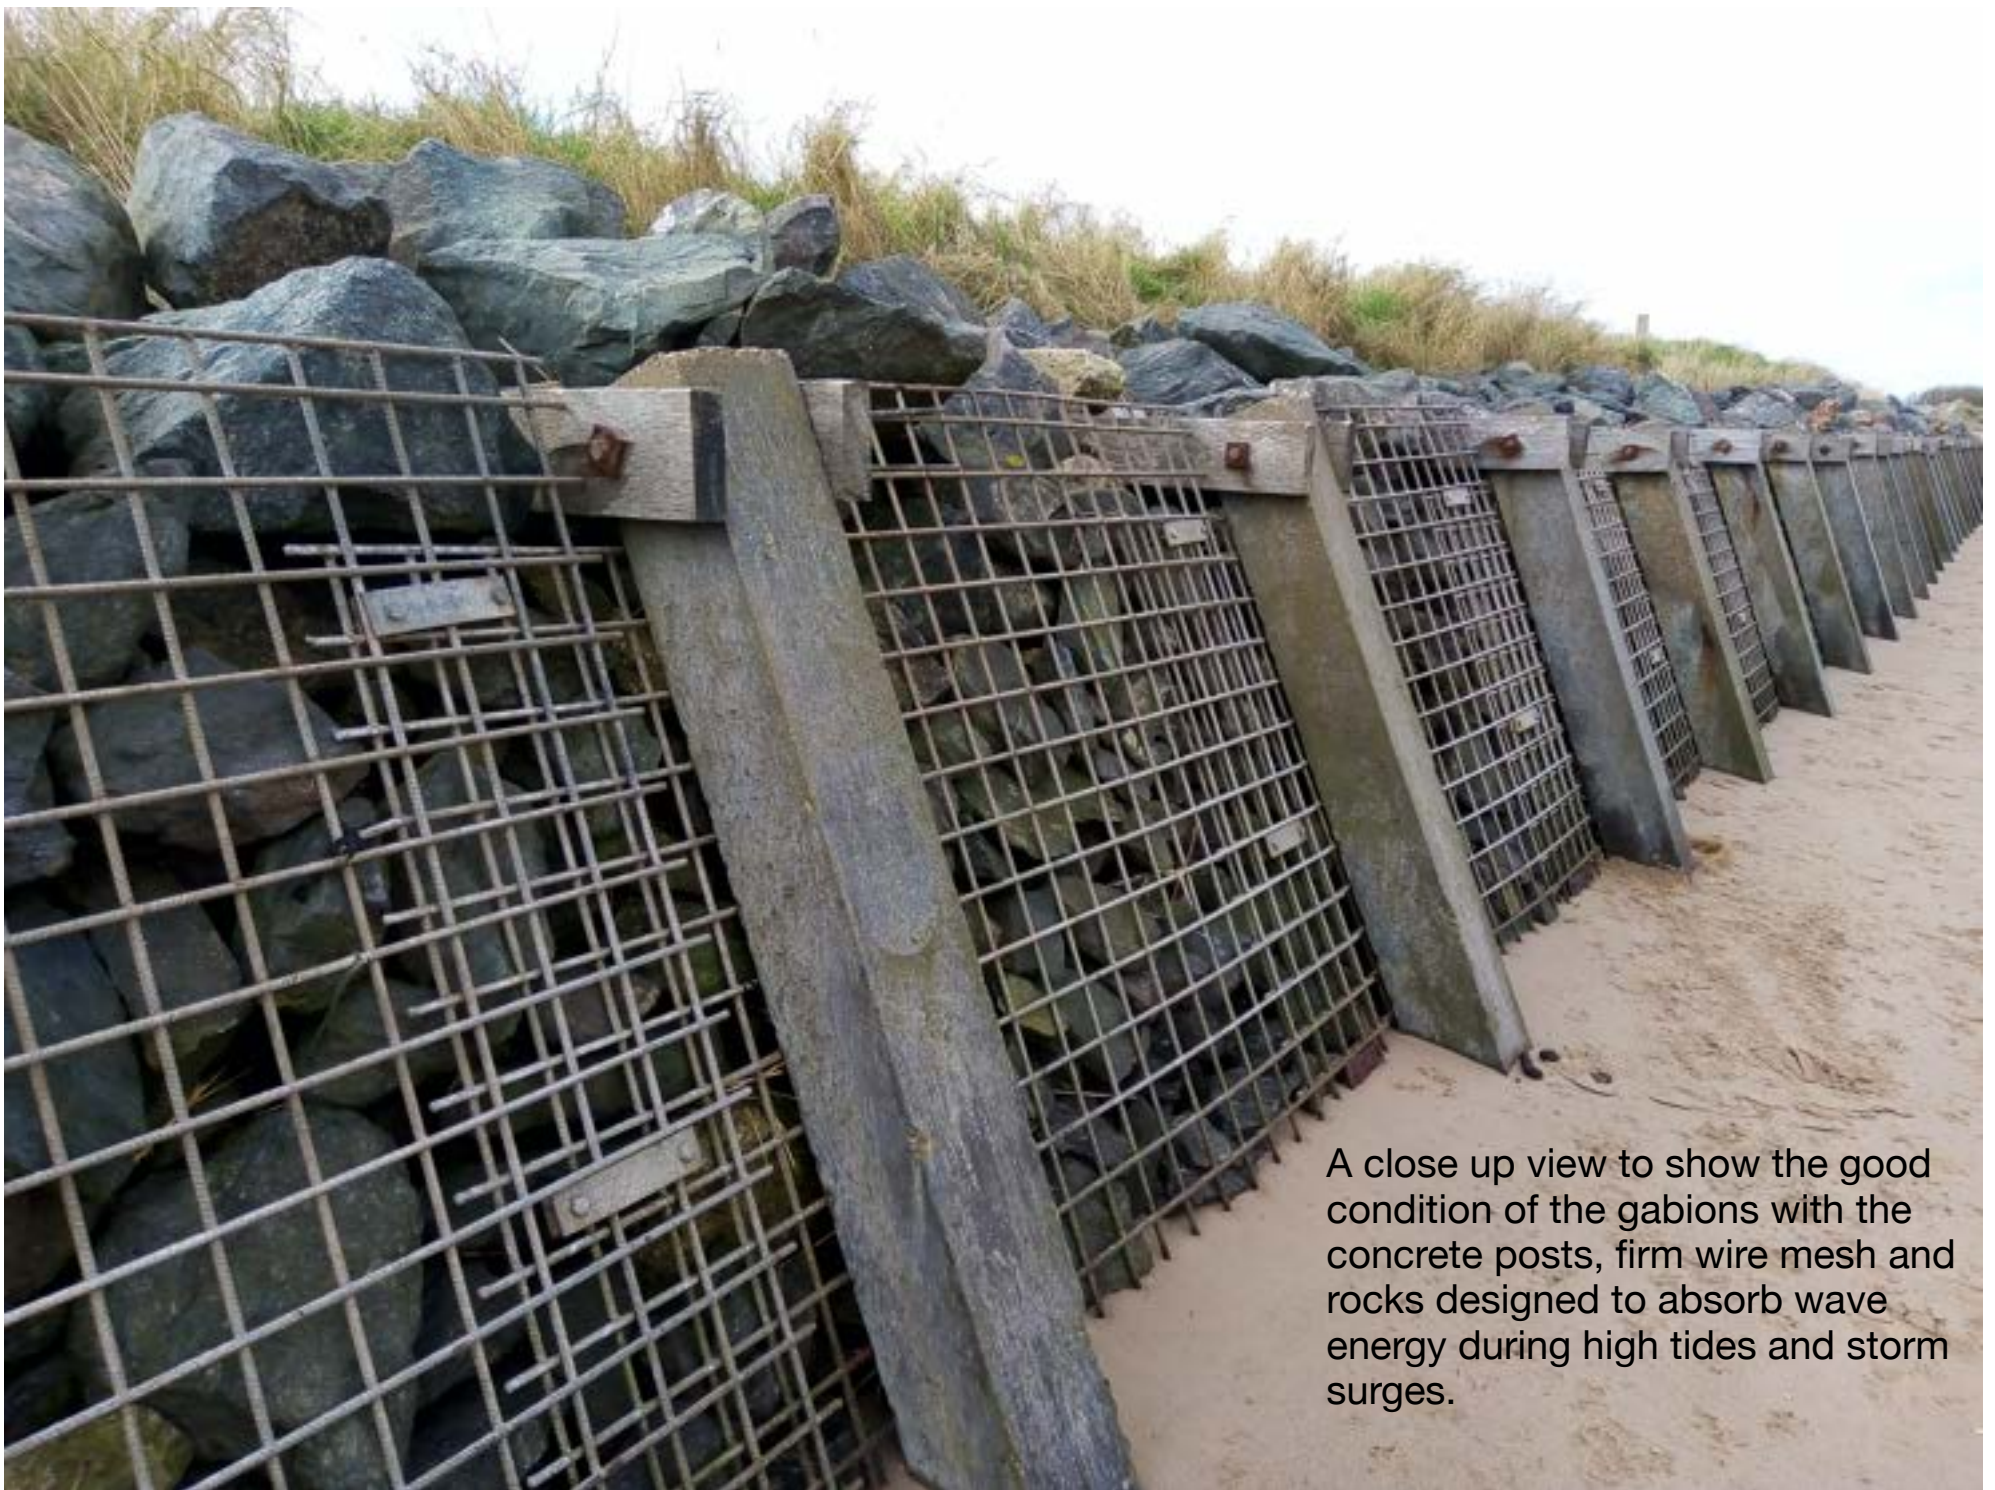
A close up view to show the good condition of the gabions with the concrete posts, firm wire mesh and rocks designed to absorb wave energy during high tides and storm surges.

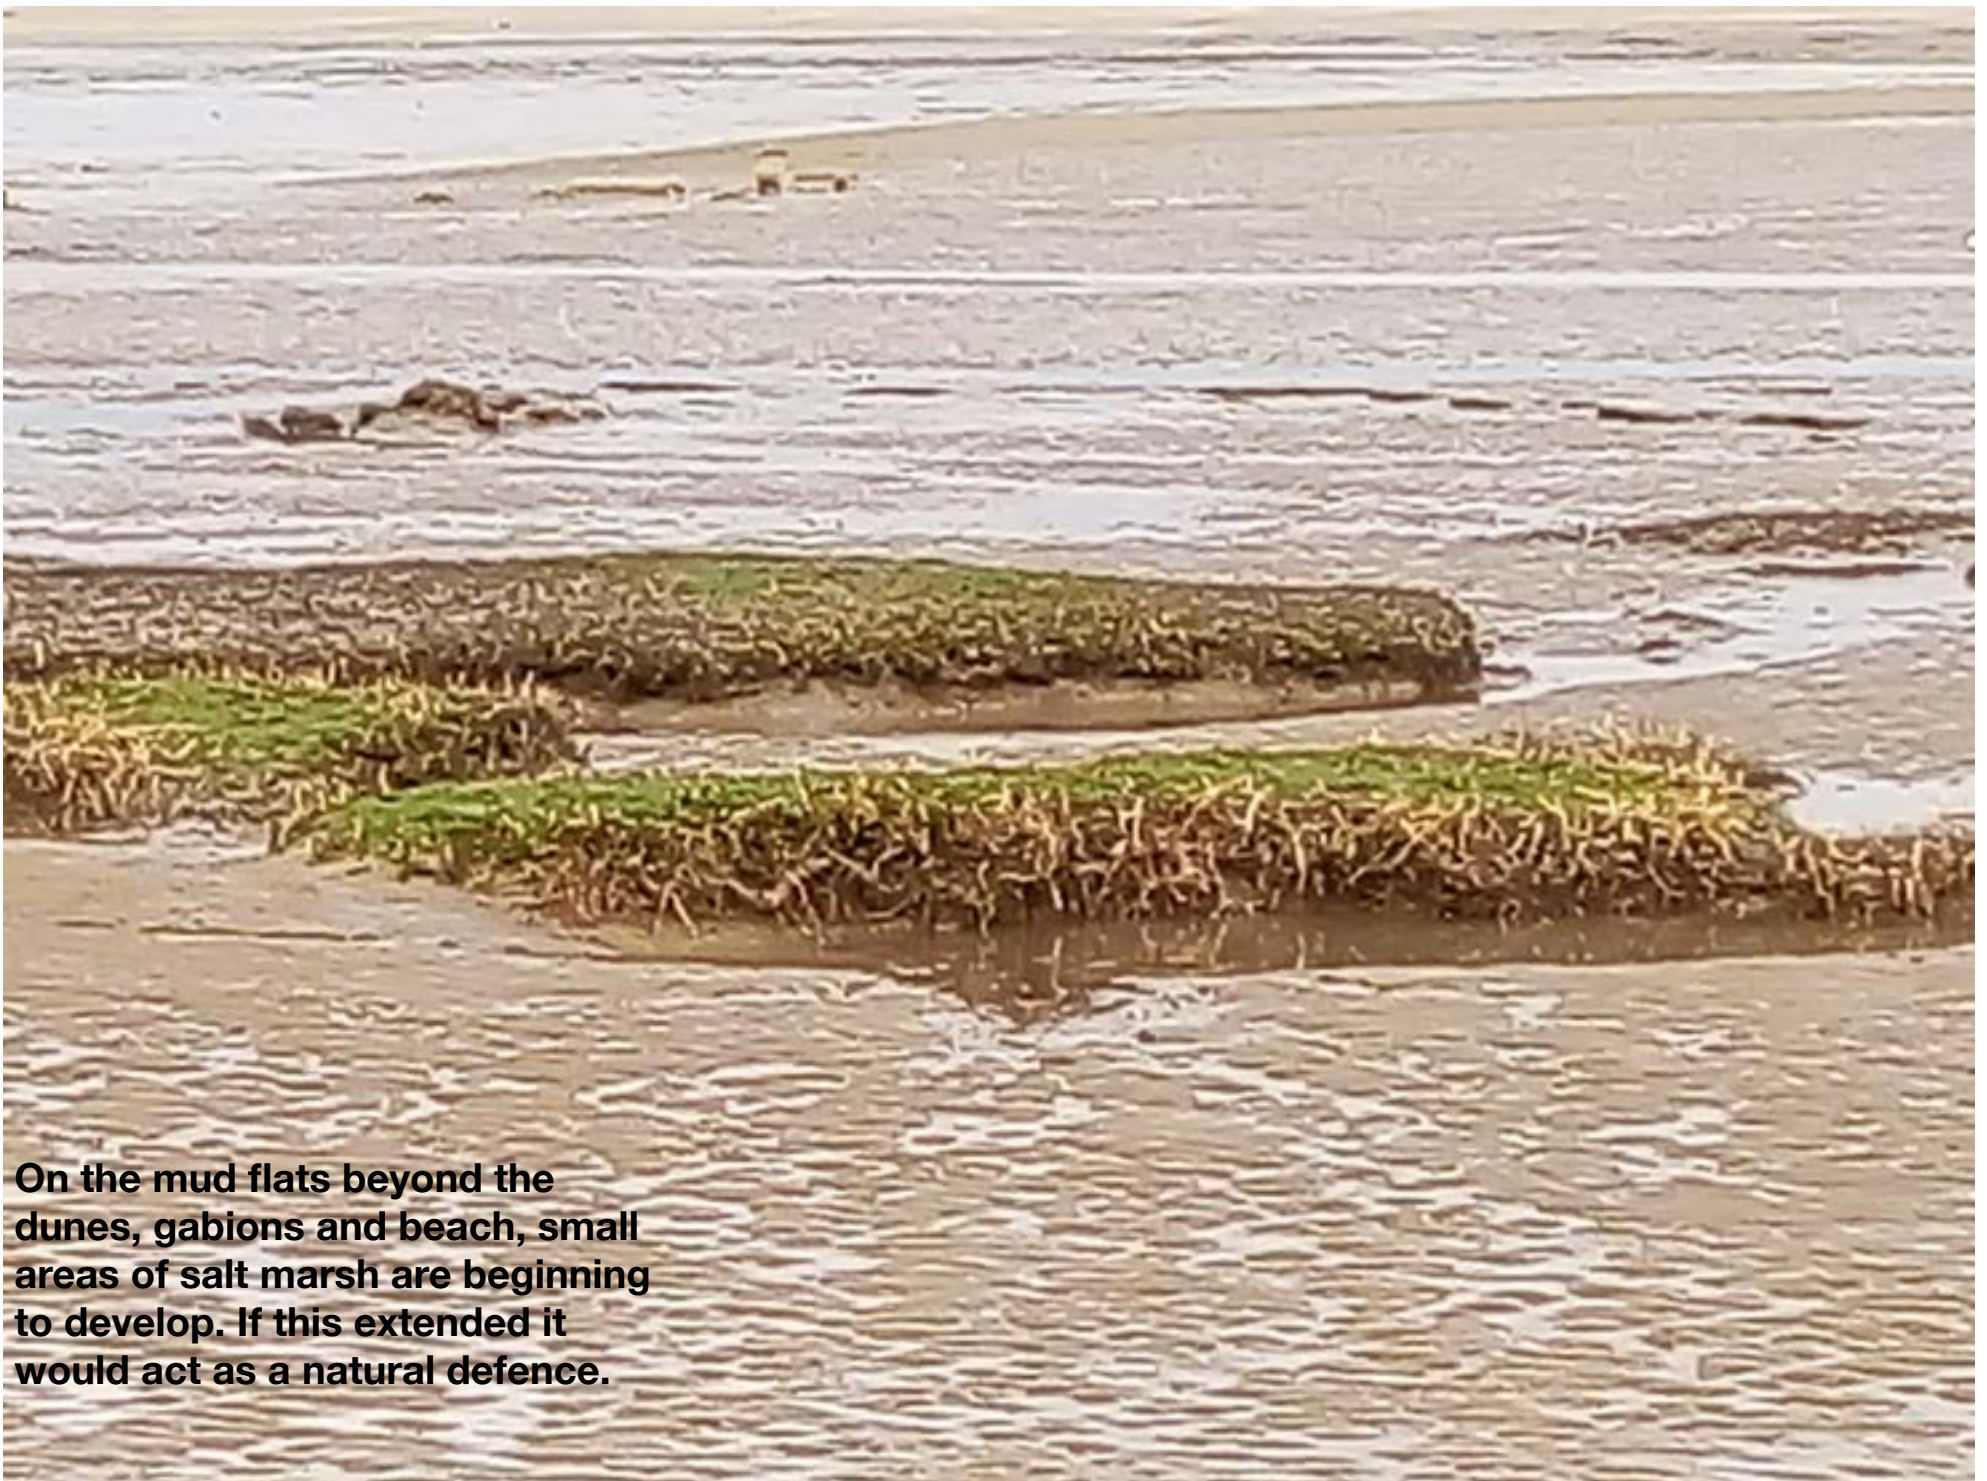
On the mud flats beyond the dunes, gabions and beach, small areas of salt marsh are beginning to develop. If this extended it would act as a natural defence.

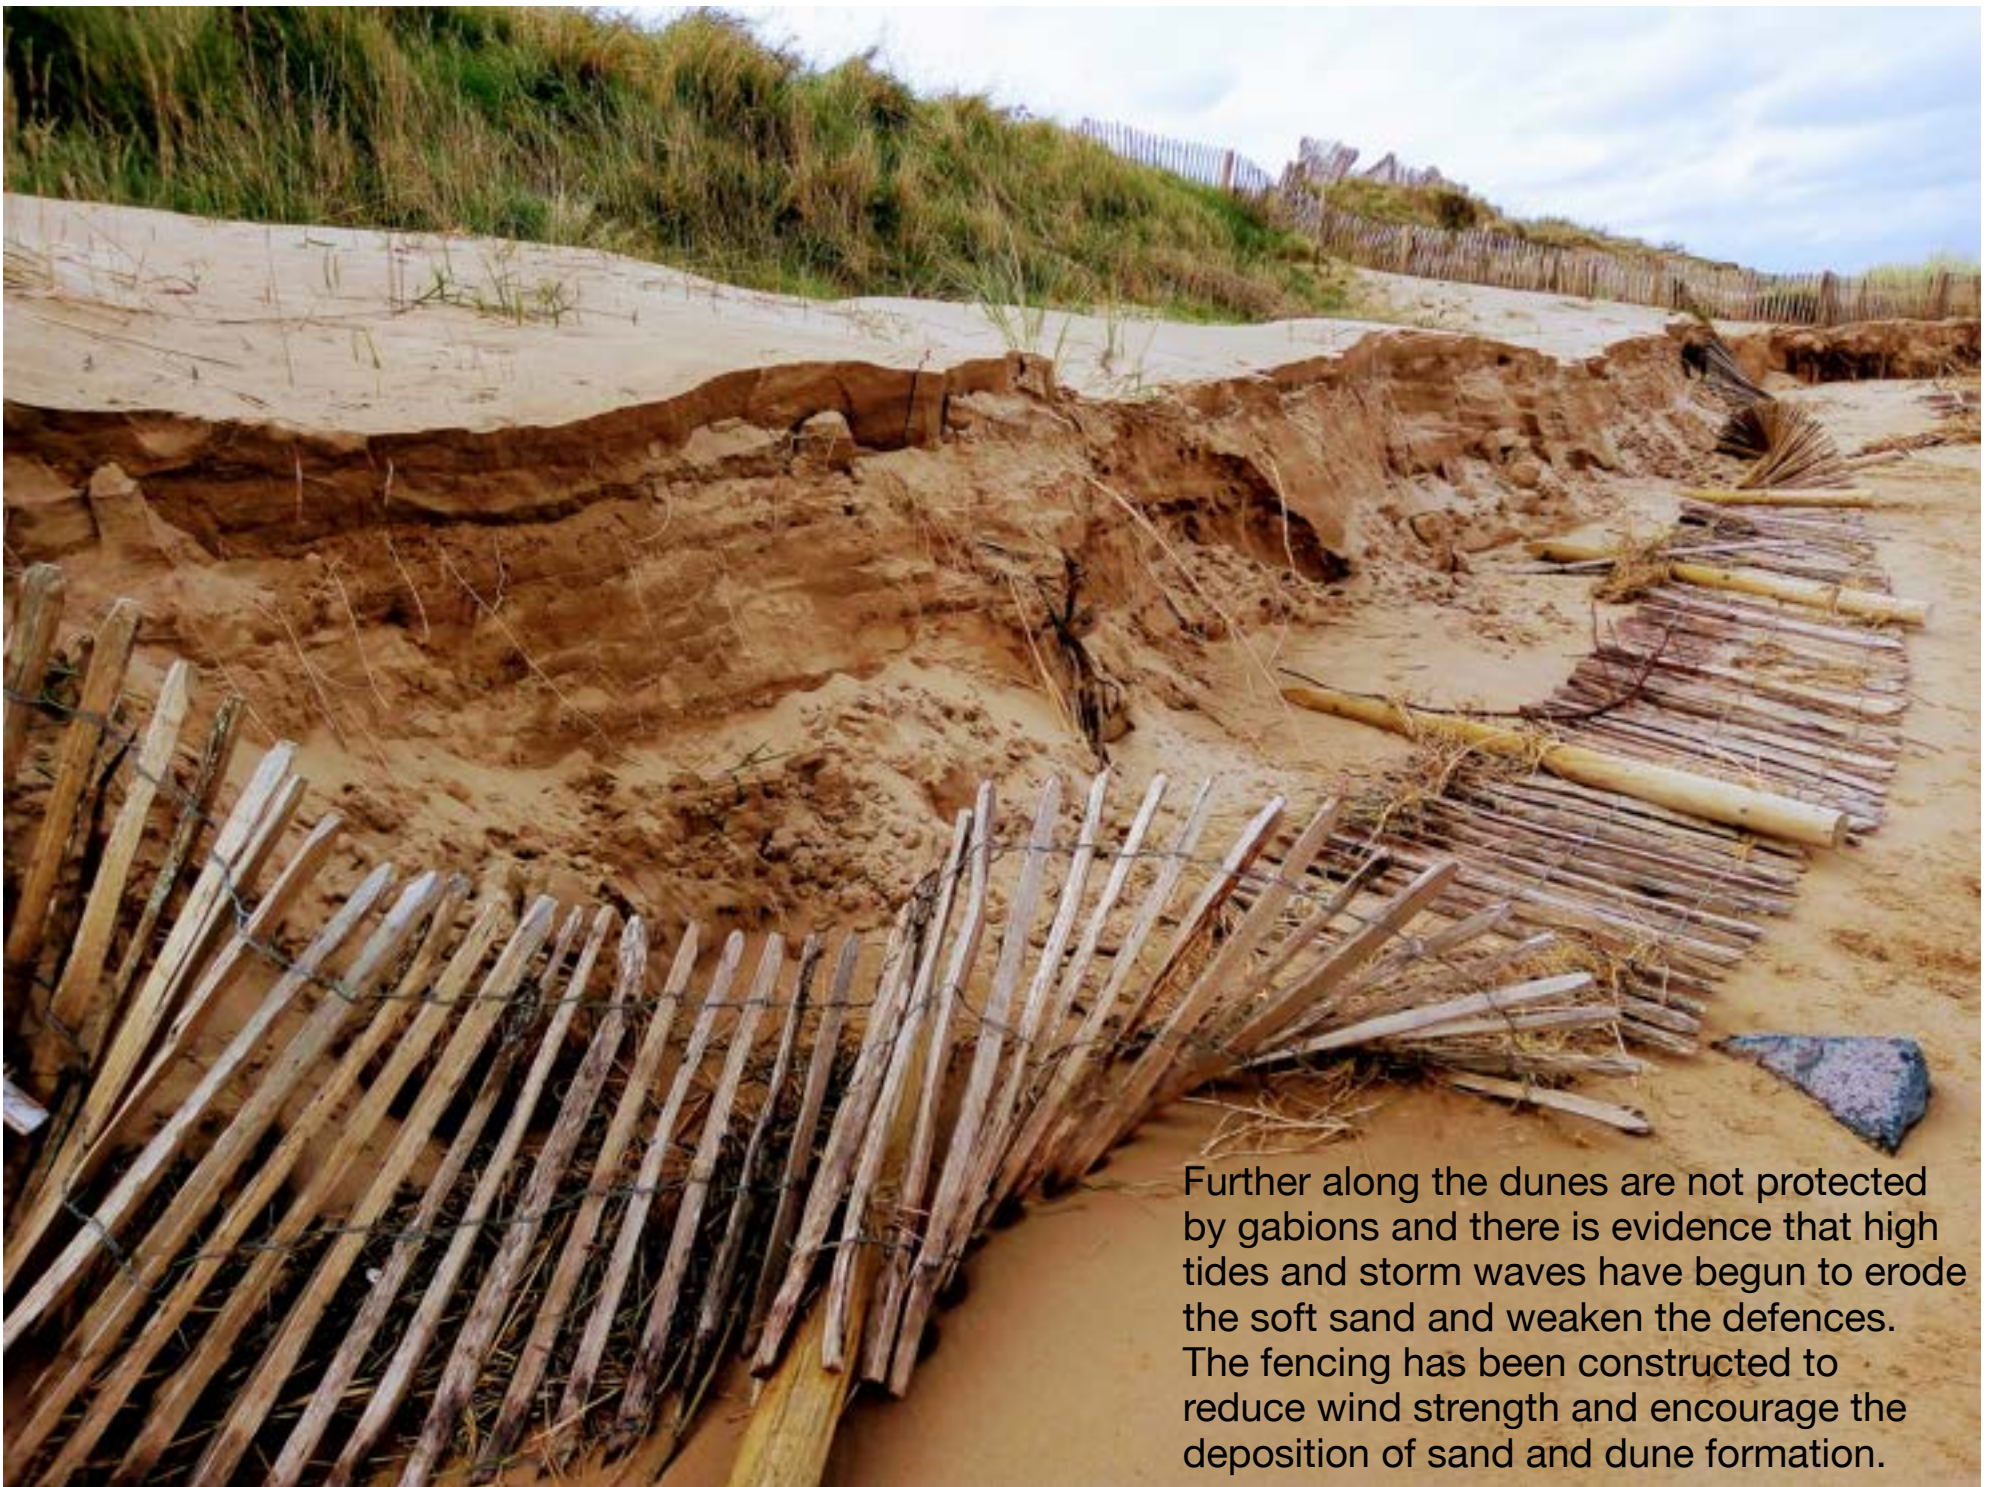
Further along the dunes are not protected by gabions and there is evidence that high tides and storm waves have begun to erode the soft sand and weaken the defences. The fencing has been constructed to reduce wind strength and encourage the deposition of sand and dune formation.

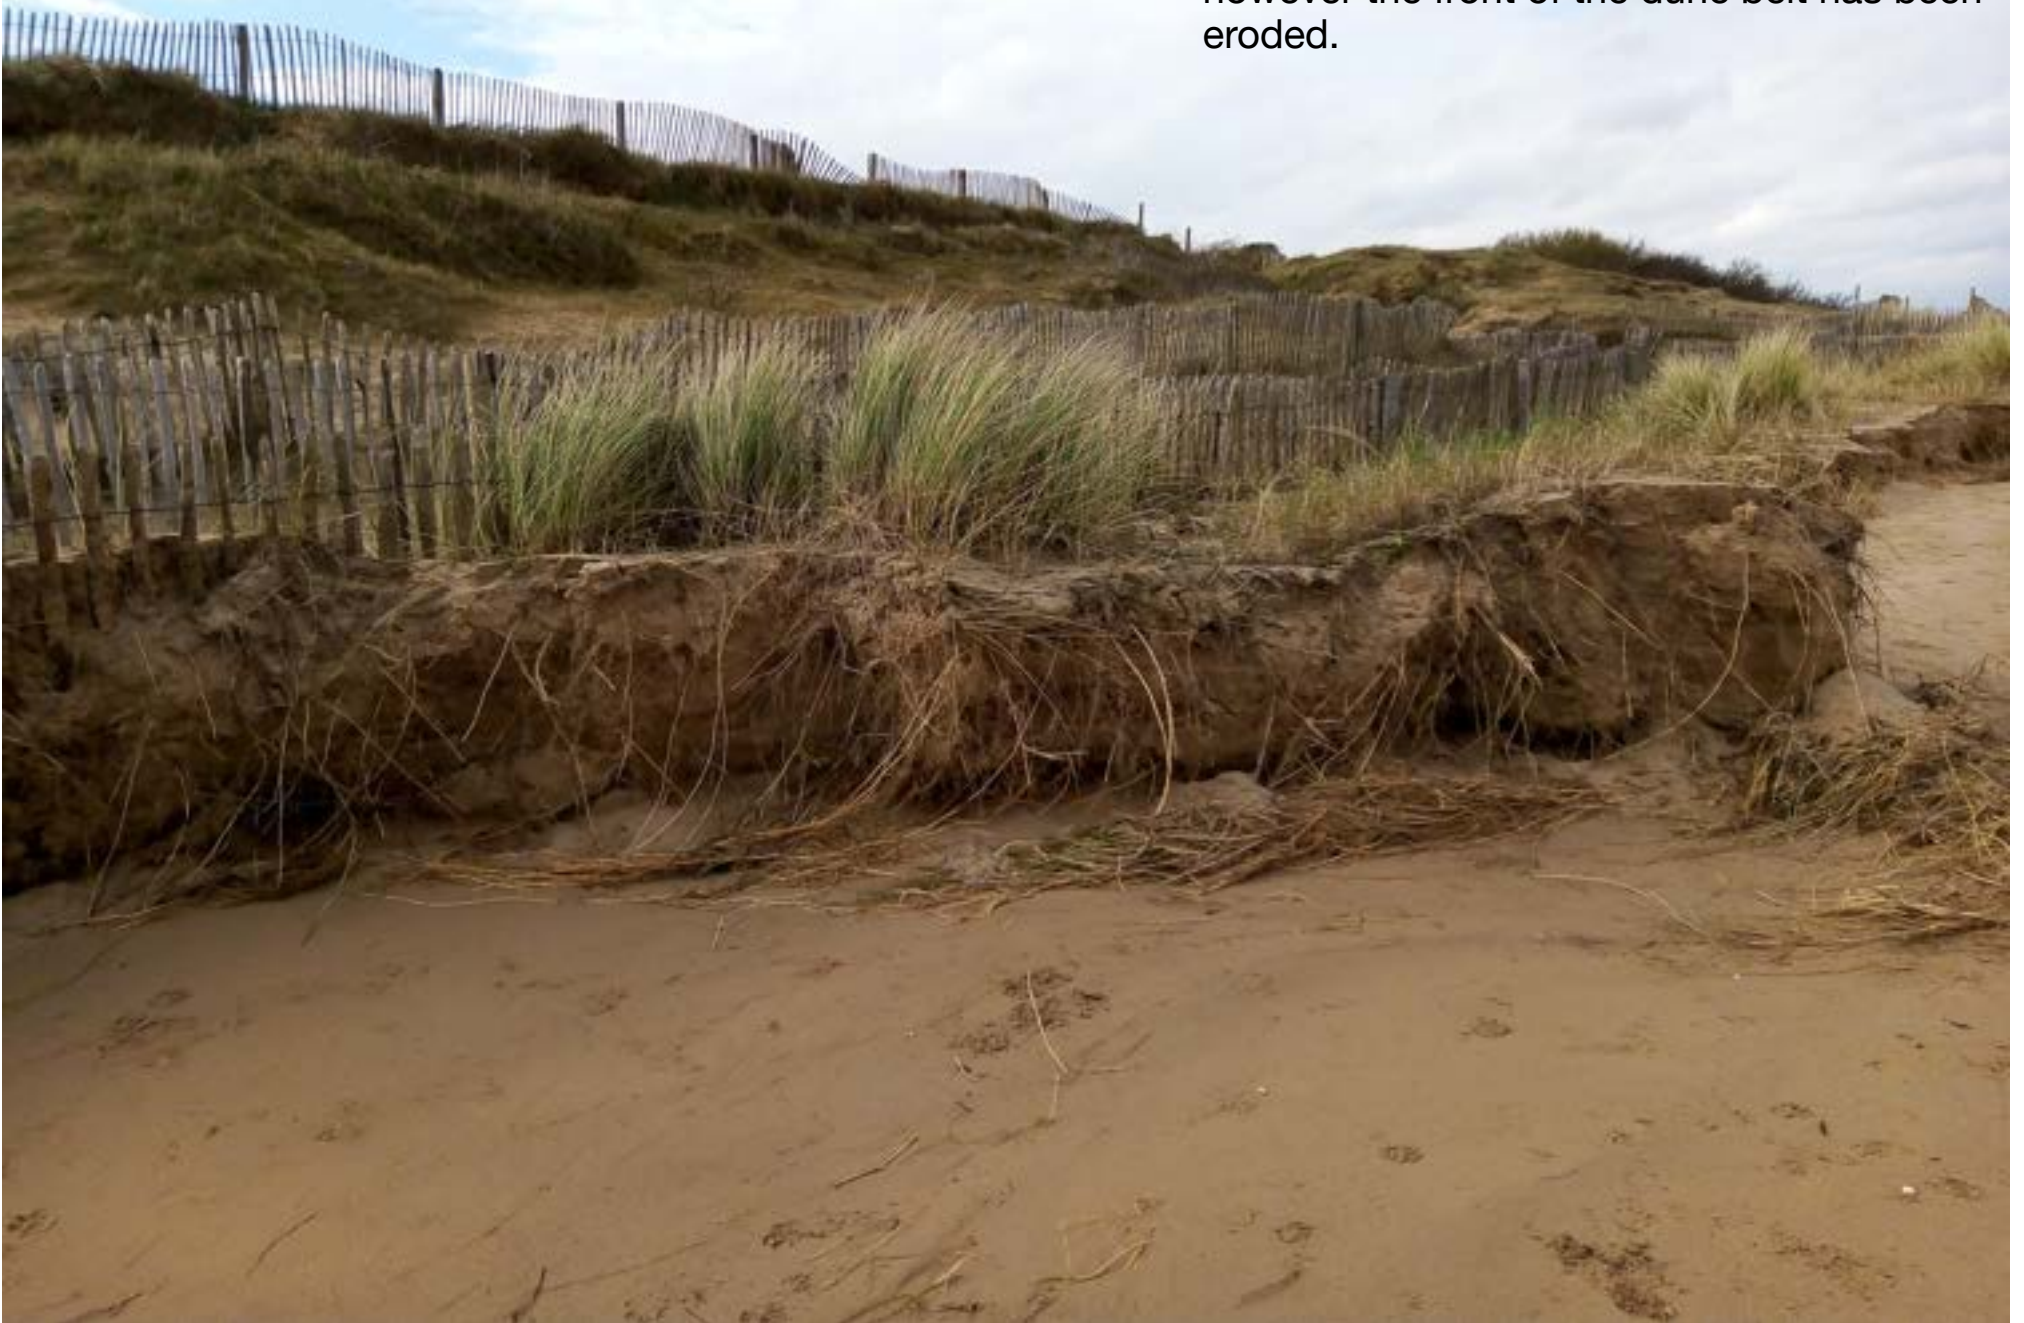
A new stone fish tailed groyne has been constructed at the southern end of the 'Fitties' / Humberston dune belt. The aim was to push a tidal channel further offshore and reduce longshore drift to develop the beach and reduce wave energy.

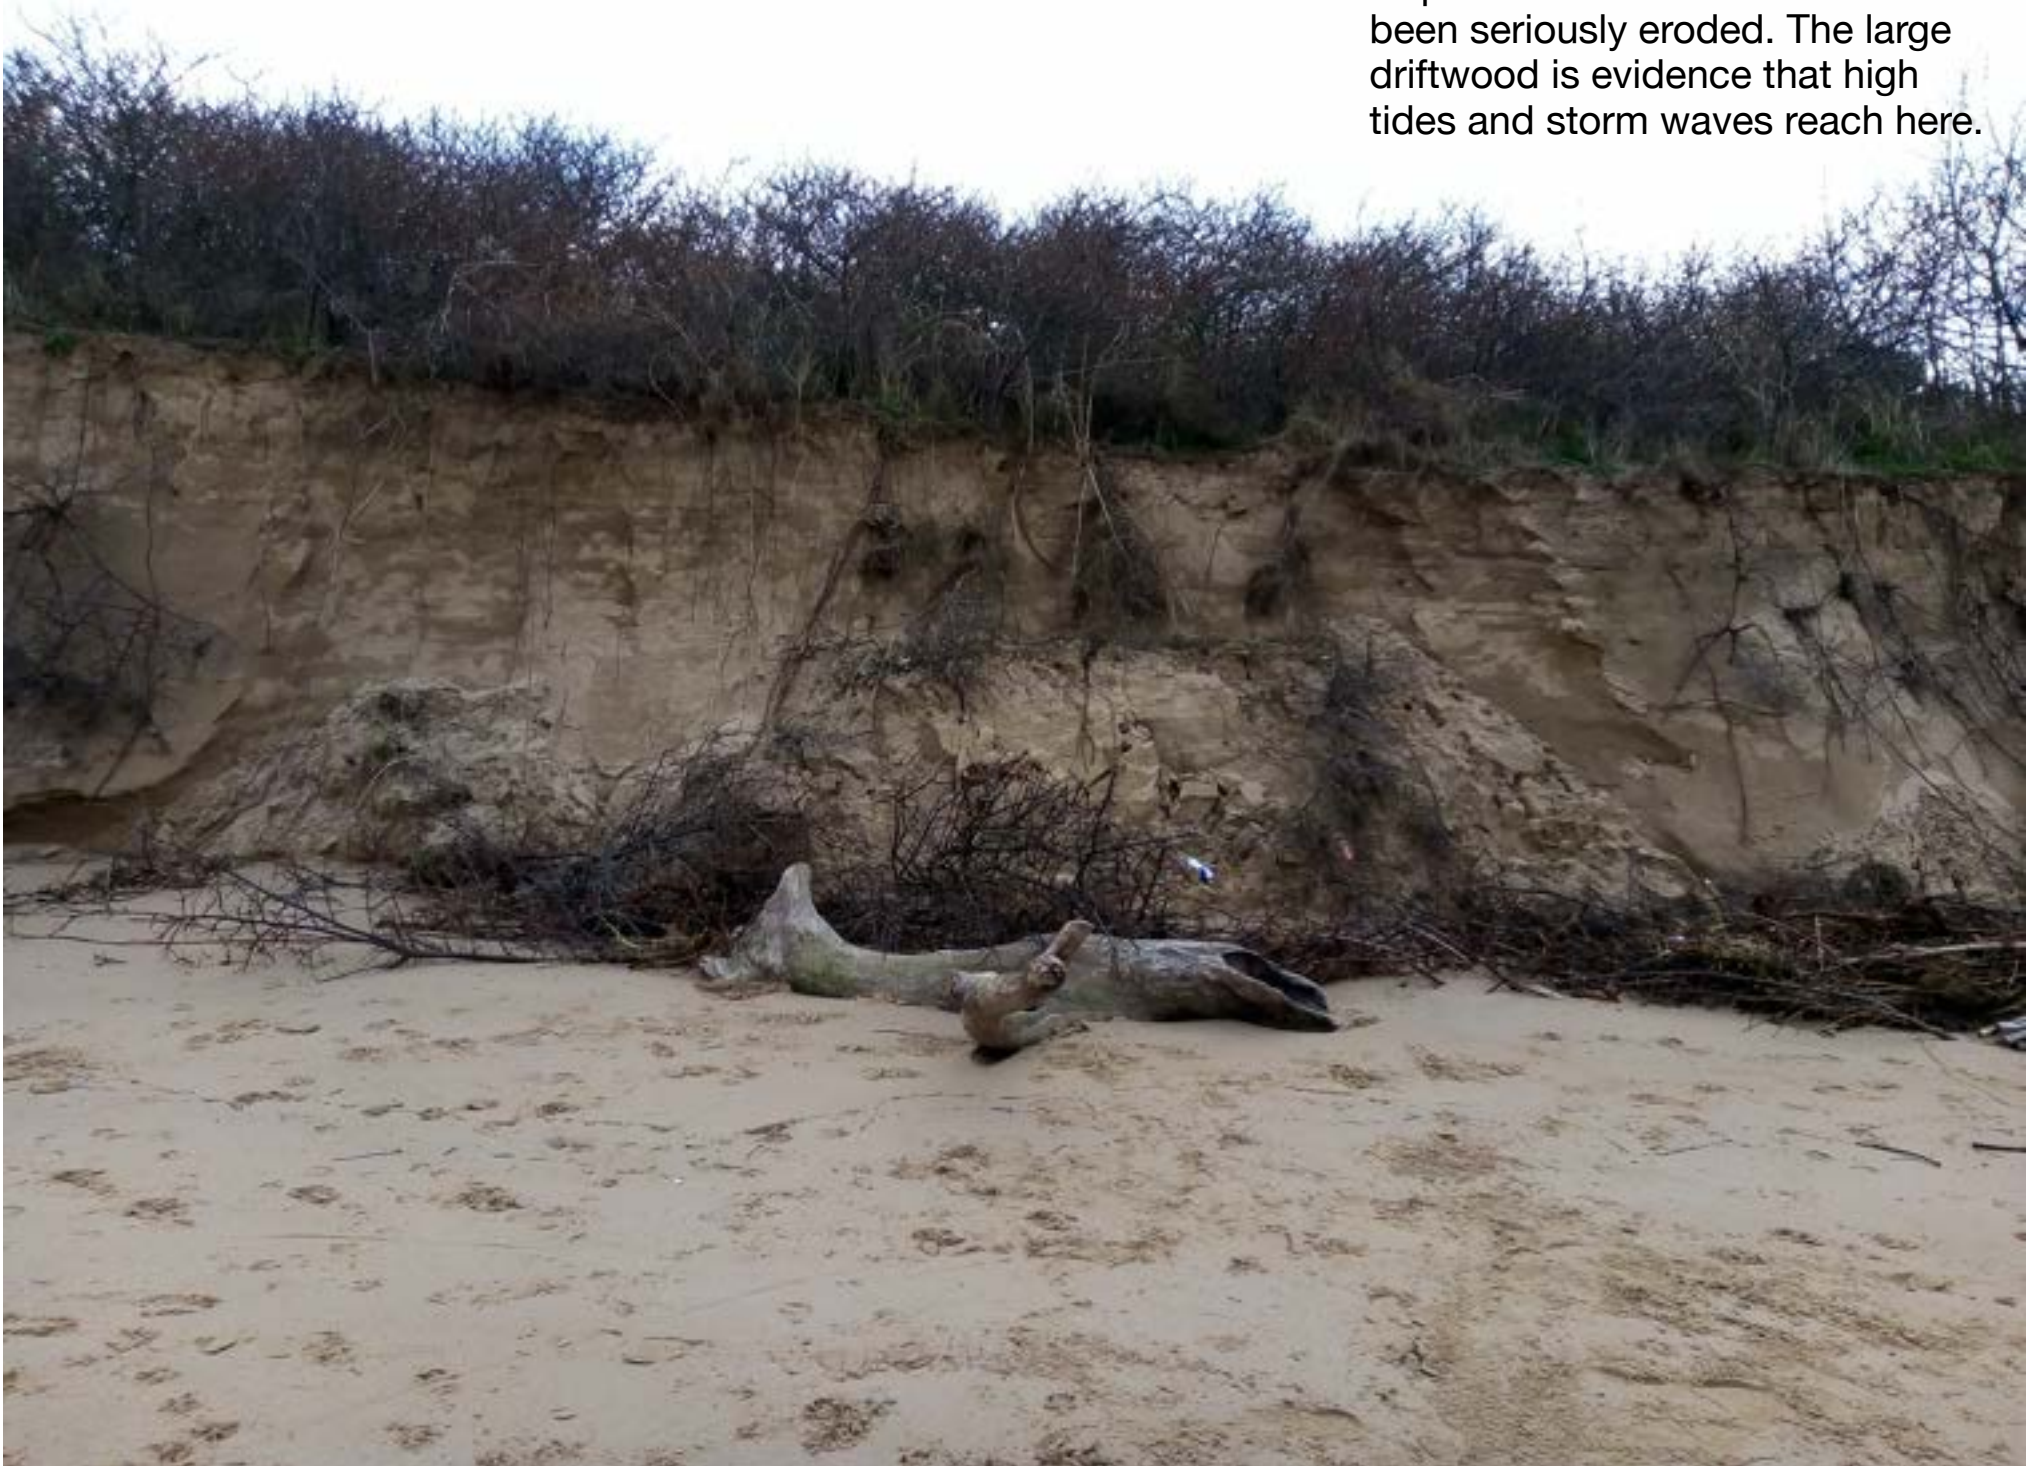
Here the eroded dunes have recently been protected with the construction of gabions. This is obviously a serious situation as these are mature dunes as shown by their height and the vegetation they support.

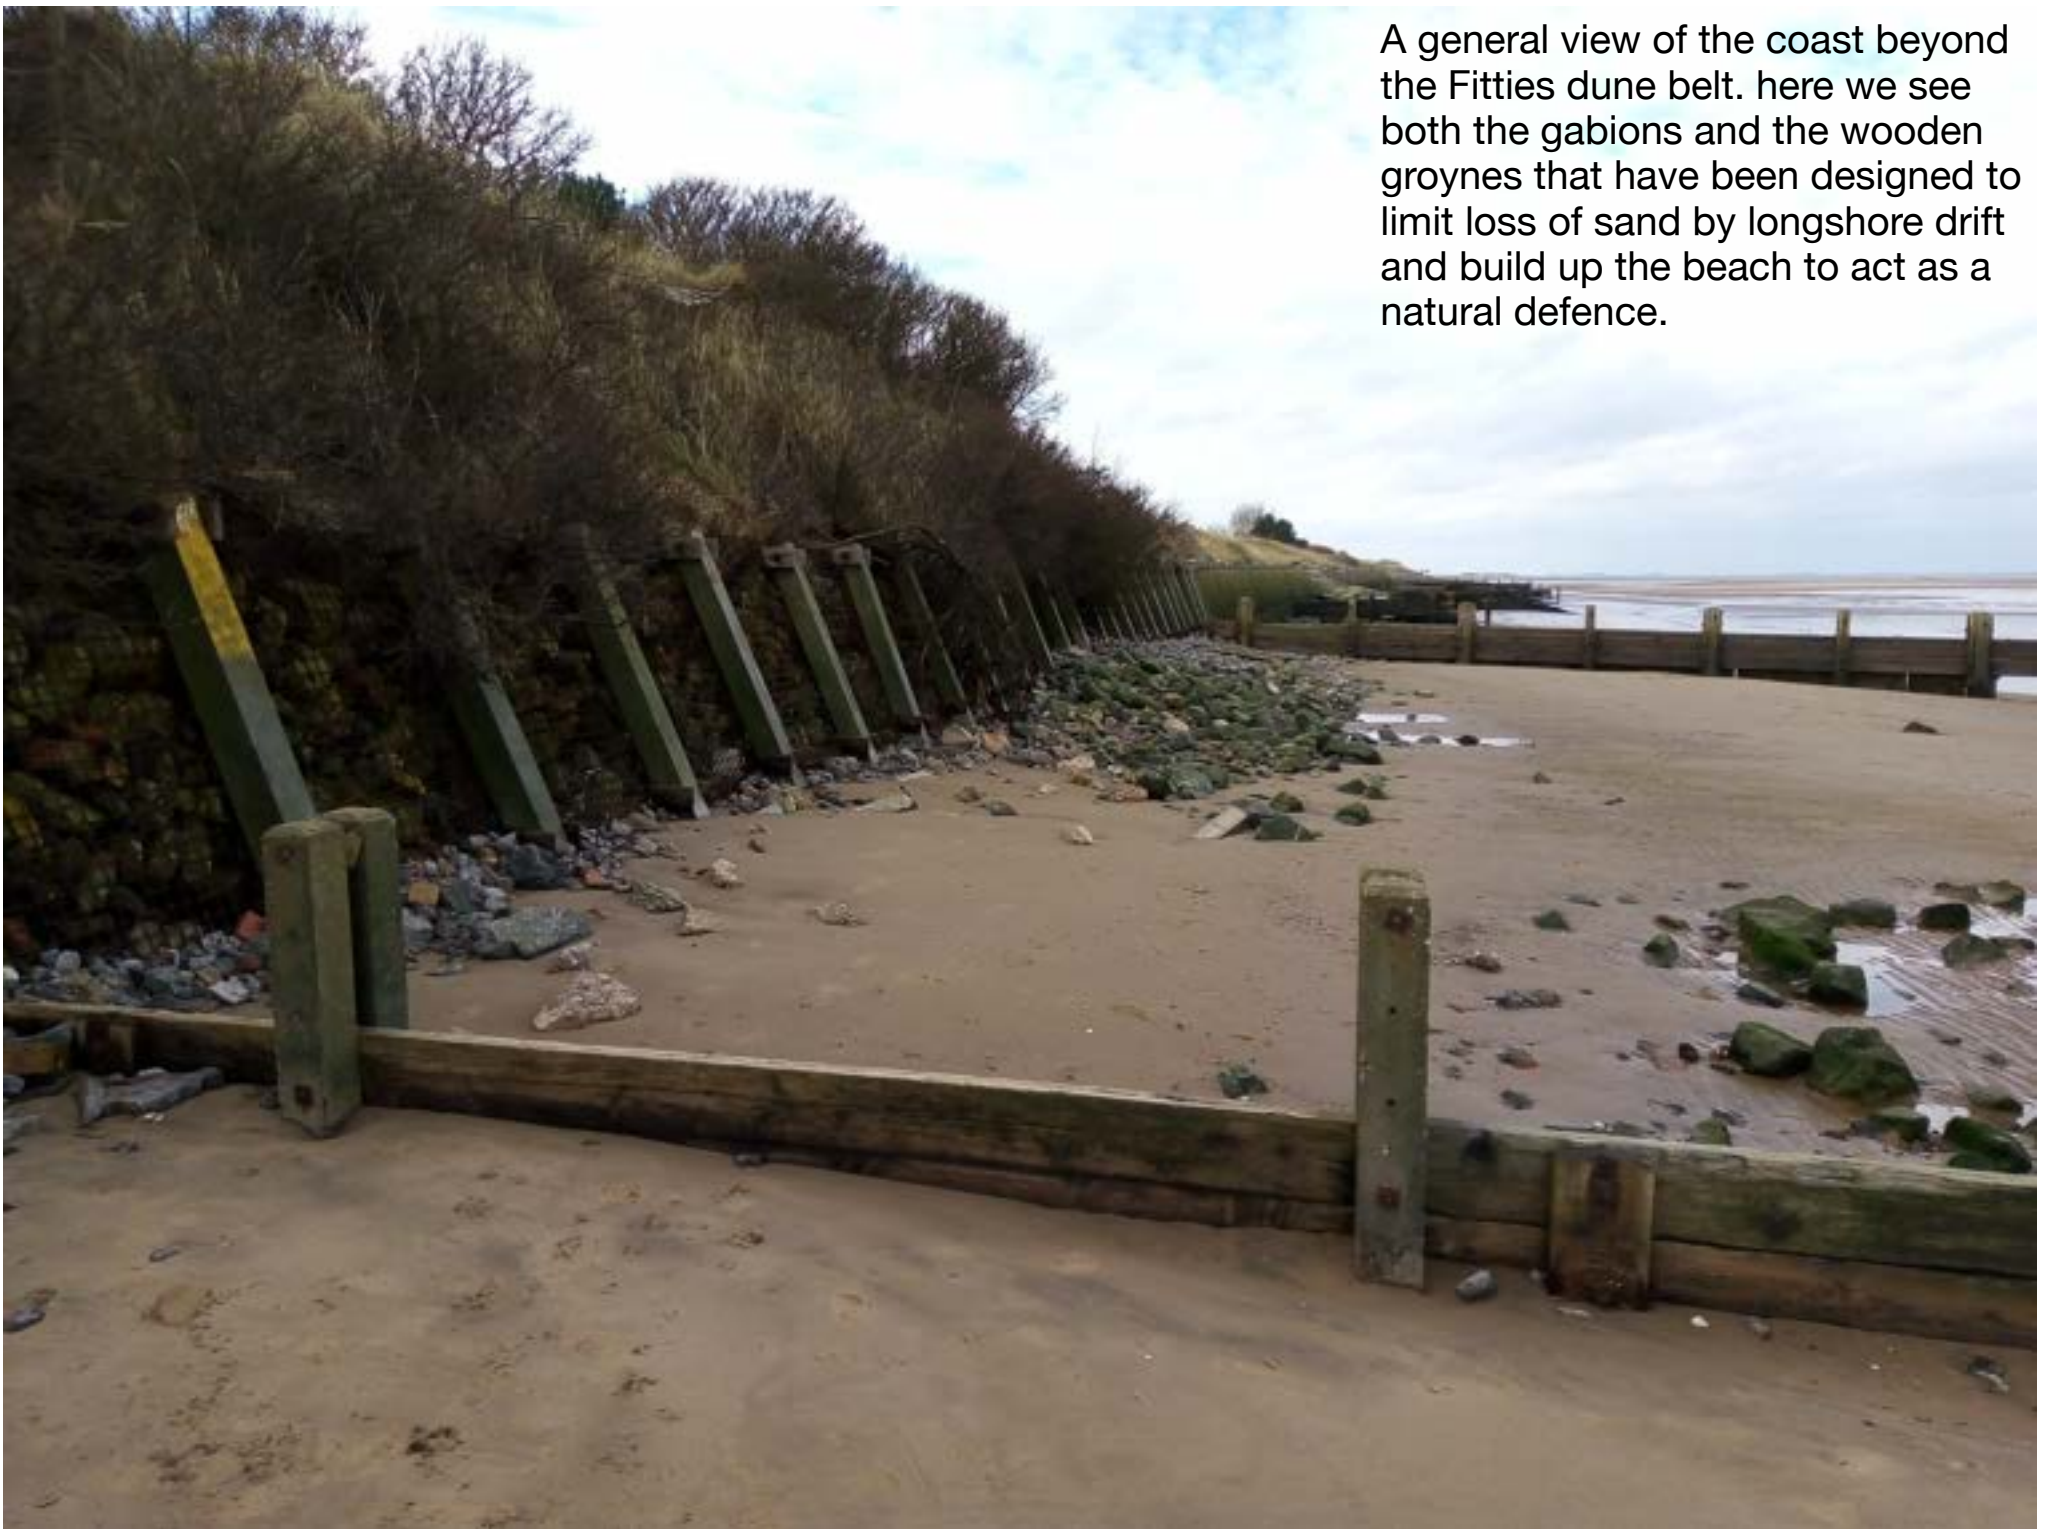
Immature sand dunes with limited vegetation and open, bare patches of sand that are not held in place and liable to be lost due to wind erosion and the formation of a blow-out, thus reducing the efficiency of the natural defence.

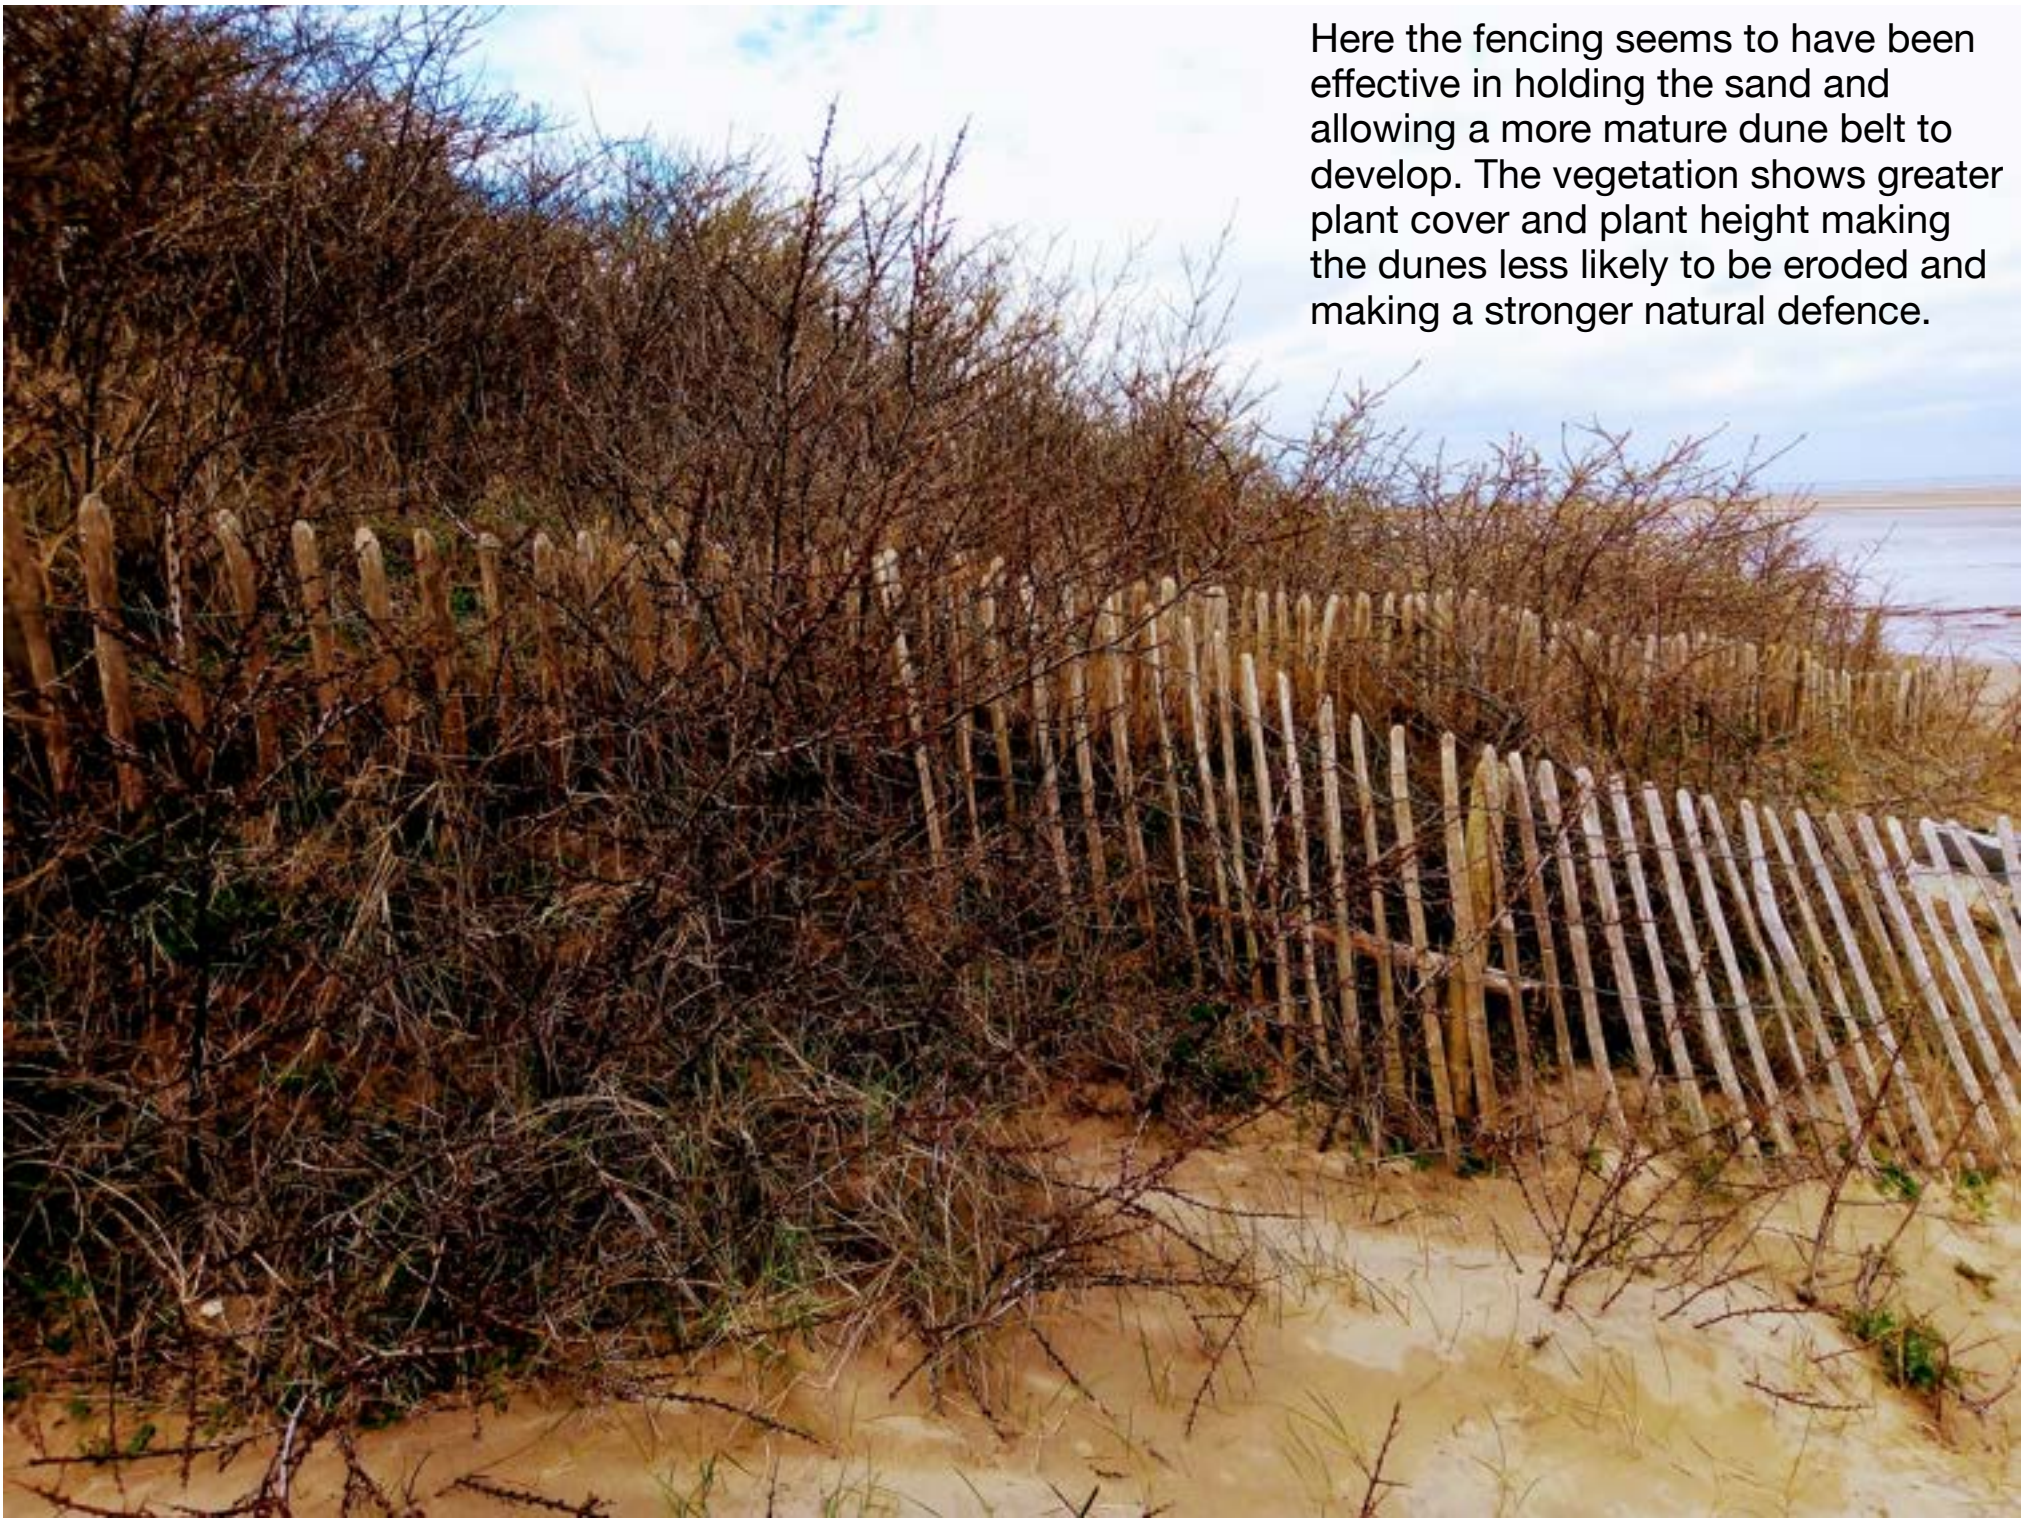
A view of a footpath through the dunes to allow access to the beach. Notice the extensive mudflats found beyond the beach at low tide out to the old fort built during WW1 to protect the estuary. Notice that footfall through the path prevents vegetation colonising the sand making it a weak point liable to erosion by wind and the formation of a blow-out.
